Jacob's Island Strategic Housing
Development, Co. Cork

Quality Audit

Document Ref:	P22-071-UQA-GEN-RP-001
----------------------	-------------------------------

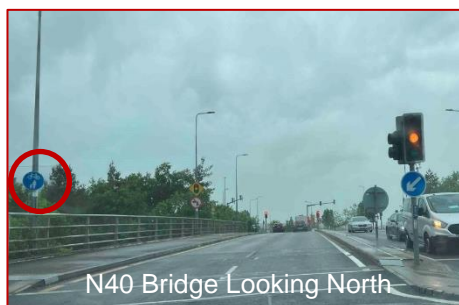
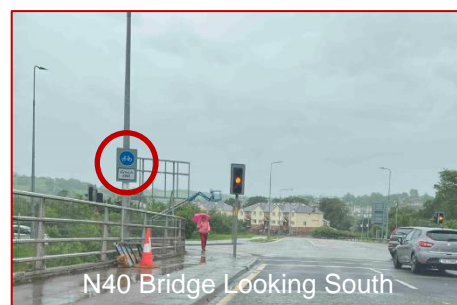
Existing cycle facilities are provided on the N40 bridge, with a shared use pedestrian/cycle path provided on both sides of the bridge. Both facilities lead to signalised pedestrian crossings on either side of the N40. These cycle facilities connect to a more comprehensive cycle network to the north of the N40, with dedicated off road cycle tracks and on-street cycle lanes provided on Mahon Link Road.

There are currently no cycle facilities to the south of the N40.
