Arborist Associates Ltd.

An Arboricultural Assessment of the Tree Vegetation on the Site Area at 'Jacob's Island', Cork, Co. Cork.

Prepared for: Hibernia Star Limited.

Date: 17th May 2022

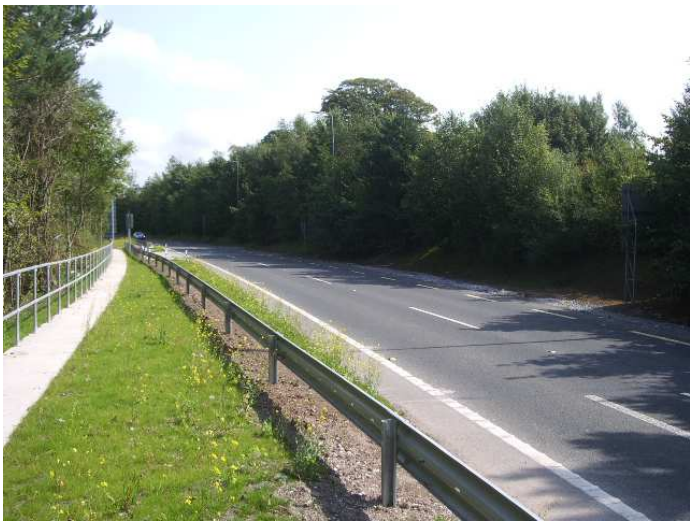
Tree No.	Tree Species	Ht. (m)	Stem Dia. (mm)	Branch Spread (m)				C-Ht. (m)	Age Class	Phys. Con.	Structural Condition Other Comments	Preliminary Recommendation	Remain Contribute in years	Cat. Grade
				N	S	E	W							
				N	S	E	W			N-north S-south E-east W- west Cat.- category Phys.-physiological	A- average Dia- diameter C-Ht.- crown height			
A Condition Assessment of the trees within the Site Area at 'Jacobs Island', Cork, Co. Cork.														
Tree Belt No.1	Pine <i>Pinus sp.</i> Lime <i>Tilia sp.</i> Birch <i>Betula pendula</i> Oak <i>Quercus sp.</i> Goat Willow <i>Salix caprea</i> Gorse <i>Ulex europaeus</i> Bramble <i>Rubus fruticosus</i>	A linear tree belt located along the boundary fence of the site area and the adjoining slip road off the Motorway. It would have initially been planted as a screen barrier as part of the road development works and consists of a mix of tree species including Pine, Lime, Oak and Birch. These are of a semi-mature age class and have established well and form a good screen barrier along the road. There is some Goat Willow establishing on the site side of the boundary fence with an undergrowth of Gorse and Bramble.									The management of this tree belt is taken to be located outside the site area. It would benefit from some selective thinning/management to reduce competition and to allow the better quality trees space to develop.	-	B2

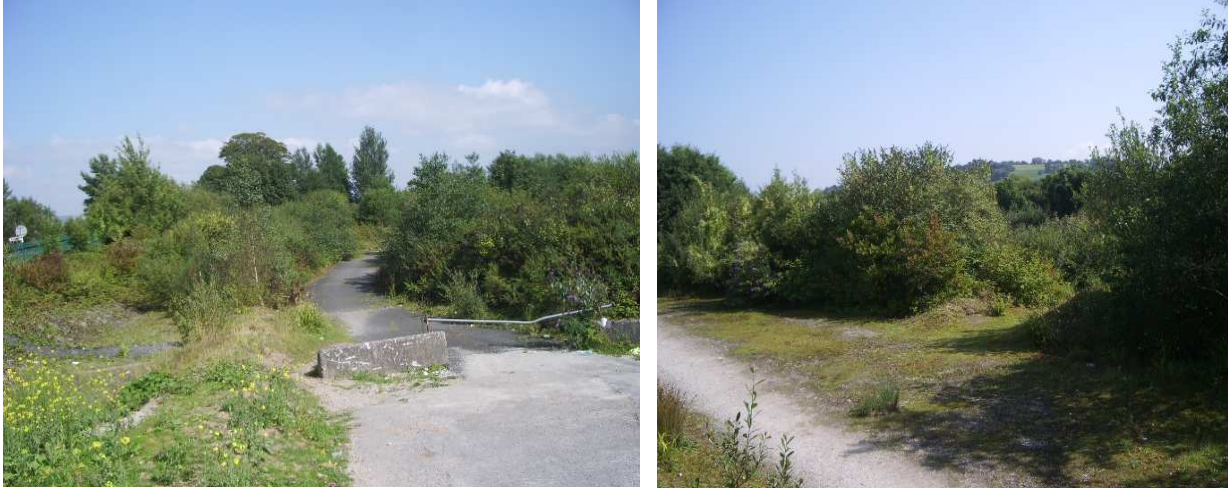
Tree No.	Tree Species	Ht. (m)	Stem Dia. (mm)	Branch Spread (m)				C-Ht. (m)	Age Class	Phys. Con.	Structural Condition Other Comments	Preliminary Recommendation	Remain Contribute in years	Cat. Grade
				N	S	E	W							
				N	S	E	W			N-north S-south E-east W- west Cat.- category Phys.-physiological	A- average Dia- diameter C-Ht.- crown height			
Scrub Area	Goat Willow <i>Salix caprea</i> Dogwood <i>Cornus alba</i> Dog Rose <i>Rosa canina</i> Buddleia <i>Buddleja davidii</i> Gorse <i>Ulex europaeus</i> Cherry <i>Prunus sp.</i> Alder <i>Alnus glutinosa</i> Elm <i>Ulmus sp.</i> Ash <i>Fraxinus excelsior</i> Sycamore <i>Acer pseudoplatanus</i> Oak <i>Quercus robur</i> Turkey Oak <i>Quercus cerris</i> Bramble <i>Rubus fruticosus</i> Seedlings	<p>It extends along the northern boundary of the site area. It consists predominately of a regeneration of Goat Willow, Dogwood, Dogrose, Bramble, Gorse, Buddleia, Cherry, Alder and Birch with Ash and Sycamore seedlings mixed throughout. The ground had previously been cleared of all vegetation and had been disturbed allowing for the development of this natural regeneration. There are some self-seeding Oak, predominately Turkey Oak developing up through the scrub.</p>

<p>The following trees are located within the scrub area inside the boundary railing.</p>												
0484	Flowering Cherry <i>Prunus avium</i>	10	220/ 110/	3	3	4	4	1	Early Mature	Fair/ Good	Fair Multiple-stemmed from base and forms	It would benefit from general tidying works around it to allow it space	20+	C2

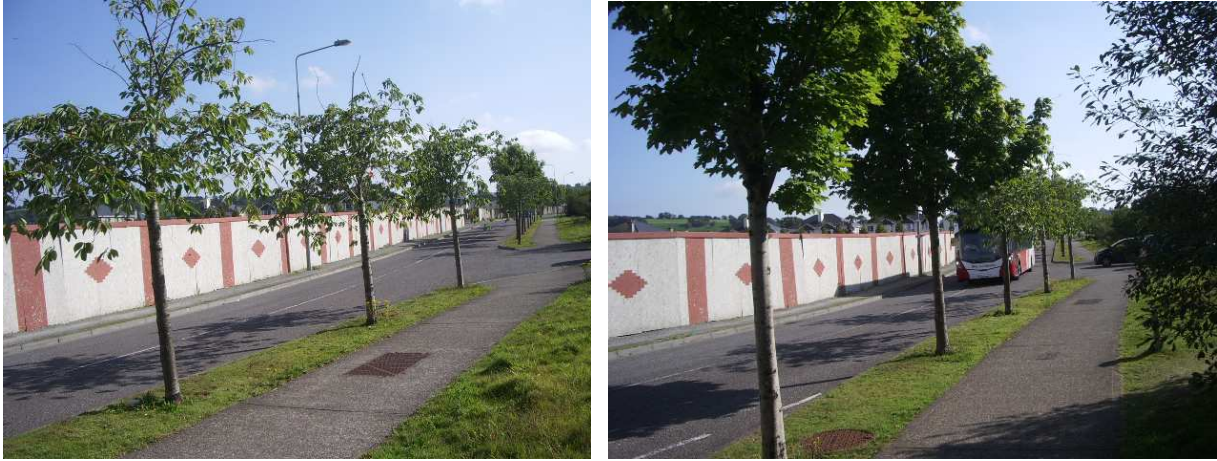
Tree No.	Tree Species	Ht. (m)	Stem Dia. (mm)	Branch Spread (m)				C-Ht. (m)	Age Class	Phys. Con.	Structural Condition Other Comments	Preliminary Recommendation	Remain Contribute in years	Cat. Grade														
				N	S	E	W																					
										N-north S-south E-east W- west Cat.- category Phys.-physiological	A- average Dia- diameter C-Ht.- crown height																	
										over the woodland canopy.																		
Tree Line No. 1	Norway Maple <i>Acer platanoides</i> Flowering Cherry <i>Prunus sp.</i> Rowan <i>Sorbus aucuparia</i>	<p>They are planted within a c.1.5m linear grass verge between the roadside kerb and the public footpath. They were planted at c.6m centres in short sections consisting of Norway Maple, Flowering Cherry and Rowan. They are of a semi-mature age class in fair condition both physiologically and structurally. The bulk of them are establishing well with some showing signs of decline throughout their crowns and are struggling to establish, others have suffered bark wounding on the lower trunks caused by the grass maintenance works. They have received pruning of their lower branches in order to raise up their crowns. Tree species, such as the Norway Maple and Cherry are known to have aggressive rooting systems and may be prone to causing structural damage to the surrounding surfaces, in particular the footpath. Some of the trees are also located within close proximity to the public lighting and may need to be removed as part of management in order to prevent the obstruction of public lighting.</p> <table border="1" data-bbox="430 801 1039 871"> <tr> <td>A</td> <td>A</td> <td>A</td> <td>A</td> <td>A</td> <td>A</td> <td>A</td> </tr> <tr> <td>6</td> <td>120</td> <td>2.5</td> <td>2.5</td> <td>2.5</td> <td>2.5</td> <td>2.2</td> </tr> </table>										A	A	A	A	A	A	A	6	120	2.5	2.5	2.5	2.5	2.2	<p>They will require ongoing maintenance in order to maintain clearance with the surrounding surfaces.</p> <p>They may require selective thinning to reduce density as they grow in size.</p>	10-20	C2
A	A	A	A	A	A	A																						
6	120	2.5	2.5	2.5	2.5	2.2

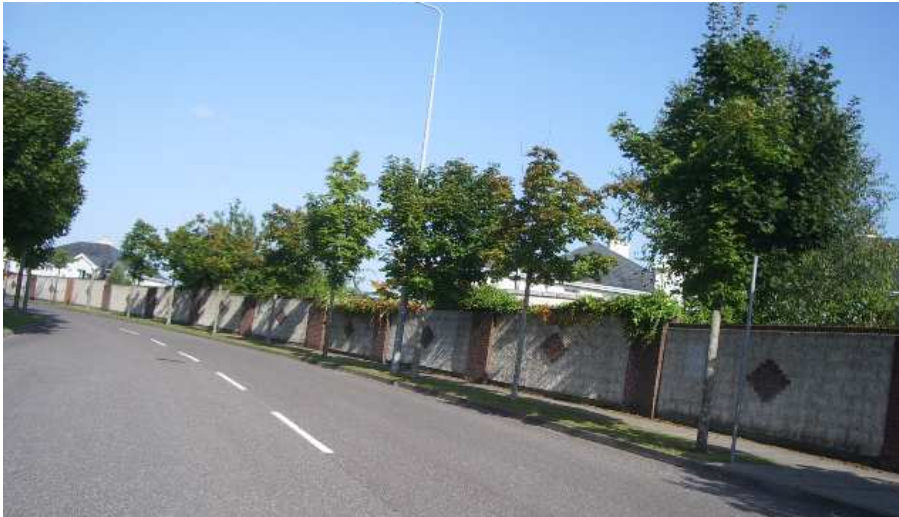
Tree No.	Tree Species	Ht. (m)	Stem Dia. (mm)	Branch Spread (m)				C-Ht. (m)	Age Class	Phys. Con.	Structural Condition Other Comments	Preliminary Recommendation	Remain Contribute in years	Cat. Grade																	
				N	S	E	W								N-north S-south E-east W- west Cat.- category Phys.-physiological																
Tree Line No.2	<p>Norway Maple <i>Acer platanoides</i></p> <p>Flowering Cherry <i>Prunus sp.</i></p> <p>Rowan <i>Sorbus aucuparia</i></p>	<p>They are located on the other side of the road and have been planted within a c.1.5m linear grass verge between the roadside kerb and the public footpath.</p> <p>They were planted at c.6m centres in short sections consisting of Norway Maple, Flowering Cherry and Rowan. They are of a semi-mature age class in fair condition both physiologically and structurally. The bulk of them are establishing well with some showing signs of decline throughout their crowns and are struggling to establish, others have suffered bark wounding on the lower trunks caused by the grass maintenance works. They have received pruning of their lower branches in order to raise up their crowns. Tree species, such as the Norway Maple and Cherry are known to have aggressive rooting systems and may be prone to causing structural damage to the surrounding surfaces, in particular the footpath. Some of the trees are also located within close proximity to the public lighting and may need to be removed as part of management in order to prevent the obstruction of public lighting. The top has either broken out or was removed from one tree leaving a tall stump.</p>										10-20	C2																		
		<table border="1"> <tr> <td>A</td> <td>A</td> <td>A</td> <td>A</td> <td>A</td> <td>A</td> <td>A</td> </tr> <tr> <td>6</td> <td>120</td> <td>2.5</td> <td>2.5</td> <td>2.5</td> <td>2.5</td> <td>2.2</td> </tr> </table>							A	A	A	A	A	A	A	6	120	2.5	2.5	2.5	2.5	2.2									
A	A	A	A	A	A	A																									
6	120	2.5	2.5	2.5	2.5	2.2
