Appendix A14.1: Scheme Walkover Summary

1.1 Introduction

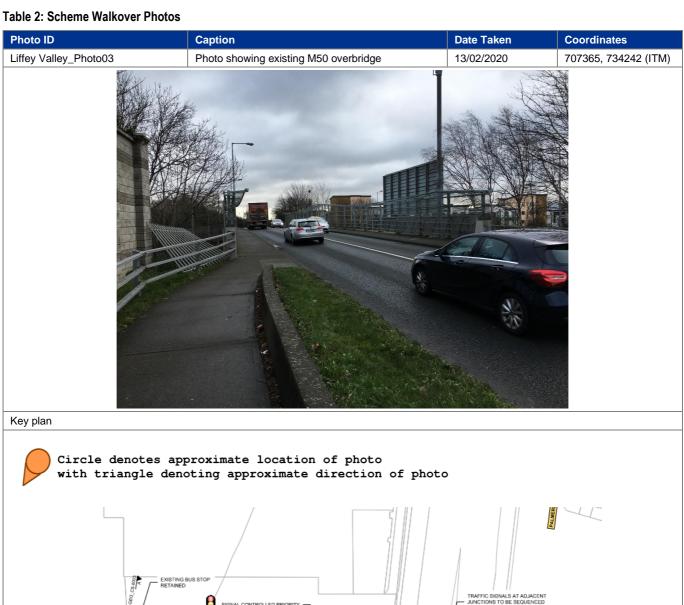
Observation	General Arrangement Drawing Sheet Number	Description	Possible Impact	Photo Number
M50 Overbridge	Sheet 5	The Proposed Scheme has highlighted land acquisition at this location. It may result in minor level changes to accommodate the works. If the bridge is to be widened significant earthworks may be required along with slope mitigation measures. No outcropping rock was noted during the walkover on the overpass route.	This may pose an issue for the earthworks balance and waste assessment and mobilising contaminants into the groundwater.	Liffey Valley_Photo03
Coldcut Road	Sheet 6	The Proposed Scheme has identified road widening on both sides of the road. A minor gradient was noted in the wooded area and walls will need to be removed to accommodate the works. Fly tipping was noted in an adjacent wooded area.	This may pose an issue for the earthworks balance and waste assessment	Liffey Valley_Photo04

Photo ID	Caption	Date Taken	Coordinates
Liffey Valley_Photo04	Photo showing fly tipping and vegetated road margin	13/02/2020	707521, 734223 (ITM)

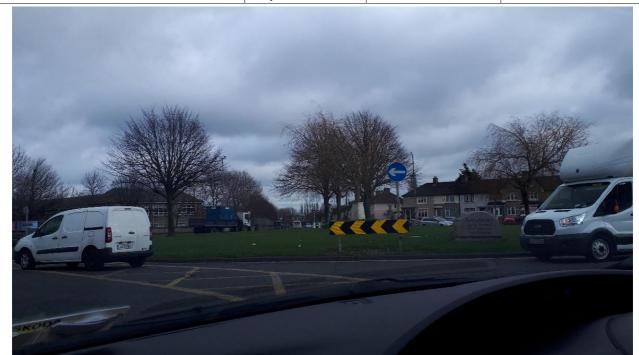
Ballyfermot Road	Sheet 7	The Proposed Scheme has highlighted land acquisition at this location. A level difference was noted between the carriageway and neighboring units.	This may pose an issue for the earthworks balance and waste assessment	Liffey Valley_Photo05
Upgrade existing roundabout to signalised junction	Sheet 13	The Proposed Scheme has highlighted major works at this location. Level changes were noted across the area, including a raised roundabout, the composition of which could be made ground.	This may pose an issue for the earthworks balance and waste assessment.	Liffey Valley_Photo10
Potential land acquisition along the Ballyfermot Road	Sheet 15	The Proposed Scheme has highlighted potential land acquisition at this location. It may result in the removal of retaining walls on both sides of the carriageway, along with notable level changes.	This may pose an issue for the earthworks balance and waste assessment.	Liffey Valley_Photo12

Photo ID	Caption	Date Taken	Coordinates
	Liffey_Valley_Photo12	Showing carriageway along the Ballyfermot Road, retaining wall either side of the carriageway	13/02/2020	710390, 733688 (ITM)
			A TOWN TO THE REAL PROPERTY OF THE PARTY OF
