An Arboricultural Assessment of the Tree Vegetation on Lands at 'Baltrasna and Milltown, Ashbourne, Co. Meath.

Prepared for: Arnub Ltd. & Aspect Homes (ADC) Ltd.

**Prepared by: Felim Sheridan F. Arbor. A, RFS Dip, Nat. Dip & NCH in
Arboriculture**

Date: 26th August 2022

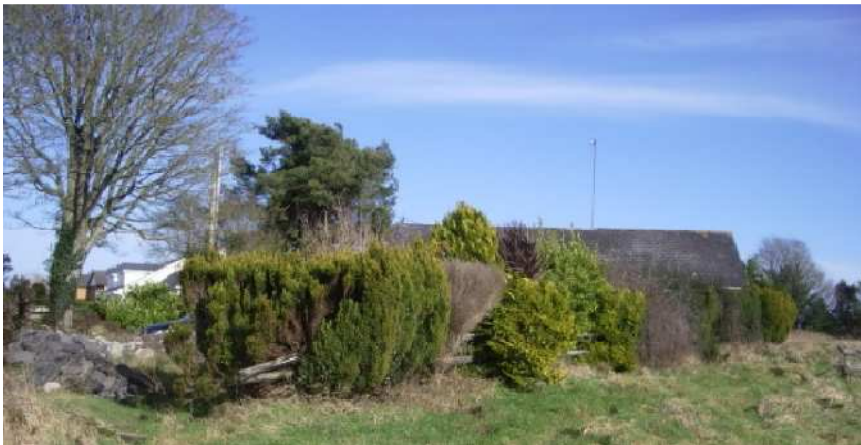
Hedge No.3A	Cherry Laurel <i>Prunus laurocerasus</i> Purple Plum <i>Prunus cerasifera 'Nigra'</i> Privet <i>Ligustrum vulgare</i> Bramble <i>Rubus fruticosus</i> Ornamental Shrubs	<p>It runs at ninety degrees to Hedge No.1 and extends in an east to west direction on the southern side of Cherry Lane.</p> <p>It is of a mature age class in fair/ poor condition physiologically and structurally. The first section forms the boundary with a private residence and consists of Cherry Laurel, Purple Plum, Privet and other ornamental shrubs. Scrub, such as Bramble, is dominating some areas. It has been trimmed on the roadside and has been allowed to grow wider on the inside. The western end of this hedge is made up of Leyland Cypress which has been trimmed into a hedge.</p> <table border="1" data-bbox="398 1137 813 1257"> <thead> <tr> <th>Average Height</th> <th>Average Width</th> </tr> </thead> <tbody> <tr> <td>2m</td> <td>3m</td> </tr> </tbody> </table>									Average Height	Average Width	2m	3m	It would benefit from some general tidying works/ trimming in order to contain the scrub development and maintain as a more structured hedge.	-	C2
Average Height	Average Width																
2m	3m

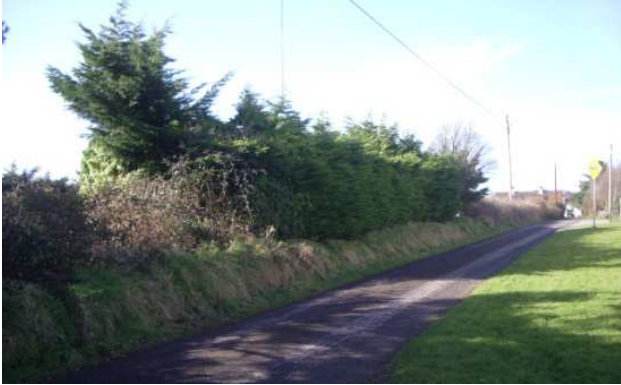
Average Height	Average Width													
2m	3m													
Hedge No. 4	Bramble <i>Rubus fruticosus</i> Ash <i>Fraxinus excelsior</i> Elder <i>Sambucus nigra</i>	It runs between Hedge Nos. 3 & 2 and has been planted to cordon off the sheds from the rear garden of the house. It is of a mature age class in fair/ poor condition physiologically and in poor condition structurally. It was initially planted as a Leyland Cypress hedge, which has since died and is being suppressed out by Bramble, seedling Ash and scrub Elder. It has some value for screening off the sheds.									It would benefit from further management.	-	C2

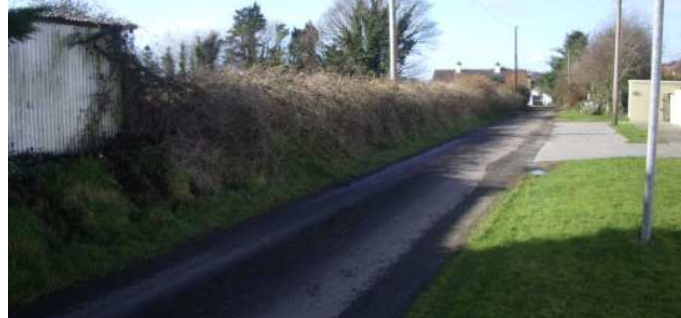
Hedge No. 5	Bramble <i>Rubus fruticosus</i> Fuchsia <i>Fuchsia magellanica</i> Lonicera <i>Lonicera nitida</i>	<p>It extends on from Hedge No. 3B and forms the boundary between the laneway and the adjoining field. It is of a mature age class in fair/ poor condition physiologically and in poor condition structurally. It consists of predominately Bramble with some Fuchsia throughout and Lonicera at the western end. It is growing on a soil bank and has received some trimming on the laneway side and has been allowed to grow wild and out on the field side.</p> <table border="1" data-bbox="392 922 813 1042"> <thead> <tr> <th>Average Height</th> <th>Average Width</th> </tr> </thead> <tbody> <tr> <td>2m</td> <td>4m</td> </tr> </tbody> </table>								Average Height	Average Width	2m	4m	It would benefit from further trimming/ tidying works.	-	C2
Average Height	Average Width															
2m	4m

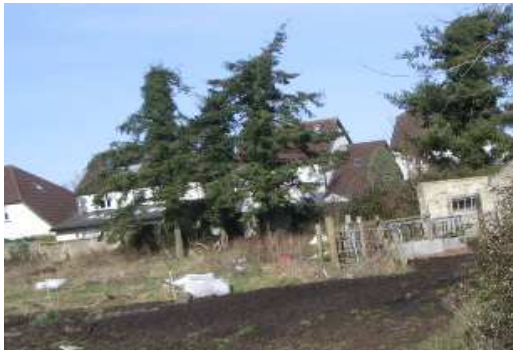
Hedge No. 9	Elder <i>Sambucus nigra</i> Dogrose <i>Rosa canina</i> Hawthorn <i>Crataegus monogyna</i> Bramble	It runs at ninety degrees to Hedge No. 8. It extends in a north-south direction and forms the boundary between two fields. It is of a mature age class in fair/ poor condition both physiologically structurally. The main hedge line would appear to be located on the east side of a wet drainage ditch. It consists predominately of Hawthorn and Elder with Bramble and Dogrose dominating the lower vegetation and encroaching out onto the lands, creating a broader, scrubby hedge in places as a result. It has not received any maintenance and has been allowed to grow up tall with some sections becoming top-heavy and being suppressed by Ivy, leaving it more prone to storm damage. The livestock is being									Reduce down to a c.1.5m height as part of the rejuvenation of the hedge. Cut Ivy where it is heavy and trim in all encroaching hedge species to create a tidy, more compact hedge and to encourage lower		C2

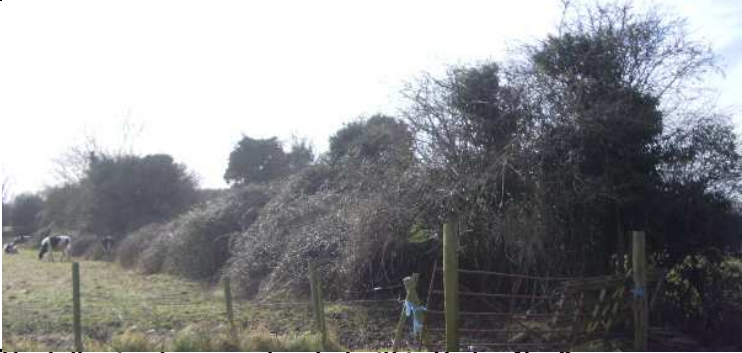
<p>The following trees are located within Hedge No. 9.</p>											
Average Height	Average Width																		
7m	7m																		
0425	Ash <i>Fraxinus excelsior</i>	11	200 (6 stems)	4	3	5	4	1	Early Mature	Fair	Fair It is multiple-stemmed from base from where it was cut/ coppiced into the hedge during past management. There are some decay wounds at the old stumps and acute union formations between some stems. It forms part of the higher bulking within this hedge.	Retain as part of the hedge bulking.	10-20	C1					
0426	Ash <i>Fraxinus excelsior</i>	11	200/ 200	3	4	3	3	3	Early Mature	Fair	Fair It forms a twin-stemmed tree from base with an acute union formation between stems with some included bark present and this may develop into a structural weakness. It is establishing up over the height of the	Retain as part of the hedge bulking at the present time.	20+	C1

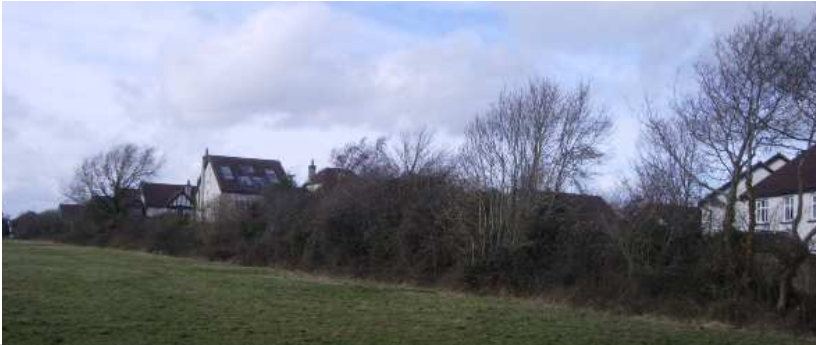
<p>The following trees are located within Hedge No. 10.</p>															
0427-0428	Oak <i>Quercus robur</i> (4 trees in total)	A 10	A 300	A 3	A 3	A 3	A 3	A 3	Early Mature	Fair	Fair They are located on the adjoining property side of the boundary drainage ditch. The bulk of them are multiple-stemmed from base. They have received pruning to raise up their crowns and to reduce their	They require no immediate attention at the present time.	20+	B2

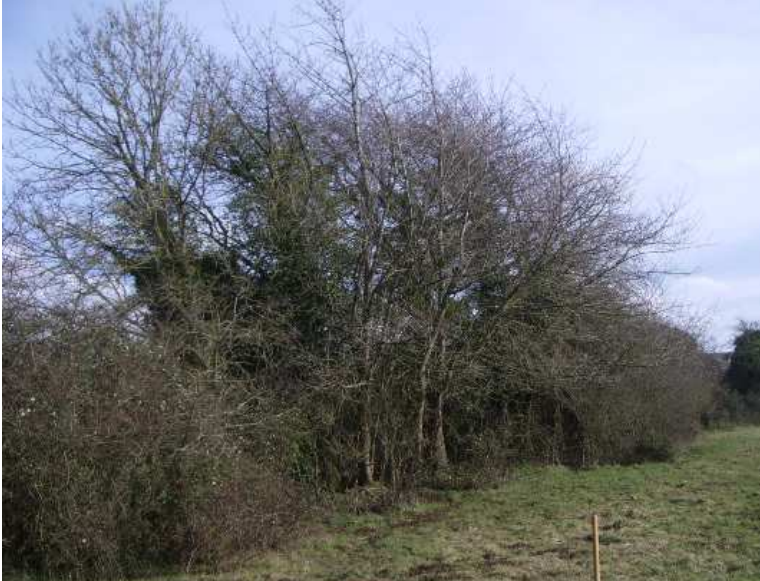
<p>The following trees are located within Hedge No. 13.</p>												
0440-0446	Flowering Cherry <i>Prunus avium</i> Ash <i>Fraxinus excelsior</i> (0440)	A 12	A 260	A 2	A 3	A 2	A 5	A 2	Early Mature/ Mature	Fair	Fair It consists of a group of Flowering Cherry trees with one Ash tree. They are growing on the hedgerow bank on the west side of the drainage ditch. They have established over the height of the hedge and form part of the one group/ canopy formation and provide support/ shelter to one another. Some soil erosion and compaction has been caused by the livestock sheltering/ grazing within this area. The Ivy cover on some trees is becoming heavy.	Make safe all large size dead/ unstable growth. Cut Ivy at ground level where it is heavy on trees. They should be maintained / managed as part of the one group structure.	20+	B2

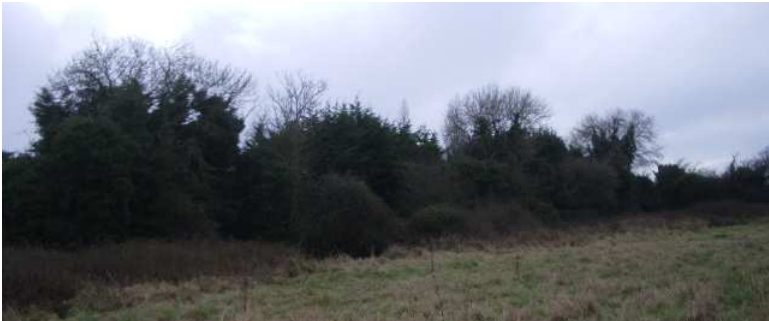
Hedge No. 16A	Dogrose <i>Rosa canina</i> Bramble	It runs at ninety degrees to Hedge Nos. 14 & 15 in a north-south direction and connects up with Hedge No.6. It forms the boundary between the fields within the site area.									It would benefit from general tidying works.	-	C2

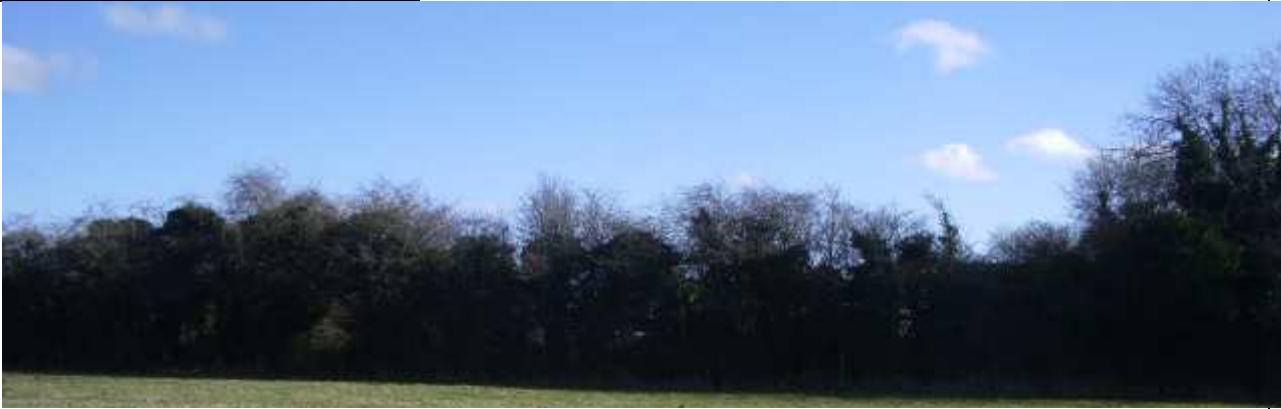
Hedge No.17	<p>Dogrose <i>Rosa canina</i> Hawthorn <i>Crataegus monogyna</i> Bramble</p>	<p>It runs at ninety degrees to Hedge No. 16B & Tree Line No.1. It runs in an east to west direction and forms the boundary between two fields.</p> <p>It is of a mature age class in fair condition both physiologically and structurally. It consists of Hawthorn, Blackthorn, Bramble and Dogrose. The main hedge line would appear to be located on the north side of a dry shallow drainage ditch. It is growing on a soil bank and has been allowed to grow up tall with scrub species, in particular Bramble,</p>									<p>Make safe large size dead/ unstable growth.</p> <p>Cut Ivy where it is heavy.</p> <p>It would benefit from the</p>	-	C2

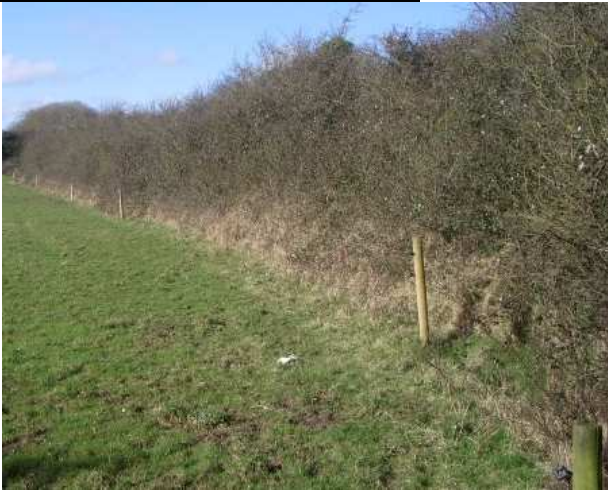
Hedge No. 16B	Dogrose <i>Rosa canina</i> Hawthorn <i>Crataegus monogyna</i> Bramble <i>Rubus fruticosus</i> Blackthorn <i>Prunus spinosa</i>	It extends southwards from Hedge No. 16A and it extends along the boundary between the site lands and the adjoining fields to the east. It is of a mature age class in fair condition physiologically and structurally. It consists of Hawthorn with Bramble and Dogrose dominating the lower vegetation. The main hedge line is located on a hedgerow bank with no defined boundary ditch. It has been trimmed on both sides in order to contain its width and it has been allowed to grow up tall. Heavy Ivy cover is suppressing some sections. The sides have been kept trimmed which has helped contain the spread of the hedge.										It would benefit from general tidying works. Cut Ivy at ground level where heavy on hedge plants.	-	C2

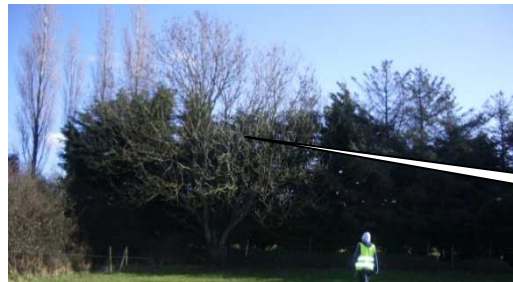
0453	Ash <i>Fraxinus</i>	11	1000	6	5	5	5	2	Early Mature	Fair/ Good	Fair It is located on the site side of the boundary fence	Requires no work at the present time.	20+	B1

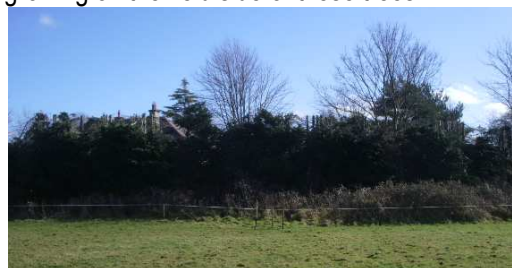
Tree Line No. 2	Leyland Cypress × <i>Cuprocyparis leylandii</i>	A 8	A 300	3	3	3	3	0	Mature	Fair	Fair It extends in a north to south direction and is located on the east boundary of the site area on the adjoining garden side of the boundary fence line. It is cordoned off from the site area by a shallow drainage ditch. Their height has been reduced in the past in order to contain size and this has impacted on their visual appearance to some degree. They have some value for screening within this area. Scrub Bramble is growing on the field side of these trees.	Trim in encroaching hedge species to tidy up this area.	20+	C2

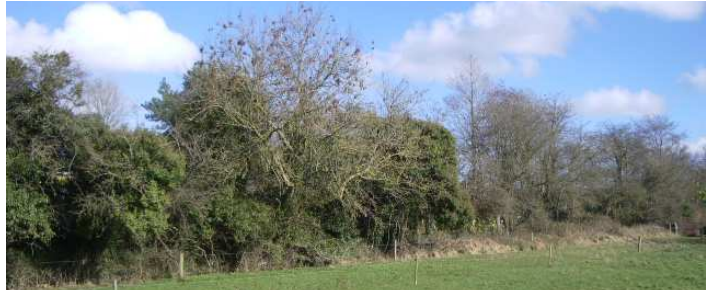
<p>The following trees are located within Hedge No. 18A.</p>									Average Height	Average Width	6m	5m	<p>It would benefit from further general tidying works on the site side and trimming in encroaching hedge species.</p> <p>Cut down to c.1.5m in height the poorly structured sections of Hawthorn that are top-heavy and prone to storm damage.</p> <p>Carry out infill planting in order to bulk up this hedge.</p>	-	C2
Average Height	Average Width																
6m	5m																
0455	Ash <i>Fraxinus excelsior</i>	13	200/ 300	3	6	6	6	3	Early Mature	Fair	Fair It is growing on the hedgerow bank and is beginning to be suppressed by Ivy. It has been forced out for the light to the south due to overcrowding / competition from the hedge. There is a secondary stem developing from its base.	Cut Ivy at ground level at the present time. Retain as part hedge bulking.	20+	C1

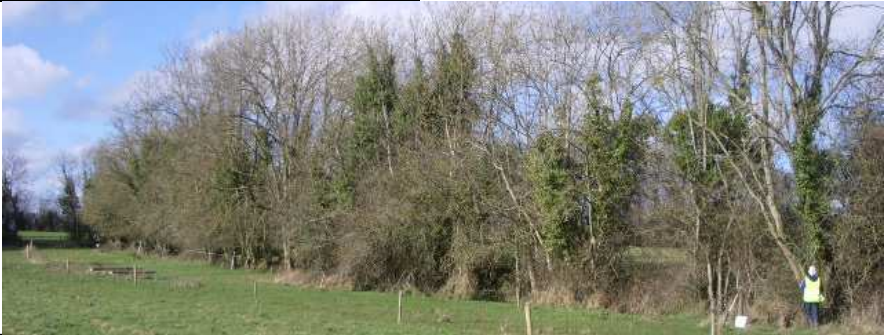
The following trees are located within Hedge No. 18B.															
0457-0462	Ash <i>Fraxinus</i>	A 14	A	A	A	A	A	A	Early Mature	Fair	Fair They form part of the hedge bulking and tower over	Make safe any large size dead/ unstable growth.	20+	B2

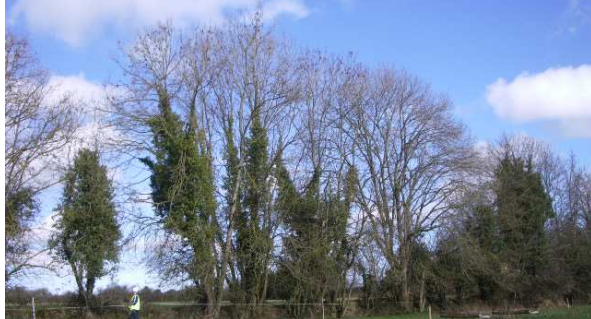
0468	Ash <i>Fraxinus excelsior</i>	A 15	A 130	A 2	A 5	A 1	A 2	A 3	Early Mature	Fair	Fair It is multiple-stemmed from base and forms part of the hedge bulking. Heavy Ivy cover on the main stems is beginning to extend up into its crown. There is a lot of soil erosion around its base.	Cut Ivy at ground level at the present time.	20+	C2
0469 & 0470	Ash <i>Fraxinus excelsior</i>	A 14	200 x 6	A 5	A 6	A 4	A 4	A 3	Mature	Fair/ Good	Fair They are growing on the hedge line and are multiple-stemmed from base with an acute union formation between some stems. They are growing up together forming part of the one group canopy formation. As a group, they are of more prominence/ value within the treescape of this area rather than as individual trees. Heavy Ivy cover on some stems is beginning to extend up its crown.	Make safe large size dead/ unstable growth. Cut Ivy at ground level where heavy on trees.	20+	B2

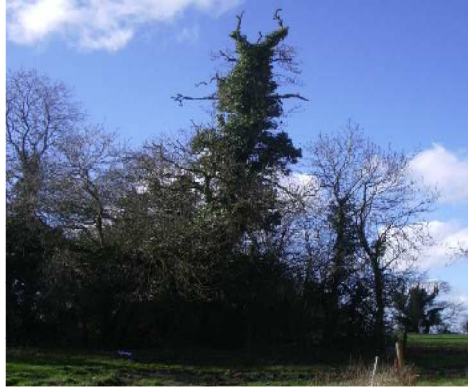
0473-0506	Ash <i>Fraxinus excelsior</i> Flowering Cherry <i>Prunus avium</i> (1)	A 11	A 180	A 2	A 2	A 4	A 4	A 3	Early Mature / Mature	Fair	Fair It is a prominent line of trees growing up within Hedge No. 19. The bulk of these trees are multiple-stemmed from base and have been cut/ coppiced into the hedge during past management, but have since been allowed to grow up into a tree line. Tree Nos. 0481, 0485-0487, 0491-0941, 0497, 0498, 0501 & 0504 are located on the west side of the drainage ditch with the remaining trees located on the eastern side of the drainage ditch. Tree No. 0489 has basal decay present and is structurally weak. It will require pruning to address structural issues and this is likely to create an opening within the group canopy structure. Tree No. 0498 has had a section removed in the past.	Make safe large size dead/ unstable growth.	20+	B2

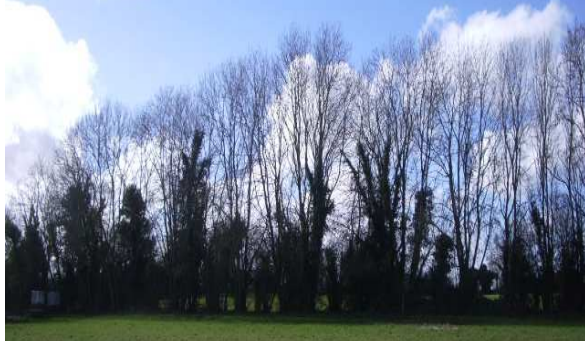
0507 & 0508	Ash <i>Fraxinus excelsior</i>	A 11	A 180	A 2	A 2	A 4	A 4	A 3	Mature	Fair	Fair They are growing up together forming part of the one group canopy formation. They are both multiple-stemmed from base and are of prominence as a group of trees. There is Ivy cover on some stems.	Make safe dead/ unstable growth.	20+	B2

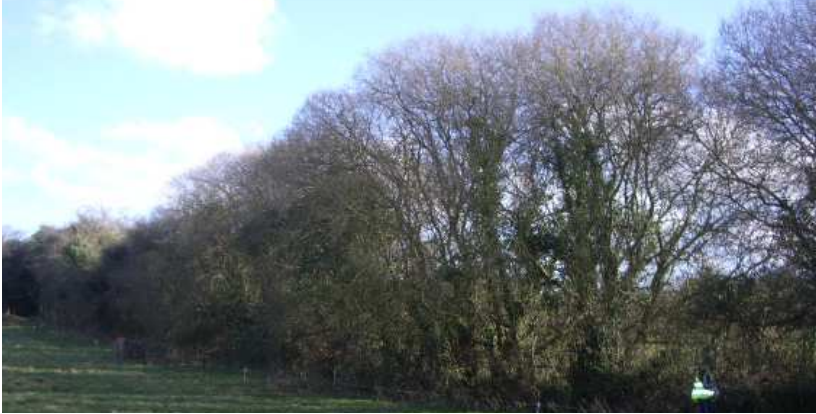
<p>The following trees are located within Hedge No. 20.</p>												
0514 – 0520	Goat Willow <i>Salix caprea</i>	A 9	A 440	A 5	A 5	A 4	A 3	A 1	Mature	Fair	Fair They are growing up together as a tree line at close spacing to one another and form part of the one continuous canopy line and as a combined group canopy formation they provide support/ shelter to one another. Their lower branches have been pruned back in the past. Some stems are beginning to be suppressed by Ivy. This species is prone to failure either partially or from the root plate.	Make safe any large size dead/ unstable growth. Cut Ivy at ground level where it is heavy.	10-20	C2

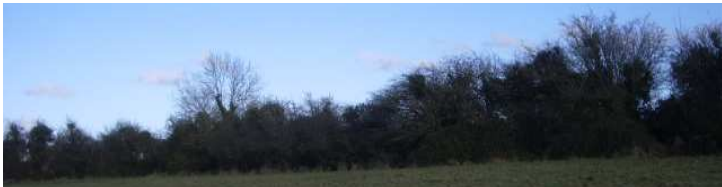
<p>The following tree is located within Hedge No. 21.</p>											Average Height	Average Width	5m	7m	species.		
Average Height	Average Width																		
5m	7m																		
0522	Ash <i>Fraxinus excelsior</i>	11	320	4	3	4	4	3	Early Mature	Fair/ Good	Fair/ Good It is beginning to establish over the height of the hedge. It is a good quality tree with Ivy cover on the main trunk beginning to extend up into its crown.	Cut Ivy at ground level and cut back the hedge in order to expose this tree.	40+	B 1					
Hedge No. 22A	Dogrose <i>Rosa canina</i> Hawthorn <i>Crataegus monogyna</i> Bramble	<p>It runs at ninety degrees to Hedge No. 12 and extends to Hedge No. 20.</p> <p>It is of a mature age class in fair condition physiologically and fair/ poor condition structurally. It consists of Hawthorn, Blackthorn, Bramble and Dogrose with Ash forming part of the upper canopy formation. The main hedge line is located on the adjoining landside (west) of the drainage ditch. It has been allowed to grow up tall and has lost sections of hedge due to being top-heavy and being suppressed by Ivy. It is located on the west side of a deep, wet, wide</p>											Management of this hedge is taken to be outside the control of this site area. It would benefit from being cut down to a height of	-	C2

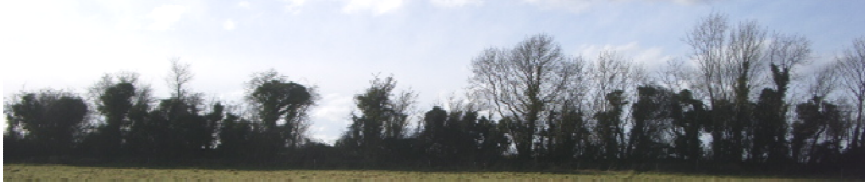
<p>The following trees are located within Hedge No.22A. (The assessment of the trees within is from the site side of the drainage ditch and is limited to what was visible from this side only.)</p>									Average Height	Average Width	6m	7m	C.1.5m to allow it to thicken up in order to improve its structure.		
Average Height	Average Width																
6m	7m																
Tree Group No. 1	Ash <i>Fraxinus excelsior</i>	A 11	200 (3 stems)	4	4	4	4	3	Early Mature/ Mature	Fair	Fair They are located on the adjoining landside (west side) of a deep wet drainage ditch. It consists of a group of stems growing loosely together to form part of the one group/ canopy formation. The bulk of them are multiple-stemmed from base and have been cut/ coppiced into the hedge during past management. Some trees are being suppressed by Ivy. Collectively, they are of more visual value rather than as individual trees.	They are best maintained/ managed as a group.	20+	C2			
Tree No.1	Ash <i>Fraxinus excelsior</i>	12	220/ 290	3	2	2	4	4	Early Mature	Fair	Fair / Poor It is located within hedge No. 22 and is cordoned off from the site area by the wet drainage ditch with no	Retain as part of the bulking within the hedge.	10-20	C1

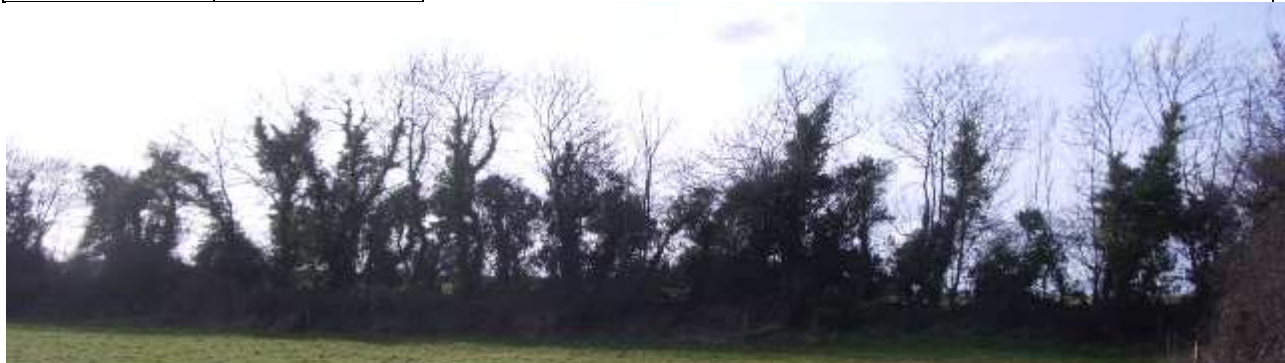
Tree Group No. 3	Ash <i>Fraxinus excelsior</i>	14	220/ 220	3	3	4	4	3	Mature	Fair	Fair It is located within the south-western corner of the site area. It consists of a group of stems growing on the hedgerow bank on the west side of the wide, deep, wet drainage ditch and, as a result, access was not possible to attach a reference tag. They are growing on a deep soil bank and are growing up together forming part of the one tree group. They are of more visual value as a group rather than as individual trees. The bulk of them are multiple-stemmed from base with heavy lvy cover on the main stems extending up into their crowns.	Make safe large size dead/ unstable growth. Cut lvy at ground level.	10-20	C2
		The following trees are located on the site side of Tree Group No. 3.												
0523 - 0524	Ash <i>Fraxinus excelsior</i>	A 17	A 700	A 8	A 7	A 8	A 5	A 4	Early Mature	Fair	Fair/ Poor They are located on the site side of the drainage ditch and form part of the overall group canopy formation within Tree Group No.3. They have asymmetrical crowns weighed out to the east due to competition. They are multiple-stemmed from base and are self-	Retain as part of the bulking at the present time. They may need to be removed in the future as part of management of the	10+	C2

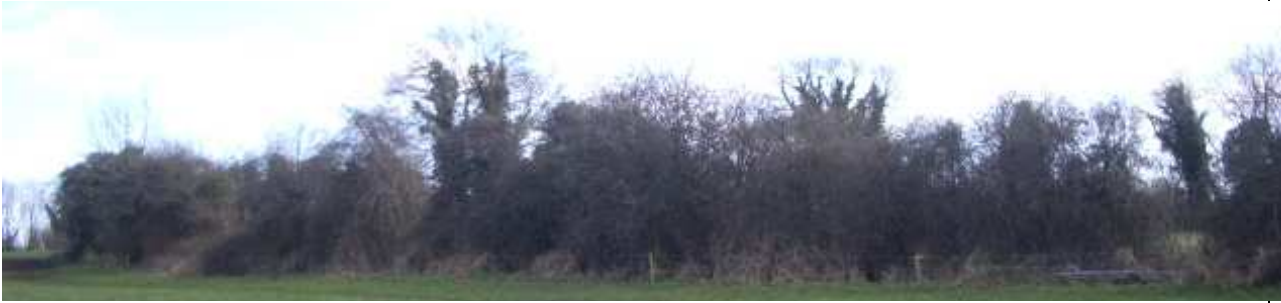
<table border="1" data-bbox="398 1061 817 1181"> <thead> <tr> <th>Average Height</th> <th>Average Width</th> </tr> </thead> <tbody> <tr> <td>5m</td> <td>5m</td> </tr> </tbody> </table> <p>The following trees are located within Hedge No. 23.</p>										Average Height	Average Width	5m	5m	<p>Cut back all encroaching hedge species in order to contain its width. Make safe large size dead/ unstable growth and cut back poorly structured sections of hedge. Cut Ivy at ground level where it is heavy.</p>	-	C2
Average Height	Average Width																	
5m	5m																	
0525	Ash <i>Fraxinus excelsior</i>	17	700	8	7	8	5	4	Mature	Fair	Poor It forms a twin-stemmed tree from a height of c.2m up with an acute union formation between stems with included bark present. It has split at this point and it	I would recommend its removal as the most appropriate management option.	<10	U

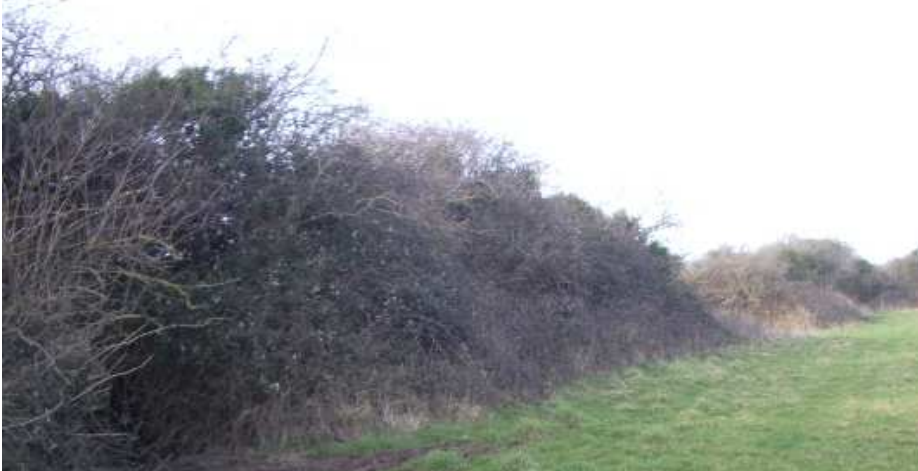
Average Height		Average Width										
		5m		9m										
Hedge No. 24B	<p>Elder <i>Sambucus nigra</i></p> <p>Dogrose <i>Rosa canina</i></p> <p>Hawthorn <i>Crataegus monogyna</i></p> <p>Bramble <i>Rubus fruticosus</i></p> <p>Blackthorn <i>Prunus spinosa</i></p> <p>Ash <i>Fraxinus excelsior</i></p>	<p>It extends southwards from Hedge No. 24A at ninety degrees to Hedge No. 23 and forms part of the western site boundary.</p> <p>It is of a mature age class in fair condition physiologically and fair/ poor condition structurally. It consists of Hawthorn and Blackthorn with some Elder. Bramble and Dogrose dominate the lower vegetation and encroach out onto the site area. The main hedgerow line is located on the west side of a shallow, dry, drainage ditch. Due to lapsed management, this hedge has been allowed to grow up tall with hedge species; in particular Bramble and Blackthorn in some places have been allowed to encroach out creating a broader hedge.</p>									Trim in encroaching hedge species and make safe large size dead/ unstable growth.	-	C2

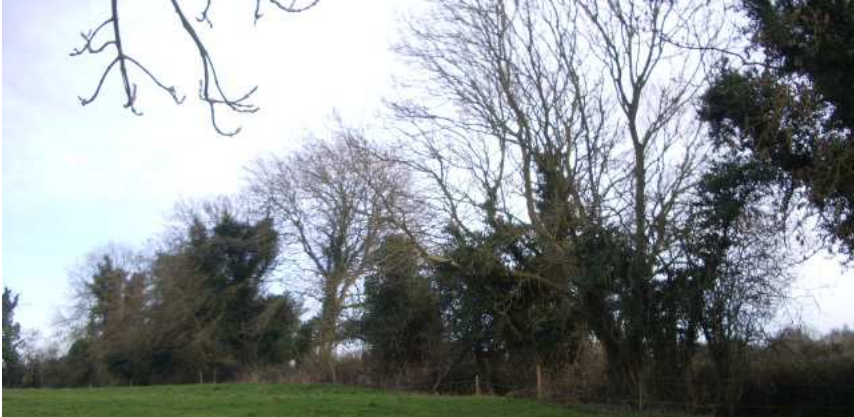
0533	Ash <i>Fraxinus excelsior</i>	14	1100	7	7	4	3	3	Mature	Fair	Poor It is a large multiple-stemmed tree from base with basal decay present. As a result, its stability has been impacted and stems are prone to failure. It beginning to be heavily suppressed by Ivy. There is evidence of previous storm damage which has left its more open/ exposed as a result.	Cut/ coppice back into the hedge.	<10	U
0534	Ash <i>Fraxinus excelsior</i>	15	600	4	7	5	4	3	Mature	Fair	Fair / Poor It was initially twin-stemmed from base; however, the northern stem has been cut back to a stump, leaving its crown asymmetrical, open and weighed to the south. Ivy cover on the main trunk is beginning to extend up into its crown.	Make safe large size dead/ unstable growth. Cut Ivy at ground level.	10-20	C1
0535	Ash <i>Fraxinus excelsior</i>	13	480/ 400	5	4	4	3	2	Mature	Fair	Fair/ Poor It is multiple-stemmed from base with an acute union formation between some stems. Ivy cover on the main stems is extending up into its crown and is	Make safe dead/ unstable growth. Cut Ivy at ground level.	10-20	C1

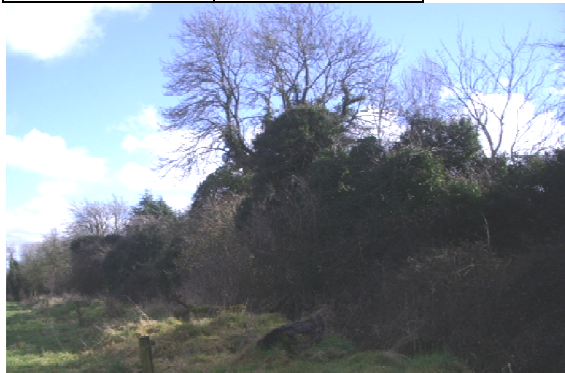
<p>The following trees are located within Hedge No. 27.</p>										Average Height	Average Width	6m	6m	species and make safe large size dead/ unstable growth.		
Average Height	Average Width																	
6m	6m																	
0546	Ash <i>Fraxinus excelsior</i>	16	700	3	5	6	3	3	Mature	Fair	Fair It is a large prominent tree with heavy Ivy cover on the main trunk extending up into its crown. The main trunk leans out to the south with basal decay also present; as a result, the stability of this tree would give rise for concern. I suspect that the top has broken out in the past.	Due to its close proximity to the neighbouring properties, I would recommend its removal as the most appropriate management option.	<10	U

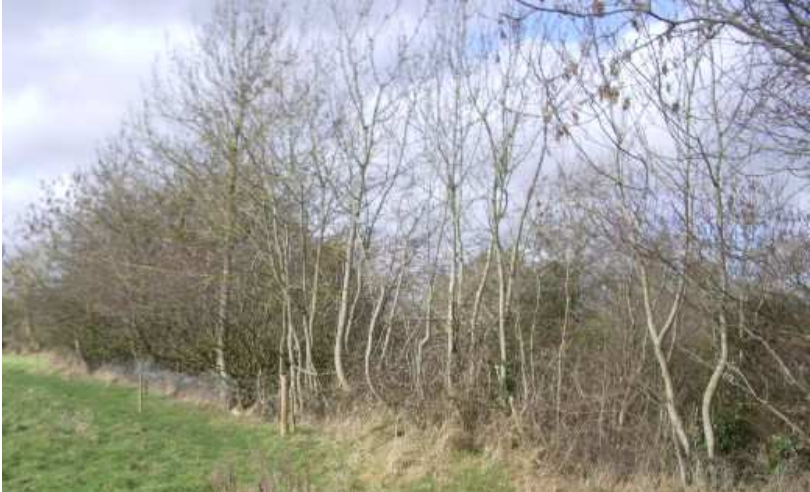
The following trees are located within Hedge No. 29.												
0574	Ash <i>Fraxinus excelsior</i>	10	230	2	2	2	2	2	Semi Mature	Good	Fair/ Good It is a good structured tree with good potential and is beginning to establish up above the height of the surrounding trees and hedge. Fencing wire is cutting into the lower trunk.	Requires no work at the present time.	40+	B1

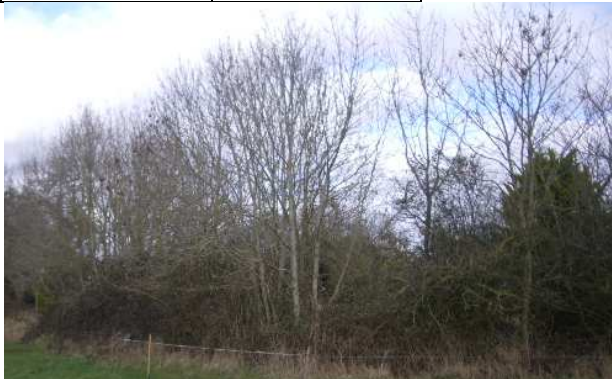
Tree Group No. 5	Ash <i>Fraxinus excelsior</i>	8	90 (6 stems)	2	2	2	2	2	Semi Mature	Fair	Fair It is located at the northern end of Hedge No. 30. It consists of self-seeded Ash trees growing up together in a group around the outskirts of Hedge No. 30 and are of some prominence as a small group of trees within this area. The bulk of them are multiple-stemmed from base.	Retain as part of a group environment. Tidy up undergrowth.	20+	C2

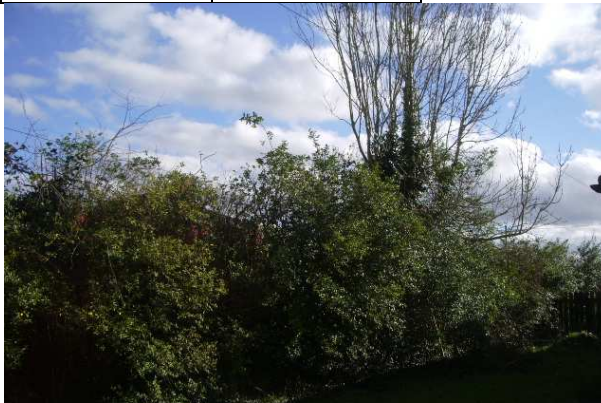
<p>The following tree is located within Hedge No 31B.</p>										Average Height	Average Width	3m	5m	It would benefit from further tidying and pruning works in order to contain.	-	C2
Average Height	Average Width																	
3m	5m																	
0582	Ash <i>Fraxinus excelsior</i>	9	330 (3 stems)	3	2	1	3	2	Early Mature	Fair/ Poor	Poor It is heavily infected by 'Bacteria Canker' of Ash. Its height has been reduced in the past and it has	I would recommend its removal as part of the management of this hedge.	< 10	U

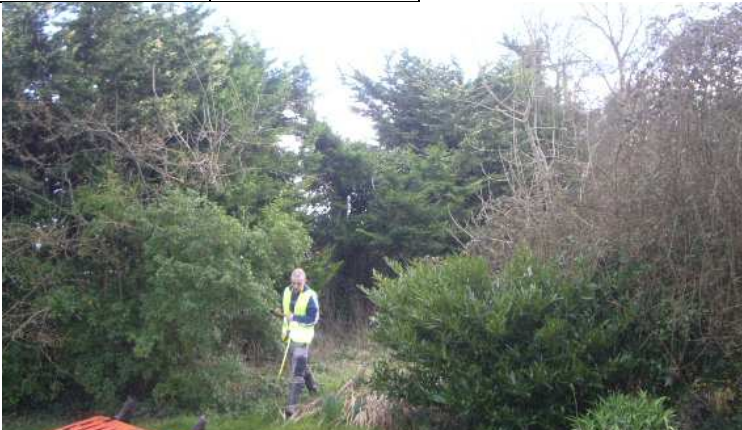
0578	Tulip Tree <i>Liriodendron tulipifera</i>	9	230	3	2	2	2	2	Semi Mature	Fair / Good	Fair It is establishing up over the scrub vegetation with Bramble growing up into its lower crown.	It would benefit from general tidying works around its base.	20-40	B1
0579	Lemon	5	120/	1	1	1	1	0	Semi	Good	Fair	Retain at the present time.	20+	C1
