**Gortyrahilly, Inchamore and
Cummeennabuddoge (CMBG) Wind Farms**

Civil & Structural Due Diligence Report

October 2020

Document Number: Project No. 201164-R0

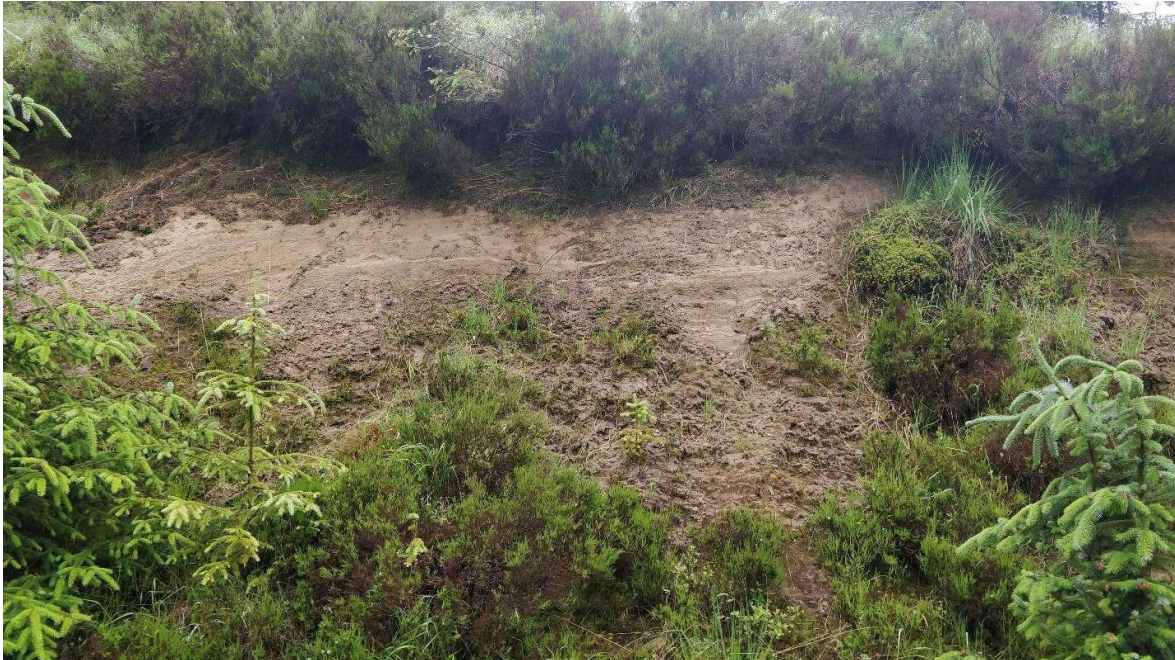
Figure 6-6: Exposed overburden cut with evidence of erosion/shallow slips (ITM 516203E,582880N)

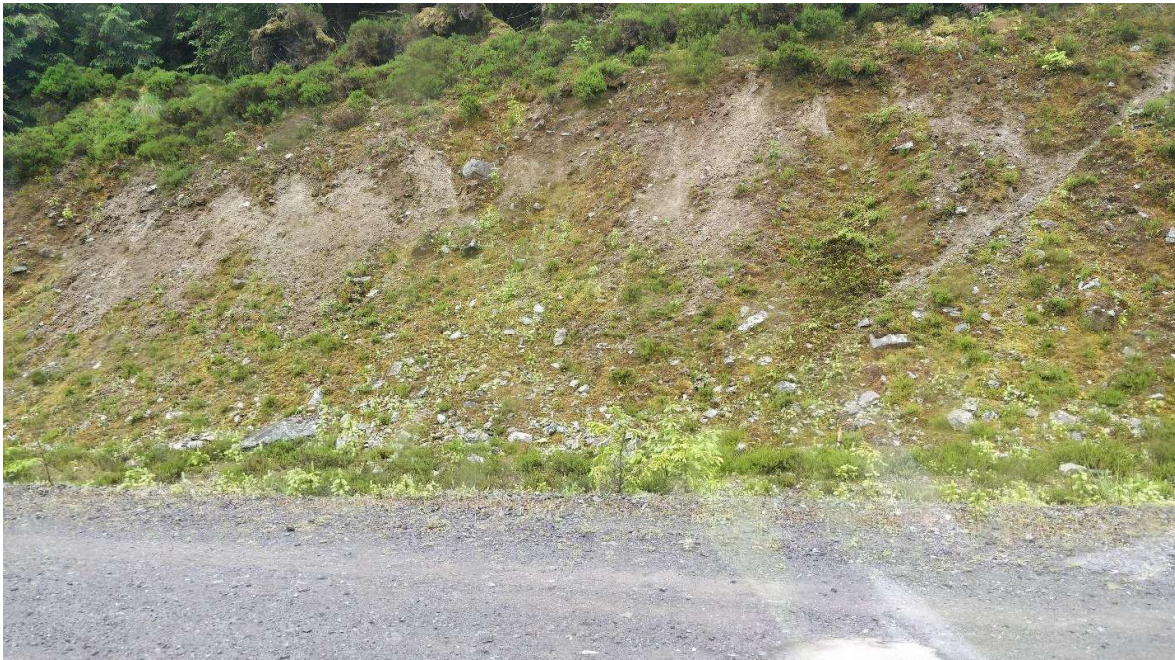
Figure 6-7: Exposed overburden cut with evidence of erosion/shallow slips (ITM 519555E,583500N)

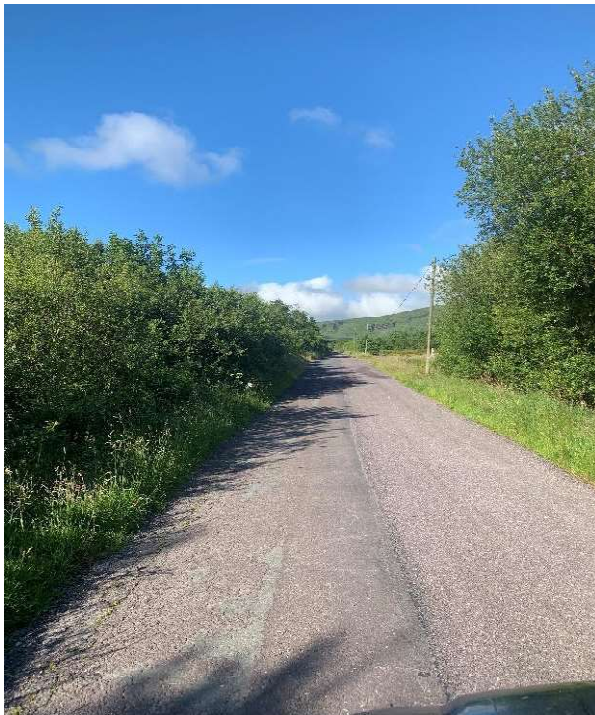
Image : 3
Existing cable running down road

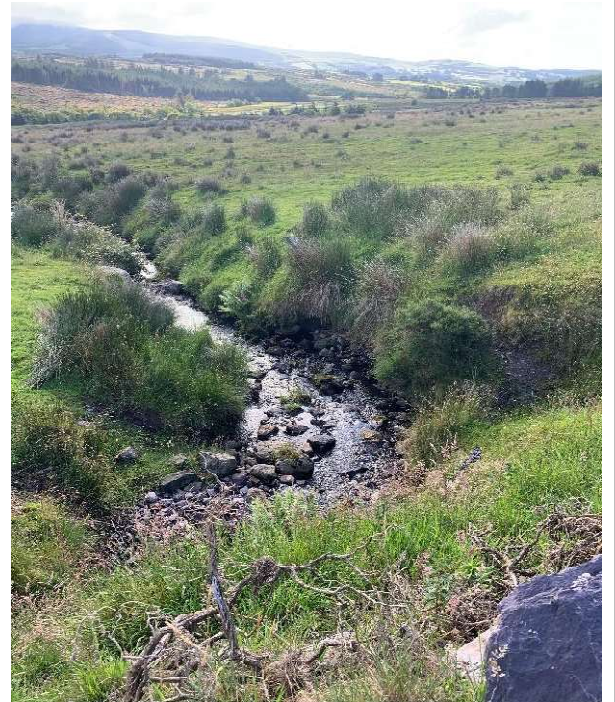
Image : 6
Stream crossing under road at this point

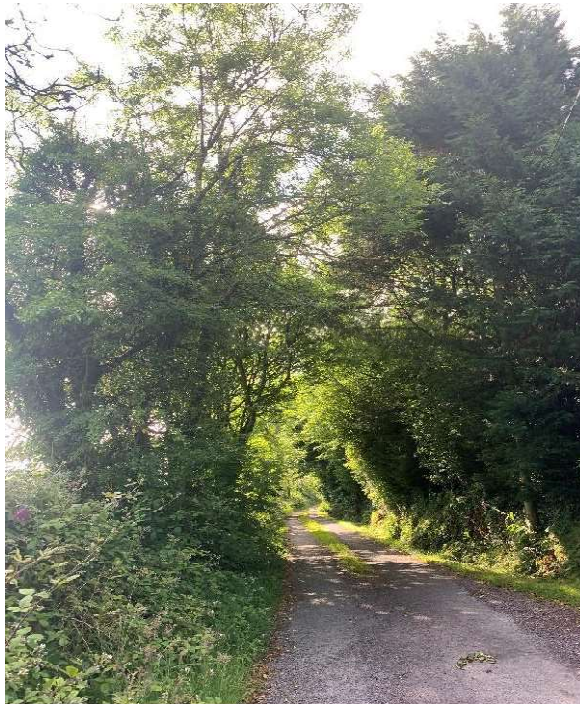
Image : 9
Mature trees and unmaintained hedgerows either side of the road

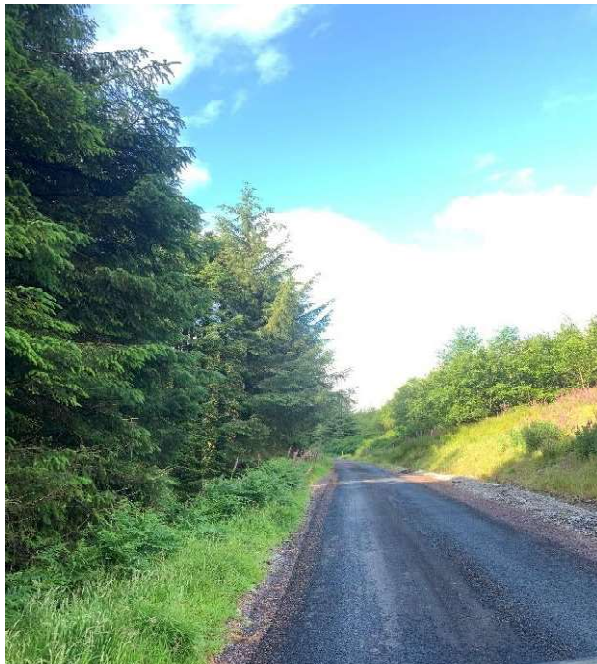
Image : 11
Possible joint bay location of existing cable running in the road

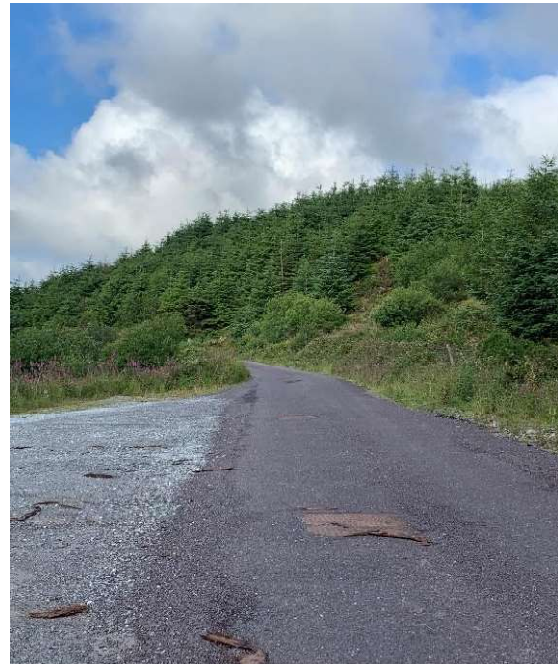
Image : 12
Joint bay on the road here with a links box and communications chambers visible.

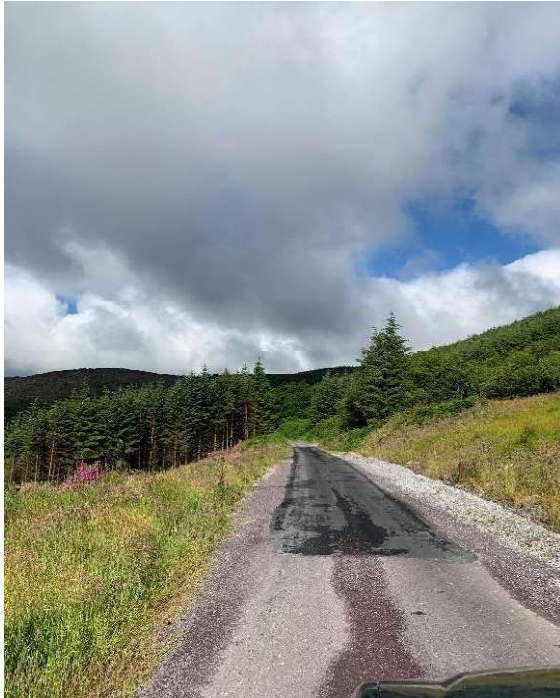
Image : 13
Possible location of joint bay which has had the covers tarred over.

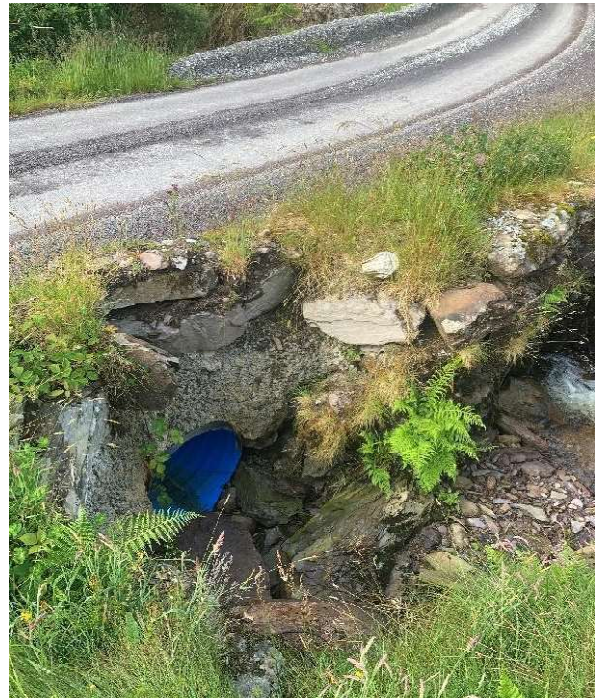
Image : 14
Two twin wall drainage pipes crossing under road.
Depth of cover approx. 500mm

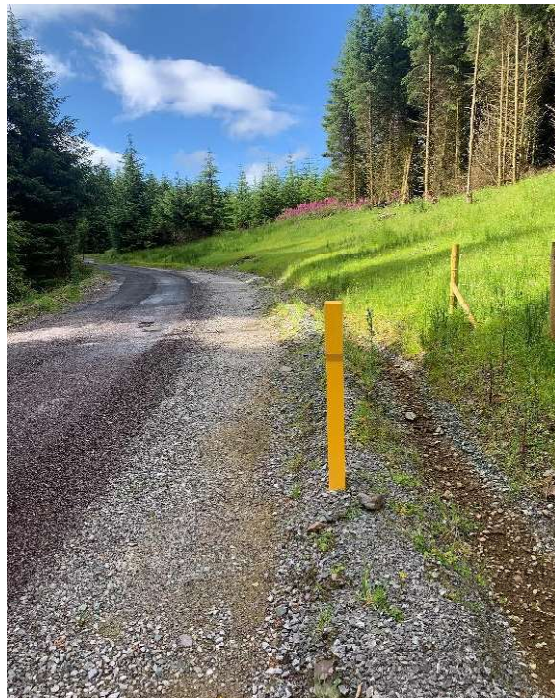
Image : 15
Ebs marker post pictured along road edge before another possible joint bay location

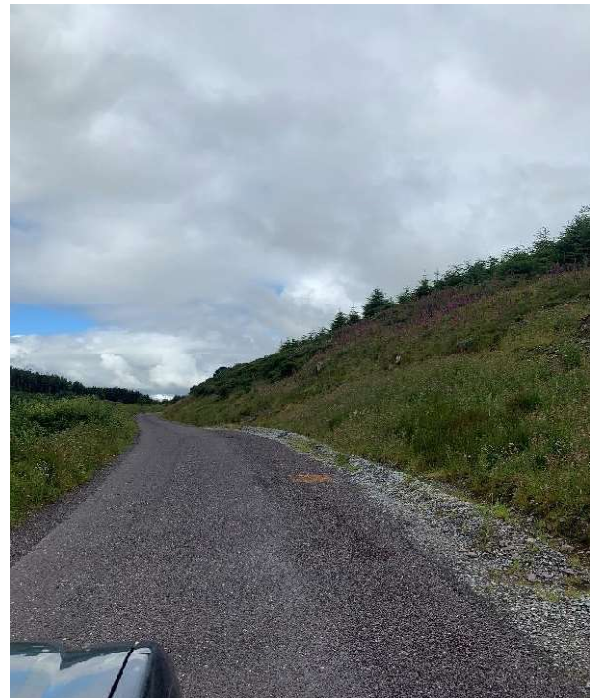
Image : 16
Joint bay on the road here with a links box and communications chambers visible.

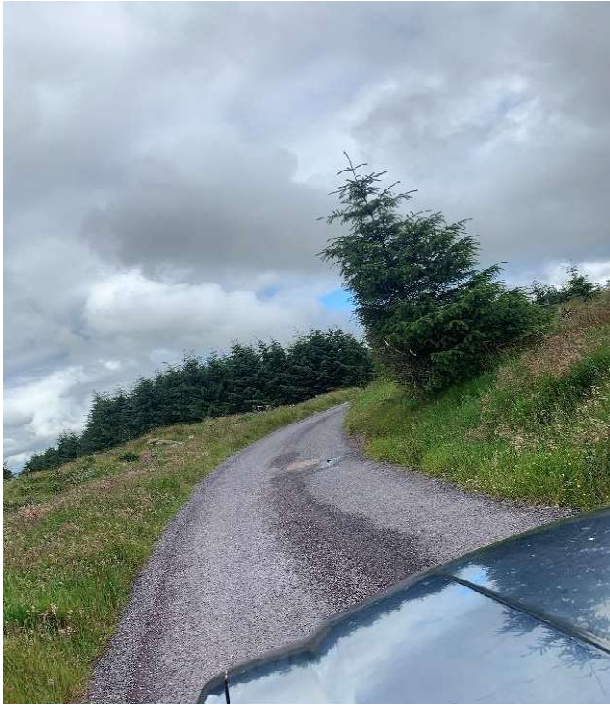
Image : 17
Joint bay located at this point

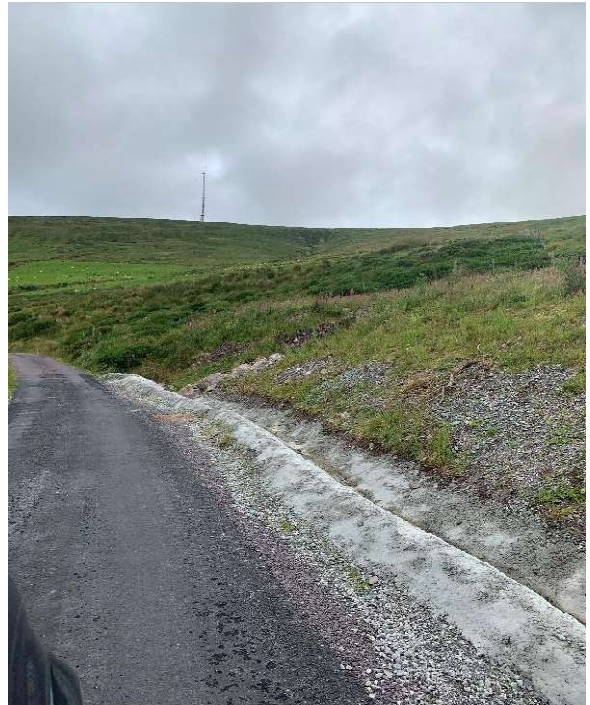
Image : 18
Joint bay on the road here with a links box and communications chambers visible.

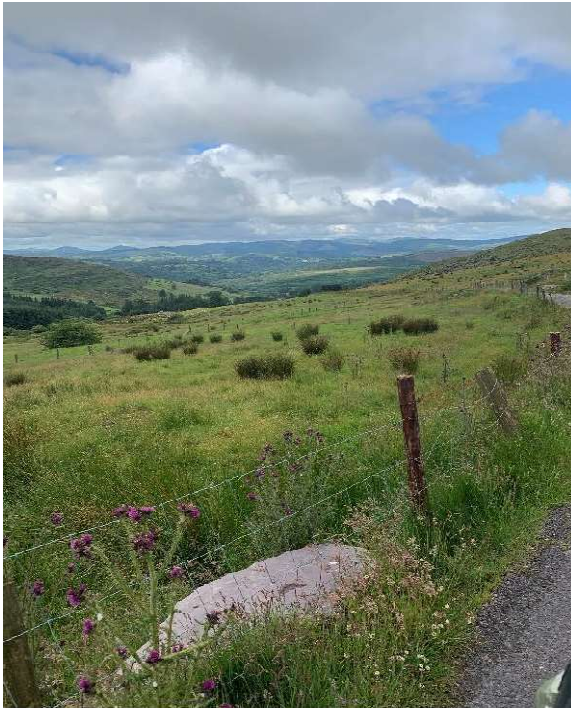
Image : 19
Storm water pipe crossing under road at this location

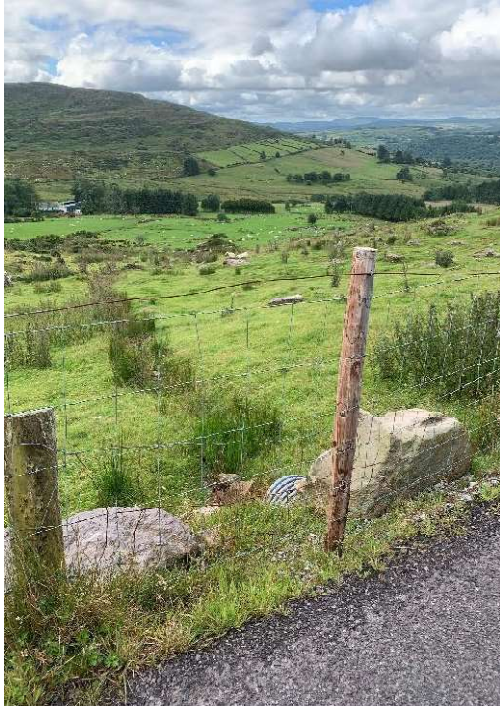
Image : 25
Storm water pipe crossing under road at this location

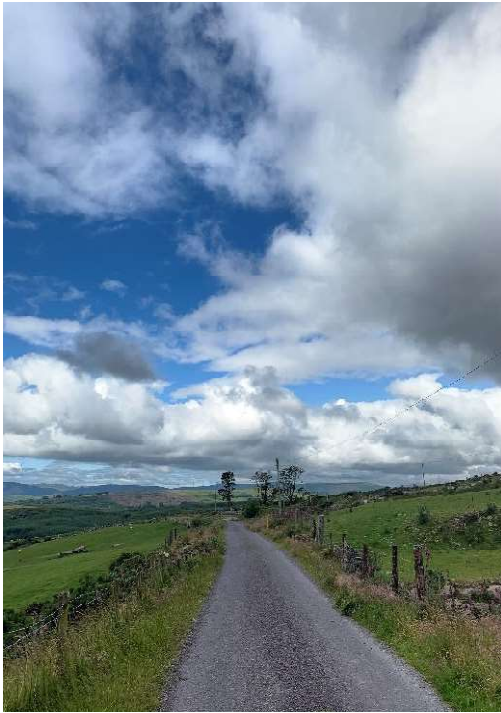
Image : 27
Esb cable maker visible on the RHS of the road edge.

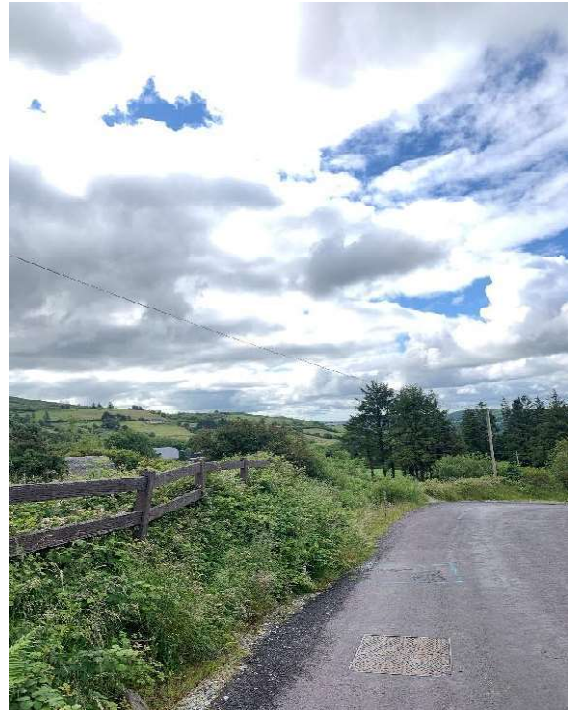
Image : 30
Joint bay on the road here with a links box and communications chambers visible.

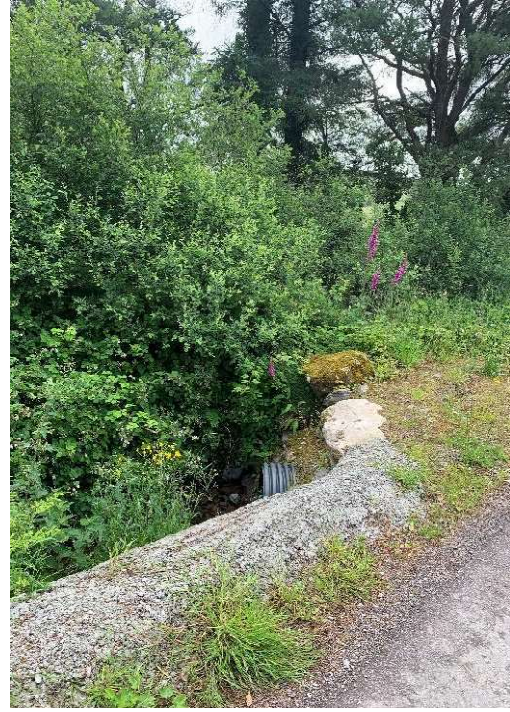
Image : 32
Storm water pipe crossing under road at this location.

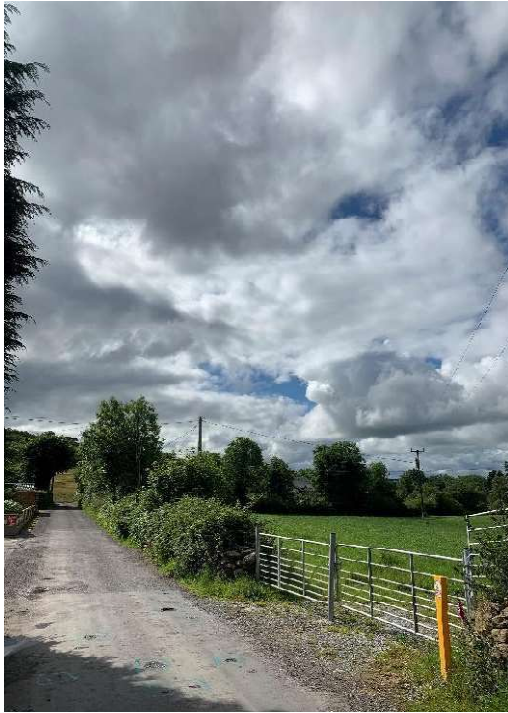
ESB have responded with relevant information of their network installations, which are adjacent to and cross the cable route. There is a high voltage cable route crossing the bridge 5 at (refer to Appendix B image 33 & 34).

Image : 33
Esb cable maker visible on the RHS of the road edge.

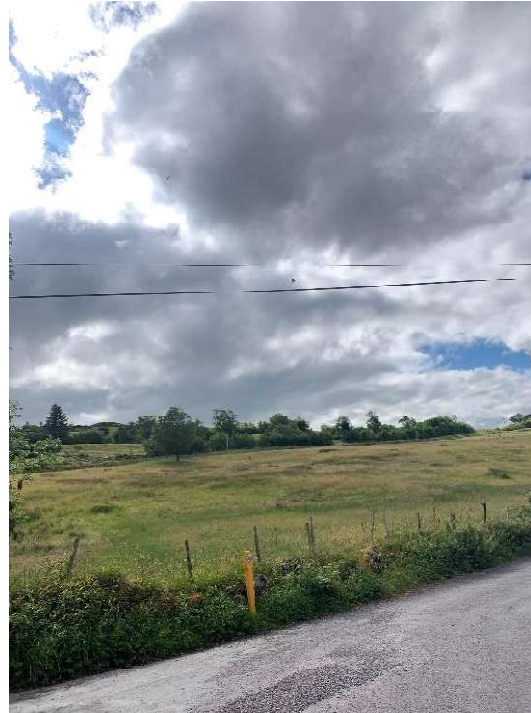
Image : 34
Esb cable maker visible on the LHS of the road edge.

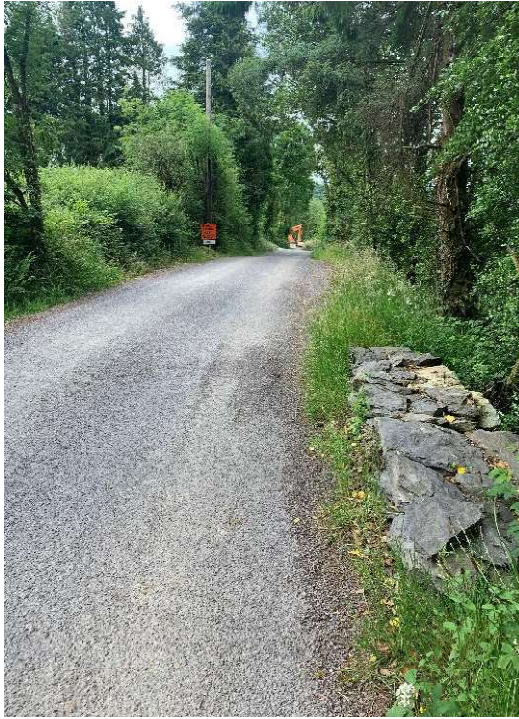
Image : 35
Storm pipe crossing under road as this location

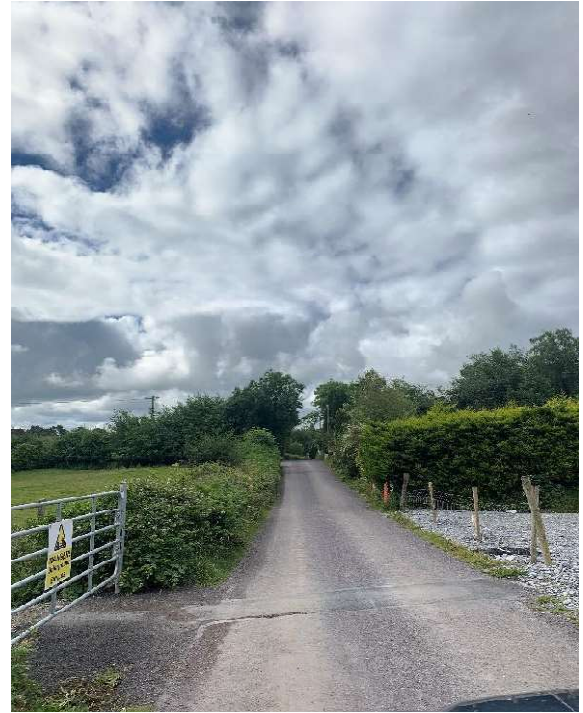
Image : 36
Visible trench scar crossing road at this location

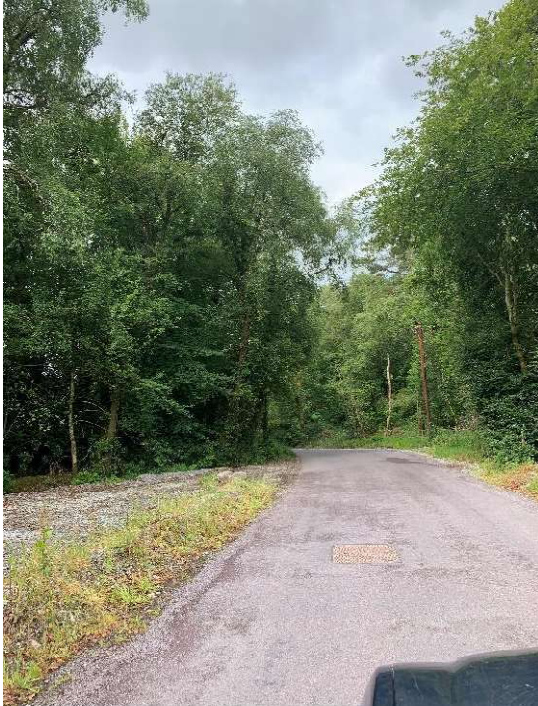
Image : 37
Joint bay on the road here with a links box and communications chambers visible.

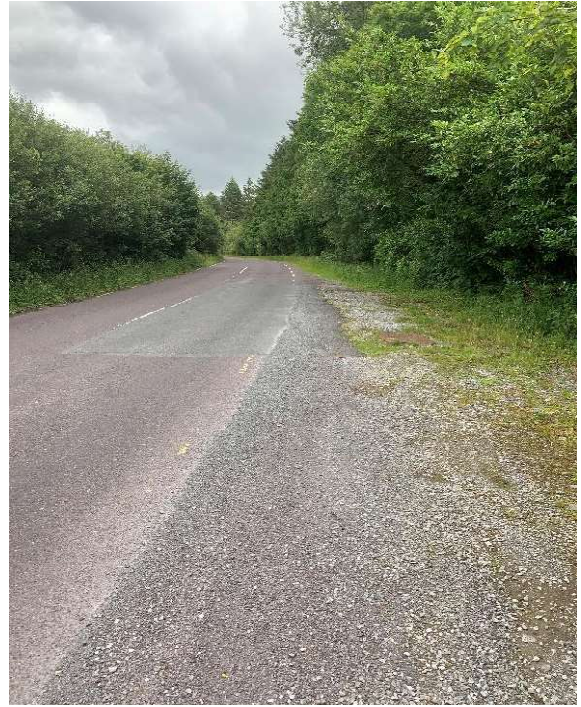
Image : 41
Joint bay on the road here with a links box and communications chambers visible.

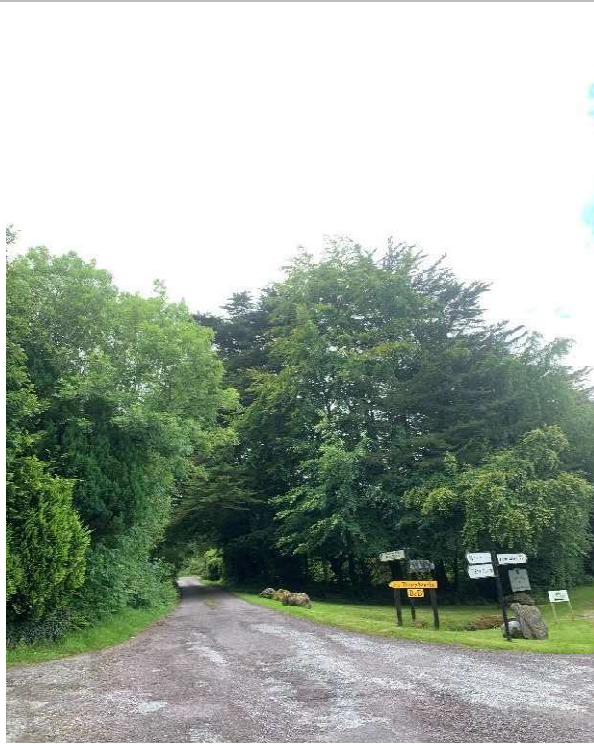
Image : 42
Joint bay on the road here with a links box and communications chambers visible.

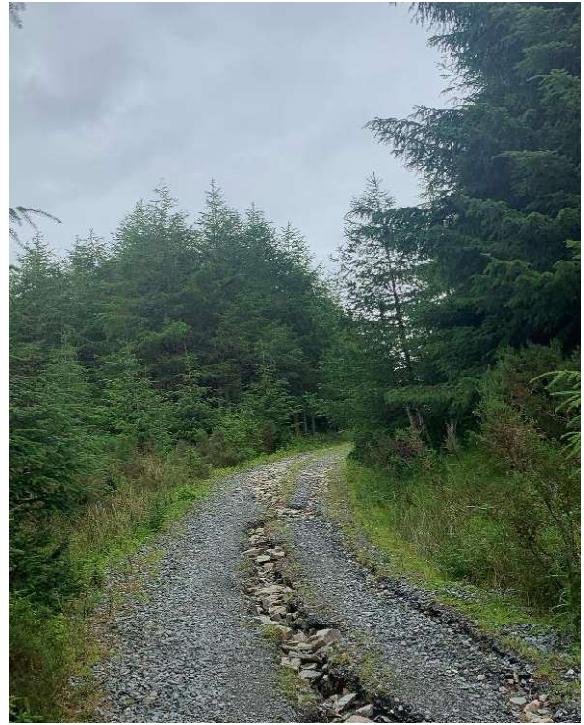
Image : 72
Forestry track on Coillte lands very step and heavily rutted

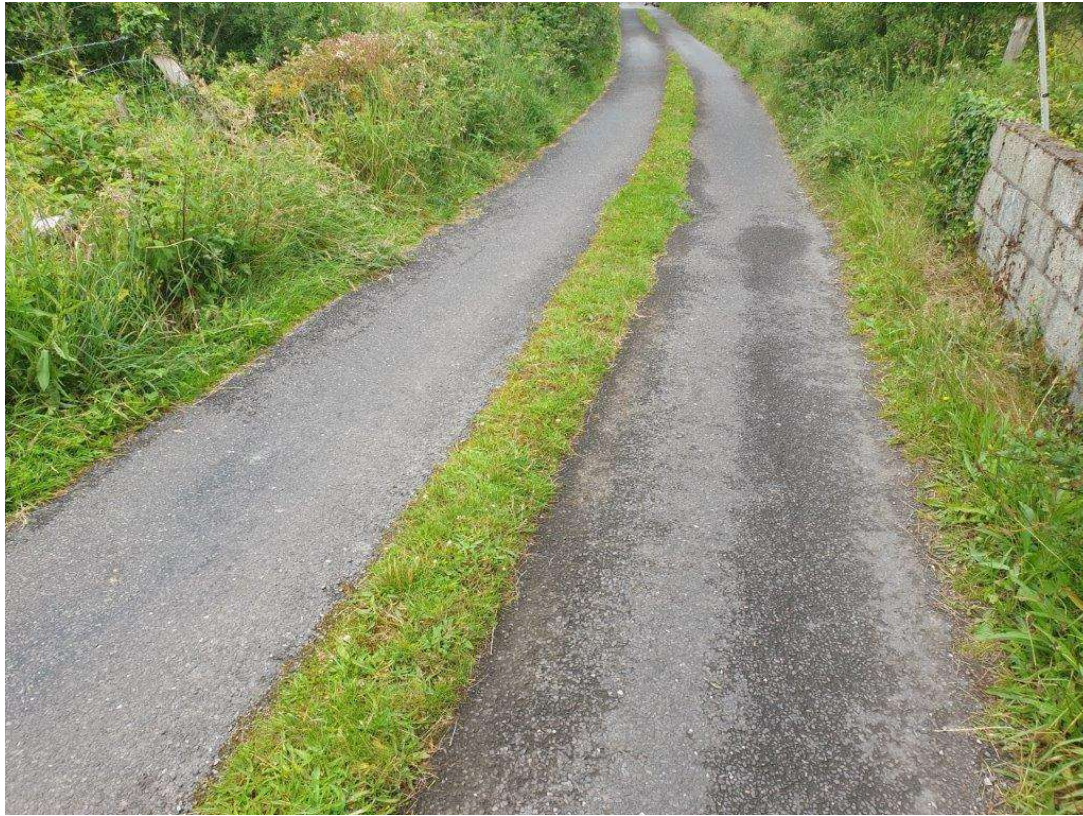
The existing bridge surface consists of tar & chip wearing course with a grassed median and is in good order generally. Some minor surface wear and abrasion is evident.

General view of bridge surface

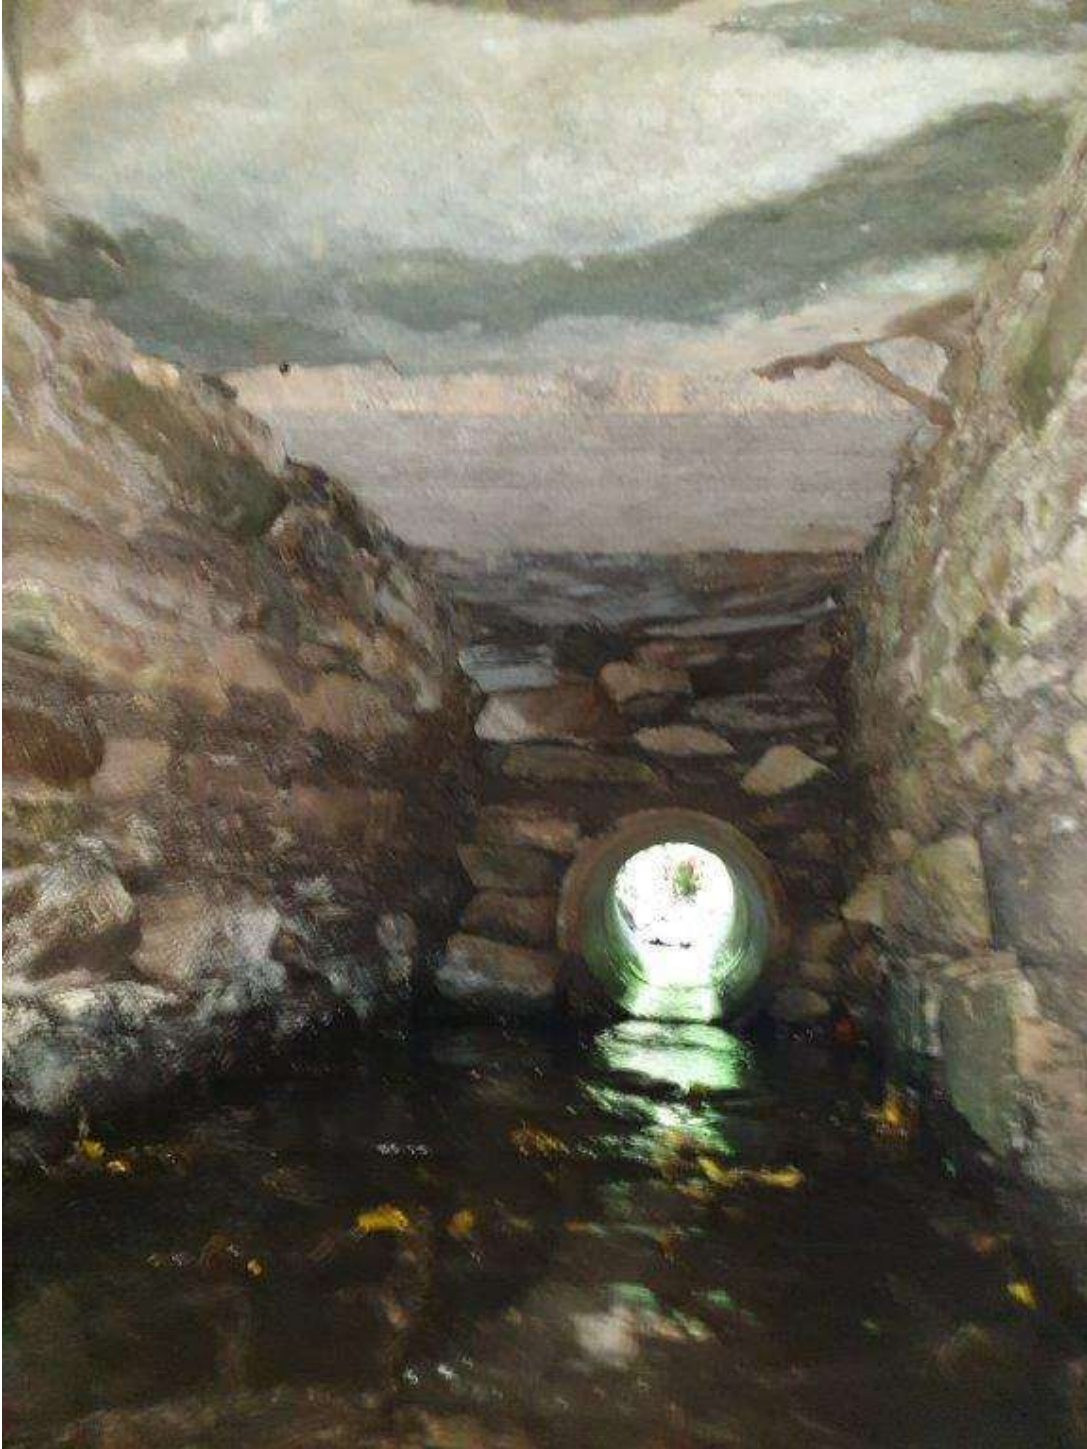
A portion of the south span has been repaired with a 450mm diameter concrete pipe for a length of 1850mm toward the east side of the span. The pipe has been installed at bed level and fully surrounded with stone / rubble.

View of south span from the west

Significant damage is evident in the deck in both spans and in the eastern spandrel wall. Repair works should be executed without delay.

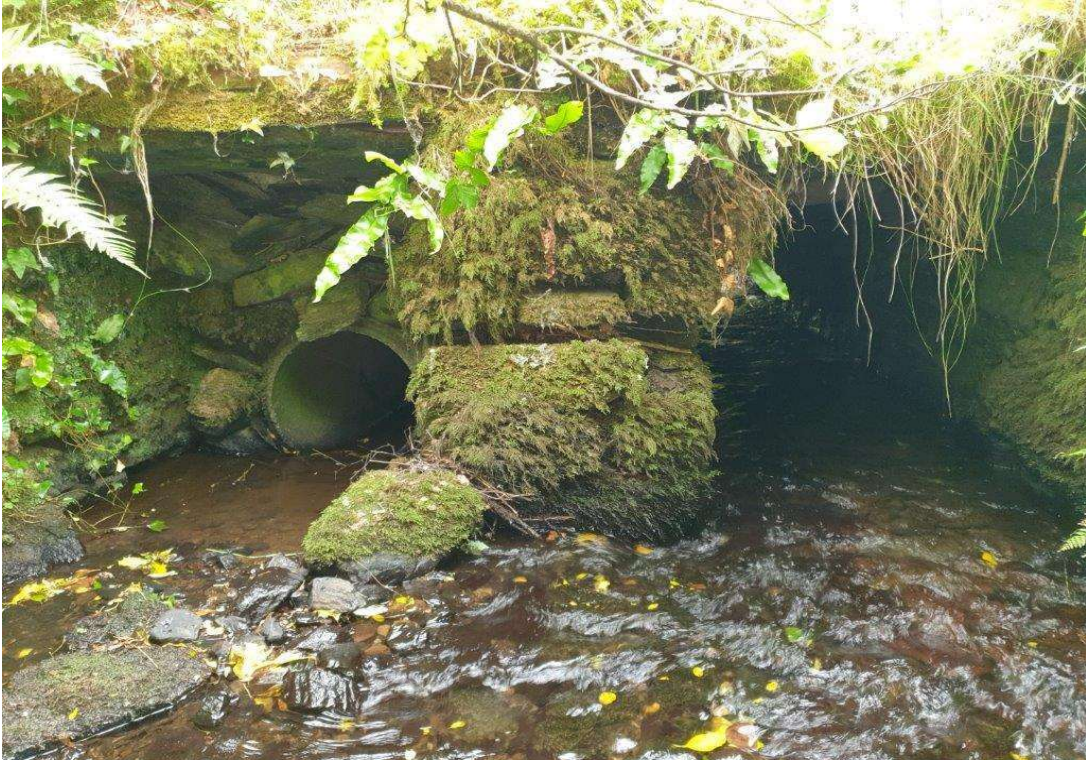
There are stone masonry spandrels on both elevations. The south end of the west spandrel has collapsed locally over a damaged section of the bridge deck.

General view of the east elevation

Maintenance repairs involving vegetation removal and general repointing of masonry elements should be completed.

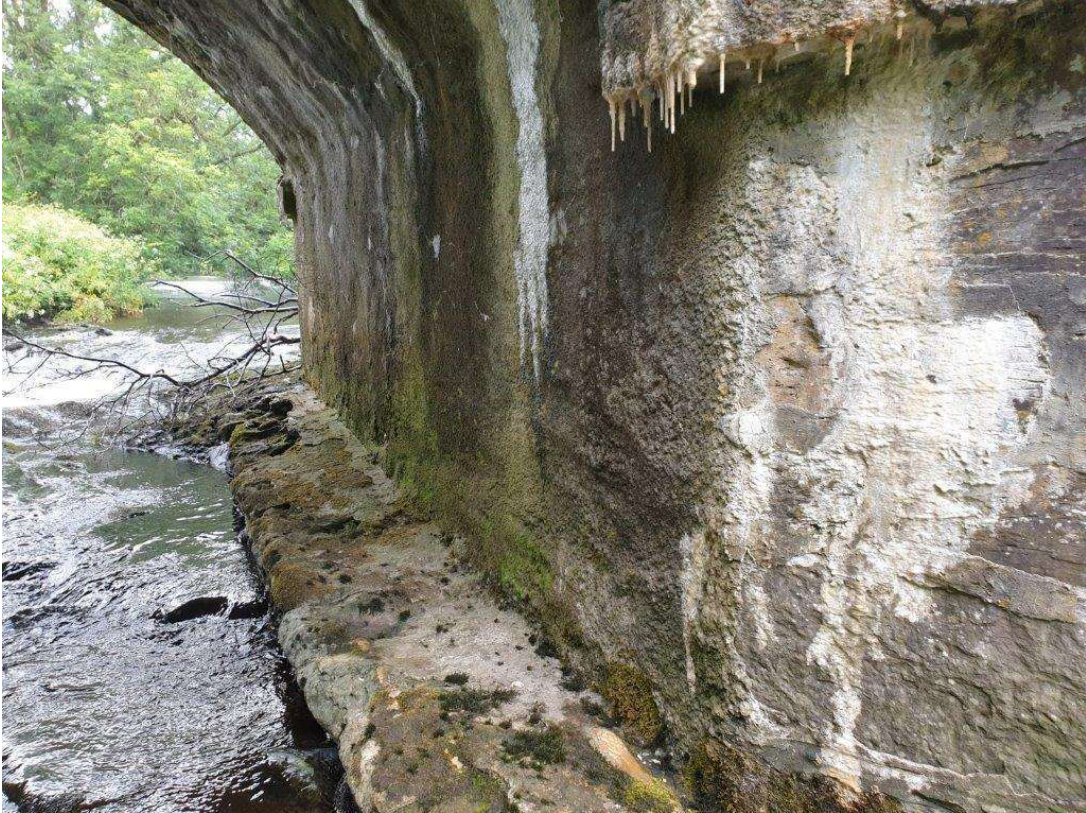
The piers are founded on bedrock. The pier faces have been repaired with gunite and the footings have been protected with grout bags. Some washout of the grout bags has occurred, however, no washout or undermining of the piers is evident.

Typical pier condition

Overall the structure is in good condition with few defects found. Maintenance repairs to the masonry elements and historical protection works to the pier and abutment footings are required. Debris should be removed from the riverbed.

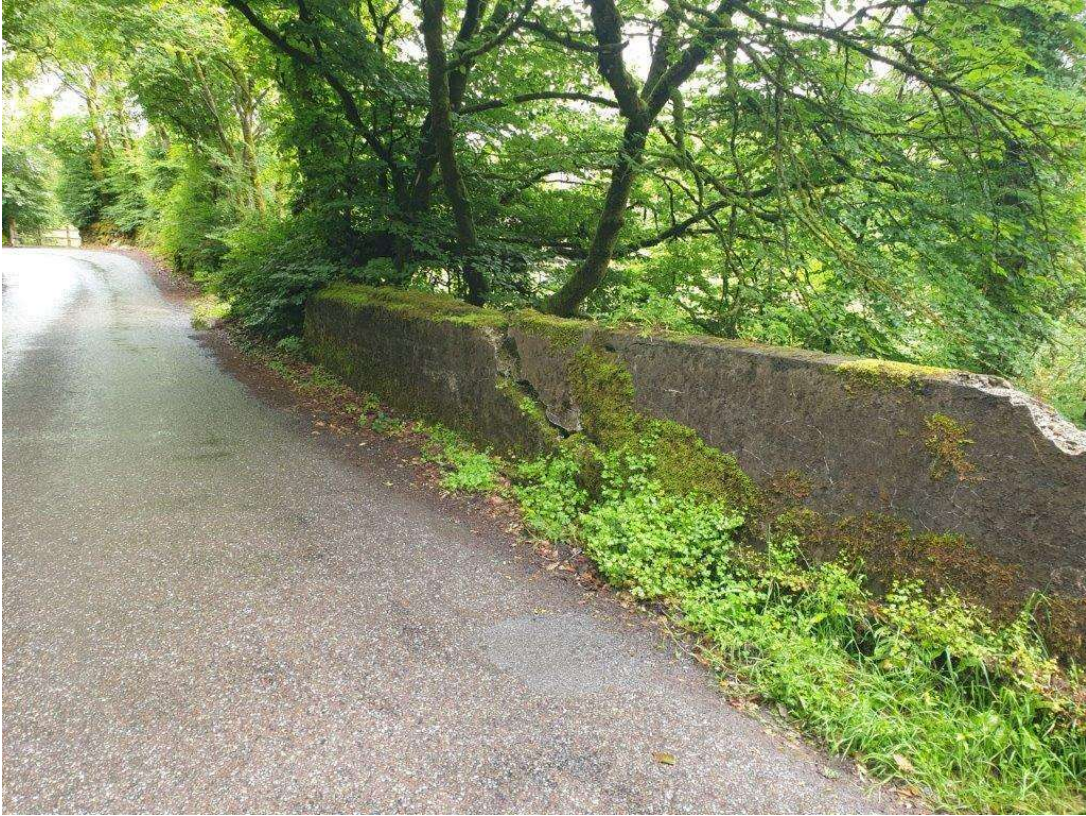
South parapet showing partial collapse extending from the centre of the bridge

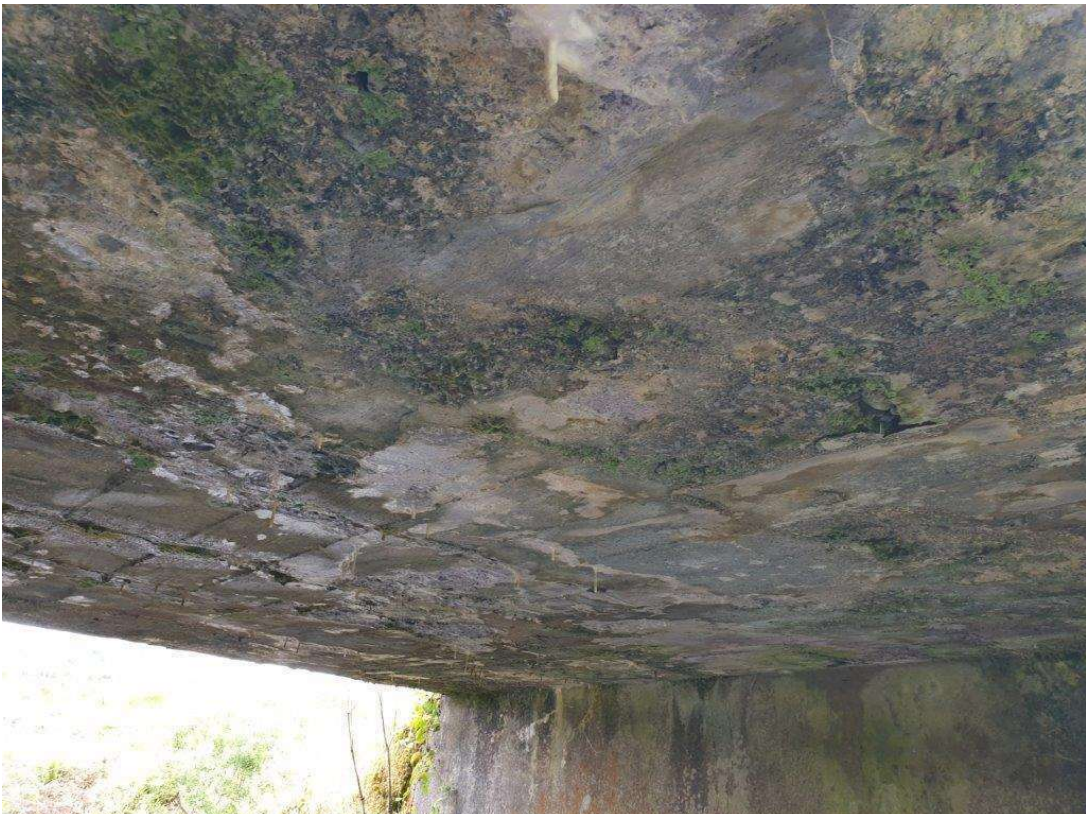
General view of the soffit of the bridge deck showing typical condition

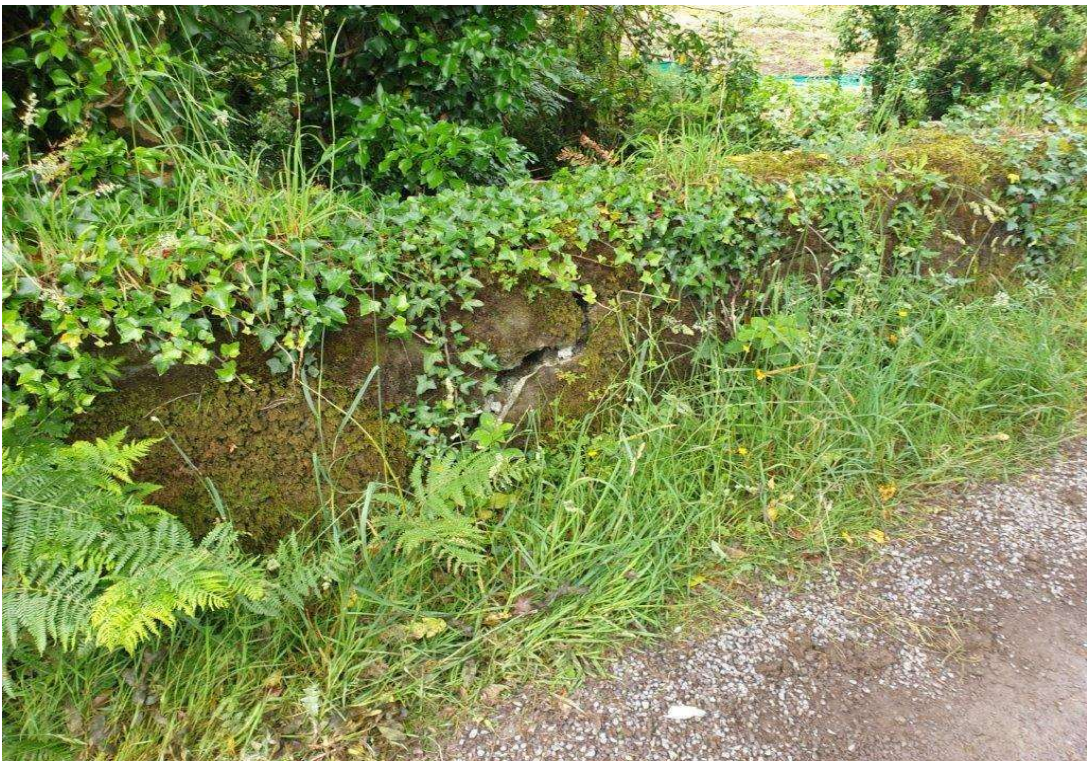
Light vegetation is present on both faces of both parapets. A 1.50m section at the north end of the east parapet is missing. The top course of stonework is missing over a 1.50m length of the north end of the west parapet. A stepped crack is evident towards the south end of the east parapet, the section between the end of the parapet and the crack has moved.

General view of the south end of the east parapet

Overall the structure is in good condition with few defects found. Maintenance repairs to the parapet walls should be undertaken.

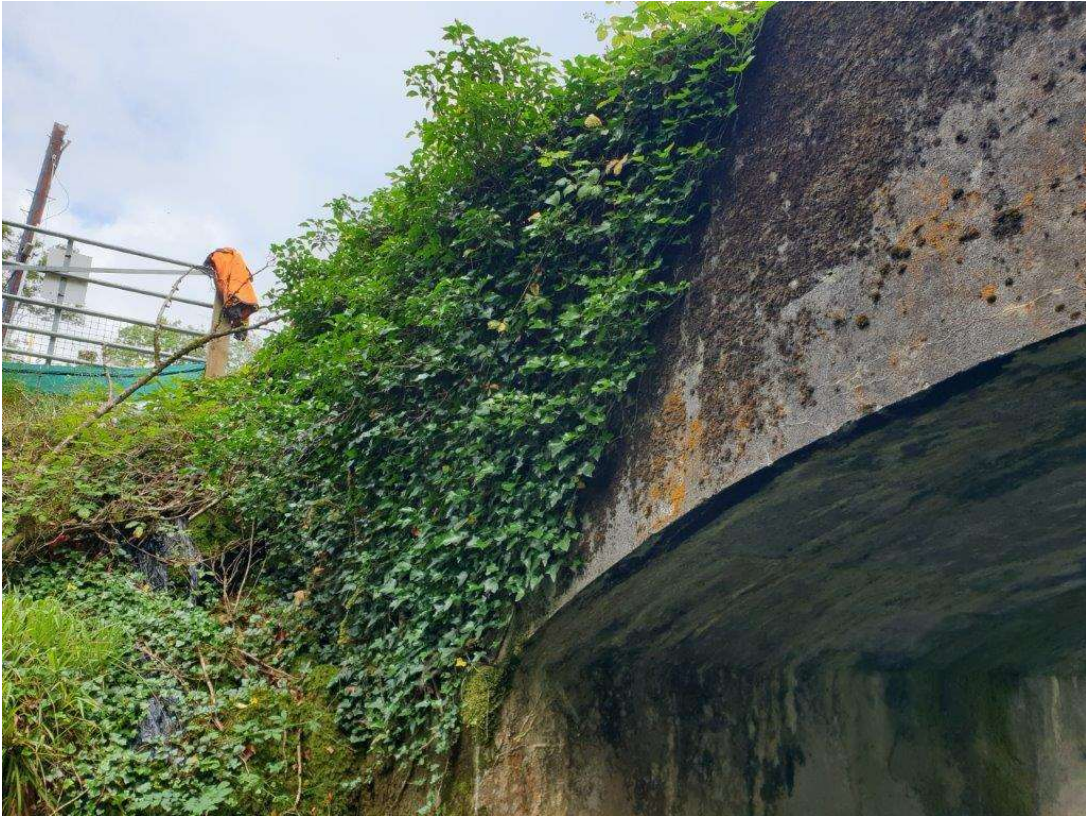
Vegetation growth on the west elevation

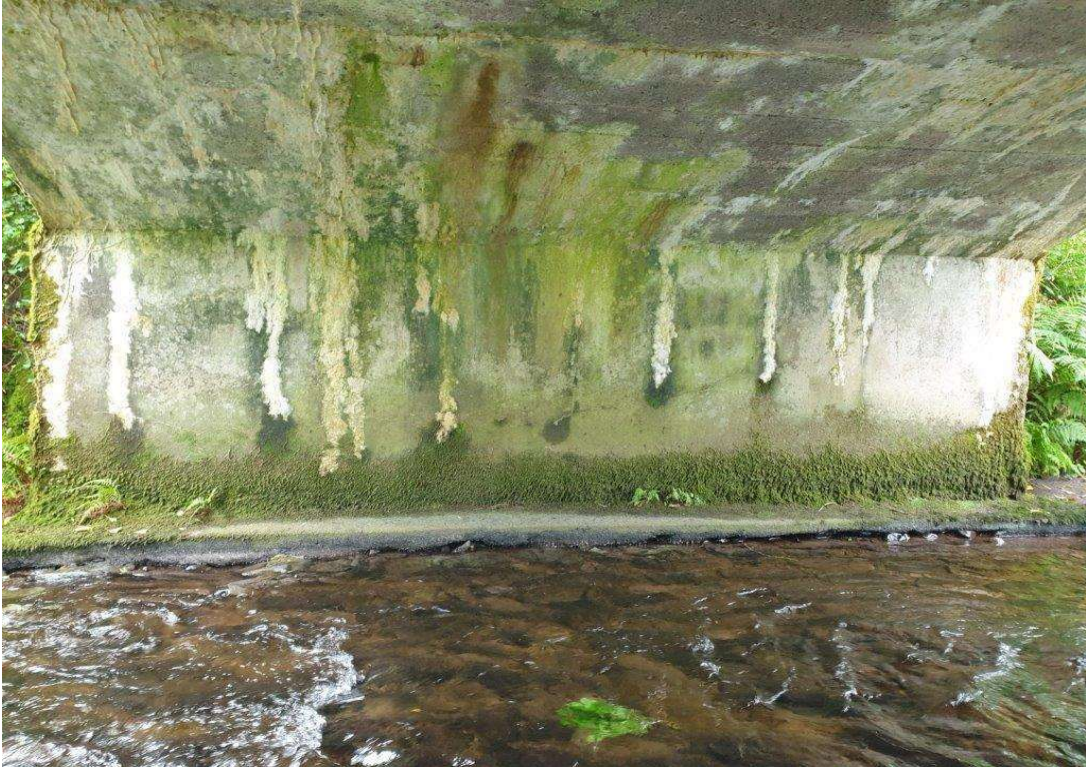
The abutments appear to be of concrete construction. There is a concrete plinth along the footing of both abutments. Some water ingress and calcite staining was noted. No significant structural defects were evident.

General view of the north abutment

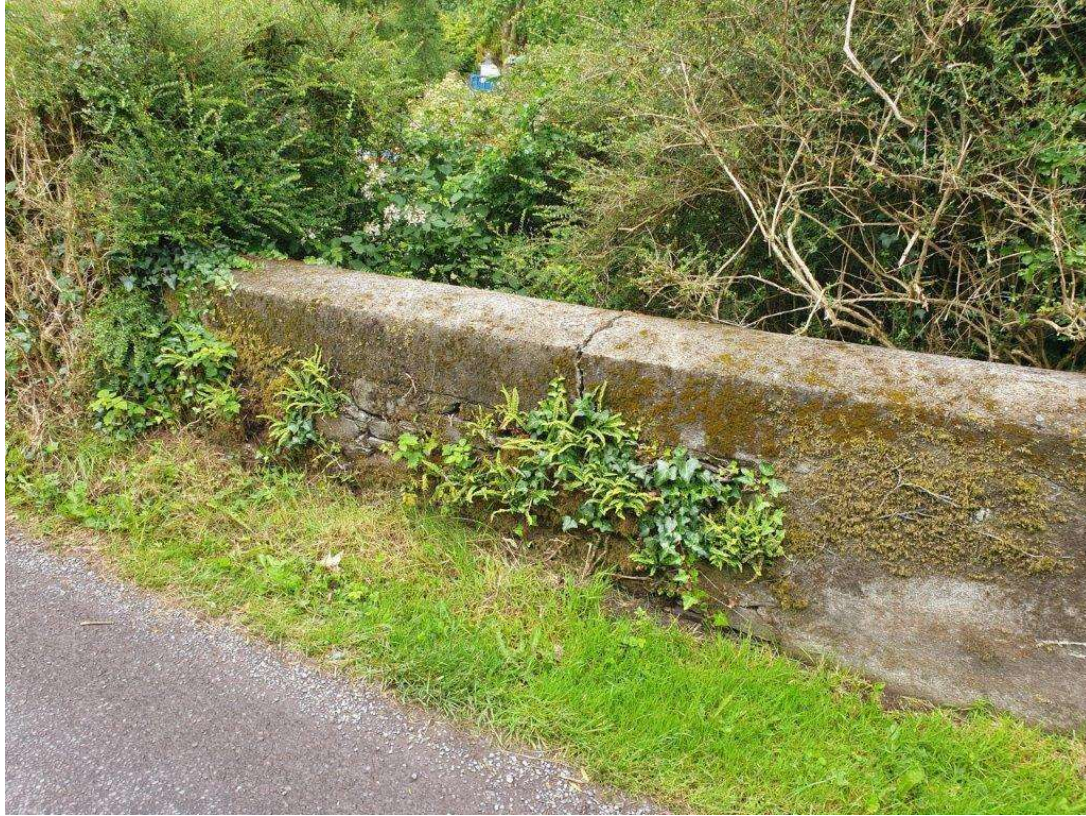
The existing parapets appear to be of masonry construction with concrete render and topping. Some cracking of the render and capping is evident but there are no significant structural defects. The parapets are 740mm - 840mm high and are both 500mm thick.

North parapet, west end

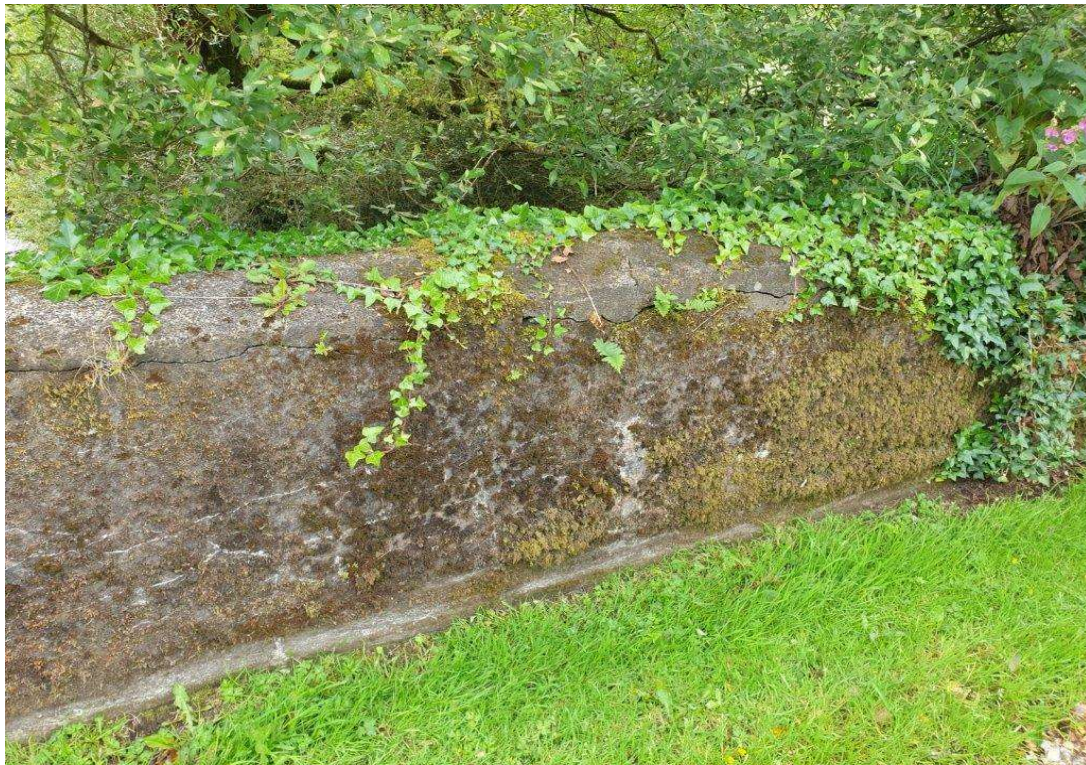
South parapet, east end
