**Gortyrahilly, Inchamore and
Cummeennabuddoge (CMBG) Wind Farms**

Civil & Structural Due Diligence Report

October 2020

Document Number: Project No. 201164-R0

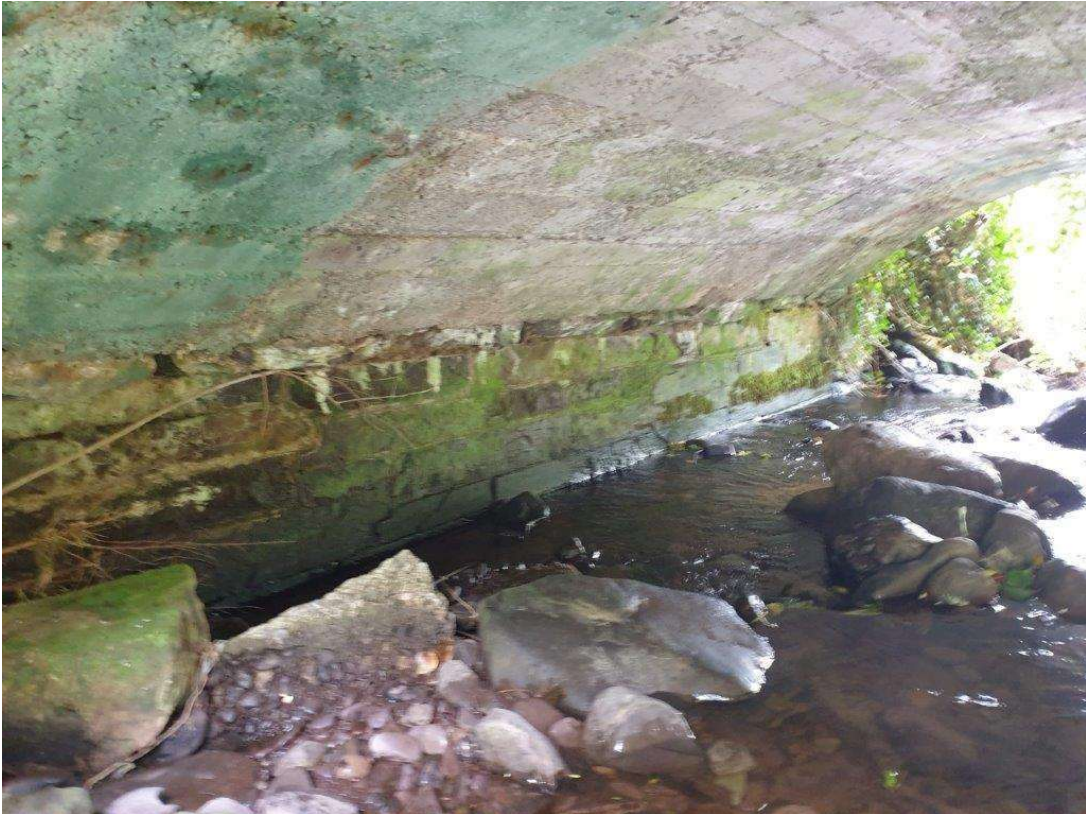
The abutments are of masonry construction with some concrete repairs. Minor defects including localised mortar loss, light vegetation, water ingress and calcite staining are evident.

Both arch barrels appear to be of concrete construction. Minor defects including localised water ingress and calcite staining are evident.

Typical condition of abutment & arch barrel

Overall the structure is in good condition with few defects found. General maintenance repairs are required.

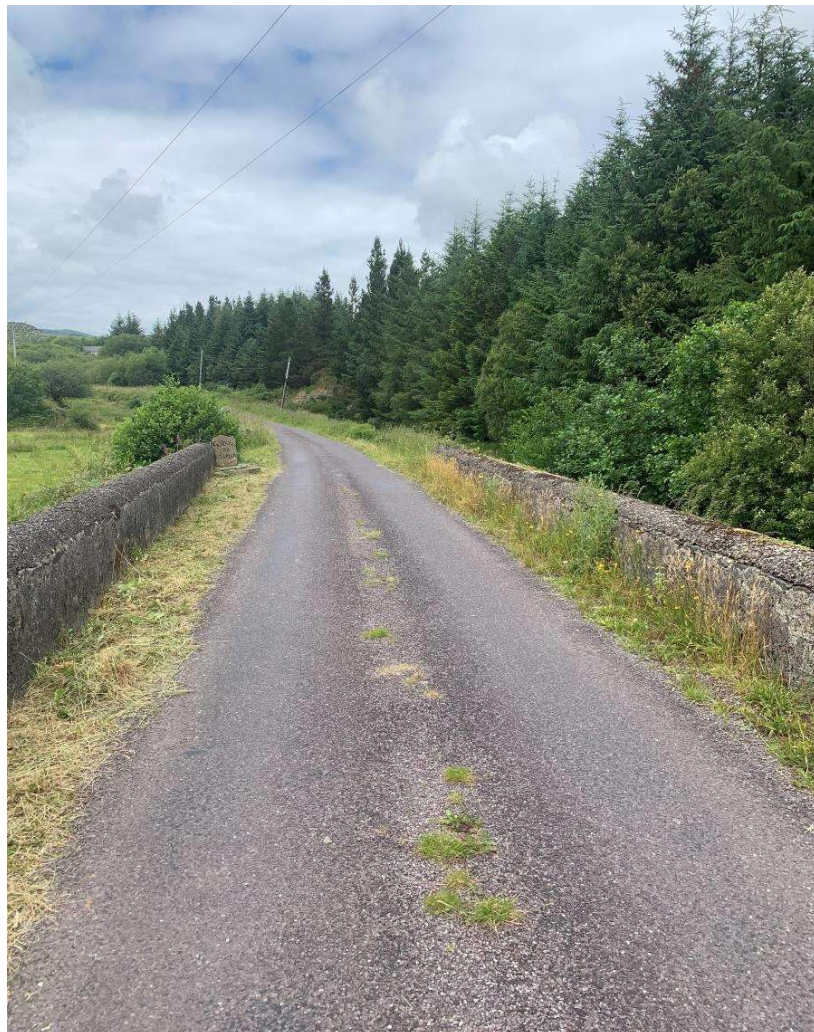
General view of the bridge surface

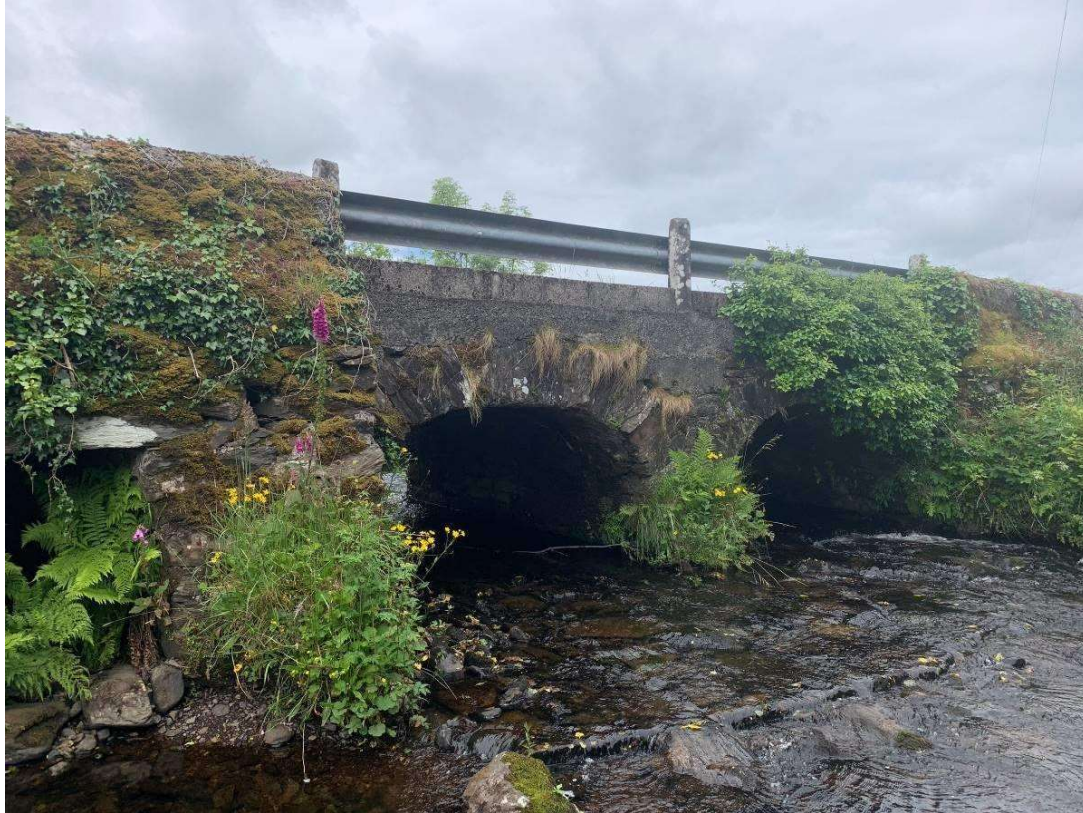
General view of bridge elevation, relief culvert shown to the left

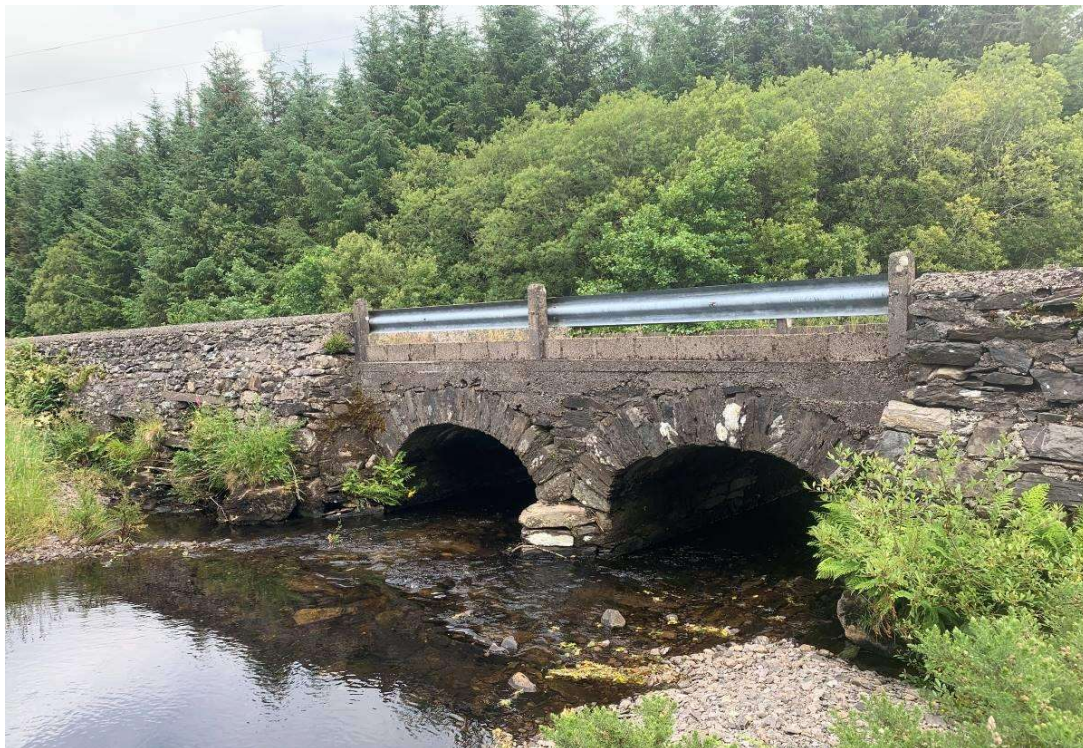
General view of bridge elevation

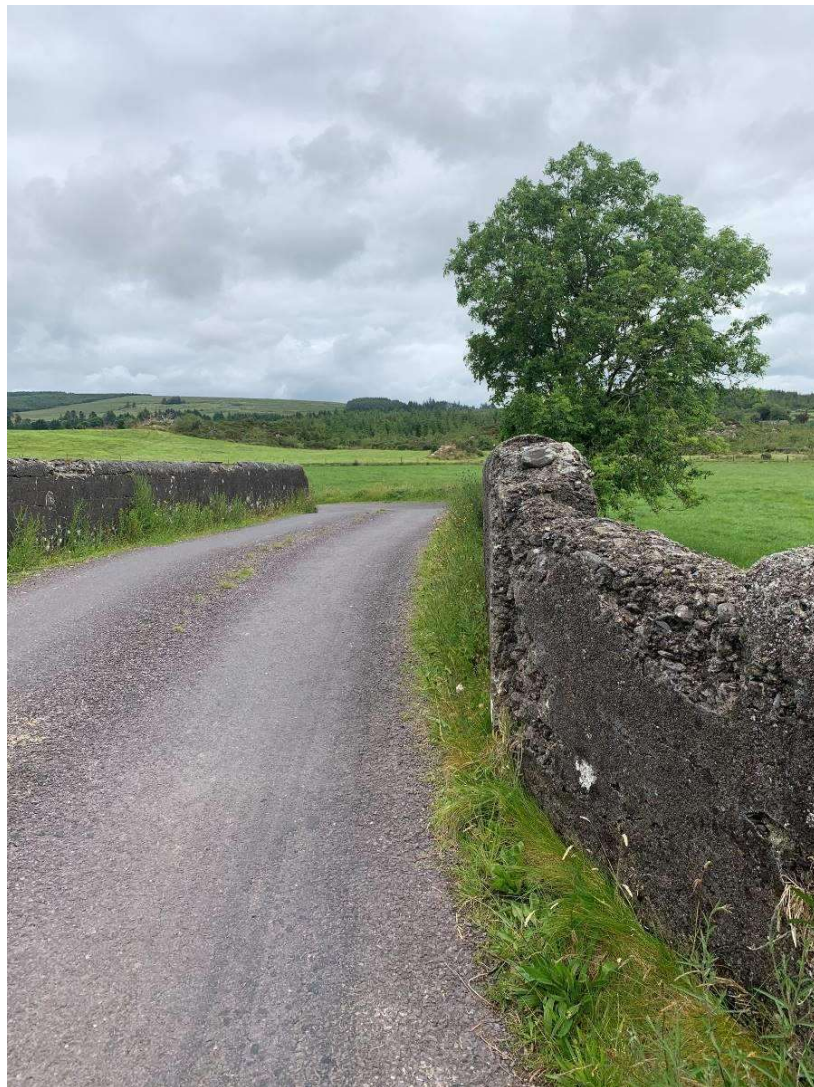
The existing bridge surface consists of tar & chip wearing course and is in good order generally.

General view of the bridge surface

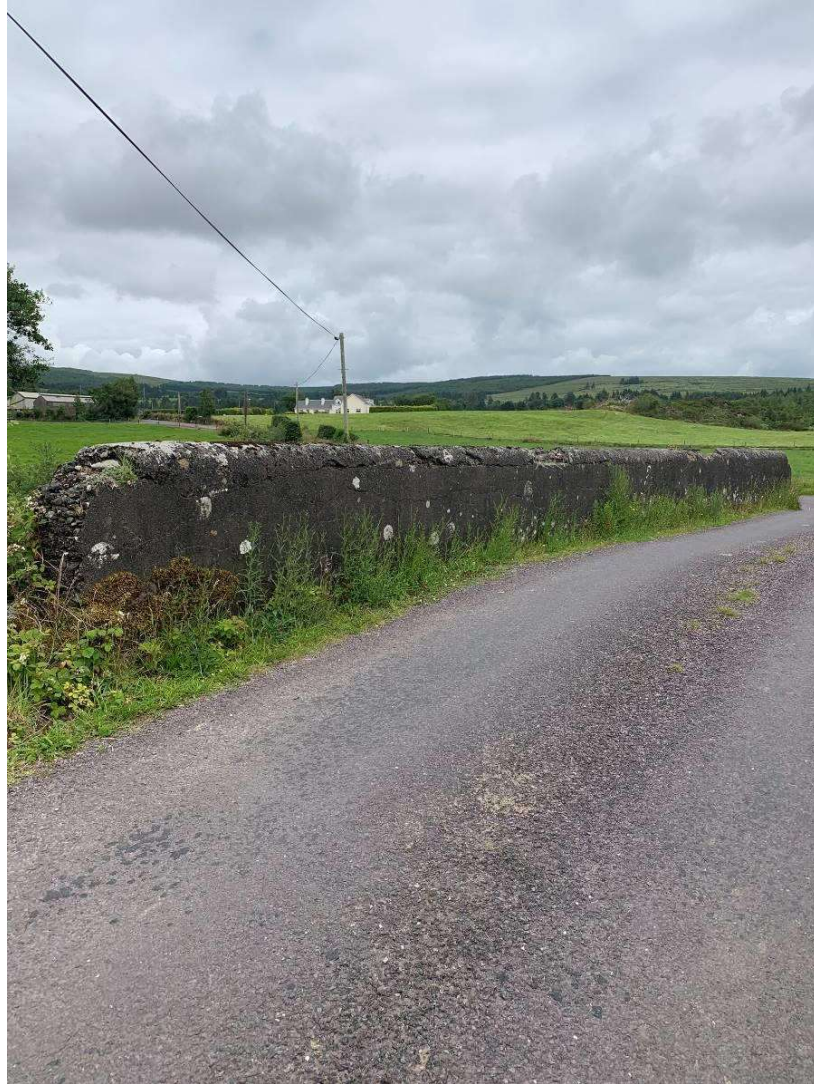
The parapets are generally in good condition. Local damage to the concrete capping was noted.

General view of the bridge parapet

Overall the structure is in good condition with few defects found. General maintenance works are required, including concrete repairs to the abutments, piers and parapets.

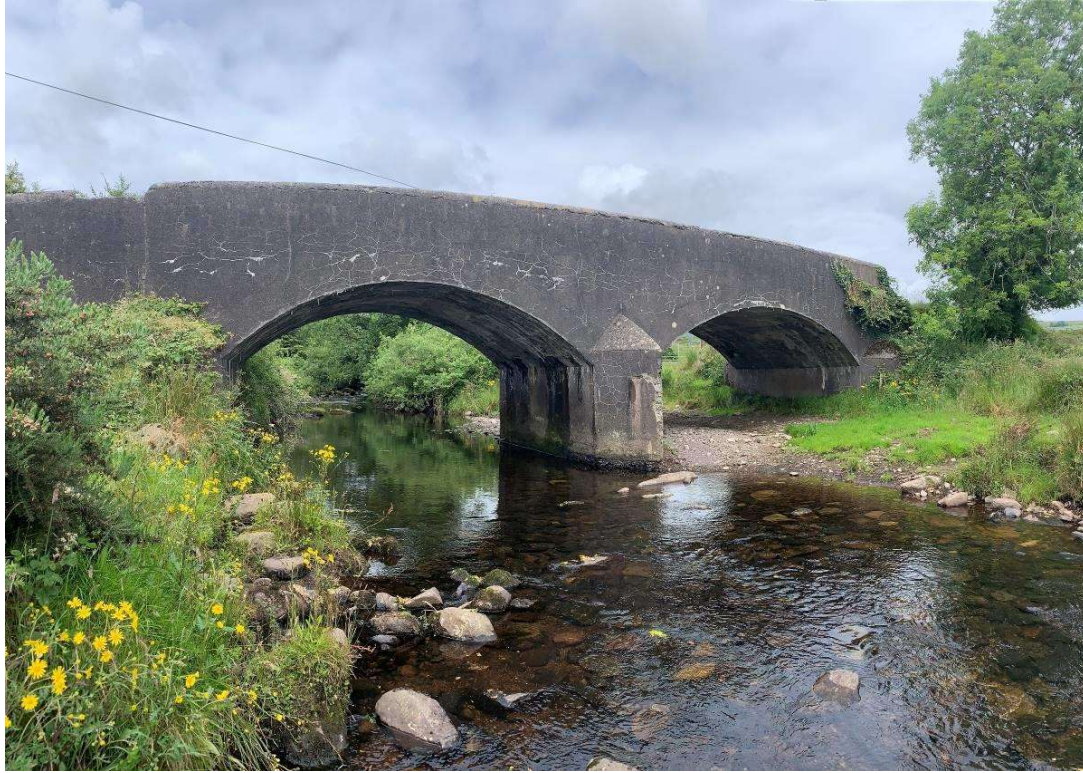
General view of bridge elevation - viewed from downstream.

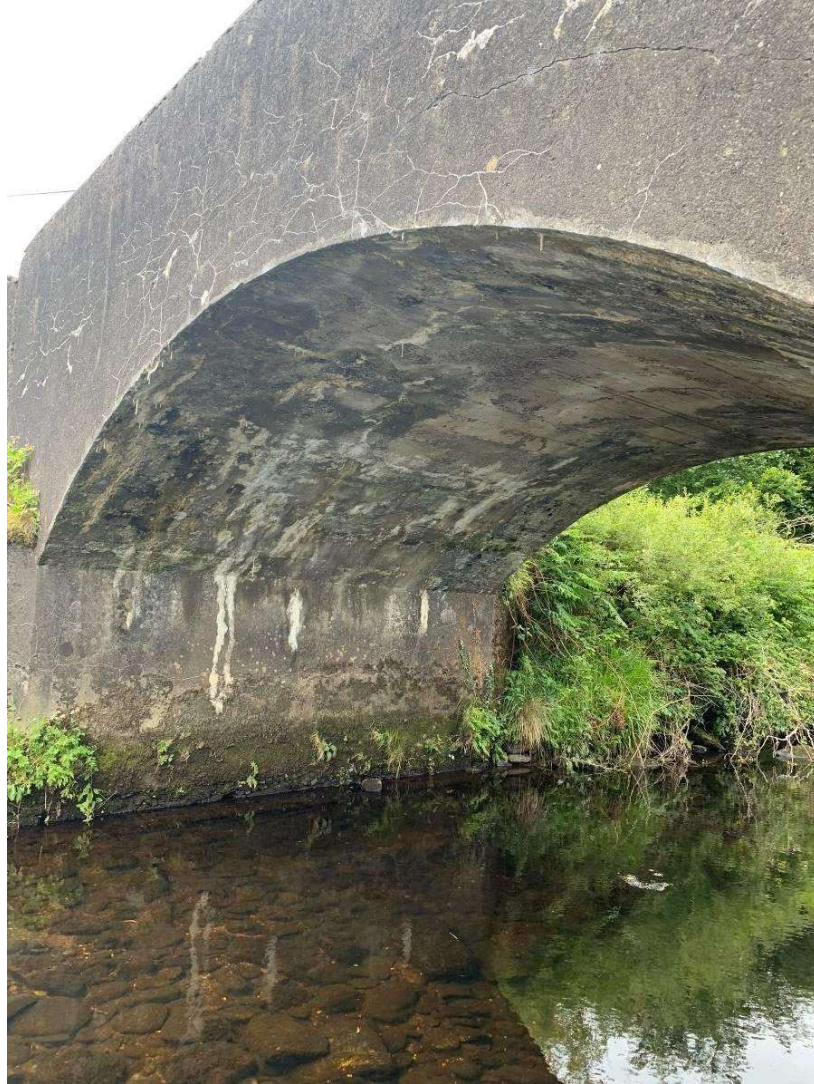
The abutments are generally in good condition. Some minor washout of the concrete is evident towards the abutment footings; however, no undermining or significant loss of material has occurred.

Both arches are constructed in concrete. No significant structural defects were noted.

General view of bridge span showing typical condition of arch barrel and abutment

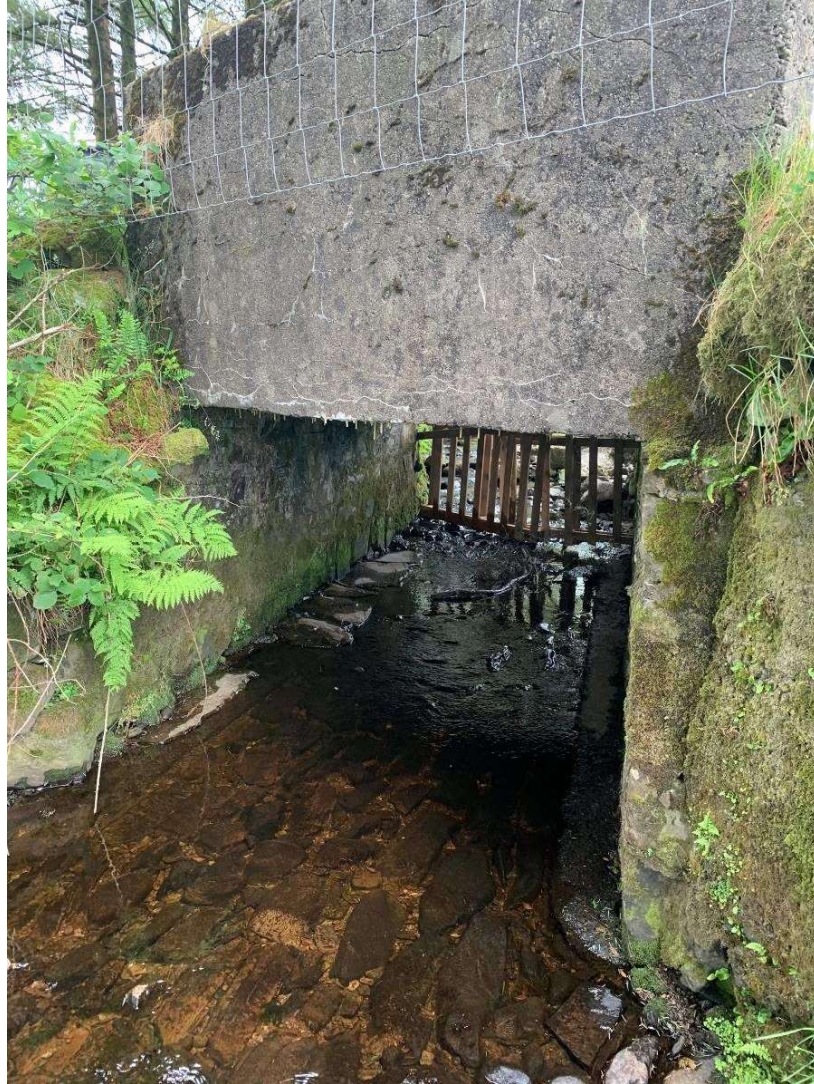
General view of the bridge elevation

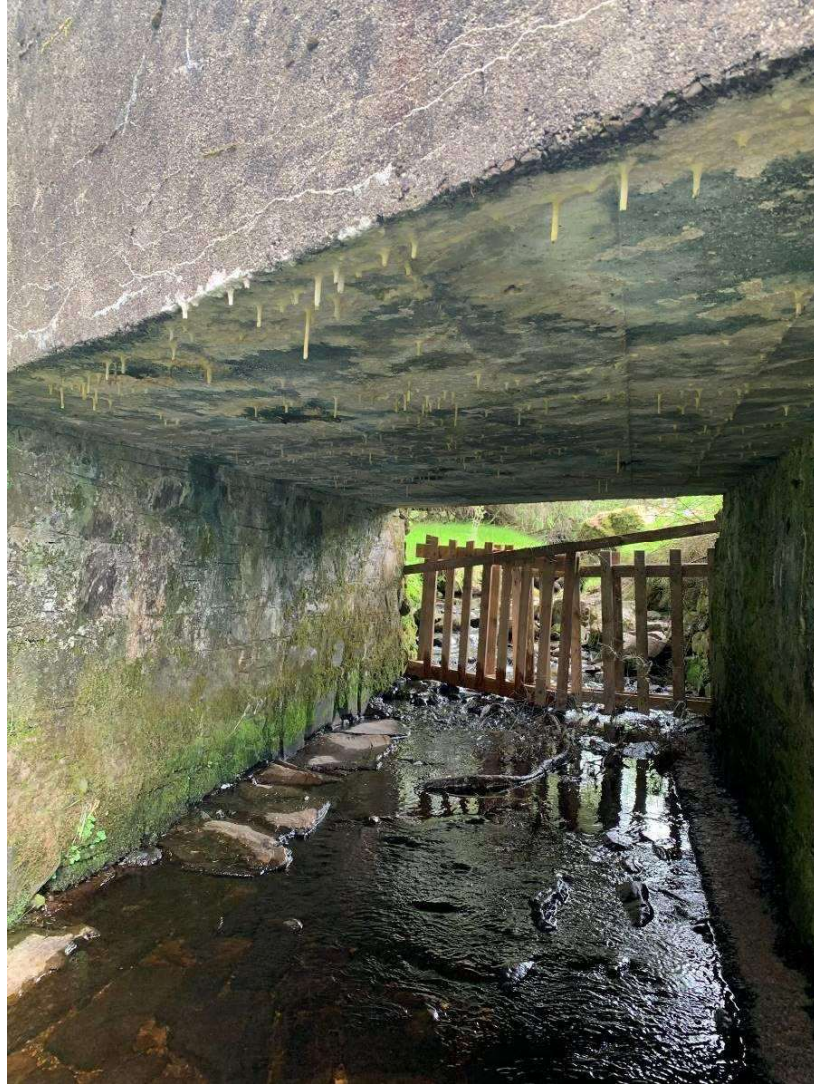
The abutments are constructed in stone masonry. Concrete repairs are evident. Some washout of joints has occurred along the base of both abutments.

No information to the exact construction of the deck slab was available. No significant structural details were noted. Water ingress and calculi staining was evident.

General view through the bridge showing the deck and abutments

Overall the structure is in fair condition with the defects mentioned above. Repairs to the parapets and abutments are required. The waterproofing of the bridge deck should be investigated with consideration to given to removing the soft verges to limit water ingress to the structure.
