## Primary Route Assessment - Port Of Foynes / Gortyrahilly

343154

Wednesday, 23 September 2020

Prepared For Coillte

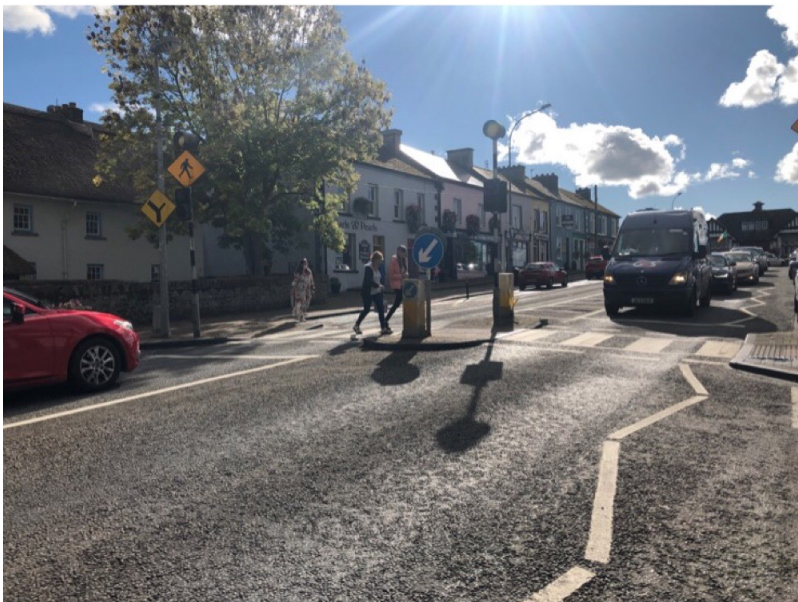
Location 11 - Mini Roundabout In Adare

Visual inspection indicates that the Loaded blade will navigate this roundabout with no issues

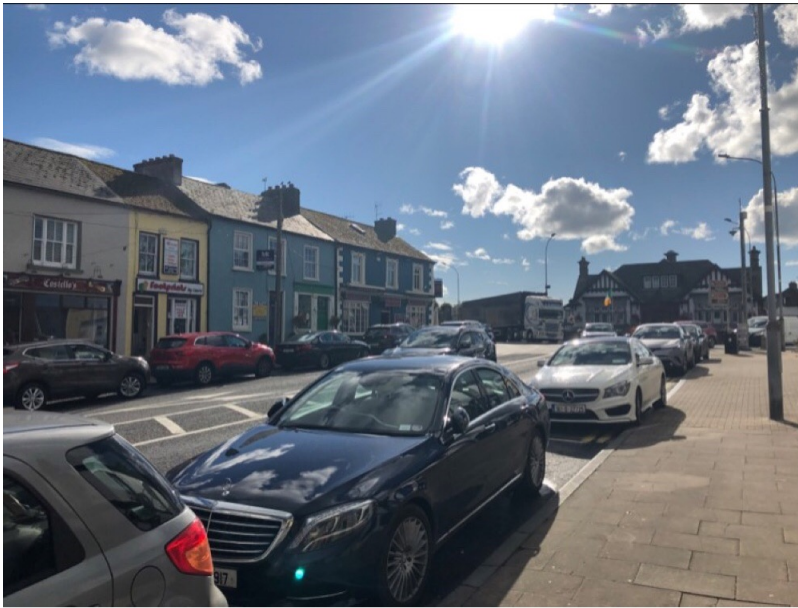
Location 12 - Splitter Island Before Left Bend On Adare

Visual inspection indicates that street furniture on splitter island is to be removed due to left hand bend afterwards.

Topographical survey is required throughout Adare to ascertain accurate mapping data

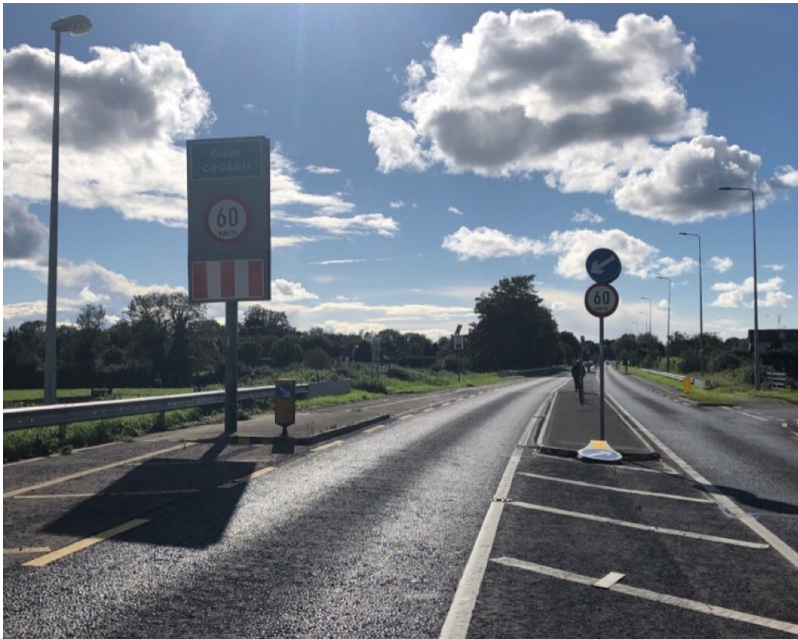
Location 14 - N21 Splitter Island  
And Right Bend At Rathkeale Road  
Junction

Direction Continue On N21  
Visual inspection indicates that a  
contraflow manoeuvre will be  
required at this location as well as  
use of manual steering.

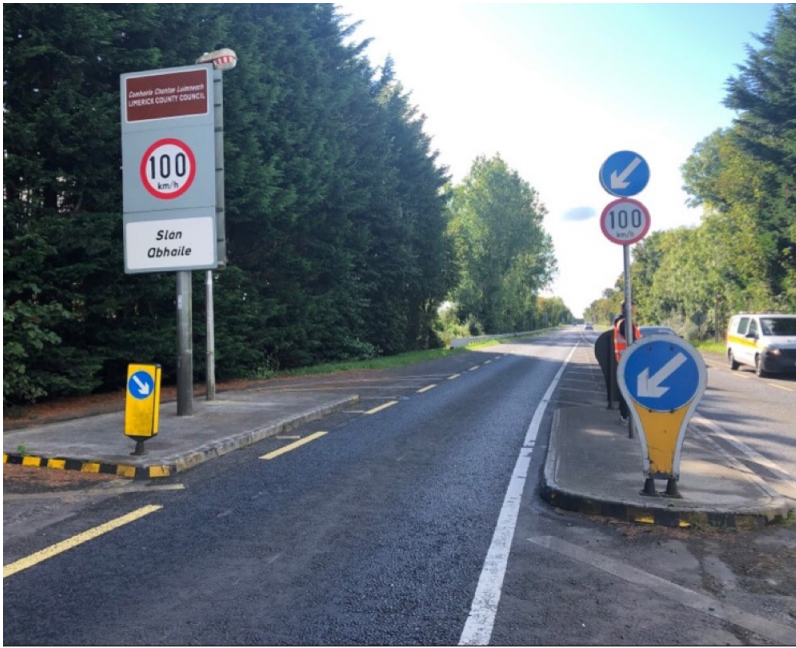
4.3m from nearside Kerb to road sign

4.7m from nearside bollard to sign

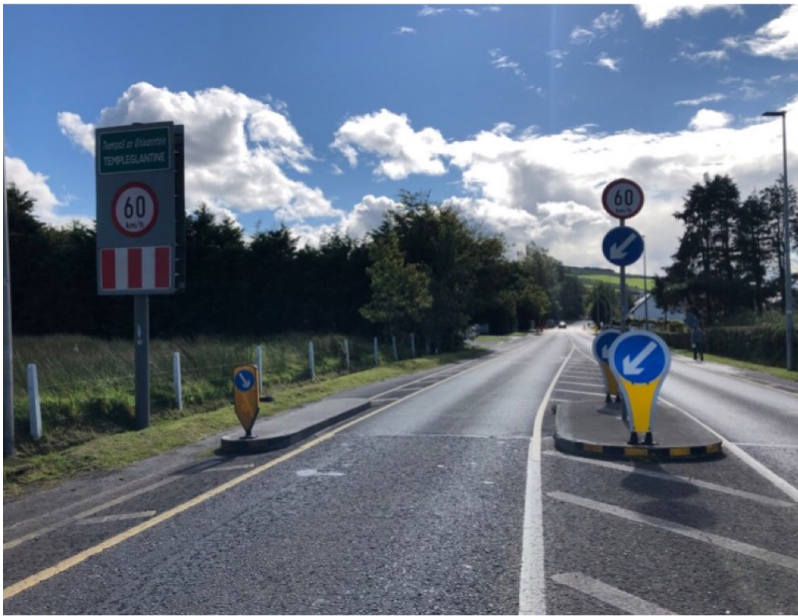
Location 22 - N21 Splitter Island At  
Exit From Newcastle West  
Direction Continue On N21  
Visual inspection indicates that no  
issues at this location  
\*Note\*  
Nearside Kerb to road sign on  
splitter island is 4.4m

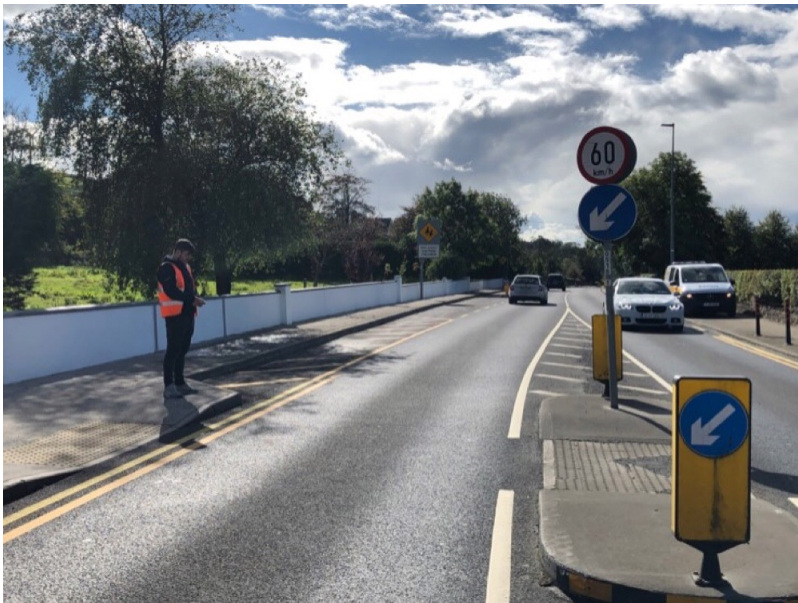
Location 23 - N21 Splitter Island  
At Entry To Templeglantine

Nearside kerb to road sign is 4.3m

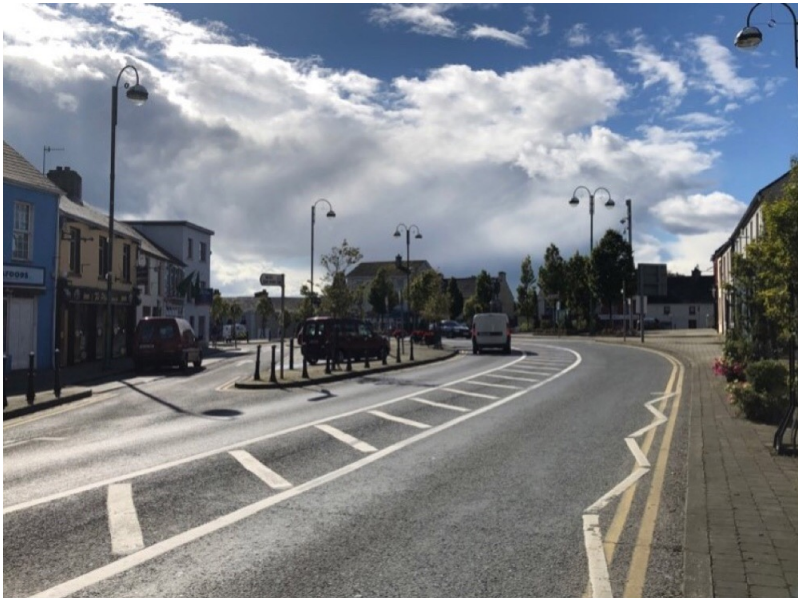
Visual inspection indicates that there are no issues with these splitter islands

\*note\* picture in reverse view

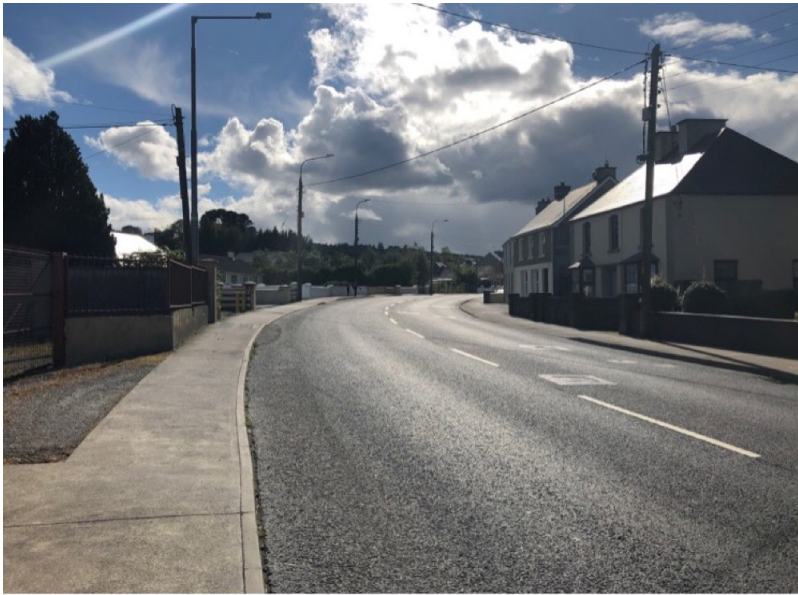
Location 28 - Left Bend On N21 In Abbeyfeale

Parking restriction will be required throughout Abbeyfeale to allow loaded blade to utilise the full width of the road.

Topographical survey is required throughout Abbeyfeale to ascertain accurate mapping data  
Swept path analysis required to confirm modifications

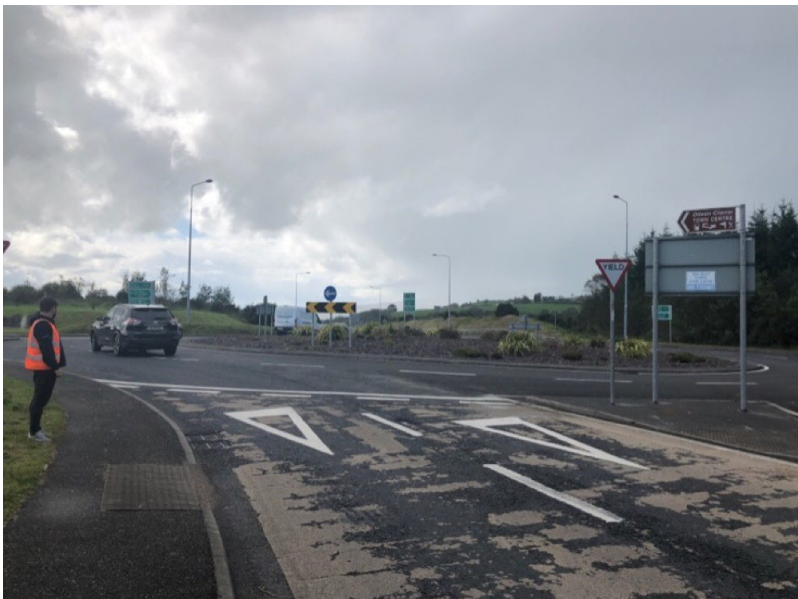
Location 29 - Right Bend In  
Abbeyfeale

Visual inspection indicates that  
loaded blade will require manual  
steering at this bend.

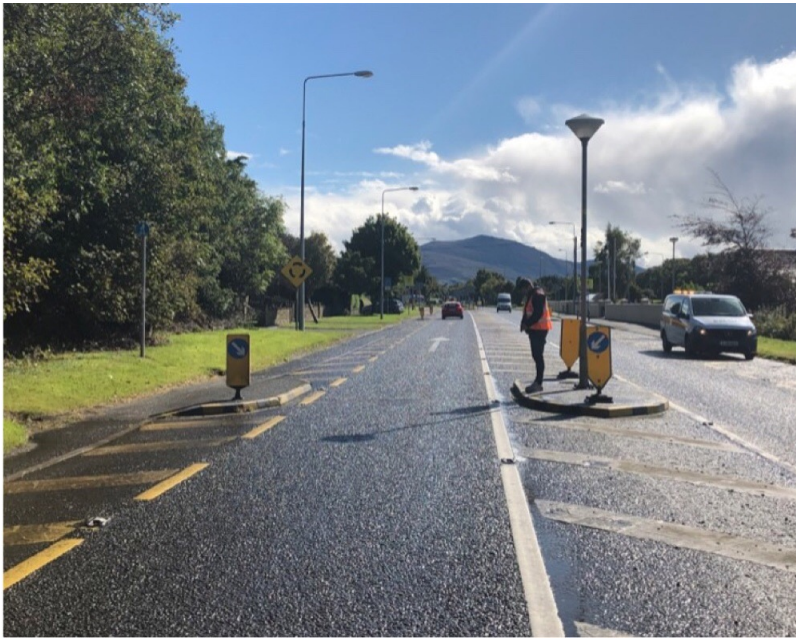
Location 38 - N22 Splitter Island At  
 Entry To Lissivigeen  
 Direction Continue On N22  
 Visual inspection indicates that  
 loaded blade component will  
 navigate with no issues.  
 \*Note\*  
 Road width - 3.8  
 Sign to sign - 5.8

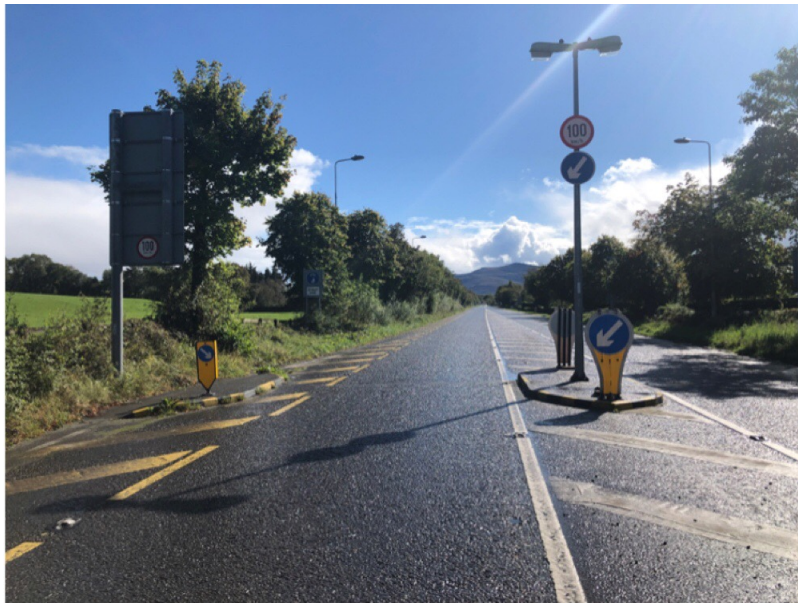
Location 42 - Lissivigeen Splitter Island Exit

Road width - 3.7m

Visual inspection indicates that loaded blade component will navigate through with no issues.

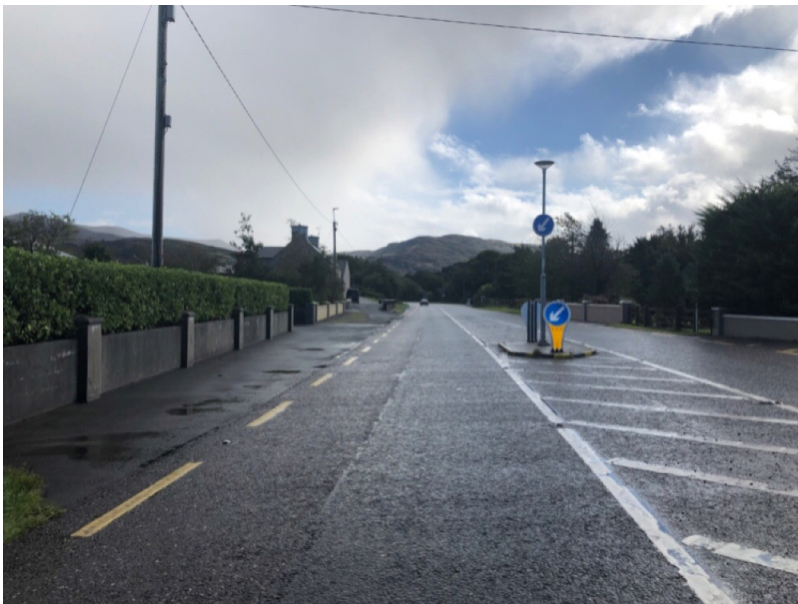
Location 44 - Glenflesk Exit Splitter  
Island

Road width - 4.8
