Primary Route Assessment - Gortrahilly Wind Farm, County Cork

343154

Wednesday, 20 October 2021

52 Locations Assessed

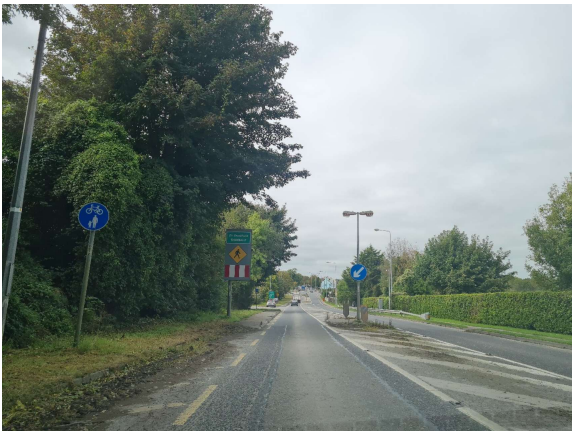
Location 3 - Splitter Island On N28

Visual inspection indicates that there are no issues at this location.

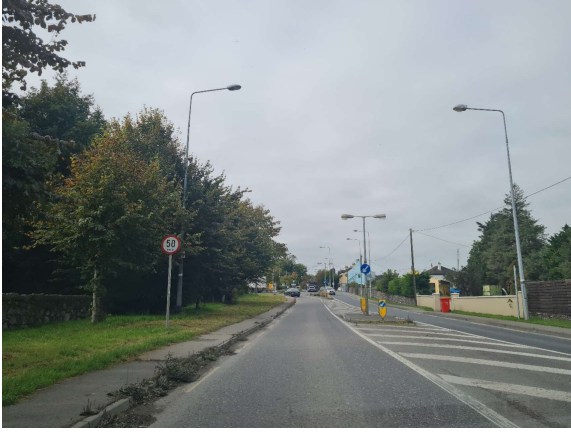
Location 4 - Splitter Island On N28

Visual inspection indicates that there are no issues at this location.

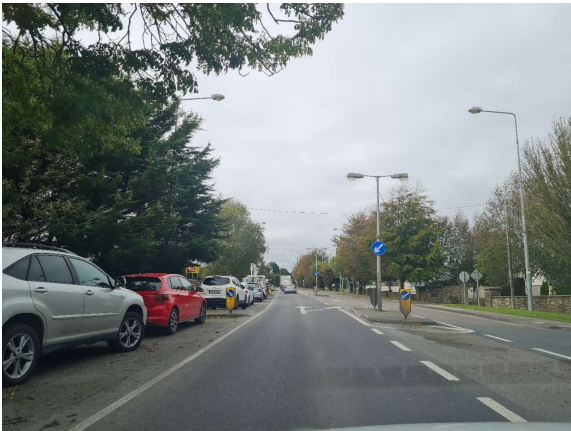
Location 6 - Splitter Island On N28

Visual inspection indicates that there are no issues at this location.

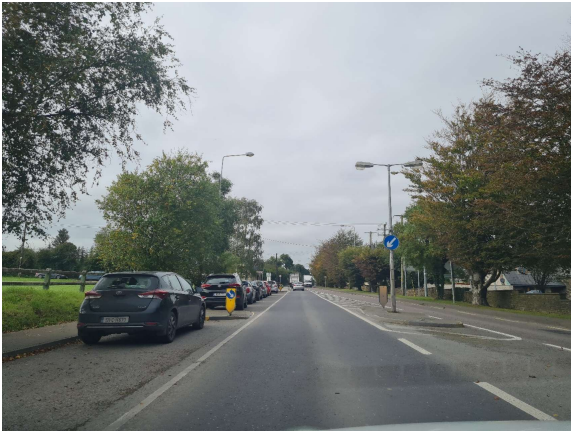
Location 7 - Splitter Island On N28

Visual inspection indicates that there are no issues at this location.

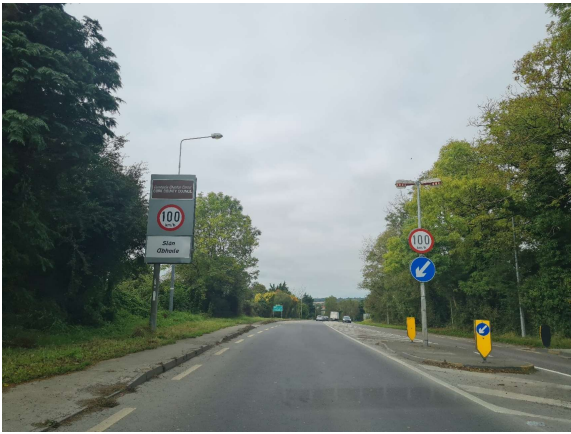
Location 8 - Splitter Island On N28

Visual inspection indicates that there are no issues at this location.

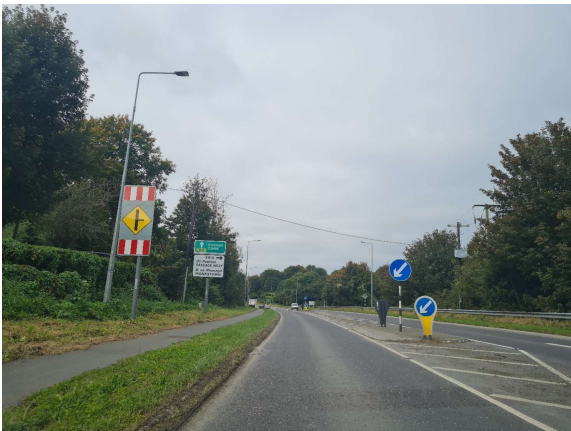
Location 9 - Splitter Island On N28

Visual inspection indicates that there are no issues at this location.

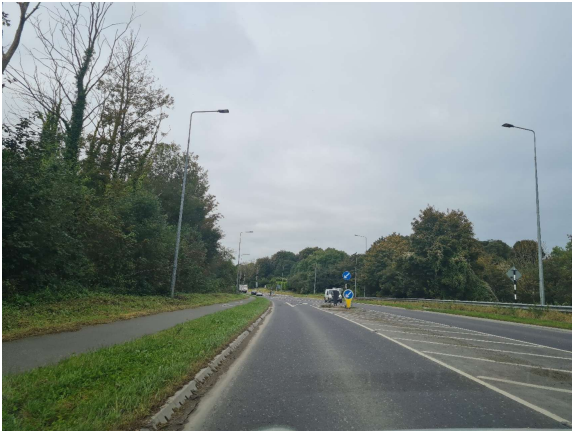
Location 10 - Splitter Island On N28

Visual inspection indicates that there are no issues at this location.

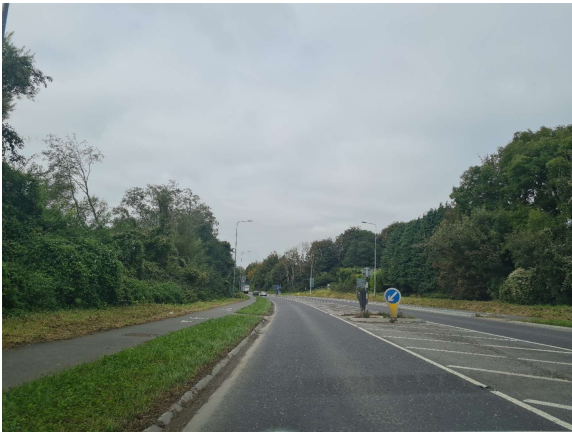
Location 11 - Splitter Island On N28

Visual inspection indicates that there are no issues at this location.

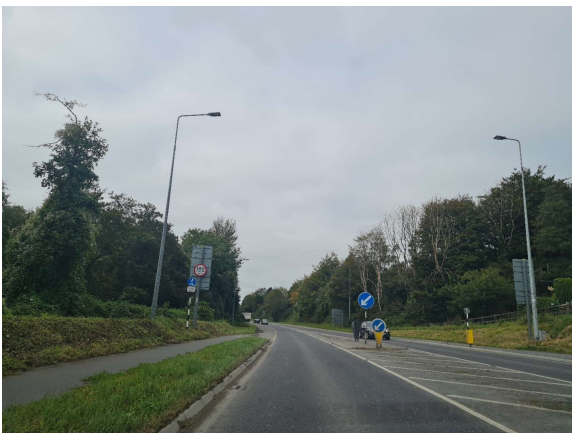
Location 12 - Splitter Island On N28

Visual inspection indicates that there are no issues at this location.

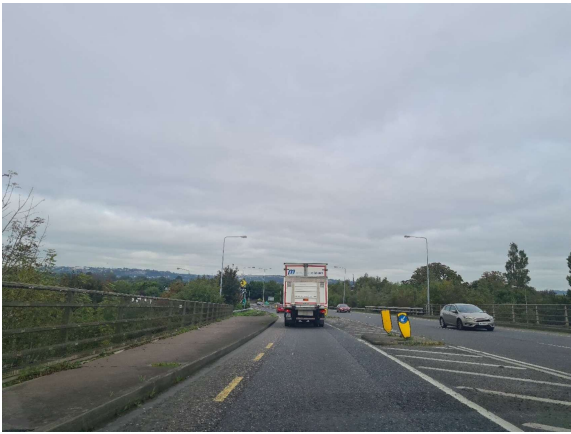
Location 14 - Splitter Island On N28

Visual inspection indicates that there are no issues at this location.

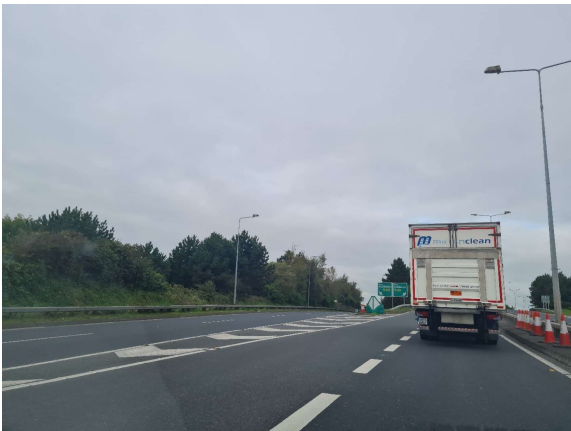
Location 15 - N28/N40 Junction

Visual inspection indicates that there are no issues at this location.

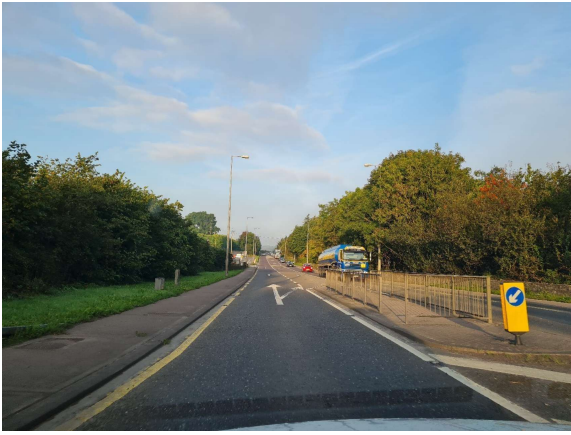
Location 16 - Splitter Island On N22

Visual inspection indicates that the loaded vehicle will navigate this location without any issues.

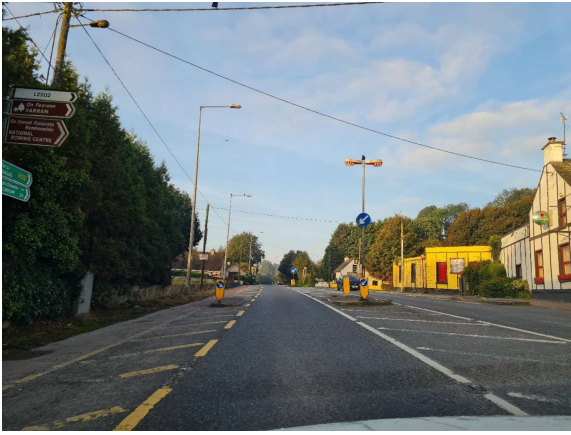
Location 19 - Splitter Island On N22

Visual inspection indicates that the loaded vehicle will navigate this location without any issues.

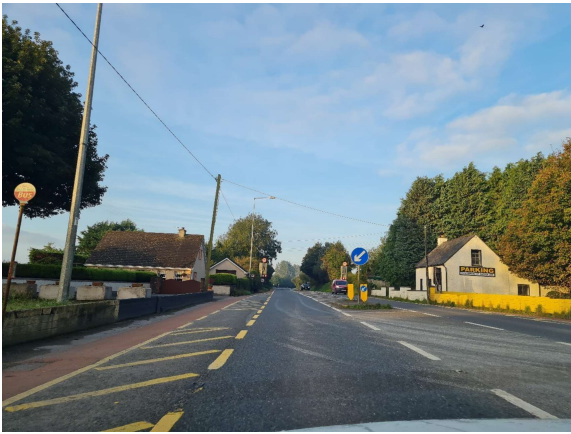
Location 20 - Splitter Island On N22

Visual inspection indicates that the loaded vehicle will navigate this location without any issues.

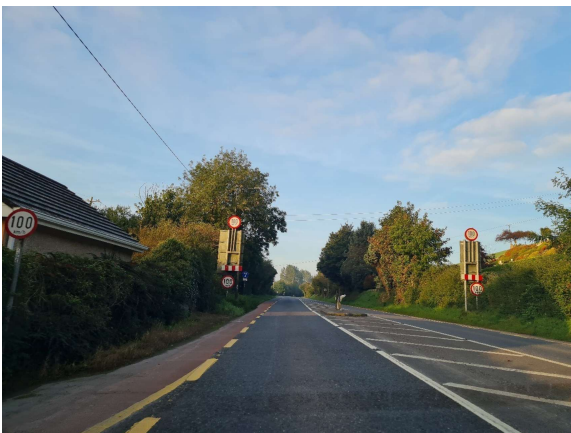
Location 21 - Splitter Island On N22

Visual inspection indicates that the loaded vehicle will navigate this location without any issues.

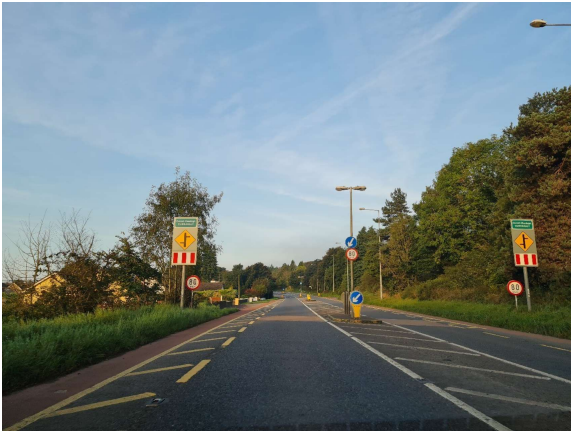
Location 22 - Splitter Island On N22

Visual inspection indicates that the loaded vehicle will navigate this location without any issues.

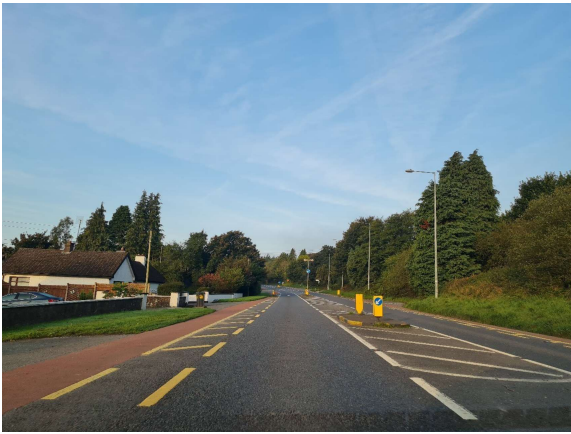
Location 23 - Splitter Island On N22

Visual inspection indicates that the loaded vehicle will navigate this location without any issues.

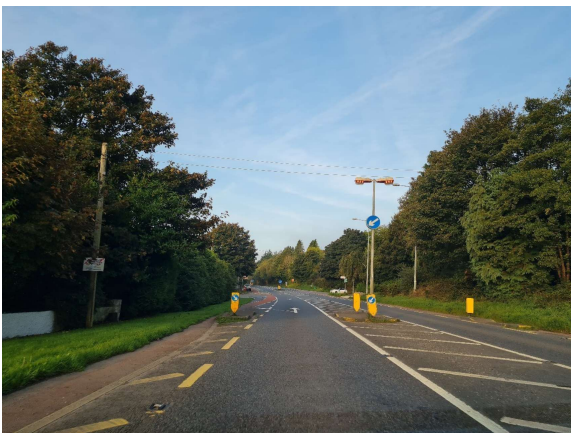
Location 24 - Splitter Island On N22

Visual inspection indicates that the loaded vehicle will navigate this location without any issues.

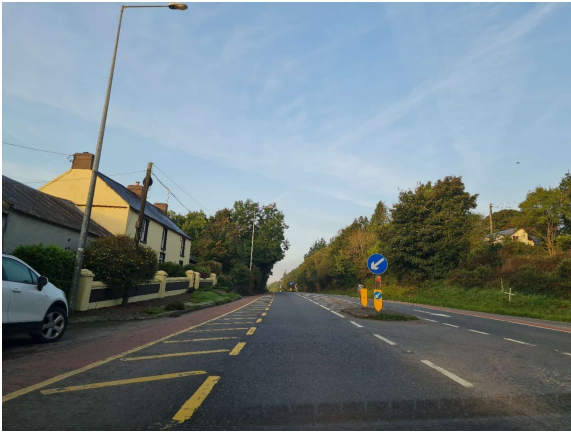
Location 25 - Splitter Island On N22

Visual inspection indicates that the loaded vehicle will navigate this location without any issues.

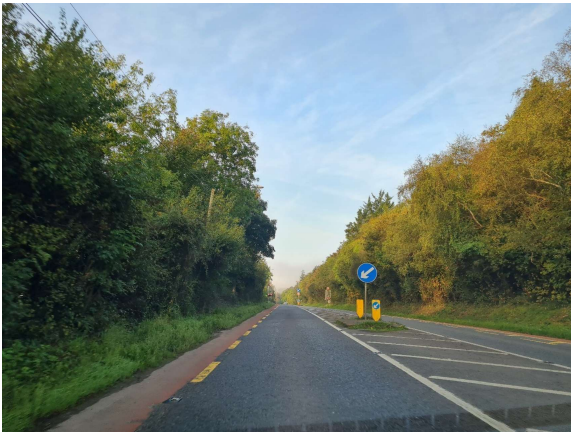
Location 26 - Splitter Island On N22

Visual inspection indicates that the loaded vehicle will navigate this location without any issues.

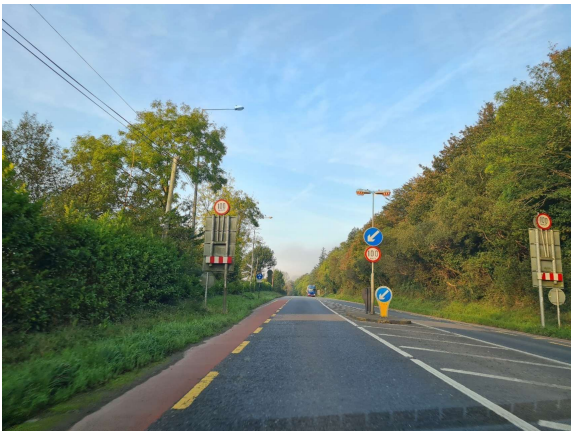
Location 27 - Splitter Island On N22

Visual inspection indicates that the loaded vehicle will navigate this location without any issues.

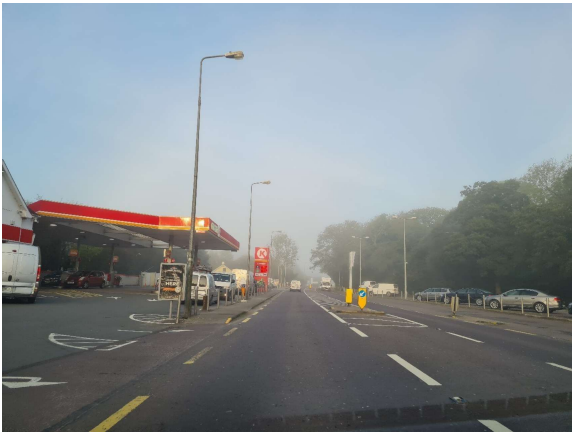
Location 29 - Splitter Island On N22

Visual inspection indicates that the loaded vehicle will navigate this location without any issues.

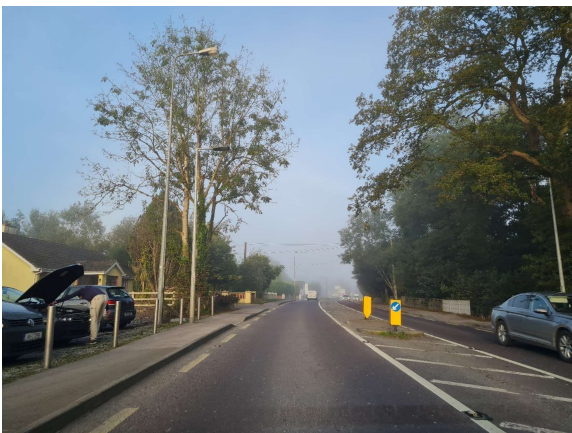
Location 30 - Splitter Island On N22

Visual inspection indicates that the loaded vehicle will navigate this location without any issues.

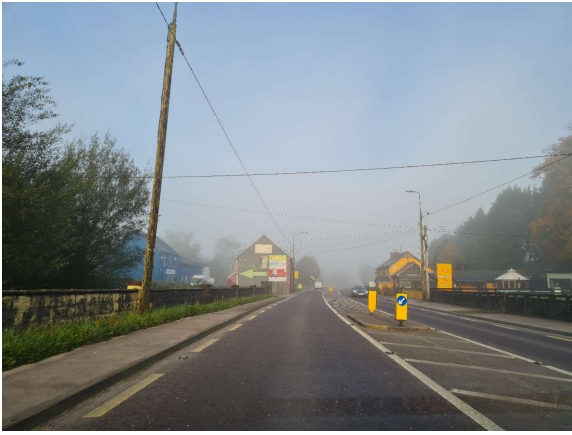
Location 31 - Splitter Island on N22

Visual inspection indicates that the loaded vehicle will navigate this location without any issues.

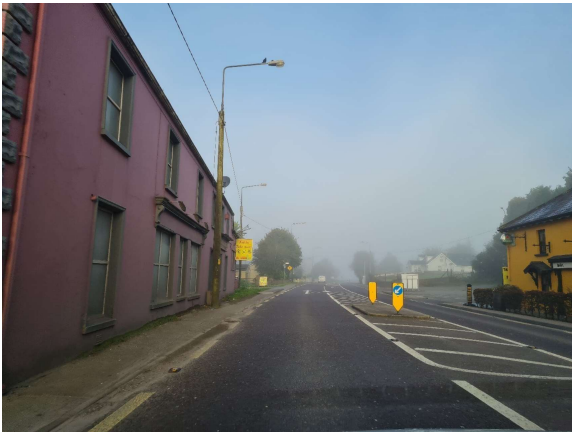
Location 32 - Splitter Island On N22

Visual inspection indicates that the loaded vehicle will navigate this location without any issues.
