Appendix D1
Arboricultural Impact
Assessment Report -
Ballymun to City
Centre

Arboricultural Assessment, Report

Scheme 03:
Ballymun To
City Centre

Project No.	TBAL001	Date	24/08/22
Project Name	BUSCONNECTS Core Bus Corridors. Emerging Preferred Routes / Public Consultation	Revision	-

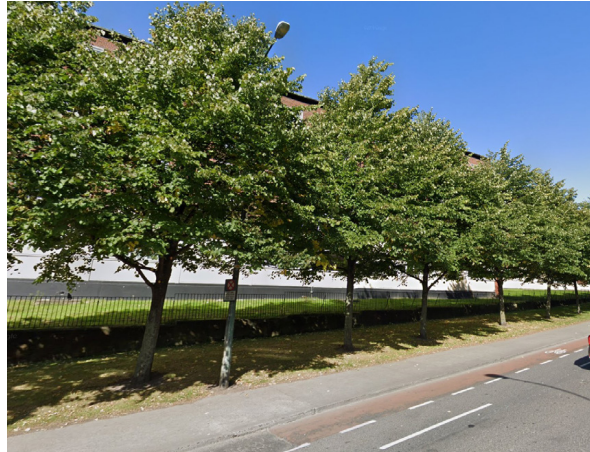
Image 2. Lime trees on Constitution Hill.

From Aran Quay to the Phibsborough Road bridge, there is a low density of urban tree stock, of which Norway maple *Acer platanoides* and London plane *Platanus × acerifolia* are the most common species located here. These trees are of a healthy mix of age profiles, with the majority being early mature. The largest single group of trees in this area, are within an wide open grass area on Constitution Hill. These benefit form these favourable soil conditions and are well developed as a result (image 2).
