Appendix D2
Arboricultural Impact
Assessment Report -
Finglas to
Phibsborough

Arboricultural Assessment, Report

Scheme 04: Finglas To City Centre

Project No.	TFIN001	Date	24/08/22
Project Name	BUSCONNECTS Core Bus Corridors. Emerging Preferred Routes / Public Consultation	Revision	-

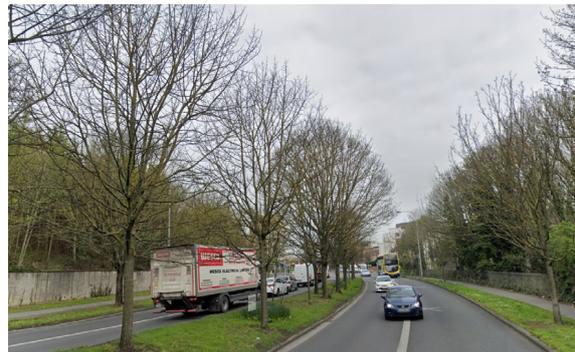
North of the Old Finglas Road and Tolka Valley apartments Fastigiata hornbeam (*Carpinus betulus 'Fastigiata'*) and Sycamore (*Acer pseudoplatanus*) populate the central median (image 7). These trees contain some poorer specimens due to poor soil conditions. More mature sycamores are located in grass verges along the western side of the roadway. These trees are better developed and have benefited from larger planting areas.

Image 7. Sycamore in the central median north of the Old Finglas Road.

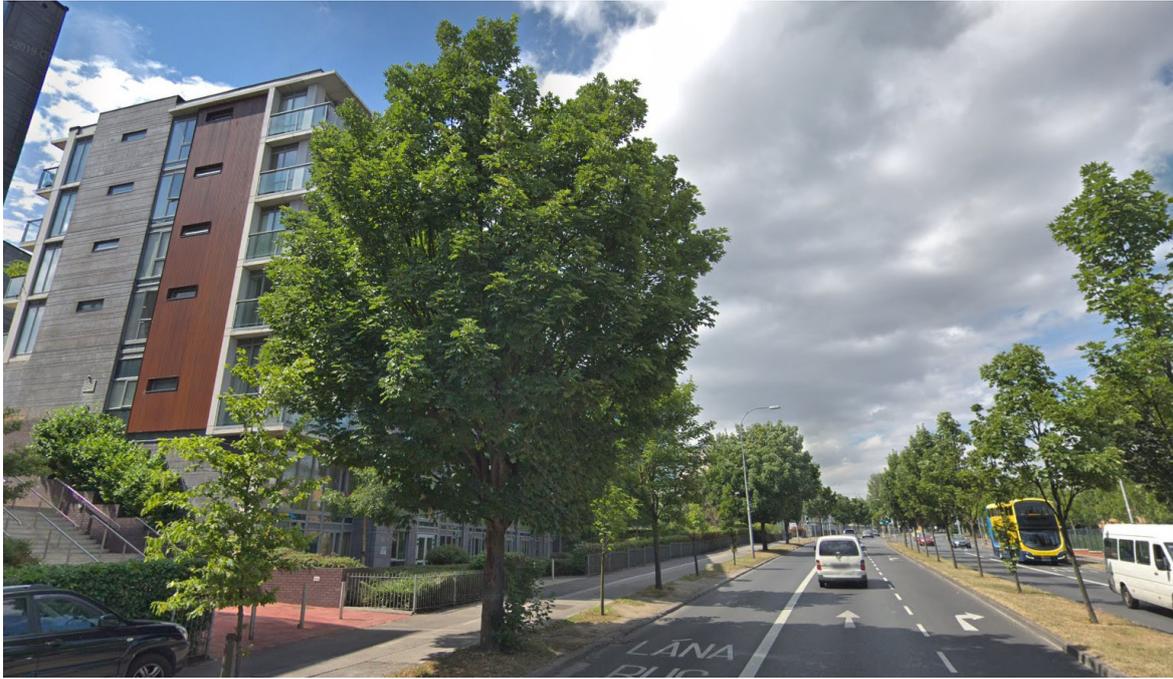
Adjacent to the Tolka and Eden Apartments, are located some of the more mature sycamore surveyed on the route (at heights of 17m) (image 8). These trees provide good amenity value to residents living in high density apartments with a lack of local open green spaces within the immediate locality.

Image 8. A larger early mature sycamore street tree adjacent to the Tolka and Eden Apartments.

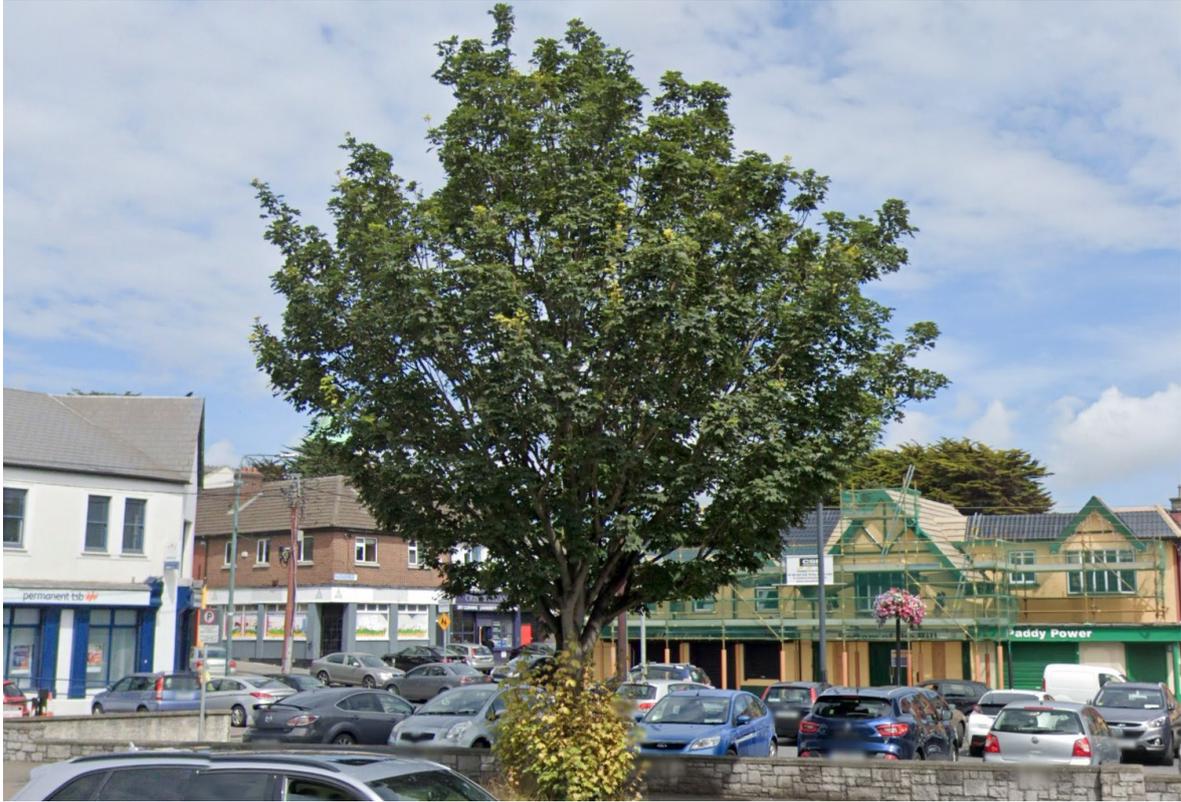
These are some of the poorer quality trees, located in this section, due to sub-optimal soil conditions and close proximity planting. Adjacent to Finglas Village are located early mature Sycamore (*Acer pseudoplatanus*) (image 12). Some of these trees exhibit basal growth near footpaths, that would be best removed for aesthetic and safety concerns.

Image 12. An early mature sycamore in Finglas village.
