BusConnects Core Bus Corridors  
Ballymun/Finglas to City Centre  
Scheme

Stage 1 Road Safety Audit

**Document Ref:** P21-026-PSW1-RP-001

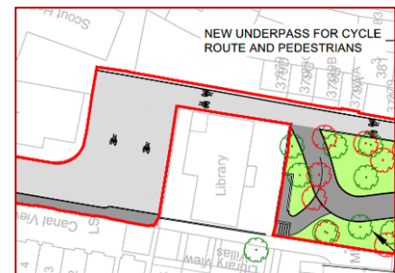
During the Site Visit it was noted that forward visibility for all road users proceeding around the north-eastern corner of the library, north of the North Circular Road, is extremely limited.

The proposed arrangement does not alter the existing road layout at this location, and insufficient forward visibility could result in collisions between opposing traffic, or between opposing vehicle/cyclist traffic.

Adequate forward visibility should be provided at this location for the anticipated operational speeds. It may be possible to provide build-outs on the northern side of the corner to guide vehicles along a route which maximises, as much as possible, forward visibility towards approaching vehicles/cyclists.

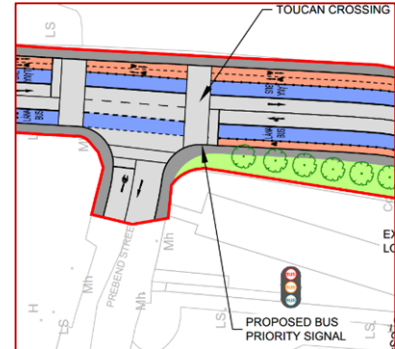
It is likely that there will be significant volumes of cyclists wishing to cross the road at the two Toucan crossings at the intersection with Prebend Street to/from TUD. No area/reservoir for crossing cyclists to wait, without either blocking pedestrians wishing to travel along the adjacent footpath or blocking cyclists wishing to proceed straight-ahead, has been indicated.

This could result in some cyclists moving out into the adjacent bus lane in order to continue along their route, with an increased risk of being struck by a vehicle in the bus lane.

The road layout should accommodate the expected volumes of crossing cyclists at this location without impeding pedestrians on the adjacent footpath or straight-ahead cyclists.

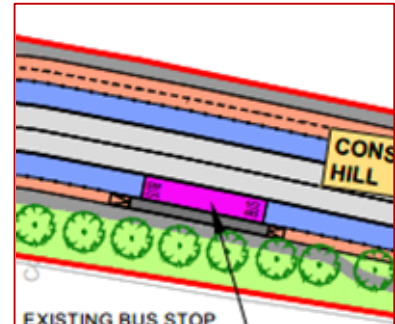
*Location:* Drawing No BCIDD-ROT-GEO\_GA-0304\_XX\_00-DR-CR-00016 (Rev S3 L02)

*Summary:* Cyclist proximity to a stationary bus at the bus stop could result in collisions between cyclists and disembarking passengers.

The route for northbound cyclists at the bus stop at Chainage A6040 is such that cyclists may be passing close to a stationary bus where visibility to them may be restricted, presenting a risk to disembarking passengers and possibly resulting in collisions between cyclists and disembarking passengers.

The layout at this location should be amended so that cyclists can safely pass the bus stop away from a stationary bus and waiting passengers.

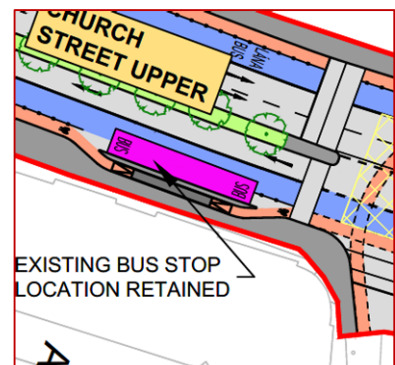
The bus stop at Chainage A6250 has been indicated as being inset from the bus lane, resulting in a very narrow island, a sudden change in direction for cyclists and a narrow footpath width.

The layout is such that cyclists may be passing close to a stationary bus where visibility to them may be restricted, presenting a risk to disembarking passengers and possibly resulting in collisions between cyclists and disembarking passengers.

The bus stop should be positioned within the adjacent bus lane and the floating-island increased in width so that there is adequate room for the island to accommodate waiting passengers without impeding cyclists, and to increase the distance between cyclists and disembarking passengers.

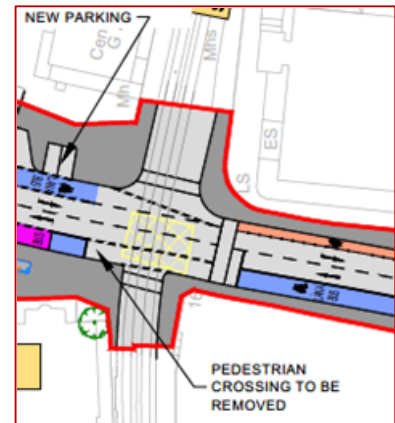
The merging of the southbound bus lane with the adjacent general-traffic lane on the Church Street approach to the junction with Chancery Street is indicated as occurring within the junction, and across the Luas tracks.

This could lead to standing vehicles within the junction and on the tram lines where vehicles in the traffic lane fail to give way to merging buses and where there is a queue downstream, with a resulting increased risk of tram/vehicle conflicts.

The reduction in the number of lanes should be completed prior to entering the junction, similar to the current arrangement. This junction should be a 'Bus Priority' signals junction.

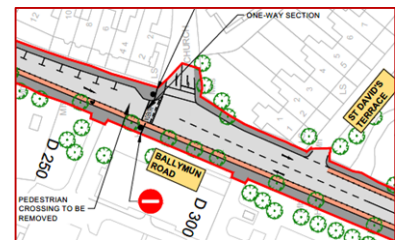
*Summary: Insufficient guidance for southbound drivers on the one-way section of Ballymun Road on the approach to the recommencement of the two-way section of road at Chainage D275*

Vehicles travelling south on the proposed new one-way section of Ballymun Road, approaching the recommencement of the two-way section of road at Chainage D275, may inadvertently enter the oncoming lane leading to collisions with oncoming traffic.

The road layout on the southbound approach should include measures (e.g. a buildout) which aligns southbound traffic with the downstream southbound lane to the south of the junction with Church Avenue.

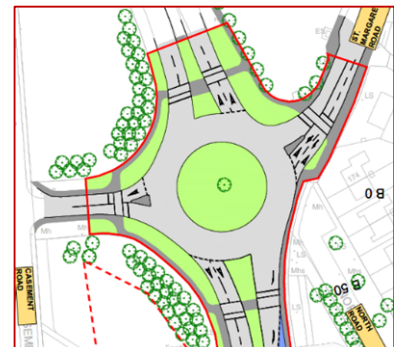
Two-lane entries are indicated on three of the arms at the St Margaret Road roundabout, however not all arms have two-lane exits.

This could result in poor lane discipline on behalf of some drivers, leading to possible side-swipe incidents on the circulating carriageway and at the exits from the roundabout.

Concentric spiral markings should be provided within the roundabout circulating carriageway.

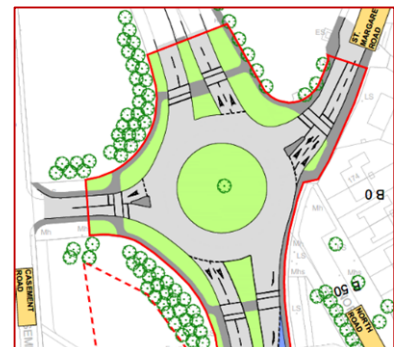
*Summary: Possible queues extending into circulating carriageway from signalised crossing of exits.*

The proximity of the signalised pedestrian crossings of the St Margaret Road & Casement Road arms of the roundabout could lead to queues extending back from the signals into the circulating carriageway, blocking adjacent entries and leading to driver frustration and rash/unsafe manoeuvres.

During the design development, the requirement for yellow junction box markings within the circulating carriageway should be assessed.

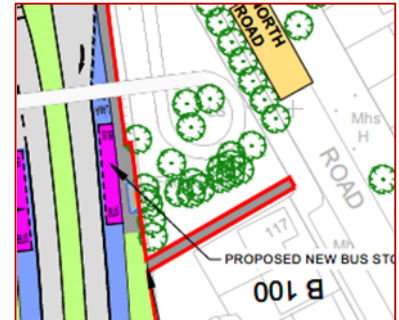
*Summary: Gap in proposed footpath provision to/from bus stop.*

A footpath is indicated between North Road & Finglas Road, near the southbound bus stop at Chainage B80, and is shown terminating at a grass verge, which will require pedestrians travelling to/from the bus-stop having to cross an unpaved area leading to possible slips, trips or falls in particular during wet or icy weather.

The footpath should extend to the bus stop.

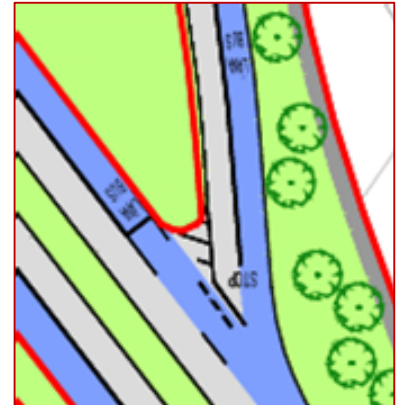
The angle of the stop line on the southbound on-ramp at the grade-separated junction is not shown as perpendicular to the direction of approaching traffic, which could lead to vehicles at the stop line protruding into the path of vehicles in the bus lane on the Finglas Road.

In addition, no stop line has been indicated on the bus lane on the on-ramp approaching the merge with the Finglas Road. It is unlikely that a bus can merge safely given the entry angle at this location, and the possible lack of visibility towards approaching traffic within the bus lane on the Finglas Road. This could result in collisions between merging bus lane traffic and straight-through southbound bus lane traffic

The stop line should be perpendicular to the direction of travel of approaching traffic.

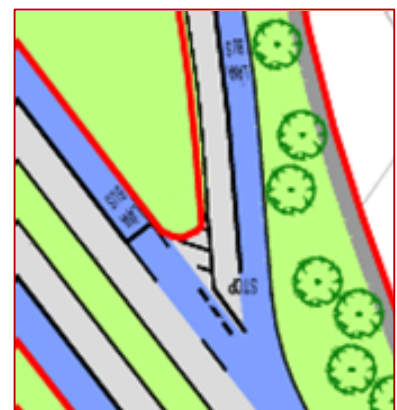
A stop line has been indicated within the bus lane only on the Finglas Road approaching the southbound merge from the Mellowes Road grade-separated junction. It appears that the intention is that only bus lane traffic will be required to stop at the signals, and that traffic in the adjacent traffic lane will be permitted to continue.

There is a risk that some drivers travelling within the bus lane may attempt to minimise perceived delays and avoid a red signal at the last minute, by undertaking a late lane-change manoeuvre leading to possible side-swipe collisions with vehicles in the adjacent traffic lane.

Measures should be provided to prevent late manoeuvres on the approach to these signals.
