Appendix 14G  
Bridge Condition Survey

# Structures Visual Inspection Report

Project Tynagh

Project reference: Project Tynagh  
Project number: 60661667

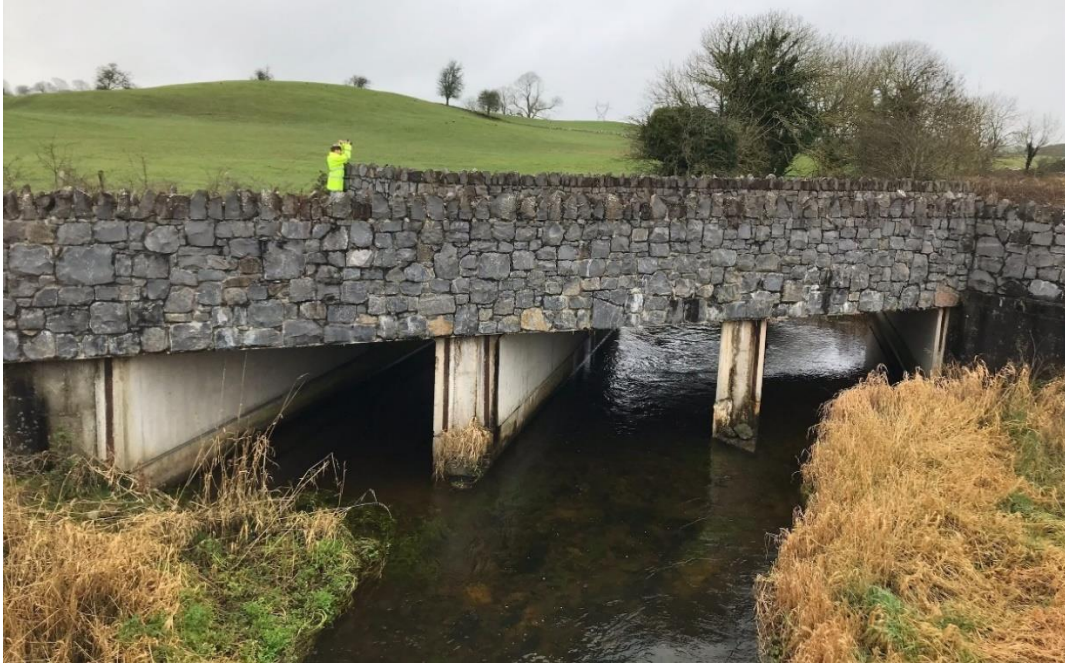
Figure 5 – East Elevation

14	Structure in General	2	Y	-	-	Structure was found to be in good condition with some minor defects to elements noted. No major defects were noted to ancillary elements which would indicate that the primary elements of the structure were in distress. See Figure 5 to Figure 16 in Appendix A for general structure photographs.

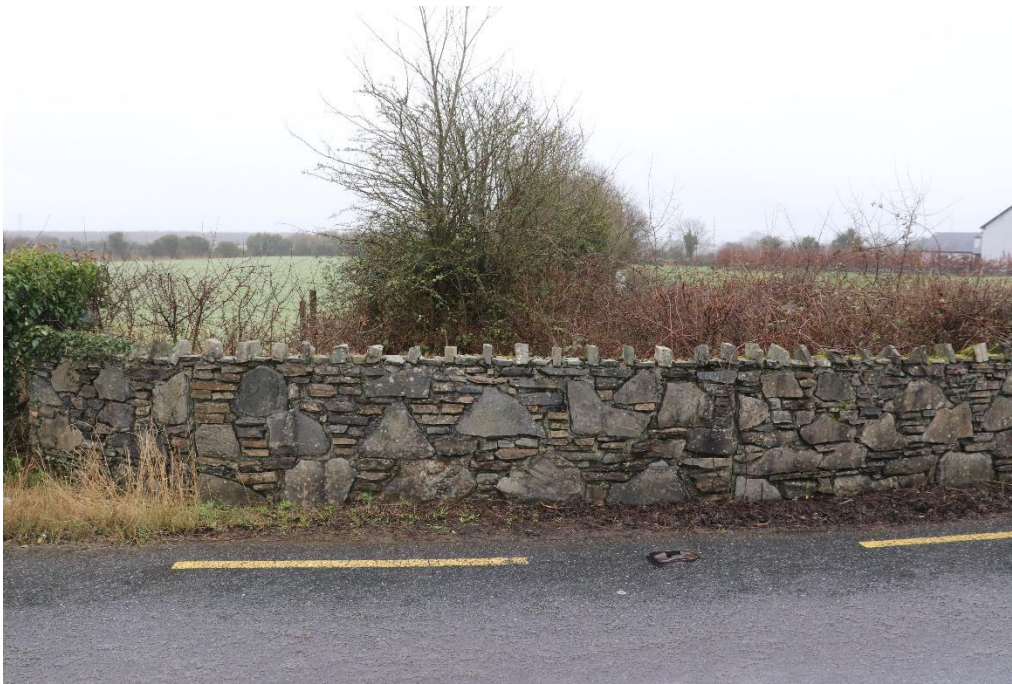
**Figure 39 – East Parapet**

Component No.	Component	Condition Rating	Maintenance Required	Defect Type	Photos	Comments
4	Parapet/safety Barrier	0	N	26	Y	Inspection of parapets was undertaken from the bridge deck. Heavy vegetation was present over the northern portion of the east parapet. If left unmaintained could damage the masonry facing. No major defects were noted to the parapets over the structure, see Figure 38 and Figure 39 in Appendix B for general condition. However, the west parapet height (450mm) is too low for pedestrians and should be increased to 1.25m in accordance with DN-REQ-03034, The Design of Road Restraint Systems (Vehicle and Pedestrian) for Roads and Bridges.
5	Embankments / Revetments	0	N	26	N	No defects noted to the east or west embankment or revetments of the structure, however, access to the east embankment was limited due to the excessive vegetation.
6	Wingwalls / Spandrel Walls / Retaining Walls	2	N	26	Y	Wing walls of the structure were found to be in good condition with some vegetation growth, see Figure 40 and Figure 48 in Appendix B. Access to the wingwalls on the east was limited due to excessive vegetation.

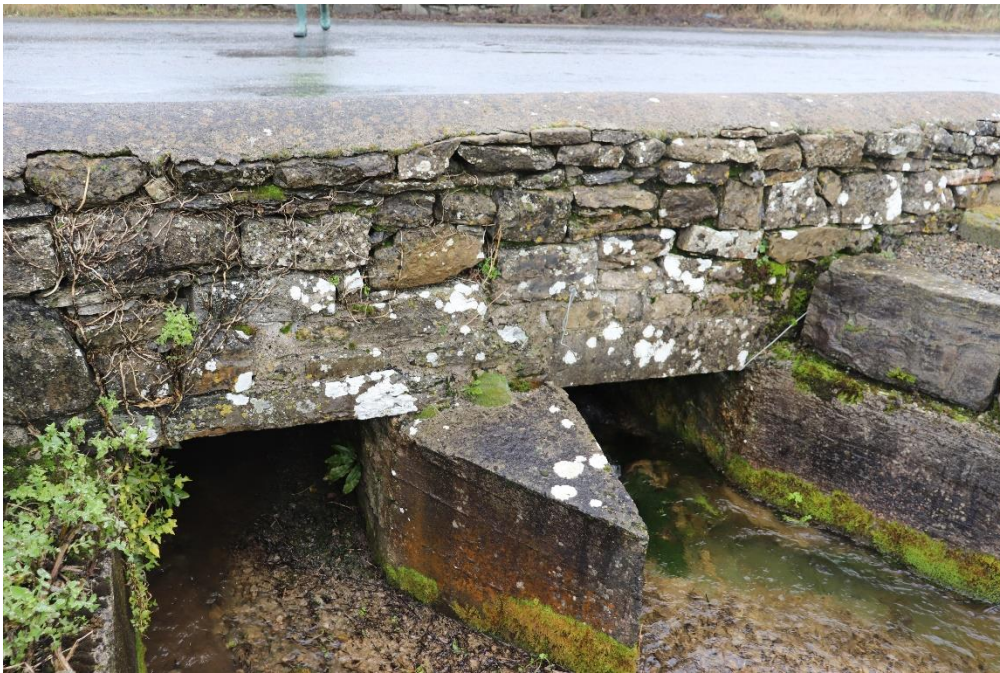
**Figure 41 – Central Pier**

7	Abutments	2	N	26	Y	Abutments to the structure were found to be in good condition with some vegetation growth, see Figure 40 and Figure 48 in Appendix B. Access to the abutments on the east was limited due to excessive vegetation.
8	Piers	0	N	-	Y	Central Pier was found to be in good condition with no defects noted, see Figure 41 in Appendix B.
9	Bearings	N/A	N/A	N/A	N/A	Not applicable to this structure.
10	Deck/Slab	0	N	-	N	No defects noted to the deck soffit of the structure. Due to the limited clearance within the structure, <1m, inspection of the soffit was not possible.
11	Beams / Girders / Transverse Beams	0	N	-	Y	Transverse capping stones and beams were found to be in good condition with no defects noted. See Figure 42 and Figure 44 in Appendix B.
12	Riverbed	2	Y	26 36	Y	Debris and silt build-up on the northeast of the structure. Otherwise, the riverbed is in good condition. See Figure 46 and Figure 49 in Appendix B.
