Appendix P
Templeogue Arch –
Structural Appraisal and
Outline Recommendations
for Repair

Templeogue Arch, Templeogue, Co. Dublin

Structural Appraisal and outline recommendations for repair

Project 22548

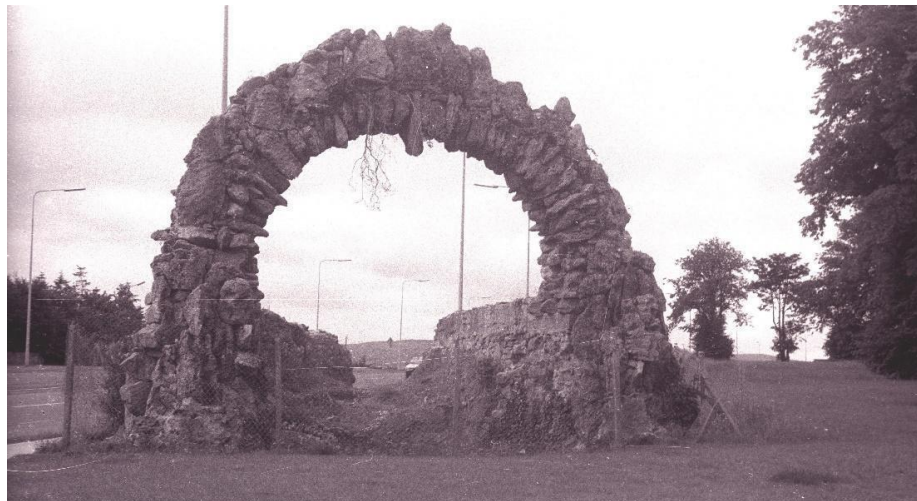
Figure 5 – Historic photo of arch, prior to stone falling from centre of arch (*Rustic Gothic Arch*) Templeogue, by Patrick Healy, 1987, South Dublin County Council, URI: <https://hdl.handle.net/10599/2696>)

The arch is largely intact and structurally stable. However several stones of the rusticated capping have fallen from the top of the arch; most of these were present on the ground at the base of the arch and were visible once the vegetation had been cleared. This loss of overburden stone is compromising the arch structure, which relies on an even distribution of weight from above in order to act as a 'true arch'.

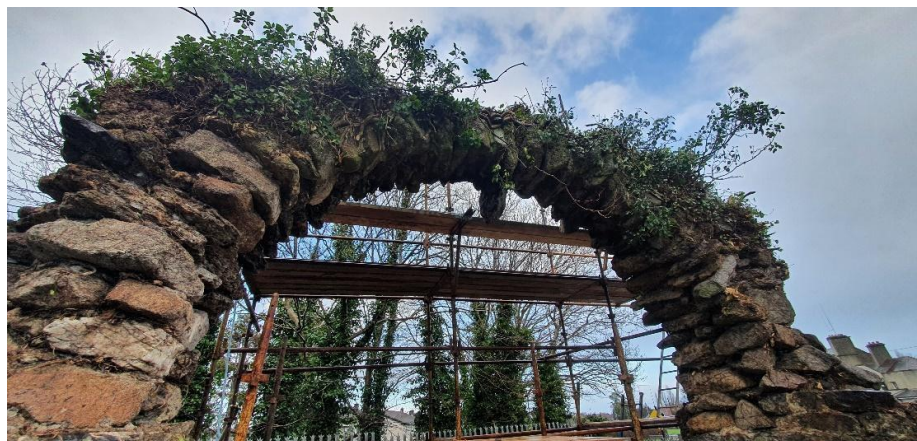
Figure 6 – Arch during vegetation removal

There were ivy roots growing on and around the arch stones. The majority of these were removed during vegetation removal works however the roots deeply embedded in joints were left until such a time as masonry works are commissioned. There were some large joints between stones exposed once the vegetation was removed. The joint at the left hand side of the key stone, which can be seen in Figure 4, was particularly wide, and so this was pinned and repointed immediately following the vegetation removal works.

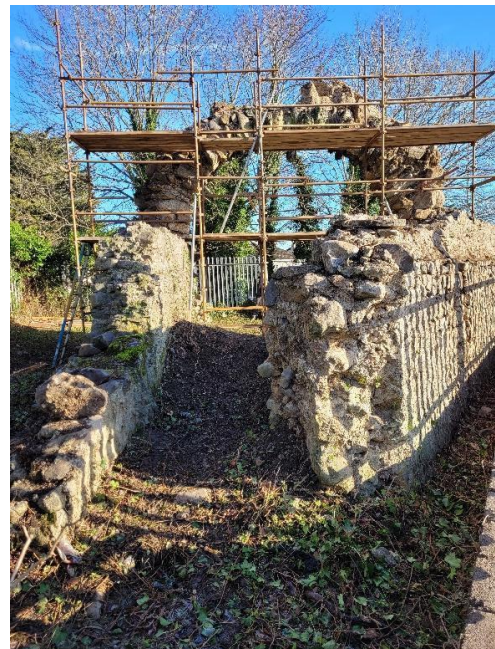
Figure 9 – Arch and flank walls after vegetation removal

The walls flanking either side of the arch are in reasonable condition. However there has been some stone and mortar loss from the wall tops and there are several vertical cracks in the walls. These cracks were likely caused by the large ivy roots growing within the masonry. The wall tops were covered in vegetation until recently, which has dislodged the top stones. These are now loose and allowing water ingress into the core of the flanking walls.

- vi. Flanking walls to be repointed in an appropriate lime-based mortar. Any remaining roots in the wall to be treated and removed as masonry works proceed. Once roots are removed, vertical cracks to be stitched using long stones across the crack.

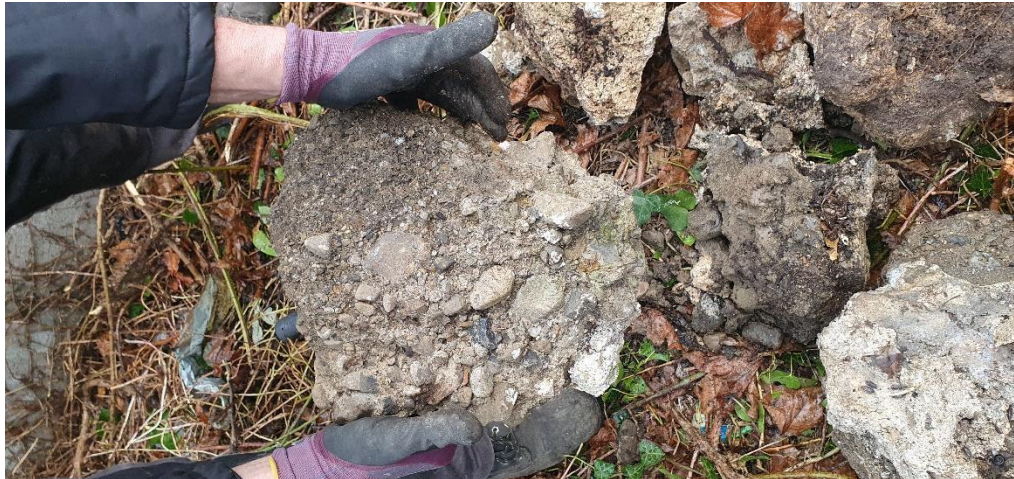
Figure 14 – Artificial stone (limecrete)

There are also large blocks of reconstituted stone, formed of large aggregates and a lime mortar to look like a conglomerate.

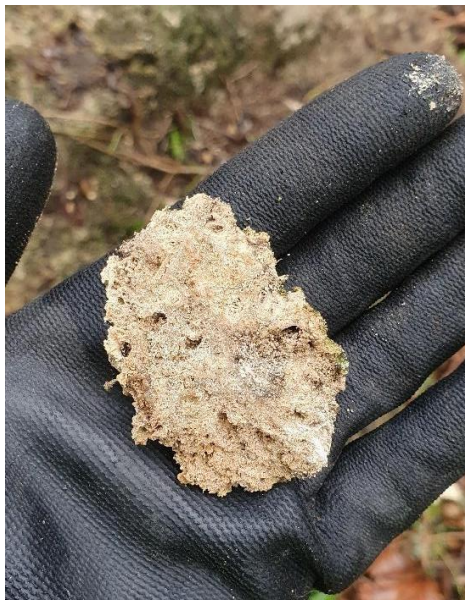
Figure 15 – Sandy mortar

There are a variety of mortar types present in the wall, generally lime-rich, with some sandier than others.

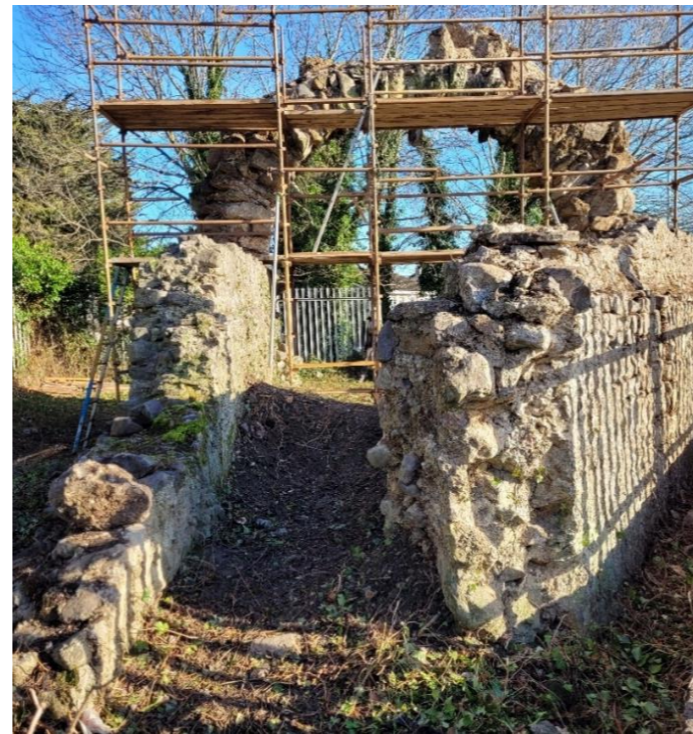
Arch and Flanking Walls viewed from South-West

Vegetation which had grown around the arch has been removed early 2022. Removal of vegetation exposed large joints around the arch - a significantly large joint was pinned and repointed promptly. Tops of the flanking walls show significant loss of stone and mortar and several vertical cracks likely due to vegetation growth. Remaining vegetation will require further treatment as per vegetation control specification prior to masonry repairs.

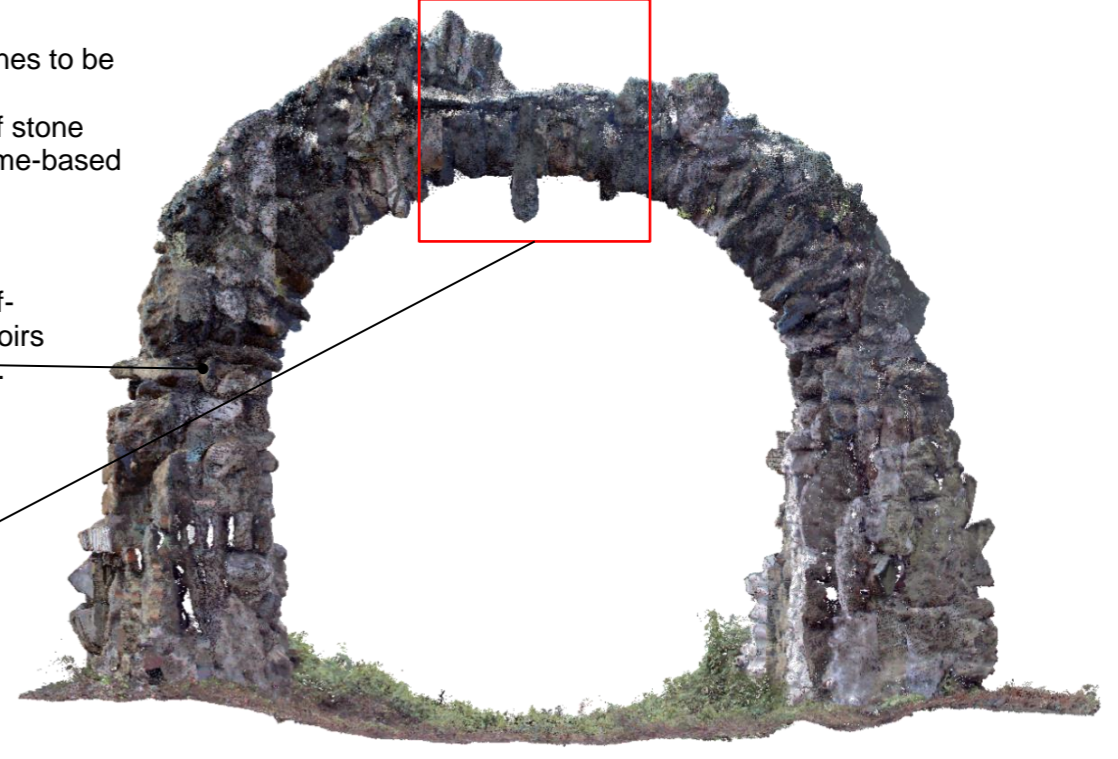
North-East Elevation of Arch

Several stones have fallen off the top of the arch. Fallen stones to be carefully identified and mock up of reinstatement created for agreement with design team. Note some supplementation of stone may be required. Stone to be re-bedded in an appropriate lime-based mortar.

Joints between stones to be repointed, ensuring a self-draining surface. Any large joints between arch voussoirs to be packed tightly with slithers of stone/natural slate. However, joints should be recessed to provide a weathered appearance.

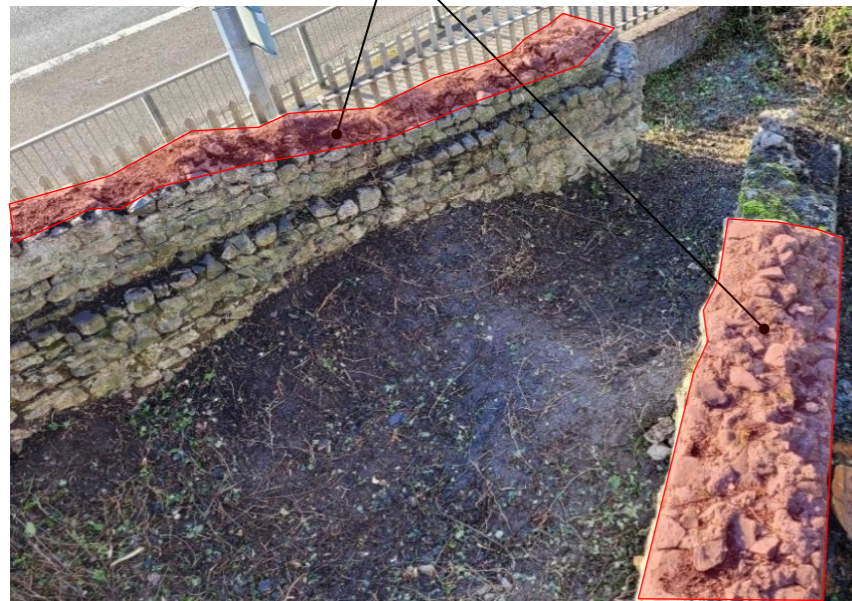
Area between Flanking Walls viewed from the top of the Arch

Stone and mortar loss from on top of flanking walls. Vegetation caused stones of top of walls to become loose and dislodged allowing water to seep into the core of the wall. Top of flanking walls require flaunching after masonry repairs and flanking walls are rebuilt to full height at the west end.

Banked earth/debris against base of flanking walls to be carefully removed to give a level surface between the walls at similar level to the outside face of the walls.

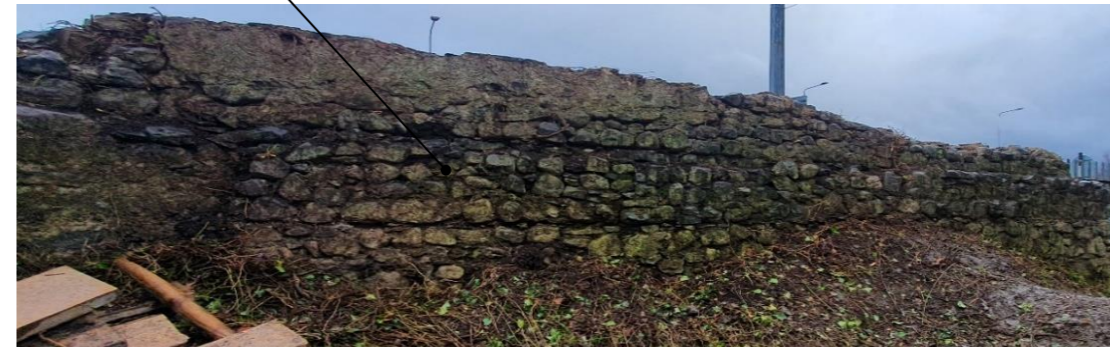
Inner face of South-East Flanking Wall

Missing stones in west end of the flanking walls. West end of flanking walls to be rebuilt to full height where stone has fallen ensuring that the walls are not easy to climb and are structurally secure.

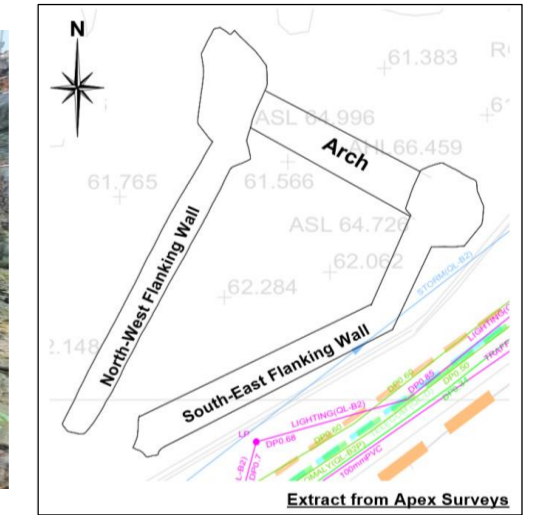
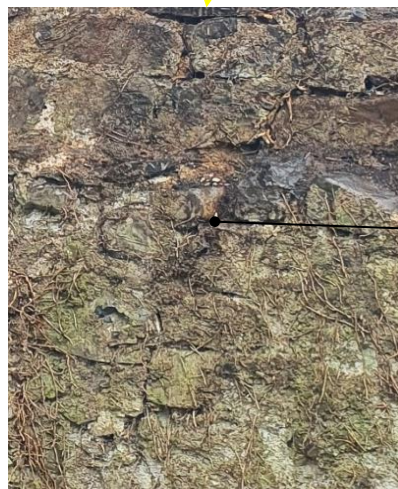
Vertical cracks in the flanking walls caused by the vegetation roots - after removal of roots, stitch vertical cracks using long stones across the crack.

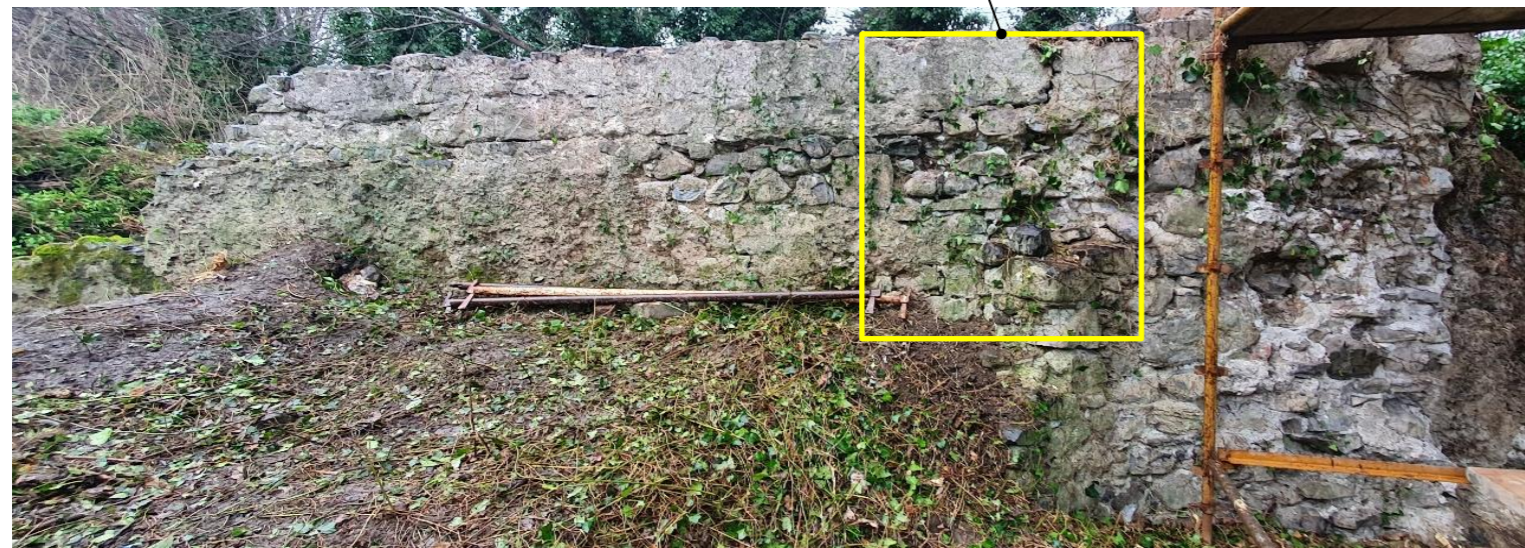
Inner face of North-West Flanking Wall

Missing stones from wall where wall joins with the base of the arch due to vegetation - require masonry works and repointing.
