## Primary Route Assessment - Firlough Wind Farm, Near Ballina, County Mayo - Rev 1

381311

Prepared For Jennings O'Donovan

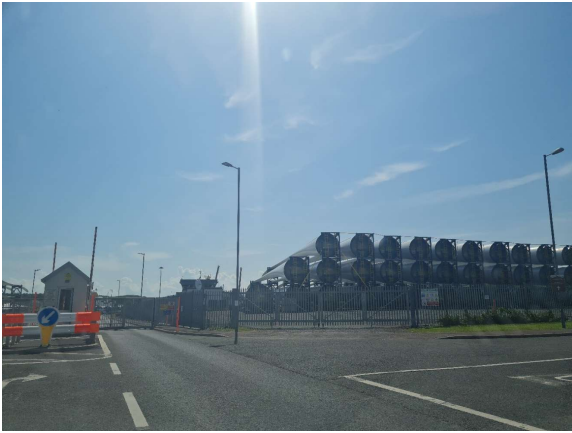
### **Location 1 - Exit From Storage Area At Killybegs Harbour**

Visual inspection indicates that the loaded vehicle will navigate out of the exit gate.

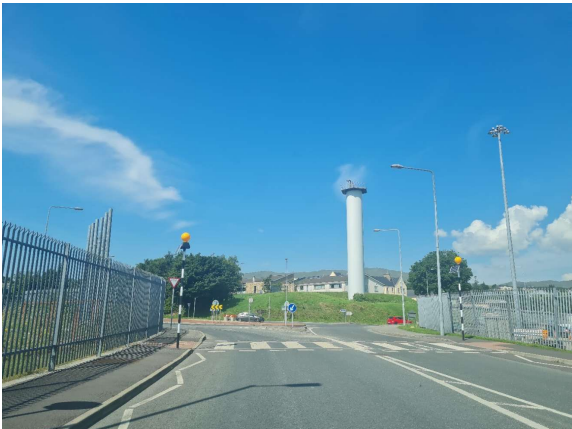
### **Location 2 - Shore Road Roundabout**

Visual inspection indicates that road widening will be required on the entry Splitter Island. Street furniture on the island to be removed.

Fence on the nearside to be removed to allow blade tip to oversail port land. Lamp post and road sign in this area to be removed.

Street furniture on the offside of the roundabout exit to be removed.

Loaded vehicle to contraflow this roundabout.

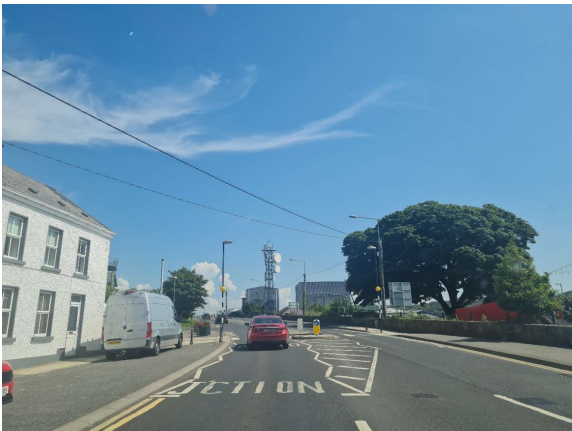
### **Location 3 - Splitter Island On R263**

Visual inspection indicates that the flexi bollards on the Splitter Island are to be removed.

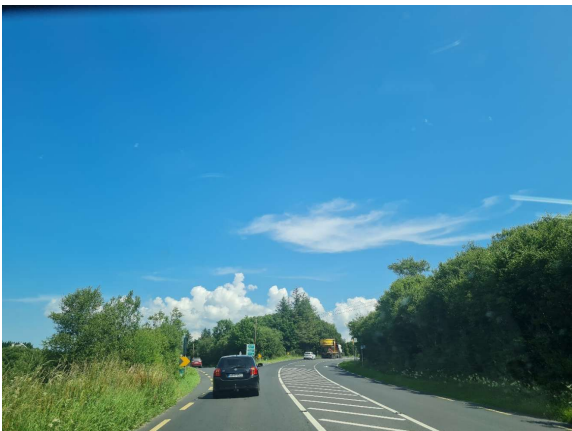
#### **Location 6 - Right Bend At R263/N56 Junction**

Visual inspection indicates that there are no issues at this location.

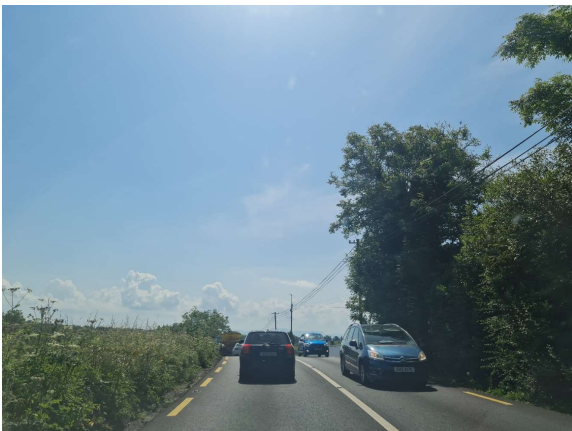
### **Location 9 - Left Bend And Crest On N56**

Visual inspection indicates that vertical analysis is required to determine whether grounding occurs.

Vertical analysis required to confirm modifications.

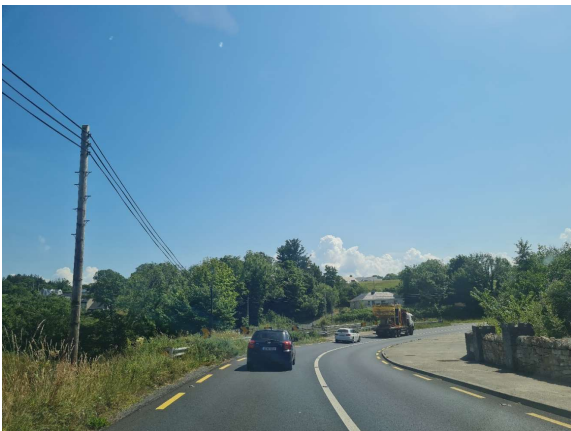
### **Location 12 - Right Bend On N56**

Visual inspection indicates that the loaded blade will navigate this bend utilizing manual steering.

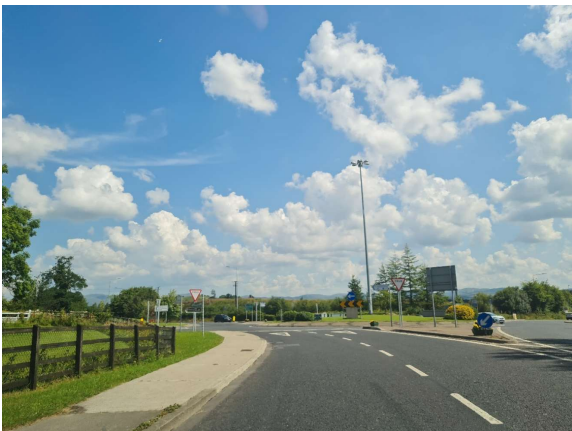
### **Location 18 - N56/R925 Roundabout**

Visual inspection indicates that the loaded vehicle will navigate this location utilising manual steering.

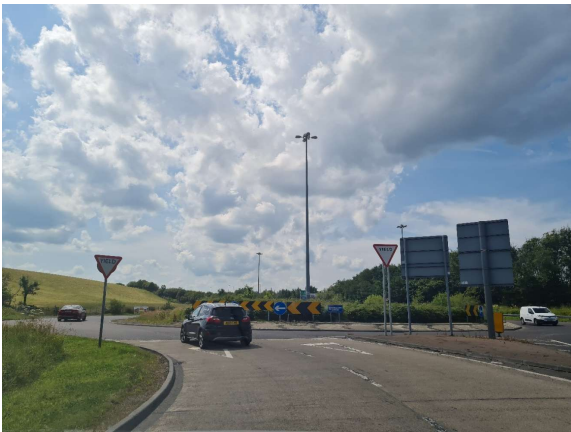
### **Location 20 - N15/R267 Roundabout**

Visual inspection indicates that road widening is required on central island.

Street furniture on the nearside and central island to be removed.

Manual steering required.

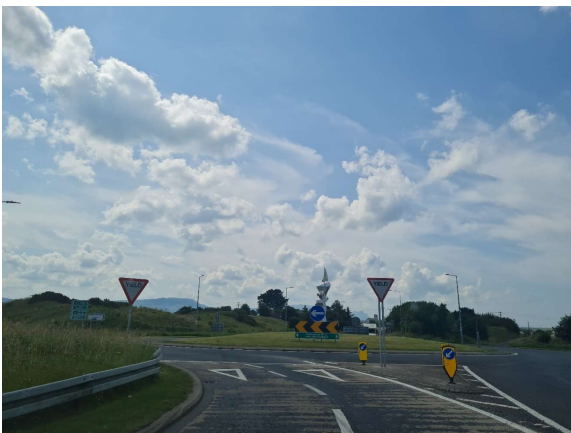
### **Location 21 - N15/R231 Roundabout**

Visual inspection indicates that road widening is required on the central island.

Road signs on entrance and exit of roundabout to be removed.

Manual steering required.

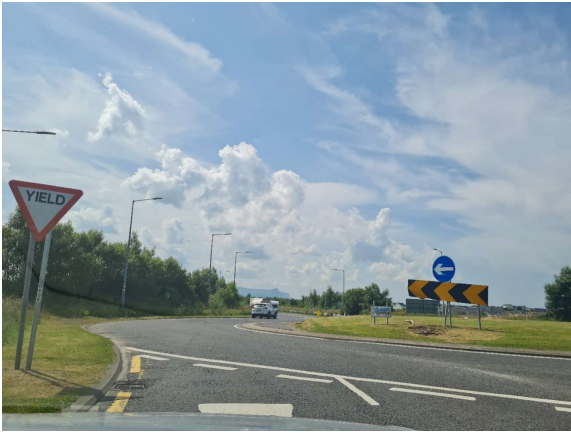
### **Location 22 - N15/R267 Roundabout**

Visual inspection indicates that road widening is required on the central island.

Road sign on central island to be removed.

Manual steering required.

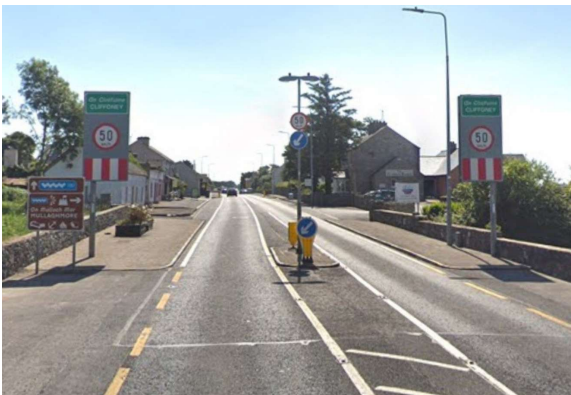
### **Location 24 - Entry Splitter Island At Cliffony**

Visual inspection indicates that the street furniture on the splitter island is to be removed.

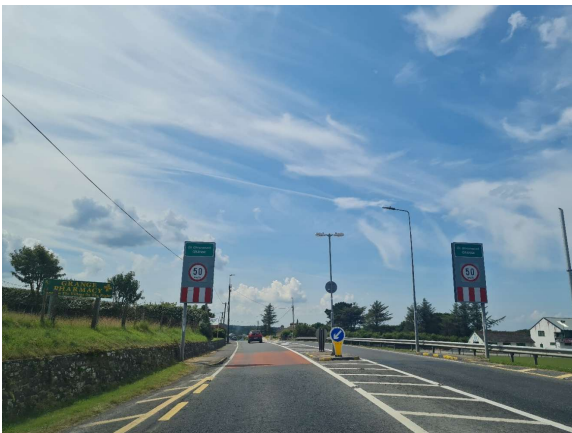
### **Location 27 - Entry Splitter Island On N15 At Grange**

Visual inspection indicates that the street furniture on the splitter island is to be removed.

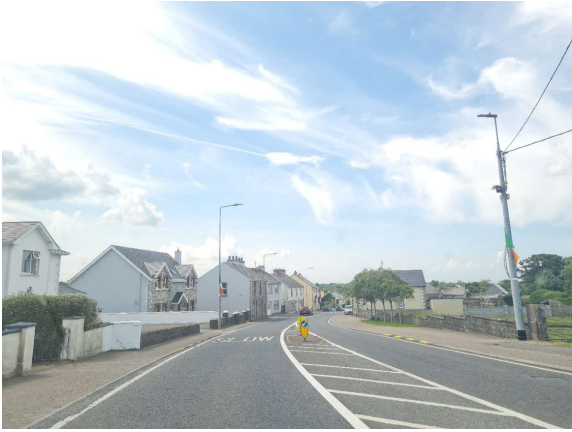
### **Location 29 - Splitter Island On N15 At Grange**

Visual inspection indicates that the street furniture on the splitter island is to be removed.

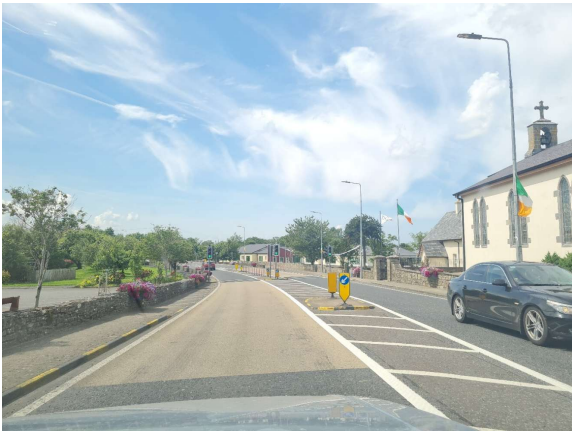
### **Location 30 - Splitter Island On N15 At Grange**

Visual inspection indicates that the street furniture on the splitter island is to be removed.

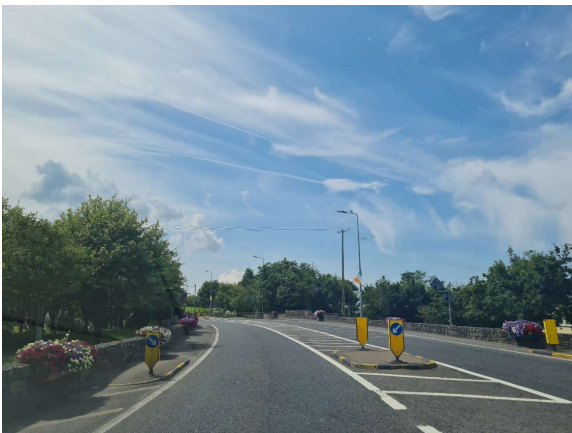
### **Location 33 - Splitter Island On N15 At Grange**

Visual inspection indicates that the street furniture on the splitter island is to be removed.

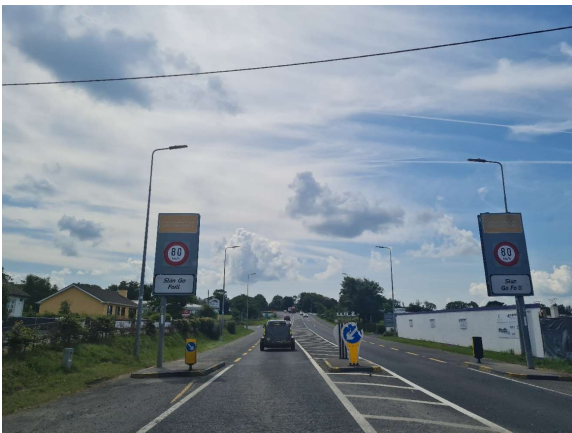
### **Location 36 - Exit Splitter Island On N15 At Grange**

Visual inspection indicates that the street furniture on the splitter island is to be removed.

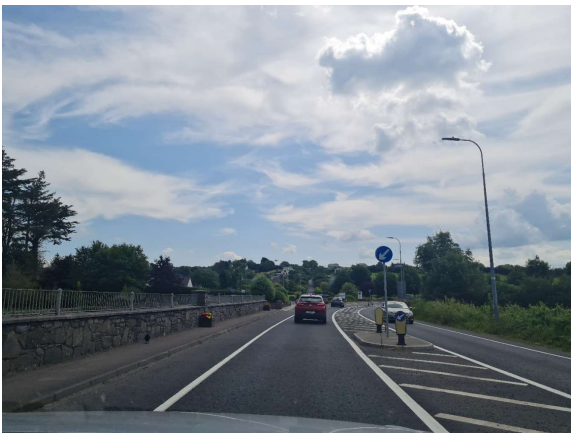
**Location 39 - Splitter Island On N15 At Rathcormac**

Visual inspection indicates that the street furniture on the splitter island is to be removed.

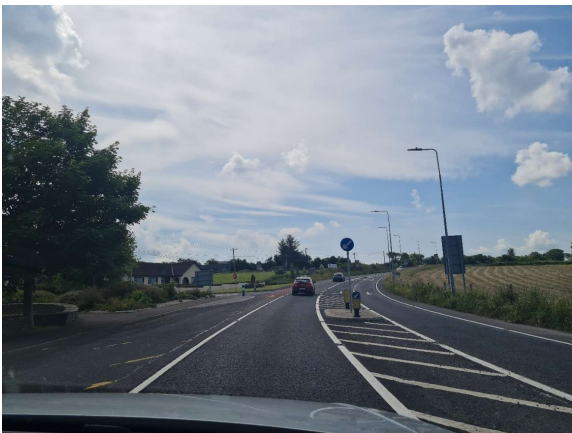
**Location 42 - Splitter Island On N15 At Rathcormac**

Visual inspection indicates that the street furniture on the splitter island is to be removed.

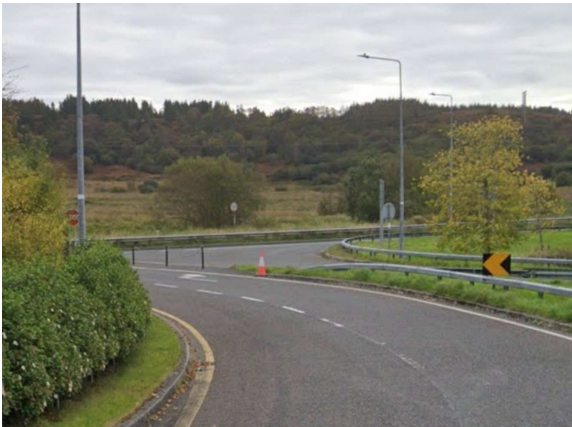
### **Location 50 - N4/N59 Junction**

Street furniture in these areas to be removed.

Manual steering required.

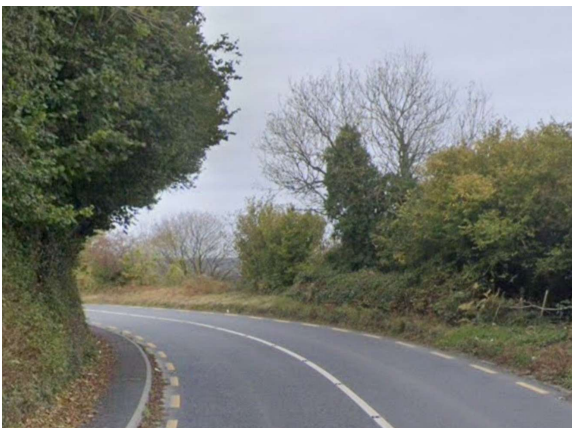
### **Location 51 - Left Bend On N59**

Visual inspection indicates that pruning is required on both sides of the road.

Manual steering required.

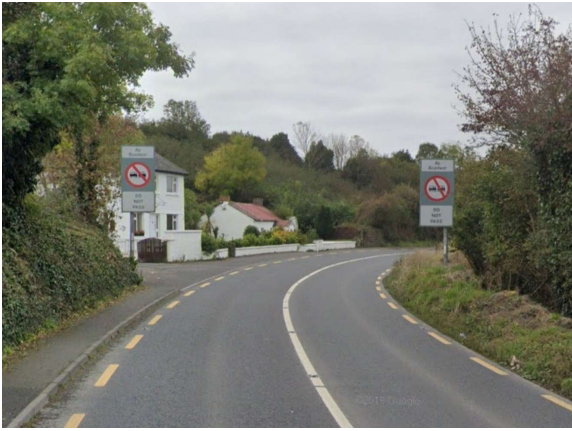
### **Location 52 - Right Bend On N59**

Visual inspection indicates that pruning is required on both sides of the road.

Manual steering required.

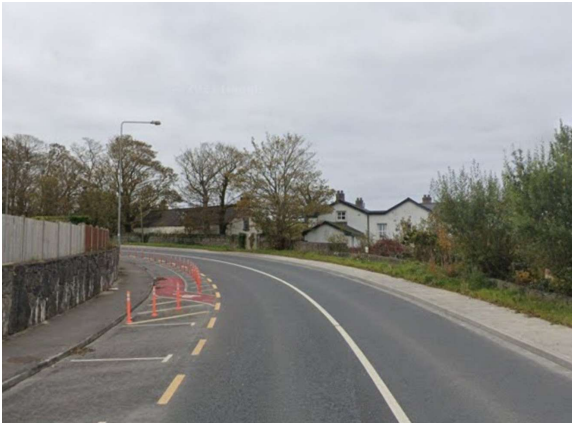
### **Location 53 - Left Bend On N59**

All overhead lines from transshipment point to the other transshipment point are to be removed to allow the blade to utilise the airspace.

Manual steering required.

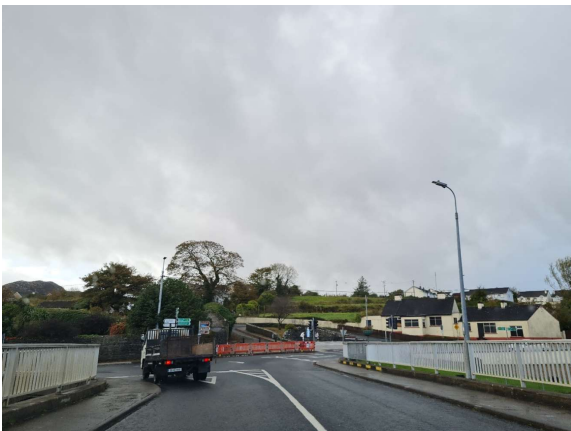
### **Location 57 - N59/R290 Mini Roundabout**

Any overhead obstructions to be removed.

Manual steering required.

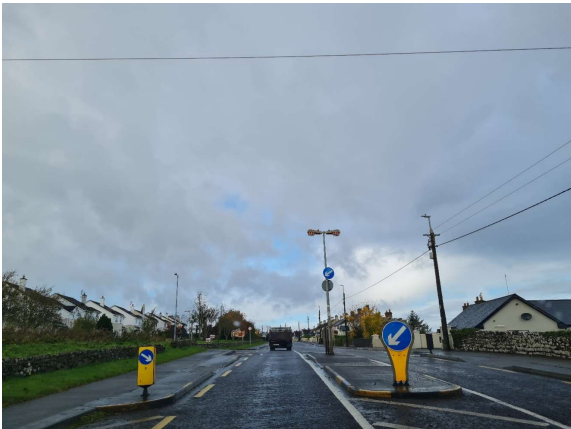
Visual inspection indicates that the overhead cables are to be removed.

Vertical Analysis of the Crest required to determine whether there are any issues.

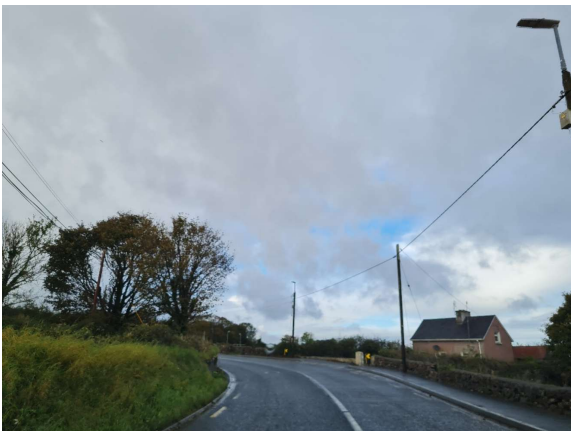
### **Location 59 - Splitter Island On N59 At Ballysadare**

Visual inspection indicates that the street furniture on the splitter island to be removed.

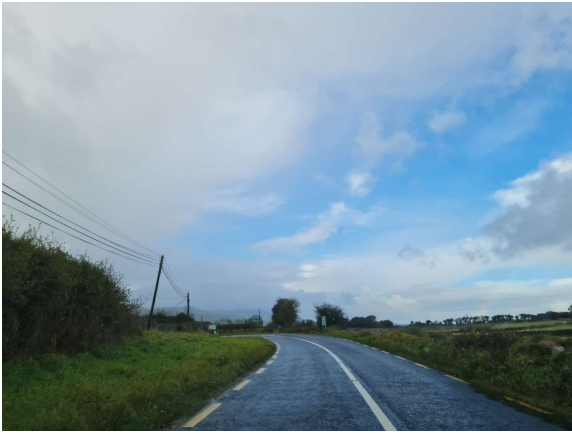
### **Location 60 - Left Bend On N59**

Visual inspection indicates that third party land is required on the nearside if the blade is transhipped back to the standard loading prior to this location. If not, it is recommend to be transhipped immediately following this location if land agreements allow.

Wall, trees and fence on the nearside to be removed.

If blade is still on lift adapter, overhead cables to be removed.

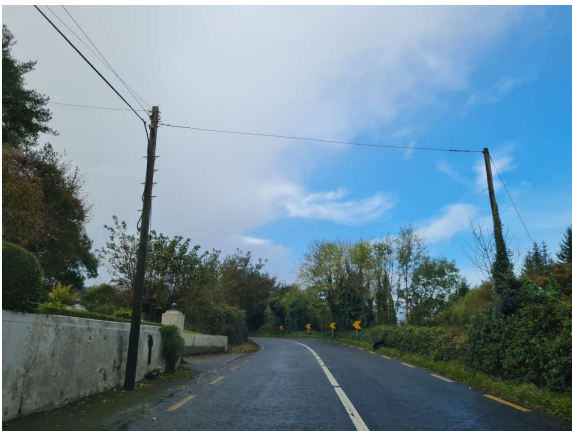
### **Location 62 - Right Bend On N59**

Visual inspection indicates that the blade will navigate this bend utilising manual steering.

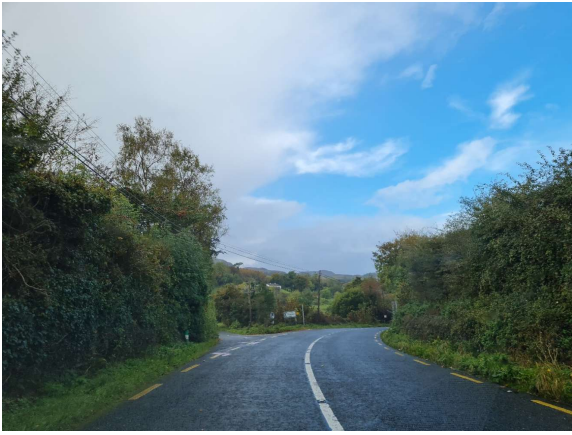
### **Location 63 - Left Bend On N59**

Visual inspection indicates that pruning is required on both sides of the road.

Utility Pole on the offside to be removed.

Manual steering required.

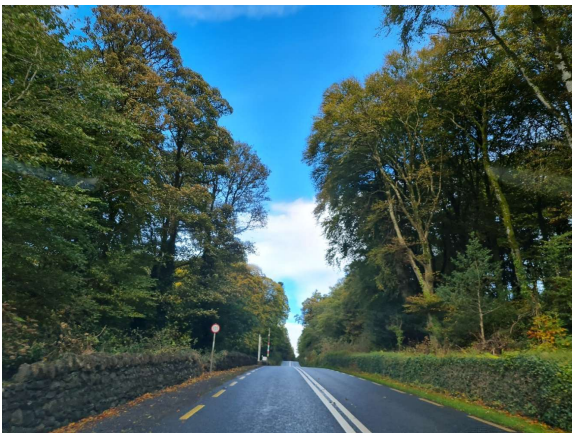
### **Location 65 - Right Bend On N59**

Visual inspection indicates that the loaded blade will navigate without issue.

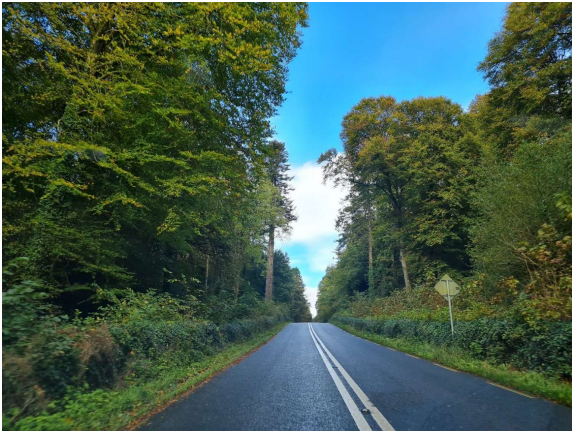
### **Location 66 - Crest On N59**

Visual inspection indicates that vertical analysis will be required to determine whether grounding occurs at this location.

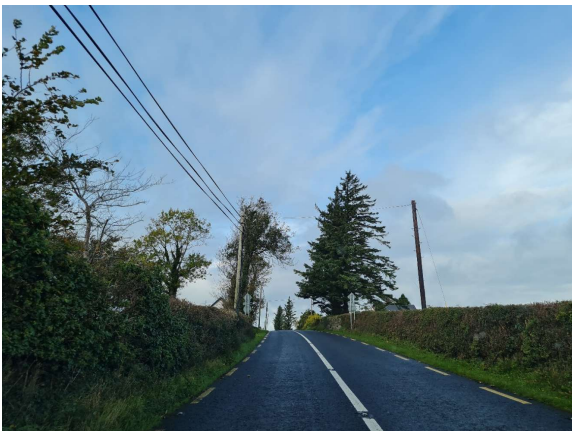
### **Location 68 - Left Bend On N59**

Visual inspection indicates that pruning is required on both sides of the road.

Manual steering required.

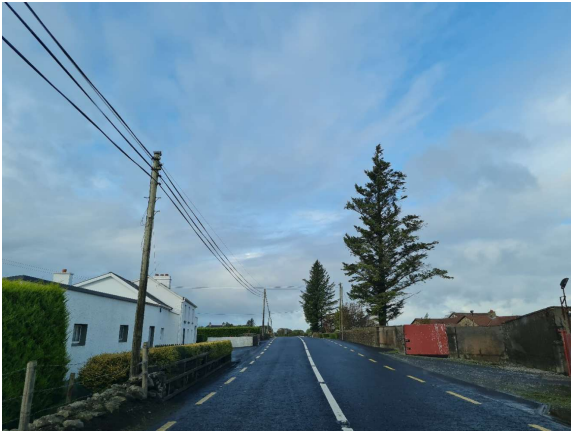
### **Location 69 - Crest On N59**

Visual inspection indicates that vertical analysis is required to determine whether grounding will occur at this location.

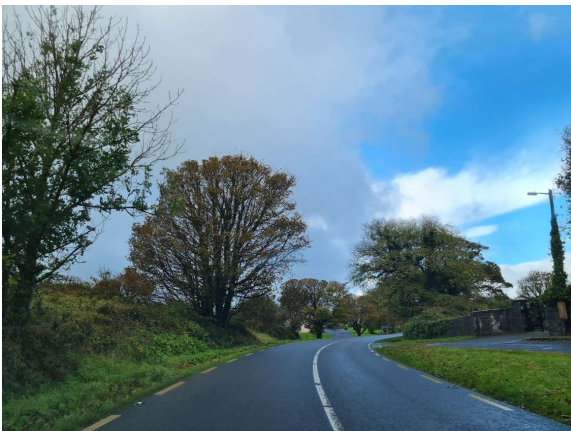
### **Location 71 - Left Bend On N59**

Visual inspection indicates that pruning will be required on the offside of the road.

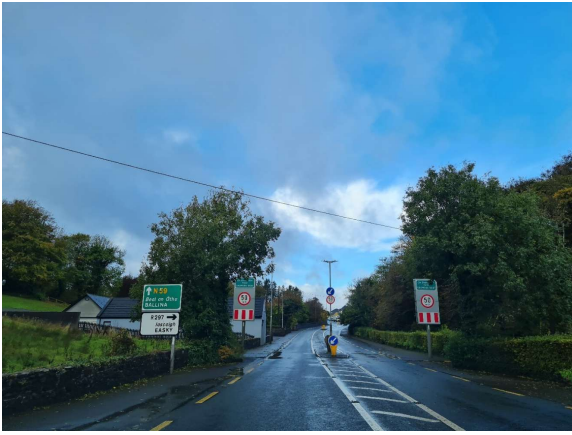
### **Location 72 - Right Bend On N59**

Visual inspection indicates that pruning will be required on both sides of the road.

Manual steering required.

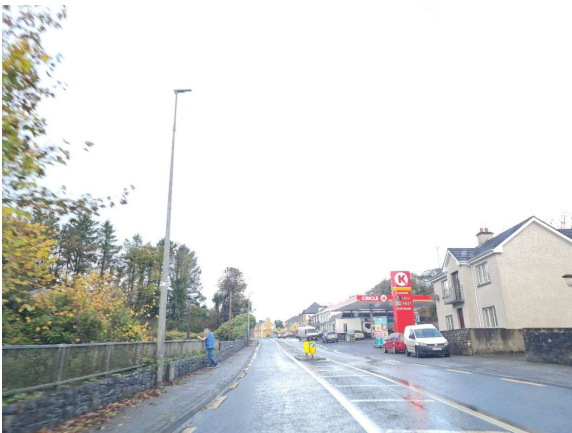
**Location 74 - Splitter Island On N59 At Dromore West**

Visual inspection indicates that the street furniture on the splitter island to be removed.

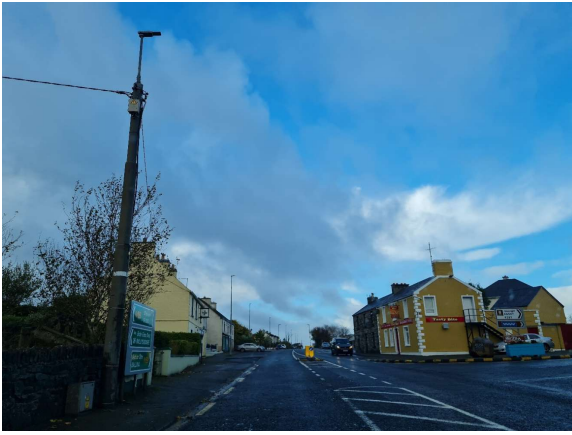
**Location 75 - Splitter Island On N59 At Dromore West**

Visual inspection indicates that the street furniture on the splitter island to be removed.

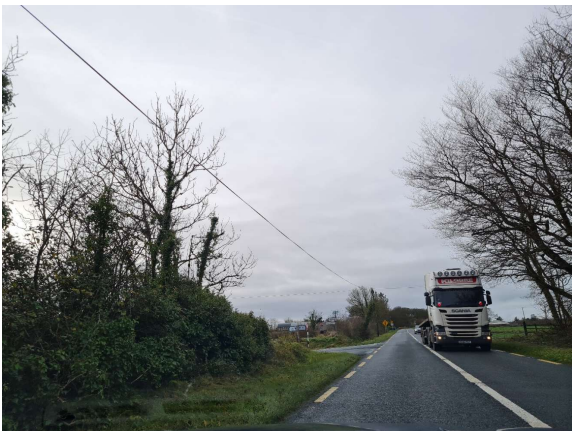
### **Location 77 - Crest And Dip On N59**

Visual inspection indicates that vertical analysis is required to determine whether any grounding issues will occur during navigation.

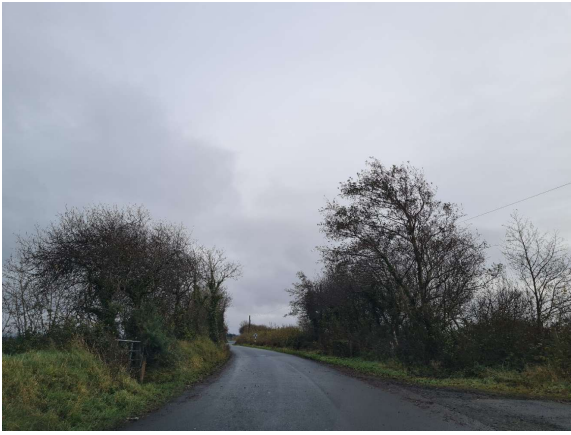
### **Location 78 - N59/L2604 Junction**

Visual inspection indicates that third party land will be required on the nearside of the junction.

Trees and vegetation on the nearside to be removed.

Street furniture on the nearside to be removed.

Swept Path Analysis required to confirm modifications.

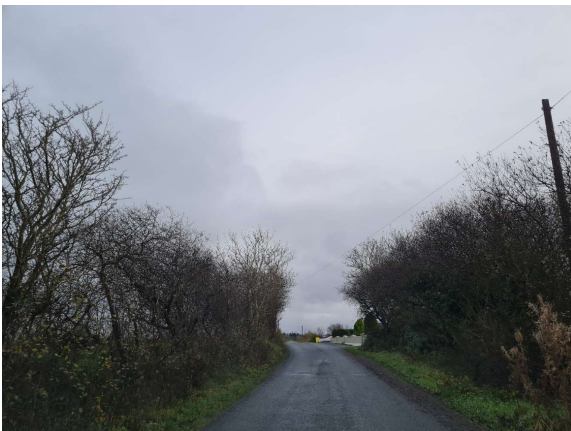
### **Location 80 - Right Bend On L2604**

Visual inspection indicates that road widening is required on the offside of the road.

Pruning required on both sides of the road.

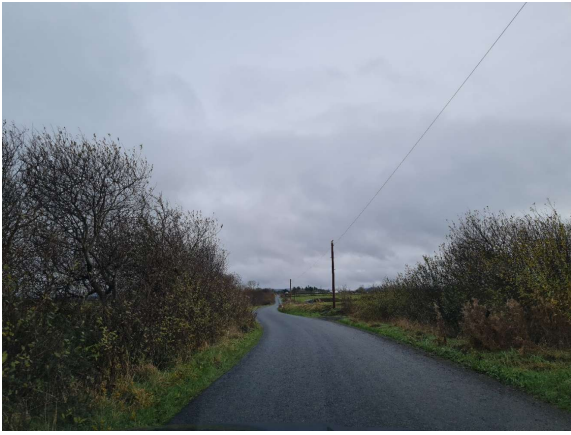
### **Location 81 - Left Bend On L2604**

Visual inspection indicates that road widening is required on the offside.

Pruning will also be required.

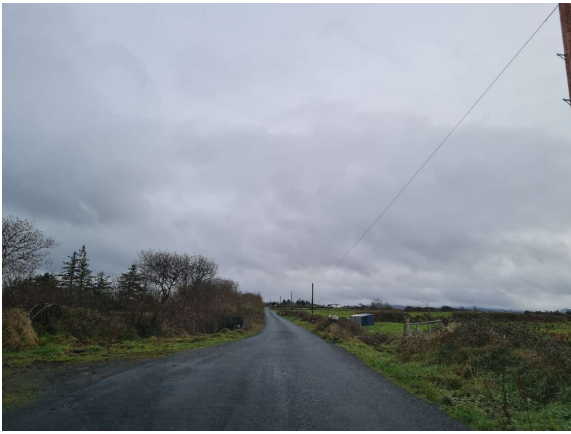
### **Location 82 - S Bend On L2604**

Visual inspection indicates that road widening is required on the nearside of the road.

Pruning required on both sides of the road.

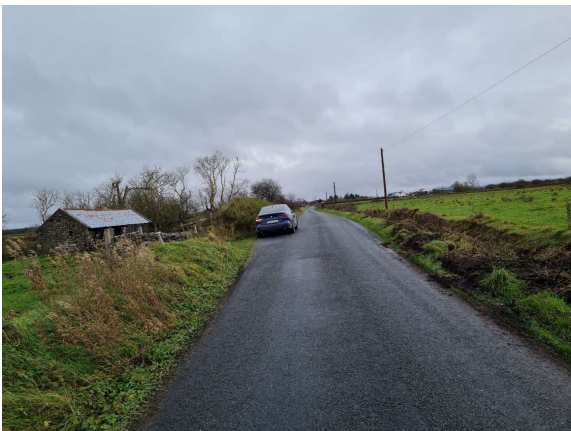
### **Location 83 - Left Bend On L2604**

Visual inspection indicates that road widening is required on the offside of the road.

Pruning required on both sides of the road.

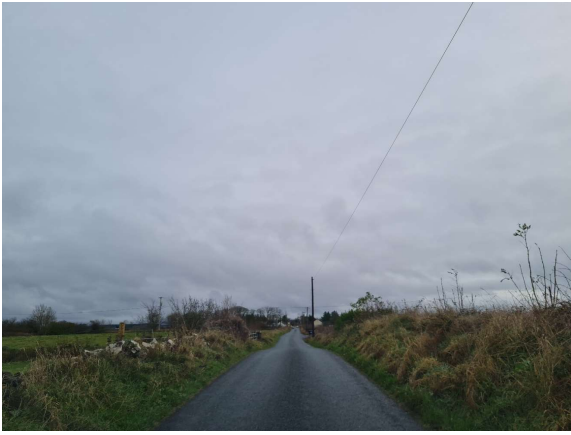
### **Location 84 - L2604**

Visual inspection indicates that the road width narrows from this location onwards.

Road will require upgrading to the turbine manufacturers specification.

Pruning will be required to provide a clear envelope as stipulated in the manufacturers specification.

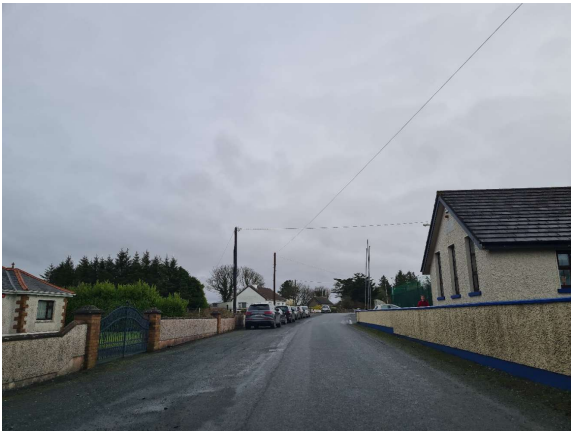
### **Location 85 - Crest On L2604**

Visual inspection indicates that vertical analysis is required to determine whether any grounding issues will occur during navigation.

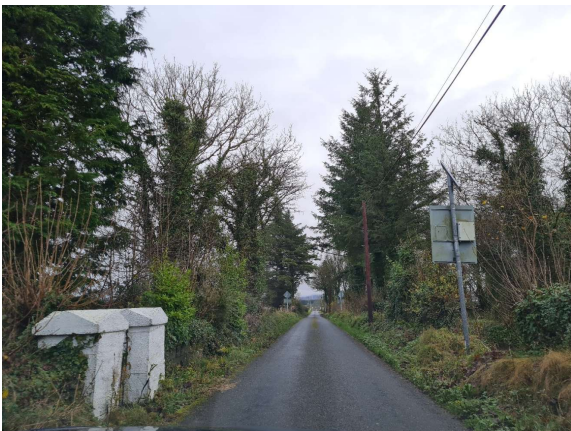
### **Location 86 - Right Bend On L2604**

Visual inspection indicates that third party land will be required at this location.

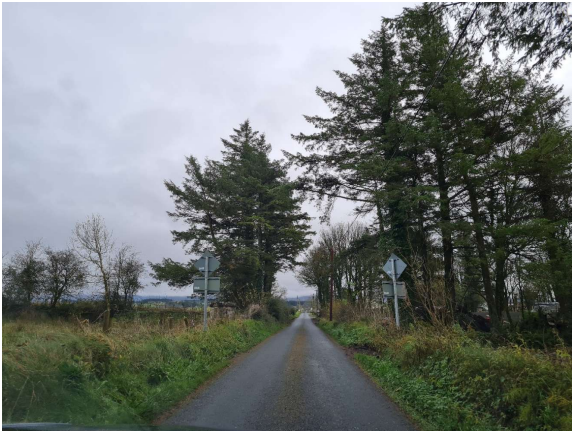
### **Location 87 - Narrow Section On L2604**

Visual inspection indicates that road widening will be required on both sides of the road.

Road sign and telegraph pole on the offside to be removed.

Pruning required on both sides of the road.

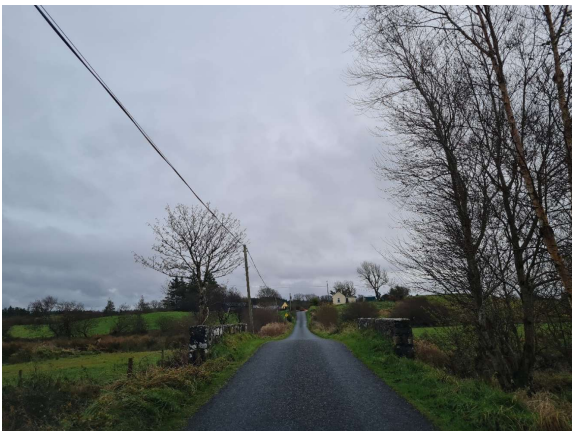
### **Location 89 - Crest On L2604**

Visual inspection indicates that vertical analysis is required to determine whether any grounding issues will occur during navigation.

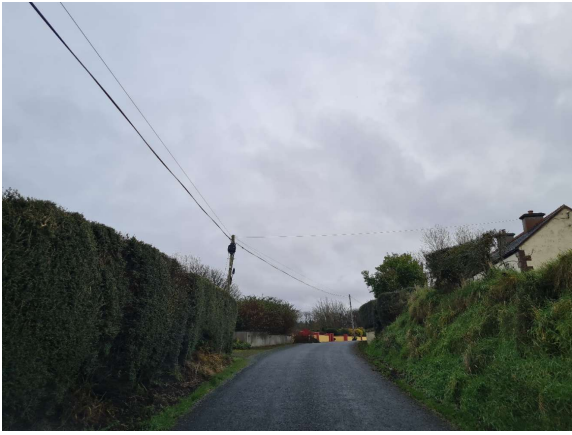
### **Location 90 - Crest On L2604**

Visual inspection indicates that vertical analysis is required to determine whether any grounding issues will occur during navigation.

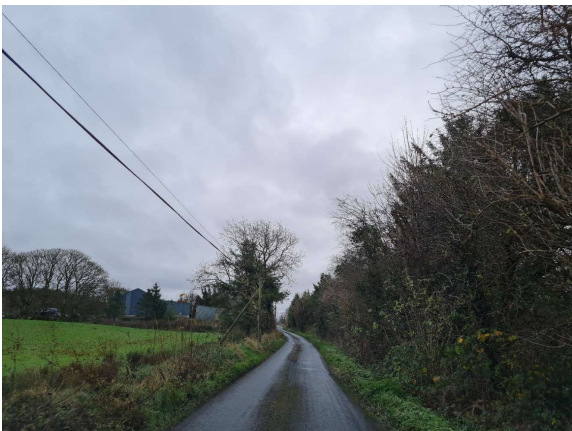
### **Location 92 - Left Bend On L2604**

Visual inspection indicates that road widening is required on the both sides of the road.

Telegraph Pole on the nearside to be removed.

Pruning required on both sides of the road.

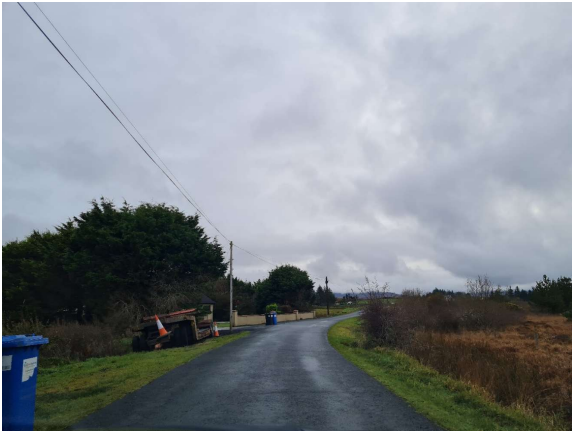
### **Location 93 - Left Bend On L2604**

Visual inspection indicates that road widening is required on the offside of the road.

Pruning required on both sides of the road.

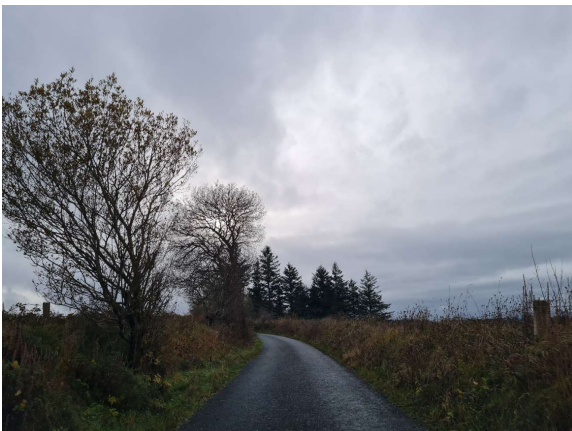
### **Location 95 - Right Bend On L2604**

Visual inspection indicates that road widening is required on the offside of the road.

Pruning required on the nearside of the road.

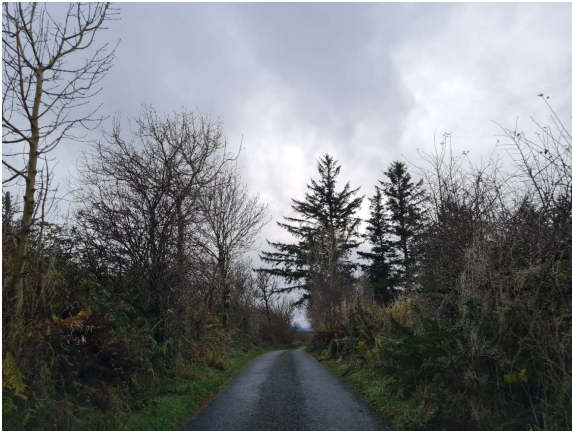
### **Location 96 - Left Bend On L2604**

Visual inspection indicates that third party land will be required on the nearside of the road.

Trees and vegetation on the nearside to be removed.

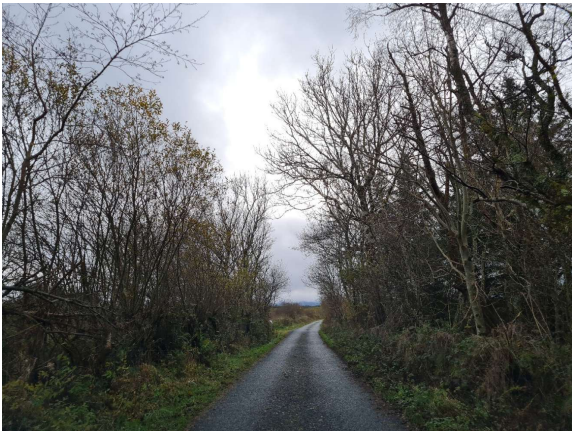
### **Location 97 - Right Bend On L2604**

Visual inspection indicates that third party land is required on the offside of the road.

Trees and vegetation on the offside to be removed.

Pruning required on the nearside.

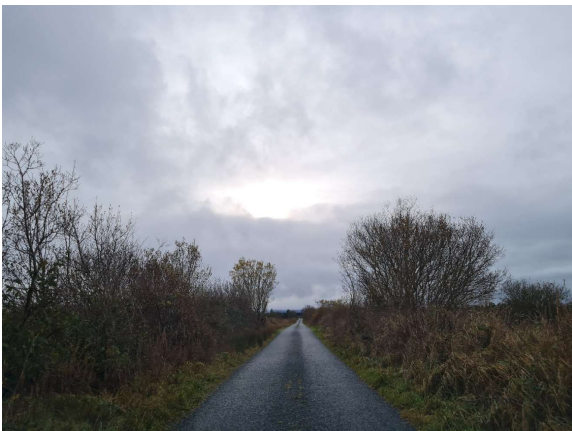
### **Location 98 - Right Bend On L2604**

Visual inspection indicates that third party land is required on the offside of the road.

Trees and vegetation on the offside to be removed.

Pruning required on the nearside.

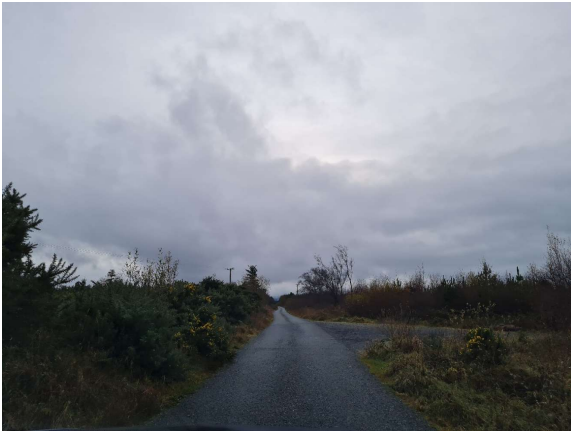
### **Location 99 - L2604**

Visual inspection indicates that the road will require upgrading to the turbine manufacturers specification.

Pruning will be required to provide a clear envelope as stipulated in the manufacturers specification.

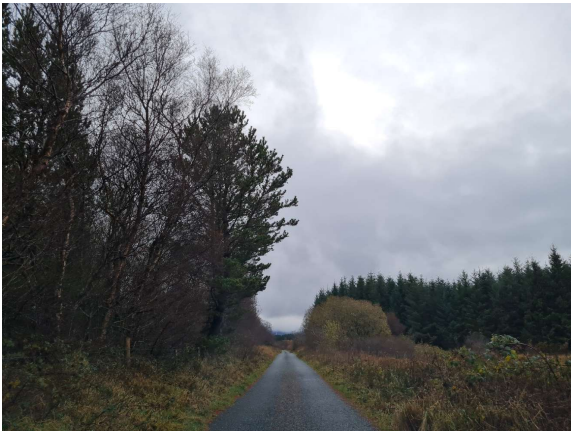
### **Location 100 - Left Bend On L2604**

Visual inspection indicates that road widening is required on the offside of the road.

Pruning required on both sides of the road.

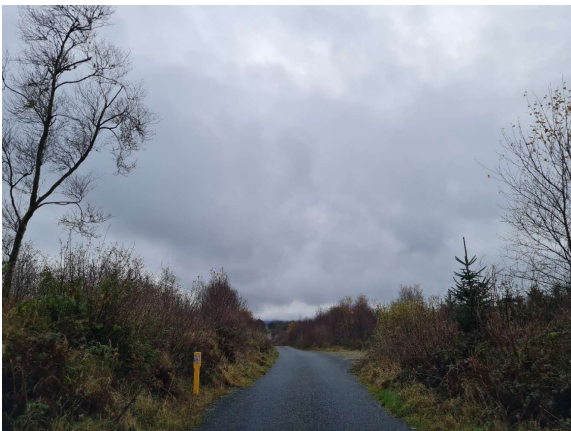
### **Location 101 - Tree On L2604**

Visual inspection indicates that road widening is required on both sides of the road.

Tree on the nearside to be pruned.

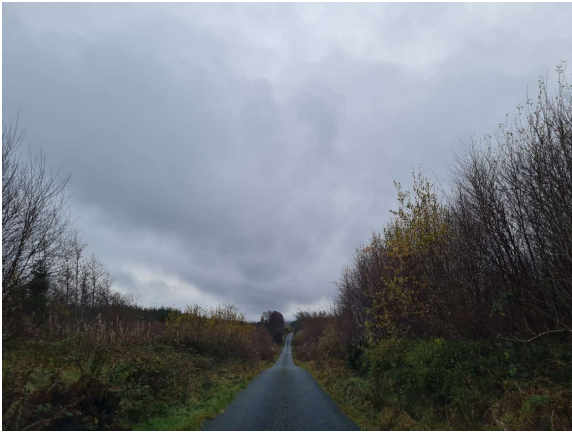
### **Location 102 - Left Bend On L2604**

Visual inspection indicates that third party land is required on the nearside of the road.

Trees and vegetation on the nearside to be removed.

Pruning required on the offside.

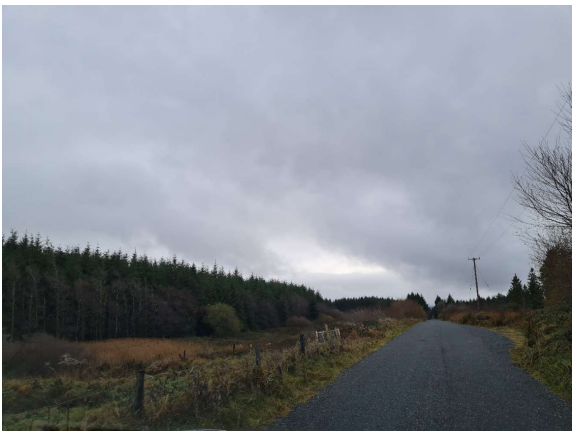
### **Location 104 - Bridge On L2604**

Visual inspection indicates that the bridge will require replacing as it is currently too narrow to allow for turbine deliveries.

Widening will be required both before and after the bridge.
