## Primary Route Assessment - Firlough Wind Farm, County Mayo, Ireland - Charlestown Route

381311

Wednesday, 29 March 2023

Prepared For Jennings O Donovan

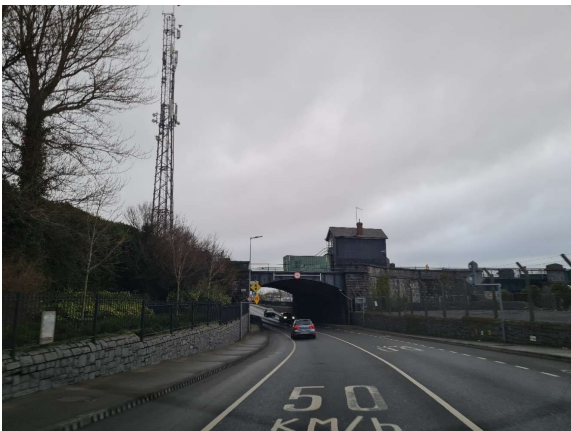
### **Location 3 - Lough Atalia Bridge**

Visual inspection indicates that there are no issues at this location. Blade will encroach into the buffer zone but not impact the bridge.

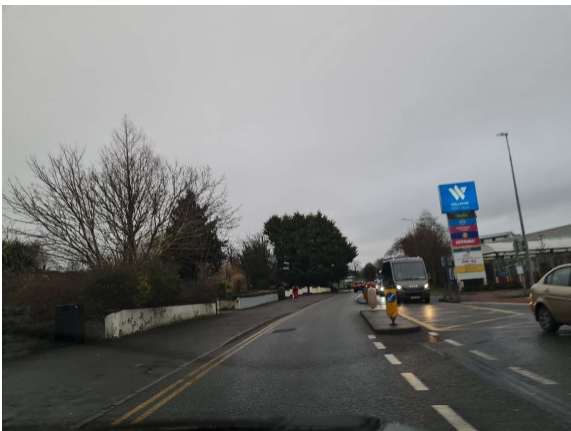
#### **Location 6 - Splitter Islands On R339**

Visual inspection indicates that the flexi bollards on the splitter Islands are to be flattened for deliveries to allow for oversail of the splitter Islands.

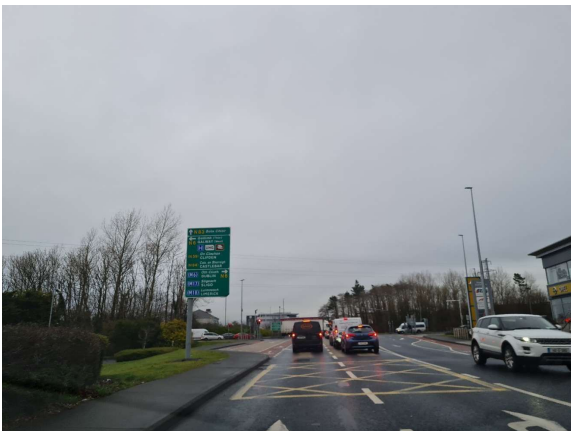
### **Location 9 - R336/N6/N83 Junction**

Visual inspection indicates that there are no issues at this location.

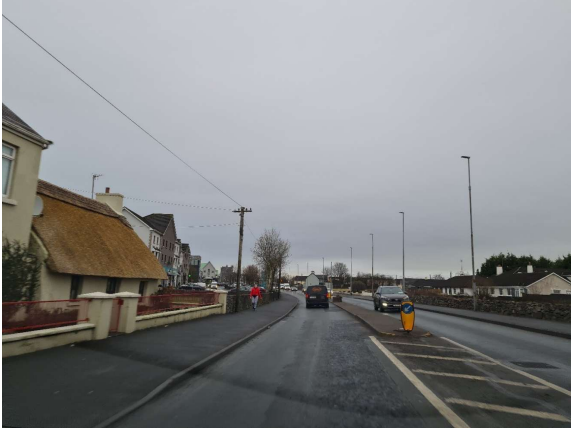
### Location 10 - Splitter Island On N83

Visual inspection indicates that there are no issues at this location.

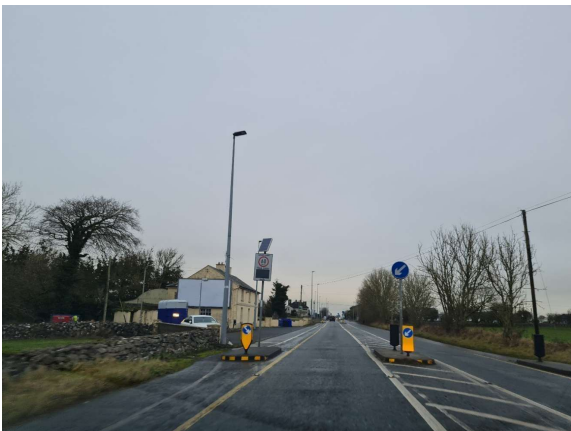
### Location 12 - Splitter Island On N83 At Knockdoe

Visual inspection indicates that the street furniture on the splitter island is to be removed.

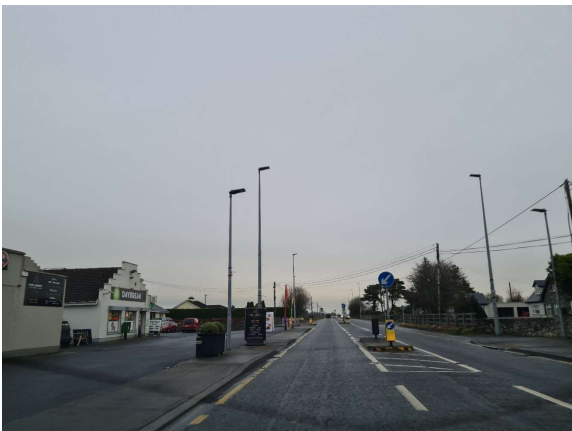
**Location 15 - Splitter Island On N83 At Knockdoe**

Visual inspection indicates that the street furniture on the splitter island is to be removed.

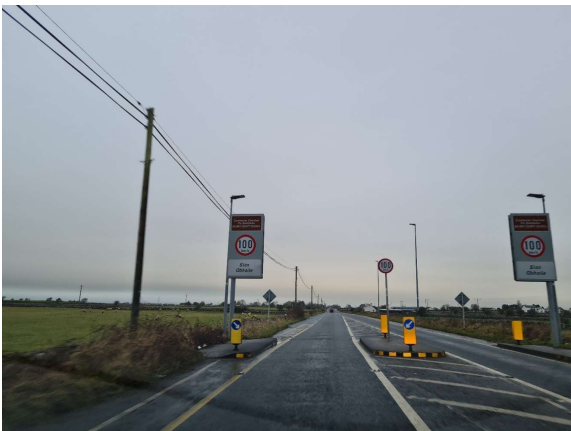
### **Location 18 - Splitter Island On N83 At Knockdoe**

Visual inspection indicates that the street furniture on the splitter island is to be removed.

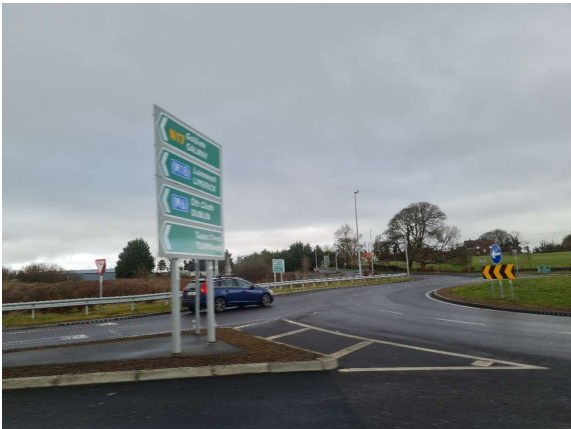
### **Location 20 - N17 Roundabout**

Swept Path Analysis indicates that the road signs on the entry Splitter Island are required to be removed due to rear projection oversail. The road sign and 2 lamp posts on the nearside are required to be removed due to blade oversail.

Street furniture on these islands to be removed.

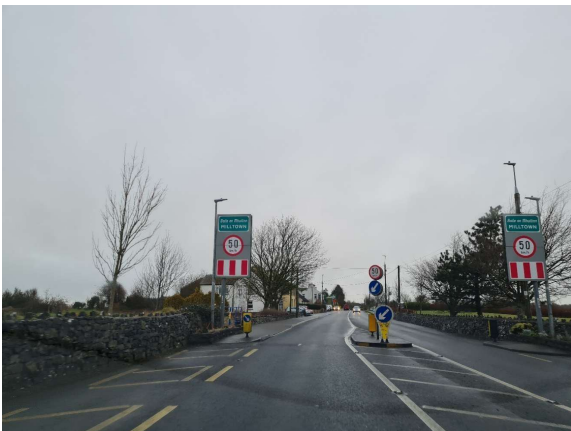
### **Location 21 - Splitter Island On N17 At Milltown**

Visual inspection indicates that the street furniture on the splitter island is to be removed.

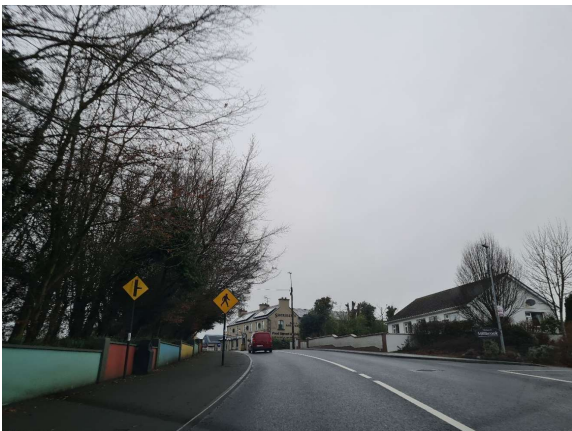
### **Location 24 - Left Bend On N17 In Milltown**

Swept Path Analysis indicates that the loaded vehicle will navigate utilising manual steering.

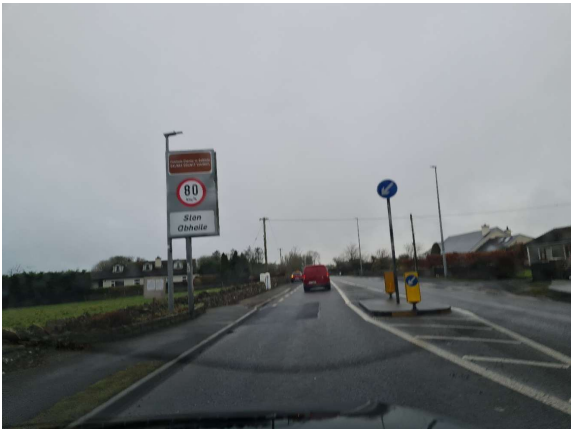
**Location 26 - Splitter Island On N17 In Milltown**

Visual inspection indicates that the street furniture on the splitter island is to be removed.

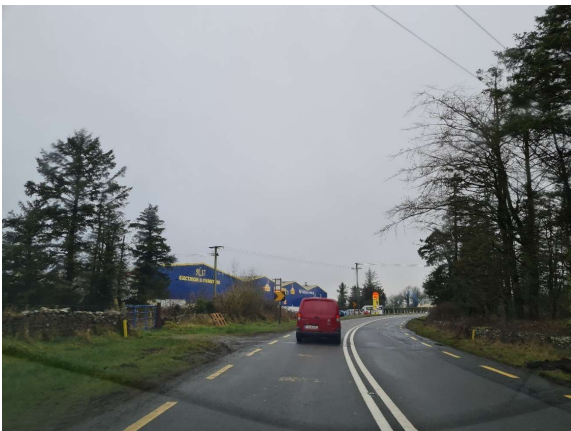
**Location 27 - Right Bend On N17 At Milltown**

Visual inspection indicates that the loaded vehicle will navigate utilising manual steering.

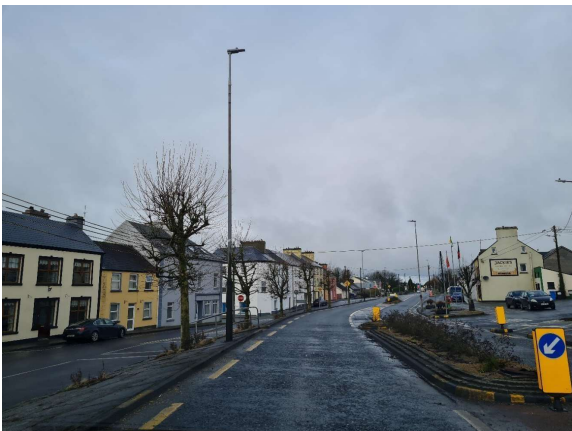
### **Location 30 - Splitter Island On N17 In Ballindine**

Visual inspection indicates that the flexi bollards on the splitter island are to be removed to allow for oversail.

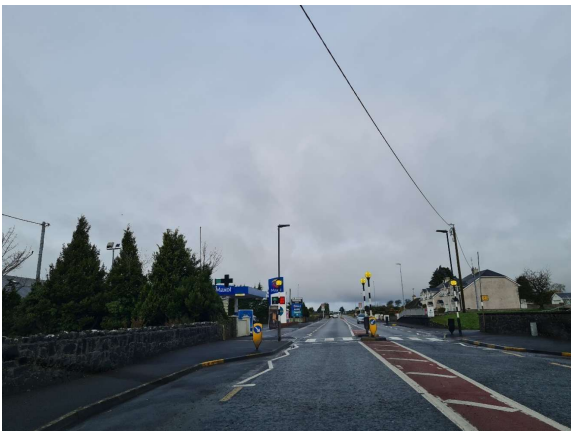
**Location 33 - Splitter Island On N17 In Ballindine**

Visual inspection indicates that the street furniture on the splitter island is to be removed.

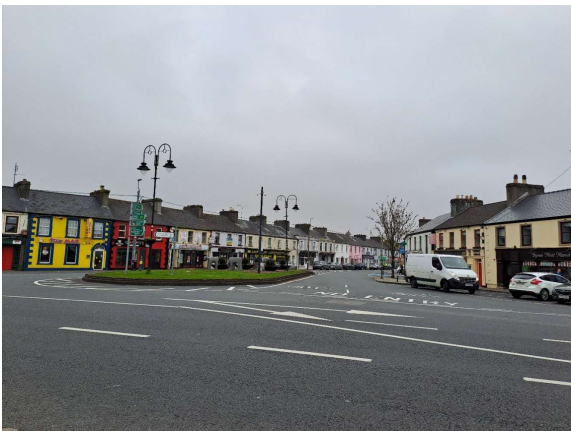
### **Location 39 - L1331 / N5 Junction In Charlestown**

Swept Path Analysis indicates the central island is required to be cleared of any obstructions to allow the trailer body to navigate.

The bollards on the offside are required to be removed along with tree pruning.

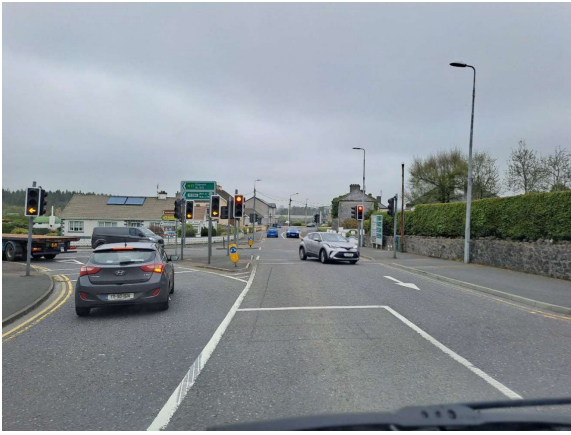
### **Location 40 - N17 / R294 Junction Tobercurry**

Swept path Analysis indicates that the loaded vehicle will navigate this location without any issues

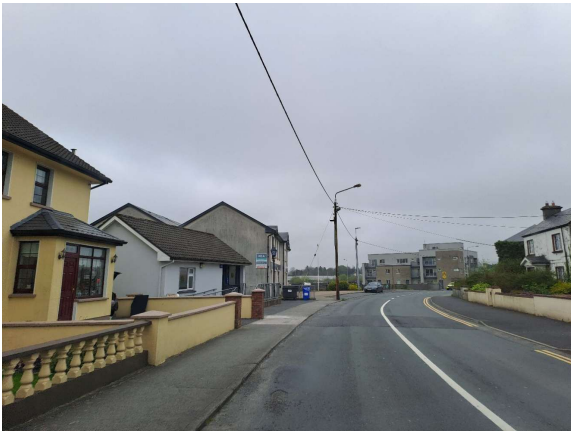
### **Location 41 - Right Bend In Tobercurry R294**

Swept Path Analysis indicates that the loaded vehicle will navigate this location utilising manual steering.

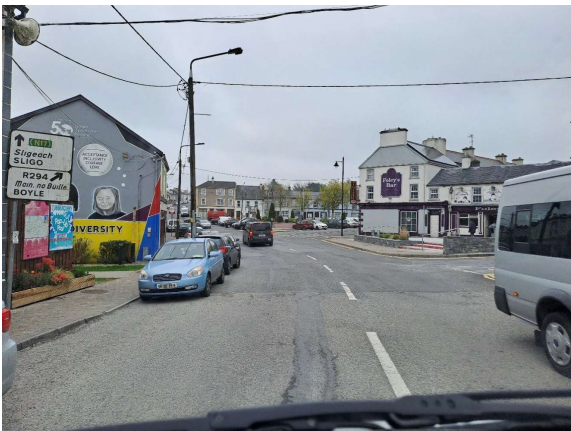
### **Location 42 - Left Hand Bend In Tobercurry R294**

Swept Path Analysis indicates that the loaded vehicle will navigate this location utilising manual steering.

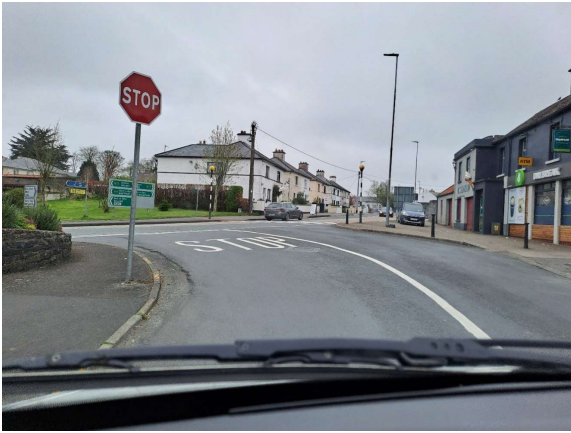
### **Location 43 - R294 / N17 Junction In Tobercurry**

Swept Path Analysis indicates that road widening is required on the protruding kerb. The lamp post and bollard on this kerb are required to be removed.

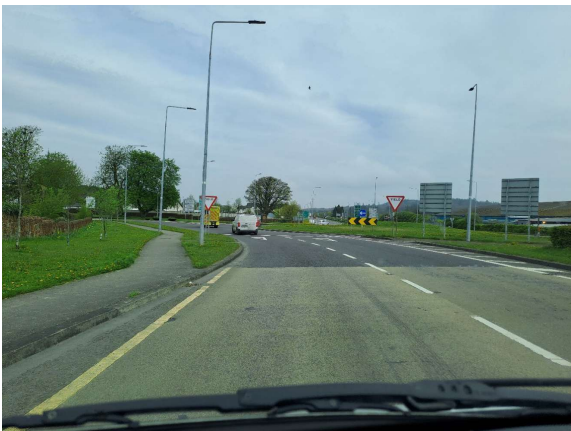
### **Location 45 - N4 Roundabout With R290**

Swept Path Analysis indicates that the 2 lamp posts on the nearside entry are required to be removed.

The chevron sign on the roundabout is required to be removed. After taking the 2nd Exit, the loaded vehicle is required to contraflow onto the exiting dual carriageway.

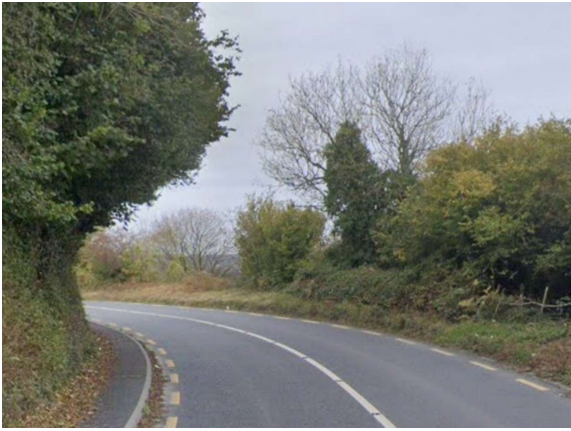
### **Location 47 - Left Bend On N59**

Visual inspection indicates that pruning is required on both sides of the road.

Manual steering required.

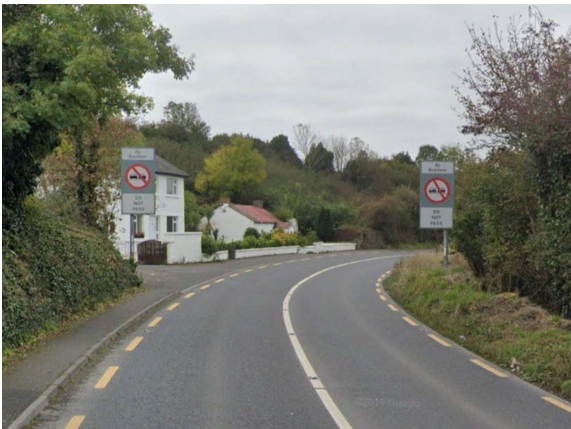
### **Location 48 - Right Bend On N59**

Visual inspection indicates that pruning is required on both sides of the road.

Manual steering required.

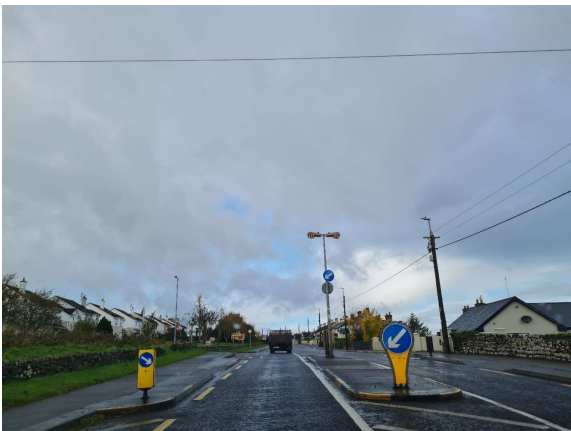
Visual inspection indicates that the overhead cables are to be removed.

Vertical Analysis of the Crest required to determine whether there are any issues.

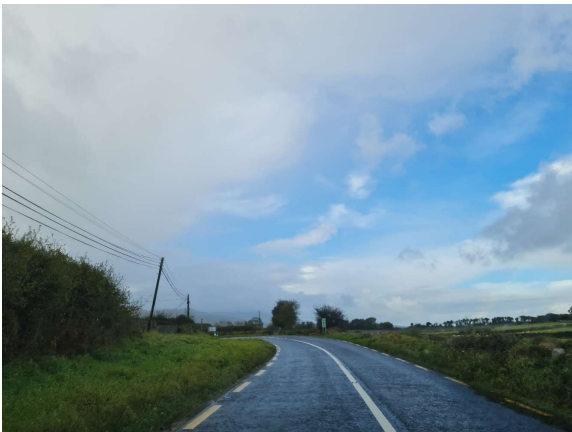
### **Location 56 - Left Bend On N59**

Visual inspection indicates that third party land is required on the nearside if the blade is transhipped back to the standard loading prior to this location. If not, it is recommended to be transhipped immediately following this location if land agreements allow.

Wall, trees, and fence on the nearside to be removed.

If blade is still on lift adapter, overhead cables to be removed.

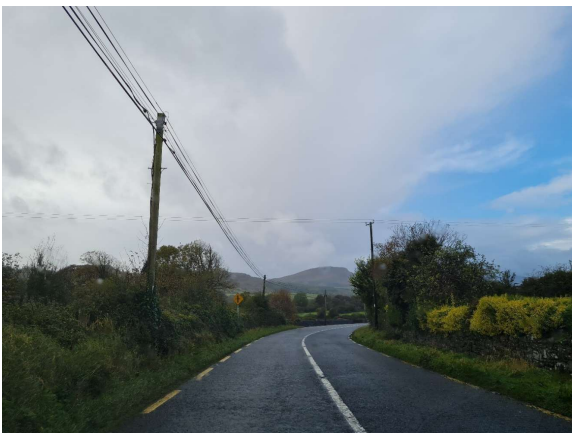
### **Location 57 - Left Bend On N59**

Visual inspection indicates that the blade will navigate utilise manual steering.

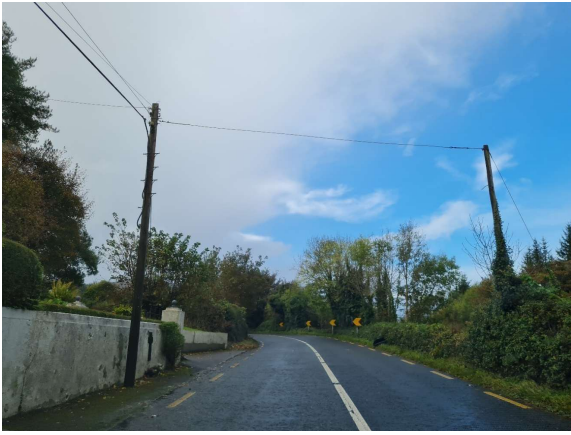
### **Location 58 - Right Bend On N59**

Visual inspection indicates that the blade will navigate this bend utilising manual steering.

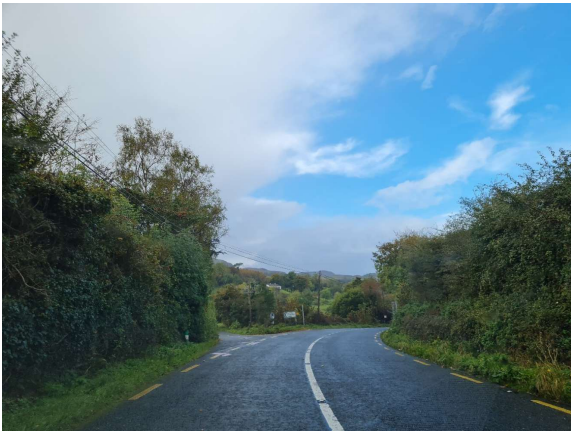
### **Location 59 - Left Bend On N59**

Visual inspection indicates that pruning is required on both sides of the road.

Utility Pole on the offside to be removed.

Manual steering required.

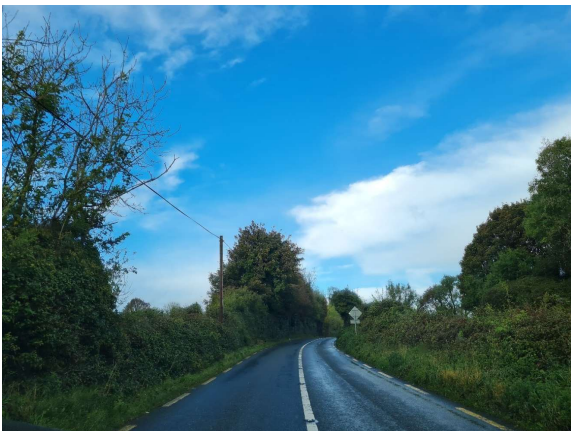
### **Location 60 - Right Bend On N59**

Visual inspection indicates that pruning is required on both sides of the road.

Manual steering required.

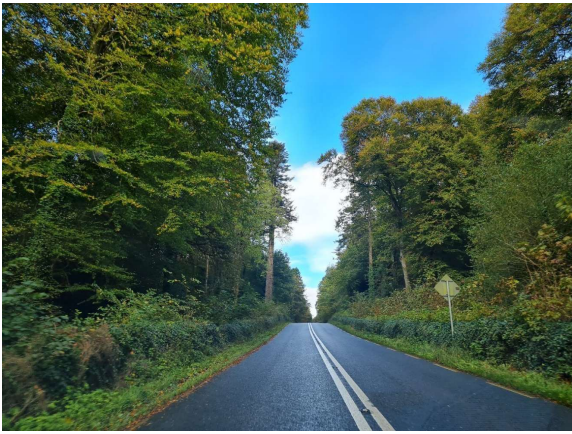
### **Location 62 - Crest On N59**

Visual inspection indicates that vertical analysis will be required to determine whether grounding occurs at this location.

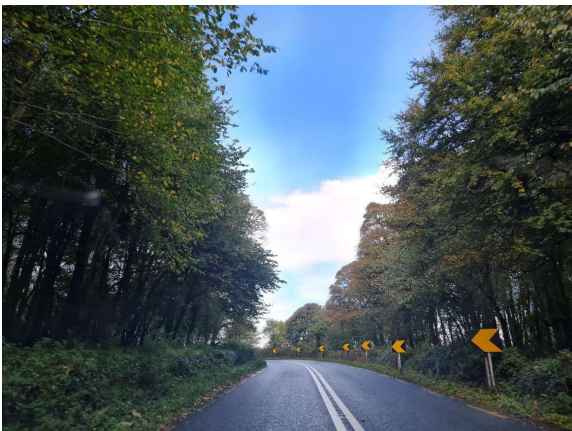
### **Location 63 - Crest On N59**

Visual inspection indicates that vertical analysis is required to determine whether grounding occurs at this location.

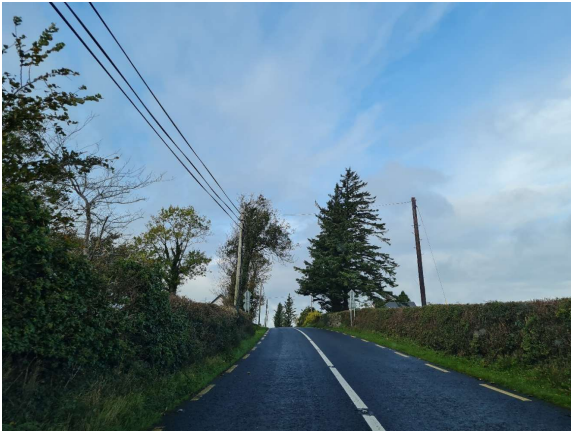
### **Location 64 - Left Bend On N59**

Visual inspection indicates that pruning is required on both sides of the road.

Manual steering required.

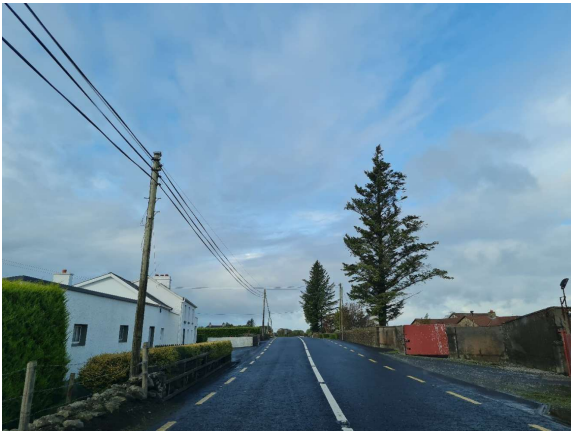
### **Location 65 - Crest On N59**

Visual inspection indicates that vertical analysis is required to determine whether grounding will occur at this location.

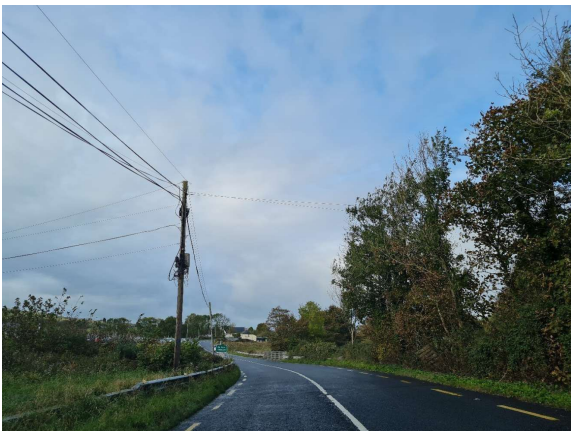
### **Location 66 - Crest On N59**

Visual inspection indicates that vertical analysis is required to determine whether grounding will occur at this location.

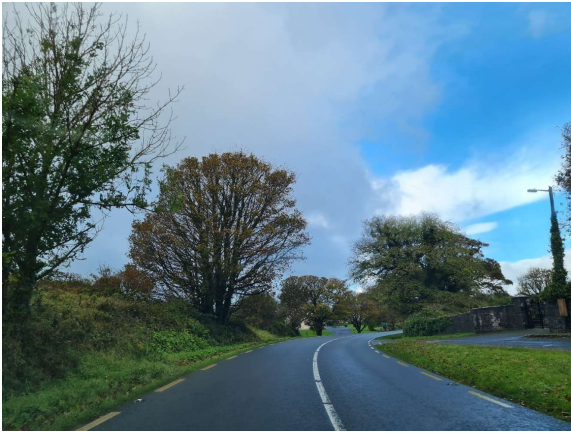
### **Location 67 - Left Bend On N59**

Visual inspection indicates that pruning will be required on the offside of the road.

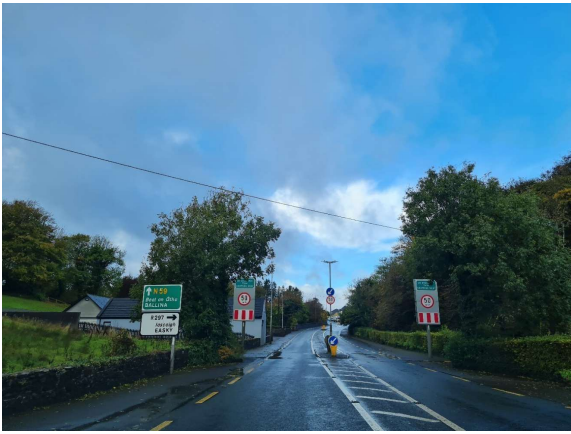
### **Location 68 - Right Bend On N59**

Visual inspection indicates that pruning will be required on both sides of the road.

Manual steering required.

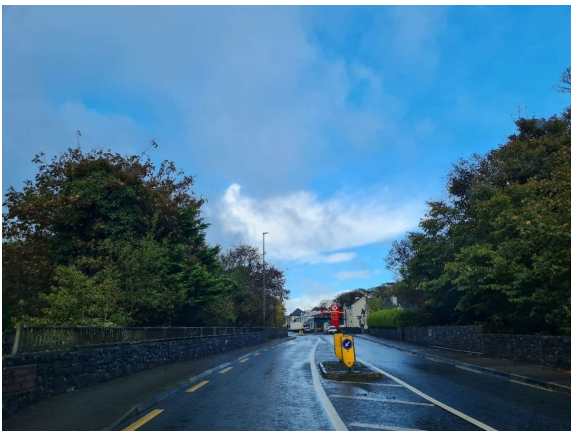
### **Location 69 - Entry Splitter Island On N59 At Dromore West**

Visual inspection indicates that the street furniture on the splitter island to be removed.

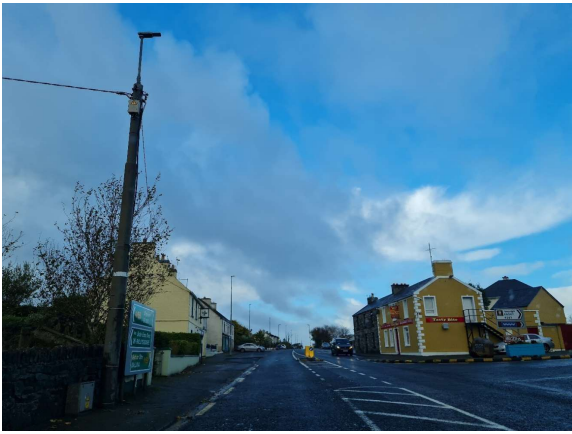
### **Location 71 - Splitter Island On N59 At Dromore West**

Visual inspection indicates that the street furniture on the splitter island to be removed.

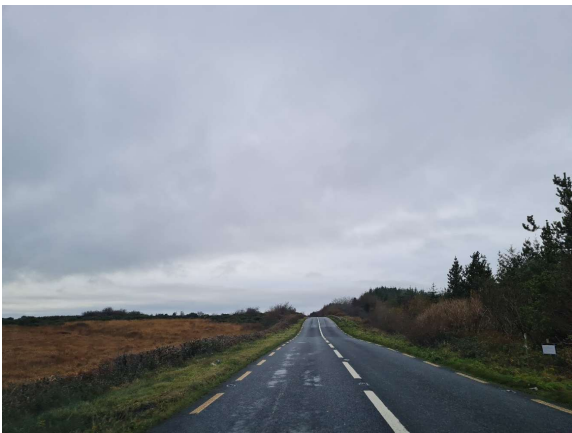
### **Location 72 - Spitter Island On N59 At Dromore West**

Visual inspection indicates that the street furniture on the splitter island to be removed.

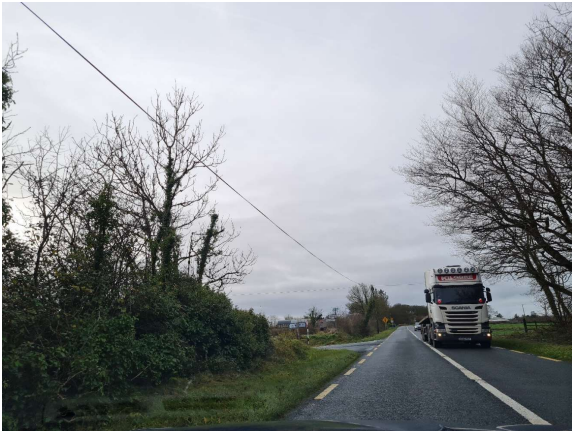
### **Location 73 - Crest And Dip On N59**

Visual inspection indicates that vertical analysis is required to determine whether any grounding issues will occur during navigation.

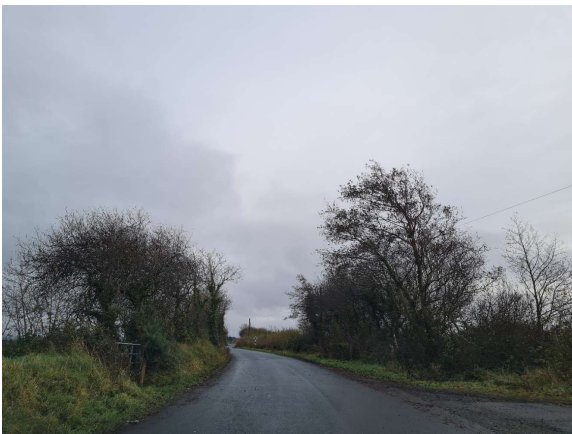
### **Location 74 - N59/L2604 Junction**

Visual inspection indicates that third party land will be required on the nearside of the junction.

Trees and vegetation on the nearside to be removed.

Street furniture on the nearside to be removed.

Swept Path Analysis required to confirm modifications.

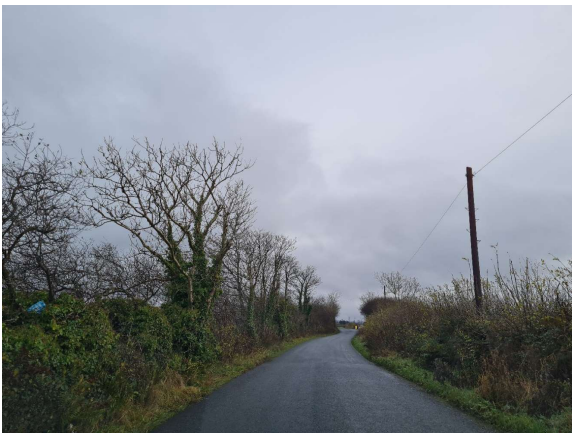
### **Location 75 - Left Bend On L2604**

Visual inspection indicates that road widening is required on the offside of the road.

Tree Pruning required on both sides of the road.

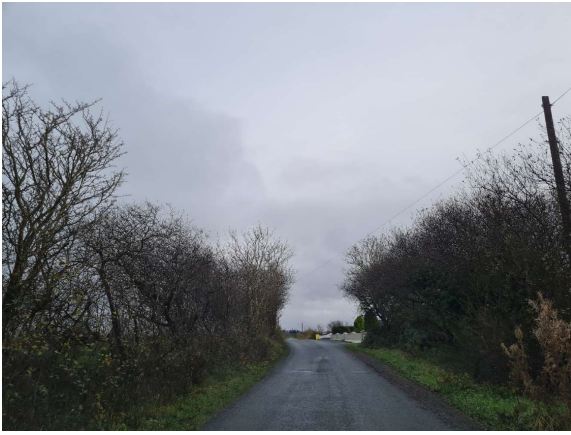
### **Location 76 - Right Bend On L2604**

Visual inspection indicates that road widening is required on the offside of the road.

Pruning required on both sides of the road.

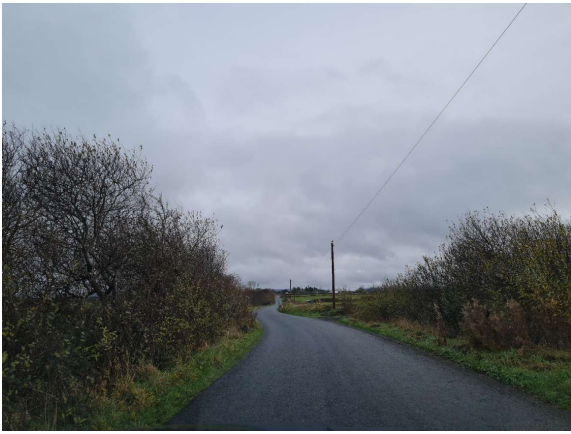
### **Location 77 - Left Bend On L2604**

Visual inspection indicates that road widening is required on the offside.

Pruning will also be required.

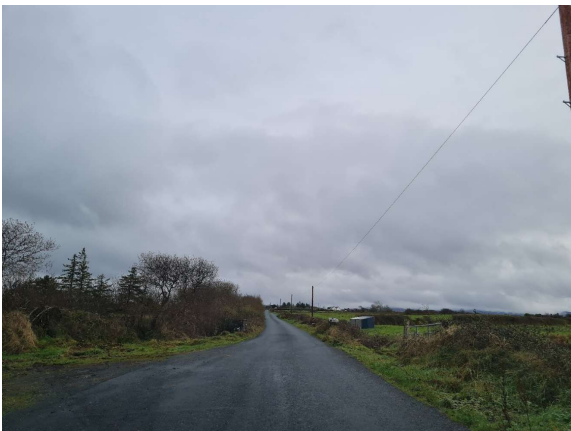
### **Location 78 - S Bend On L2604**

Visual inspection indicates that road widening is required on the nearside of the road.

Pruning required on both sides of the road.

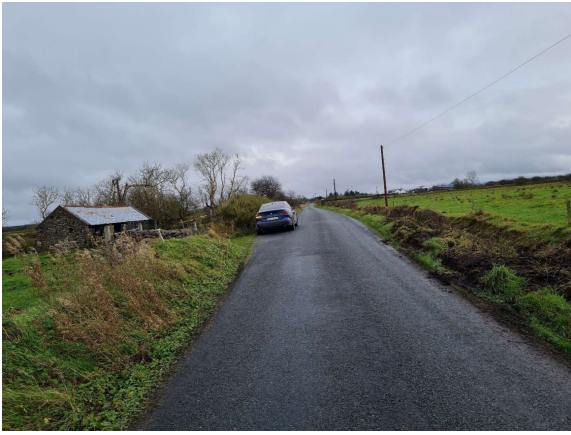
### **Location 79 - Left Bend On L2604**

Visual inspection indicates that road widening is required on the offside of the road.

Pruning required on both sides of the road.

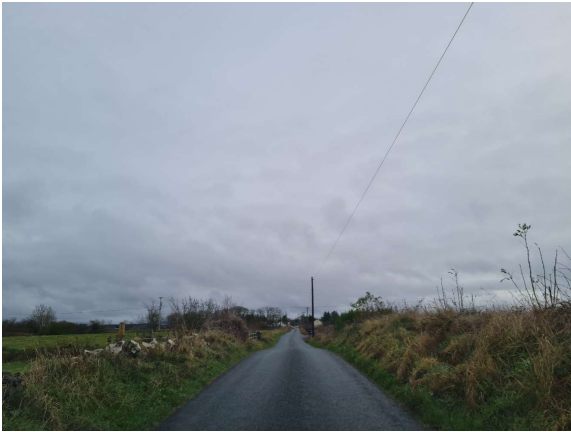
### **Location 80 - L2604**

Visual inspection indicates that the road width narrows from this location onwards.

Road will require upgrading to the turbine manufacturers specification.

Pruning will be required to provide a clear envelope as stipulated in the manufacturer's specification.

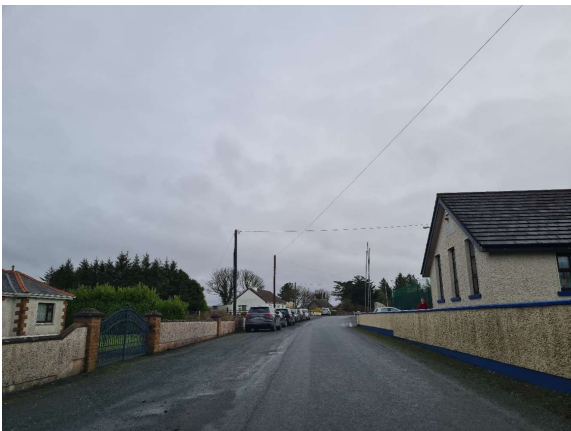
### **Location 81 - Crest On L2604**

Visual inspection indicates that vertical analysis is required to determine whether any grounding issues will occur during navigation.

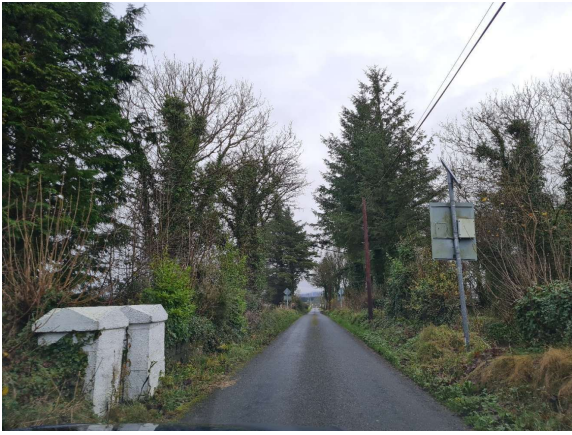
### **Location 82 - Right Bend On L2604**

Visual inspection indicates that third party land will be required at this location.

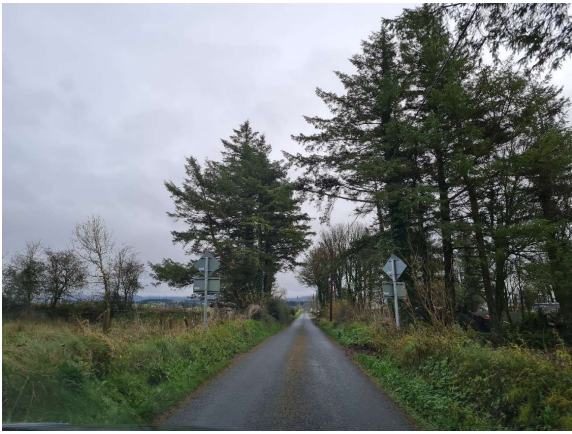
### **Location 83 - Narrow Section On L2604**

Visual inspection indicates that road widening will be required on both sides of the road.

Road sign and telegraph pole on the offside to be removed.

Pruning required on both sides of the road.

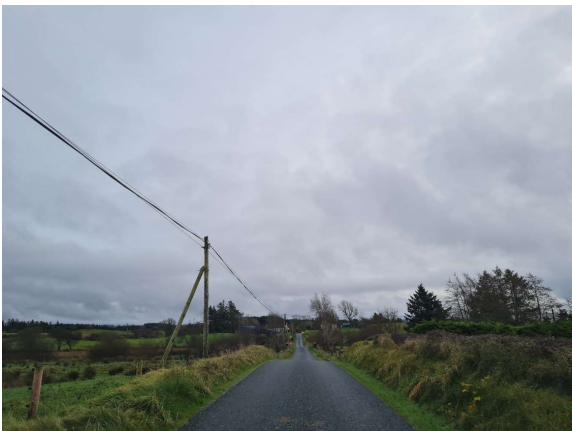
### **Location 84 - Road Signs On L2604**

Visual inspection indicates that road widening will be required on both sides of the road.

Road signs to be removed.

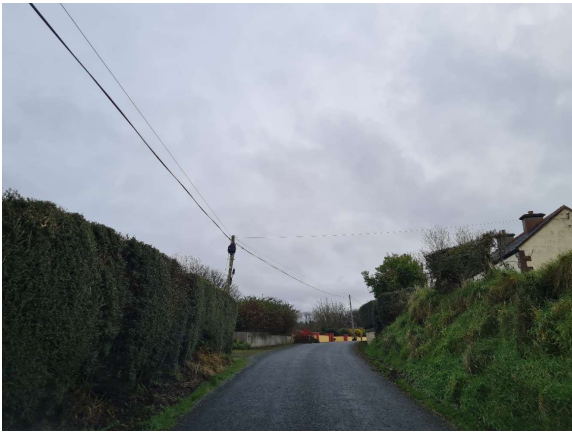
### **Location 86 - Crest On L2604**

Visual inspection indicates that vertical analysis is required to determine whether any grounding issues will occur during navigation.

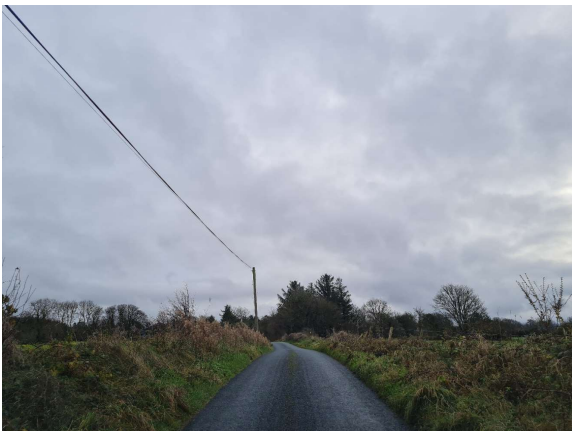
### **Location 87 - Right Bend On L2604**

Visual inspection indicates that third party land will be required at this location.

Street furniture will require removal.

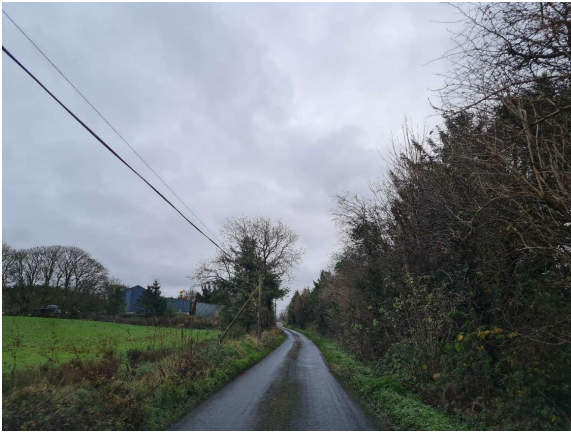
### **Location 88 - Left Bend On L2604**

Visual inspection indicates that road widening is required on both sides of the road.

Telegraph Pole on the nearside to be removed.

Pruning required on both sides of the road.

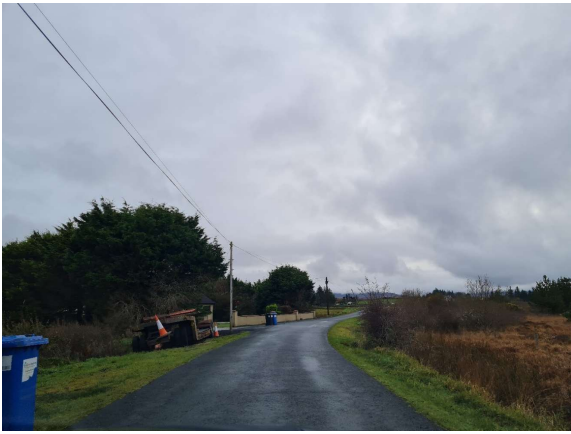
### **Location 89 - Left Bend On L2604**

Visual inspection indicates that road widening is required on the offside of the road.

Pruning required on both sides of the road.

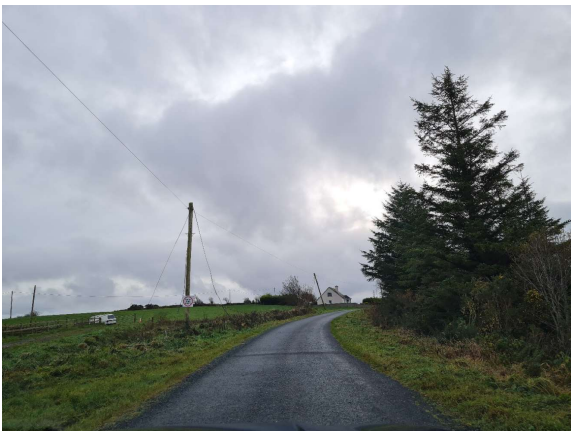
### **Location 90 - Right Bend On L2604**

Visual inspection indicates that road widening is required on the offside of the road.

Pruning required on both sides of the road.

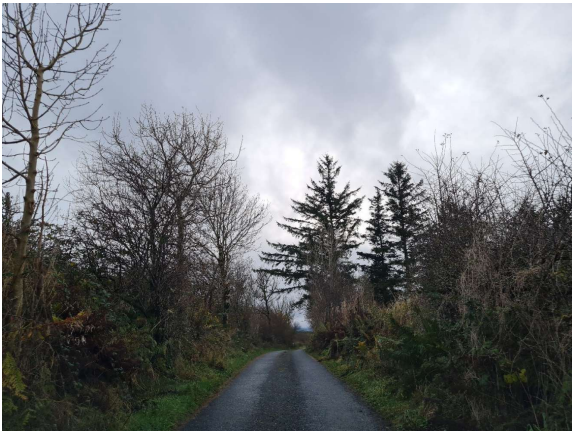
### **Location 92 - Left Bend On L2604**

Visual inspection indicates that third party land will be required on the nearside of the road.

Trees and vegetation on the nearside to be removed.

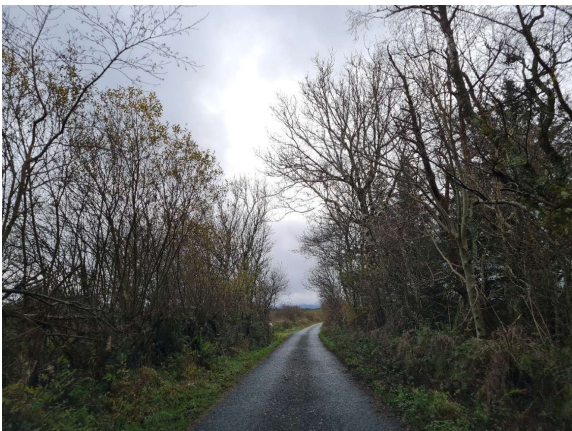
### **Location 93 - Right Bend On L2604**

Visual inspection indicates that third party land is required on the offside of the road.

Trees and vegetation on the offside to be removed.

Pruning required on the nearside.

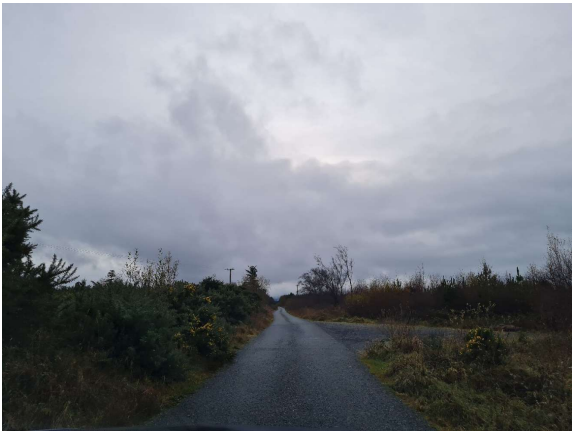
### **Location 95 - L2604**

Visual inspection indicates that the road will require upgrading to the turbine manufacturers specification.

Pruning will be required to provide a clear envelope as stipulated in the manufacturer's specification.

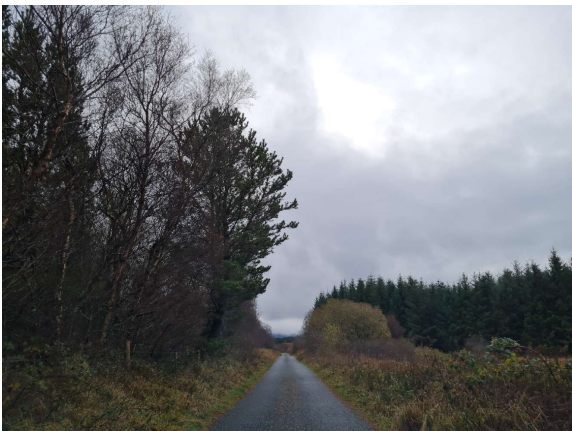
### **Location 96 - Left Bend On L2604**

Visual inspection indicates that road widening is required on the offside of the road.

Pruning required on both sides of the road.

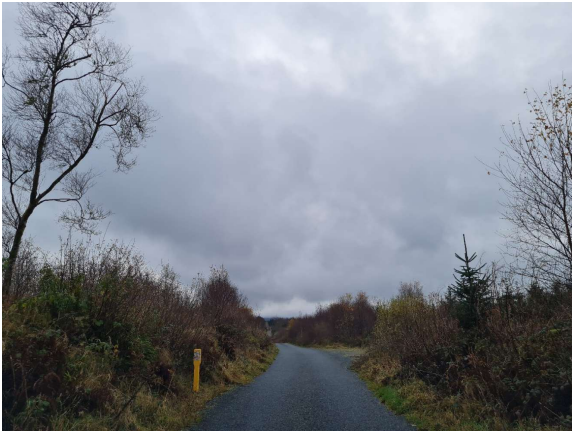
### **Location 97 - Tree On L2604**

Visual inspection indicates that road widening is required on both sides of the road.

Tree on the nearside to be pruned.

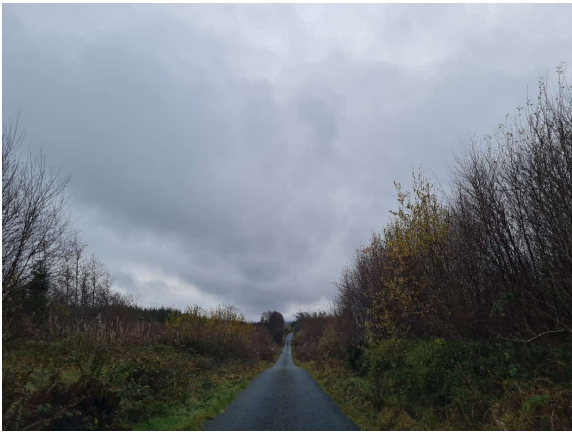
### **Location 98 - Left Bend On L2604**

Visual inspection indicates that third party land is required on the nearside of the road.

Trees and vegetation on the nearside to be removed.

Pruning required on the offside.

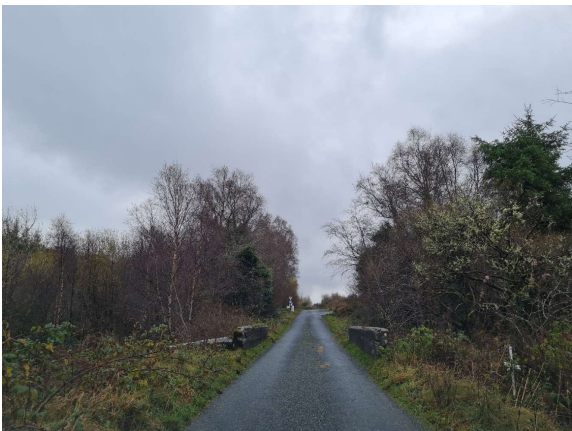
### **Location 99 - Crest On L2604**

Visual inspection indicates that vertical analysis is required to determine whether any grounding issues will occur during navigation.

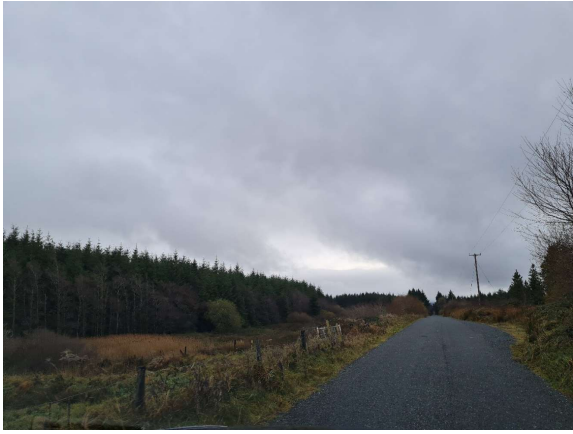
Visual inspection indicates that the bridge will require replacing as it is currently too narrow to allow for turbine deliveries.

Widening will be required both before and after the bridge.
