# Appendix I

## Accessibility Audit Report

# Ringsend to City Centre Core Bus Corridor Scheme

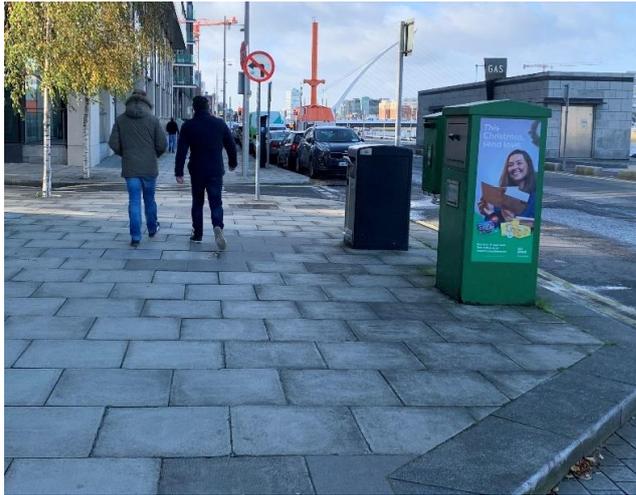
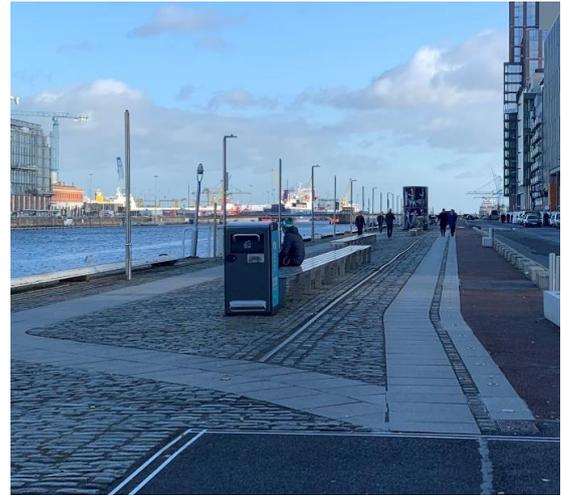
Street furniture was not considered to be as prolific throughout the south quays as on the north quays. Where street furniture was noted, such as post boxes, parking meters, bins etc, these were located out of the direct line of travel and invariably located in footpath buildouts. In some locations however bollards and lighting columns were placed in the centre of the footpath and should be relocated as part of the scheme design. Stainless steel bollards may potentially lead to glare in bright sunshine and may not be sufficiently contrasted in colour with the pavement to alert visually impaired pedestrians of their presence. They should be removed if considered unnecessary and improved upon visually if required as part of the design of the scheme.

### Well placed street furniture on the south quays
