Appendix A14.1
Scheme Walkover
Summary

Appendix A14.1: Scheme Walkover Summary

The following is a summary of the observations by the Land, Soils, Geology and Hydrogeology Environmental Impact Assessment Team following a physical walkover of the Bray to City Centre Core Bus Corridor Scheme (hereafter referred to as the Proposed Scheme). The walkovers occurred on 29 January 2020, 17 August 2022 and 23 March 2023. The drawings used to determine the type and extent of proposed works, and in turn, to inform the site walkovers were the General Arrangement drawings which are contained in Volume 3 of the Environmental Impact Assessment Report (EIAR).

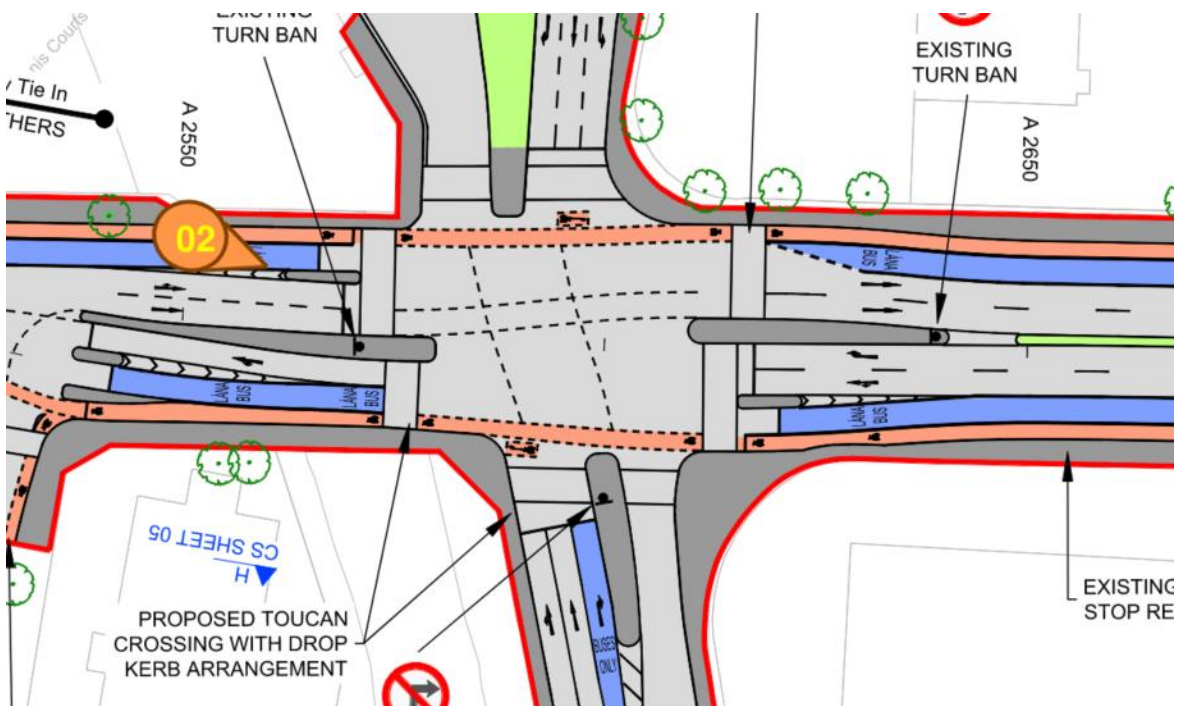
Observation	General Arrangement Drawing Sheet Number*	Description	Possible Impact	Photo Number
Petrol station	Sheet 08	Historic activities at petrol stations may have resulted in oil leaks into the surrounding soils and groundwater in the past.	This may pose an issue for the earthworks balance and waste assessment and mobilising contaminants into the groundwater.	Bray_Photo01
Donnybrook Junction – Dublin Bus Depot	Sheet 08	Historical maps indicate there used to be a train depot, Electricity Supply Board (ESB) electrical holding yard and a quarry at this location. Due to the historical land use at this location, it may be a source of contamination.	This may pose an issue for the earthworks balance and waste assessment and mobilising contaminants into the groundwater.	Bray_Photo02
UCD	Sheet 12 to 14	Upgrade works are noted at University College Dublin (UCD). Final details are to be confirmed after the completion of the UCD masterplan. Level changes are noted along the access ramp including mature trees and a perimeter wall.	This may pose an issue for the earthworks balance and waste assessment.	Bray_Photo03

Photo ID	Caption	Date Taken	Coordinates
Bray_Photo03	Photo showing proposed area of UCD interchange	23/03/2023	718730, 730223 (ITM)

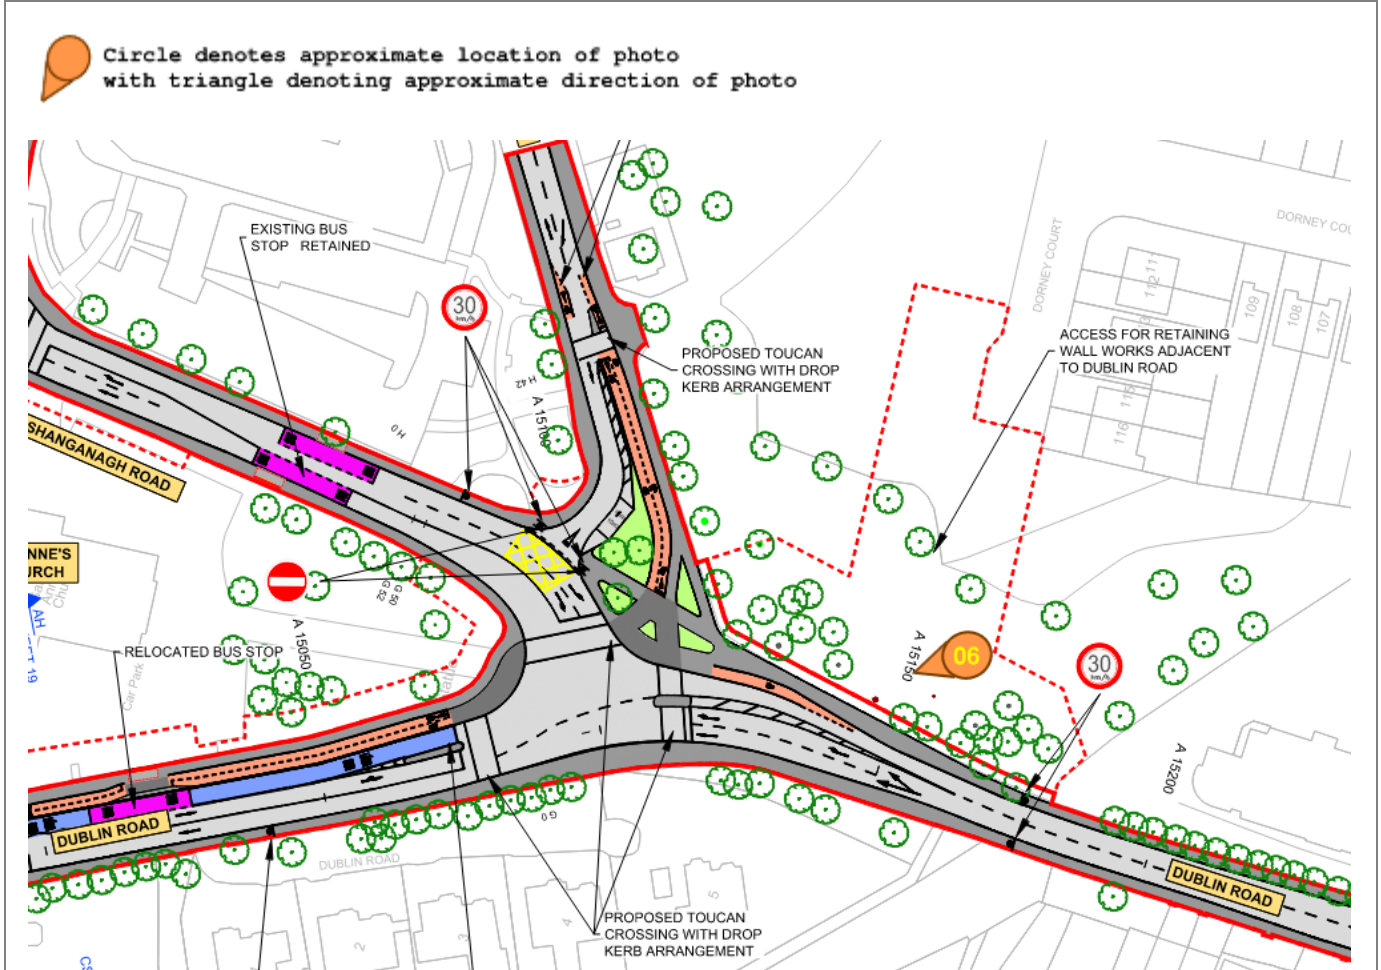
Observation	General Arrangement Drawing Sheet Number*	Description	Possible Impact	Photo Number
St. Laurence's Subway	Sheet 20	The existing subway is to be widened to accommodate N11 footway works. It is likely that the topsoil will be stripped, and level changes will be required at this location to accommodate the works.	This may pose an issue for the earthworks balance and waste assessment.	Bray_Photo05
Bridge crossing near St. Anne's Church, Shankill	Sheet 43	The Proposed Scheme will pass over the local bridge. Strengthening of the retaining wall is proposed at this location. A significant level change is noted with the surrounding area. The historic maps indicate a tram track at this location. Due to past land use, the surrounding ground may also be a source of contamination.	This may pose an issue for the earthworks balance and waste assessment	Bray_Photo06
St. James Church / Shanganagh Cemetery / Shanganagh Park	Sheet 47 and 48	Land acquisition is noted along this section of the route. Due to the nature of the works, existing infrastructure and historical land use at this location, it may be a source of contamination.	This may pose an issue for the earthworks balance and waste assessment	Bray_Photo07

Photo ID	Caption	Date Taken	Coordinates
Bray_Photo07	Adjacent to cemetery	23/03/2023	725492,720591 (ITM)

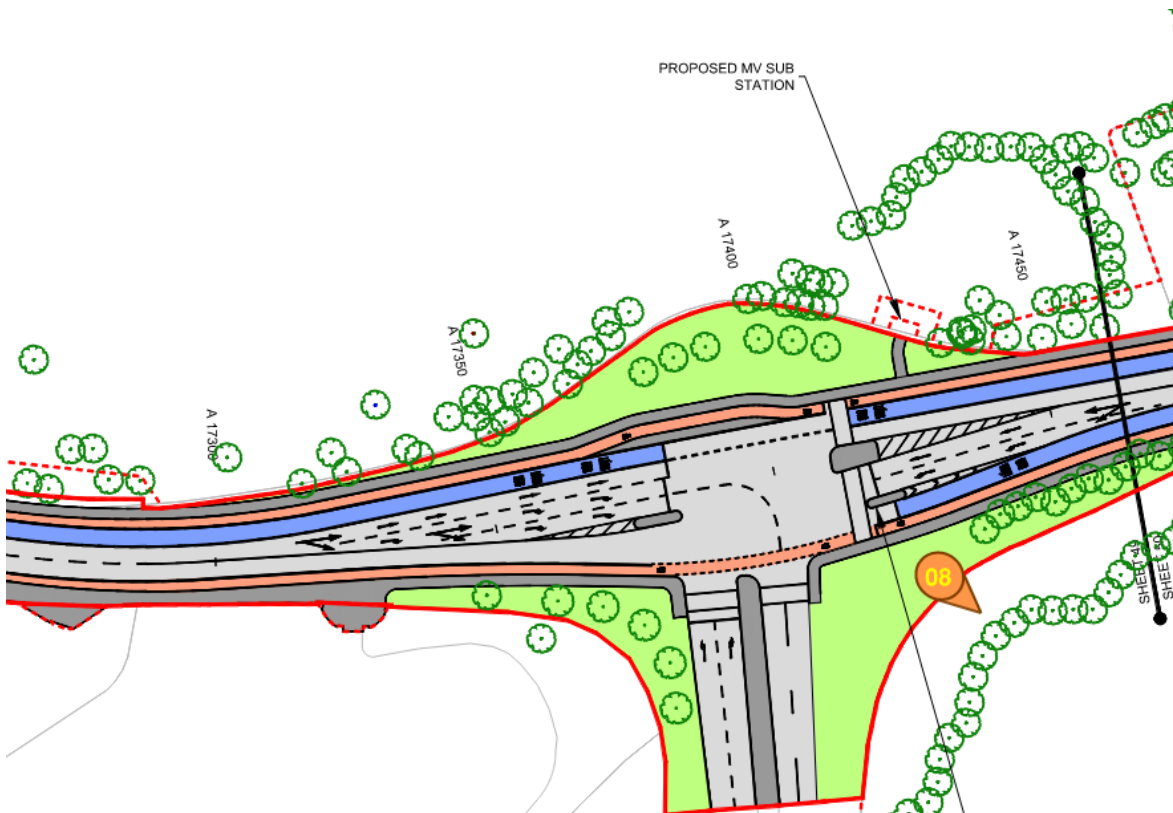
Wilford Junction Construction Compound (BR1)	Sheet 49	A construction compound is proposed to the south of Wilford Junction. It is likely that the topsoil will be stripped, and level changes will be required at this location to accommodate the works.	This may pose an issue for the earthworks balance and waste assessment	Bray_Photo08
Petrol station	Sheet 50 and 51	Decommissioning works are expected at an existing Circle K petrol station on the southbound side of the Dublin Road in Bray due to proposed widening works. Historic activities at petrol stations may have resulted in oil leaks into the surrounding soils and groundwater in the past. This will likely require land take, there is also possible presence of made ground. The area's build up is uncertain and may be overlying potentially contaminated soil, mitigation measures may need to be put in place. Ground Investigation will be required to confirm the ground conditions.	This may pose an issue for the earthworks balance and waste assessment and mobilising contaminants into the groundwater.	Bray_Photo09

Photo ID	Caption	Date Taken	Coordinates
Bray_Photo09	Petrol Station Bray town	23/03/2023	725841, 719357 (ITM)
