## INCHAMORE WIND FARM, CO. CORK

### **VOLUME IV APPENDICES**

## Inchamore Wind Farm, Co. Cork

Chapter 15 – Traffic & Transportation

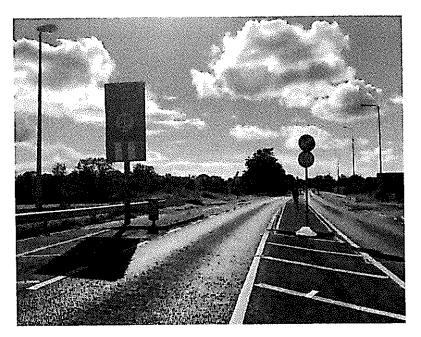
Location 14 - N21 Splitter Island And Right Bend At Rathkeale Road Junction

Direction Continue On N21 Visual inspection indicates that a contraflow manoeuvre will be required at this location as well as use of manual steering.

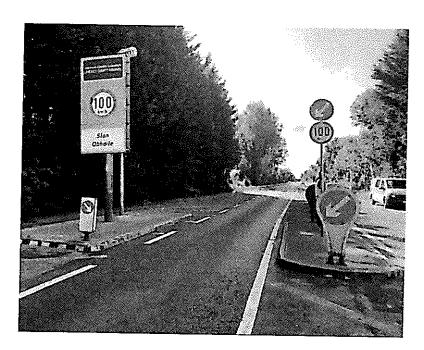
Location 17 - N21 Splitter Island At Exit From Croagh

Direction Continue On N21 Visual inspection indicates that there are no issues at this location.

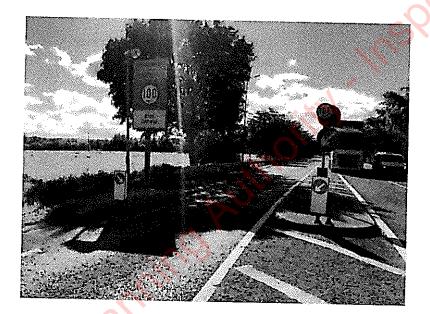
Location 22 - N21 Splitter Island At Exit From Newcastle West Direction Continue On N21 Visual inspection indicates that no issues at this location \*Note\*

Nearside Kerb to road sign on splitter island is 4.4m

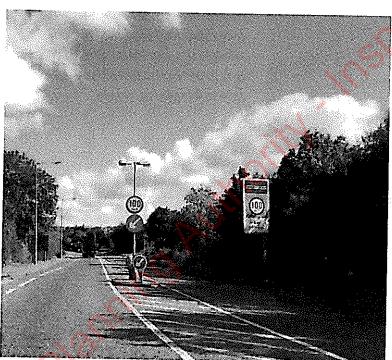
# Location 26 - N21 Splitter Island At Entry To Abbeyfeale

Direction Continue On N21 Visual inspection indicates that there are no issues at this location Width measured at 4.4m from nearside Kerb to road sign \*Note\* picture in reverse view

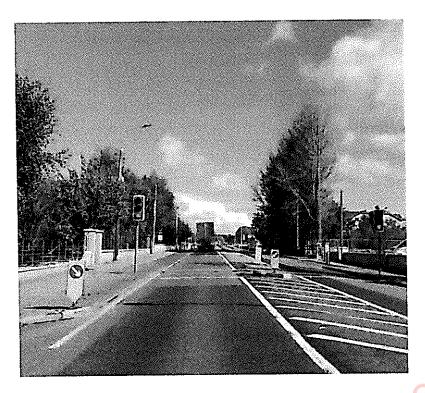
Location 27 - 6x Splitter Islands In N21 In Abbeyfeale
Direction Continue On N21 Visual inspection indicates that there are no issues with these splitter islands

\*note\* picture in reverse view

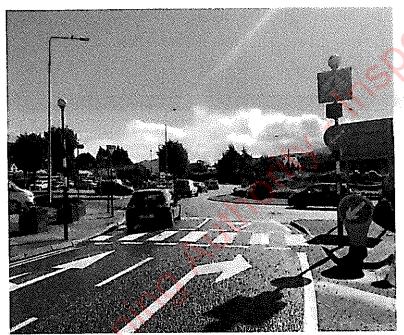
Location 36 - N22/L3010 Park
Roundabout
Direction Continue On N22
Manual steering required- No
issues at this location Swept path
analysis recommended to
confirm

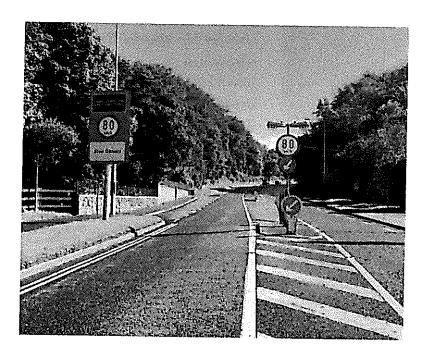
Location 37 - Splitter Island
Numerous After Roundabout
Direction Continue On N22 Visual
inspection indicates that loaded
blade will navigate this spiller island
without issue \*Note\*
Road width - 4.5

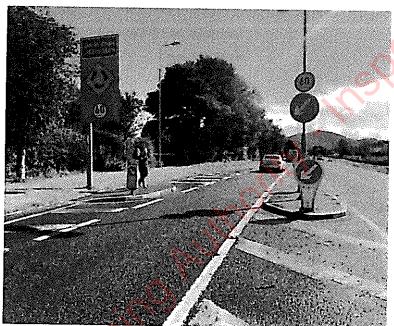
Location 38 - N22 Splitter Island At Entry To Lissivigeen Direction Continue On N22 Visual inspection indicates that loaded blade component will navigate with no issues. \*Note\*

Road width - 3.8

Sign to sign - 5.8

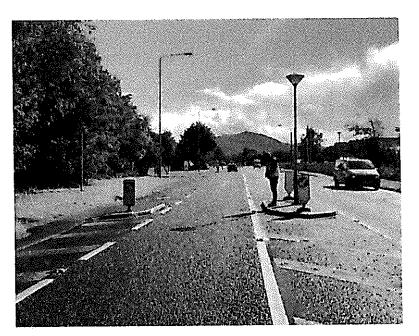
Location 39 - N22 Splitter Island In Lissivigeen

Direction Continue On N22 Visual inspection indicates that loaded blade will navigate through will no issues.

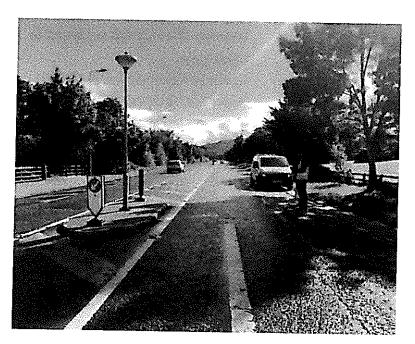
#### Location 41

\*Note\*

Road width - 3.7m

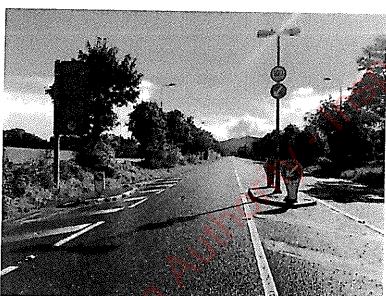
# Location 42 - Lissivigeen Splitter Island Exit

Visual inspection indicates that loaded blade component will navigate through with no issues. \*Note\* Road width - 5.0m
