**APPENDIX 13.1:**

**AI BRIDGES TELECOMMUNICATIONS IMPACT STUDY**

## Inchamore Wind Farm Telecommunications Impact Study

Gortyrhilly, Inchamore and Cummeennabudoge (CMDC)  
Wind Farms  
Civil & Structural Due Diligence Report

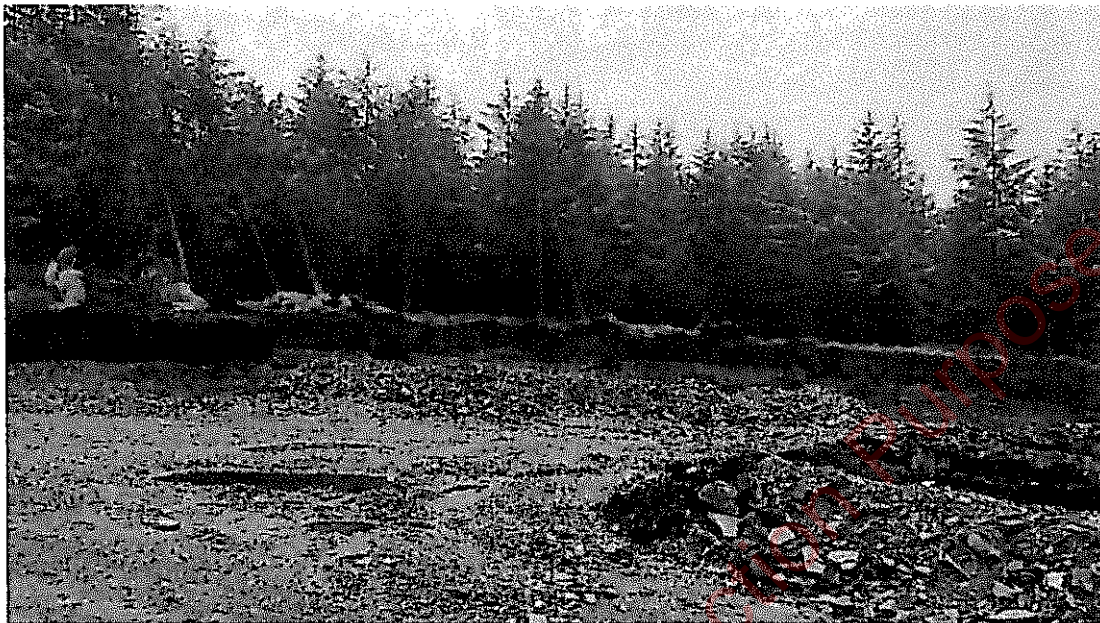
Route C runs between Inchamore Windfarm and Cummeennabuddoge (CMBG) Windfarm (waypoints F-G-J-K). Route C is typically proposed to be installed along existing forestry tracks with some alternative routes through Coillte forestry and privately owned farmland in the northern sections of this route. The forest tracks were typically cut into the existing topography, although some embankments were also noted. The ground conditions observed in the cuttings (Figure 6-3) included 1.0m to 1.5m of peat overlying till and/or weathered rock, with some rock outcrops also observed.

**Figure 6-3: Ground conditions observed along route C**

In areas of peat either a geotextile membrane should be incorporated into the floor of the trench to support the ducts or the peat should be excavated down to the top of the till/weathered rock stratum. No special measures are anticipated for areas of till, weathered rock or road hardcore, which should be excavatable. In areas where rock is present along the edge of the road the trench excavation process may be hindered by this rock.

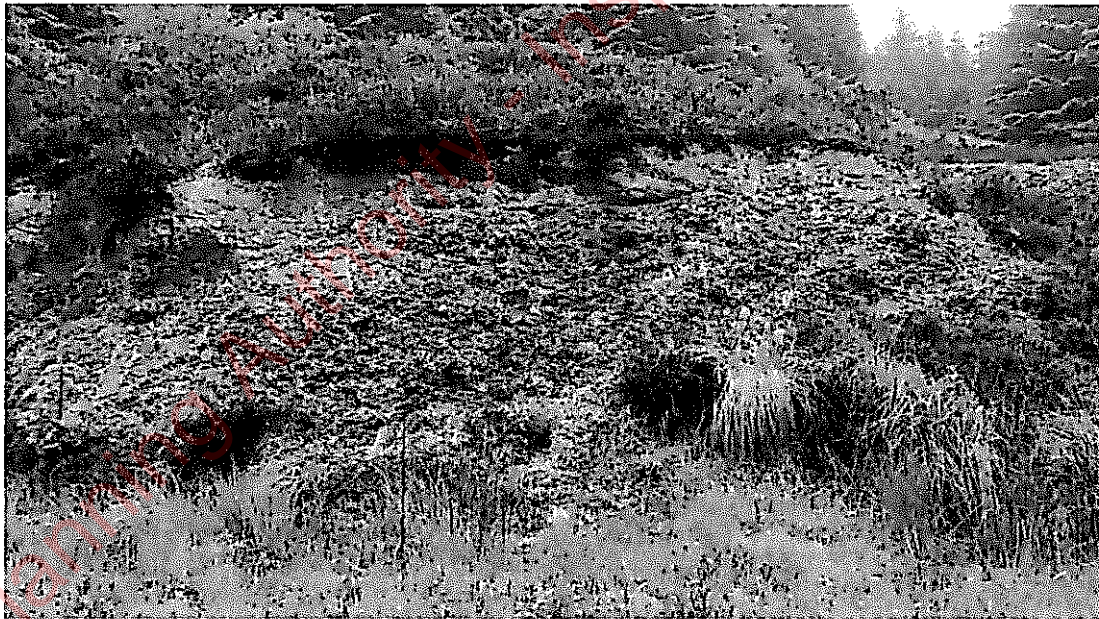
Between waypoints J and K, the existing track levels out vertically with the cross slope falling south to north as observed, with the track typically being cut with near-vertical edges into the southern side of the track, and occasionally on both sides of the track. Some deeper sections of cut were observed to have exposed peat overlying till consisting of a cohesive material with sand and gravel content. Several locations were observed to have been subjected to erosion with shallow slips evident as shown in Figure 6-4 to Figure 6-7 inclusive with approximate ITM coordinates provided for each location. As described in Section 5.2, historic landslide events were also identified on the GSI online mapping portal in the River Clydagh valley. As such, there is a risk associated with potential landslides along route C should this option be progressed to construction. This risk could be managed by felling trees where necessary and cutting the adjacent slopes to a suitable gradient of 1V:2H or shallower. Some alternative routes are proposed along route C between waypoints G and K which typically pass through steeper areas which would require tree felling to permit the installation of the cables.

Figure 6-5: Exposed overburden cut with evidence of erosion/shallow slips (ITM 516203E, 582876N)

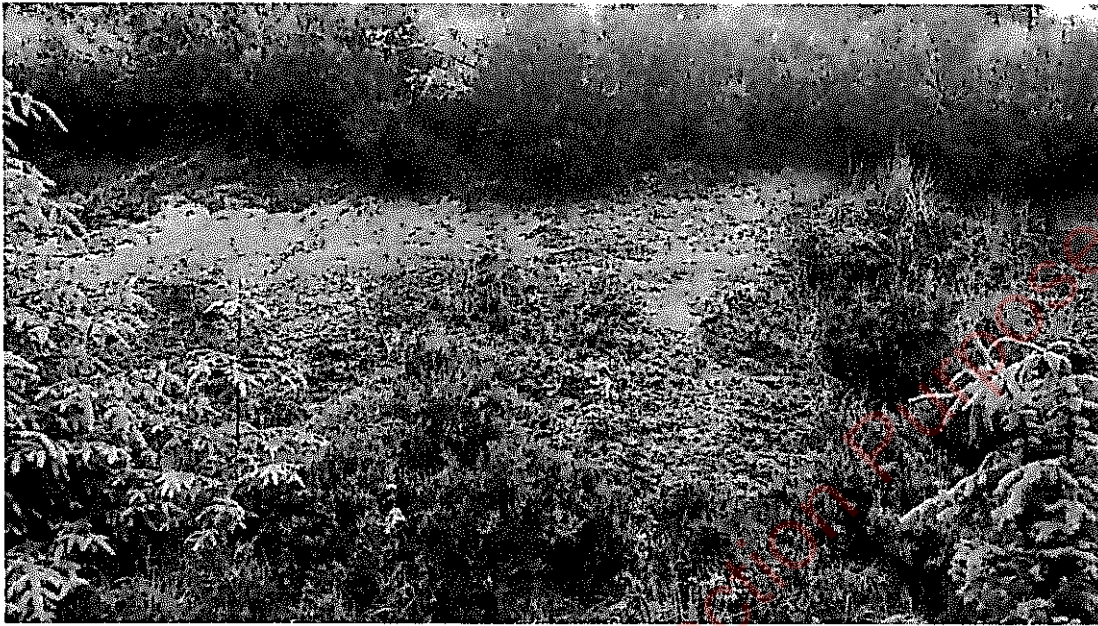
Figure 6-6: Exposed overburden cut with evidence of erosion/shallow slips (ITM 516203E, 582880N)

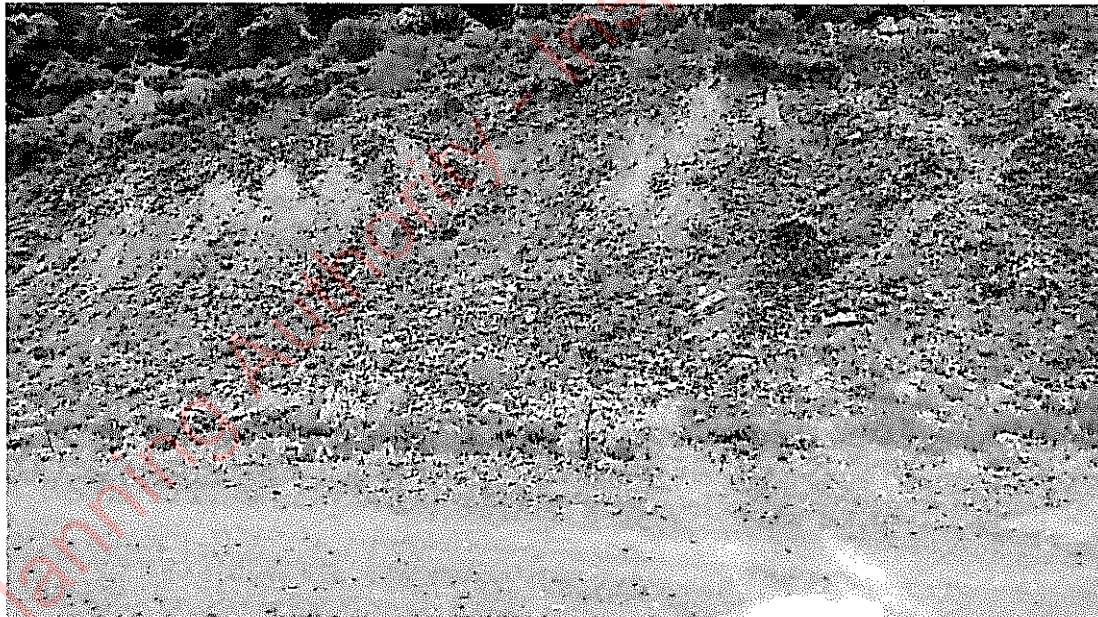
Figure 6-7: Exposed overburden cut with evidence of erosion/shallow slips (ITM 519555E, 583500N)

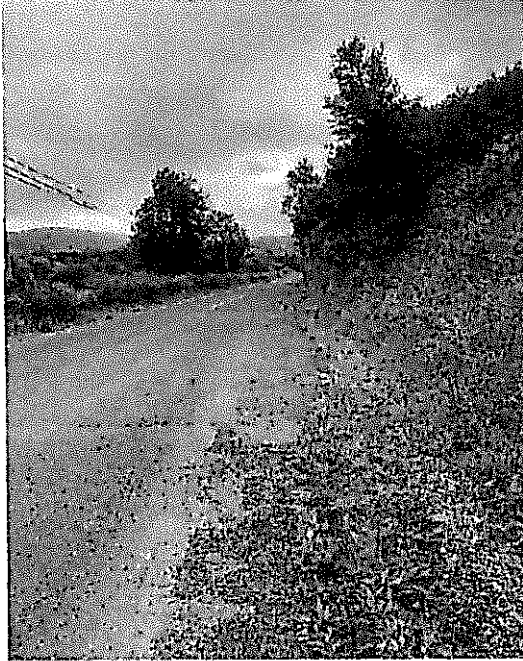
**Image : 41**  
Joint bay on the road here with a links box and communications chambers visible.

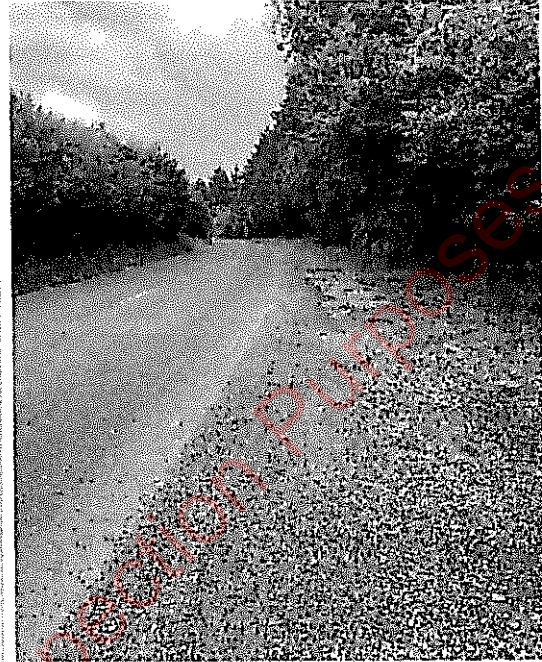
**Image : 42**  
Joint bay on the road here with a links box and communications chambers visible.

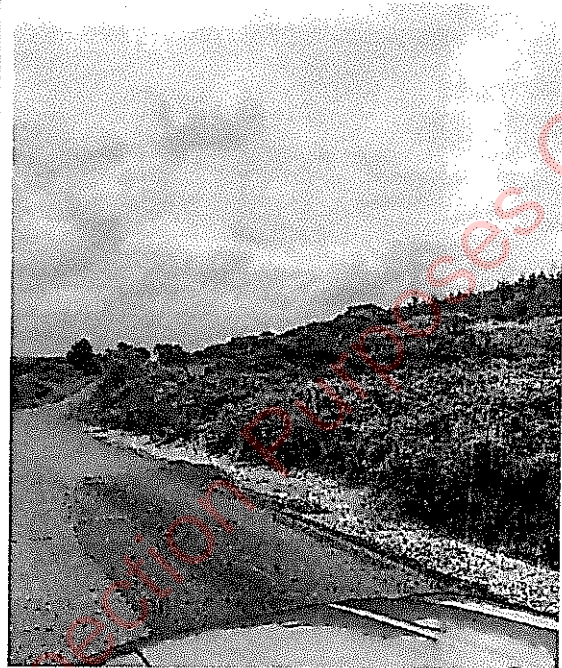
Main risks are the existing cables in the road as highlighted in images 52 to 54 and will only work if there is a substation built in Inchamore to take the cable before eventually going to Ballyvouskill substation through the Coillte lands.

**Image : 52**  
Joint bay on the RHS of the road at this location with a links box and communications chambers visible.

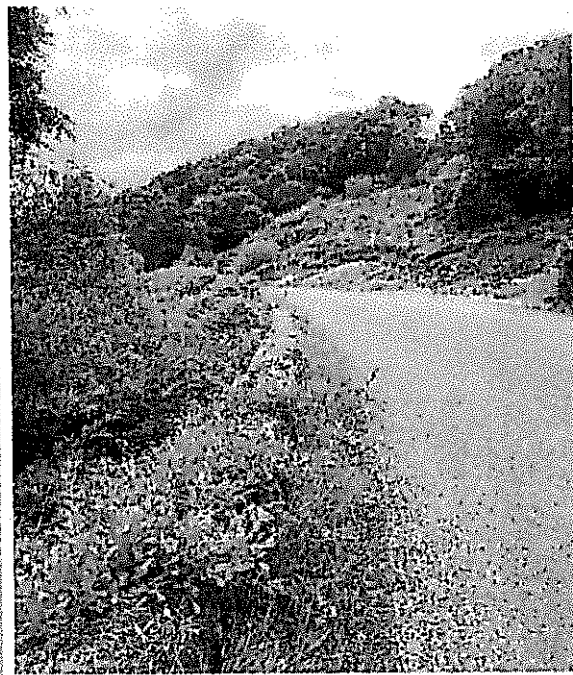
**Image : 53**  
Stone wall to LHS of the road as there is a significant elevation change from the roads surface to the existing ground

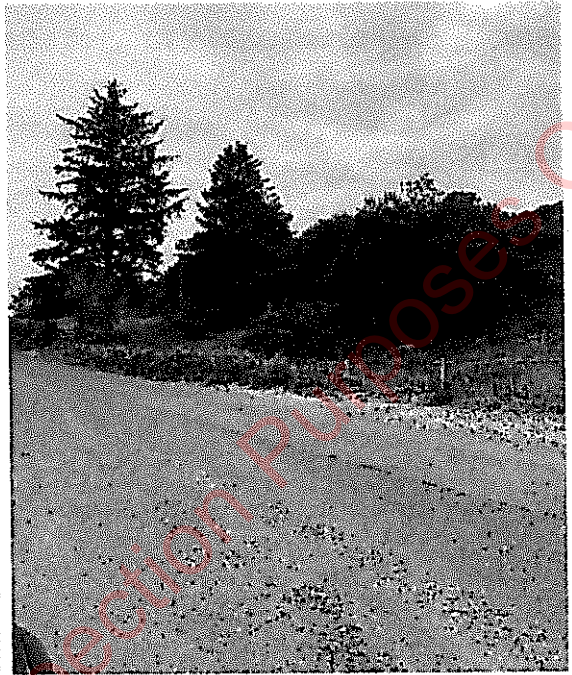
**Image : 54**  
Joint bay on the RHS of the road at this location with a links box and communications chambers visible.

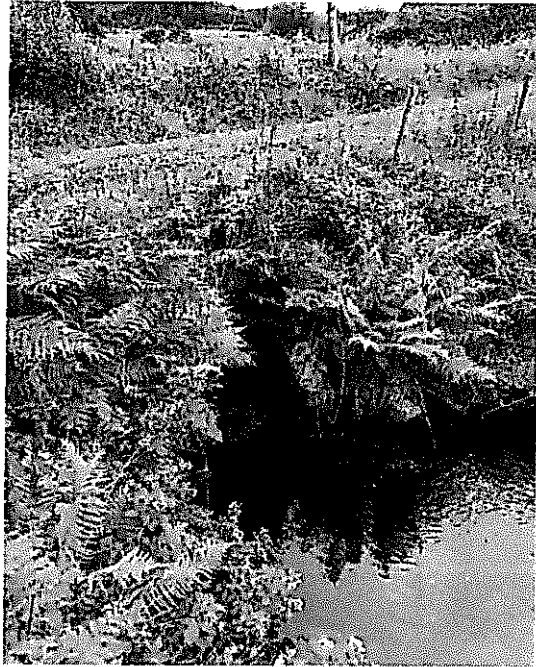
**Image : 55**  
Box stone culvert crossing at this location

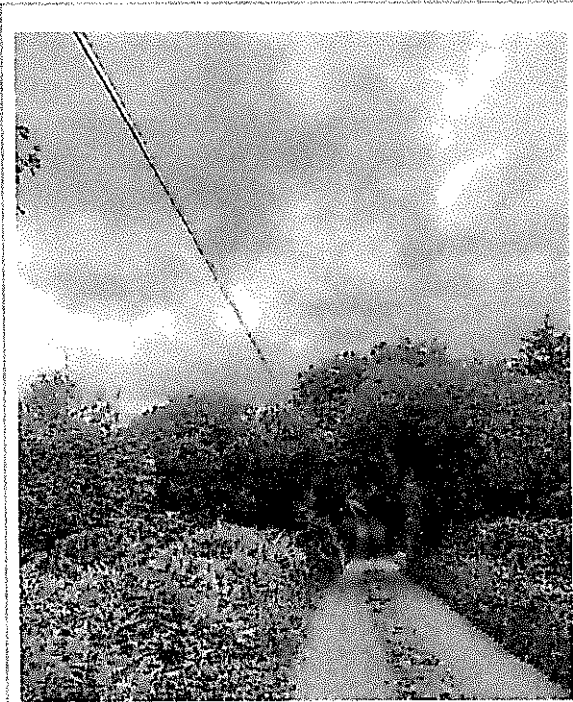
**Image : 61**  
Storm pipe crossing road at stone wall parapet

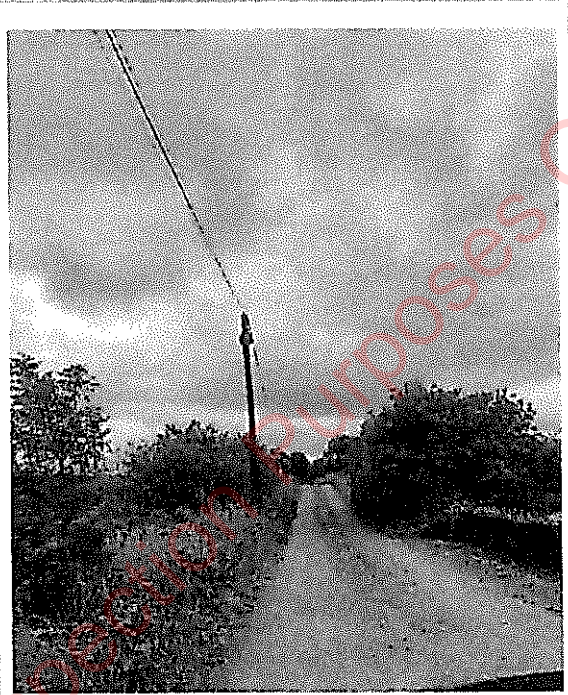
**Image : 63**  
Storm pipe crossing road at stone wall parapet

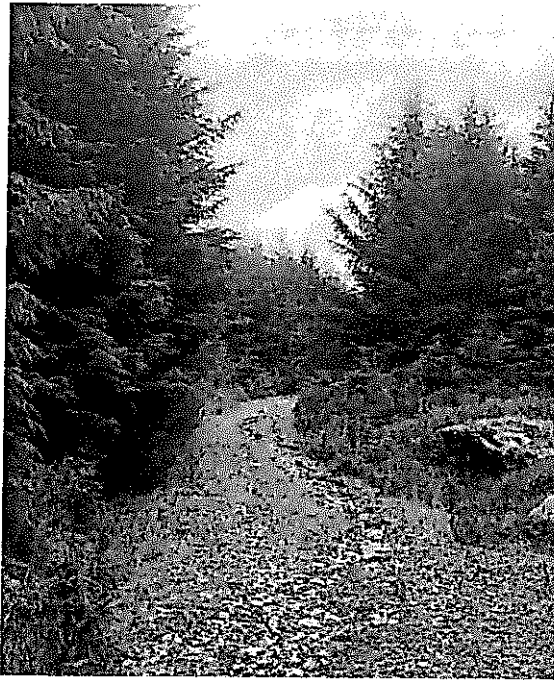
**Image : 72**  
Forestry track on Coillte lands very step and heavily rutted

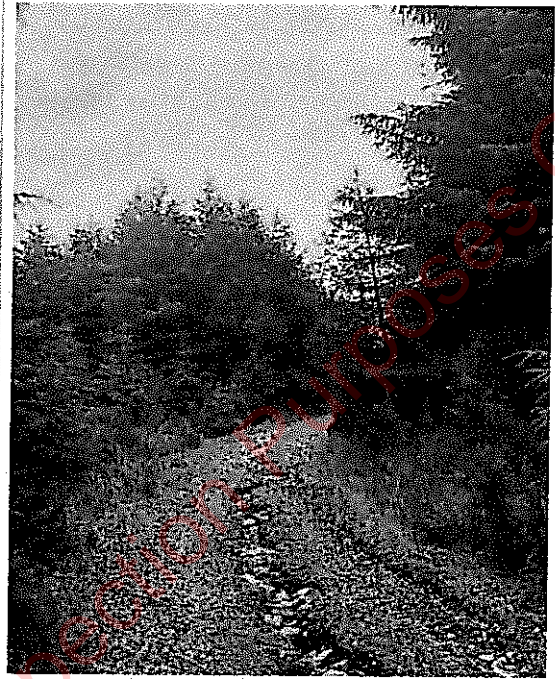
**Image : 73**  
Forestry track on Coillte lands very step and heavily rutted

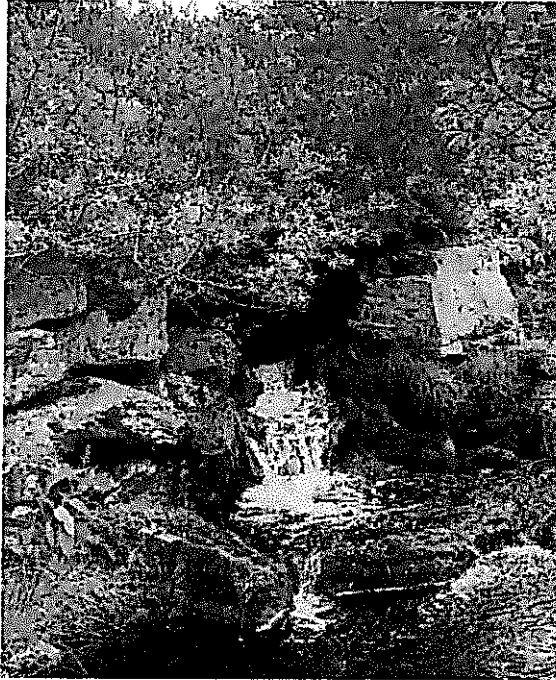
**Image : 80**  
Stream crossing track at this location with a partial collapsed storm pipe

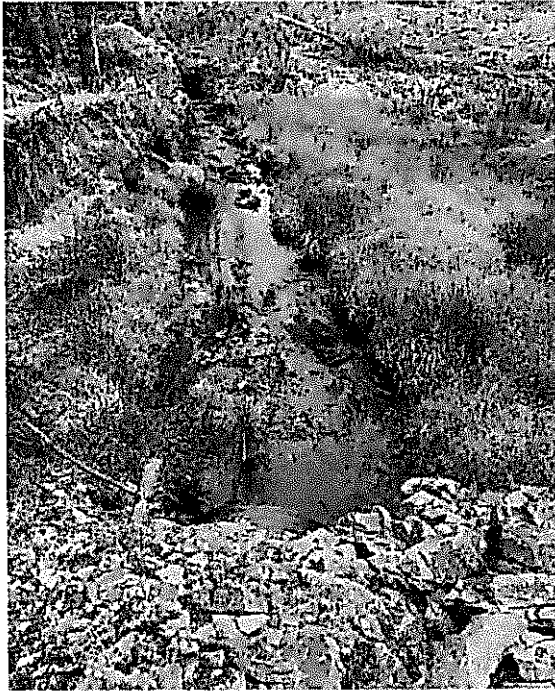
**Image : 82**  
Stream crossing track at this location with a partial collapsed storm pipe

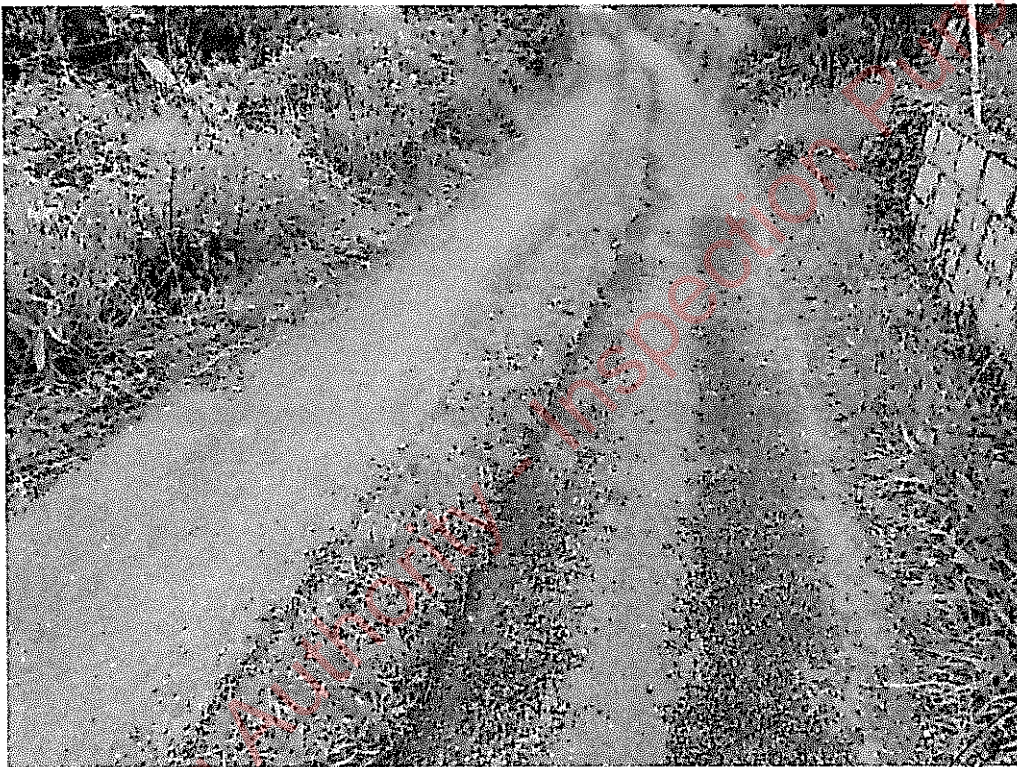
The existing bridge surface consists of tar & chip wearing course with a grassed median and is in good order generally. Some minor surface wear and abrasion is evident.

General view of bridge surface

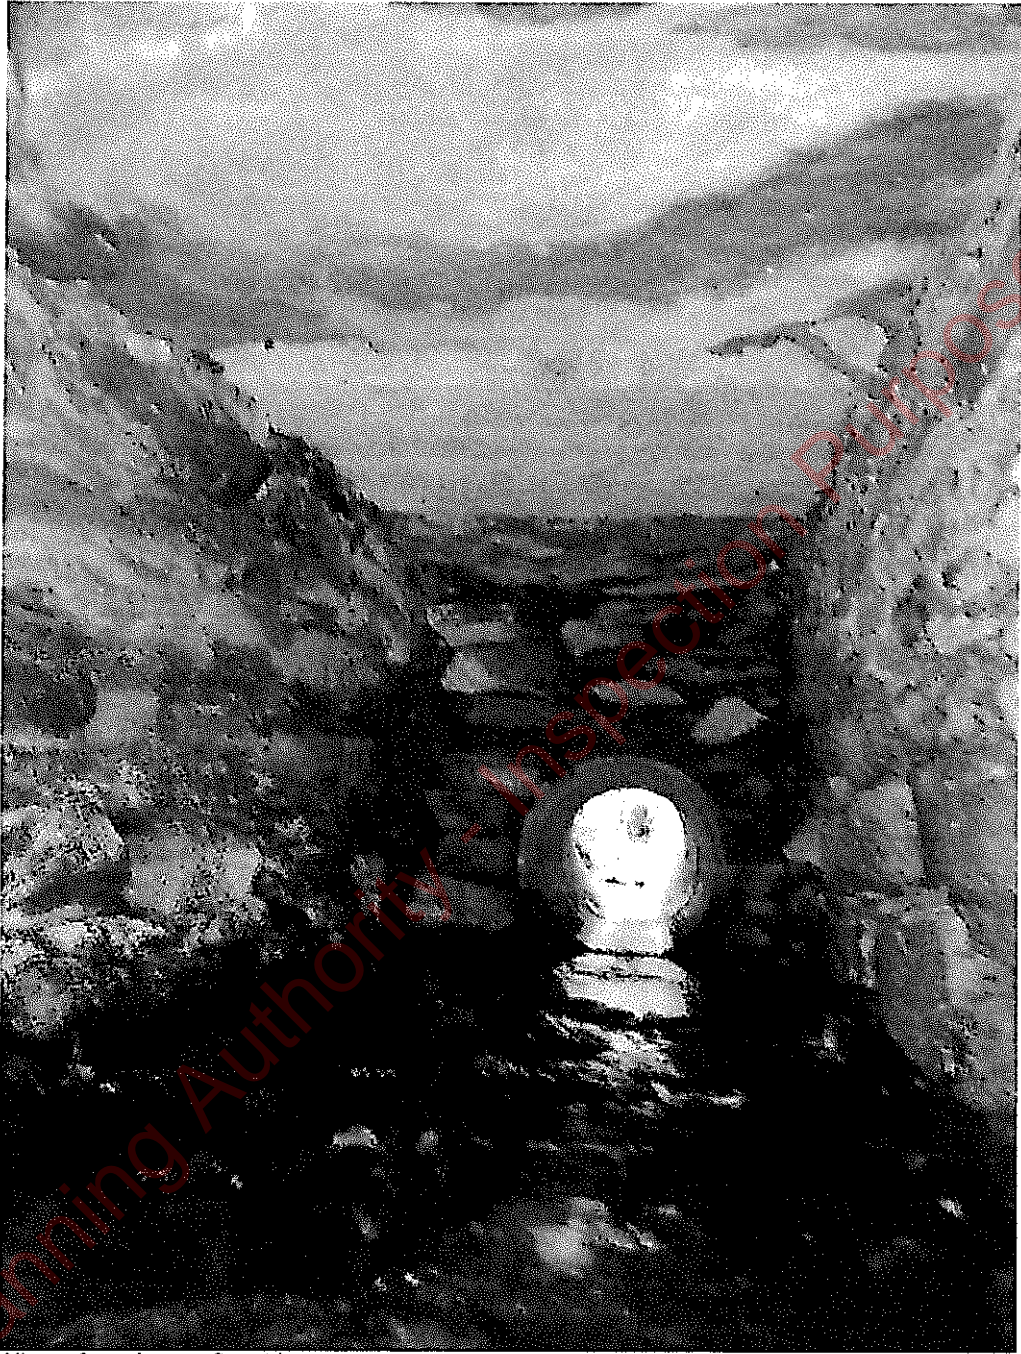
A portion of the south span has been repaired with a 450mm diameter concrete pipe for a length of 1850mm toward the east side of the span. The pipe has been installed at bed level and fully surrounded with stone / rubble.

View of south span from the west

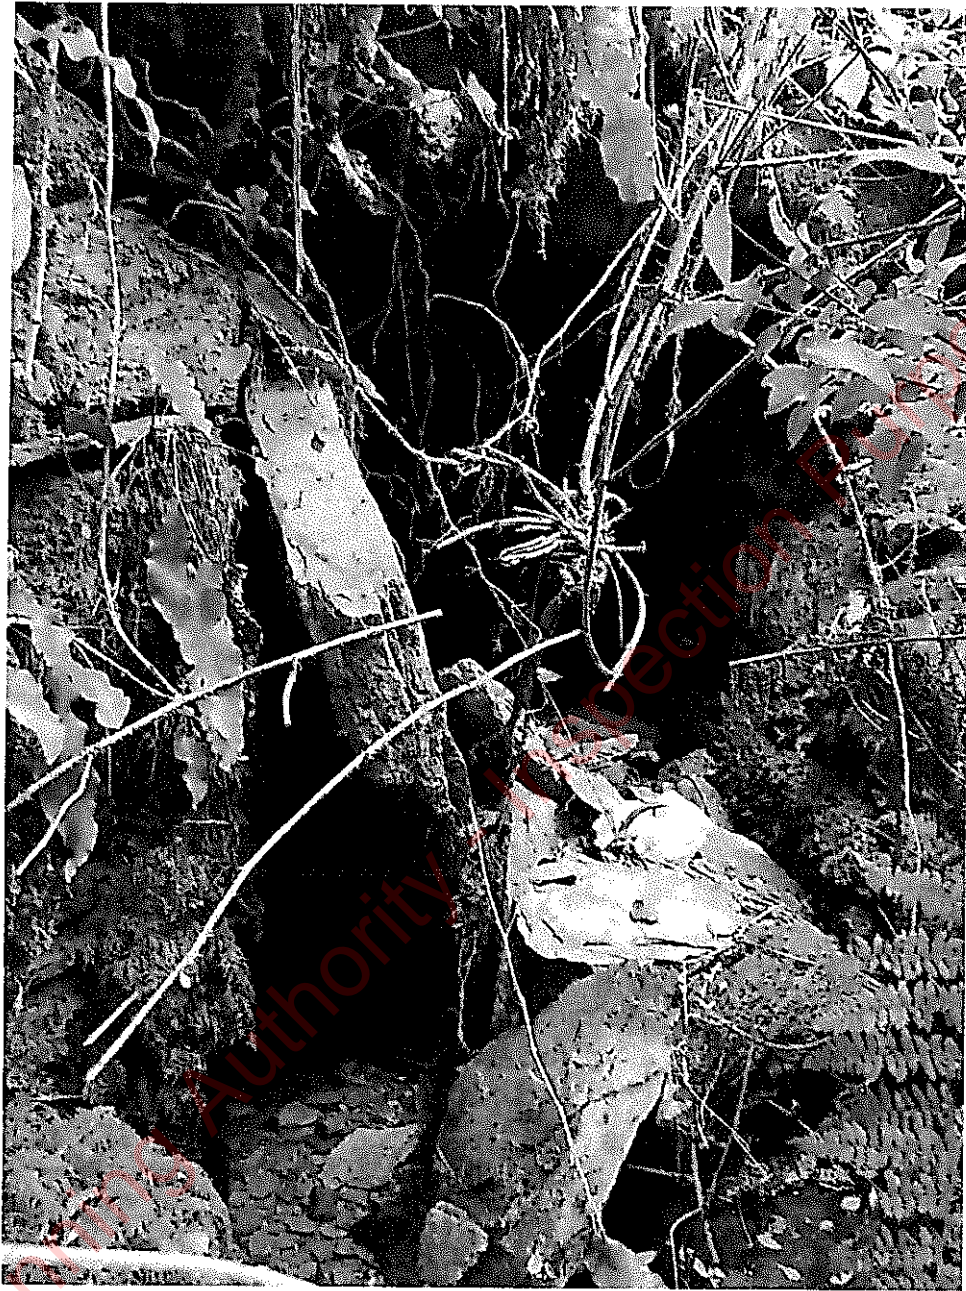
There are stone masonry spandrels on both elevations. The south end of the west spandrel has collapsed locally over a damaged section of the bridge deck.

Collapsed stones at the west end of the south span

Significant damage is evident in the deck in both spans and in the eastern spandrel wall. Repair works should be executed without delay.

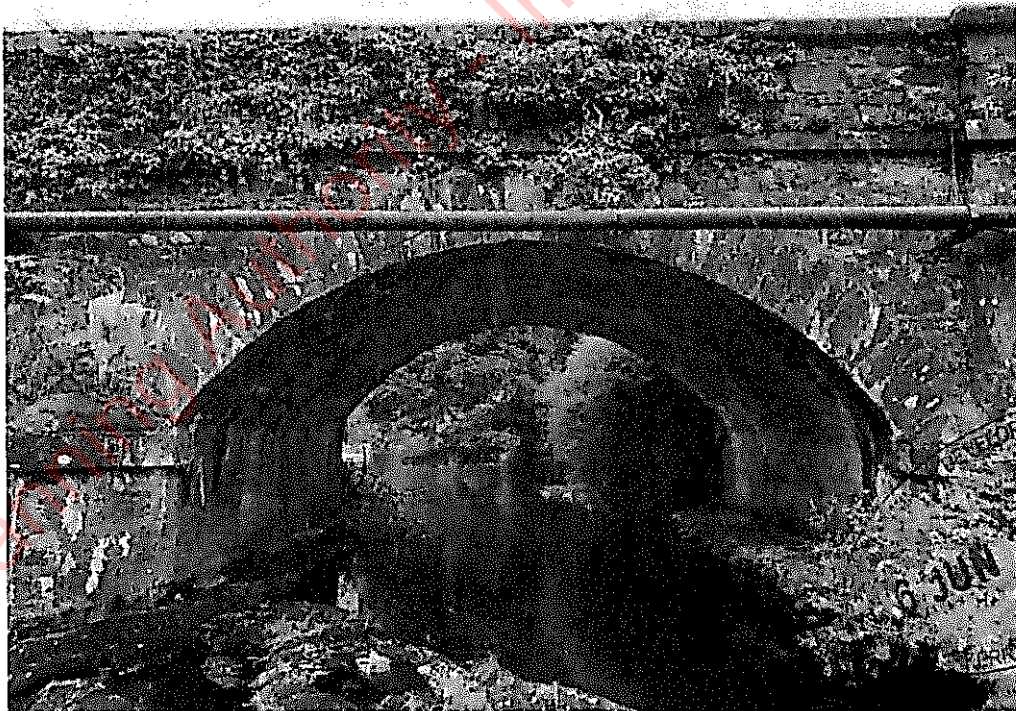
The arch barrels have been repaired with gunite. Minor defects such as water ingress, calcite staining, and leaching are noted. Some of the gunite has deteriorated in the most western span and the original stones are exposed.

General view of the eastern span, looking upstream

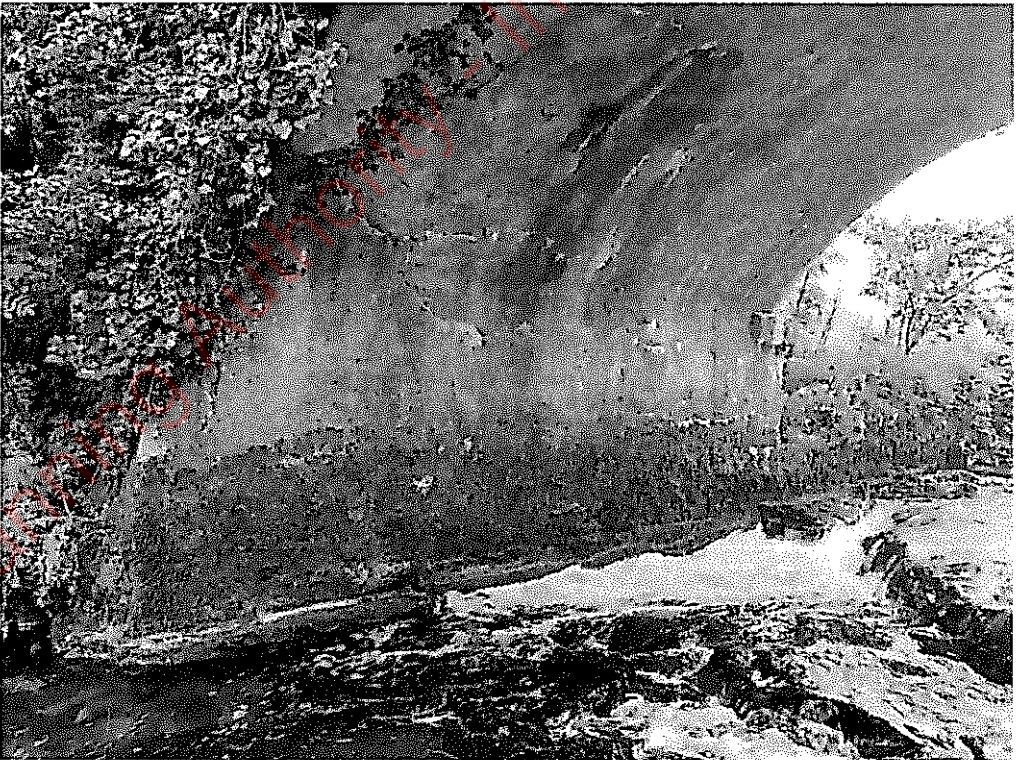
The abutments are founded on bedrock. The face of both abutments has been repaired with gunite. Some minor vegetation growth is present. Minor cracks are noted in the gunite, however, no bulging or movement of the abutments is evident. The abutment footings have been protected with grout bags.

Western abutment

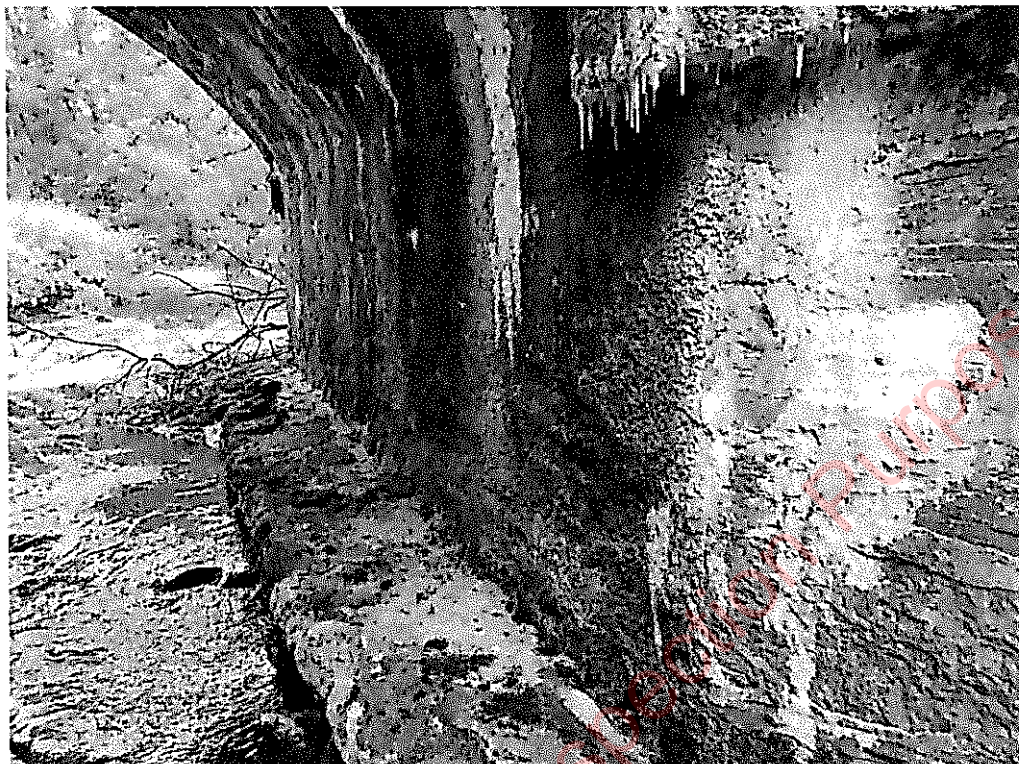
The piers are founded on bedrock. The pier faces have been repaired with gunite and the footings have been protected with grout bags. Some washout of the grout bags has occurred, however, no washout or undermining of the piers is evident.

Typical pier condition

Overall the structure is in good condition with few defects found. Maintenance repairs to the masonry elements and historical protection works to the pier and abutment footings are required. Debris should be removed from the riverbed.

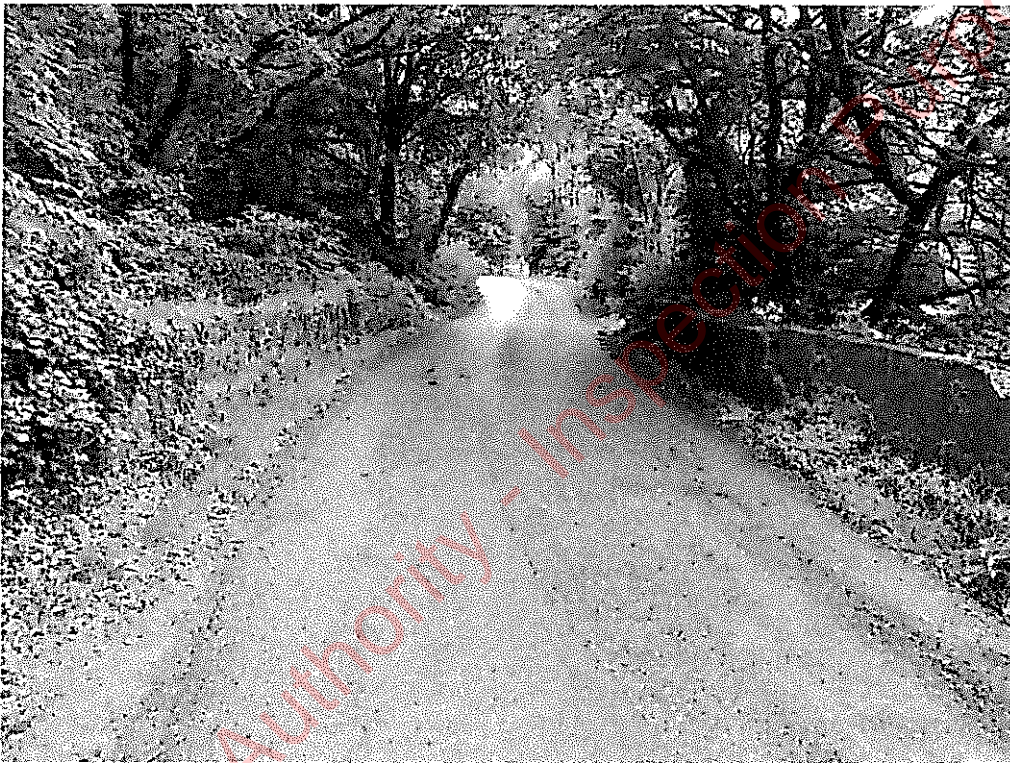
The existing bridge surface consists of dense bitumen macadam wearing course and is generally in good order. Some minor potholing, wear and abrasion are evident.

General view of the bridge surface

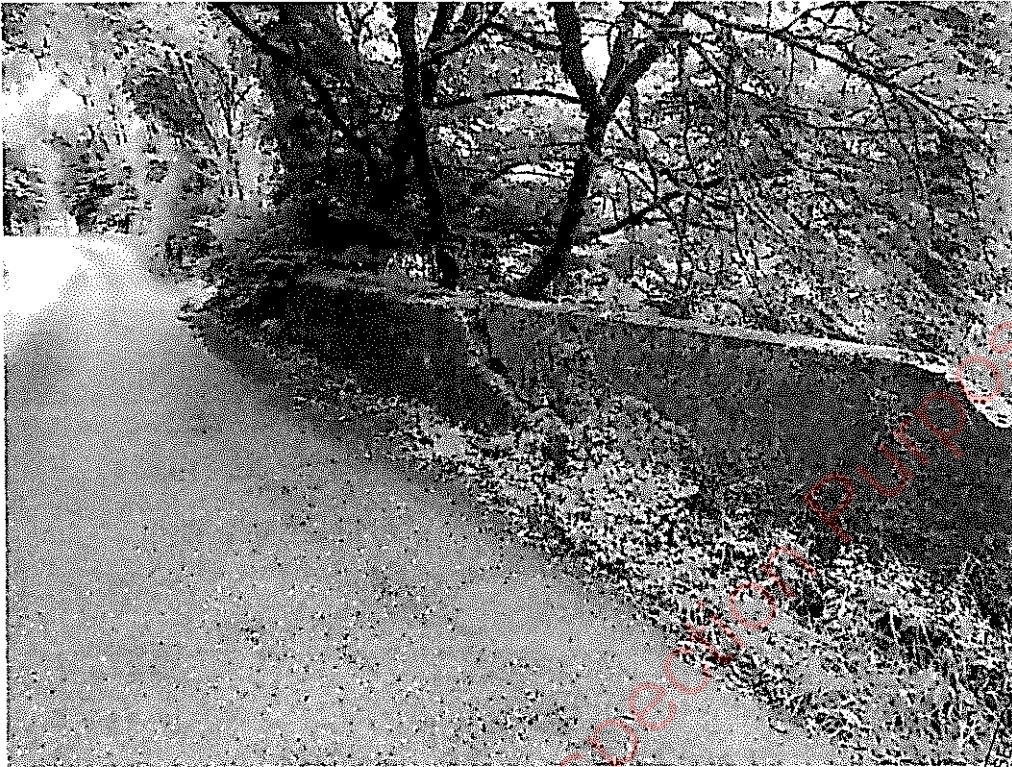
South parapet showing partial collapse extending from the centre of the bridge

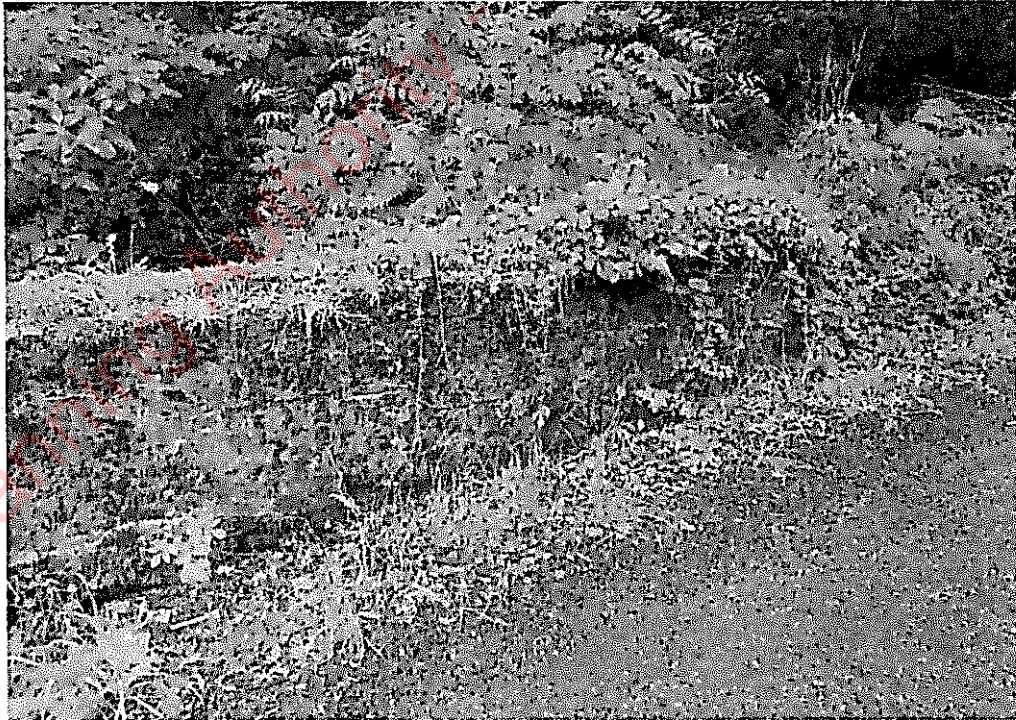
General view of the north verge and parapet

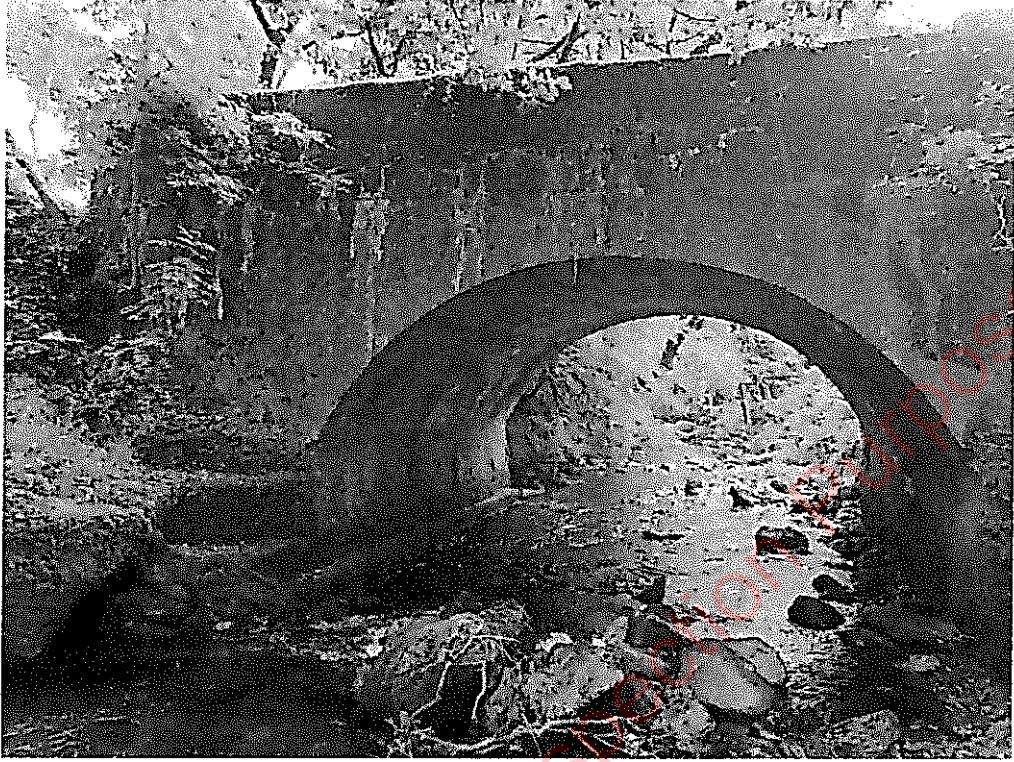
General view of the north elevation, looking downstream

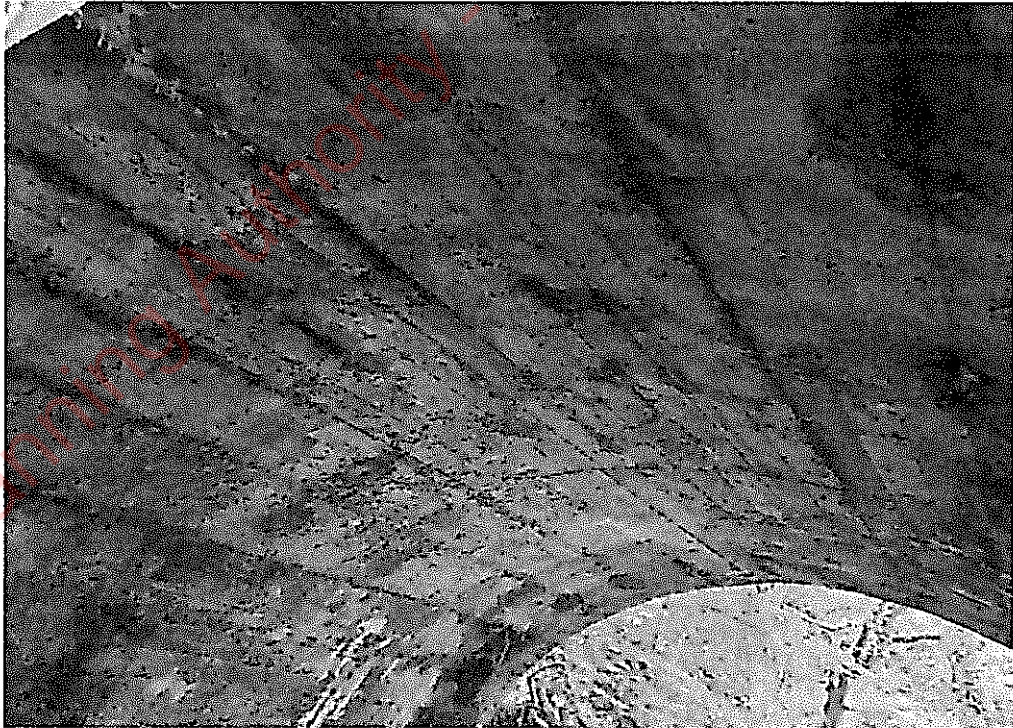
General view of the arch soffit

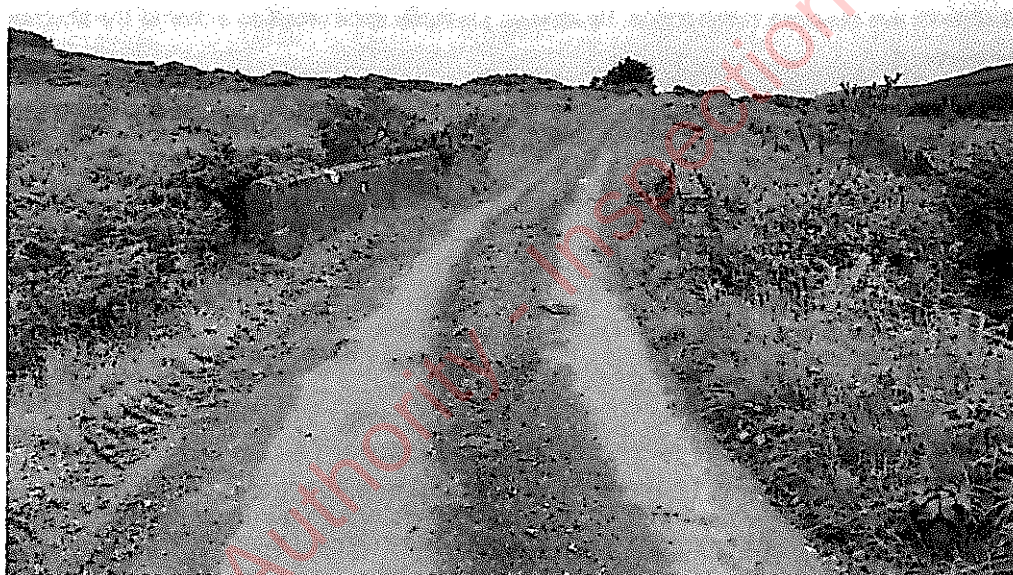
The existing bridge surface consists of tar & chip wearing course and is generally in good condition. Some wear and abrasion is evident.

General view of the bridge surface looking south

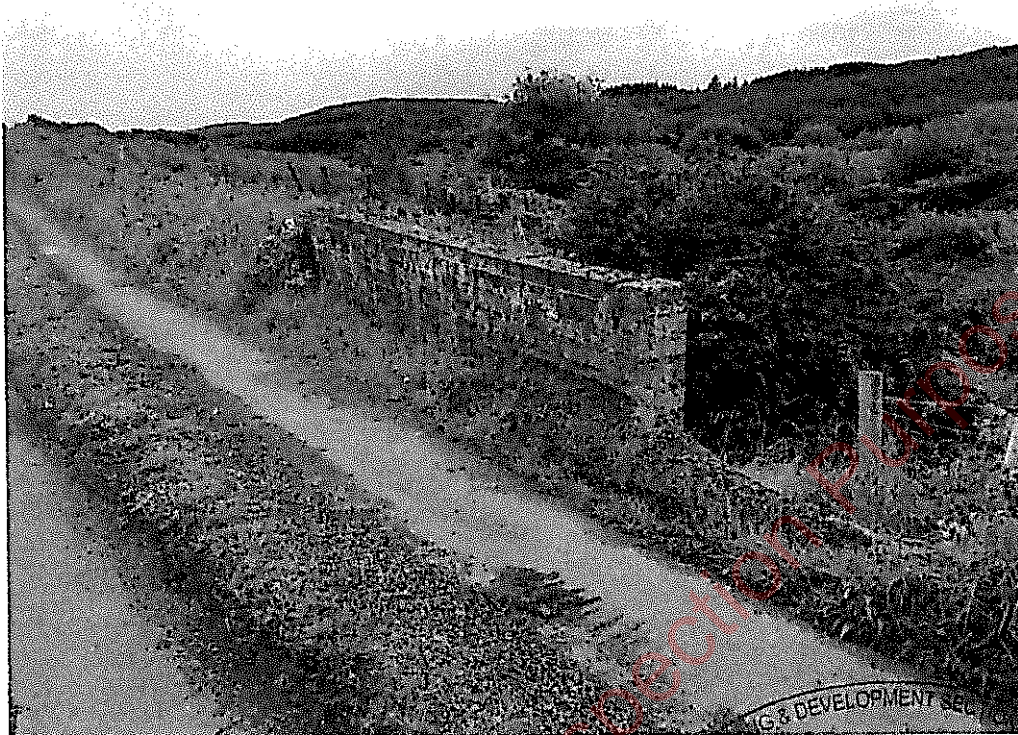
Both parapets are in good condition generally. Historical damage possibly due to vehicle impact is evident at the south end of the east parapet, however, displacement of the parapet has not occurred.

General view of bridge surface and west parapet

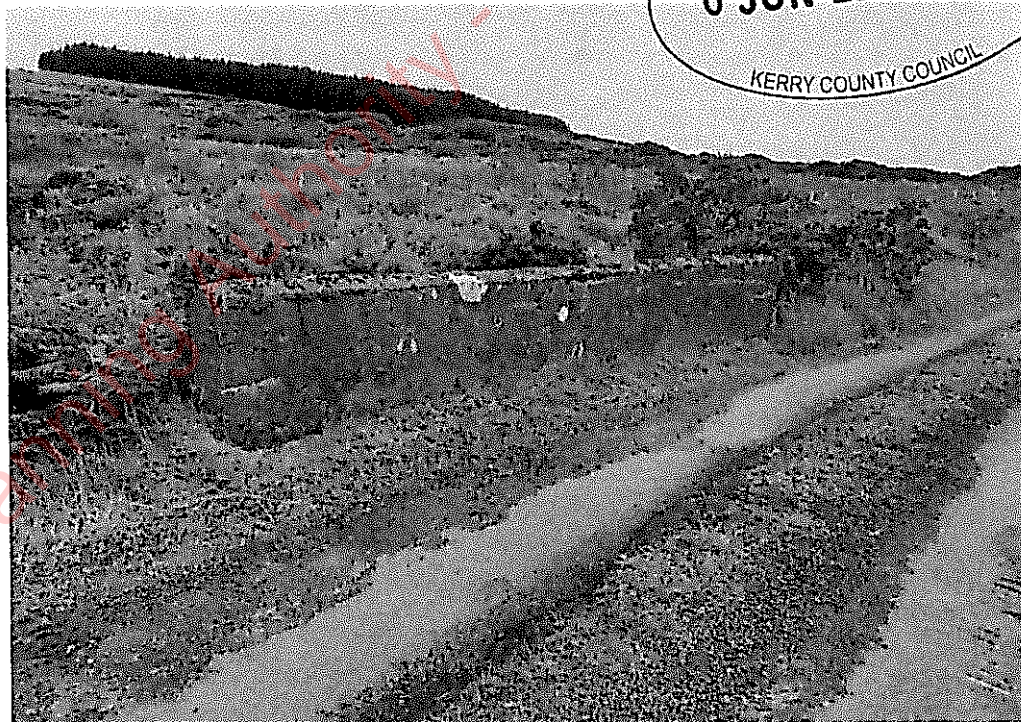
General view of bridge surface and east parapet

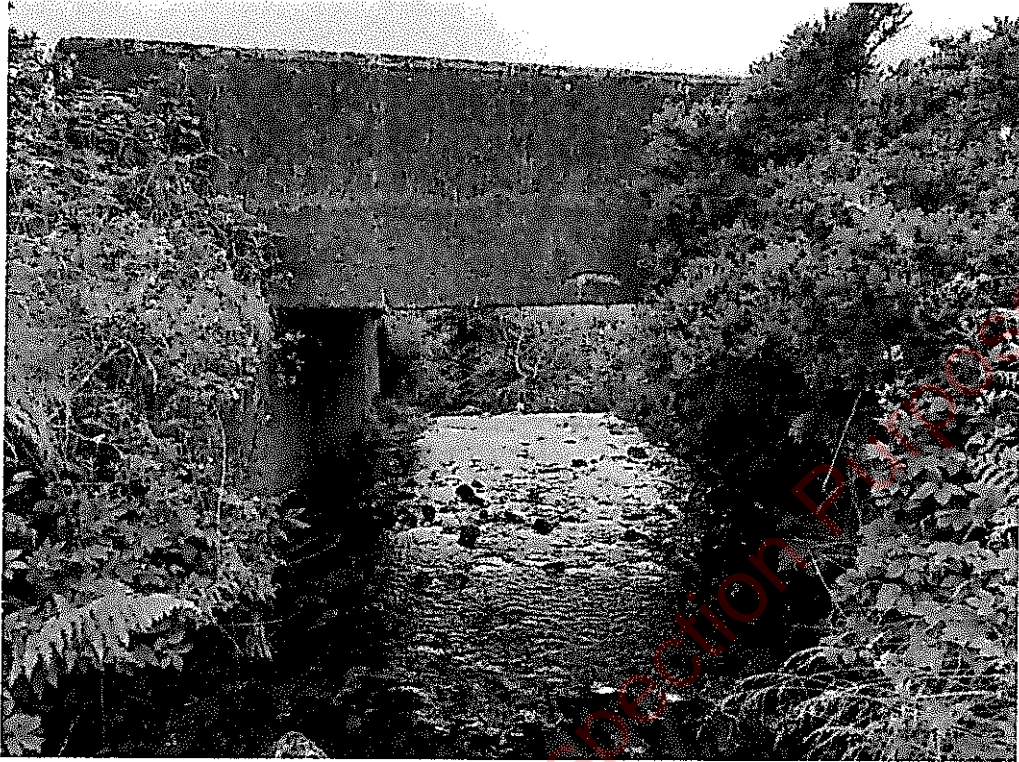
General view of east elevation, looking downstream

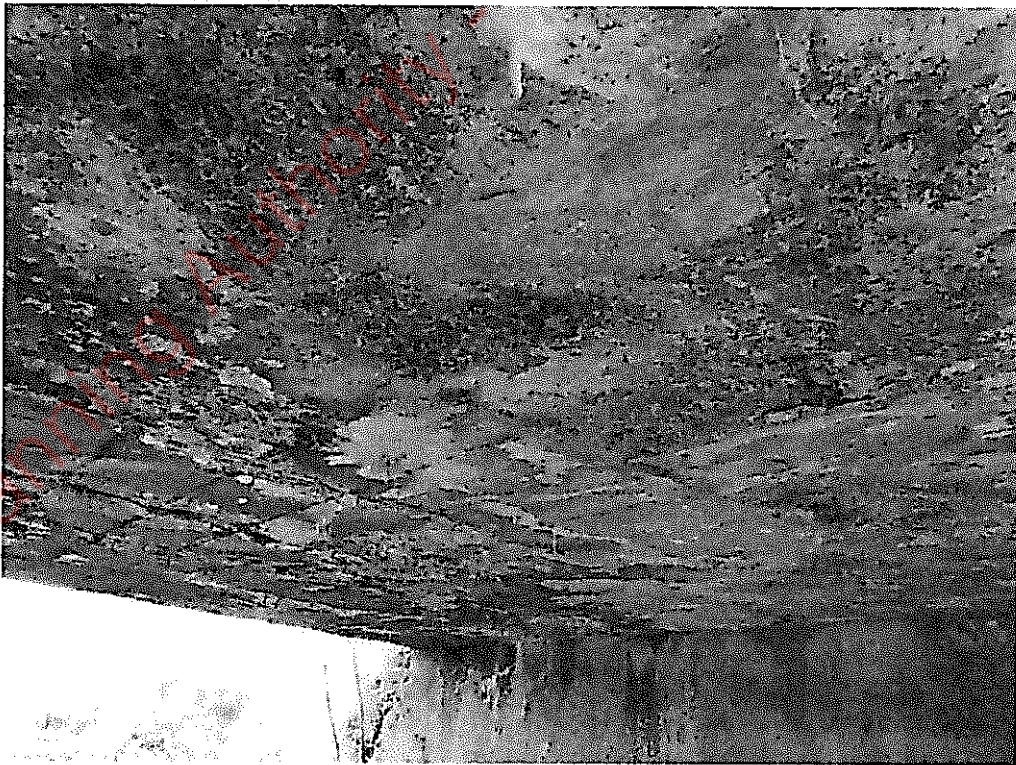
No information to the exact construction detail of the was available and no structural steel or reinforcing steel elements were evident. Some water ingress and calcite staining is evident generally along with some local scaling of the soffit surface. No significant structural defects were noted.

General view of the soffit of the bridge deck showing typical condition

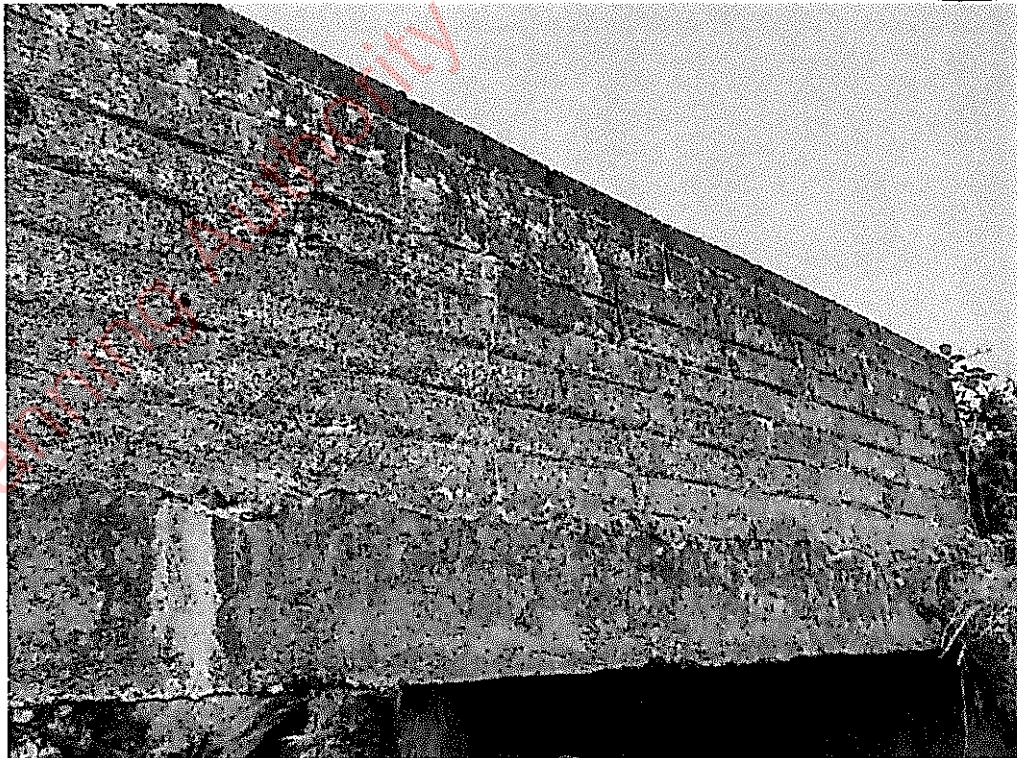
General view of the west elevation
