**APPENDIX 13.1:**

**AI BRIDGES TELECOMMUNICATIONS IMPACT STUDY**

## Inchamore Wind Farm Telecommunications Impact Study

Gortyrhilly, Inchamore and Cummeennabudoge (CMDC)  
Wind Farms  
Civil & Structural Due Diligence Report

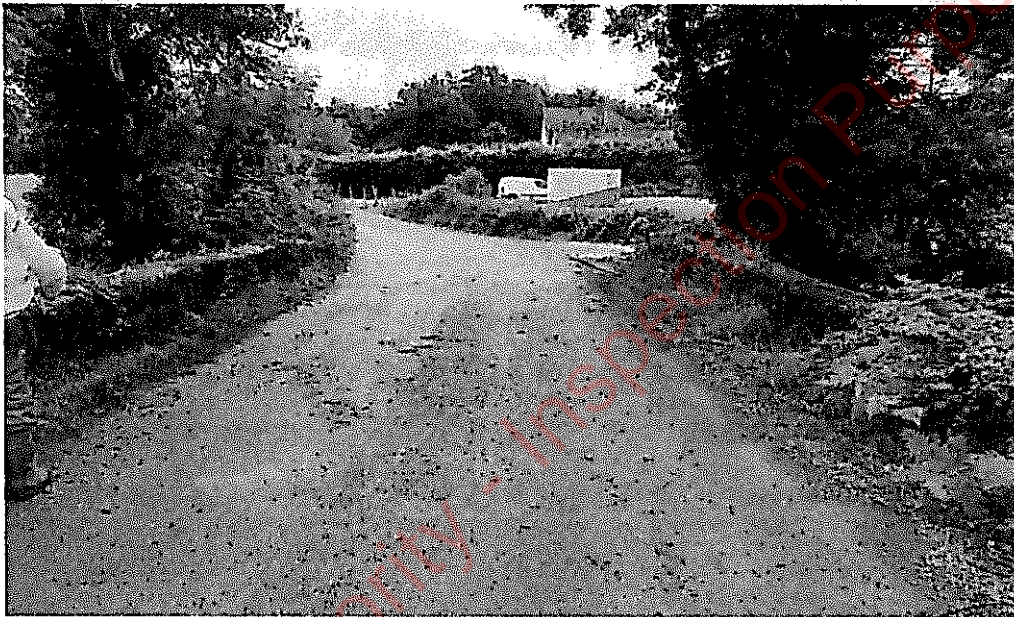
The existing bridge surface consists of tar & chip wearing course and is in good order generally.

General view of the bridge surface looking south

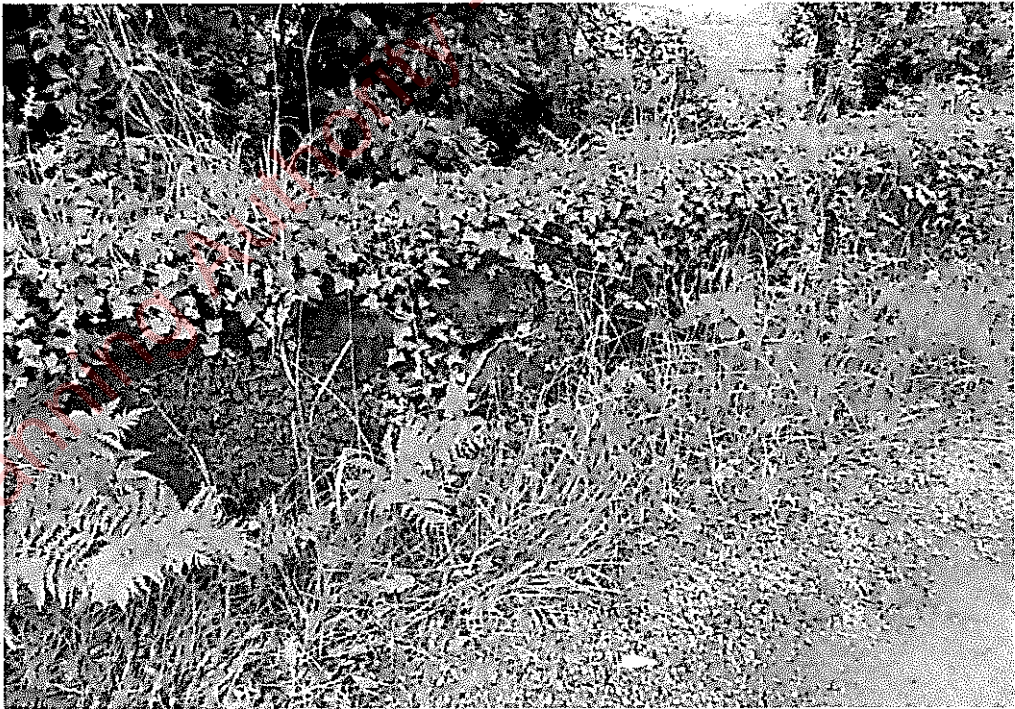
Light vegetation is present on both faces of both parapets. A 1.50m section at the north end of the east parapet is missing. The top course of stonework is missing over a 1.50m length of the north end of the west parapet. A stepped crack is evident towards the south end of the east parapet, the section between the end of the parapet and the crack has moved.

General view of the south end of the east parapet

Overall the structure is in good condition with few defects found. Maintenance repairs to the parapet walls should be undertaken.

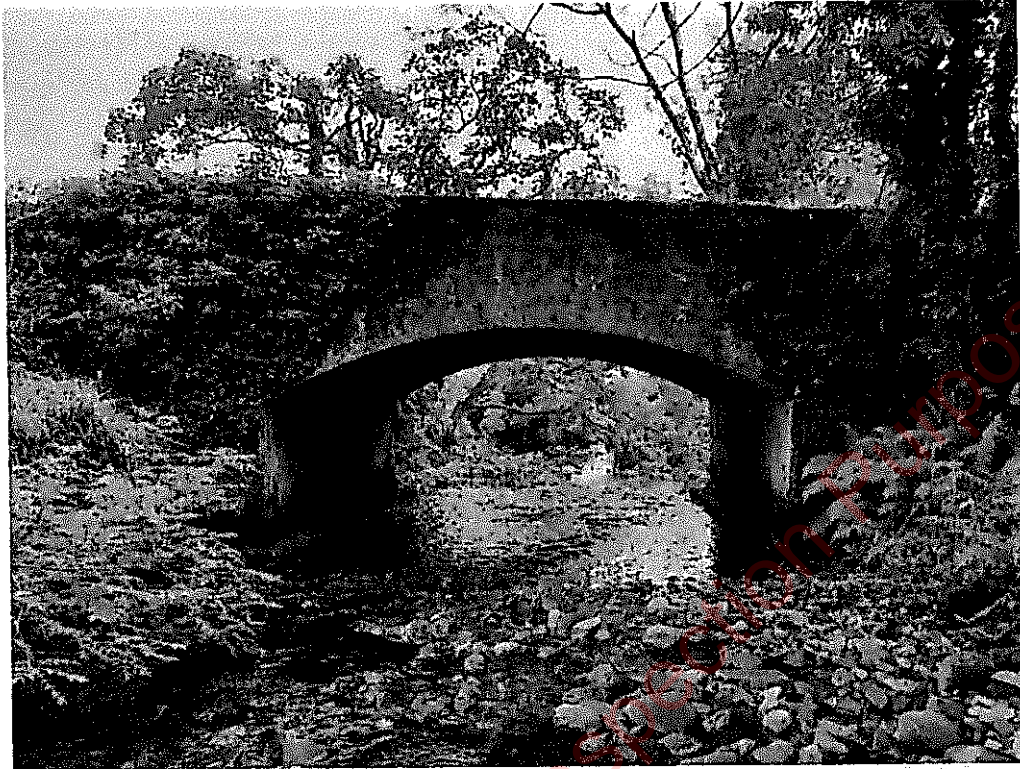
There is a continuous crack between the arch barrel and spandrel walls on both elevations. This appears to be historical and is possibly due to differential movement between the solid concrete arch section and the spandrel walls.

General view of the west elevation, looking downstream

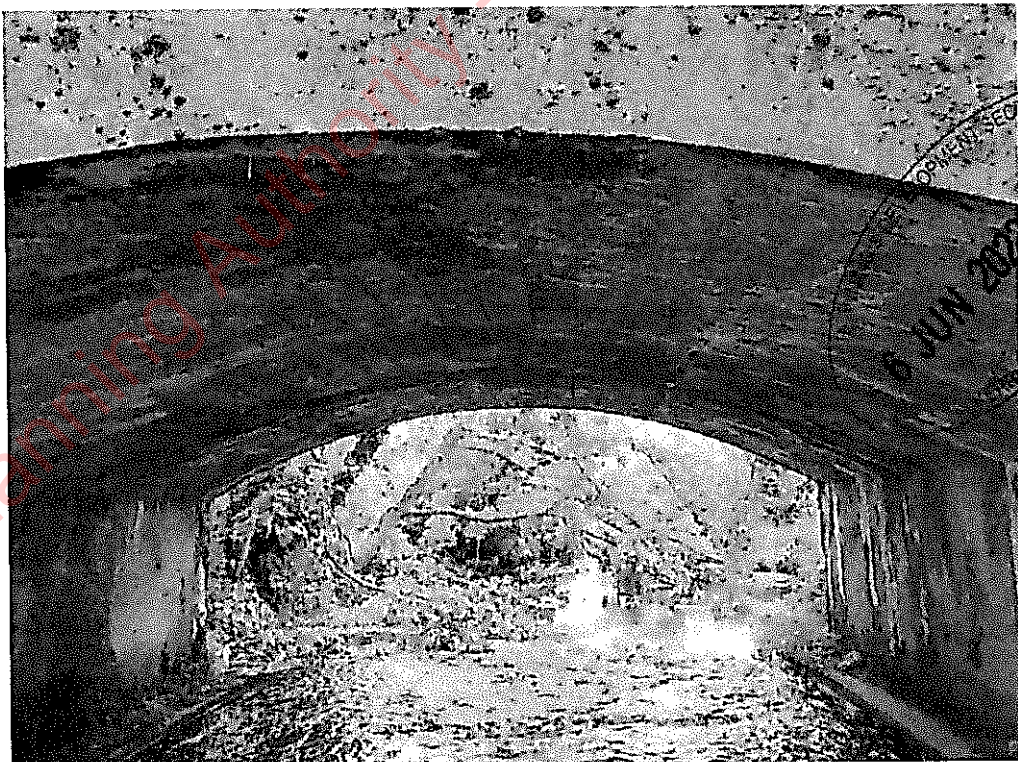
The arch barrel is of concrete construction. Some water ingress and calcite staining is evident. No obvious structural defects were noted.

General view of the arch barrel

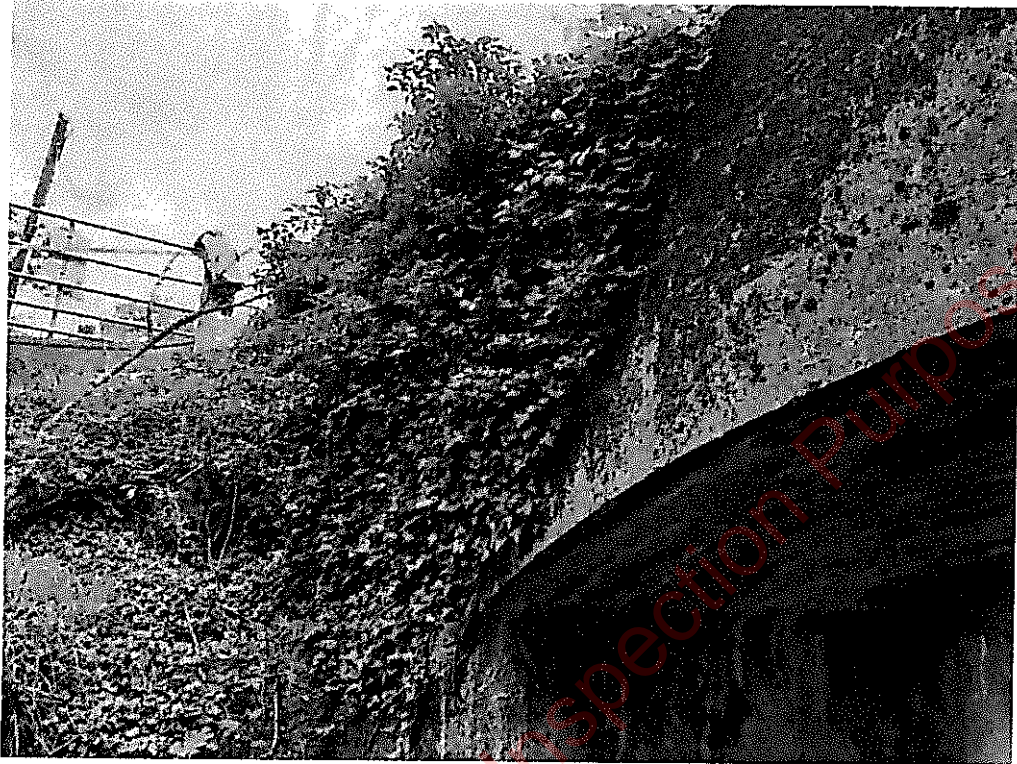
Vegetation growth on the west elevation

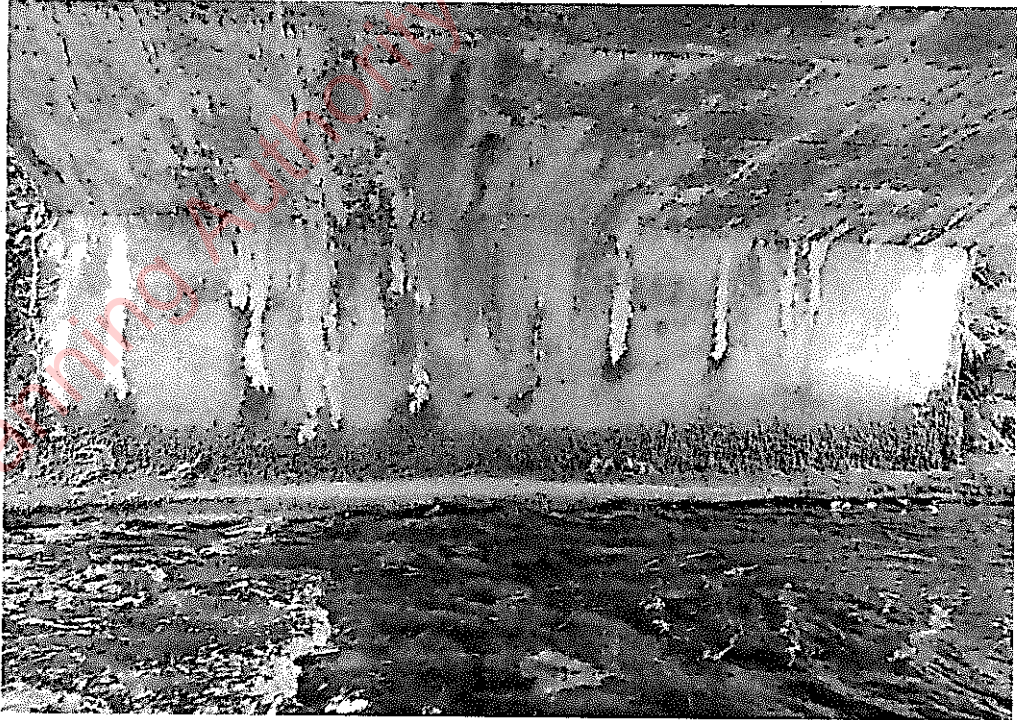
The abutments appear to be of concrete construction. There is a concrete plinth along the footing of both abutments. Some water ingress and calcite staining was noted. No significant structural defects were evident.

General view of the north abutment

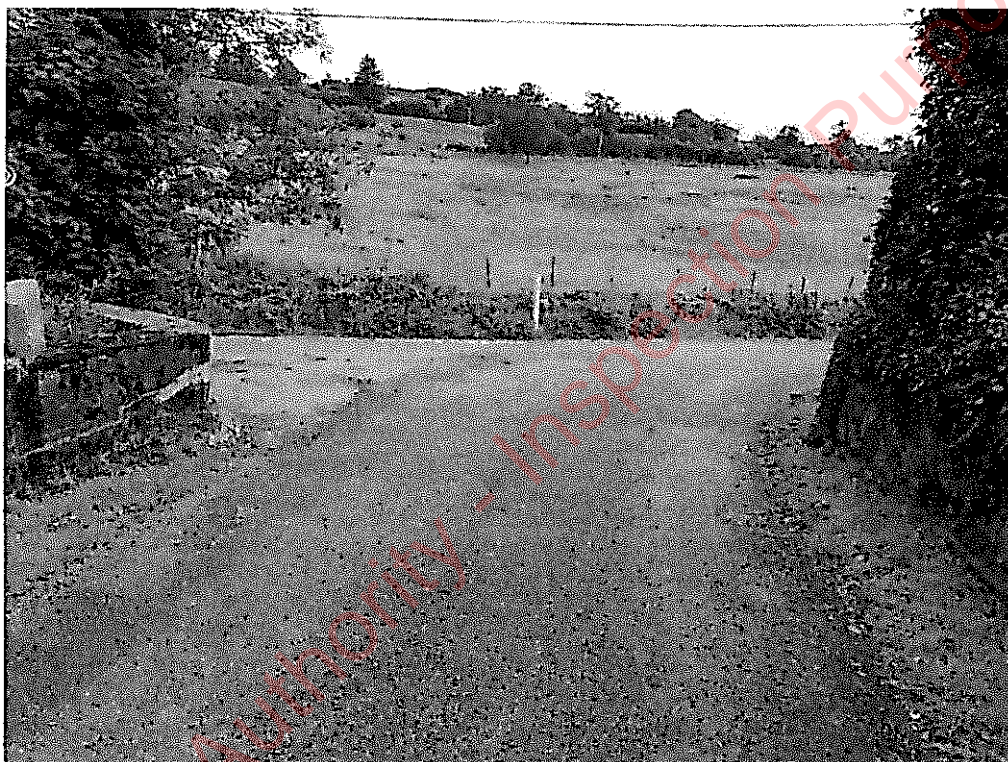
The existing bridge surface consists of tar & chip wearing course and is in good order generally.

General view of the bridge surface looking east

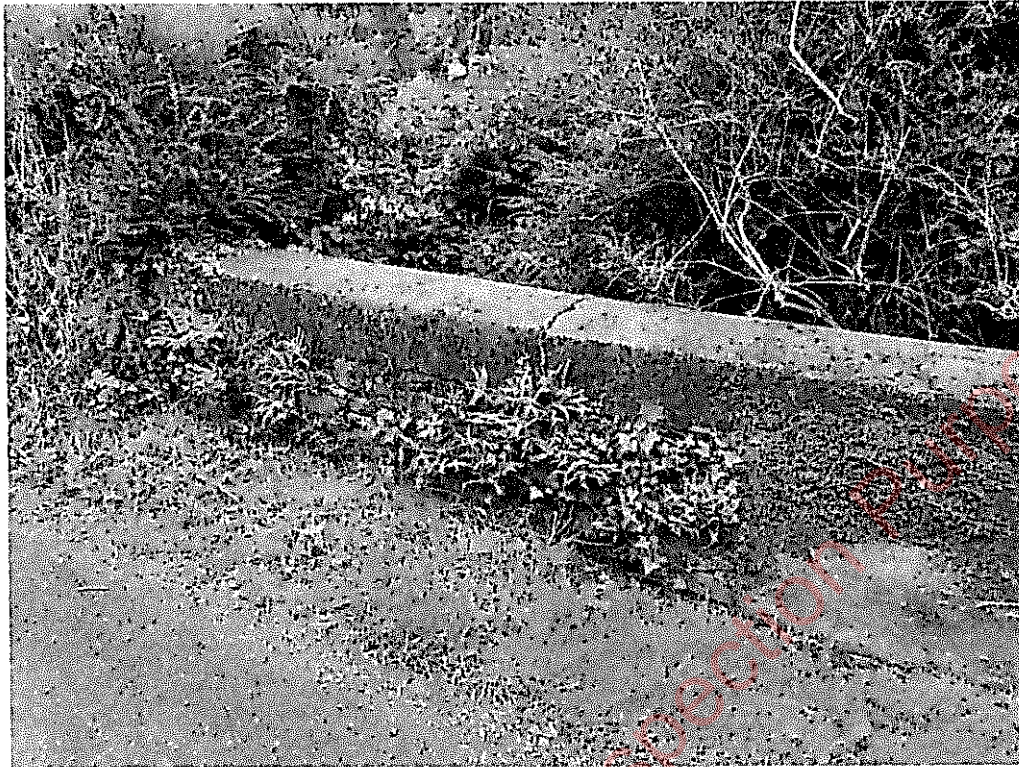
The existing parapets appear to be of masonry construction with concrete render and topping. Some cracking of the render and capping is evident but there are no significant structural defects. The parapets are 740mm - 840mm high and are both 500mm thick.

North parapet, west end

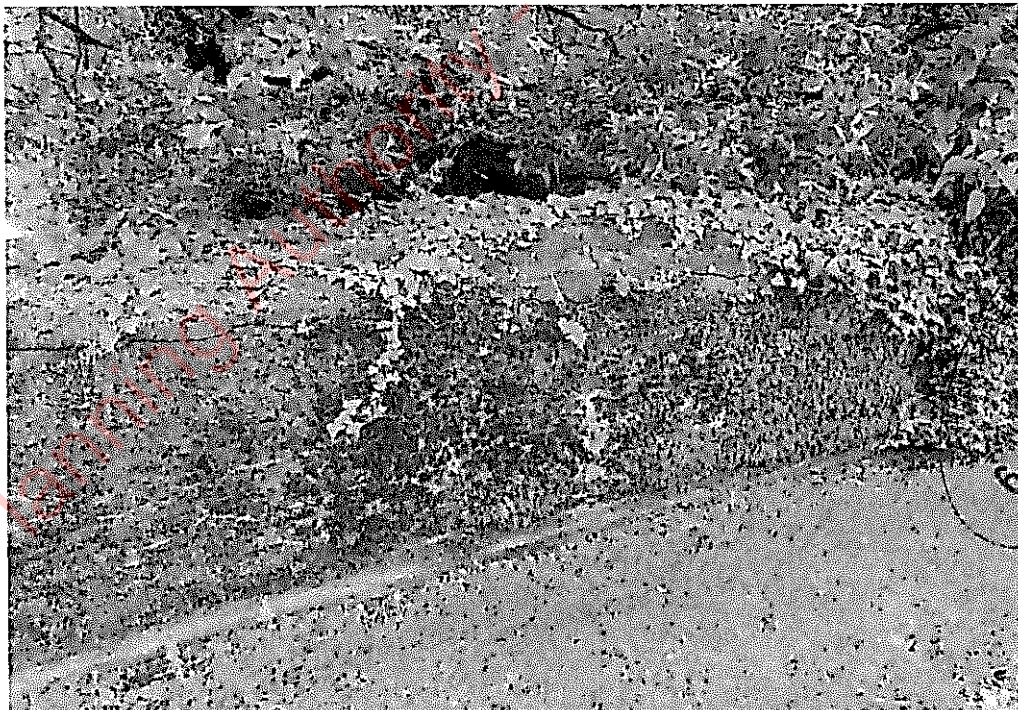
South parapet, east end

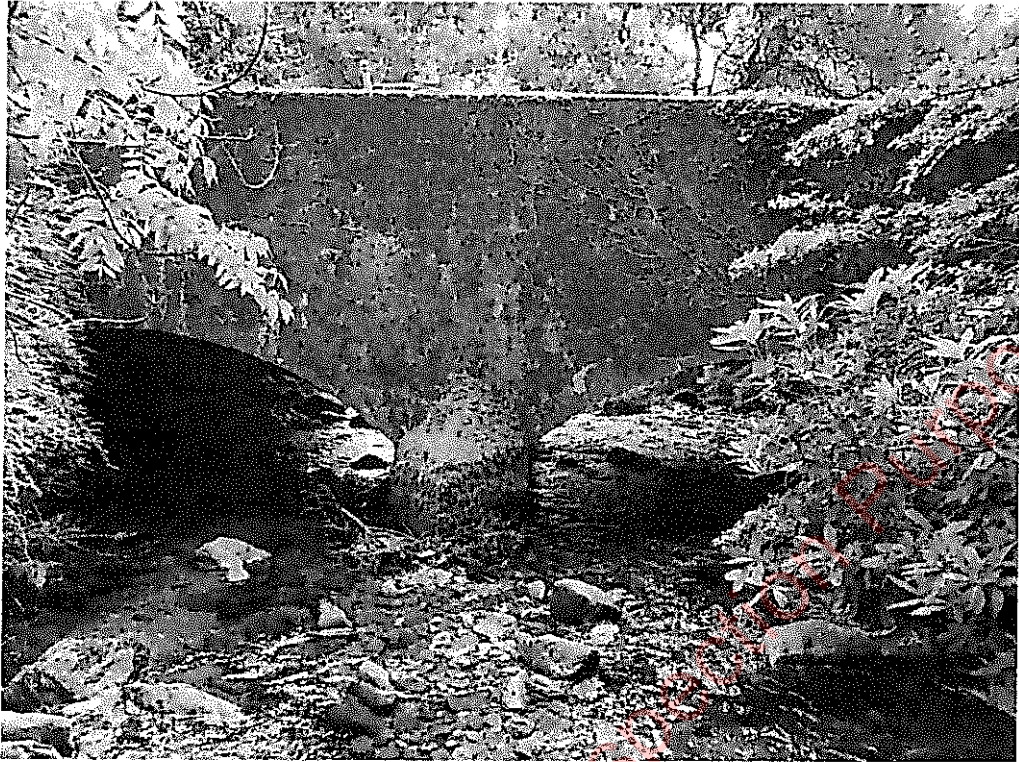
Vegetation growth is present on both spandrels, however, no significant defects are evident.

General view of the west elevation

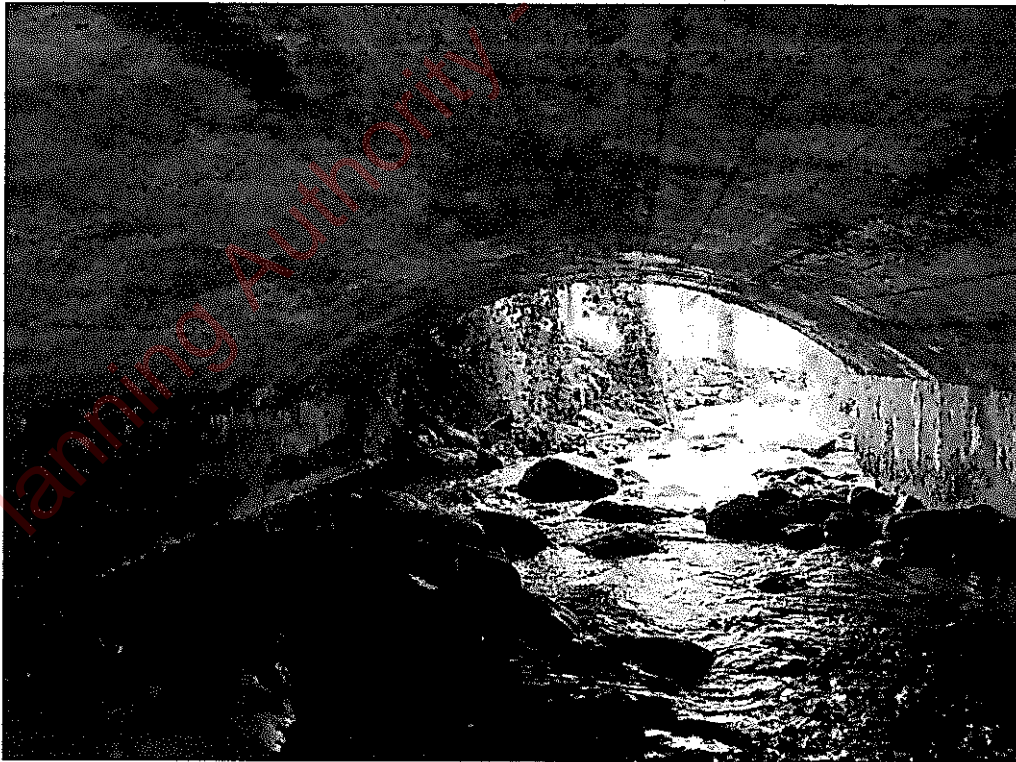
Both arch barrels appear to be of concrete construction. Minor defects including localised water ingress and calcite staining are evident.

View through east arch, looking south

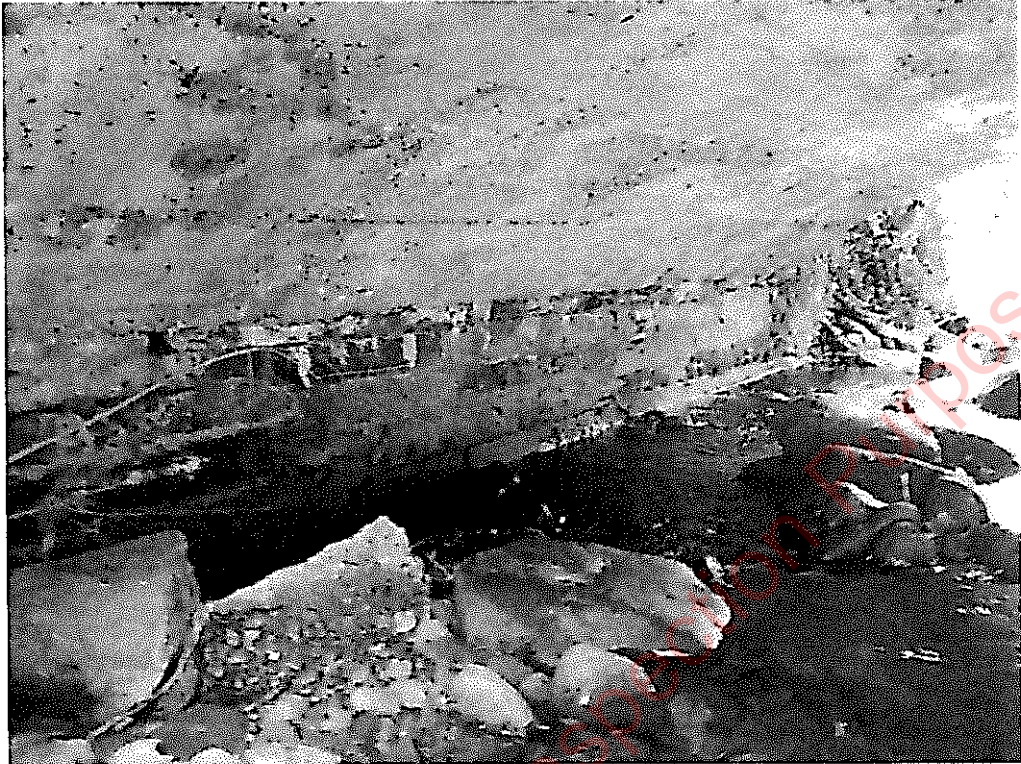
The abutments are of masonry construction with some concrete repairs. Minor defects including localised mortar loss, light vegetation, water ingress and calcite staining are evident.

Typical condition of abutment & arch barrel

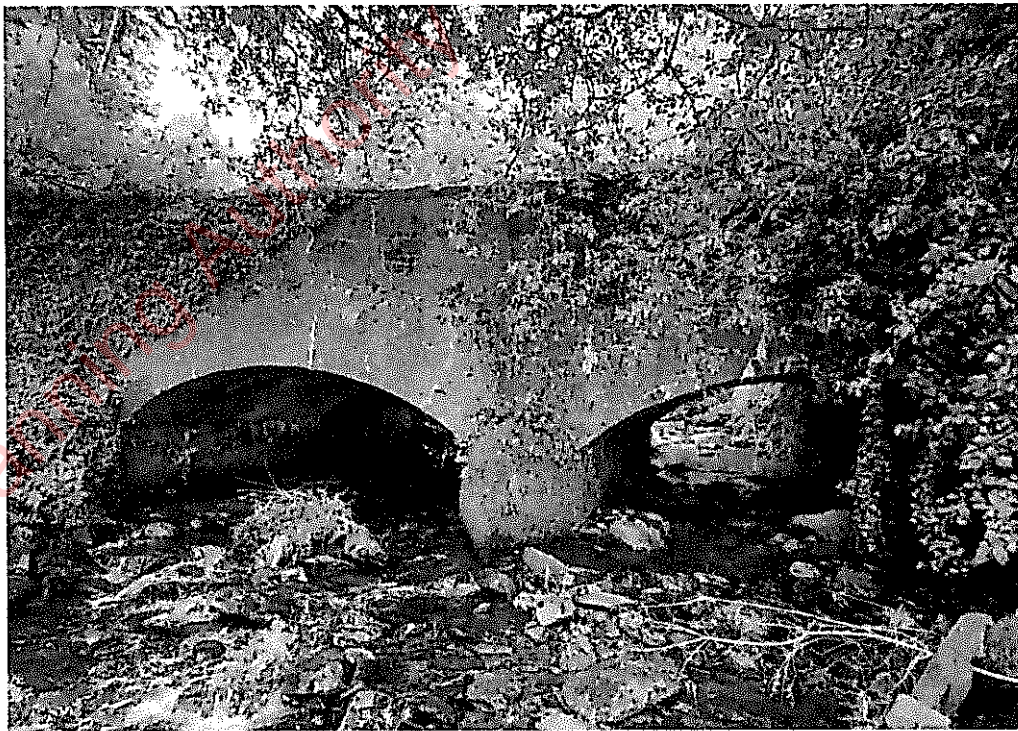
General view of south elevation

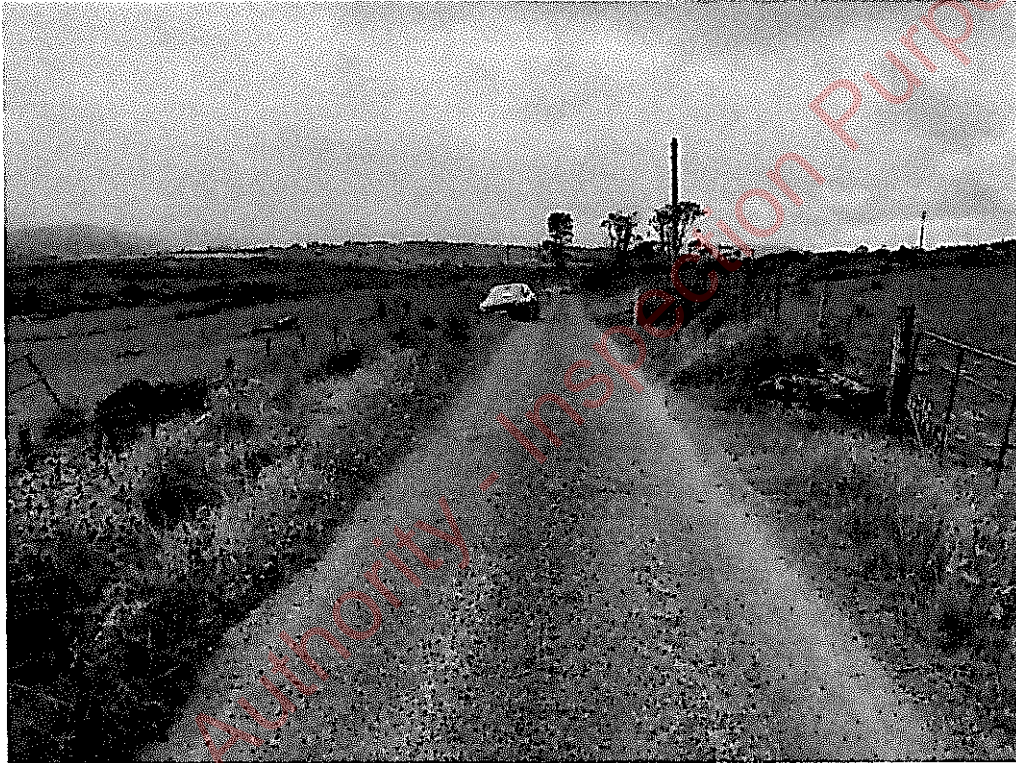
The existing bridge surface consists of tar & chip wearing course and is in good order generally.

General view of the bridge surface from the east

The arch barrel is in poor condition and requires reinstatement of missing stones and repointing. Consideration should be given to removing the soft verges and sealing the bridge surface to limit water ingress to the structure. Vegetation removal and repointing of masonry elements is required throughout.

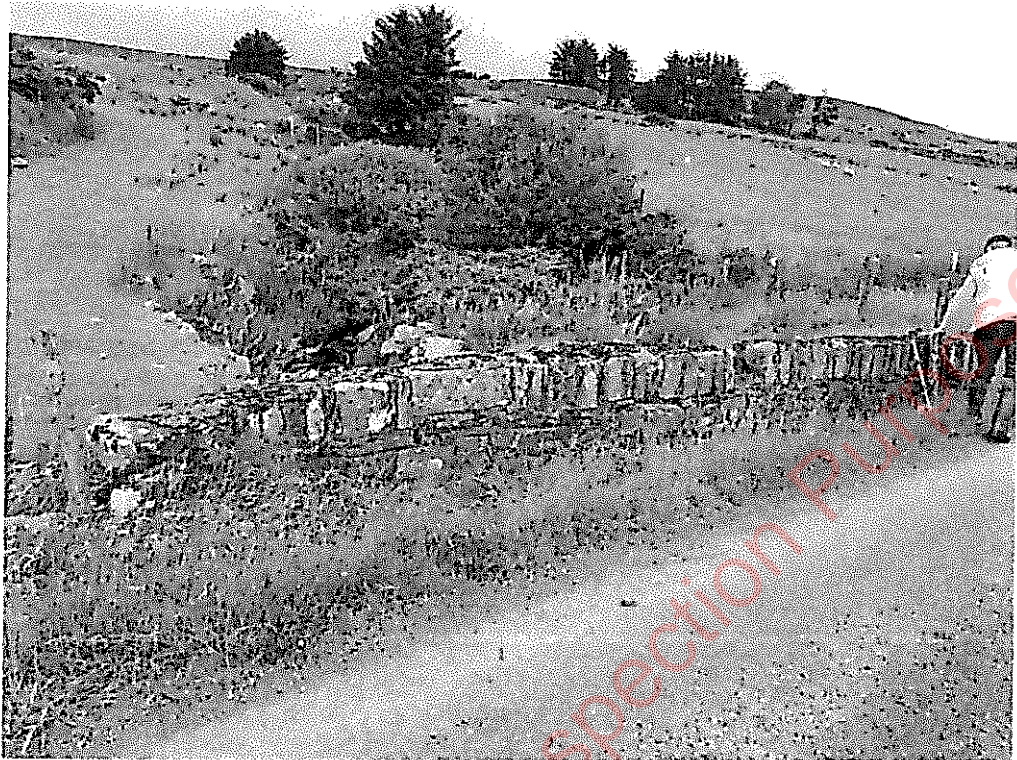
A short section (approx. 1m long) at the east end of the north parapet has been knocked. Two to three capping stones are missing from the centre of the north parapet.

Light vegetation and a minor loss of pointing was noted generally.

General view of the north parapet

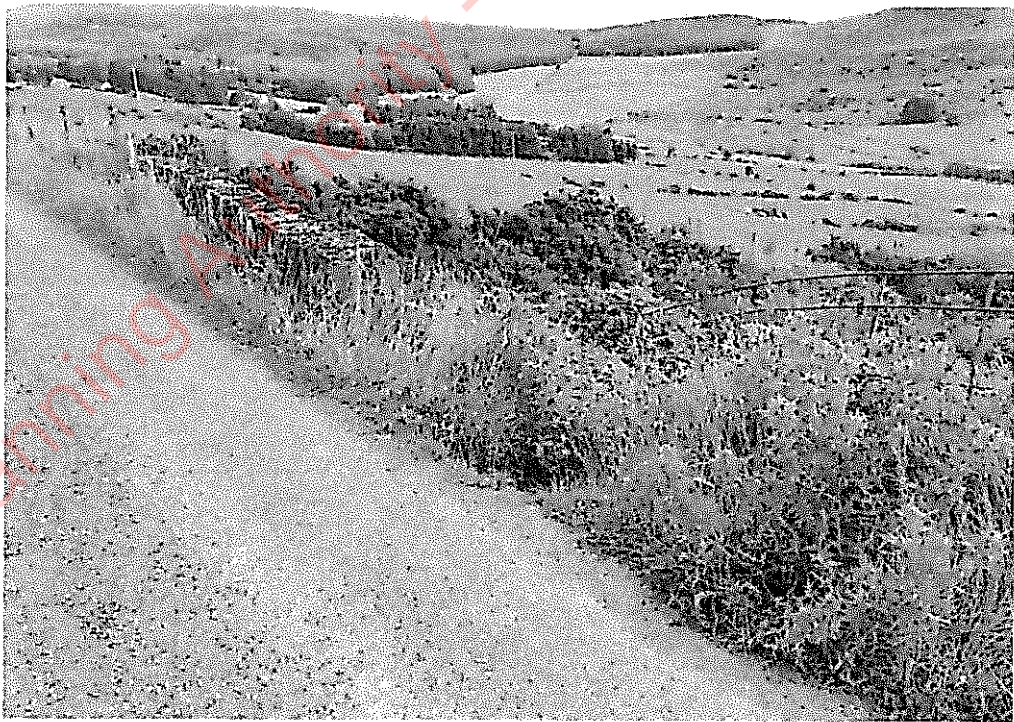
General view of the south parapet

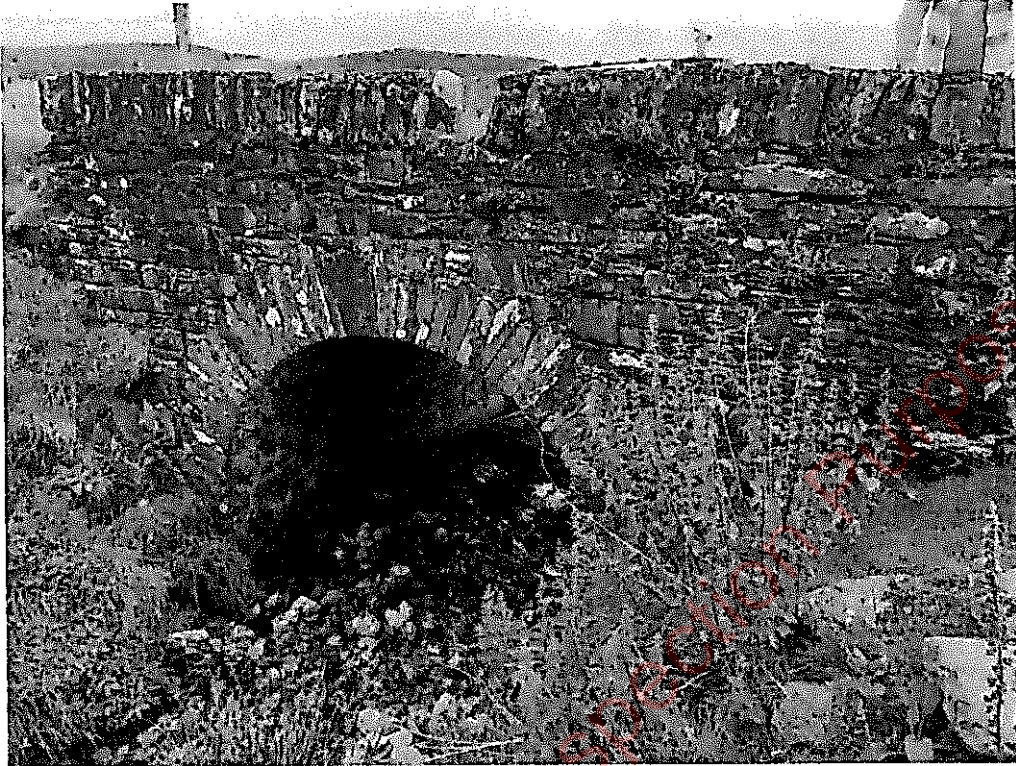
North elevation

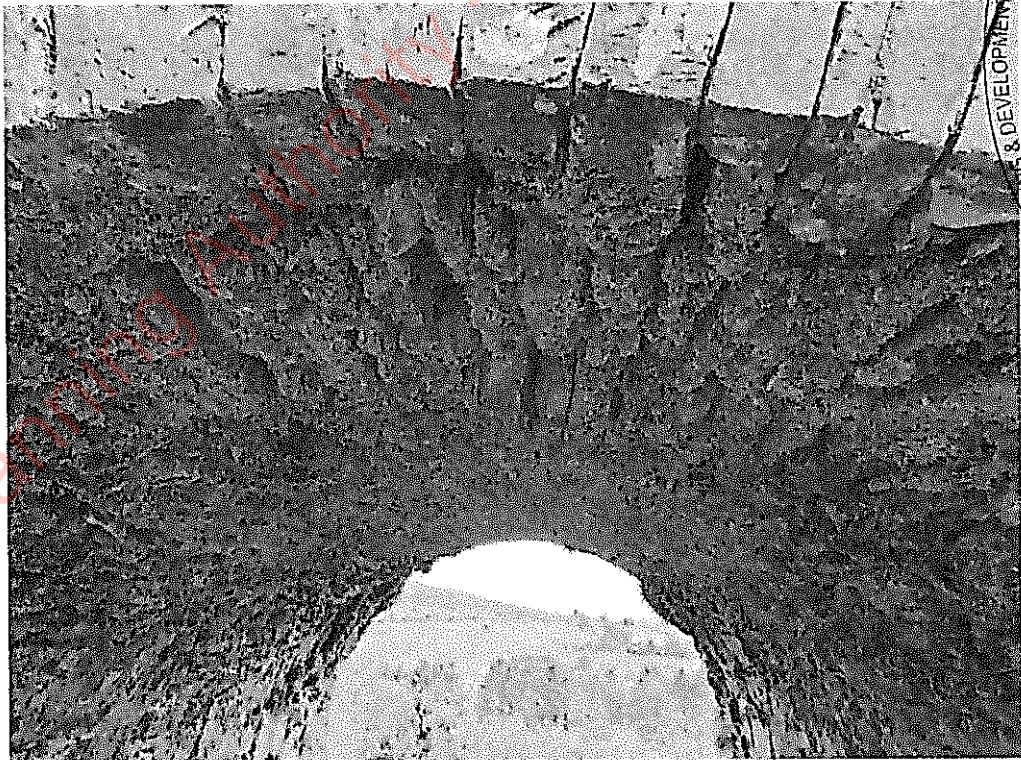
General view of the arch barrel from the north

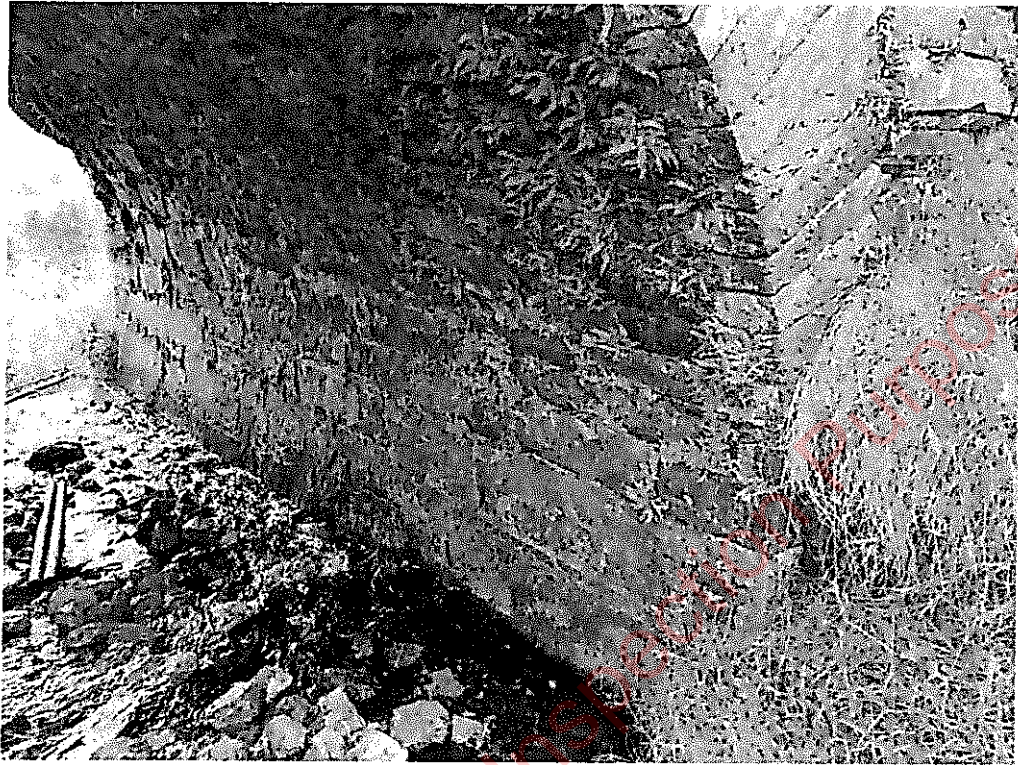
General view of the west abutment and arch barrel

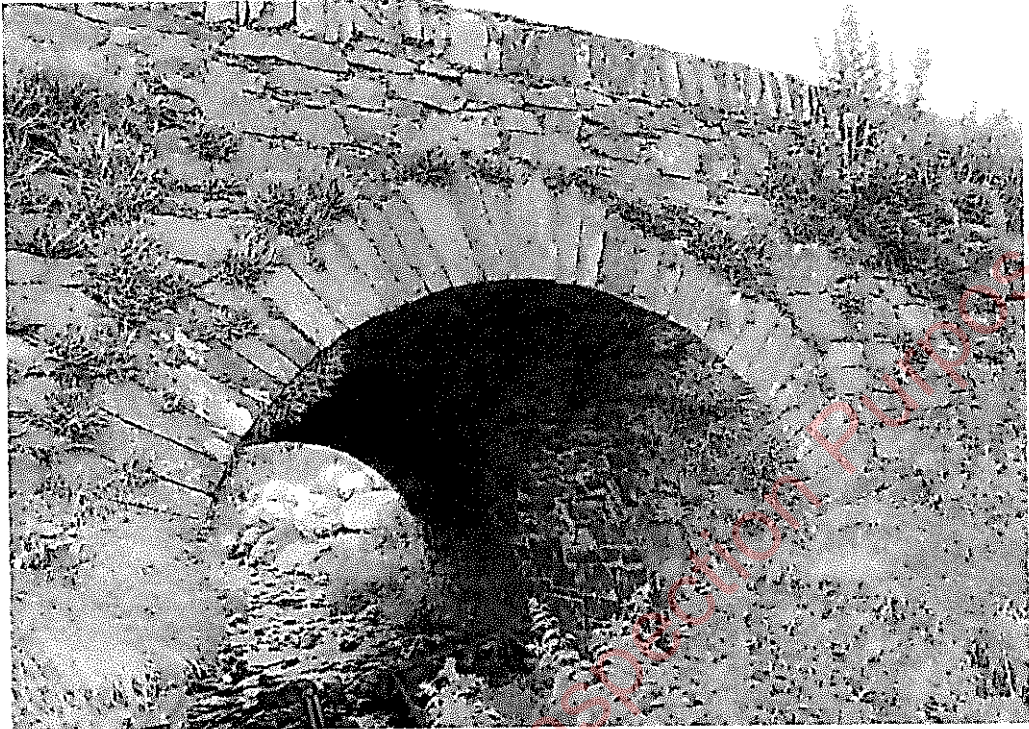
General view of the south elevation

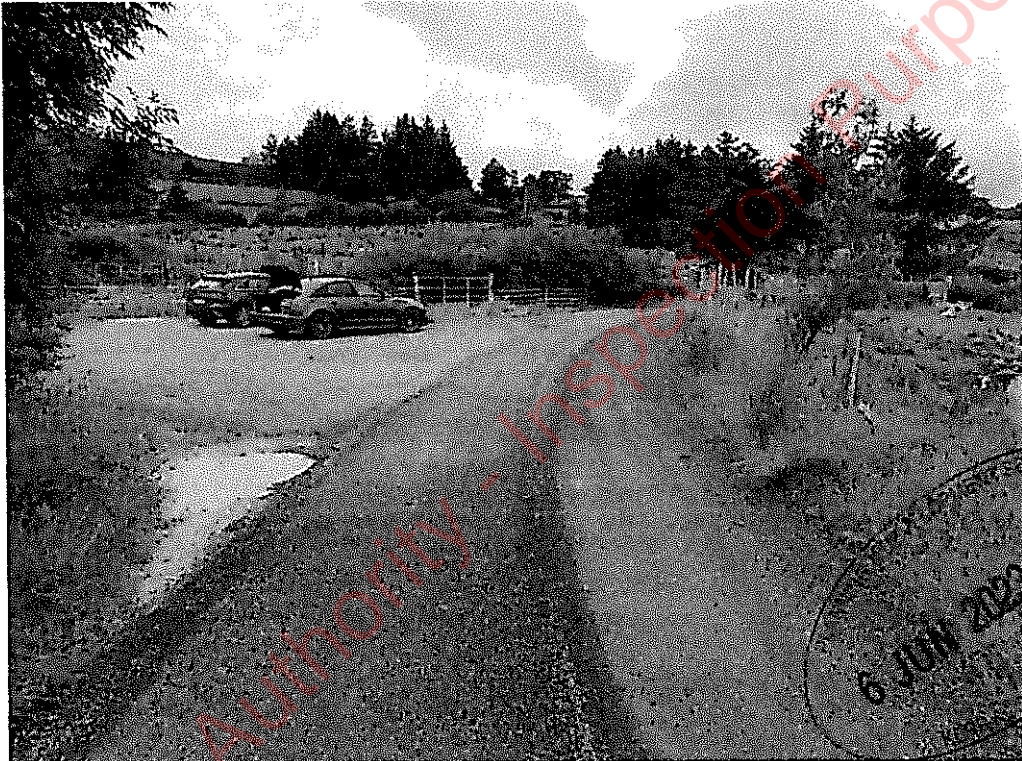
The existing bridge surface consists of tar & chip wearing course which has been recently overlaid and is in good condition.

General view of the bridge surface, looking north

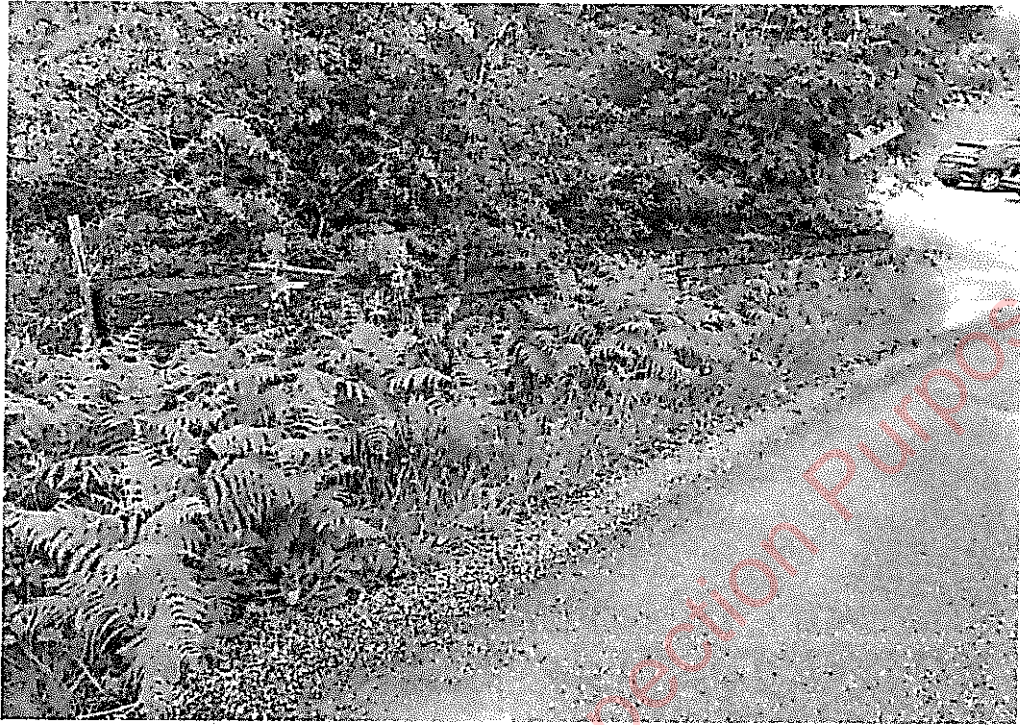
There is one stepped vertical crack in the centre of the west parapet. There are three stepped vertical cracks in the east parapet.

Light vegetation and a minor loss of pointing was noted generally.

General view of the west parapet

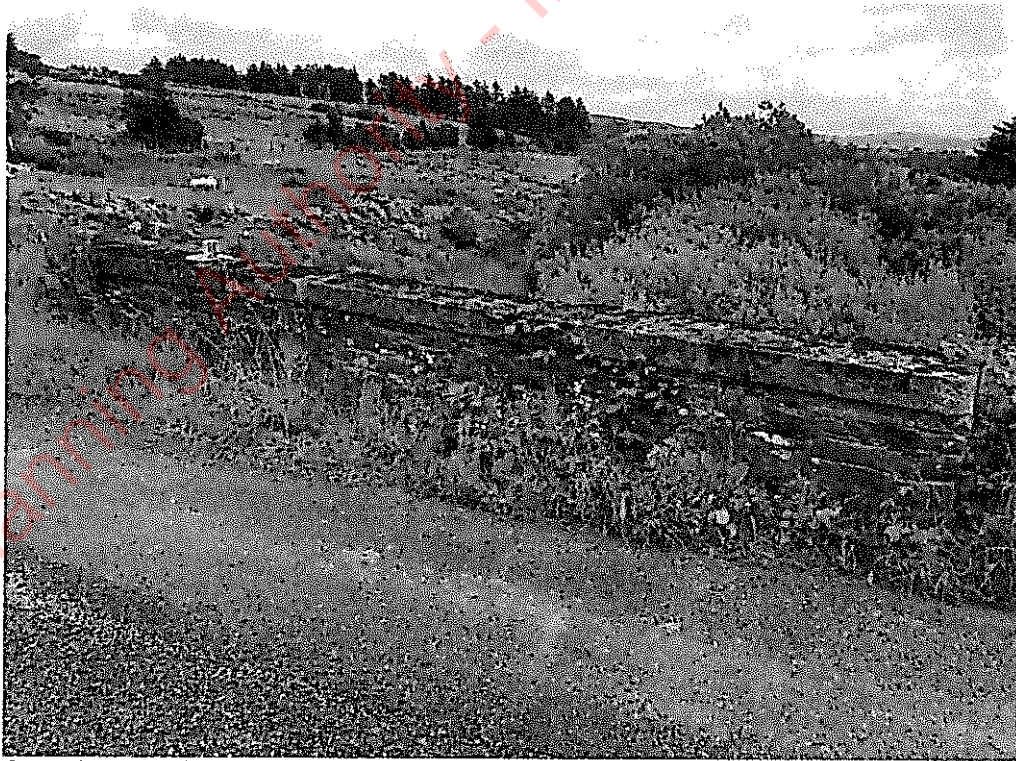
General view of the east parapet

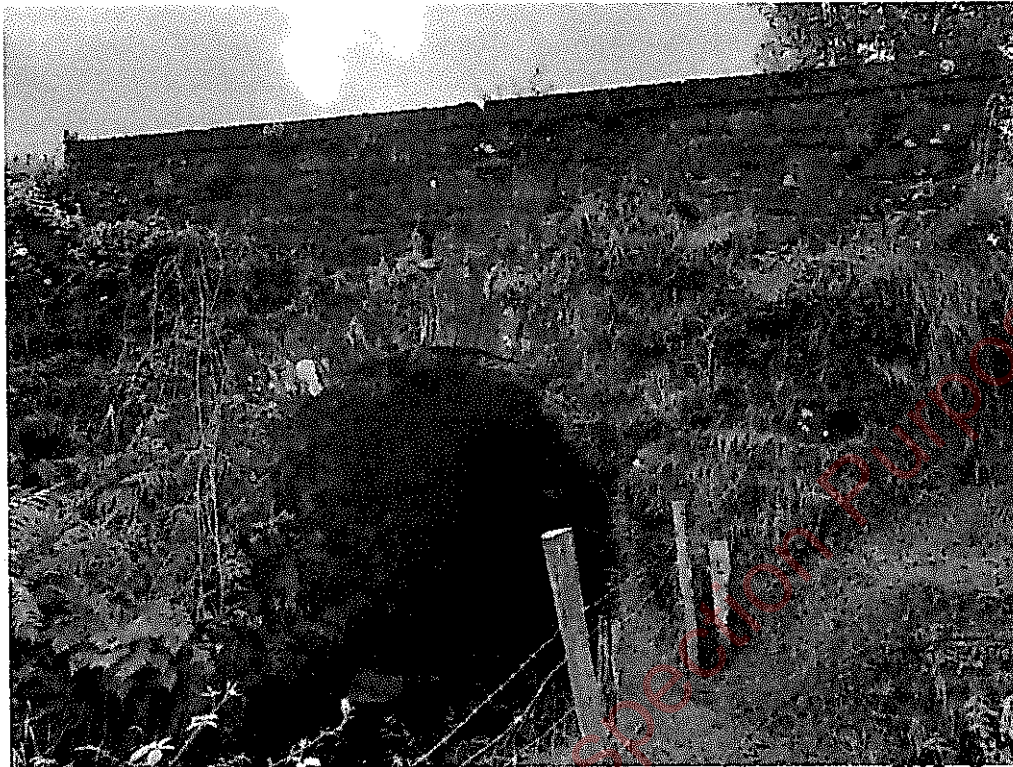
General view of the east elevation

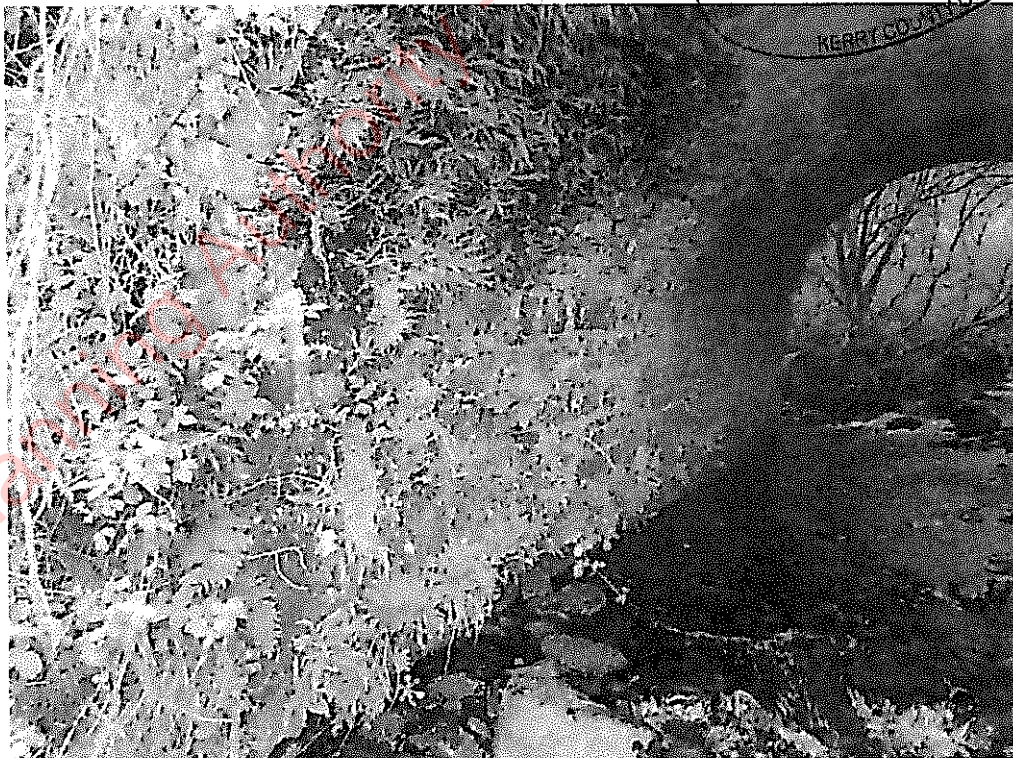
The abutments are generally in good condition. Vegetation removal and repointing works are required.

General view of the south abutment

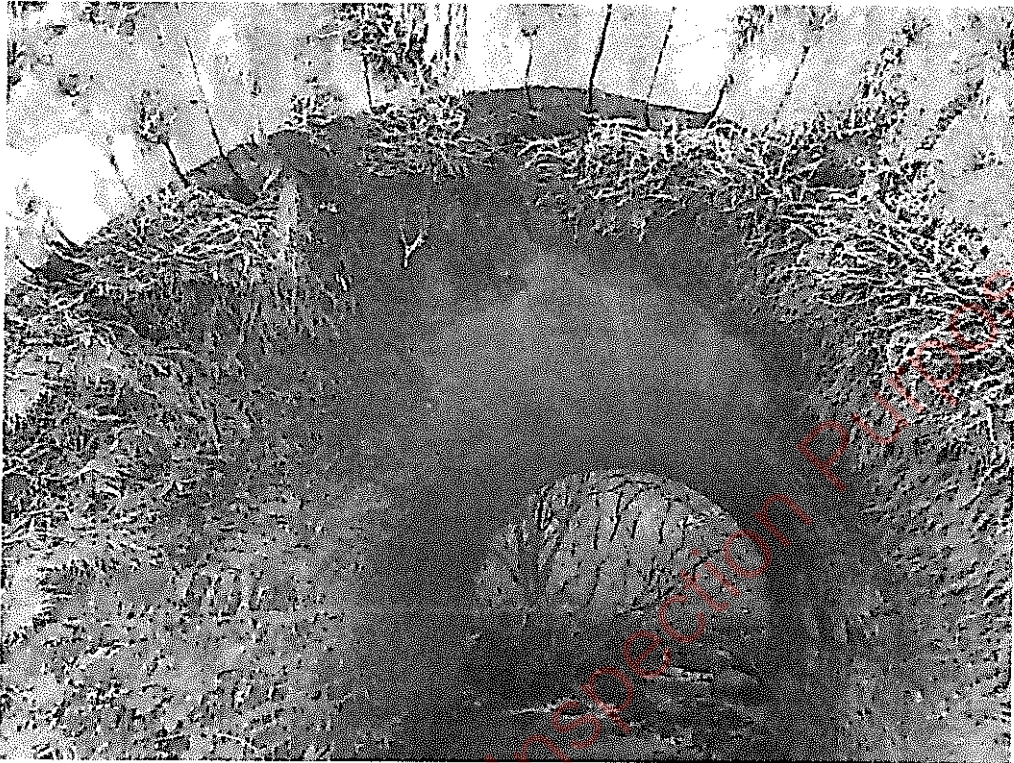
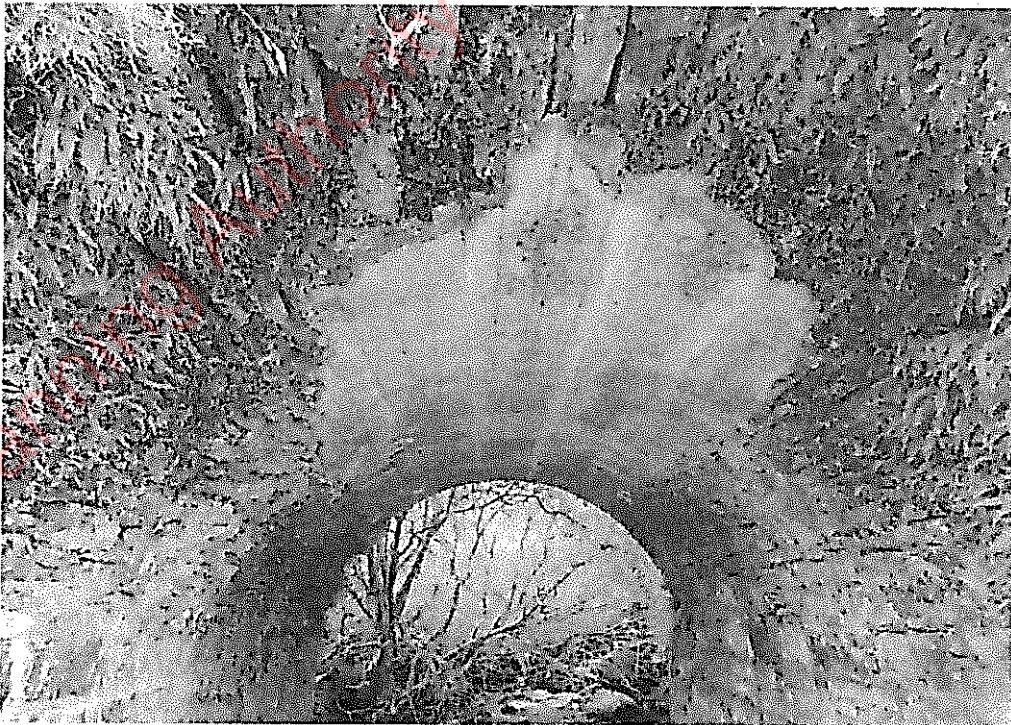
A substantial portion of the arch barrel has been repaired with a concrete plug between the quarter points, starting at the west face of the bridge and extending approx. two thirds of the length of the arch.

Open joints are evident in the masonry sections. Water ingress and light vegetation are noted.

General view of the arch barrel from the east

Overall the structure is in fair condition. Maintenance repairs including vegetation removal and repointing of open joints should be carried out. Consideration should be given to sealing the bridge surface by removing the soft verges:

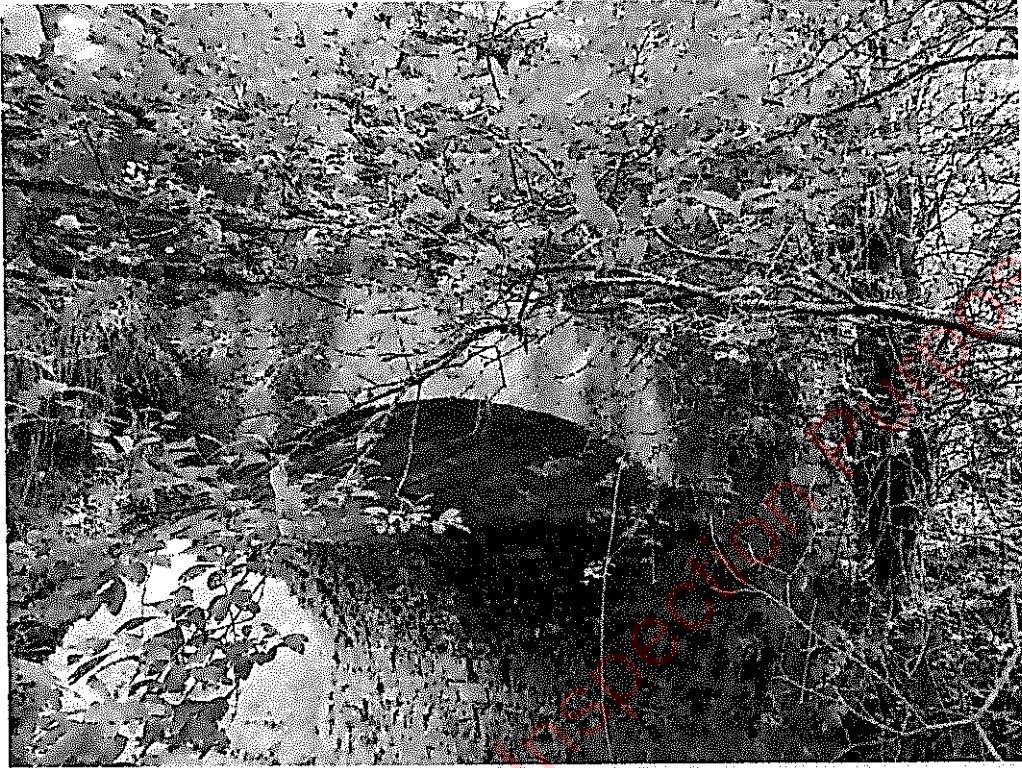
General view of the west elevation
