**APPENDIX 13.1:**

**AI BRIDGES TELECOMMUNICATIONS IMPACT STUDY**

## Inchamore Wind Farm Telecommunications Impact Study

Gortyrhilly, Inchamore and Cummeennabudoge (CMDC)  
Wind Farms  
Civil & Structural Due Diligence Report

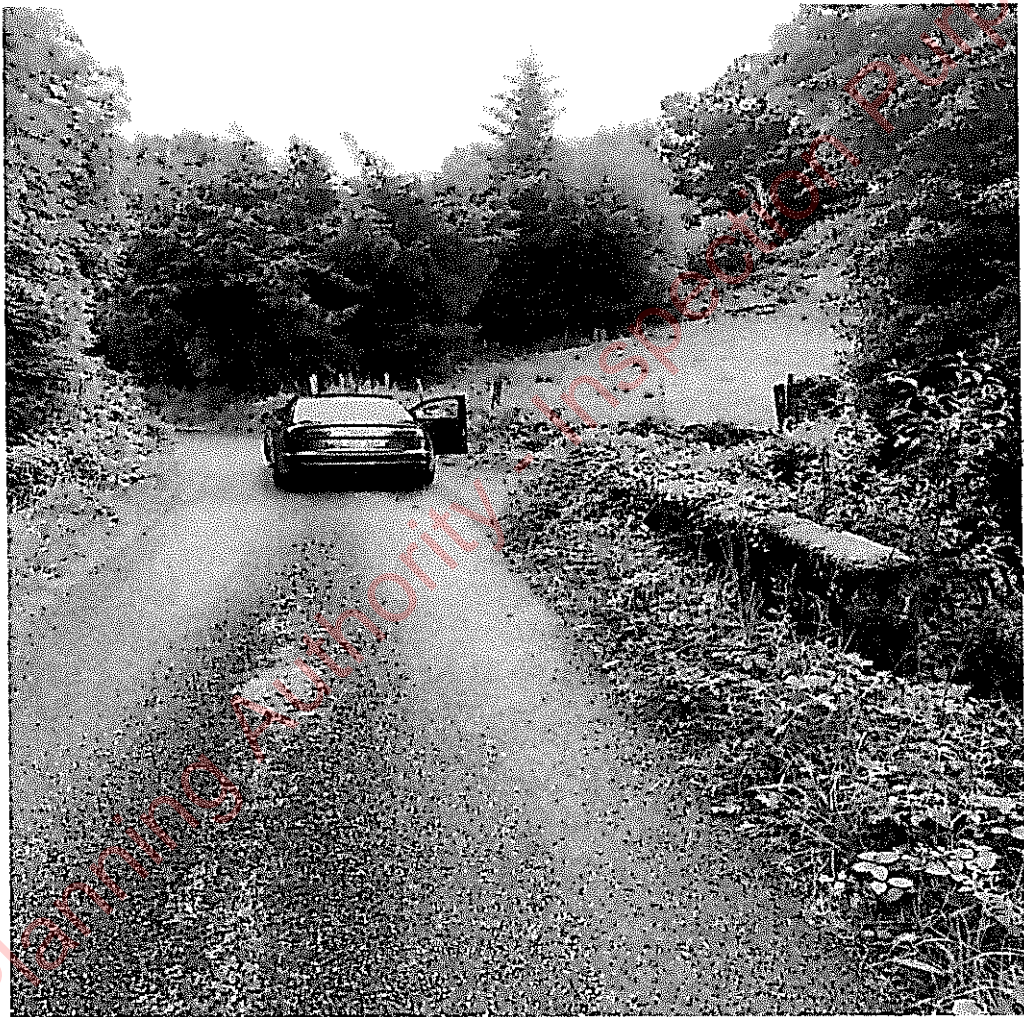
The existing bridge surface consists of tar & chip wearing course and is in good order generally.

General view of the bridge surface looking south

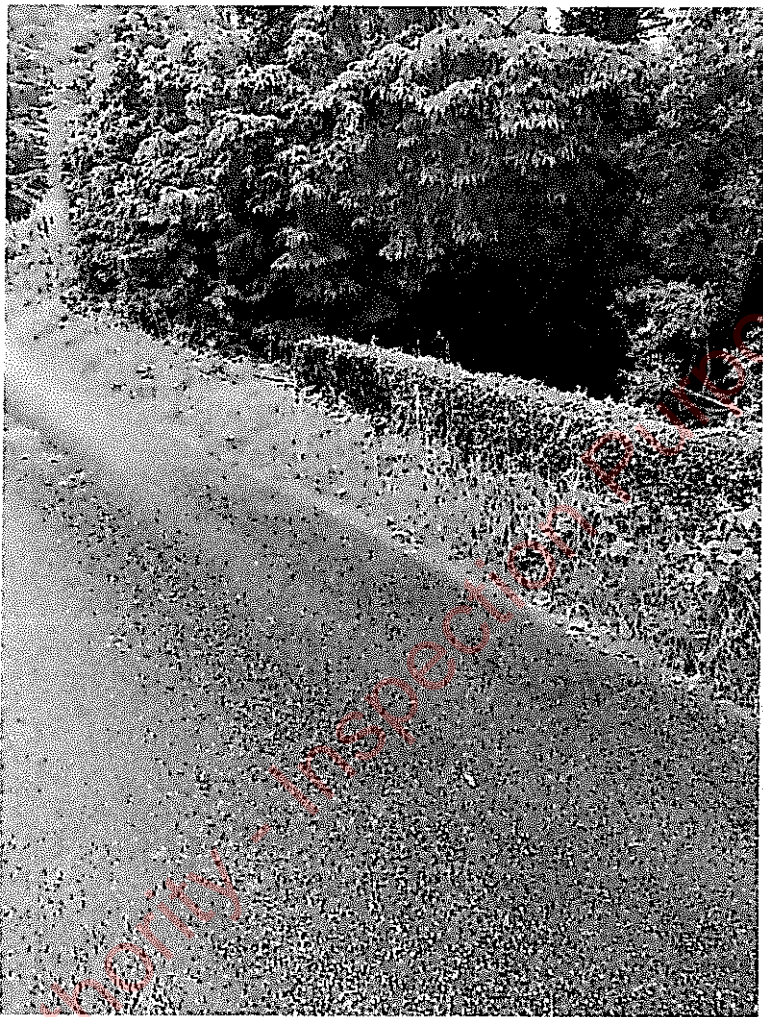
Vegetation is present on both faces of the parapets, no significant defects are evident in the areas that could be viewed.

General view of the east parapet

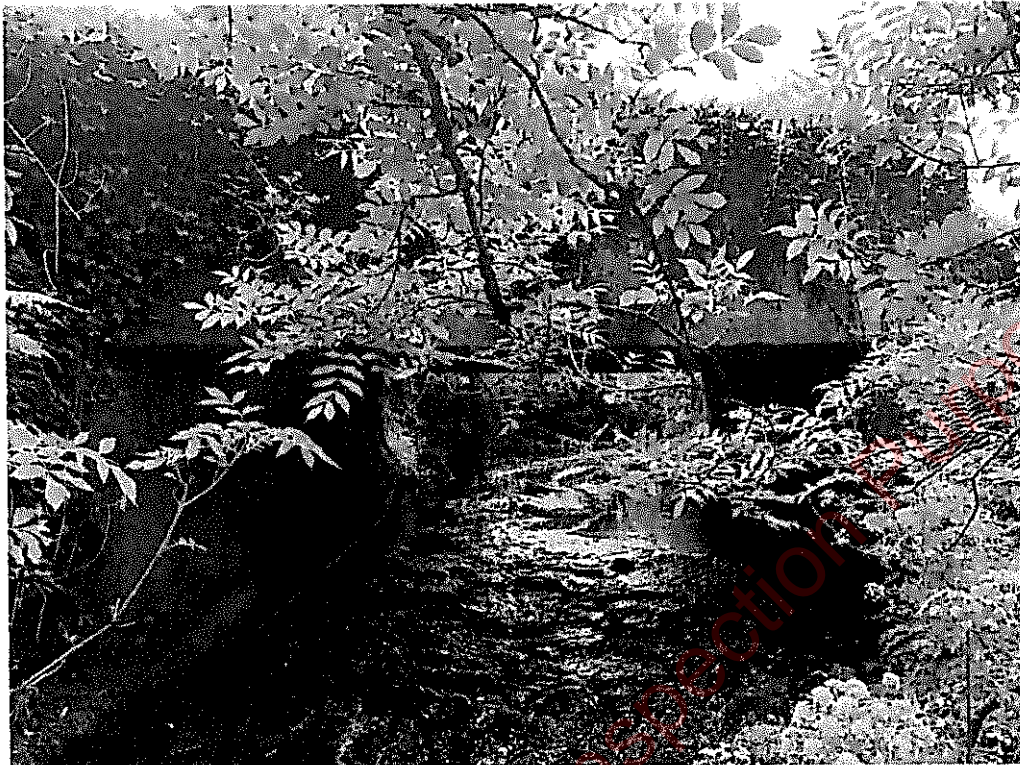
General view of the bridge elevation

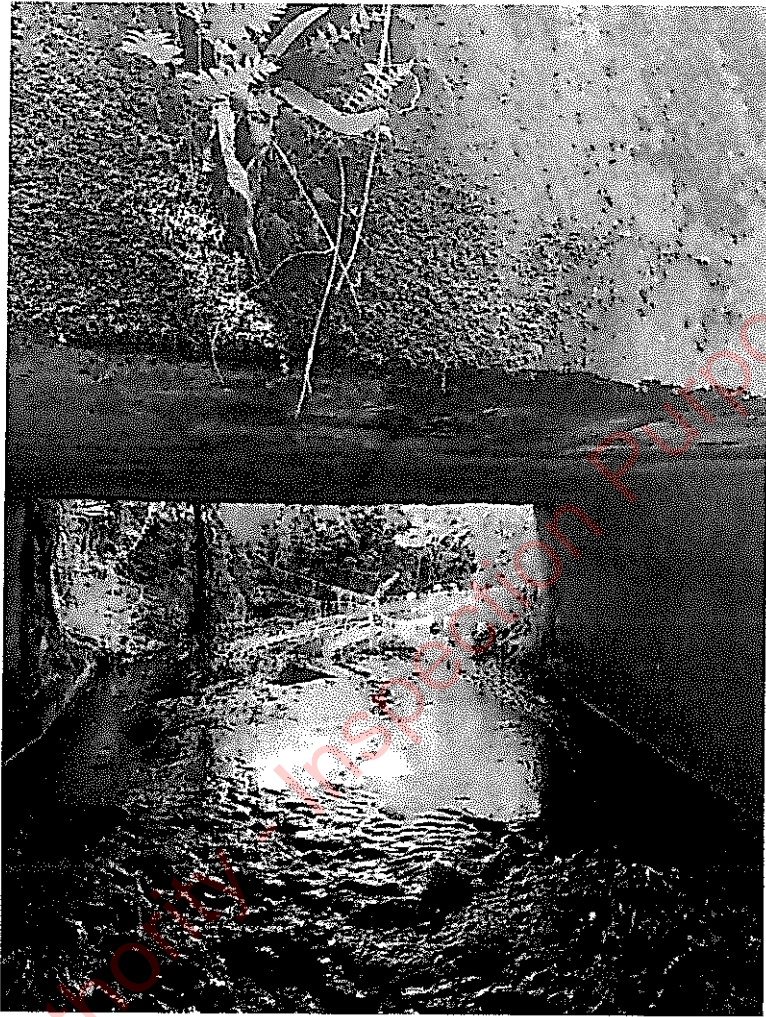
No information to the exact construction detail of the slab was available, but no significant structural defects were noted and the deck appears to be in good condition.

General view of the deck soffit

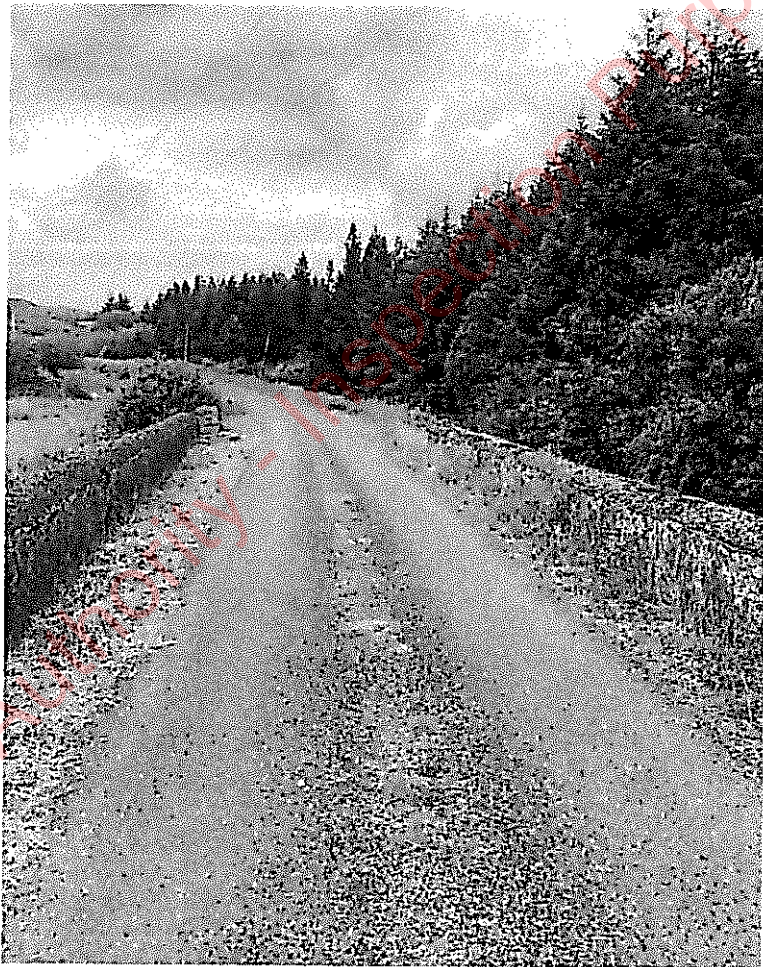
The existing bridge surface consists of tar & chip wearing course and is in good order generally.

General view of the bridge surface

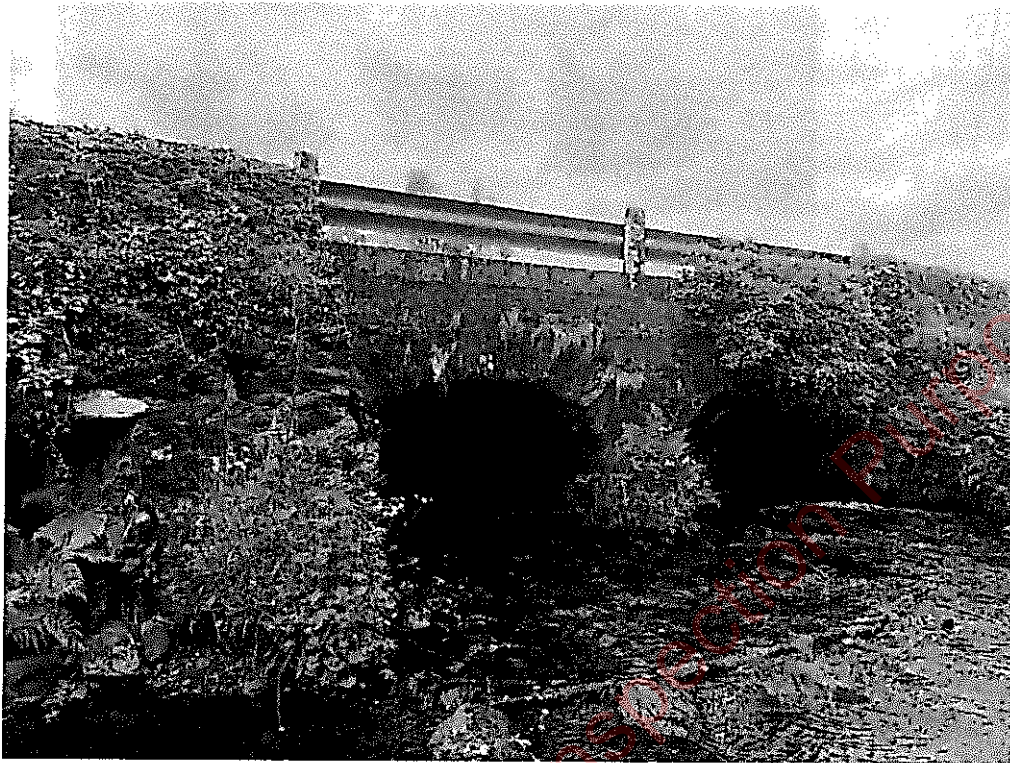
General view of bridge elevation, relief culvert shown to the left

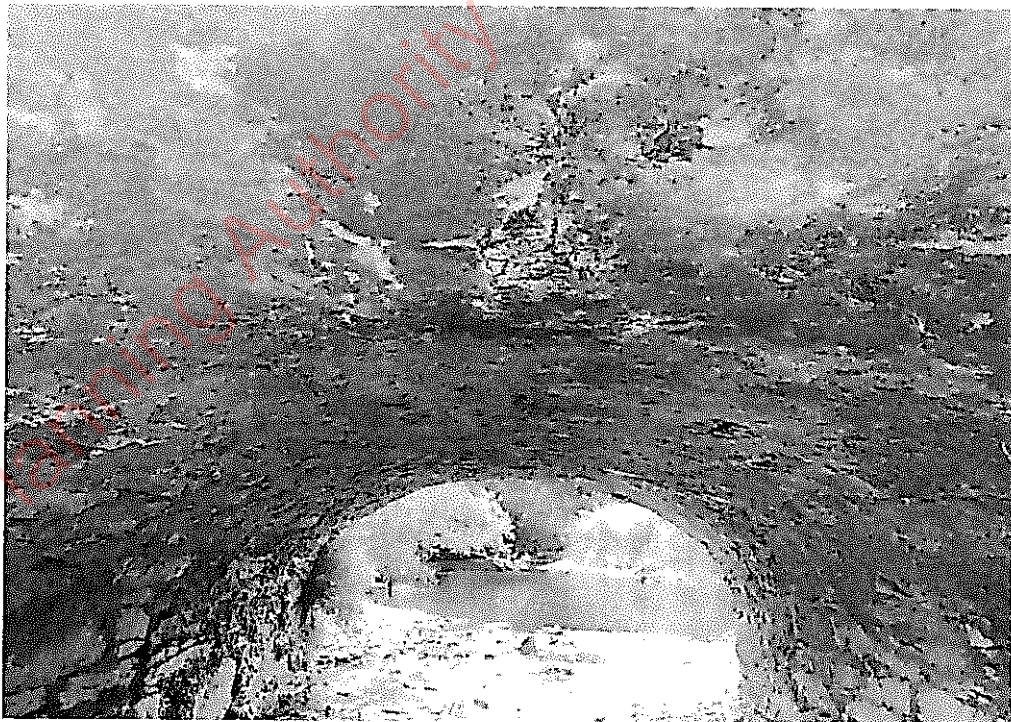
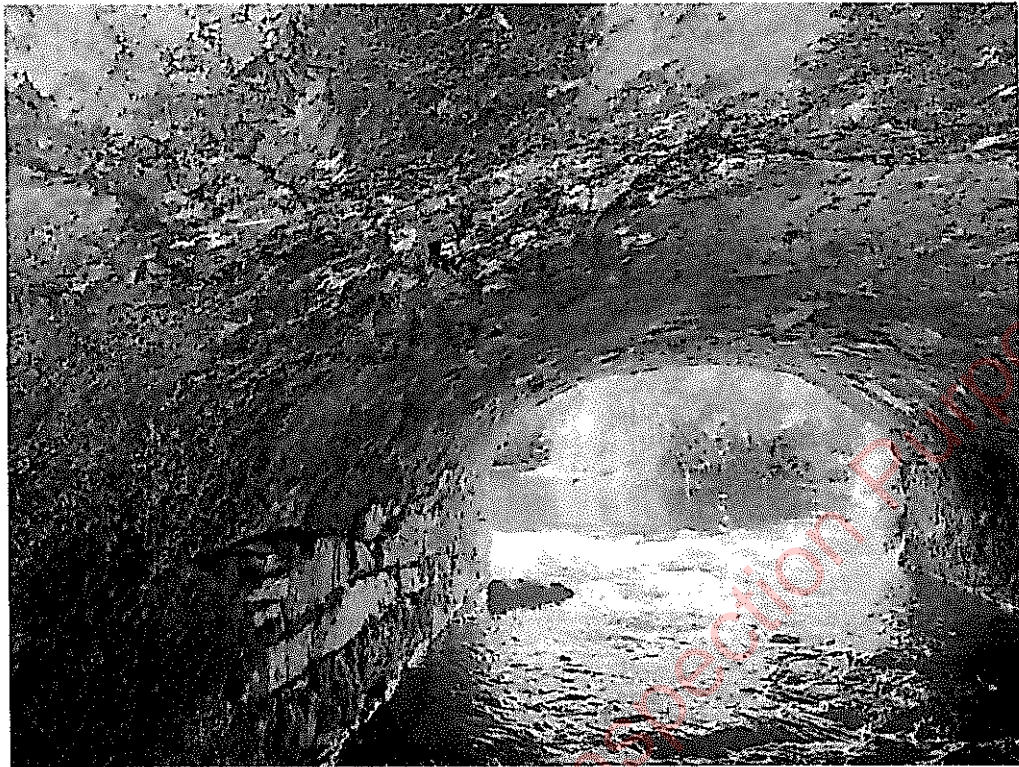
The arch barrels are generally in good condition. Full access to the culverts was not possible due to vegetation growth and dropped masonry, however, the areas that could be inspected appeared to be in poor condition with damaged and missing stones noted.

General view through arch barrel

The culverts are in poor condition and further investigation is required to confirm the full extent of the damage noted. This investigation should include removal of vegetation from the retaining walls.

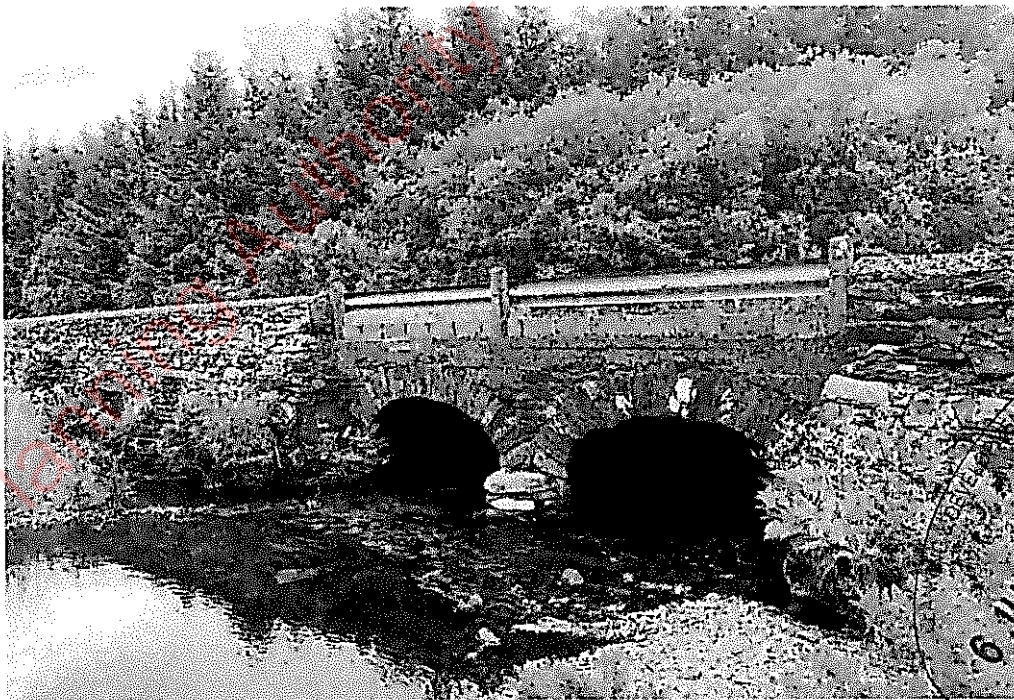
General view of bridge elevation

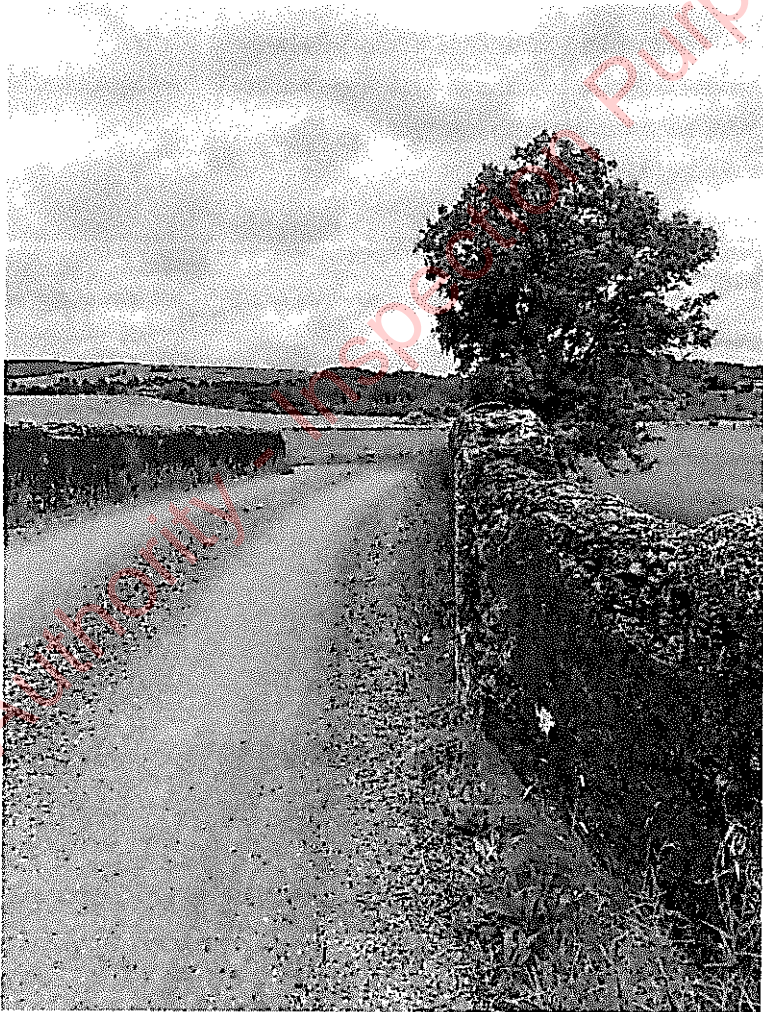
The existing bridge surface consists of tar & chip wearing course and is in good order generally.

General view of the bridge surface

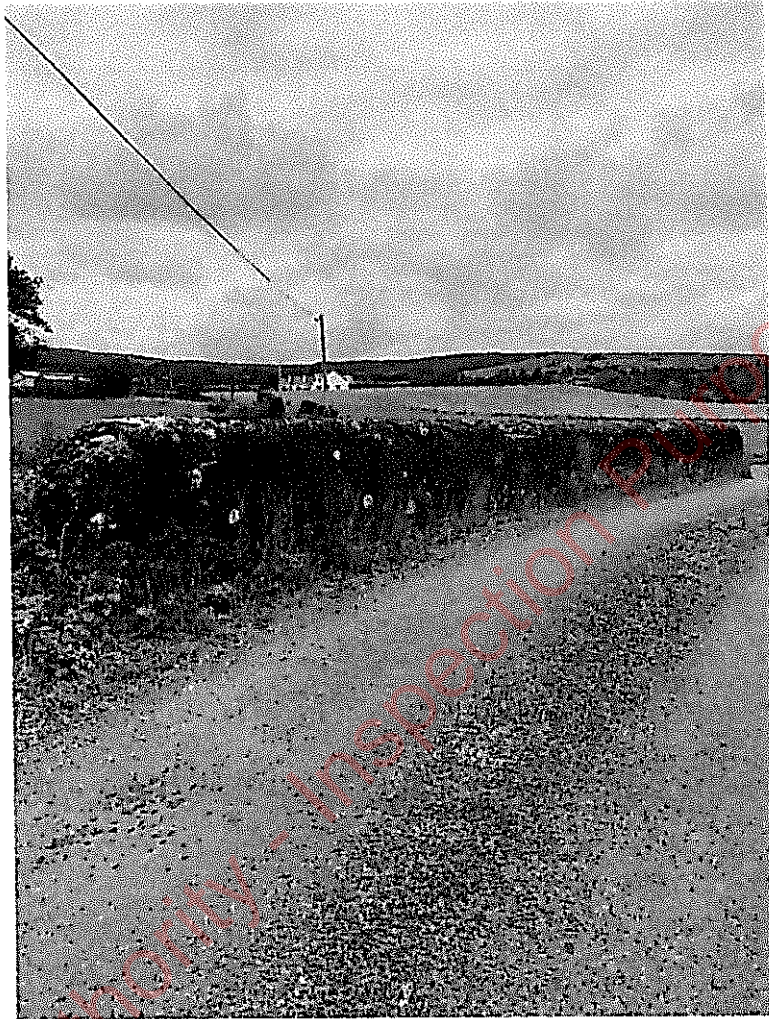
The parapets are generally in good condition. Local damage to the concrete capping was noted.

General view of the bridge parapet

Overall the structure is in good condition with few defects found. General maintenance works are required, including concrete repairs to the abutments, piers and parapets.

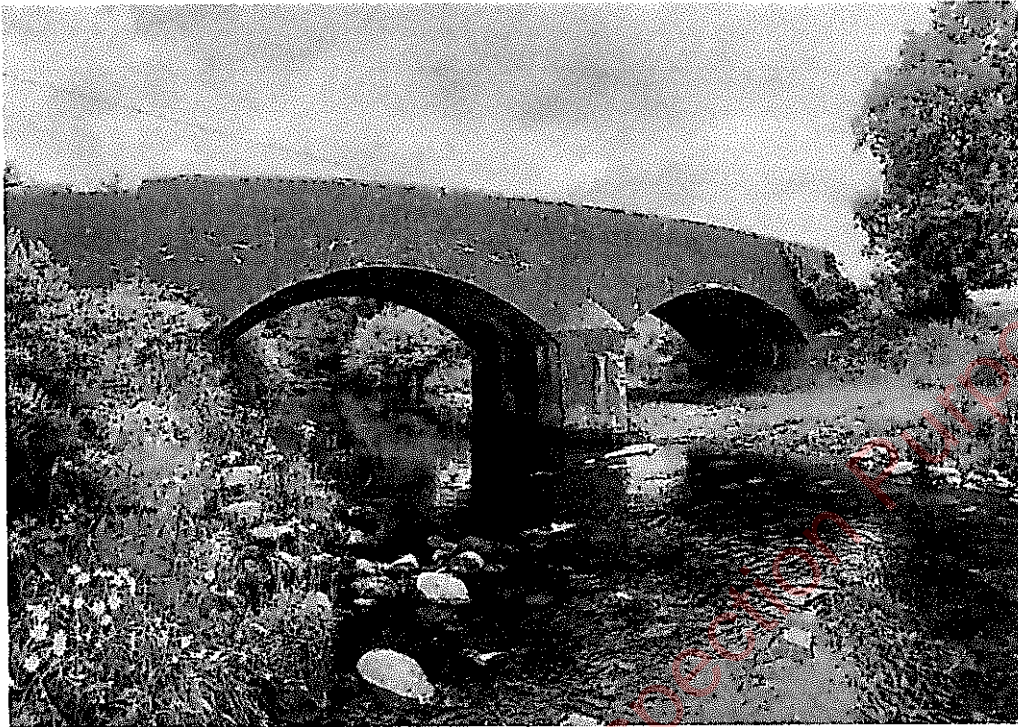
General view of bridge elevation - viewed from downstream.

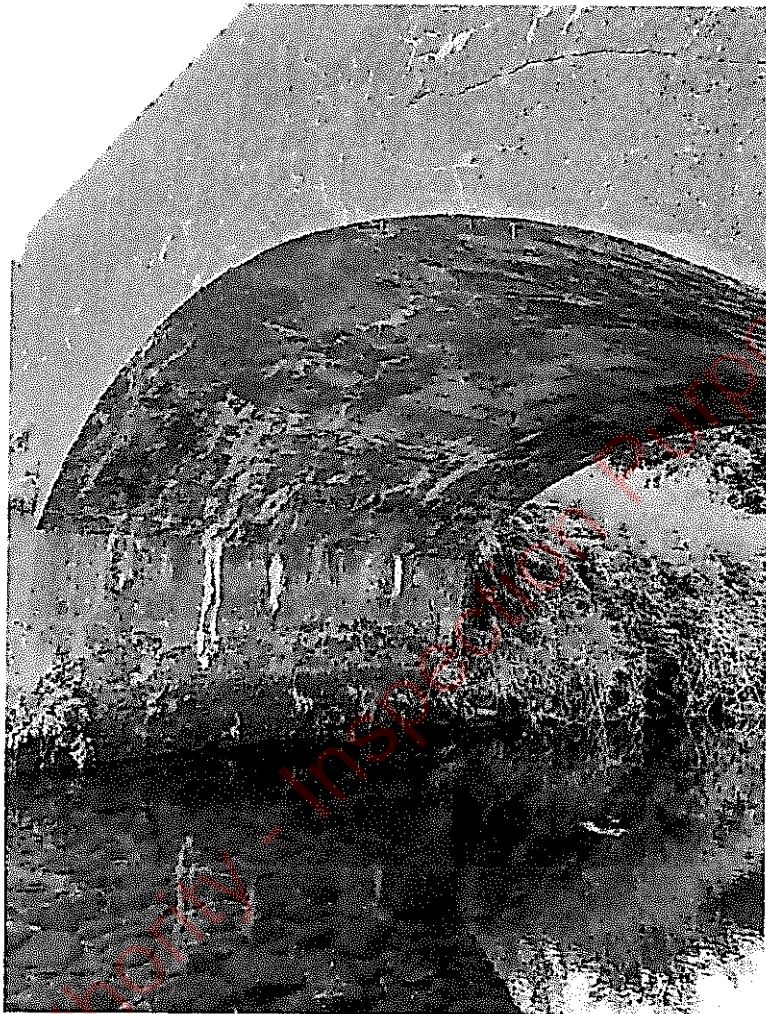
The abutments are generally in good condition. Some minor washout of the concrete is evident towards the abutment footings; however, no undermining or significant loss of material has occurred.

Both arches are constructed in concrete. No significant structural defects were noted.

General view of bridge span showing typical condition of arch barrel and abutment

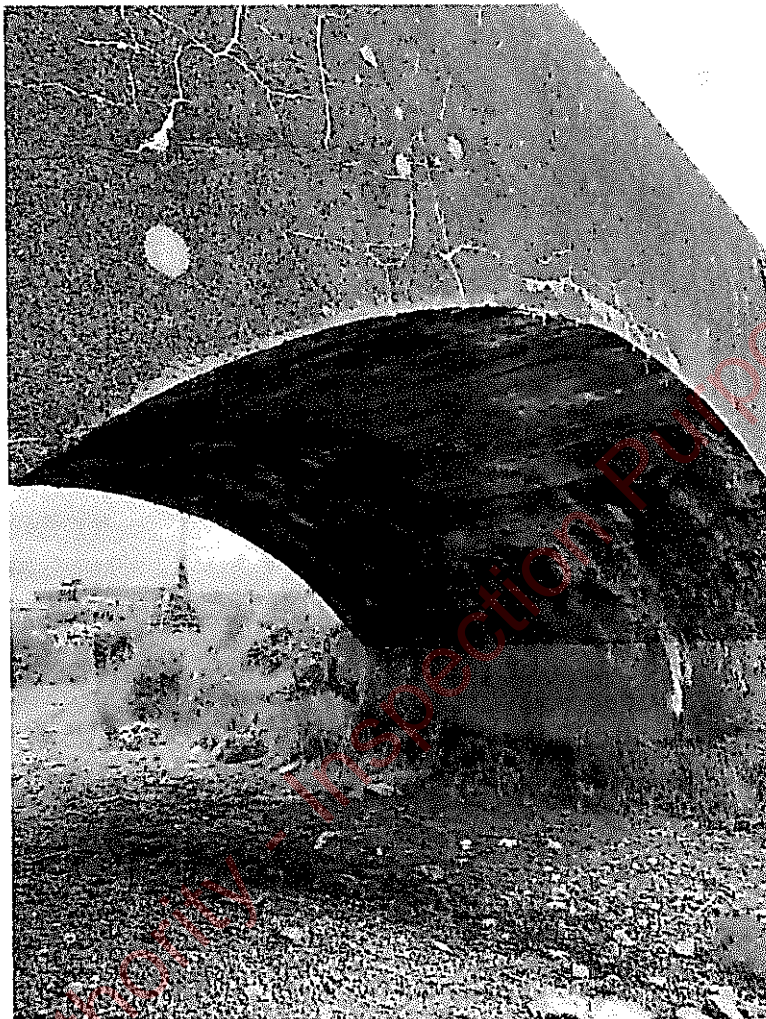
General view of bridge span showing typical condition of arch barrel and abutment

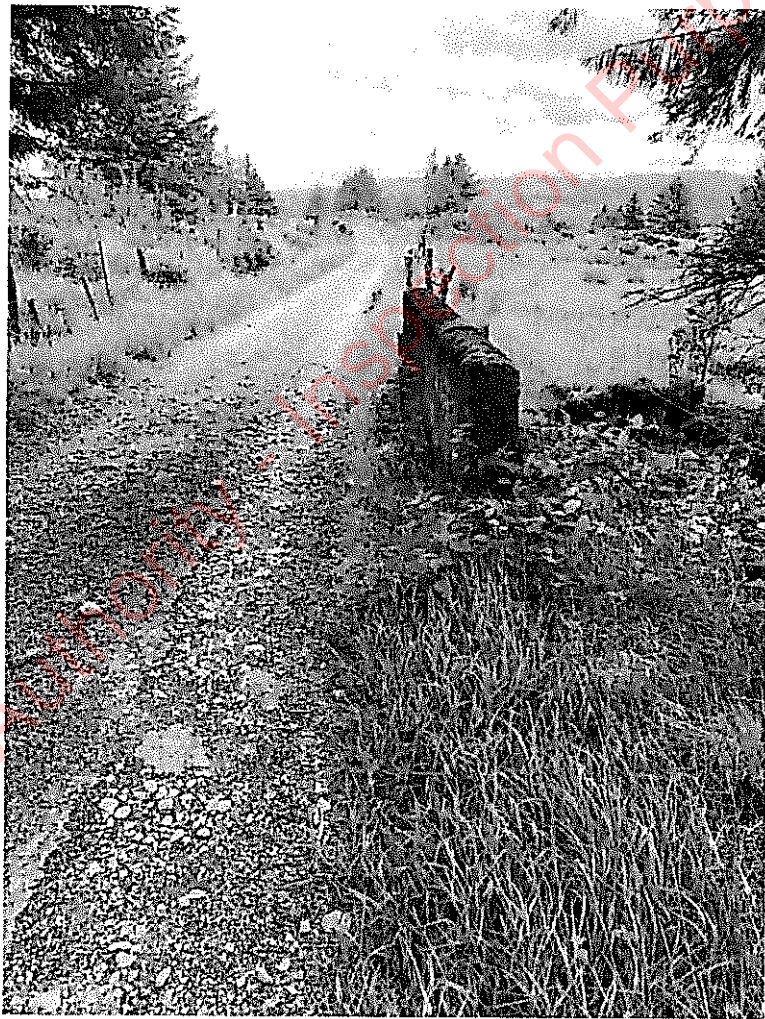
General view of the bridge surface

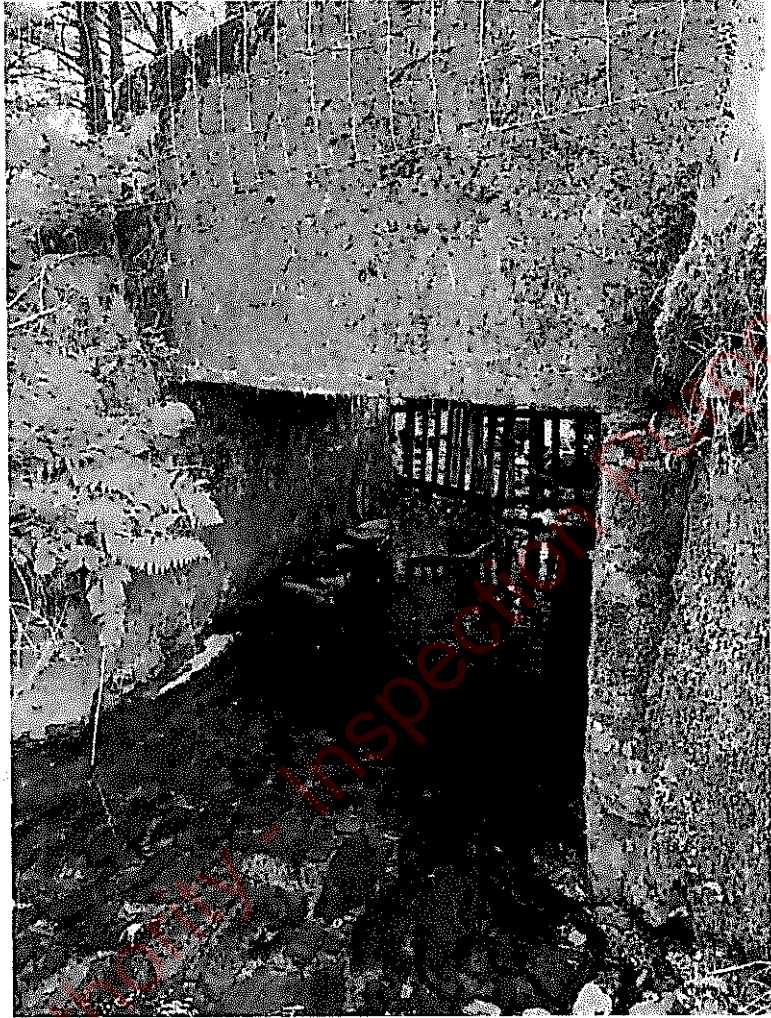
General view of the bridge elevation

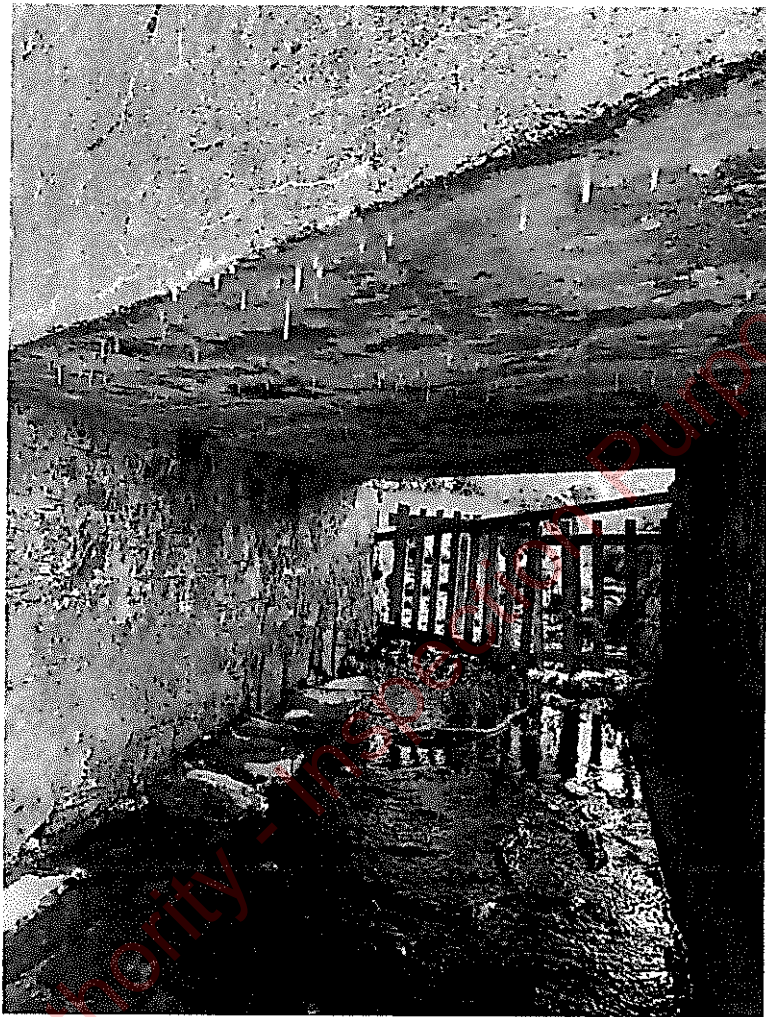
The abutments are constructed in stone masonry. Concrete repairs are evident. Some washout of joints has occurred along the base of both abutments.

No information to the exact construction of the deck slab was available. No significant structural details were noted. Water ingress and calculi staining was evident.

General view through the bridge showing the deck and abutments

Overall the structure is in fair condition with the defects mentioned above. Repairs to the parapets and abutments are required. The waterproofing of the bridge deck should be investigated with consideration to given to removing the soft verges to limit water ingress to the structure.
