Chapter 08

Landscape and Visual

Appendix 8.1

Arboricultural Impact Assessment

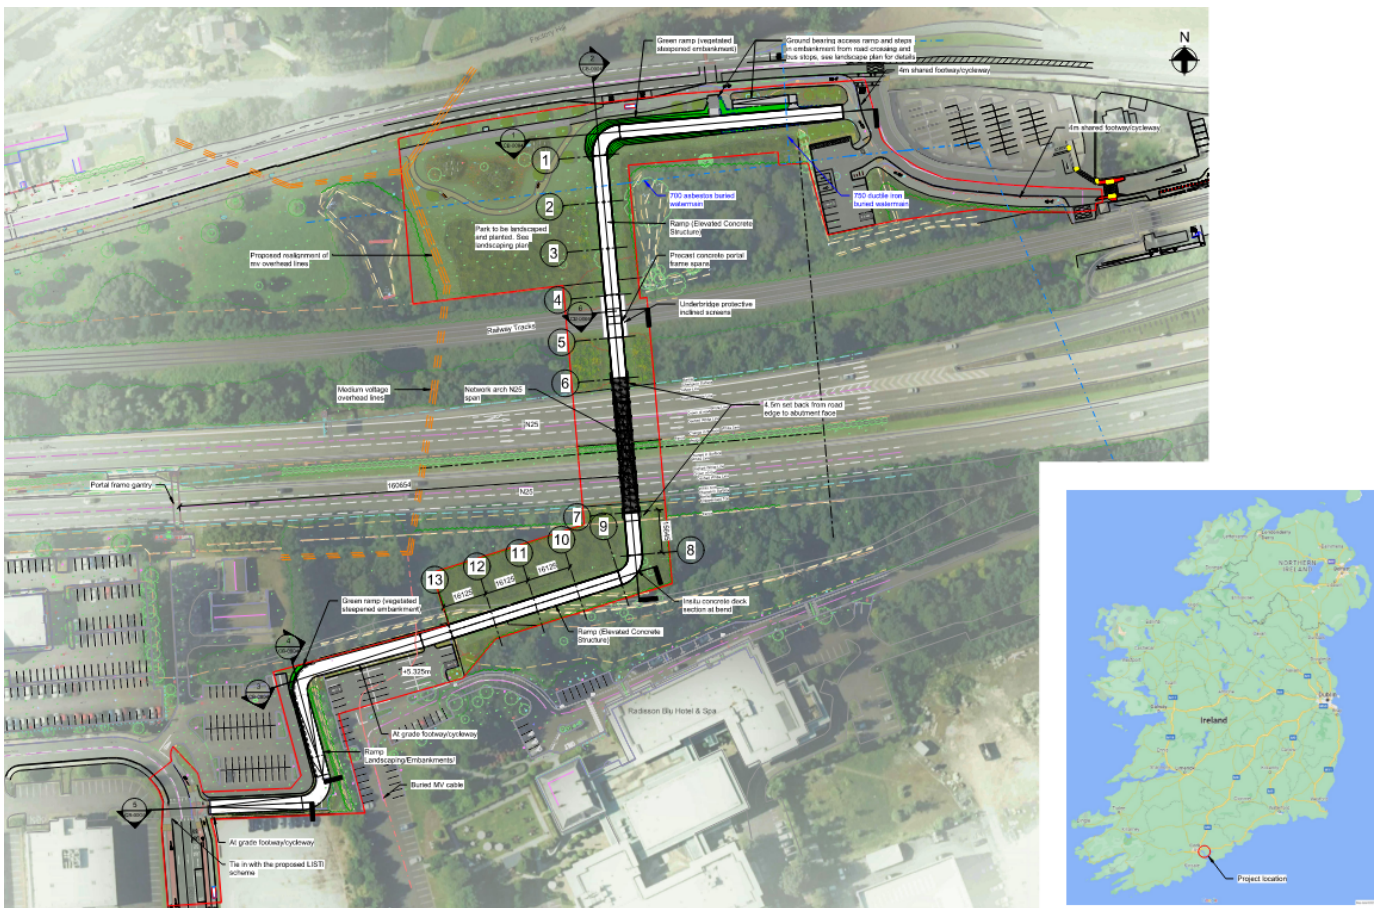
- I. The proposed development is a pedestrian and cycle bridge connecting Little Island train station to Eastgate business park. The Northern end of the bridge will adjoin to Island Corporate Park road, to the West of Little Island train station carpark. From this entrance, the bridge runs parallel to the N25 road and Irish rail line, before crossing them from point (ITM 51.907084N, -8.358132W) to point (ITM 51.906728N, -8.358068W). The bridge then turns South East at a negative angle over a stream and around the boundaries of Radisson Blu Hotel & Spa visitor carpark, then finally into Eastgate Business Park, adjoining the Eastgate road (see Fig. 1).

Fig. 1 Aerial image showing the RLB of the construction zone for the proposed pedestrian and cycle bridge connecting Little Island Train Station to Eastgate Business Park. All trees within these boundary lines are required to be removed to facilitate the development (ARUP Sketch Title: N25 LIPCB- Tree Survey Area Extents)

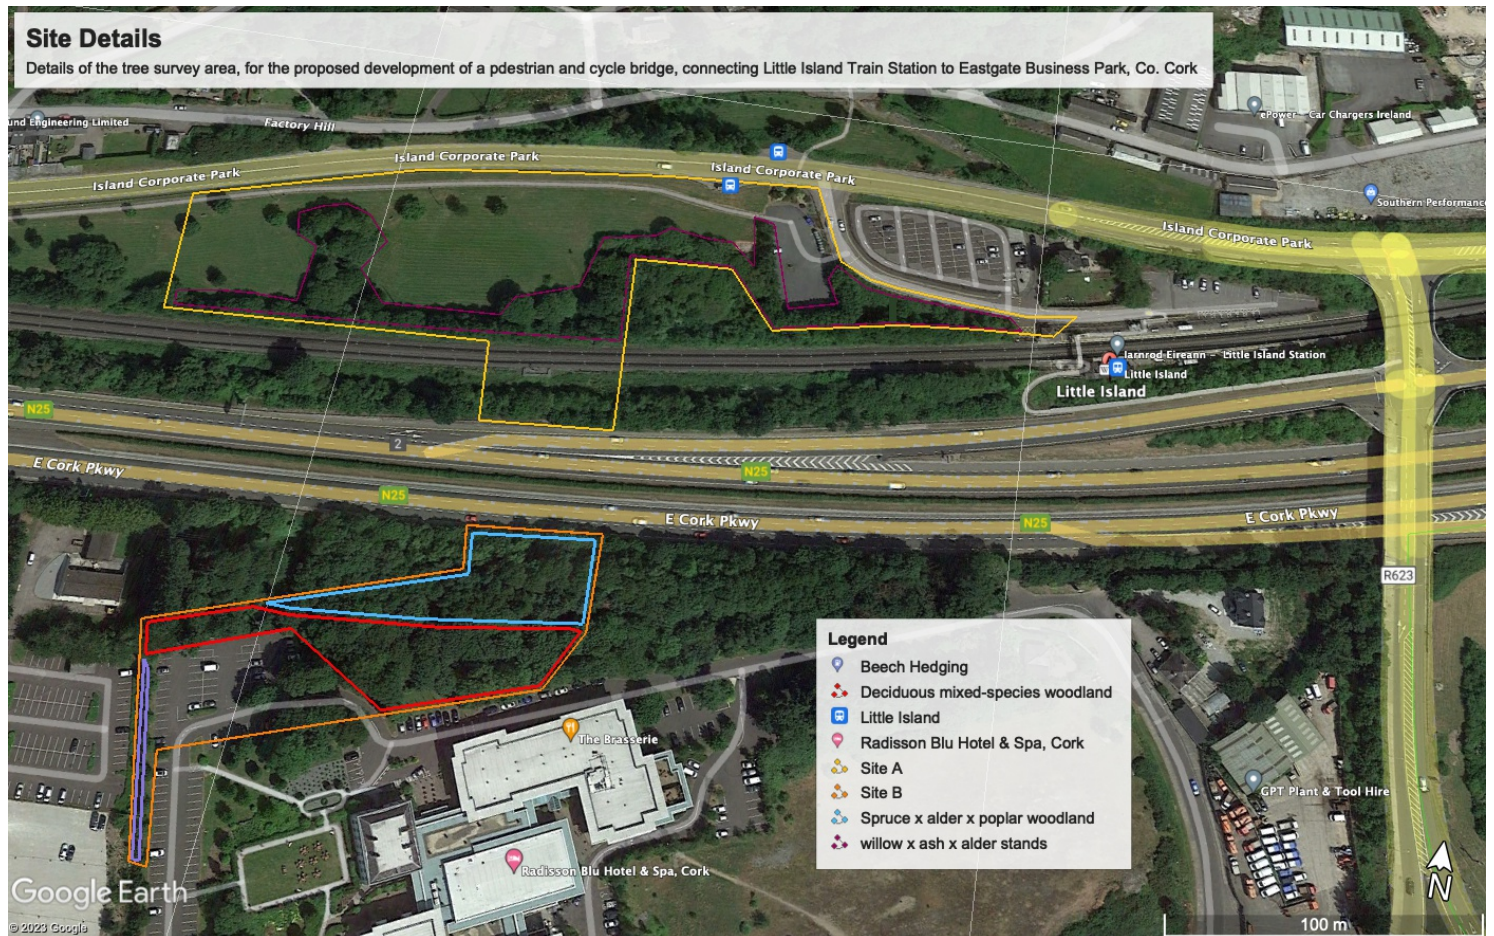
- I. The Northern tree survey Site, Site A, is located to the West of Little Island Train Station, around Island Corporate Park. The perimeter measurement of the tree survey area of Site A is ~716m, with an area of ~4.09 acres (see Fig. 2).
- II. Site A consists of thirteen (13) individual parkland trees and twenty nine (29) tree groups.
- III. Existing features on Site A include a large park green (see Fig.1) with concreted walking path and scattered park benches, two (2) protruding wetland areas, and a carpark for Island Corporate Park with a perimeter measurement of ~120m and an area of ~0.18 acres. Within the carpark are recycling bins, pedestrians and vehicles.

- I. The Southern tree survey Site, Site B, spans from the woodlands adjacent to the N25 road, South towards the Radisson Blu Hotel & Spa, following the boundary line of its carpark towards Eastgate Business park. The perimeter measurement of the tree survey area is ~491m, with an area of ~1.62 acres. The tree survey area measures 10-20m around the proposed development (see Fig.2).

- II. Site B consists of two (2) woodlands, eleven (11) decurrent parkland trees and one (1) hedgerow.
- III. Existing features on Site B include a deep stream running West to East through the tree survey area. The stream's course follows the horizontal boundary lines between the two (2) woodlands (see Fig.2). At higher elevation to the South of the stream, there is a carpark for the Radisson Blu Hotel & Spa, with a perimeter measurement within the tree survey area of ~229m and an area of ~0.47 acres. Within the carpark are pedestrians and vehicles.

Fig. 2 Aerial image showing the tree survey area. Yellow lines delineate the boundaries of Site A; orange lines delineate the boundaries of Site B; the dark pink lines delineate the willow x ash x alder stands; the red lines delineate the area of the deciduous mixed-species woodland; the blue lines delineate the spruce x alder x poplar woodland; and the purple lines delineate the beech hedging (Google Earth Pro, 2022).

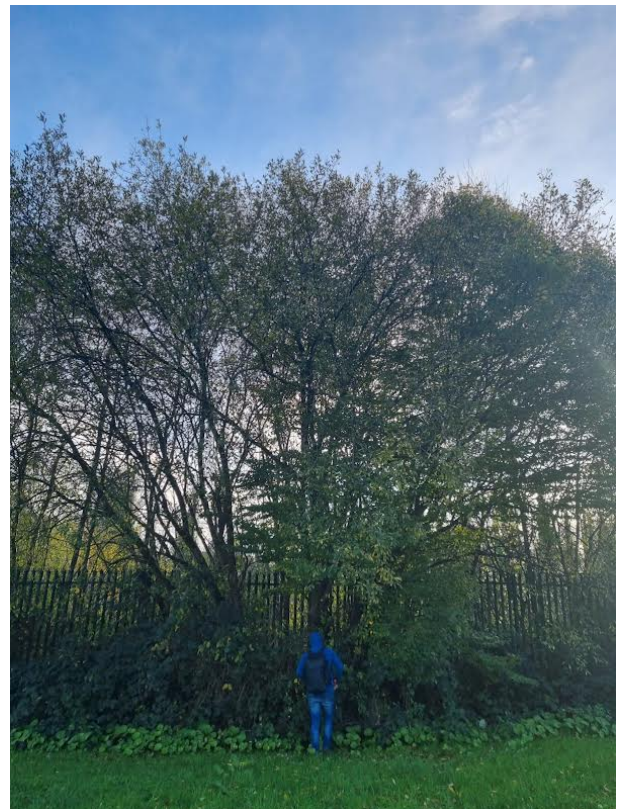
- III. Along the Southern fence-line of Site A between the park, the Irish Rail line, the N25 and around the carpark, are native groups of three (3) excurrent high canopy tree species with high maturing heights (>12m) (see *fig.4*). These alder (*Alnus*) x grey willow (*Salix cinerea*) x ash (*Fraxinus excelsior*) stands consist of around 398 trees, categorised in this report into 21 groups. In addition there are 6 groups of understory scrub species, including hazel (*Corylus*) and hawthorn (*Crataegus*) (*Perrin et al. 2008*).

Fig.4 Example of Site A's alder x grey willow x ash stands

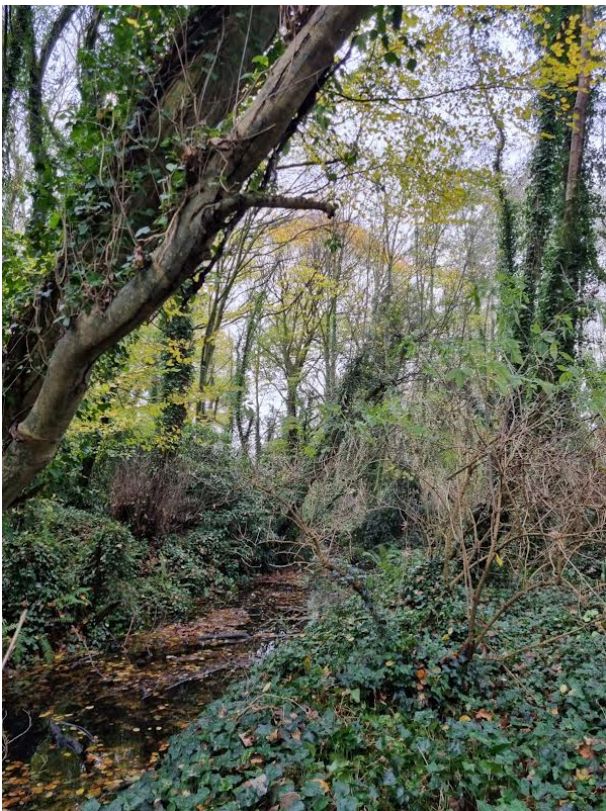
Fig.7 Site B's deep stream running East-West between the deciduous and spruce x ash x alder woodlands
