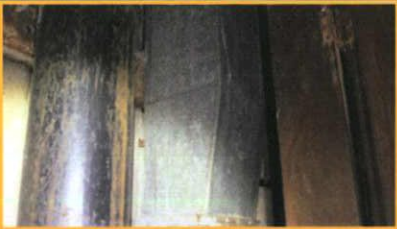
Ref No.	Building	Location or Functional Space	Sample No.	Material Description, surface treatment and condition	Extent	Asbestos identified (presumed, strongly presumed or identified)	Product type	Condition	Surface treatment	Asbestos type	Material assessment score	Recommendations	Photo
57	Fingal Co. Co. Office and Carpark Moore Lane	3 <sup>rd</sup> floor ladies WC Riser		Woven rope gaskets to air handling duct		Chrysotile	2	1	1	1	5	Removal and disposal as asbestos waste by a competent contractor prior to work likely to cause disturbance.

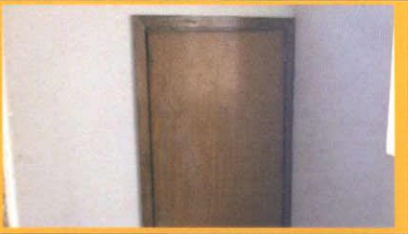
Ref No.	Building	Location or Functional Space	Sample No.	Material Description, surface treatment and condition	Extent	Asbestos identified (presumed, strongly presumed or identified)	Product type	Condition	Surface treatment	Asbestos type	Material assessment score	Recommendations	Photo
61	Fingal Co. Co. Office and Carpark Moore Lane	3 <sup>rd</sup> floor half landing	2027301	Insulation board back of riser doors		Amosite	2	2	2	2	8	Removal and disposal as asbestos waste by a competent contractor prior to work likely to cause disturbance.

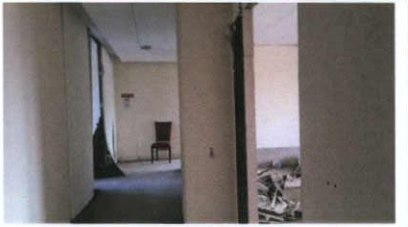
62	Fingal Co. Co. Office and Carpark Moore Lane	3 <sup>rd</sup> floor corridor		Plasterboard partitions to offices and rooms. MMMF in walls.		NAD

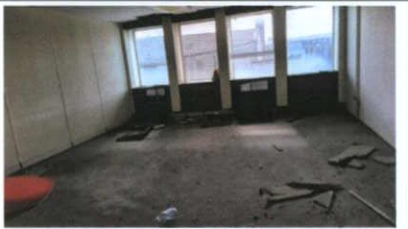
63	Fingal Co. Co. Office and Carpark Moore Lane	3 <sup>rd</sup> floor office	2027320	Wall mounted heater felt		NAD

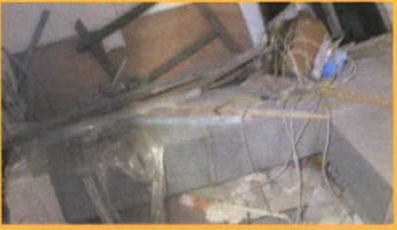
Ref No.	Building	Location or Functional Space	Sample No.	Material Description, surface treatment and condition	Extent	Asbestos identified (presumed, strongly presumed or identified)	Product type	Condition	Surface treatment	Asbestos type	Material assessment score	Recommendations	Photo
69	Fingal Co. Co. Office and Carpark Moore Lane	2 <sup>nd</sup> floor office		Red adhesive to ductwork	NQ	Chrysotile	1	0	0	1	2	Removal and disposal as asbestos waste by a competent contractor prior to work likely to cause disturbance.

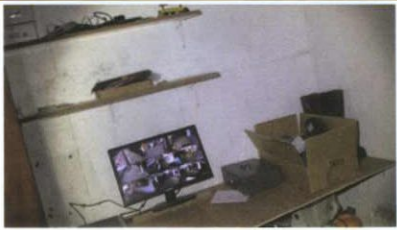
72	Fingal Co. Co. Office and Carpark Moore Lane	Ground floor Security room				No visible asbestos containing materials identified.

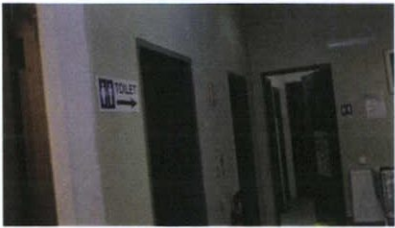
Ref No.	Building	Location or Functional Space	Sample No.	Material Description, surface treatment and condition	Extent	Asbestos identified (presumed, strongly presumed or identified)	Product type	Condition	Surface treatment	Asbestos type	Material assessment score	Recommendations	Photo
85	Fingal Co. Co. Office and Carpark Chinese Restaurant	Ground floor Old lift lobby		Under floor coverings not disturbed.		No visible asbestos containing materials identified.

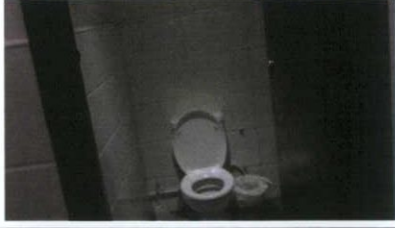
87	Fingal Co. Co. Office and Carpark Chinese Restaurant	Ground floor WC				No visible asbestos containing materials identified.

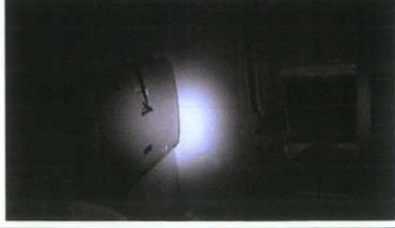
88	Fingal Co. Co. Office and Carpark Chinese Restaurant	Ground floor WC				No visible asbestos containing materials identified.

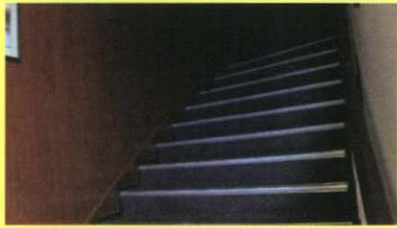
Ref No.	Building	Location or Functional Space	Sample No.	Material Description, surface treatment and condition	Extent	Asbestos identified (presumed, strongly presumed or identified)	Product type	Condition	Surface treatment	Asbestos type	Material assessment score	Recommendations	Photo
89	Fingal Co. Co. Office and Carpark Chinese Restaurant	Stairway ground to 1 <sup>st</sup> floor.		Fixed flooring not disturbed.		Presumed to contain asbestos VFT.						Investigation by a competent contractor prior to work likely to cause disturbance.

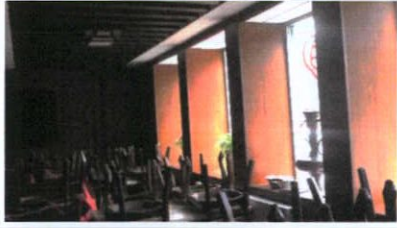
90	Fingal Co. Co. Office and Carpark Chinese Restaurant	1 <sup>st</sup> floor Openplan restaurant				No visible asbestos containing materials identified.

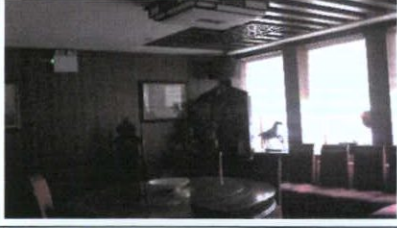
91	Fingal Co. Co. Office and Carpark Chinese Restaurant	1 <sup>st</sup> floor Private restaurant rooms				No visible asbestos containing materials identified.

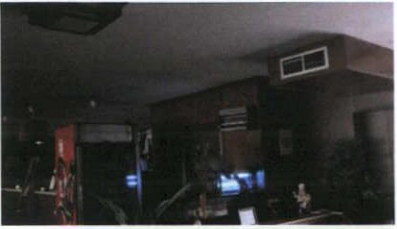
Ref No.	Building	Location or Functional Space	Sample No.	Material Description, surface treatment and condition	Extent	Asbestos identified (presumed, strongly presumed or identified)	Product type	Condition	Surface treatment	Asbestos type	Material assessment score	Recommendations	Photo
93	Fingal Co. Co. Office and Carpark Chinese Restaurant					No visible asbestos containing materials identified.

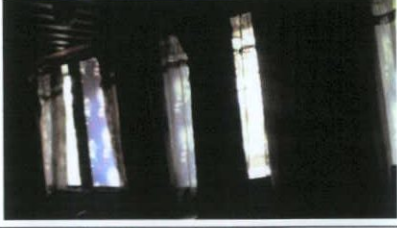
95	Fingal Co. Co. Office and Carpark Chinese Restaurant					No visible asbestos containing materials identified.

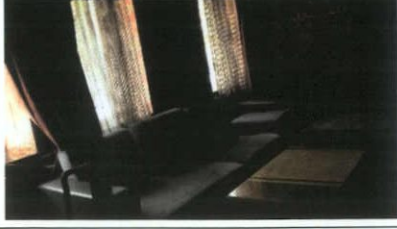
96	Fingal Co. Co. Office and Carpark Chinese Restaurant					No visible asbestos containing materials identified.

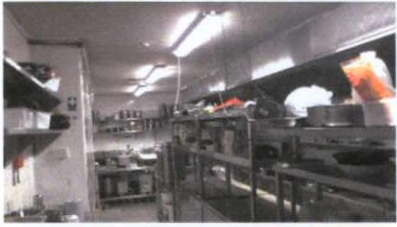
102	Fingal Co. Co. Office and Carpark Chinese Restaurant	1 <sup>st</sup> floor Main kitchen		Modern refurb. Ceramic tiles to floors.		No visible asbestos containing materials identified.

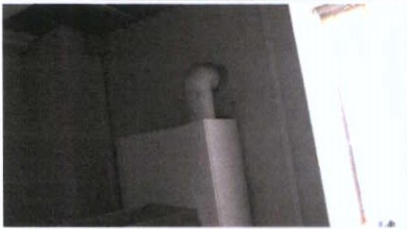
Ref No.	Building	Location or Functional Space	Sample No.	Material Description, surface treatment and condition	Extent	Asbestos identified (presumed, strongly presumed or identified)	Product type	Condition	Surface treatment	Asbestos type	Material assessment score	Recommendations	Photo
117	Fingal Co. Co. Office and Carpark Chinese Restaurant	2 <sup>nd</sup> floor Water tank room		Modern gas boiler		NAD

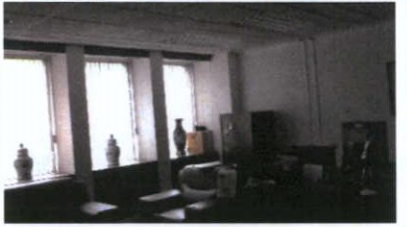
118	Fingal Co. Co. Office and Carpark Chinese Restaurant	2 <sup>nd</sup> floor Front room				No visible asbestos containing materials identified.

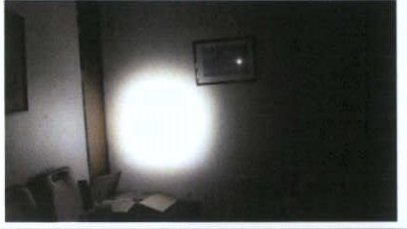
119	Fingal Co. Co. Office and Carpark Chinese Restaurant	2 <sup>nd</sup> floor Front room				No visible asbestos containing materials identified.

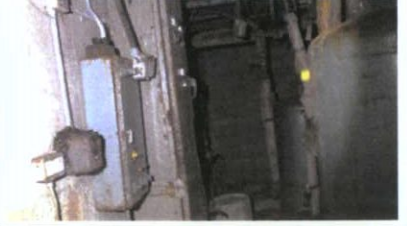
120	Fingal Co. Co. Office and Carpark	Basement		Old electrical panels		No visible asbestos containing materials identified.

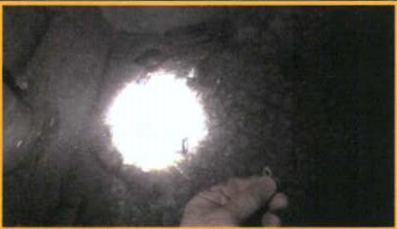
Ref No.	Building	Location or Functional Space	Sample No.	Material Description, surface treatment and condition	Extent	Asbestos identified (presumed, strongly presumed or identified)	Product type	Condition	Surface treatment	Asbestos type	Material assessment score	Recommendations	Photo
121	Fingal Co. Co. Office and Carpark	Basement Plantroom		Asbestos string to MMMF insulation on floor	Small amount	Chrysotile	2	2	2	1	7	Removal and disposal as asbestos waste by a competent contractor prior to work likely to cause disturbance.

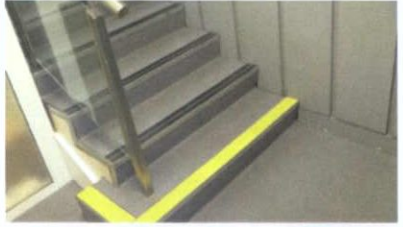
Ref No.	Building	Location or Functional Space	Sample No.	Material Description, surface treatment and condition	Extent	Asbestos identified (presumed, strongly presumed or identified)	Product type	Condition	Surface treatment	Asbestos type	Material assessment score	Recommendations	Photo
13	No. 59/60 O'Connell Street	Basement stairway		Plastic threads		No visible asbestos containing materials identified

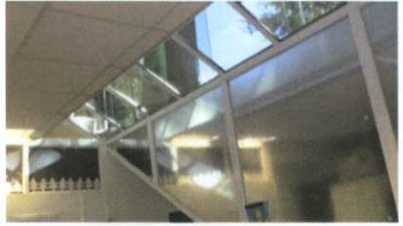
14	No. 59/60 O'Connell Street	Basement Public info office				No visible asbestos containing materials identified

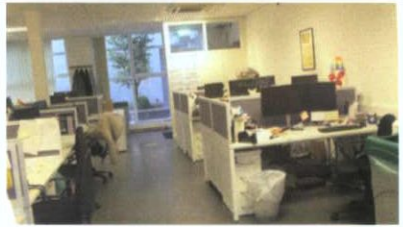
15	No. 59/60 O'Connell Street	Basement Public info office				No visible asbestos containing materials identified

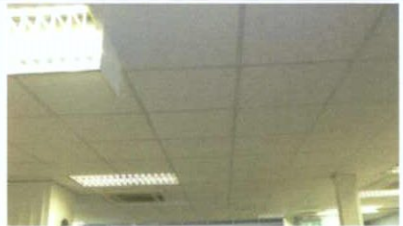
16	No. 59/60 O'Connell Street	Basement Public info office		Mineral fibre ceiling tiles		No visible asbestos containing materials identified

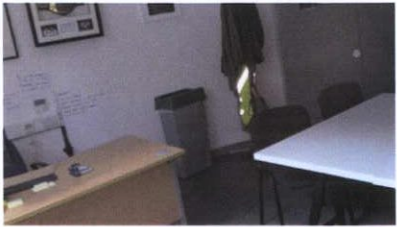
Ref No.	Building	Location or Functional Space	Sample No.	Material Description, surface treatment and condition	Extent	Asbestos identified (presumed, strongly presumed or identified)	Product type	Condition	Surface treatment	Asbestos type	Material assessment score	Recommendations	Photo
21	No. 59/60 O'Connell Street	Basement office				No visible asbestos containing materials identified

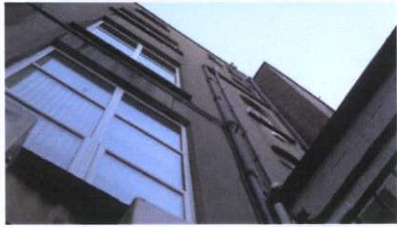
23	No. 59/60 O'Connell Street	Building exterior rear		Plastic downpipes generally		No visible asbestos containing materials identified

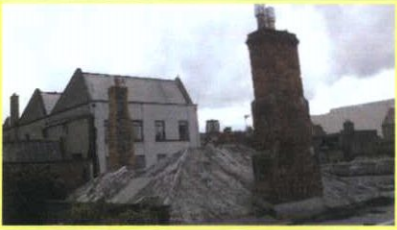
Ref No.	Building	Location or Functional Space	Sample No.	Material Description, surface treatment and condition	Extent	Asbestos identified (presumed, strongly presumed or identified)	Product type	Condition	Surface treatment	Asbestos type	Material assessment score	Recommendations	Photo
33	No. 59/60 O'Connell Street	Garage		Roofs not accessible		Presumed to contain asbestos roofing felts						Investigation by a competent contractor prior to work likely to cause disturbance.

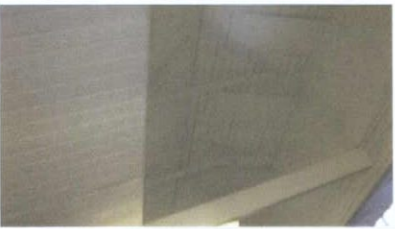
Ref No.	Building	Location or Functional Space	Sample No.	Material Description, surface treatment and condition	Extent	Asbestos identified (presumed, strongly presumed or identified)	Product type	Condition	Surface treatment	Asbestos type	Material assessment score	Recommendations	Photo
37	No. 59/60 O'Connell Street	Ground floor carpark		Timber cladding on roof		No visible asbestos containing materials identified

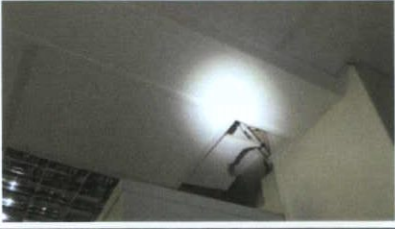
39	No. 59/60 O'Connell Street	Ground floor office				No visible asbestos containing materials identified

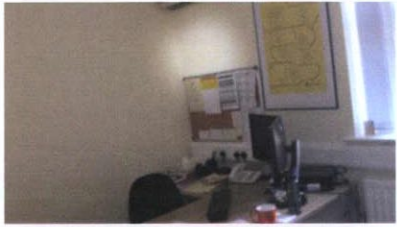
Ref No.	Building	Location or Functional Space	Sample No.	Material Description, surface treatment and condition	Extent	Asbestos identified (presumed, strongly presumed or identified)	Product type	Condition	Surface treatment	Asbestos type	Material assessment score	Recommendations	Photo
41	No. 59/60 O'Connell Street	Ground floor office				No visible asbestos containing materials identified

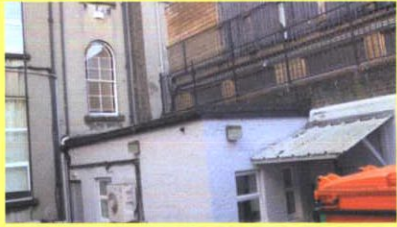
43	No. 59/60 O'Connell Street	Building exterior flat roof		Substrate roofing felt		Presumed asbestos						investigation by a competent contractor prior to work likely to cause disturbance.

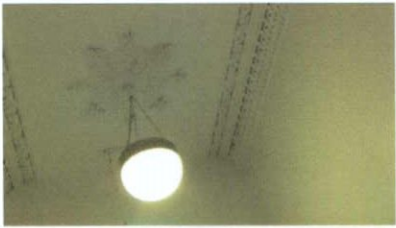
Ref No.	Building	Location or Functional Space	Sample No.	Material Description, surface treatment and condition	Extent	Asbestos identified (presumed, strongly presumed or identified)	Product type	Condition	Surface treatment	Asbestos type	Material assessment score	Recommendations	Photo
61	No. 59/60 O'Connell Street	No. 60 Ground floor front				No visible asbestos containing materials identified

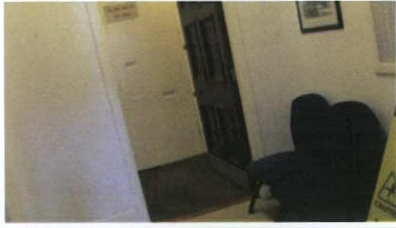
62	No. 59/60 O'Connell Street	Ground floor front offices				No visible asbestos containing materials identified

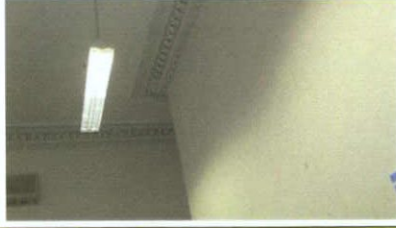
63	No. 59/60 O'Connell Street	Ground floor front corridor				No visible asbestos containing materials identified
