# ABOUT SAFETY LTD.

**Client:** *Dublin Central GP Ltd*

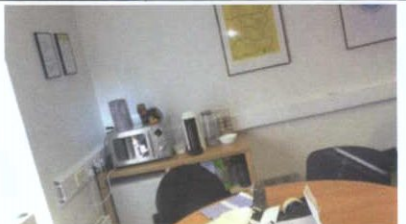
104	No. 59/60 O'Connell Street	1 <sup>st</sup> floor Office				No visible asbestos containing materials identified

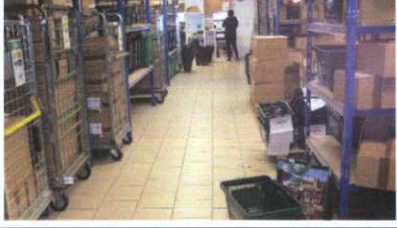
28	No. 58 O'Connell St.	Ground floor Back store room		Ceramic tiles to floor		No visible asbestos containing materials identified.

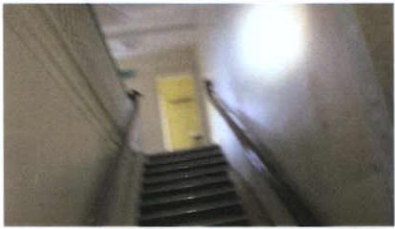
Ref No.	Building or Area of Site	Location or Functional Space	Sample No.	Material Description, surface treatment and condition	Extent	Asbestos identified (presumed, strongly presumed or identified)	Product type	Condition	Surface treatment	Asbestos type	Material assessment score	Recommendations	Photo
1	No. 43 O'Connell St.			Plastic thread 12osings to stairway		No visible asbestos containing materials identified.

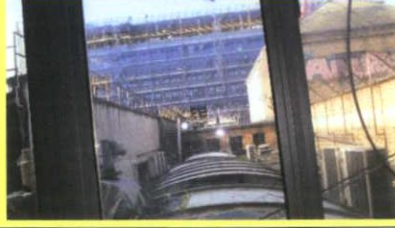
4	No. 43 O'Connell St.	Back buildings and roof		No access		Presumed to contain asbestos						Investigation prior to work likely to cause disturbance.

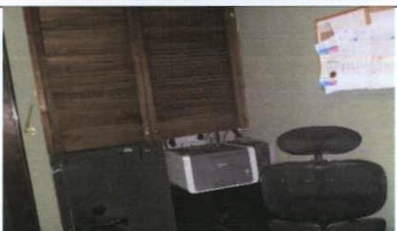
23	No. 43 O'Connell St. Ned Kellys	Basement Office				No visible asbestos containing materials identified.							 
24	No. 43 O'Connell St. Ned Kellys	Ground floor office up spiral stairway				No visible asbestos containing materials identified.

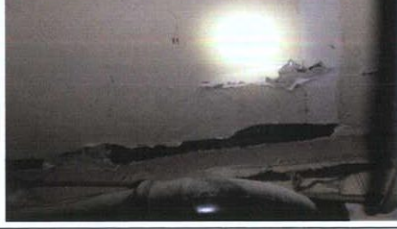
40	No. 43 O'Connell St. Ned Kellys	Ground floor Ladies WC Ceiling void				No visible asbestos containing materials identified.

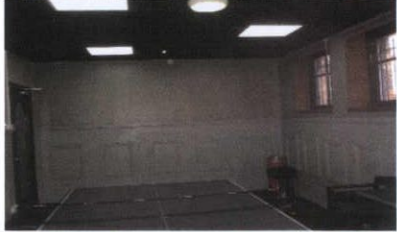
42	No. 43 O'Connell St. Ned Kellys	Ground floor Snooker room				No visible asbestos containing materials identified.							 
43	No. 43 O'Connell St. Ned Kellys	1st floor Front room				No visible asbestos containing materials identified.

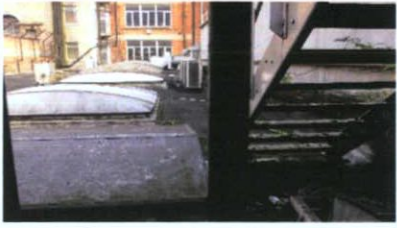
47	No. 43 O'Connell St. Ned Kellys	1 <sup>st</sup> floor Roofs				No visible asbestos containing materials identified.
