DDC PLAN NO 15432/22
 13/12/2022

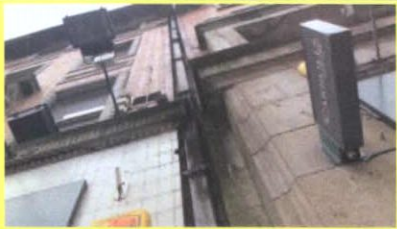
Ref No.	Building or Area of Site	Location or Functional Space	Sample No.	Material Description, surface treatment and condition	Extent	Asbestos identified (presumed, strongly presumed or identified)	Product type	Condition	Surface treatment	Asbestos type	Material assessment score	Recommendations	Photo
1	No. 57 O'Connell St.	Front façade		Lead sealed cast-iron downpipe collars		Presumed to contain asbestos woven rope packing.						Investigation by a competent contractor prior to work likely to cause disturbance.

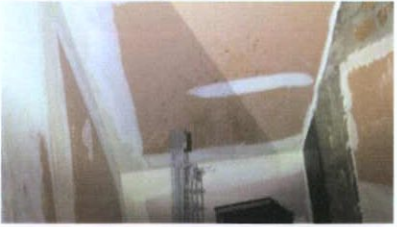
Ref No.	Building or Area of Site	Location or Functional Space	Sample No.	Material Description, surface treatment and condition	Extent	Asbestos identified (presumed, strongly presumed or identified)	Product type	Condition	Surface treatment	Asbestos type	Material assessment score	Recommendations	Photo
5	No. 57 O'Connell St.	Basement		Plasterboard under stairway		No visible asbestos containing materials identified.

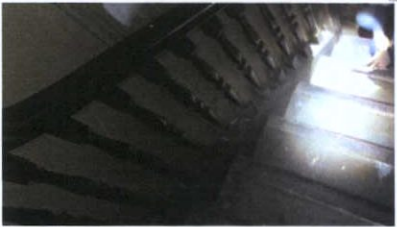
Ref No.	Building or Area of Site	Location or Functional Space	Sample No.	Material Description, surface treatment and condition	Extent	Asbestos identified (presumed, strongly presumed or identified)	Product type	Condition	Surface treatment	Asbestos type	Material assessment score	Recommendations	Photo
17	No. 57 O'Connell St.	1 st floor Stairway to 2 nd floor	2029301	Brown lino to steps		NAD

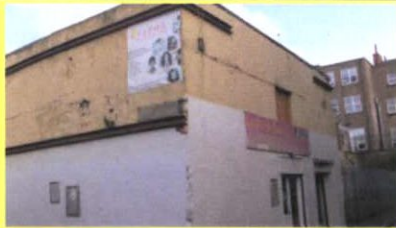
Ref No.	Building or Area of Site	Location or Functional Space	Sample No.	Material Description, surface treatment and condition	Extent	Asbestos identified (presumed, strongly presumed or identified)	Product type	Condition	Surface treatment	Asbestos type	Material assessment score	Recommendations	Photo
1	60A O'Connell St.	Roof		Flat roof - not accessible.		Presumed to contain asbestos						Investigation by a competent contractor prior to work likely to cause disturbance.

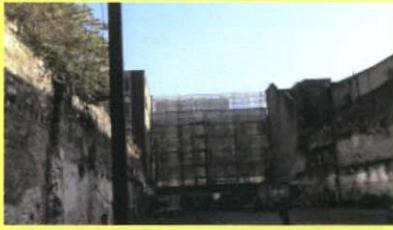
Ref No.	Building or Area of Site	Location or Functional Space	Sample No.	Material Description, surface treatment and condition	Extent	Asbestos identified (presumed, strongly presumed or identified)	Product type	Condition	Surface treatment	Asbestos type	Material assessment score	Recommendations	Photo
1	No. 50-51 O'Connell St.	Vacant site		Under hardstand		Presumed to contain asbestos						Investigation by a competent contractor during excavation or work likely to cause disturbance.

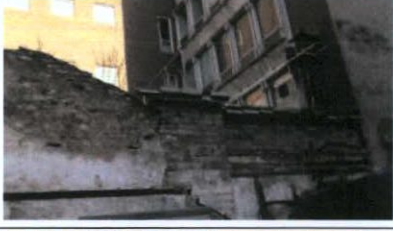
3	No. 50-51 O'Connell St.	Old walls				No visible asbestos containing materials identified.

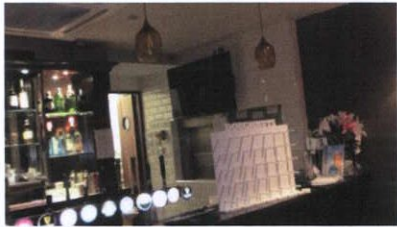
Ref No.	Building or Area of Site	Location or Functional Space	Sample No.	Material Description, surface treatment and condition	Extent	Asbestos identified (presumed, strongly presumed or identified)	Product type	Condition	Surface treatment	Asbestos type	Material assessment score	Recommendations	Photo
5	No. 61 O'Connell Street	Ground floor Bar areas				No visible asbestos containing materials identified.

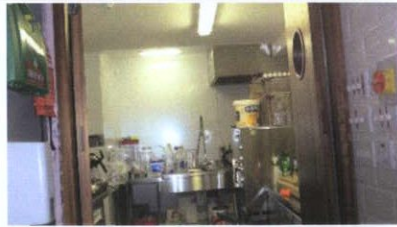
7	No. 61 O'Connell Street	Ground floor Bar areas				No visible asbestos containing materials identified.

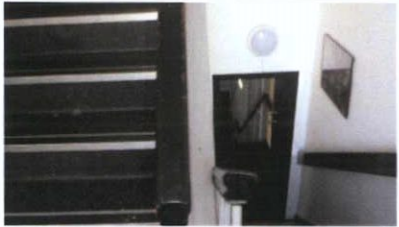
Ref No.	Building or Area of Site	Location or Functional Space	Sample No.	Material Description , surface treatment and condition	Extent	Asbestos identified (presumed, strongly presumed or identified)	Product type	Condition	Surface treatment	Asbestos type	Material assessment score	Recommendations	Photo
21	No. 61 O'Connell Street	Stairway to 2 nd floor				No visible asbestos containing materials identified.

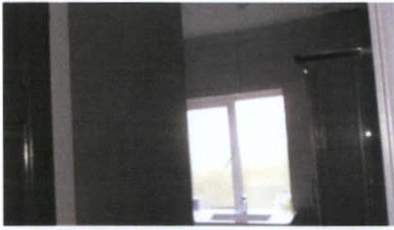
Ref No.	Building or Area of Site	Location or Functional Space	Sample No.	Material Description, surface treatment and condition	Extent	Asbestos identified (presumed, strongly presumed or identified)	Product type	Condition	Surface treatment	Asbestos type	Material assessment score	Recommendations	Photo
29	No. 61 O'Connell Street	3 rd floor Offices WC				No visible asbestos containing materials identified.
