DPC PLAN NO 5432/22
 RECEIVED: 13/12/2022

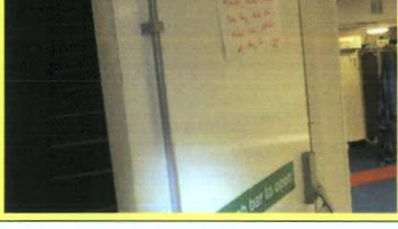
24	No. 44 O'Connell Street	Ground floor		Integral areas of fire doors in the building		Presumed to contain asbestos						Investigation of all fire doors by a competent contractor prior to work likely to cause disturbance.

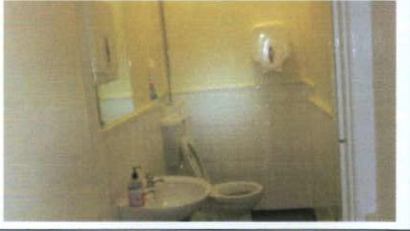
31	No. 44 O'Connell Street	Ground floor WC		Fixed floor not disturbed		Presumed to contain VFT and/or adhesive						Investigation by a competent asbestos contractor prior to work likely to cause disturbance.

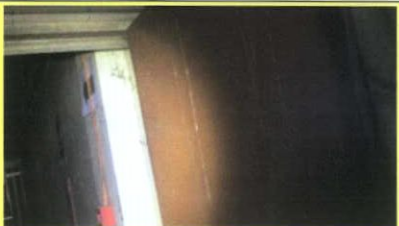
43	No. 44 O'Connell Street	Basement		Integral areas of fire doors		Strongly presumed to contain asbestos						Investigation by a competent asbestos contractor prior to work likely to cause disturbance.

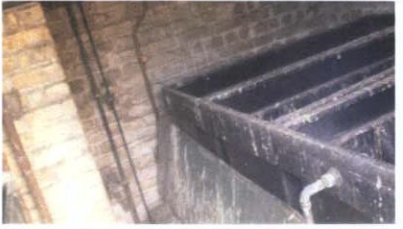
4	No. 45 O'Connell Street	Roof Tank room		Plastic water tanks		No visible asbestos containing materials identified.

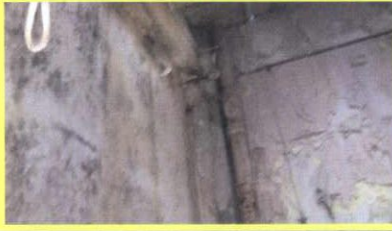
43	No. 45 O'Connell Street	Ground floor Back corridor Rooms		Lead sealed cast-iron collars		Presumed to contain woven rope packing in collars						Investigation by a competent contractor prior to work likely to cause disturbance.

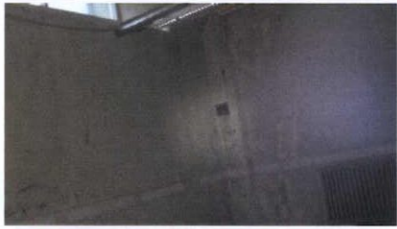
Ref No.	Building or Area of Site	Location or Functional Space	Sample No.	Material Description, surface treatment and condition	Extent	Asbestos identified (presumed, strongly presumed or identified)	Product type	Condition	Surface treatment	Asbestos type	Material assessment score	Recommendations	Photo
45	No. 45 O'Connell Street	Ground floor back rooms				No visible asbestos containing materials identified.

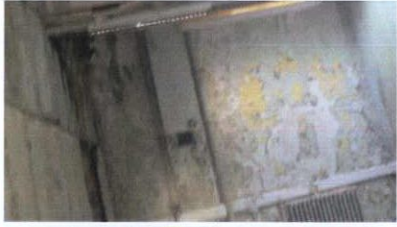
46	No. 45 O'Connell Street	Ground floor back rooms				No visible asbestos containing materials identified.

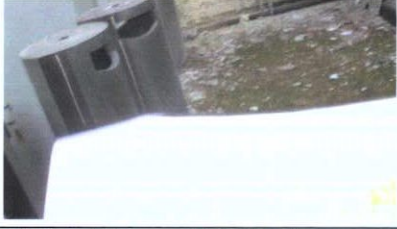
47	No. 45 O'Connell Street	Ground floor back rooms				No visible asbestos containing materials identified.

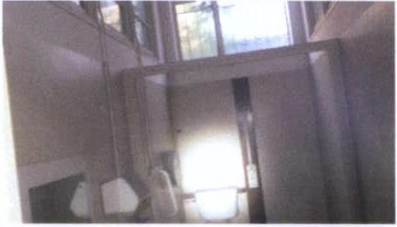
Ref No.	Building or Area of Site	Location or Functional Space	Sample No.	Material Description, surface treatment and condition	Extent	Asbestos identified (presumed, strongly presumed or identified)	Product type	Condition	Surface treatment	Asbestos type	Material assessment score	Recommendations	Photo
49	No. 45 O'Connell Street	Ground floor Back corridor				No visible asbestos containing materials identified.

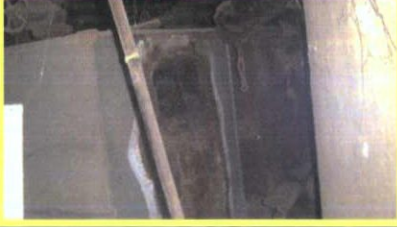
56	No. 45 O'Connell Street			Integral areas of boilers and flues		Strongly presumed to contain asbestos gaskets and seals						Dismantling and investigation by a competent contractor prior to work likely to cause disturbance.

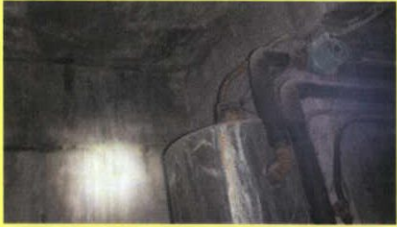
Ref No.	Building or Area of Site	Location or Functional Space	Sample No.	Material Description, surface treatment and condition	Extent	Asbestos identified (presumed, strongly presumed or identified)	Product type	Condition	Surface treatment	Asbestos type	Material assessment score	Recommendations	Photo
57	No. 45 O'Connell Street	Basement Boiler room		Immersion flange gasket		Strongly presumed to contain asbestos						Investigation by a competent contractor prior to work likely to cause disturbance.

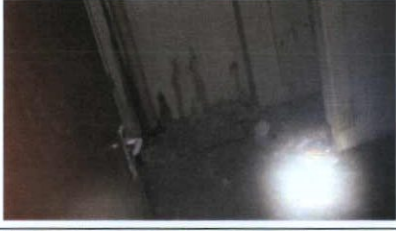
63	No. 45 O'Connell Street	Basement Back corridor Female shower		Common grey VFT and Evode		NAD

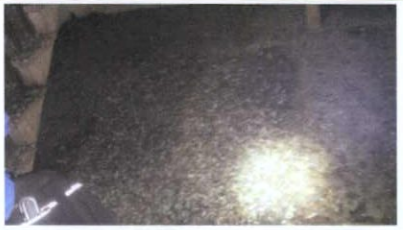
66	No. 45 O'Connell Street	Basement lobby Front of building	2030418	VFT and adhesive		NAD

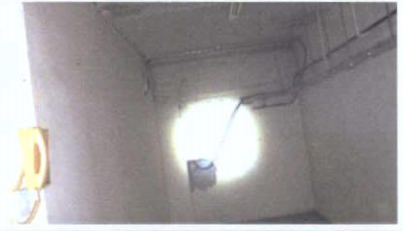
67	No. 45 O'Connell Street	Basement Lobby Store room				No visible asbestos containing materials identified.

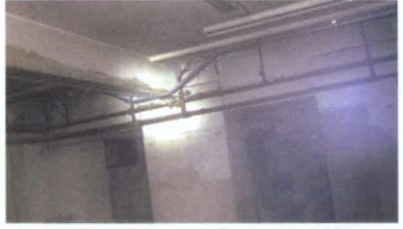
68	No. 45 O'Connell Street	Basement back store rooms				No visible asbestos containing materials identified.

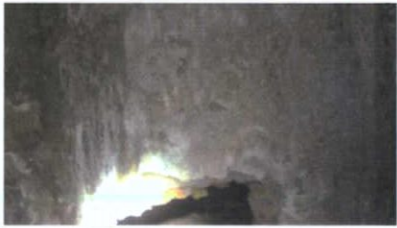
Ref No.	Building or Area of Site	Location or Functional Space	Sample No.	Material Description, surface treatment and condition	Extent	Asbestos identified (presumed, strongly presumed or identified)	Product type	Condition	Surface treatment	Asbestos type	Material assessment score	Recommendations	Photo
69	No. 45 O'Connell Street	Basement Coal cellar				No visible asbestos containing materials identified.
