A4.7.3.2. Archival research describing the development on the site from 1916 to present

A4.7.3.3. Summary of forensic analysis findings

This report was prepared at the request of Molloy & Associates Conservation Architects to inform the Dublin Central Built Heritage Review for Hammerson Plc. The purpose of the work was to analyse the physical fabric of buildings on O'Connell Street, Parnell Street, Henry Street, Moore Street, Moore Lane and Henry Place; and to use the physical evidence gathered through study of the building materials to gain a better understanding of the significance and dating of each of the buildings. This report refers to buildings from Sites, 3,4 and 5 on Henry Street, Moore Street and Moore Lane¹.

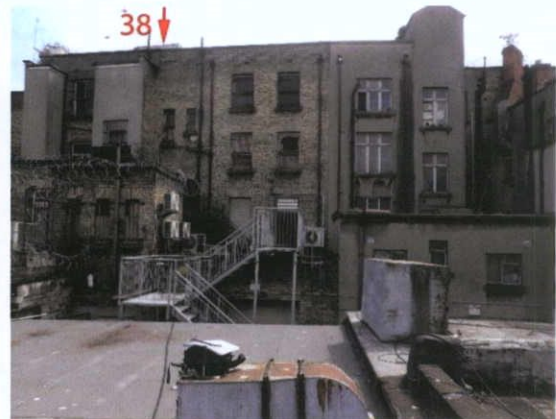
Fig.4.2.3: No.38 Henry Street forming part of a terrace using identical c.1920 yellow stock brick.

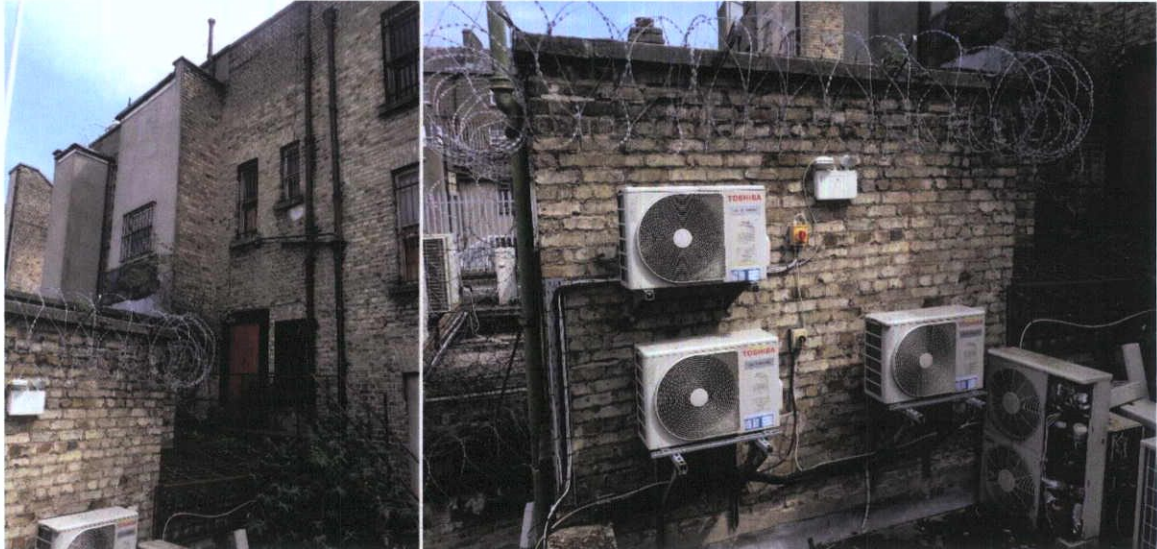
Fig.4.2.4: Yellow stock brick masonry fabric used for the rear and for the return of the building. The same brick is used in the neighbouring rear elevations of Nos.37 and 39 Henry Street, and all three buildings appear to have been erected at the same time.

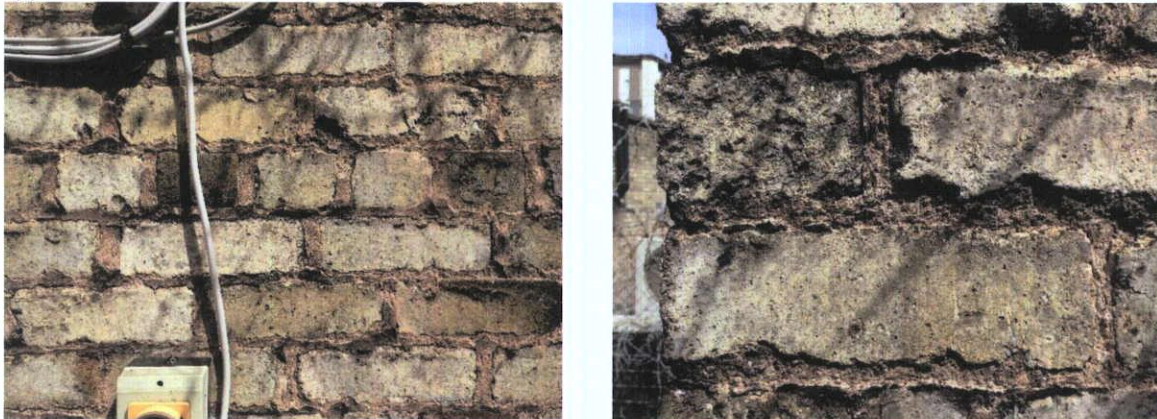
Fig.4.2.5: Slightly pinkish coloured bedding mortar due to the presence of abundant brick aggregate.

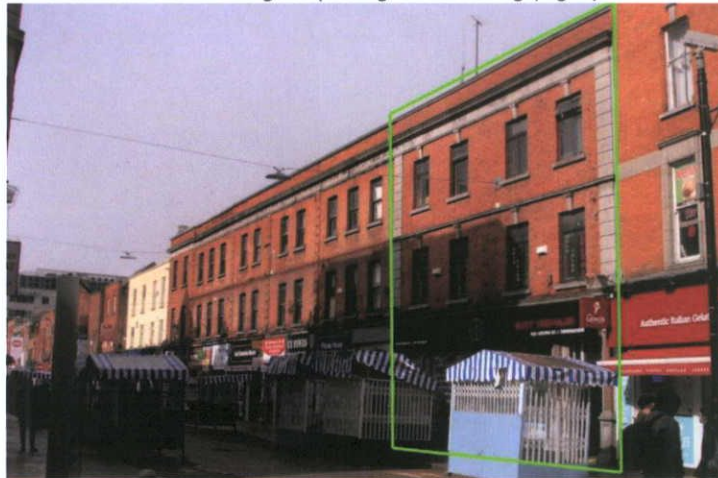
Fig.4.6.2: 1-2 Moore Street. The brickwork is remarkably free from soiling, indicating that it has been cleaned in the relatively recent past.

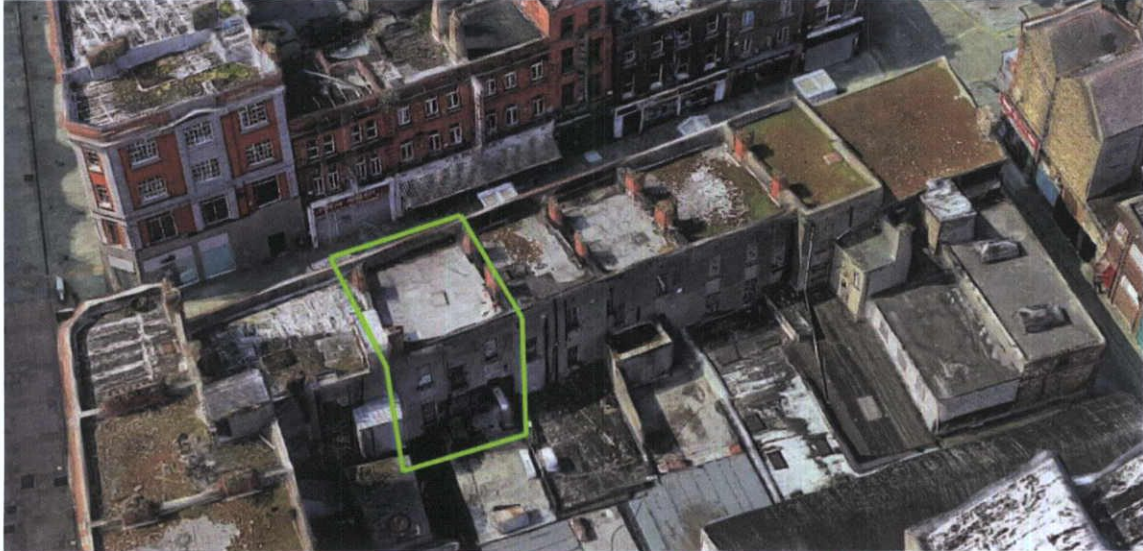
Fig.4.7.5: GoogleMaps view showing the flat roof and rendered rear elevation of the building.
