4.9 5 Moore Street: The three-storey two-bay brick-fronted terraced building rising to a limestone frieze and cornice, built c.1917, has brick ‘soldier’ quoins and a modern shopfront at ground floor level. The architectural detail is uniform across the terrace, with identical limestone detailing at parapet and shopfront level, and with brick specials forming a string course between the first and second floor levels. The brickwork was finished with flush joints. No.5 was built c.1917 as part of a single build with Nos.3, 4 and 6 Moore Street.

4.10 6 Moore Street: The three-storey three-bay brick-fronted terraced building rising to a limestone frieze and cornice, built c.1917, has brick specials forming a string course between first and second floor levels, and with 'soldier' quoins farming the building, having a modern shopfront at ground floor level. The building forms part of a group with Nos.4,5,and 6 Moore Street.

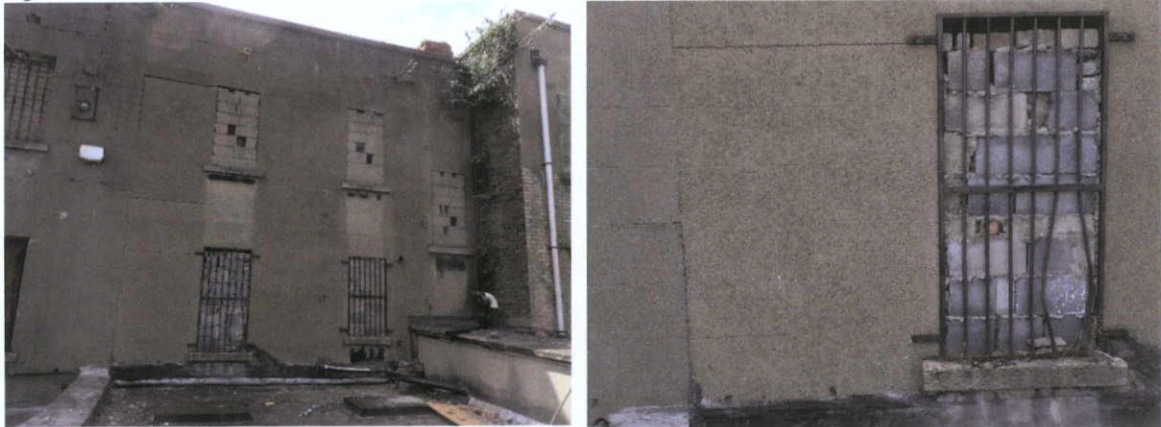
Fig.4.10.3: The rear elevation has a Portland Cement render which has weathered differently to its neighbor, indicating that the cement binders are slightly different in composition.

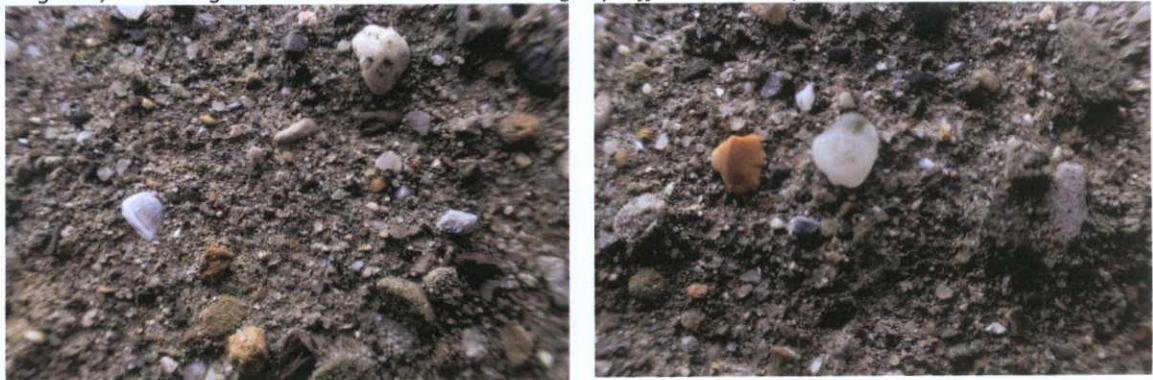
Fig.4.10.3: Detail of the aggregate standing proud of the surface of the render at the rear of No.6 Moore Street consisting of rounded natural aggregate and shell.

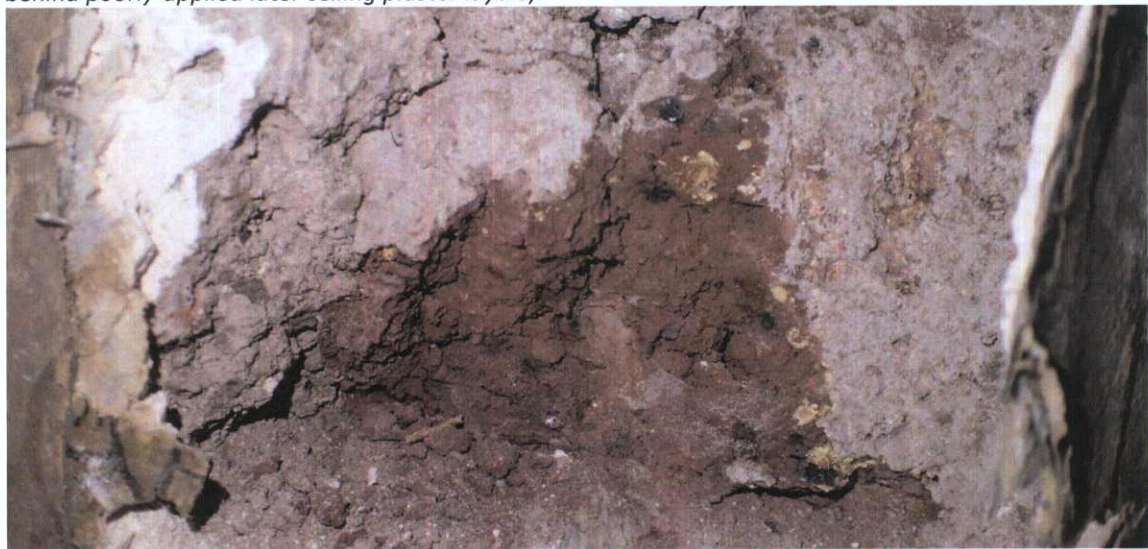
Fig.4.12.7: Hand-made clamp-fired brick with angular limestone aggregate similar to that seen at No.42 O'Connell Street and other Georgian buildings in the area. This type of brick may have been fired at the Moore Street brickfield.

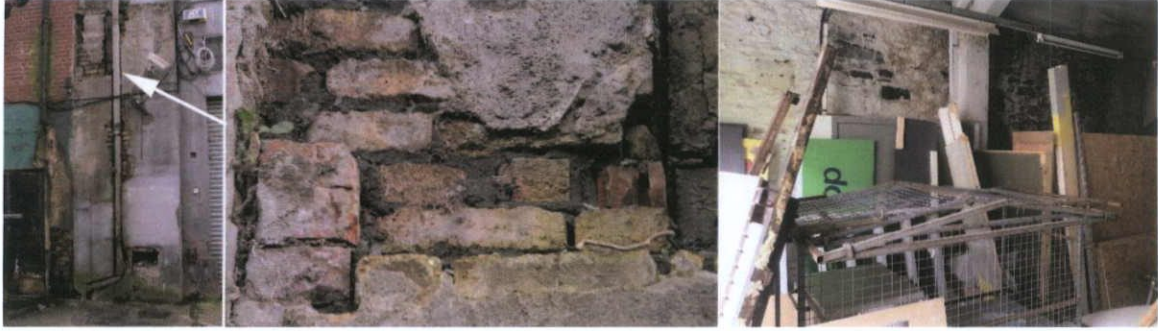
Fig.4.15.3: Exposed wall end at the junction of 5-8 and 9 Henry Place shows a mix of bricks in Portland Cement bedding mortars; internally, the limewash east wall at ground floor level is Calp limestone masonry, and consistent with 19th century work.

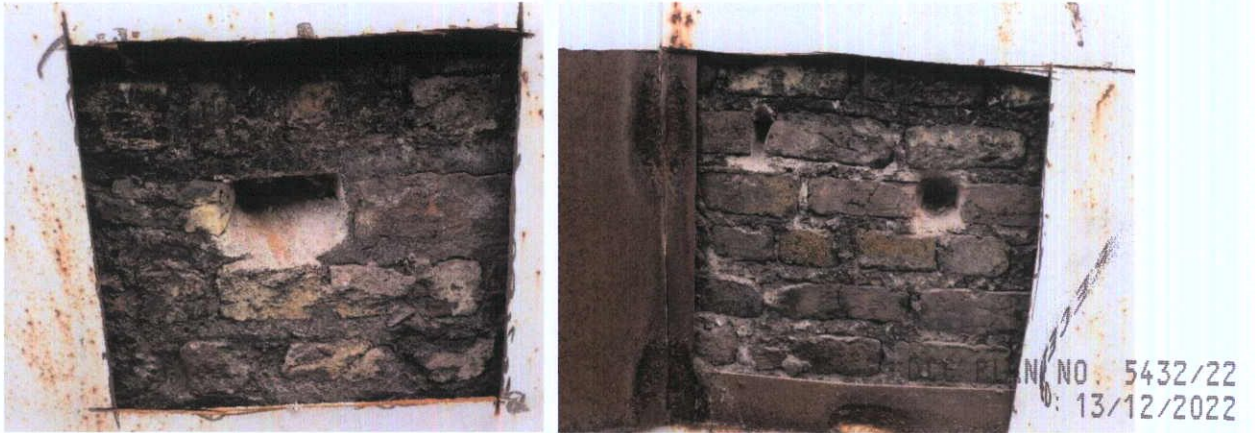
Fig.4.16.3: Nineteenth century yellow stock brick, first floor level, west elevation.

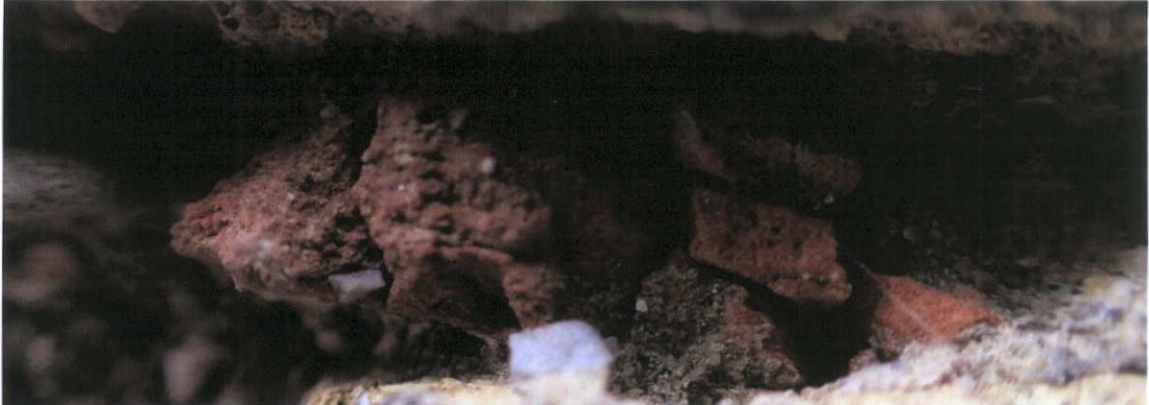
Fig.4.17.5: Crushed brick used as aggregate in the mortar.

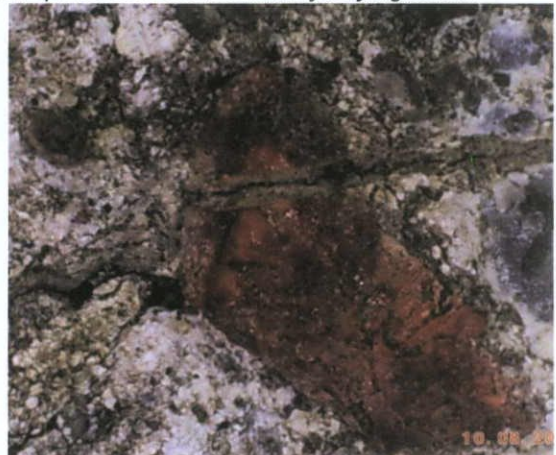
Fig. 4.17.9: Crushed brick in the mortar.

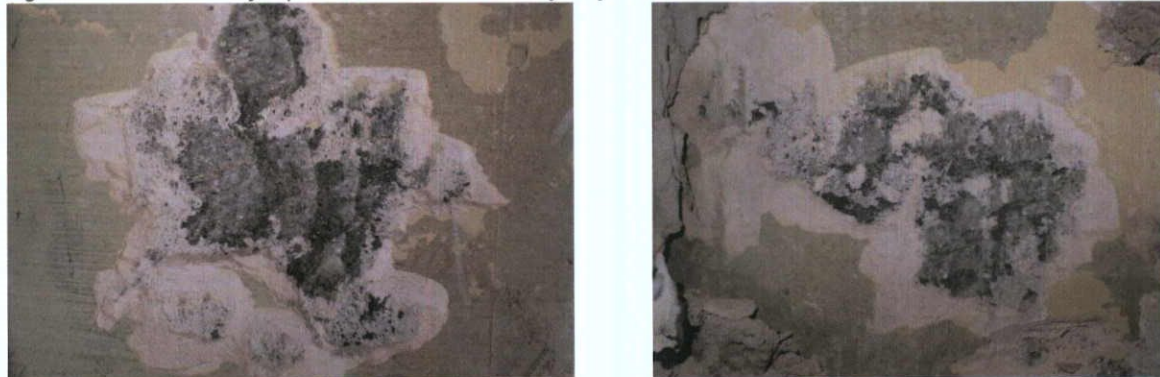
Fig. 4.17.13: Cement used to plaster the inside of the north wall at first floor level.

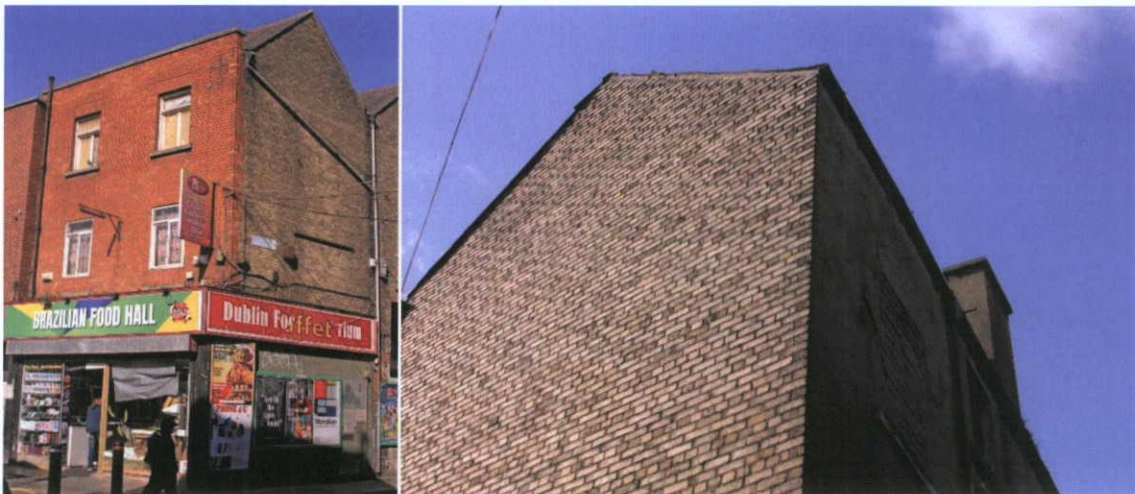
Fig.5.1.1: Façade and side (south) elevations of No.10 Moore Street with the rear (east) rendered.

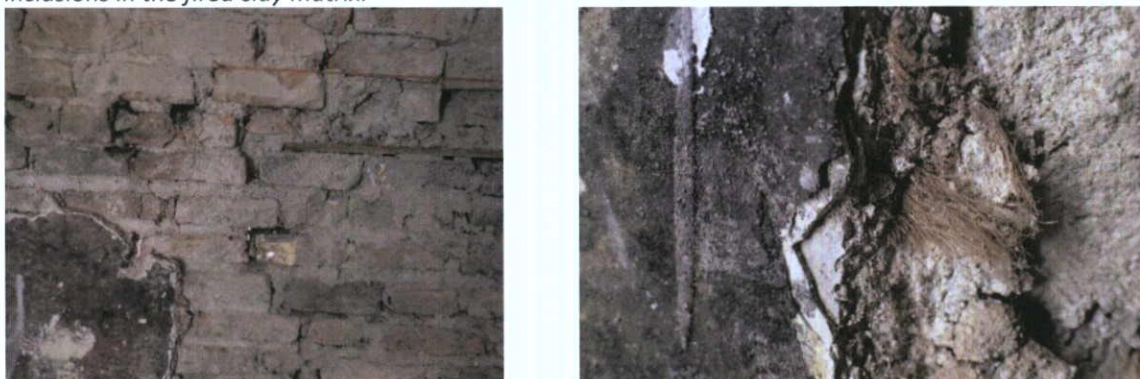
A 'creephole' can be seen in the north elevation at second floor level which is indicated by a disturbance and subsequent patching of the brick masonry fabric, suggesting that this part of the building is associated with the 1916 Easter Rising. The walls retain early haired lime plaster adjacent to the 'creephole' as well as 'lined' pointing joints.

Fig.5.1.9: Internal face of the wall show in Fig.5.1.6 with a change in both brick and mortar at the 'creep hole' (left); while the surviving wall plaster has early haired lime plaster layers surviving beneath twentieth century surface finishes (right).

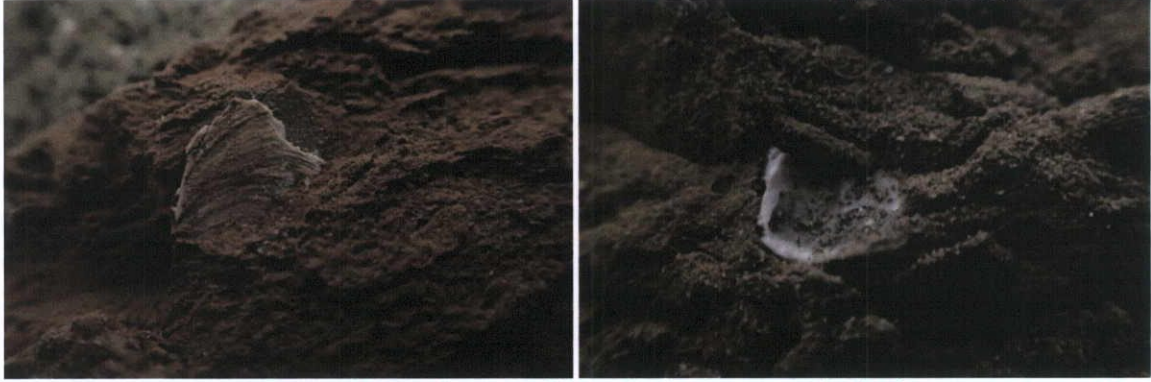
The late eighteenth/early nineteenth century brick in the party wall with No.12 Moore Street is a distinctive hand-made clamp-fired brick containing shell inclusions. This type of brick is also seen in the brick masonry of Nos. 10, 12, 18, 20 and 21 Moore street, and is also found in the chimney stack of No.59 O’Connell Street. These bricks are poorly formed and probably hand-moulded, with distortions exacerbated by the firing process. Firing was uncontrolled with some bricks under-fired and relatively ‘soft’, and other bricks showing ‘hot spots’ and areas which were over-fired, vitrified, coloured black and appearing glassy. The raw clay shows no evidence of processing or sorting.

Fig.5.3.3: 13 Moore Street, Ground Floor: Detail of burnt shell inclusions in the brick.

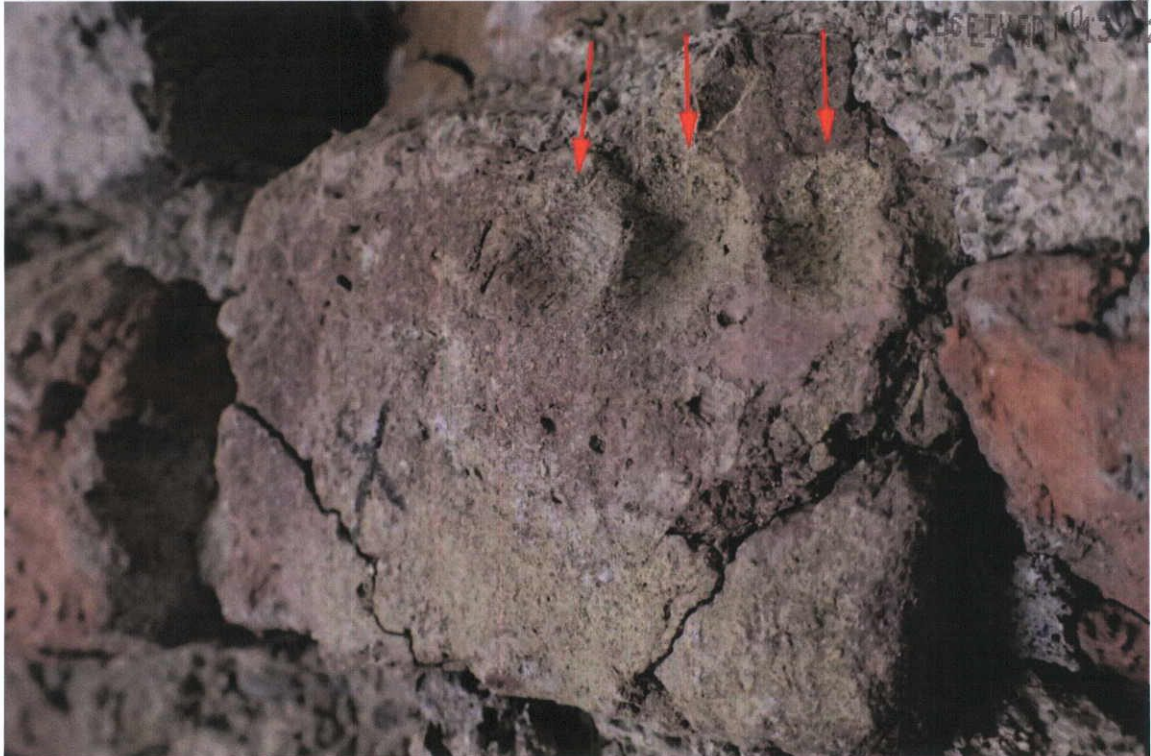
A distinctive eighteenth century hand-made clamp-fired brick type is found at Nos. 10, 13, 18, 20 and 21 Moore Street. At ground floor level of No13 Moore Street, one of these bricks bears the fingermarks of a child (Fig.5.3.4) and is rare physical evidence of the common use of child labour in brickmaking and construction in eighteenth and nineteenth century Ireland. A proportion of this brick is 'shell lime' brick and shows such striking similarities that they should be considered contemporaneous.

Fig.5.3.4: Fingerprint impression (probably from a child or young adolescent) formed in the brick. This occurs when the brick is 'green' and is turned prior to firing.

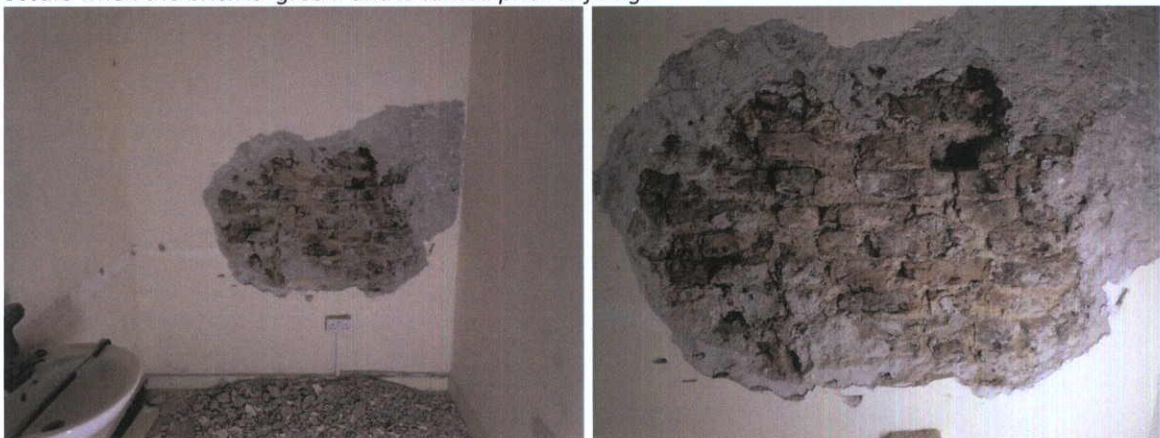
Fig.5.3.5: Internal party wall at upper floor level showing hand-made brick bedded in a lime bedding mortar.

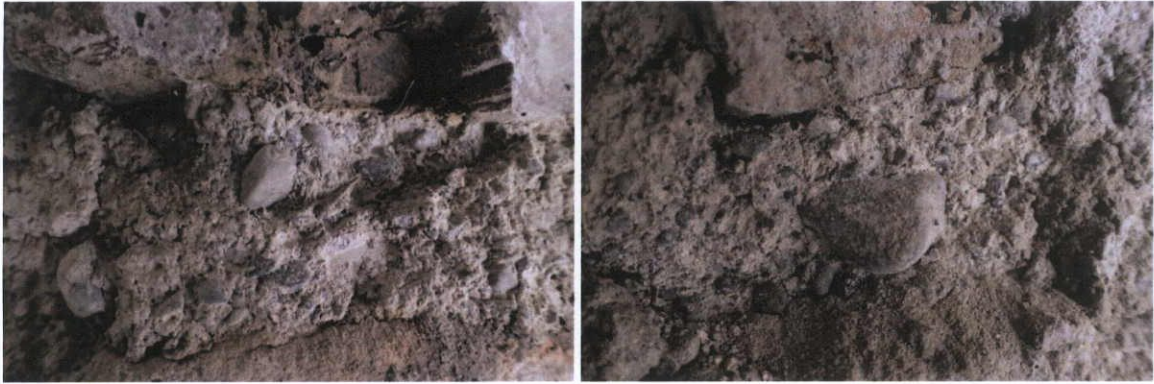
Fig.5.3.6: The original bedding mortar is lime based, without obvious pozzolanic additions, and containing rounded limestone pebble to gravel-sized aggregate.

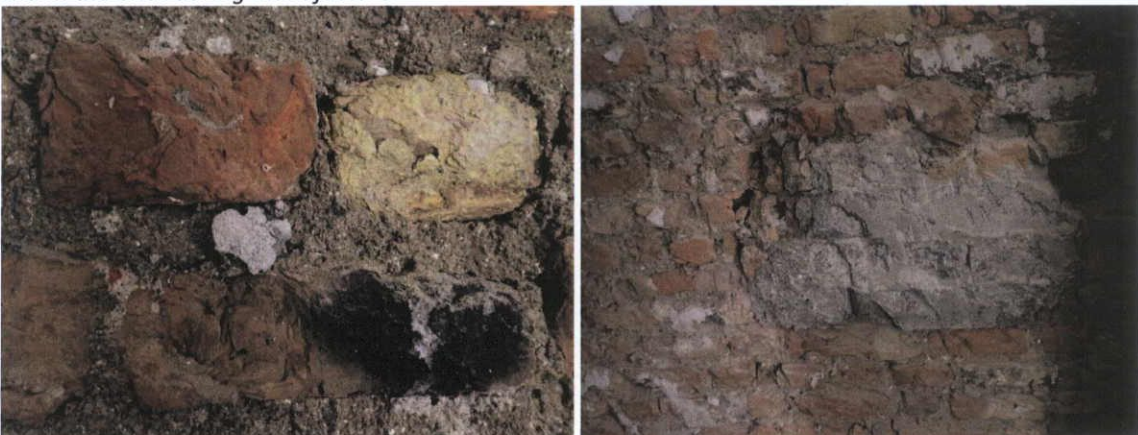
Fig.5.3.9: Late eighteenth/early nineteenth century brickwork, ground floor, south wall, with concrete infill.

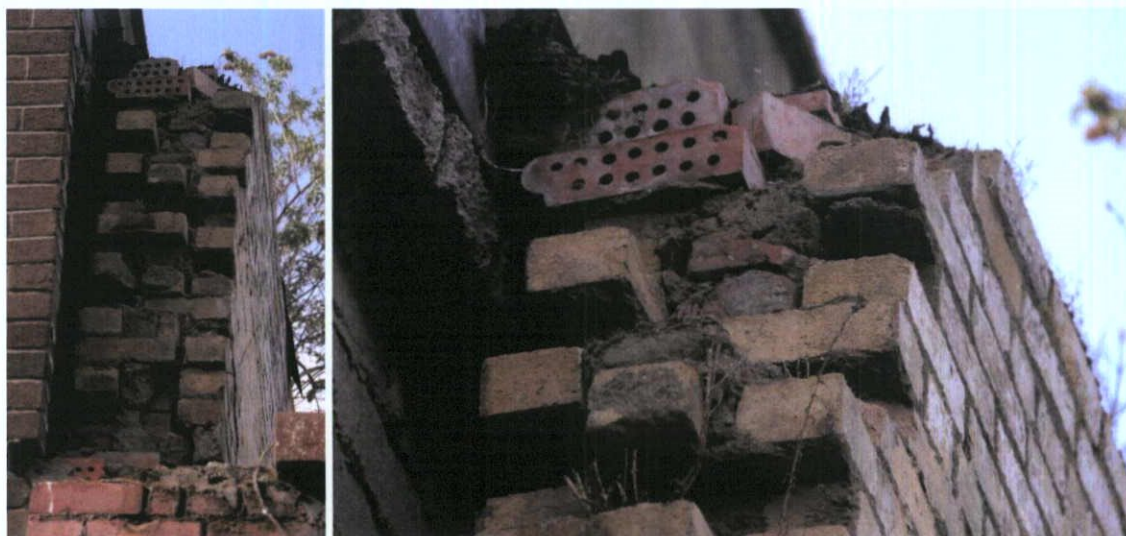
Fig.5.6.2: Detail of the inner leaf of yellow stock brick forming the west wall at first floor level; with moulded perforated red brick indicating decorative treatment to the west elevation of the building.

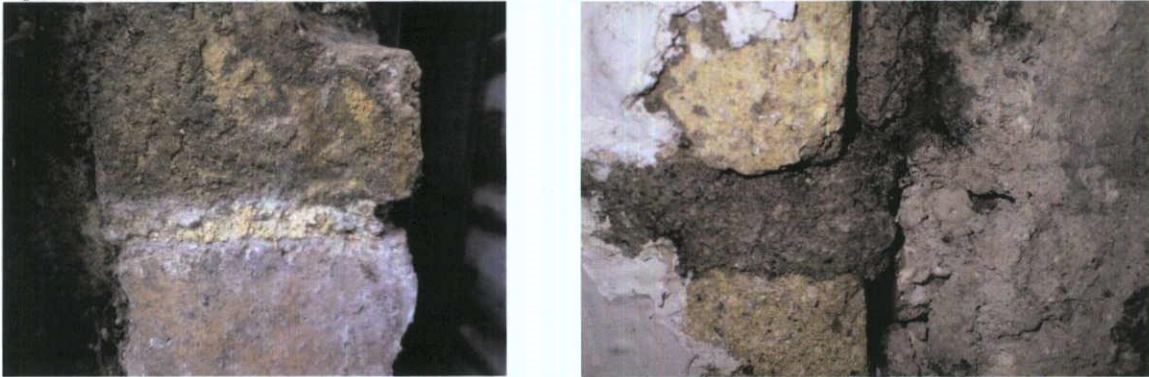
Fig.5.6.8: Detail of yellow stock brick from the inner face of the south wall bedded in a lime-rich mortar; and the inner face of the east wall showing coarse yellow brick bedded in a cement mortar (right).

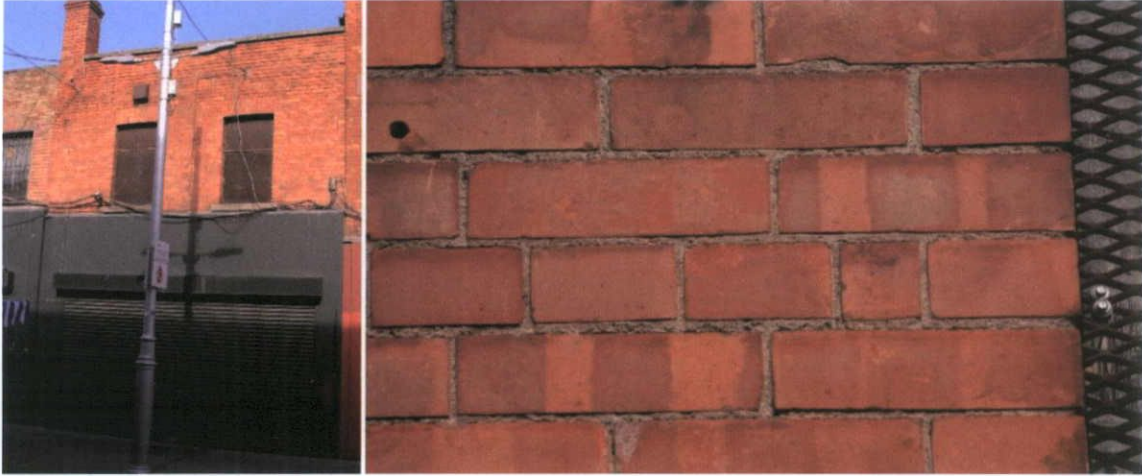
Fig.5.7.3: The first floor has brick with 'kiss marks' from the firing process. This type of brick is found in buildings in Dublin City from the 1890s and used thereafter for a number of decades.

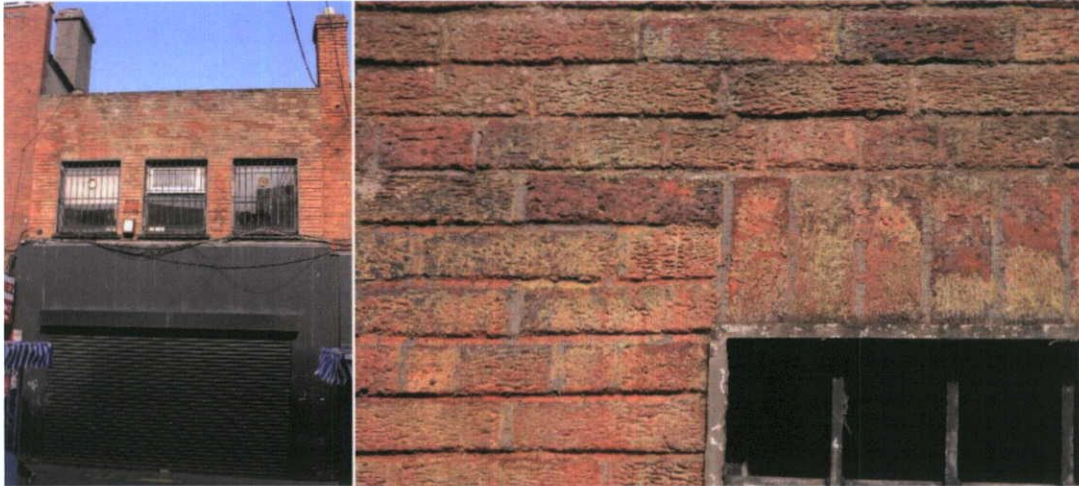
Fig.5.8.1: General view of 19 Moore Street with a detail of the painted brick at first floor level.

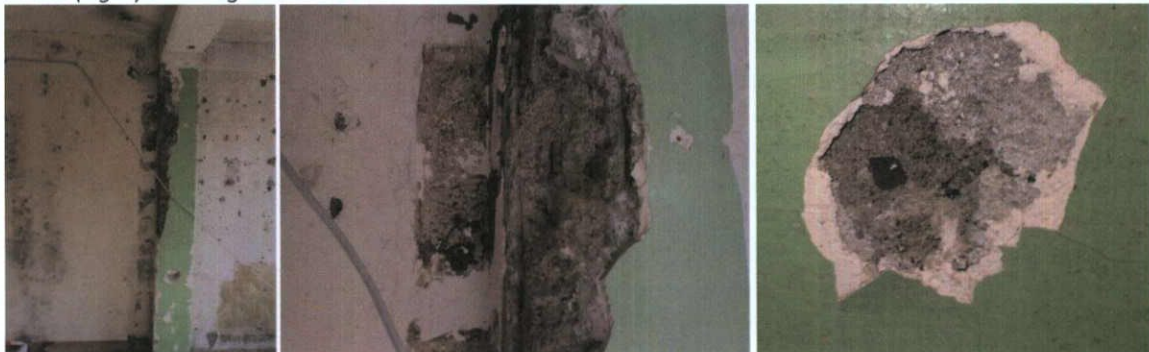
Fig.5.8.4: The party wall (left) and inner face of the west wall (right) are of concrete.

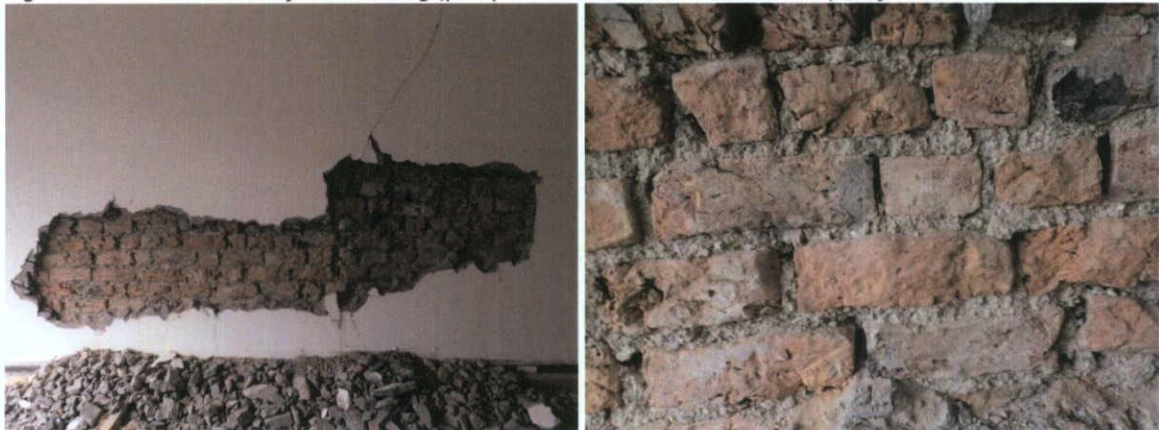
Fig.6.1.4: The party wall between Nos.20 and 21 is of hand-made clamp-fired brick laid in deep lime mortar joints.

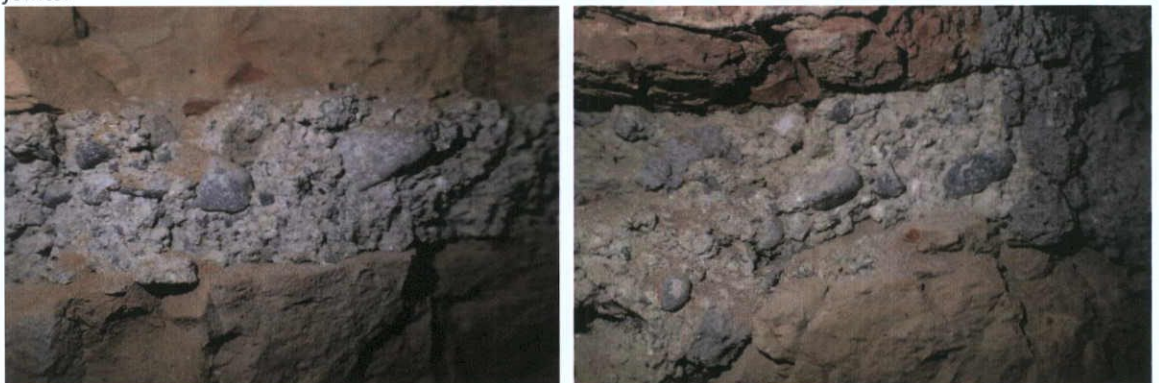
Fig.6.1.5: The lime mortar joints bedding the hand-made clamp-fired brick consist mainly of sub-rounded limestone aggregate with scarce angular lime lumps.

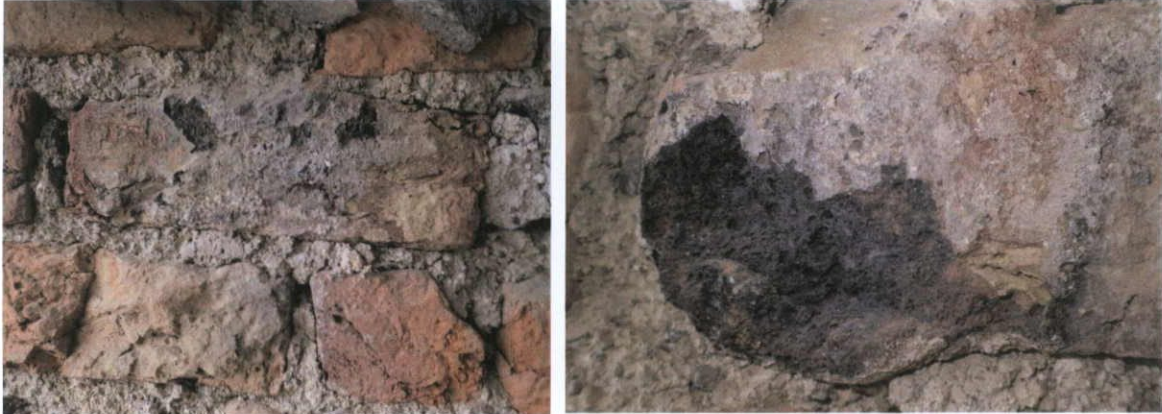
Fig.6.1.7: Many of the bricks were unevenly fired, with sections over-fired and partially vitrified.

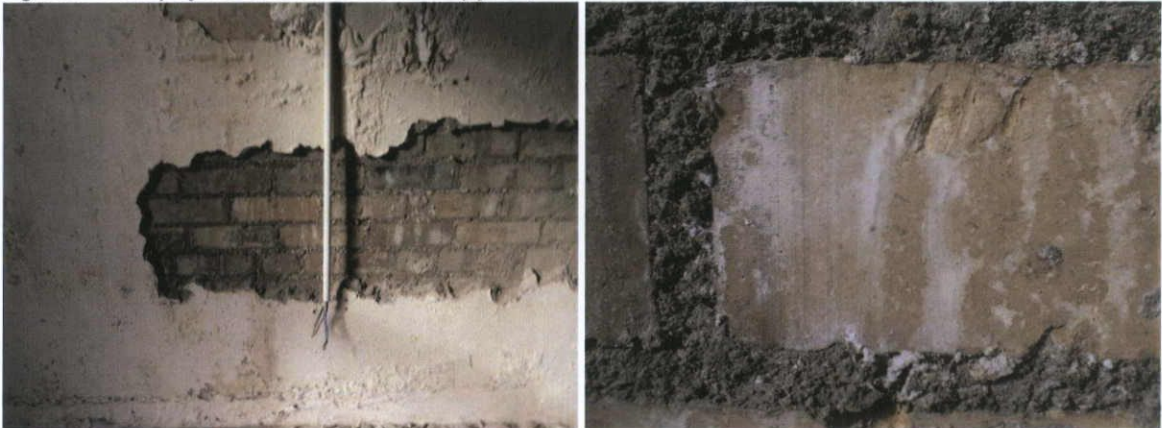
Fig.6.1.8: The north wall (party wall with No.22) consists of kiln-fired extruded machine-cut yellow stock brick. Similar brick is found in the link building between 42 O'Connell Street and O'Connell Hall.
