**Appendix A6** Building Materials Analysis Report

This report was prepared at the request of Molloy & Associates Conservation Architects to inform the Dublin Central Built Heritage Review for Hammerson Plc. The purpose of the work was to analyse the physical fabric of buildings on O'Connell Street, Parnell Street, Henry Street, Moore Street, Moore Lane and Henry Place; and to use the physical evidence gathered through study of the building materials to gain a better understanding of the significance and dating of each of the buildings. This report is Volume 2 (of 2)<sup>1</sup> and focuses on the buildings contains in Sites 1 and 2 in the Dublin Central project.

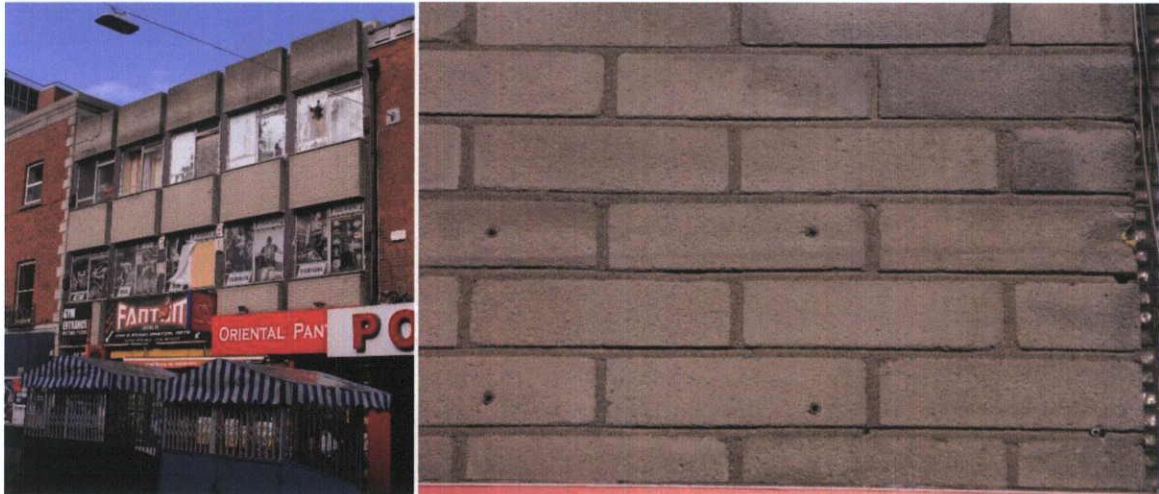
Fig.6.2.2: Detail of the concrete brick on the façade.

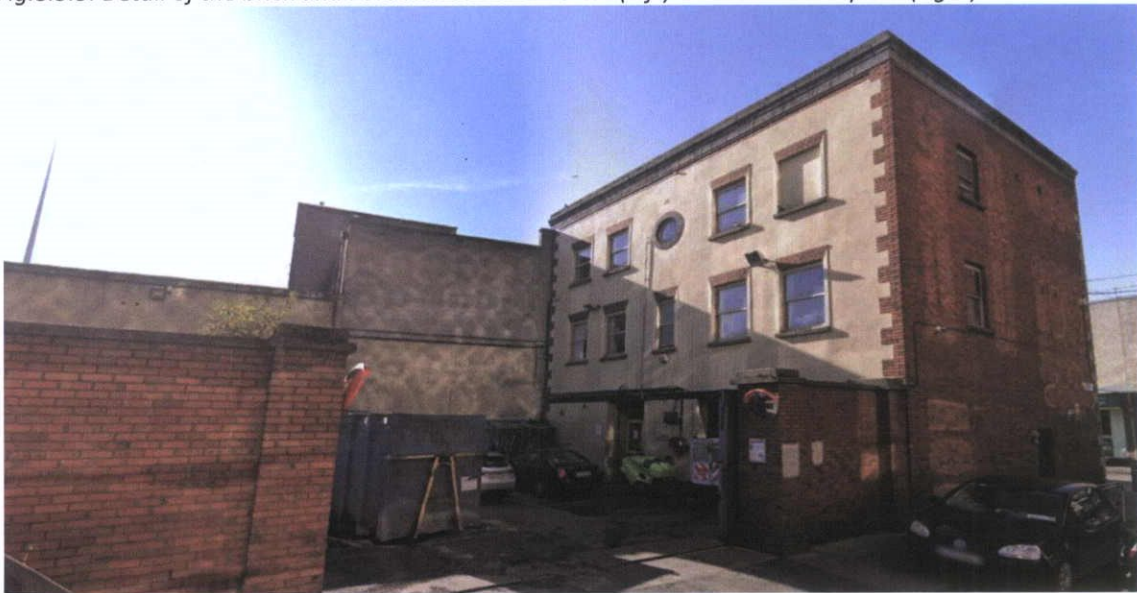
Fig.8.3.4: View of the north elevation and rear from Rahilly Parade.

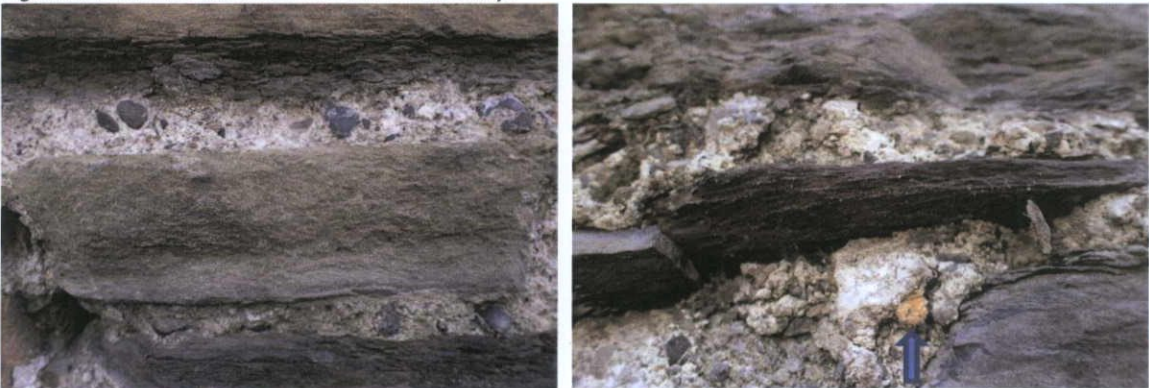
Fig.6.4.5: Deep lime mortar joints with poorly sorted predominantly coarse limestone aggregate, slate pinnings and scarce coarse brick aggregate (arrowed).

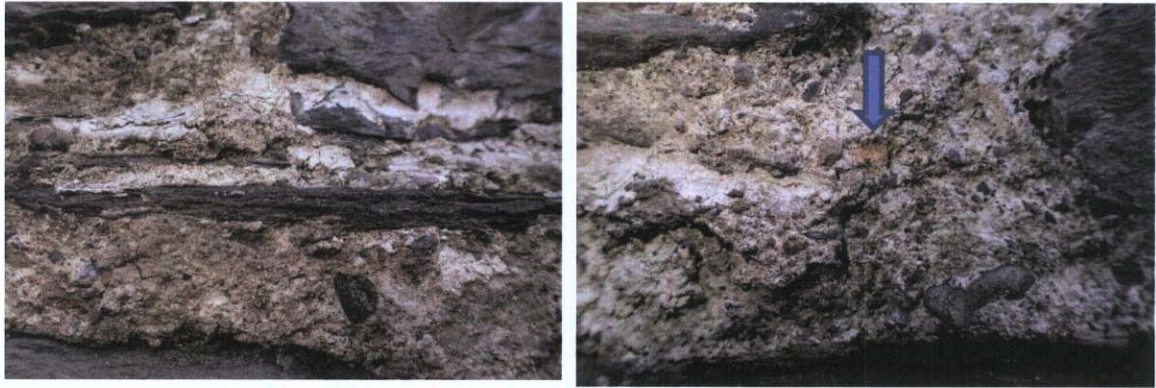
Fig.6.4.6: Slate pinnings (left) and coarse brick aggregate (right, arrowed) as an occasional component of the aggregate fraction of the mortar.

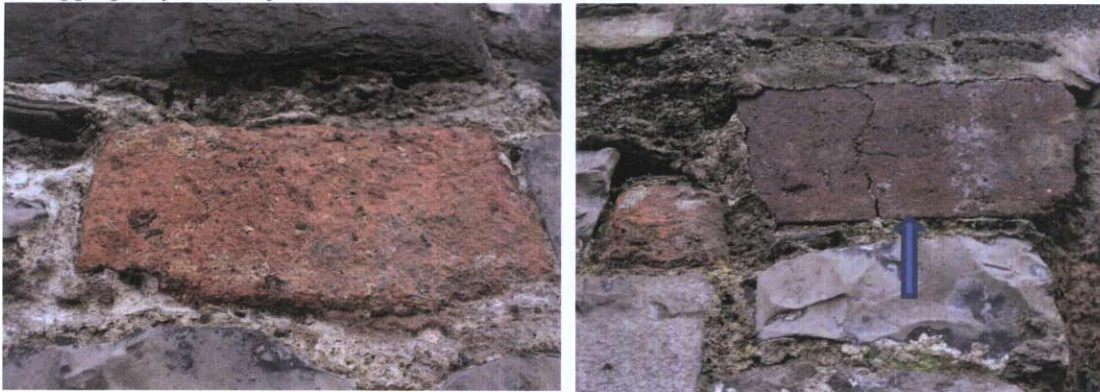
Fig.8.4.9: Warped hand-made clamp fired brick (left) while the upper course contain occasional imported brick (right, arrowed) presumably added as a levelling-up course before the concrete was poured).

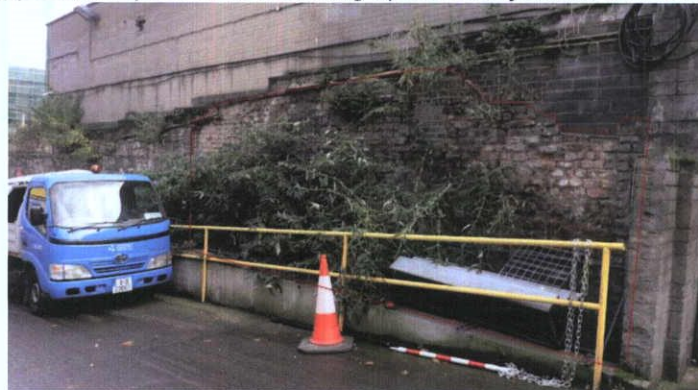
Fig.8.4.10: The western section of the wall is composed of red and yellow place brick, and appears to represent internal lining.

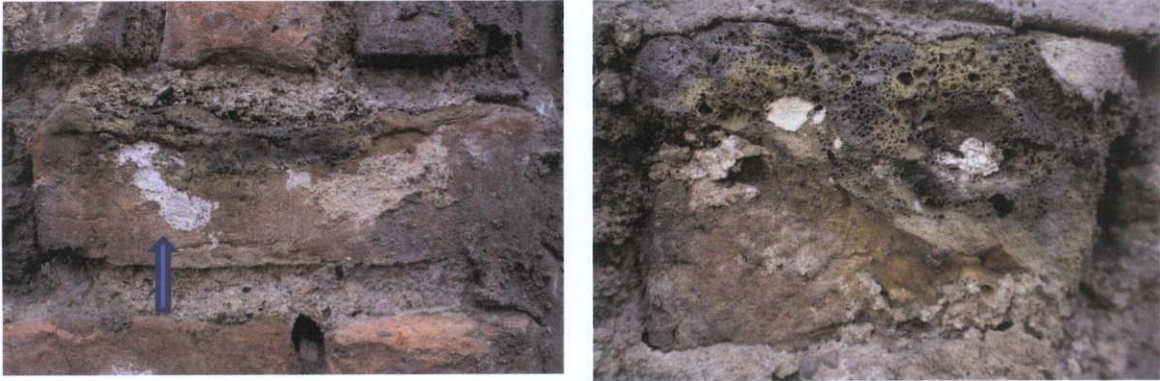
Fig.8.4.12: Poorly-fired place brick in a deep lime-based mortar joint, showing a remnant of a lime-based plaster adhering to part of the surface (left, arrowed). Right: Poorly-fired place brick showing vitrified areas, voids, warping, but with traces of limewash on the surface of the brick.

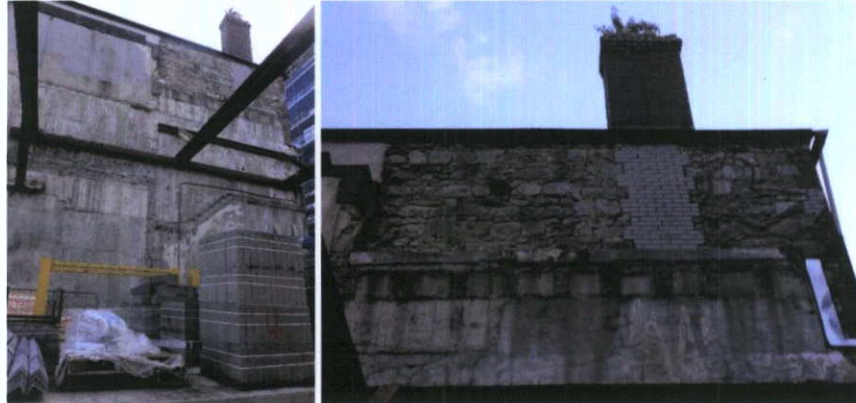
Fig.4.2.3: Reinforced concrete on the south side, with historic masonry of the adjacent property visible at the south-west corner of the site.

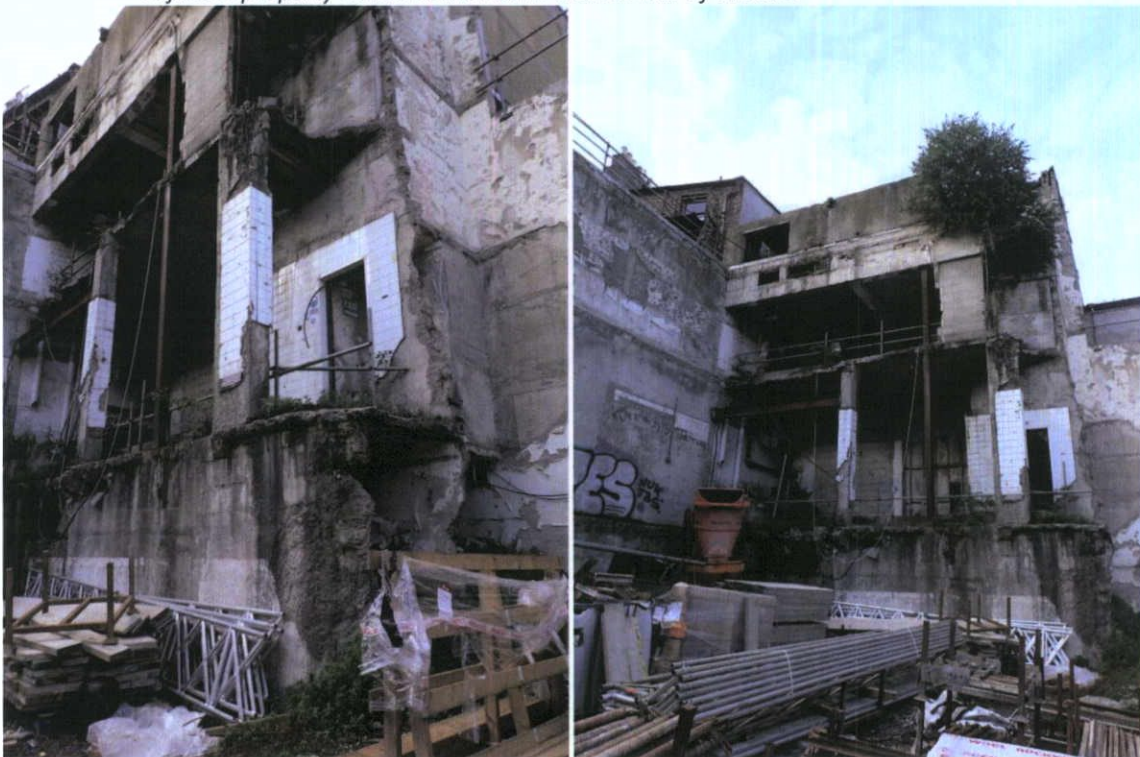
Fig.4.2.4: Reinforced concrete structures on the north side of the vacant lot.

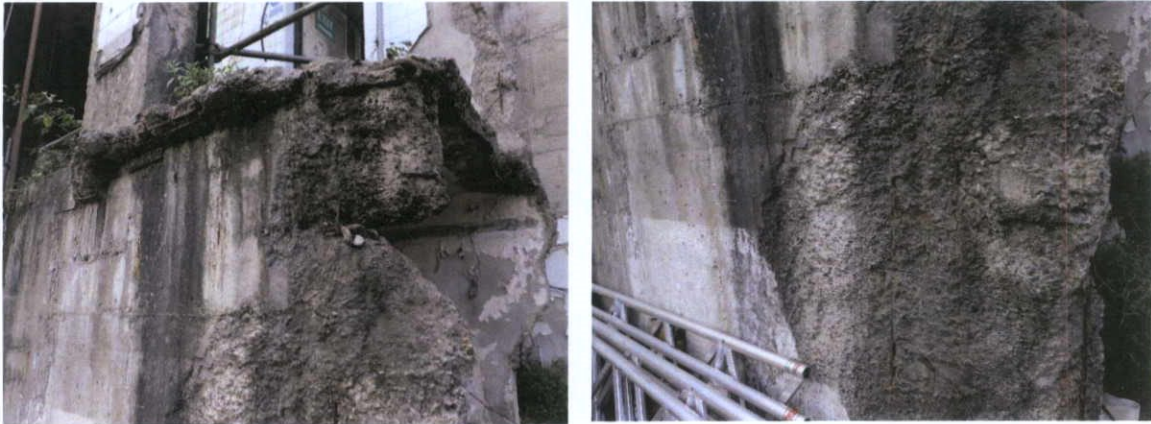
Fig.4.2.5: Detail of reinforced concrete structure on the north side of the site.

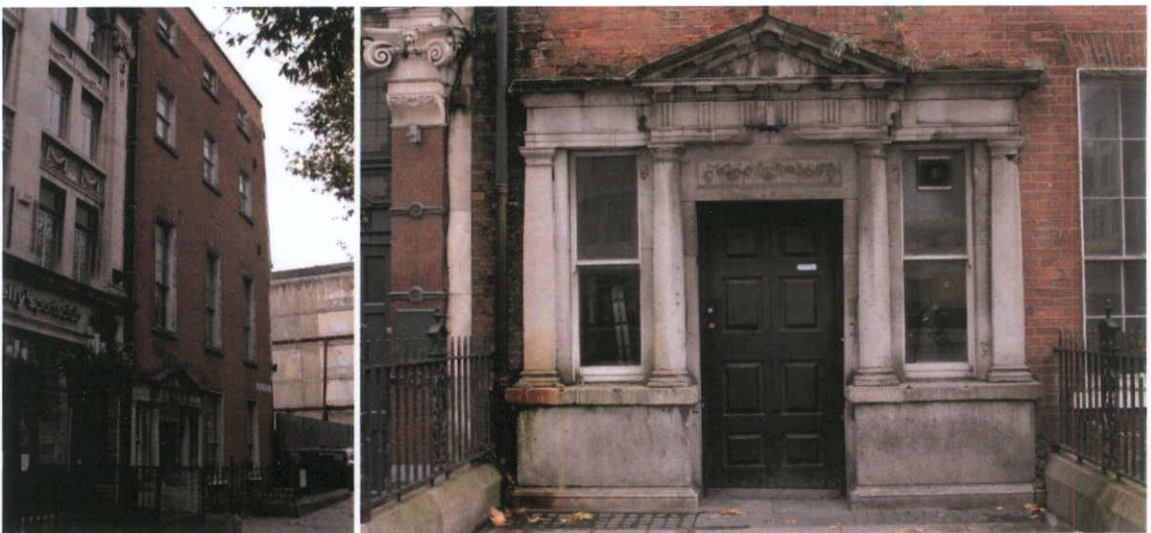
Fig.4.3.1: Four-storey-over-basement façade with parapet in later brick, with railings on a granite plinth enclosing the basement well; and a tripartite Neo-Classical doorway of imported English limestone.

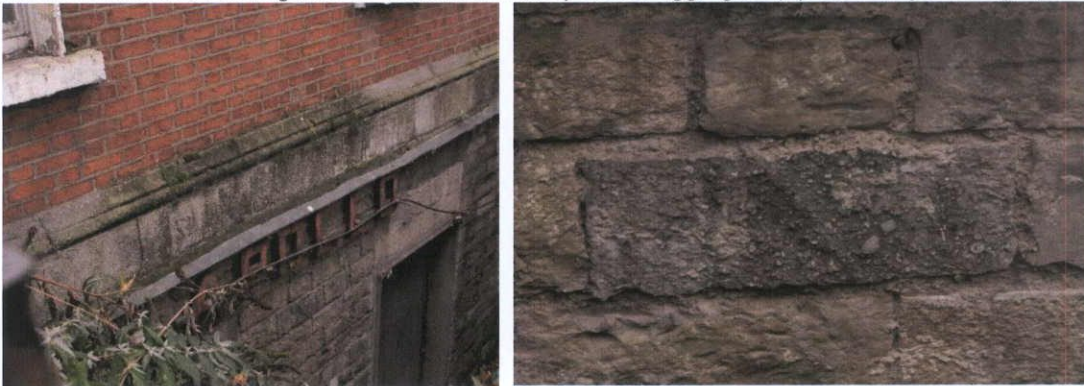
Fig.4.3.5: The basement level is separated from the brick superstructure by a moulded granite strong course, with the well-cut Calp limestone face of the basement wall laid in a coarse-grained lime mortar. One large limestone block is coarsely fossiliferous and may be Ardbraccan limestone.

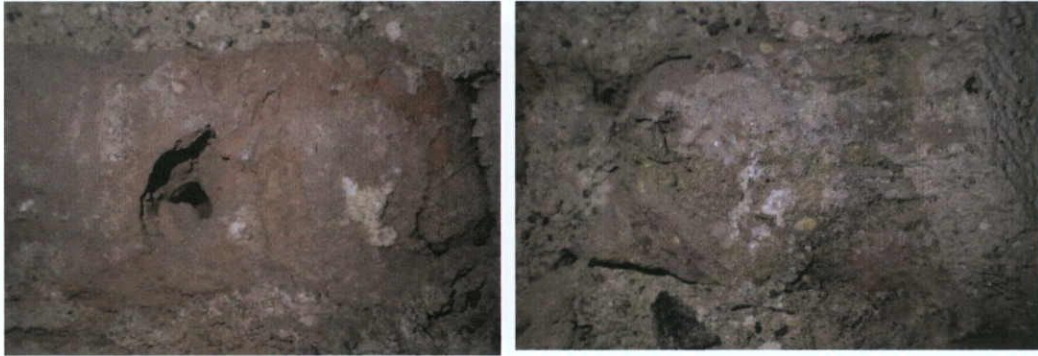
Fig.4.3.7: Place bricks in a coarse-grained lime bedding mortar. Internal walls at first floor level.

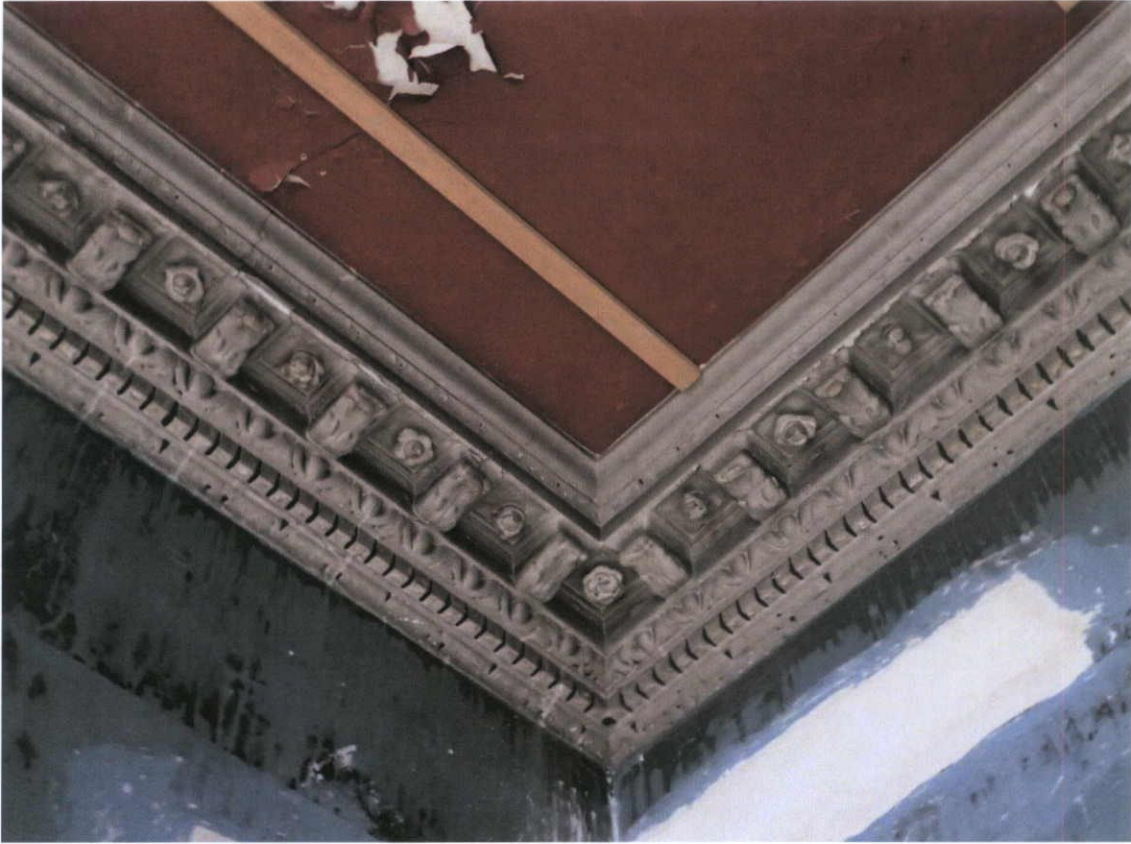
Fig.4.3.12: Detail of the ceiling at the head of the staircase showing three different materials:

- a) Flatwork ceiling plaster (probably haired lime with additions)
- b) Ornate cornice probably built out from timber or brick base
- c) Flatwork wall plaster (probably not haired, but likely to contain brick pozzolan).

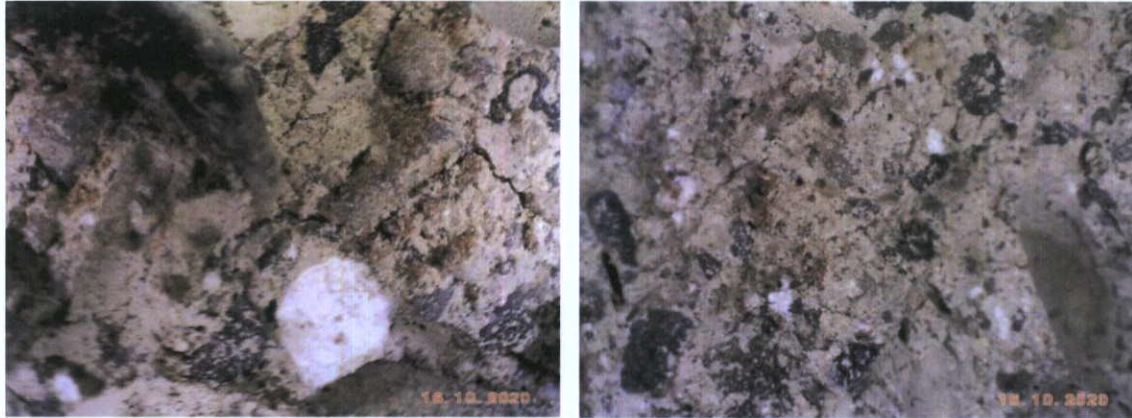
Fig.4.3.14: Microscopic views of a coarse-grained pozzolanic lime mortar used to bed the place brick of the internal walls and wall linings of 41 O'Connell Street. Note common occurrence of large lime lumps.

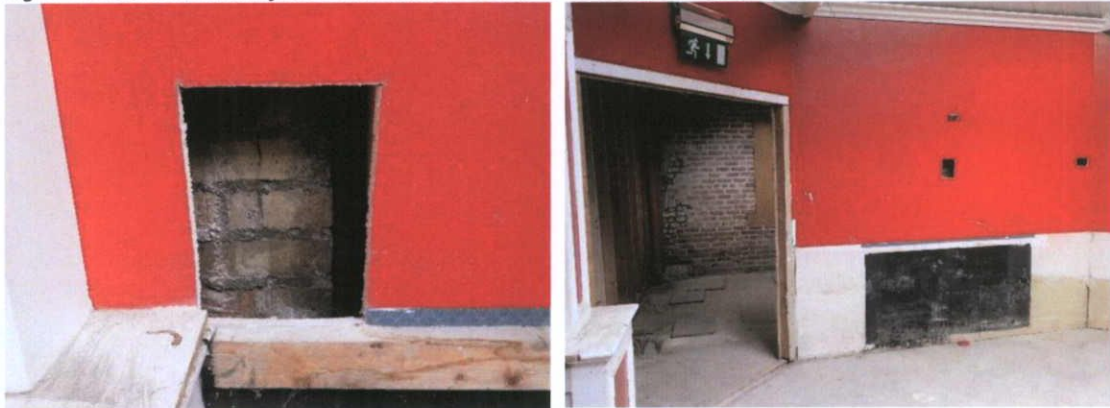
Fig.4.4.2: The brickwork is covered by modern plasterboard.

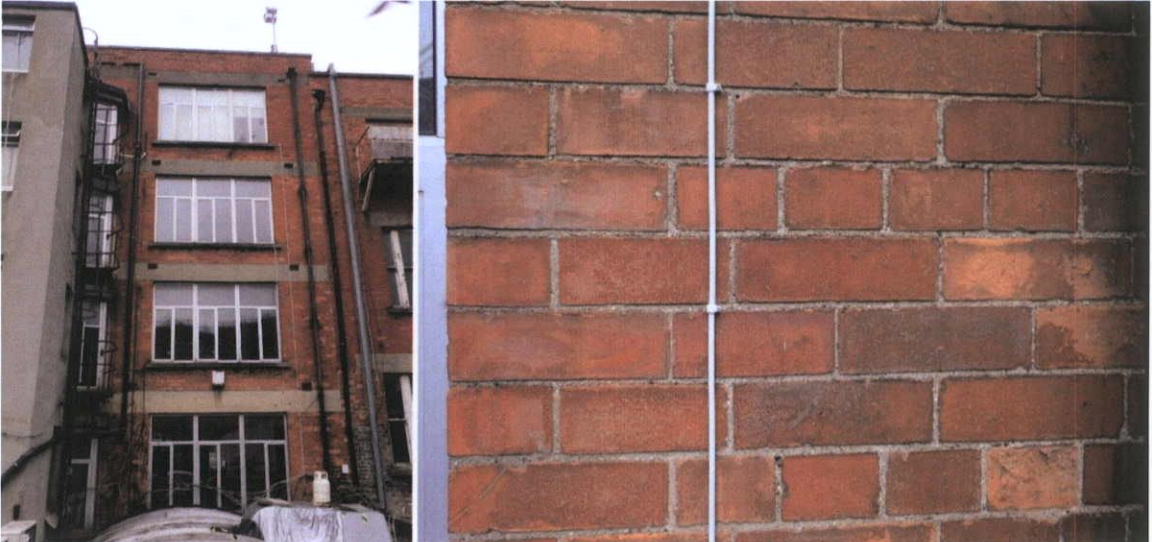
Fig.5.1.2: The rear is composed of machine-cut red brick laid in English garden bond with a lime-cement mortar and having concrete courses above the window openings.

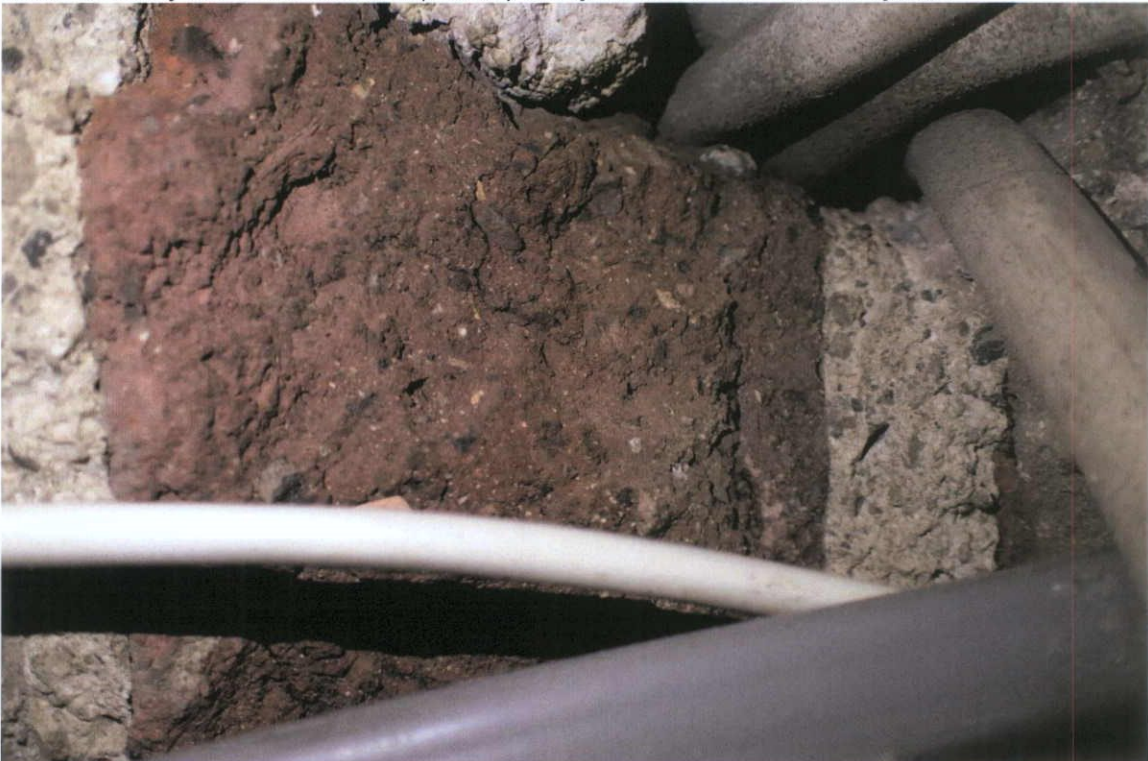
*Fig.5.1.9: Detail of a clamp-fired brick seen at basement level showing limestone inclusions.*

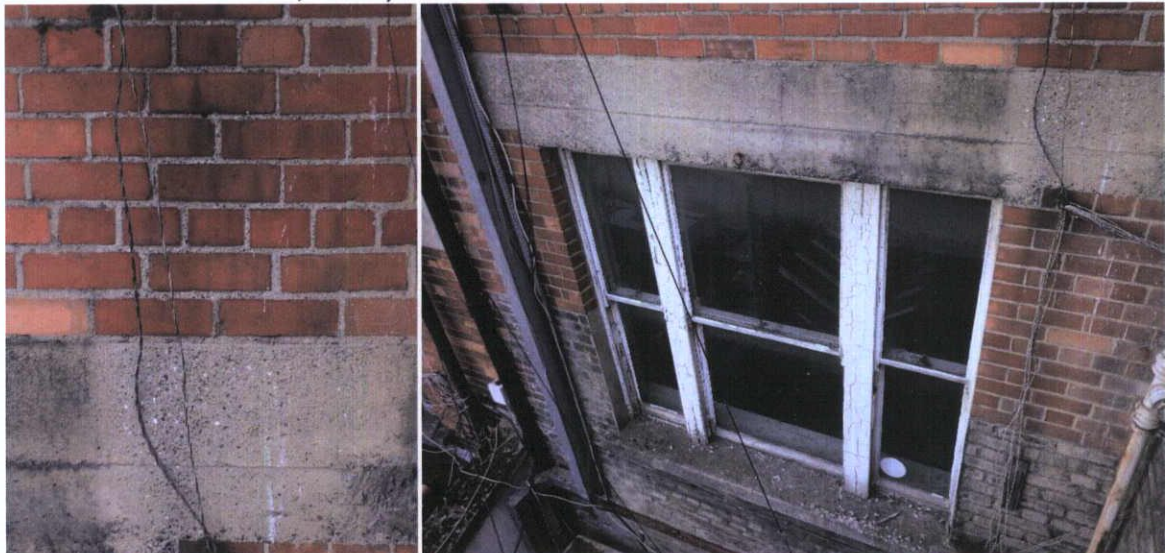
Fig.5.2.2: Detail of the 1920s machine-cut brick and concrete lintel of the superstructure, above yellow stock brick at the rear basement level.

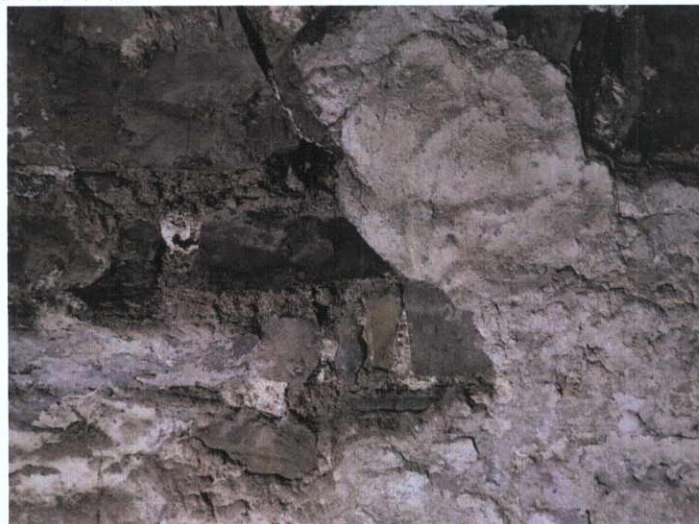
Fig.5.2.3: Dublin Calp limestone at basement level with single-coat lime plaster and multiple coats of limewash.

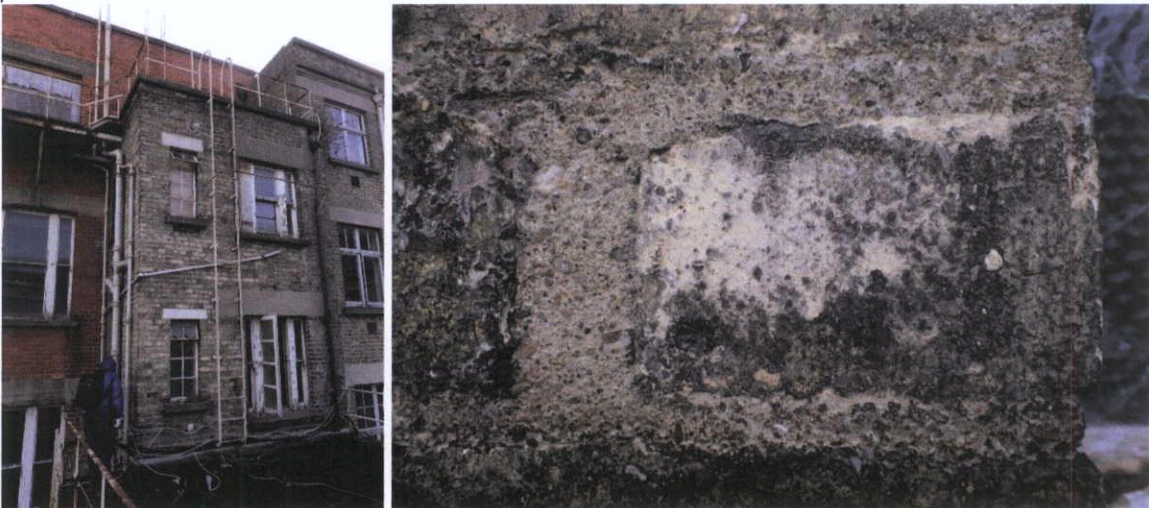
Fig.5.2.6: The return is made from c.1920s yellow stock brick in a lime-cement mortar, with concrete lintels above the openings and forming the parapet coping.

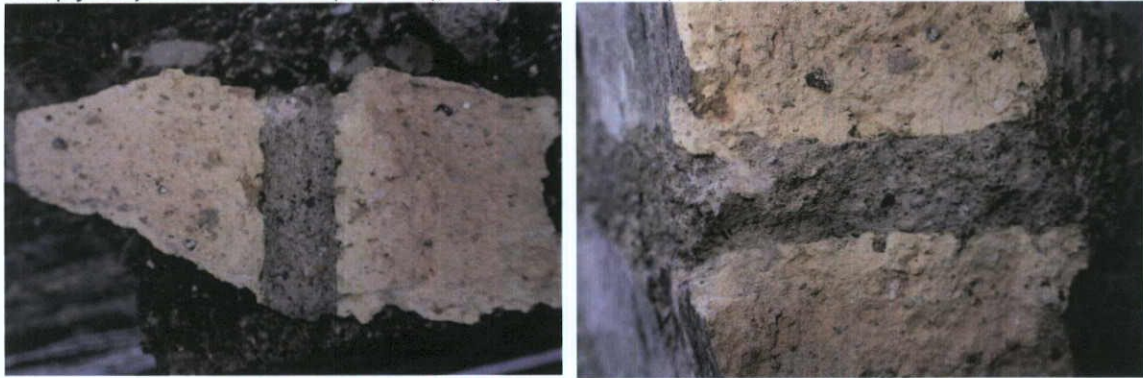
Fig.5.2.8: Cross section showing the 1920s brick with natural stone inclusions in an evenly-fired matrix and bonded with a cementitious bedding mortar. Sample #90.

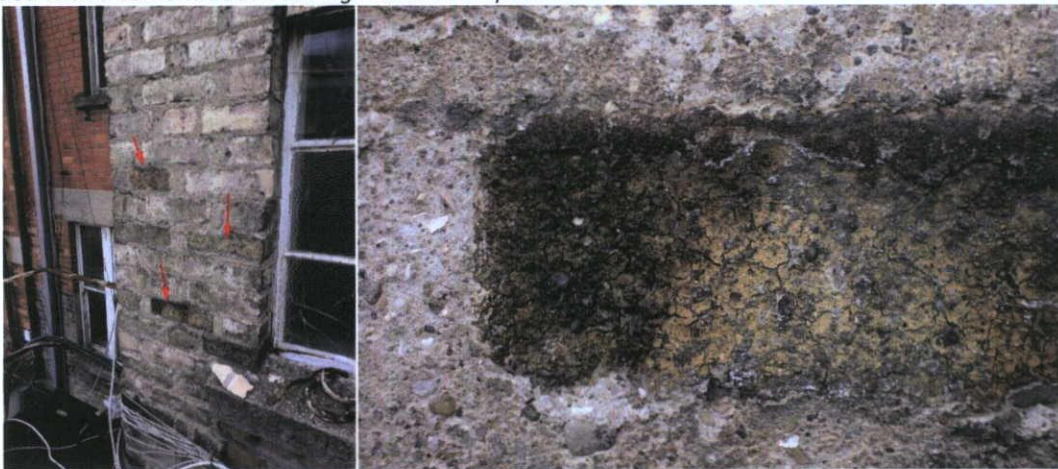
Fig.5.2.10: Salvaged earlier clamp-fired yellow stock brick in the return.

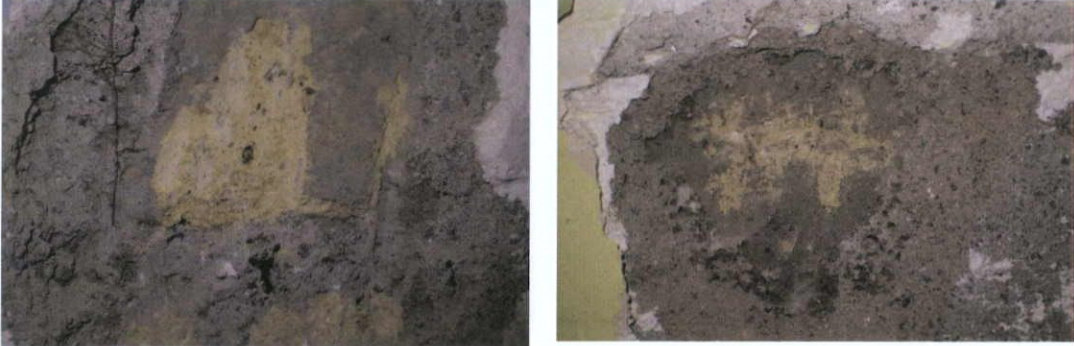
Fig.5.2.13: 1920s yellow stock brick in cementitious mortar exposed in the party walls of the north (left) and east (façade) walls of the first floor level.

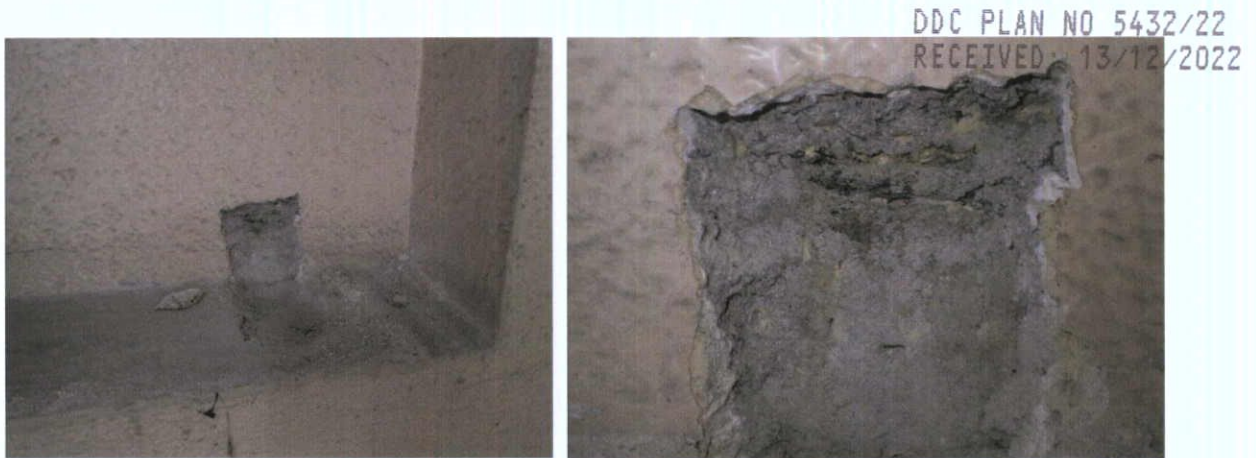
Fig.5.2.16: 1920s yellow stock brick in cementitious mortar exposed in the party walls of the south wall at ground floor level.

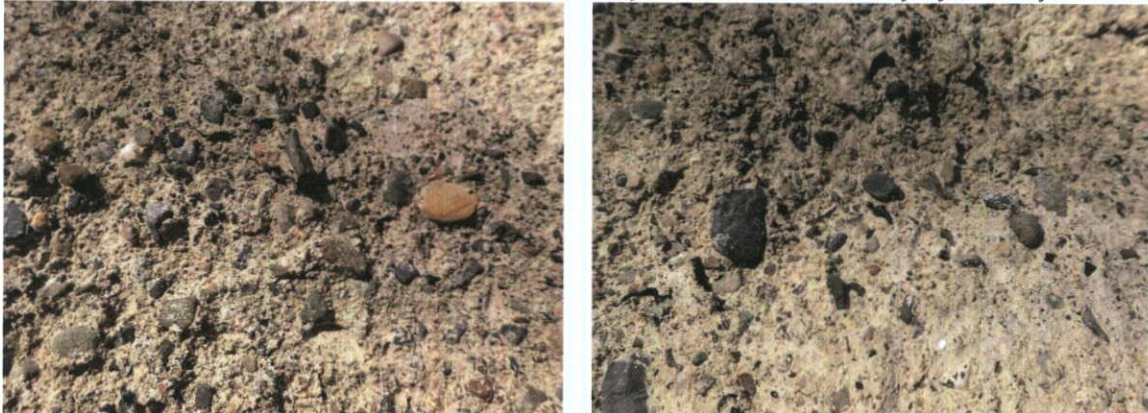
Fig.5.3.6: Detail of the mortar showing rounded limestone, quartz, greywacke and other lithic aggregate.

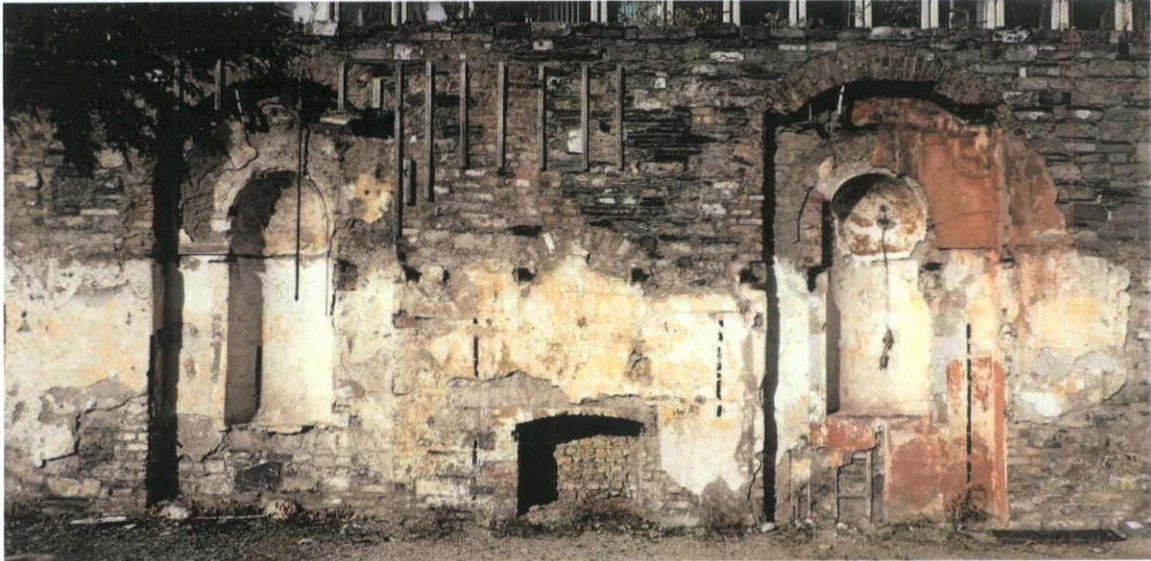
**Building B:** This section consists of a chimney breast with a shallow-arched brick fireplace flanked by arched recesses containing plaster (statue?) niches (Fig.5.3.7). The wall has timber battens attached to the upper part of the wall as a later alteration. The walls are primarily Dublin Calp limestone with a brick fireplace, brick relieving arch and brick flue. The plaster niches contain a binder-rich plaster mix with brick pozzolan and underfired calcined limestone (Fig.5.3.8). The fireplace is formed by brick with a limewash and is similar to nineteenth century fabric (Fig.5.3.9). The eastern arch is composed of a gypsum plaster on a keyed and netted plaster substrate (Figs.5.3.11-5.3.12). The walls are therefore two-phase, with twentieth century

Fig.5.3.7: General view of 'Building B'.

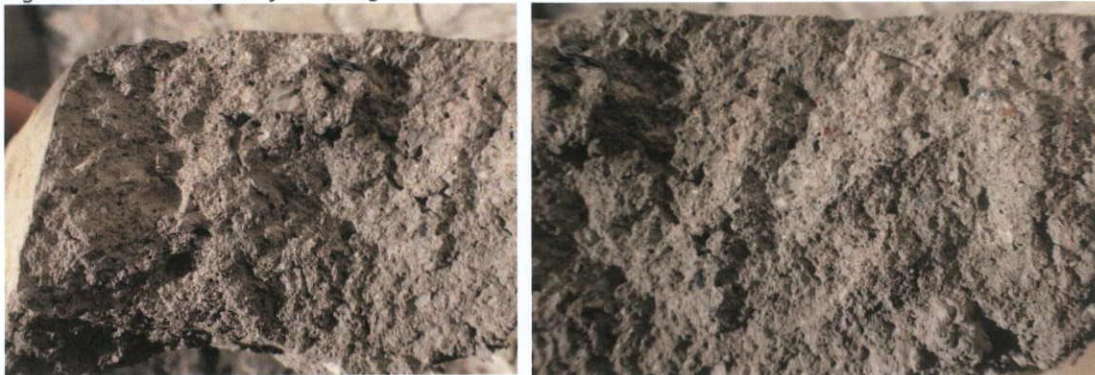
Fig.5.3.8: Cross-section of plaster from the niches.

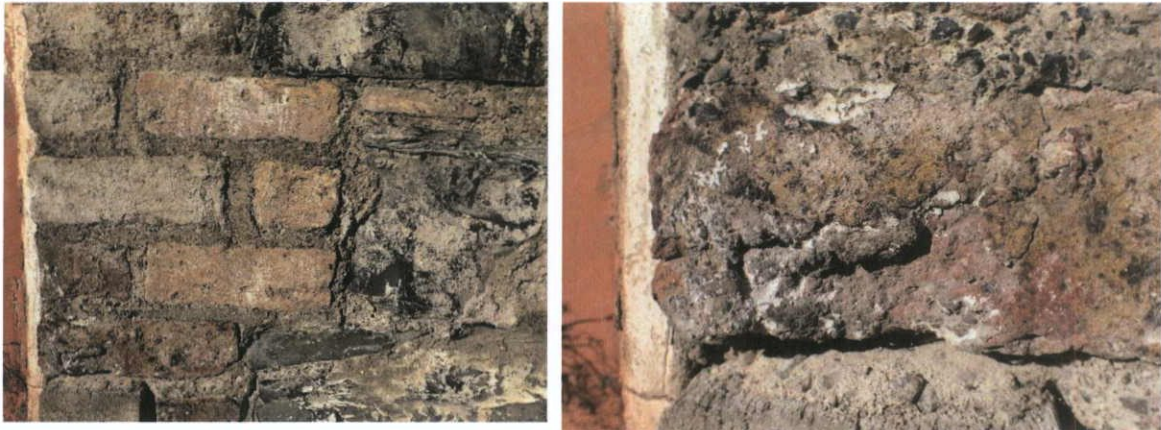
Fig.5.3.14: The chimney breast is edged by irregular clamp-fired brick.

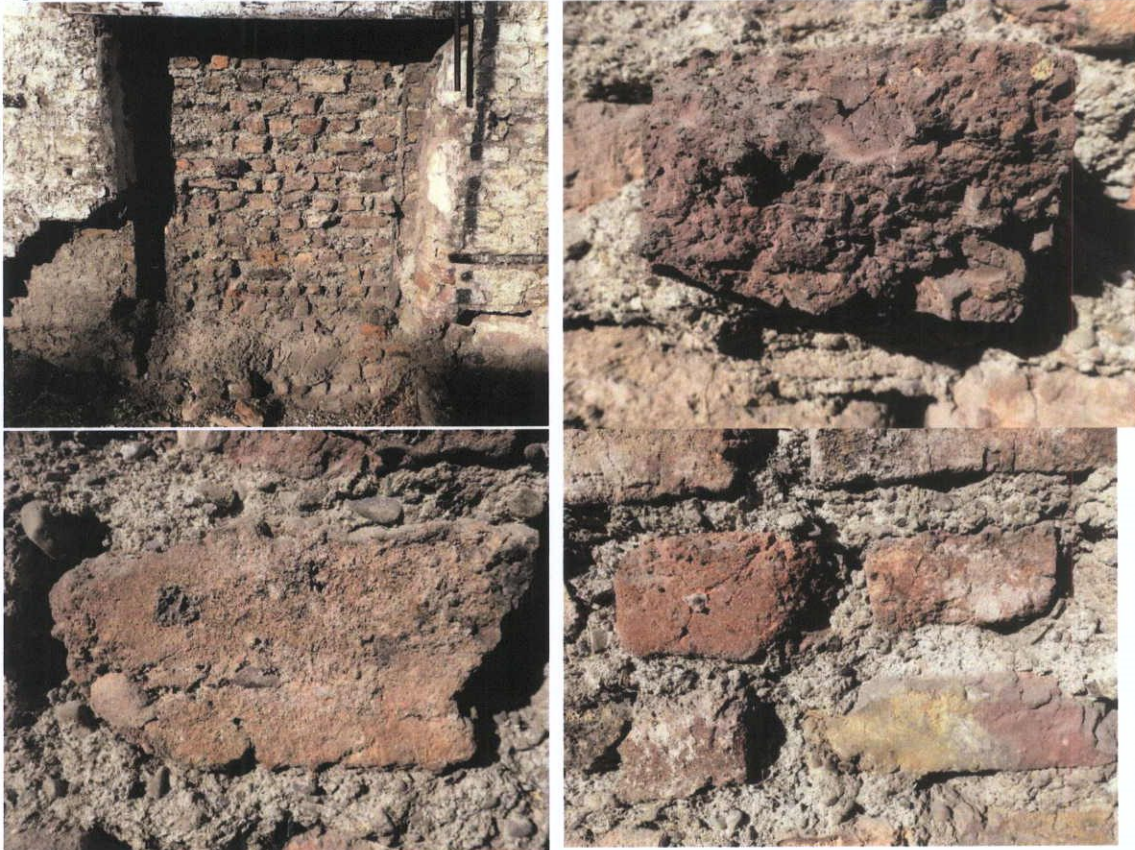
Fig.5.3.20: Irregular clamp fired brick in lime bedding joints infilling a door opening.

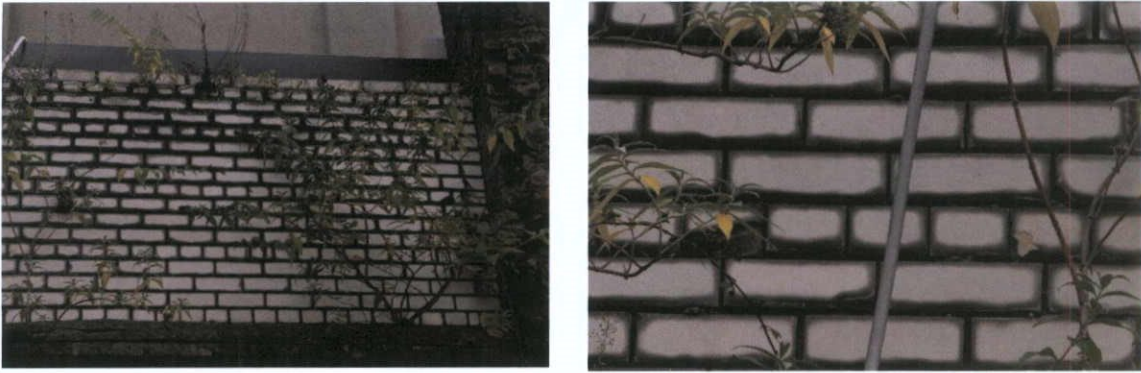
Fig.5.3.24: White glazed 'encaustic' brick which became popular towards the end of the 19<sup>th</sup> and early 20<sup>th</sup> century for bathrooms, kitchens, high traffic areas and some rear elevations.

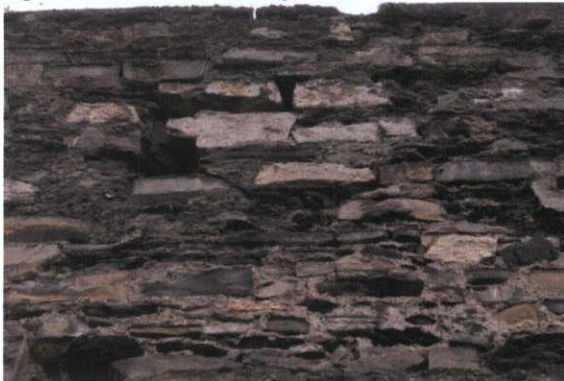
Fig.5.3.28: Calp limestone masonry.

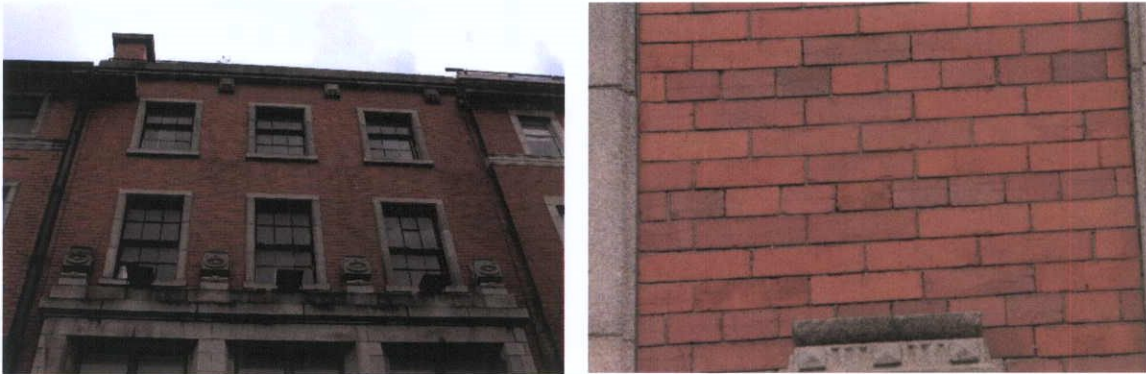
Fig.5.4.1: Brickwork at the façade of 57 O’Connell Street.

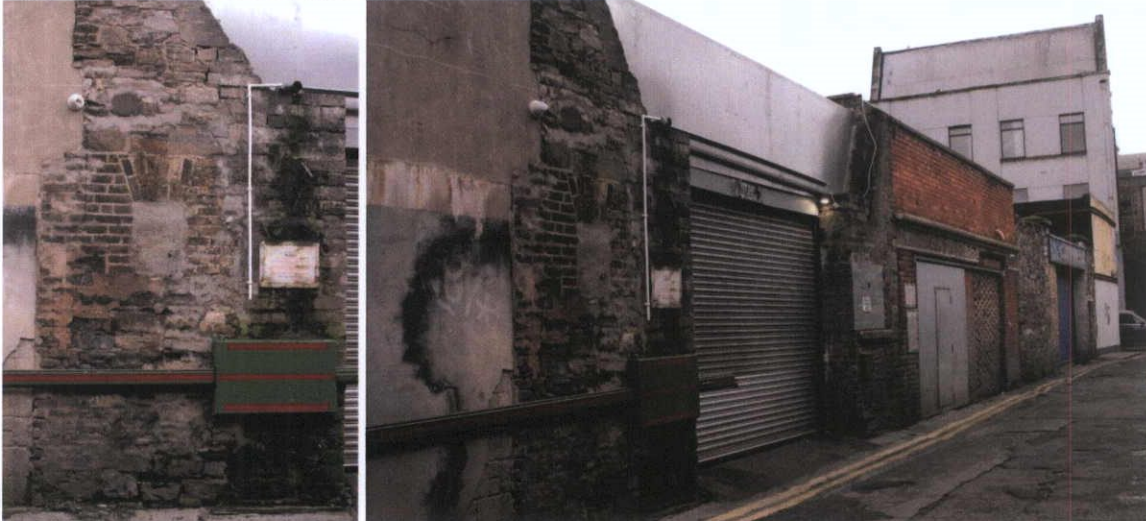
The rear on Moore Lane has a fragment of Calp limestone masonry with a brick opening, and a granite window cill on the south side. The brick forming the window is hand-made clamp-fired yellow stock brick with black vitrified zones; however, the yellow surface conceals a red core. This brickwork retains flush lime bedding/pointing mortar. These bricks are bedded in a coarse-grained lime mortar. The yellow stock brick jambs on the south side of the opening has a cylindrical groove - said to be from a bullet impact from the 1916 Easter Rising.

Fig.5.4.2: Calp masonry fabric at the rear of the building with a brick window, and a granite cill.
