BUILDING HISTORY

BUILDING SURVEY

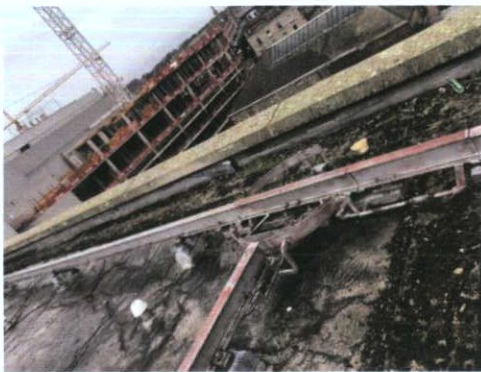
Plate 29: West roof — track for cleaning windows

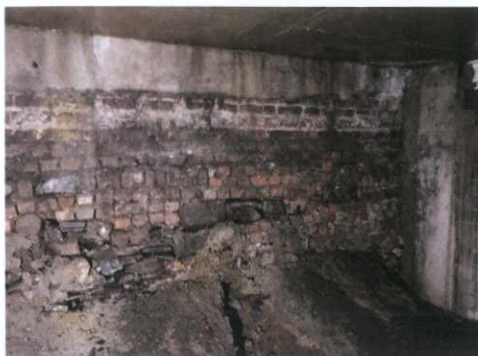
Plate 38: Brick and limestone wall in basement

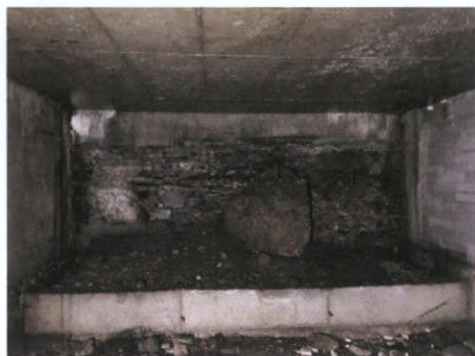
Plate 39: Limestone wall in basement

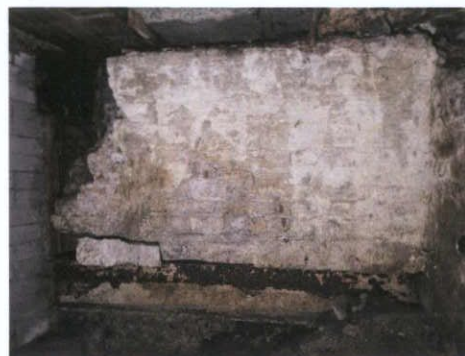
Plate 40: Limewashed wall in basement

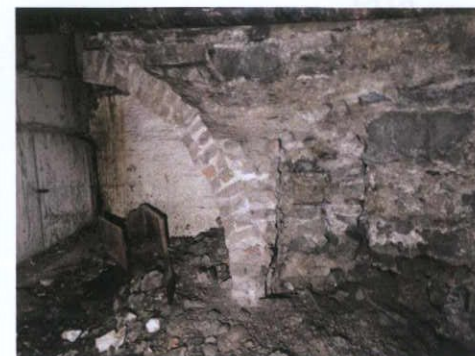
Plate 41: Vault and masonry in basement

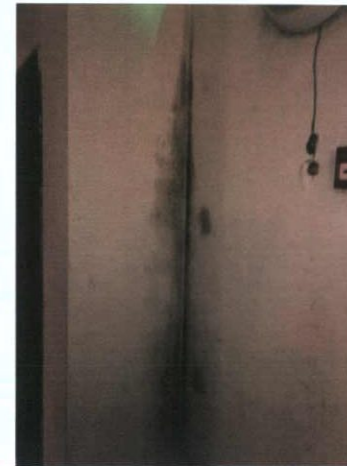
Plate 59: Signs of dampness and mould growth at rear of restaurant

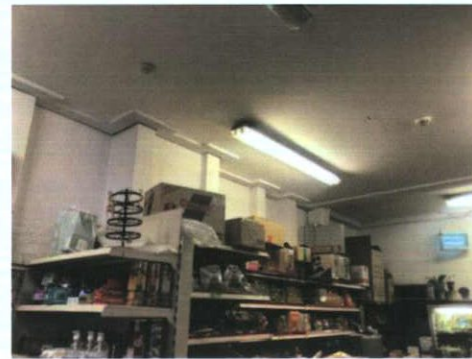
Plate 66: Stock room leading to staff WC

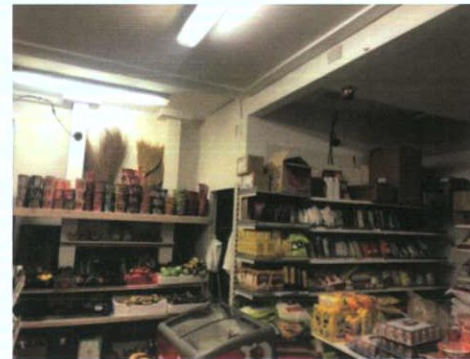
Plate 67: South wall of shop showing door to stock room at the rear; concrete piers abound

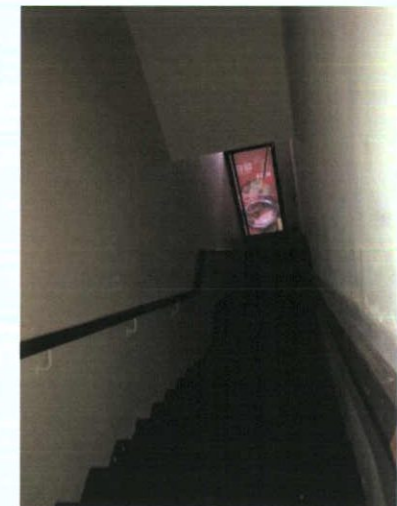
A stairway leads to O'Connell Street for emergency access. Damage to lighting services is visible. Walls were concrete construction.

Plate 138: Damage to lighting in fire exit staircase

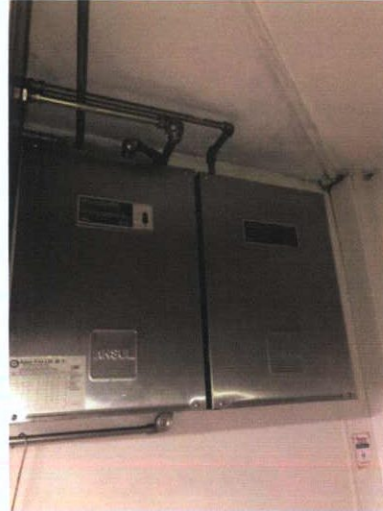
Plate 149: Fire suppression system located in kitchen

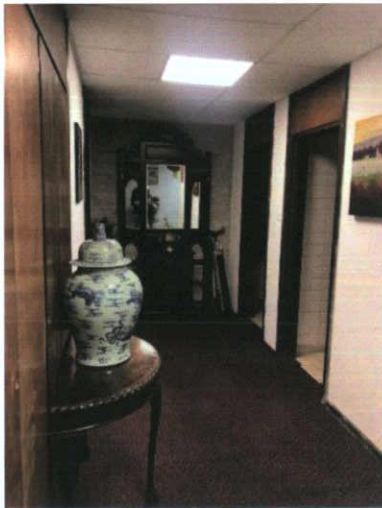
Plate 176: WC lobby with concrete black wall in rear that separates the back building from the front

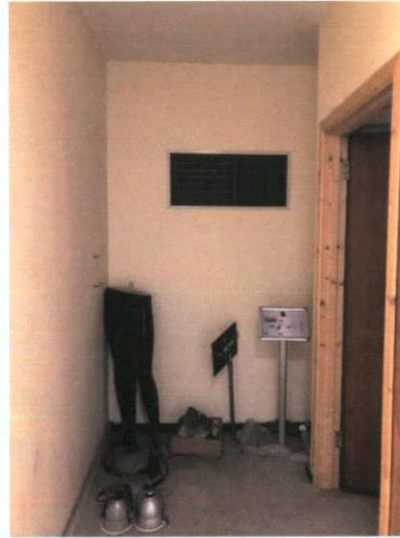
Plate 198: Level entrance lobby showing grille from service riser behind

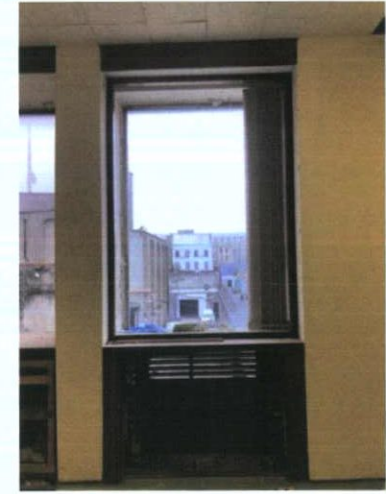
Plate 204: Typical window with ventilation unit below removed and air inlet grilles visible

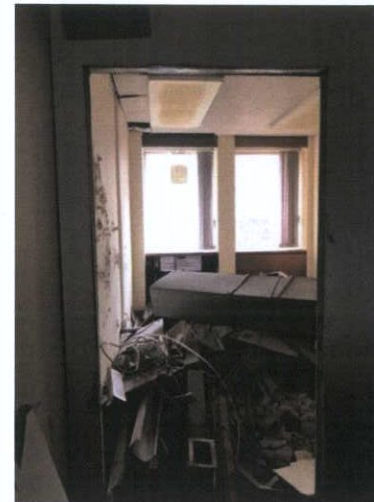
Plate 223: Inaccessible office to south of reception area

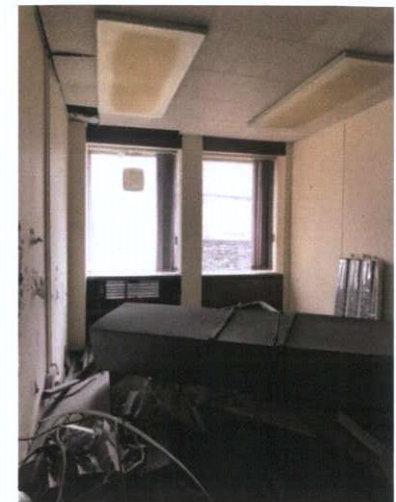
Plate 224: Image showing suspended ceiling and old lighting in office

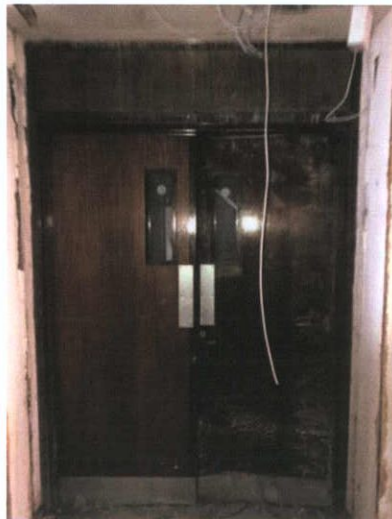
Plate 225: Exit doors to front of building that have been blocked up behind to separate areas

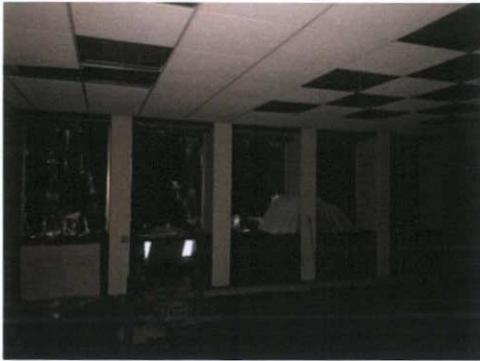
Plate 226: Room 1 — South wall

Water damage is evident in many areas of the level including on walls, ceilings and floors. Old floor finish has been lifted and the concrete floor is now visible. Ceiling panels are damaged, and some have been removed.

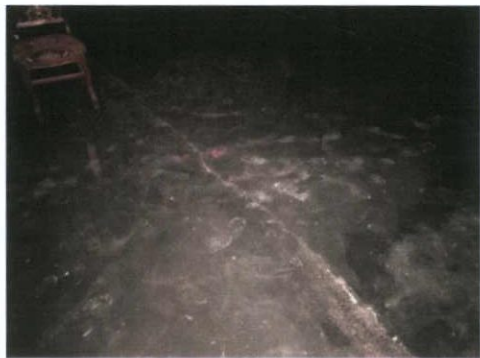
Plate 230: Concrete floor finish

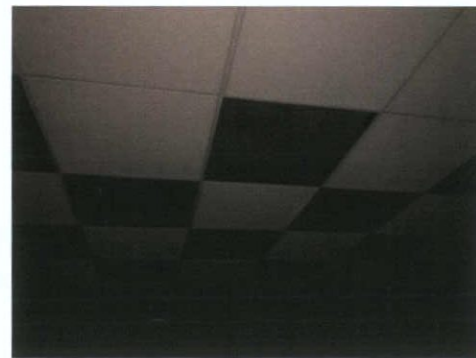
Plate 231: Ceiling panels removed

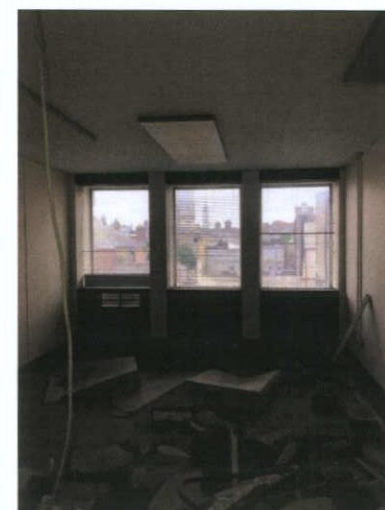
Plate 280: Room 14 — suspended ceiling material

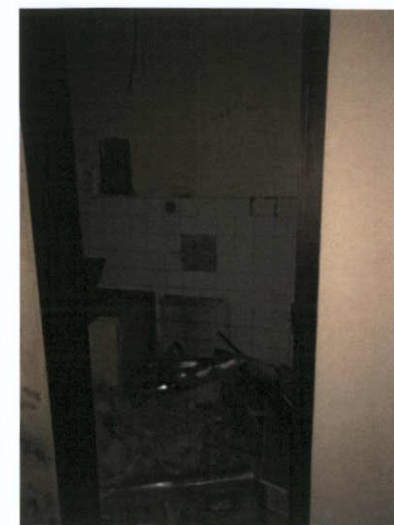
Plate 292: Female WC entry from main hallway- not accessible

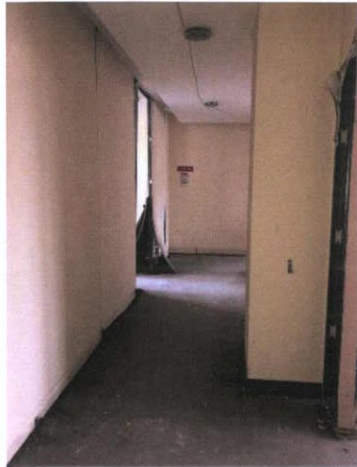
Plate 305: Carpet visible underneath metal stud partitions

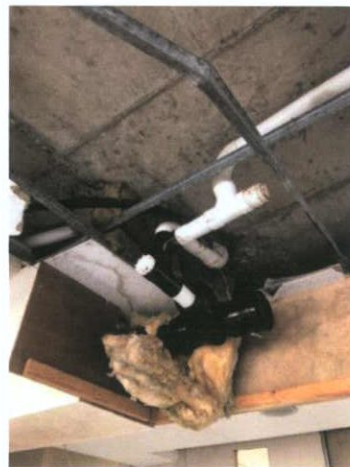
Plate 361: Exposed drainage pipes in ceiling
