EIAR Chapter 15 Cultural Heritage (Architectural)

Dublin Central Project – Site 2 & No.61 O'Connell Street Upper

Appendix 15.7 Building inventory, record and description for No.50-51 O'Connell Street Upper

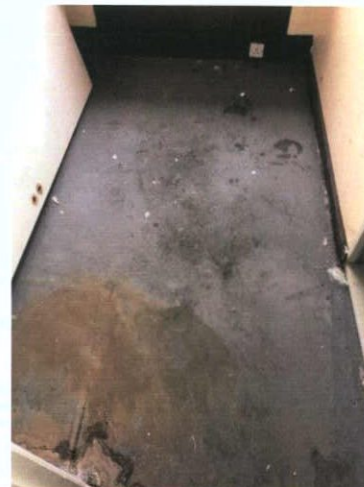
Plate 405: Room 1 — Concrete floor

There is a lot of damage to the remaining paintwork. Some suspended ceiling panels removed/damaged. Windows are all single glazed aluminium frame. Some ventilation units have been removed beneath the windows. Metal stud partitions have been damaged in some rooms.

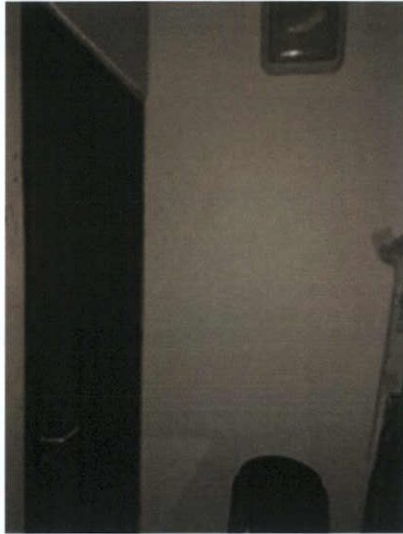
Plate 505: Door to level two

Mandy handrails are damaged and doors to floors are blocked by miscellaneous items. This stairwell is not fit for use as a fire escape in its current condition.

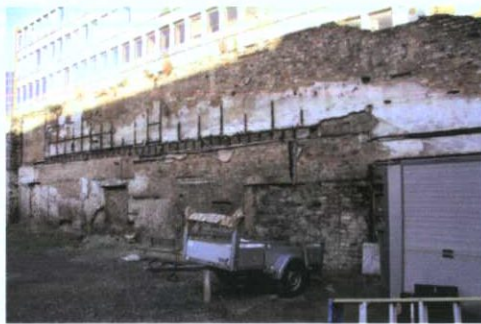
Plate 6: View to south-west; joist pockets in former party wall

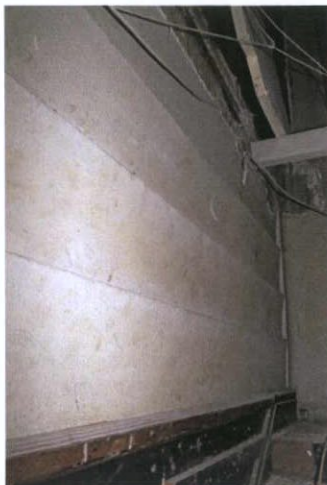
Plate 19: G-5 – Plaster to south wall arrow is NE
