3.0 DESCRIPTION OF PROPOSED REPAIR WORKS TO RETAINED FAÇADES WITH SITE 2

Note: Buildings façades were inspected from the ground only, detailed condition assessments will be prepared post inspection at close-range.

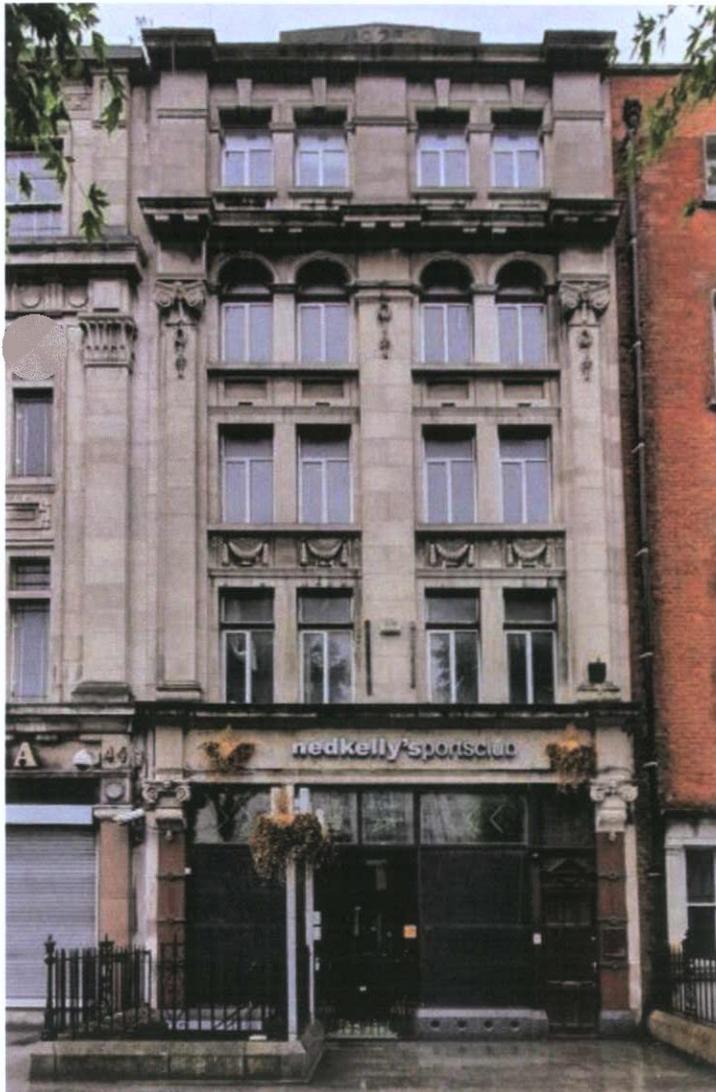
Fig. 6 The façade of No.43 O’Connell Street Upper will be retained and repaired. The new development will be constructed behind the façade. On the upper levels the existing uPVC windows will be removed and timber casements will be installed.

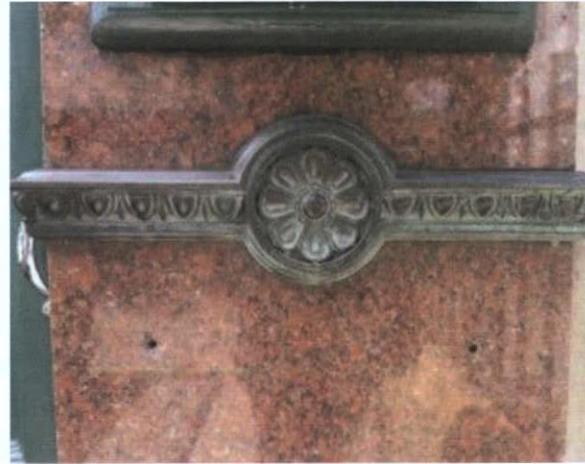
Fig. 9 Detail of decorative bronze fixtures with rosette motif and egg-and-dart straps mounted on pink granite clad pilaster.

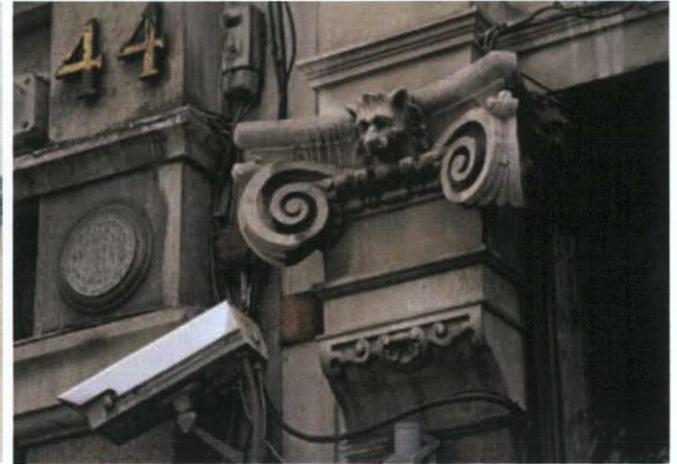
Fig. 10 Carved Portland stone Ionic order capital with lions' head detail. Masonry will be gently cleaned to remove soiling. Redundant services and fixtures to be removed.

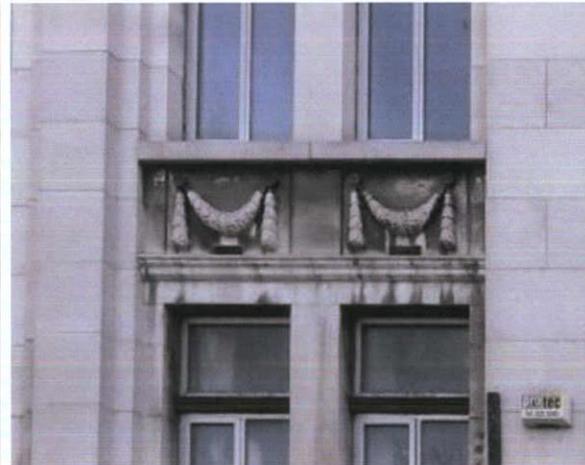
Fig. 12 Recessed bays of paired windows to first and second floors, with carved swag on window apron. Note the original timber transoms surviving on first and third floor level windows otherwise uPVC window frames throughout. Replacement windows proposed to match original, as informed by surviving profiles and historic photographs.

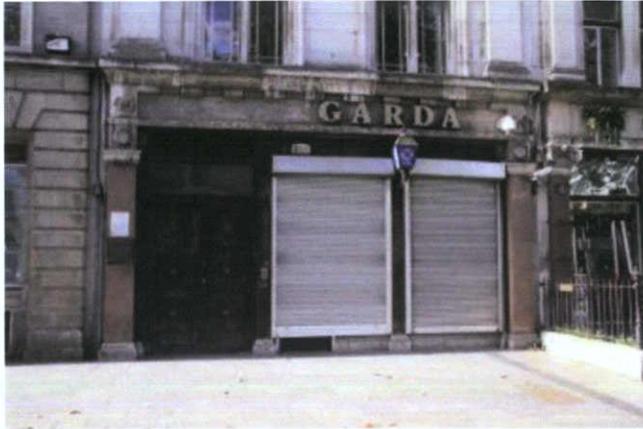
Fig. 16 Original shop front to ground floor, comprising polished pink granite pilasters with stylised capitals. Replacement glazed shop windows set within to timber frames over granite stall risers. Later glazing to be replaced. Granite plinth below windows to be removed to facilitate access via new entrance doors.

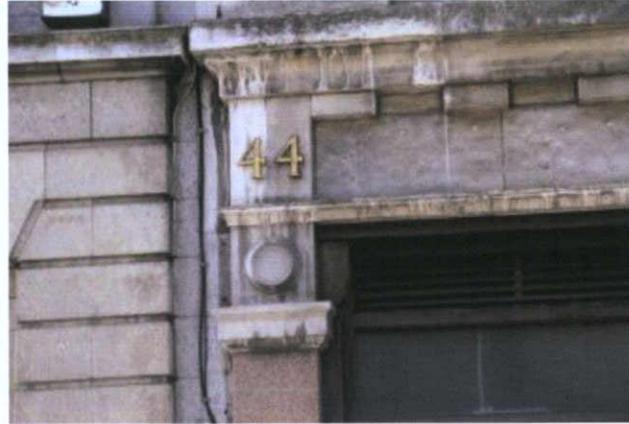
Fig. 17 Detail circular medallions and '44' numbering on frieze above capital and Portland stone frieze with carved modillion cornice. Masonry elements to be gently cleaned.

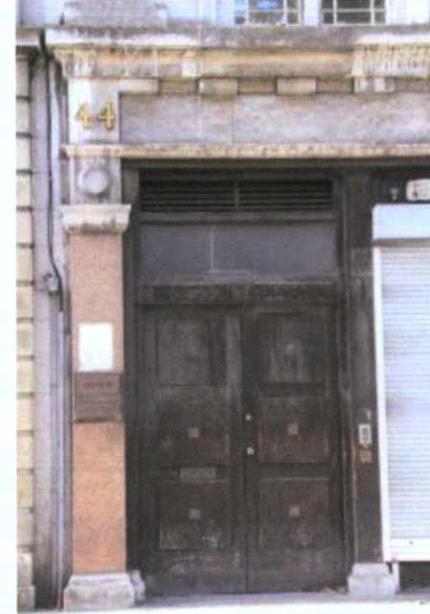
Fig. 17 Double-leaf timber panelled doors to south with raised central studs, carved timber architrave with circular medallion motif and plain glazed transom; ventilated grille over. Existing double door to be retained and repaired.

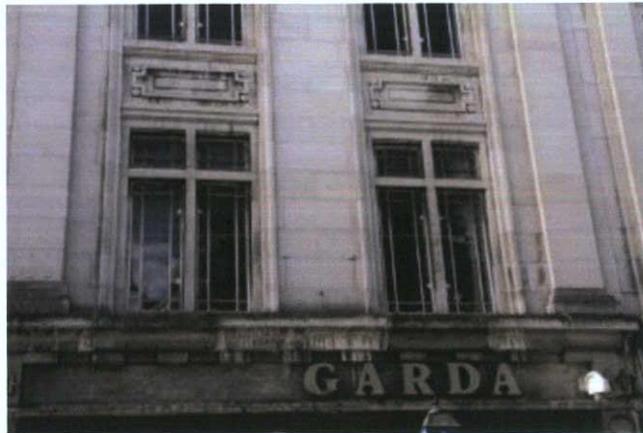
Fig. 18 Steel casement windows with fixed transom lights over to be restored by specialist.

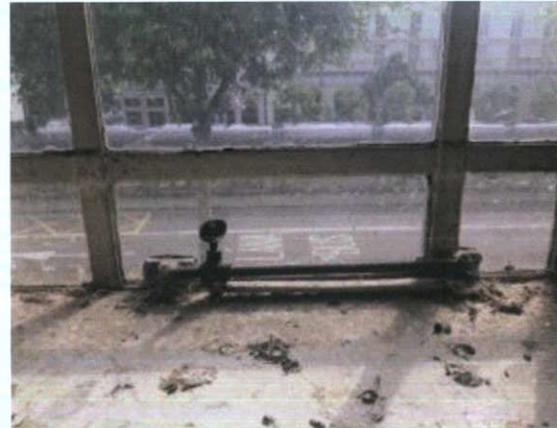
Fig. 19 Detail of metal casement openings, original fixings intact. Steel windows to be restored.

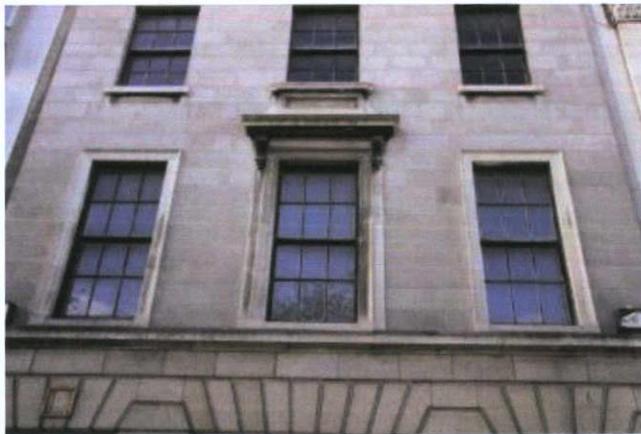
Fig. 26 Carved Portland stone surrounds to first floor, and central ope having carved granite hood moulding supported on corbel brackets; Portland stone sills to second floor, with central window having carved, Portland stone panelled apron. Masonry to be gently cleaned.

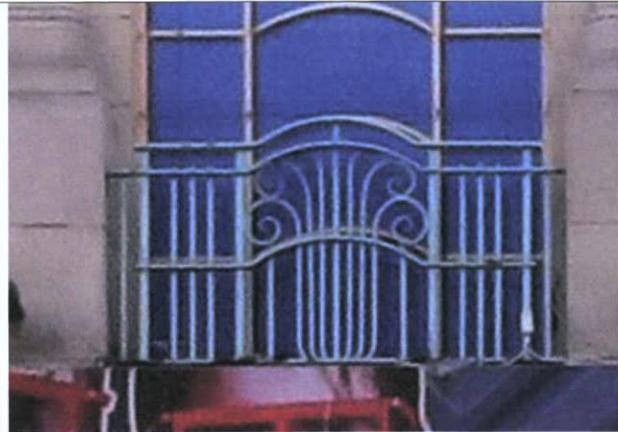
Fig. 31 Decorative railings at first floor level between bays, to be restored and refinished.

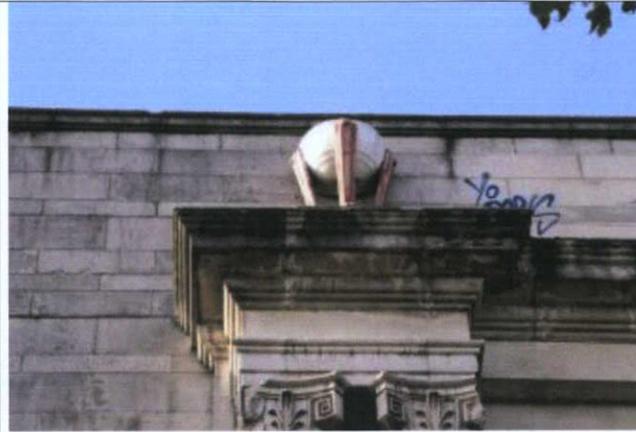
Fig. 32 Integrated bowls of light supported on tripods to be integrated into new lighting scheme.

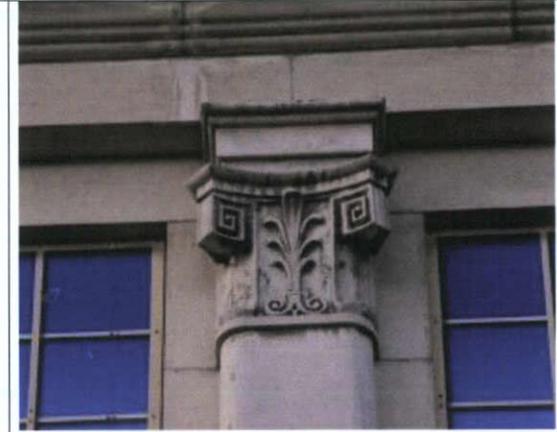
Fig. 33 Detail of art deco inspired detail on capitals. All masonry elements to be gently cleaned to remove graffiti and soiling.

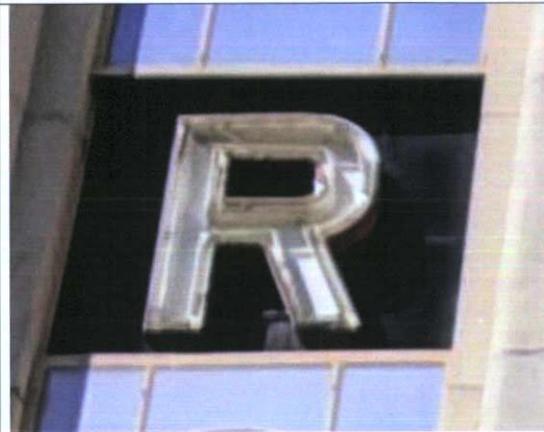
Fig. 34 Neon lighting in individually mounted lettering. Signage to be retained and restored subject to inspection by specialist.

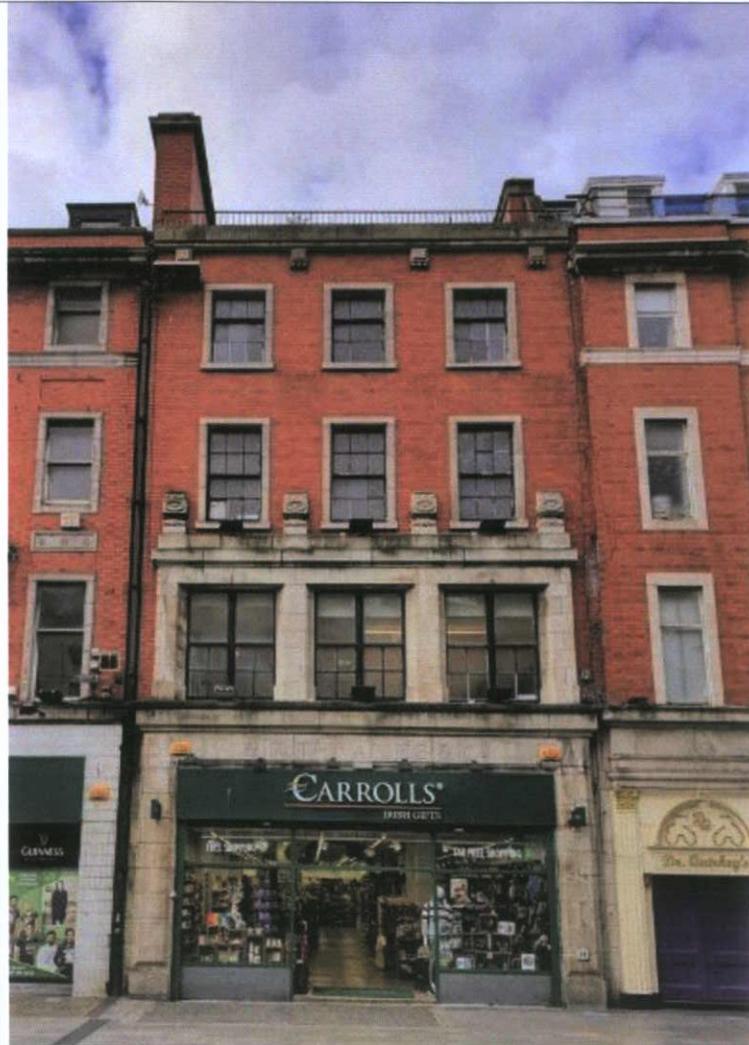
Fig. 37 The façade of No.57 O'Connell Street Upper will be retained and repaired. The new development will be constructed behind the façade.

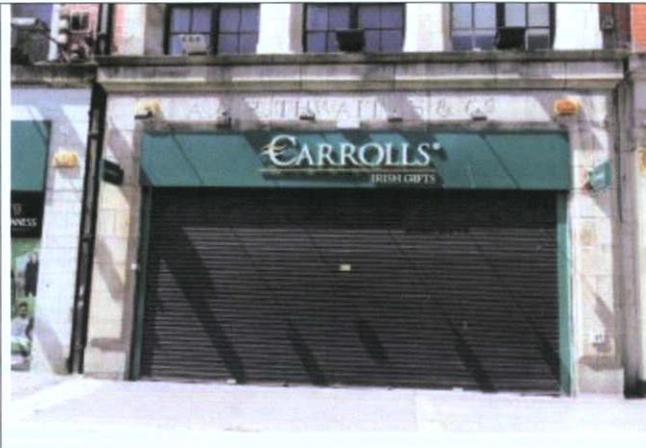
Fig. 39 Granite ashlar shop front with solitary plinths flanking either side of modern shopfront infill; incised lettering to fascia reading, A & R THWAITES & CO

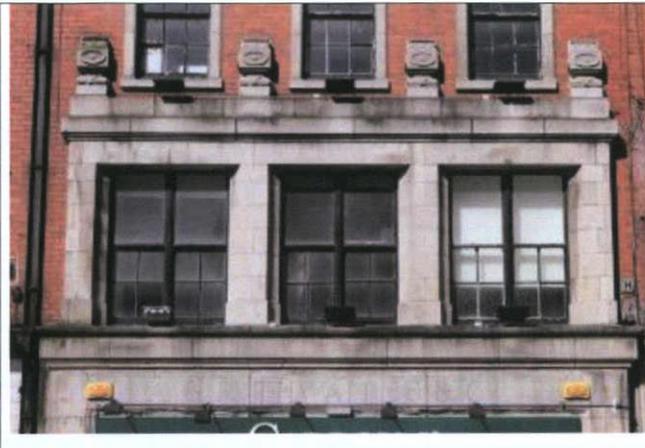
Fig. 40 Projecting granite ashlar, tripartite breakfront, having cornice and blocking course of carved granite ashlar surmounted by stylised granite medallions. Granite ashlar surrounds and cills to all window openings

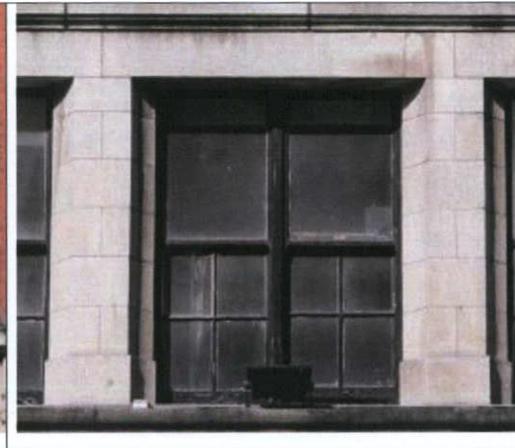
Fig. 41 One-over-four paired timber windows at first floor.

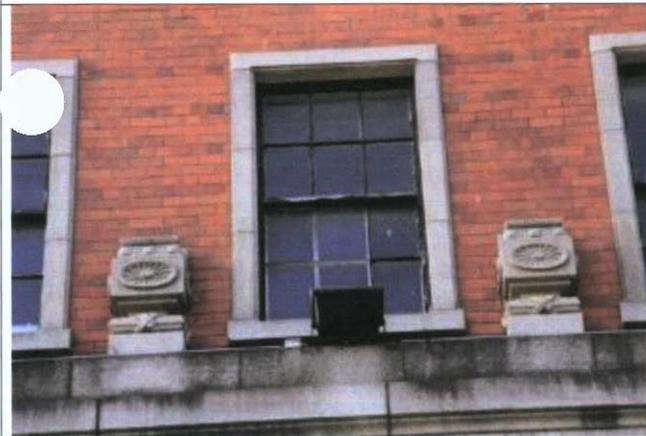
Fig. 42 Six-over-six timber sash windows.

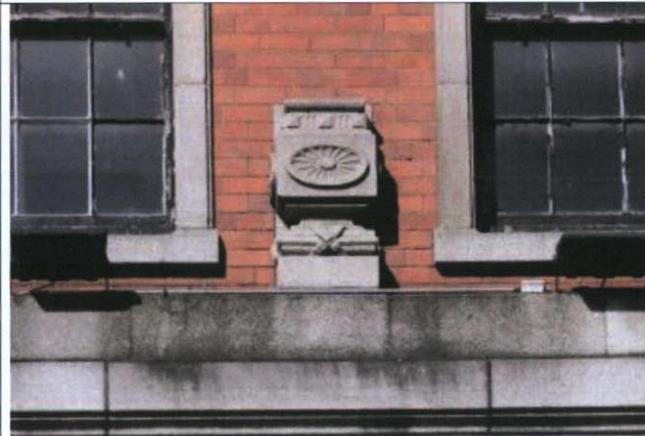
Fig. 43 Detail of carved granite medallion.

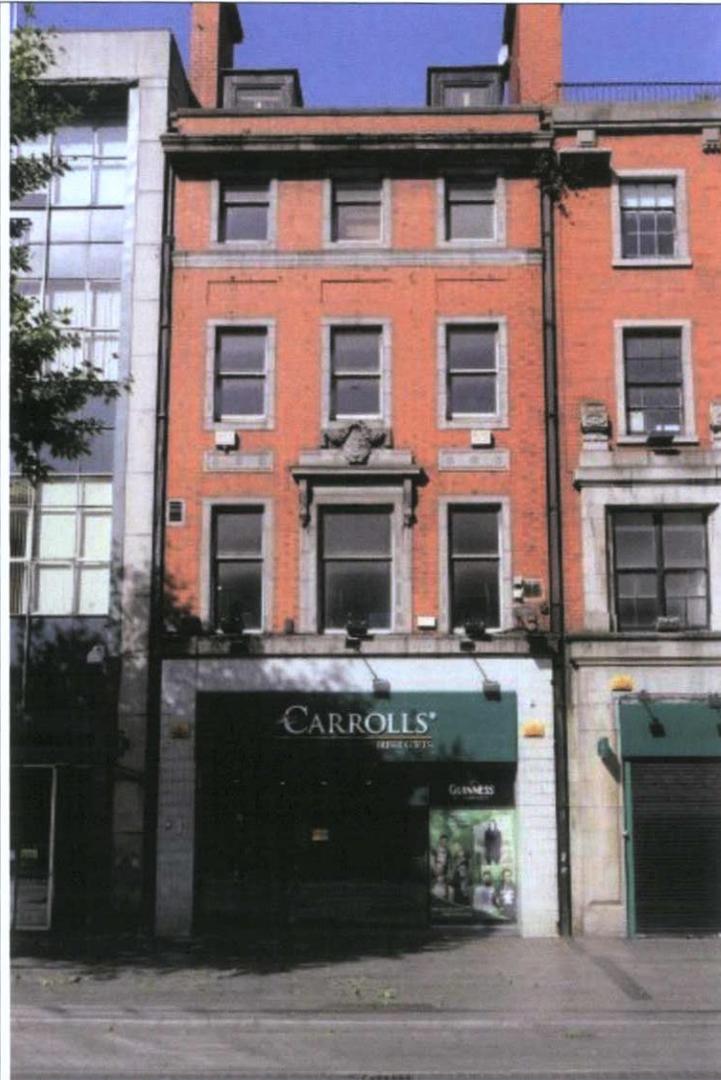
Fig. 45 The façade of No.58 O’Connell Street Upper will be retained and repaired. The new development will be constructed behind the façade.

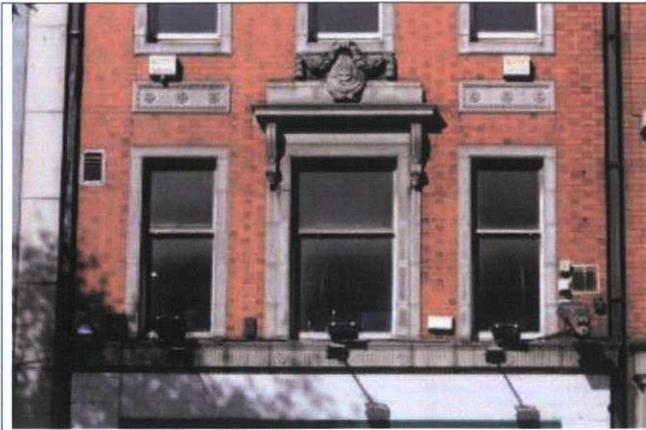
Fig. 47 Decorative plaque with swags over corniced hood moulding set to central, first floor window.

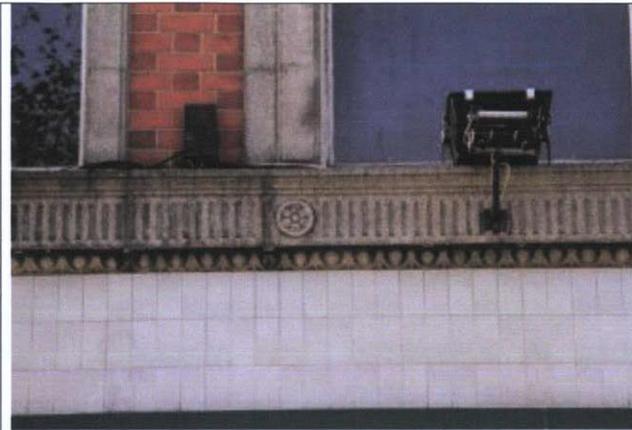
Fig. 48 Original granite plat band over modern shop front.

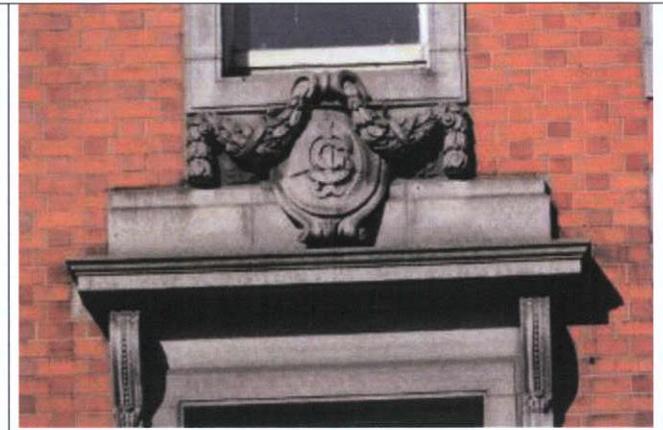
Fig. 49 Plaque bearing inscription, "JGC."

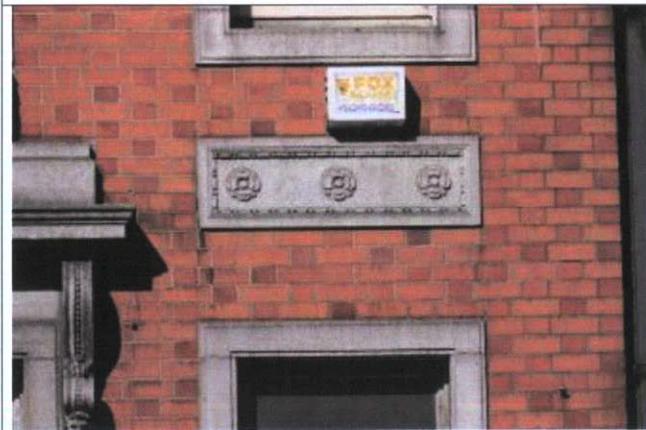
Fig. 50 Panelled granite window aprons to second floor, with decorative rosettes.

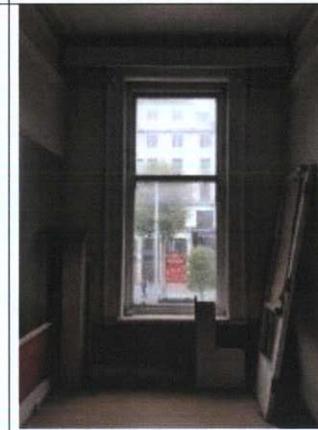
Fig. 52 Timber sash windows with moulded architraves internally and without shutters.

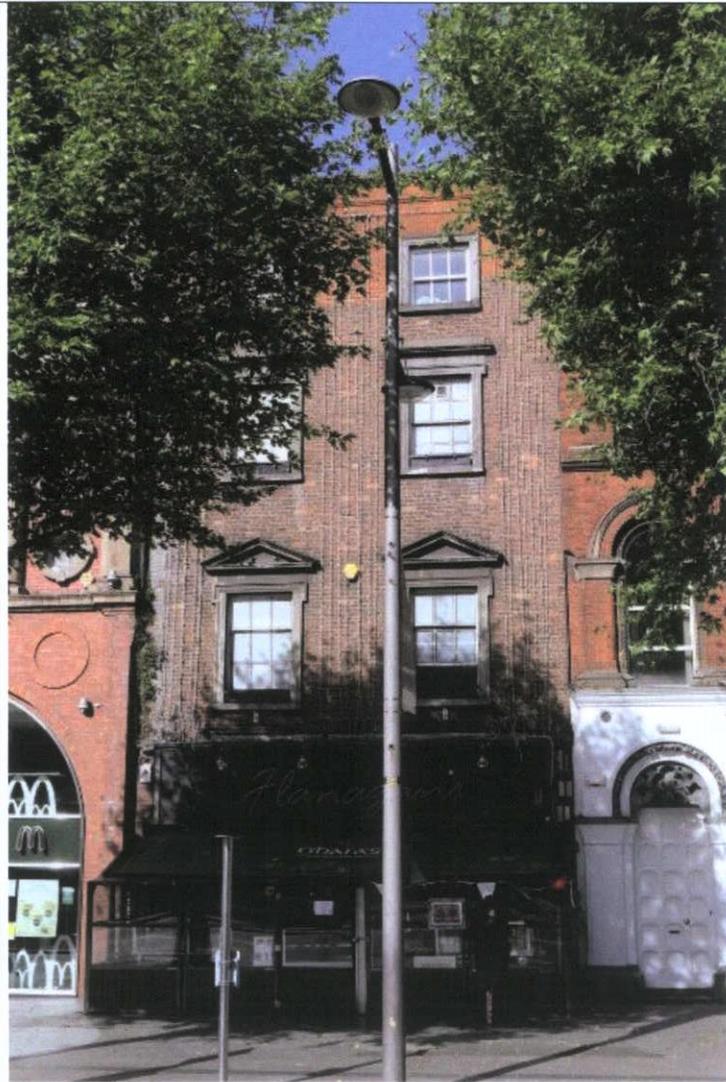
Fig. 53
The upper levels of the existing front façade of No.61 Upper O'Connell Street (a Protected Structure) will be retained and repaired. The later shopfront will be removed and a new, contemporary shopfront installed, incorporating a pedestrian link through the structure from O'Connell Street to Henry Place.
