4.0 DESCRIPTION OF THE PROJECT

4.1 Location, Size and Scale of the Development

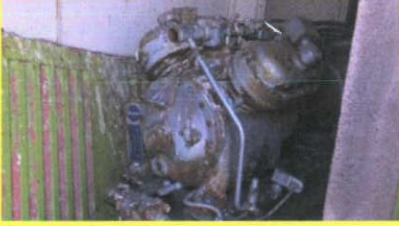
4	Fingal Co. Co. Office and Carpark Moore Lane	6 th floor boiler room		Gaskets to generator		Presumed						Further inspection is required by a competent contractor prior to any disturbance.

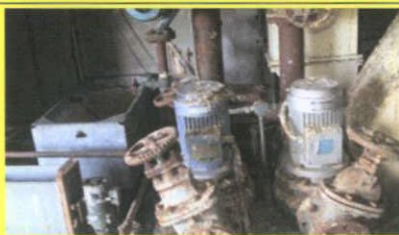
8	Fingal Co. Co. Office and Carpark Moore Lane	6 th floor boiler room		Pipework flange gaskets		Strongly presumed to contain asbestos						Dismantling and investigation by a competent contractor prior to work likely to cause disturbance.

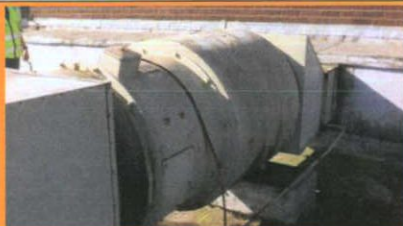
12	Fingal Co. Co. Office and Carpark Moore Lane	5 th floor roof		Rope seals to air handling ductwork	NQ.	Chrysotile	2	1	1	5	5	Removal and disposal as asbestos waste by a competent contractor prior to work likely to cause disturbance.

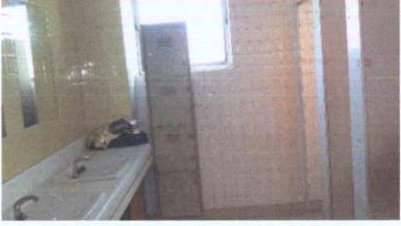
20	Fingal Co. Co. Office and Carpark Moore Lane	5 th floor Ladies WC				NAD

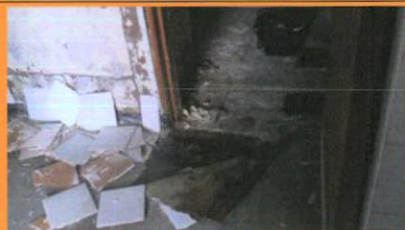
28	Fingal Co. Co. Office and Carpark Moore Lane	5 th floor kitchen	2027313 2027314	VFT and adhesive		Chrysotile	1	0	0	1	2	Removal and disposal as asbestos waste by a competent contractor prior to work likely to cause disturbance.

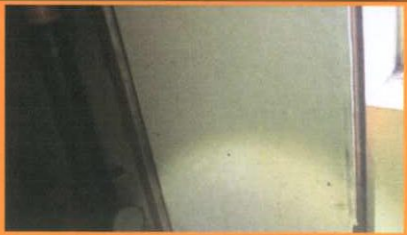
32	Fingal Co. Co. Office and Carpark Moore Lane	4 th floor half landing		Insulation board back of riser doors	1 SM approx.	Amosite	2	2	2	2	8	Removal and disposal by a competent contractor prior to any works likely to cause disturbance.

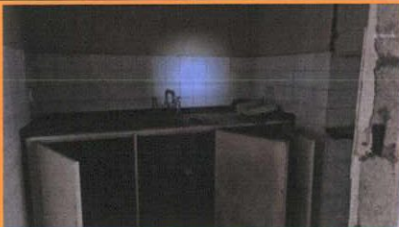
44	Fingal Co. Co. Office and Carpark Moore Lane	4 th floor Kitchenette	2027316	Sink pads		Chrysotile	1	0	0	1	2	Removal and disposal as asbestos waste by a competent contractor prior to work likely to cause disturbance.

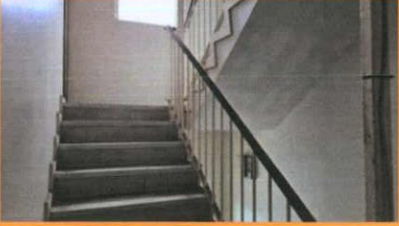
60	Fingal Co. Co. Office and Carpark Moore Lane	3 rd floor West stairway	2027325 2027326	VFT's and grey thread nosings		Chrysotile	1	0	0	1	2	Removal and disposal as asbestos waste by a competent contractor prior to work likely to cause disturbance.

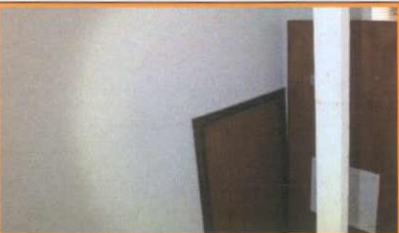
64	Fingal Co. Co. Office and Carpark Moore Lane	3 rd floor half landing	2027301	Insulation board to dry riser doors		Amosite	2	2	2	2	8	Removal and disposal as asbestos waste by a competent contractor prior to work likely to cause disturbance.

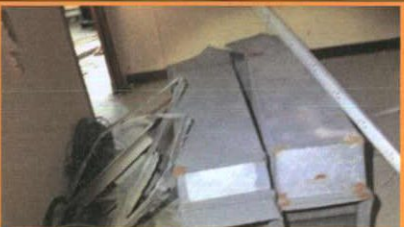
68	Fingal Co. Co. Office and Carpark Moore Lane	2 nd floor office		Red adhesive to ductwork		Chrysotile	1	0	0	1	2	Removal and disposal as asbestos waste by a competent contractor prior to work likely to cause disturbance.

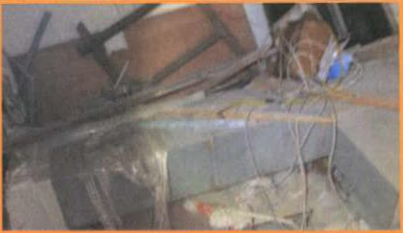
70	Fingal Co. Co. Office and Carpark Moore Lane	2 nd floor office		AIB to back of panel	1 SM approx.	Chrysotile	2	2	2	2	8	Removal and disposal as asbestos waste by a competent contractor prior to work likely to cause disturbance.

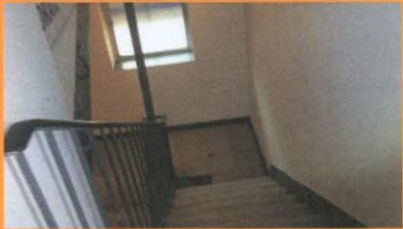
71	Fingal Co. Co. Office and Carpark Moore Lane	2 nd floor office		VFT and grey thread nosings		Chrysotile	1	0	0	1	2	Removal and disposal as asbestos waste by a competent contractor prior to work likely to cause disturbance.

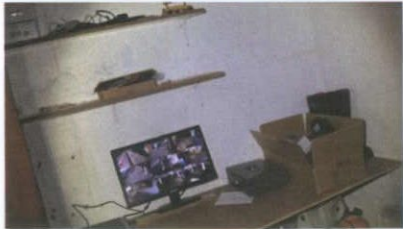
72	Fingal Co. Co. Office and Carpark Moore Lane	Ground floor Security room				No visible asbestos containing materials identified.
