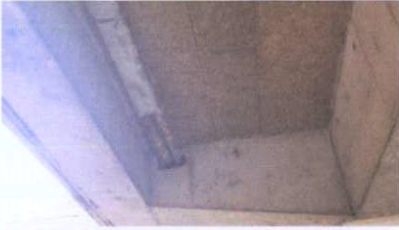
Ref No.	Building	Location or Functional Space	Sample No.	Material Description, surface treatment and condition	Extent	Asbestos identified (presumed, strongly presumed or identified)	Product type	Condition	Surface treatment	Asbestos type	Material assessment score	Recommendations	Photo
73	Fingal Co. Co. Office and Carpark Moore Lane	1 st floor carpark		Strammit board insulation to floor slab over carpark		No visible asbestos containing materials identified.

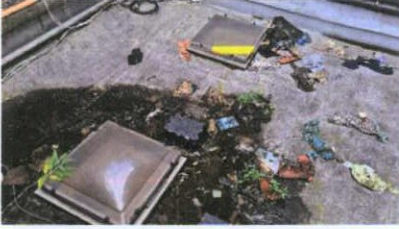
74	Fingal Co. Co. Office and Carpark Moore Lane	1 st floor carpark		Polycarbonate roof lights		No visible asbestos containing materials identified.

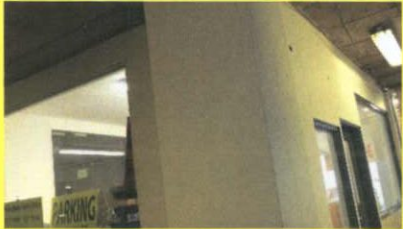
Ref No.	Building	Location or Functional Space	Sample No.	Material Description, surface treatment and condition	Extent	Asbestos identified (presumed, strongly presumed or identified)	Product type	Condition	Surface treatment	Asbestos type	Material assessment score	Recommendations	Photo
77	Fingal Co. Co. Office and Carpark Moore Lane	Ground floor Car Park		Occupied		Presumed to contain asbestos						Investigate prior to work likely to cause disturbance.

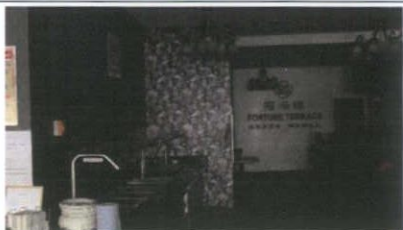
80	Fingal Co. Co. Office and Carpark Chinese Restaurant	Ground floor Lobby				No visible asbestos containing materials identified.

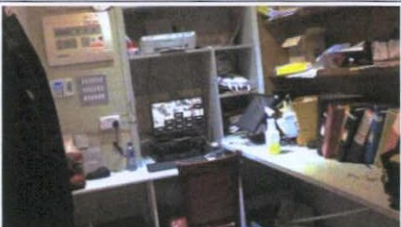
Ref No.	Building	Location or Functional Space	Sample No.	Material Description, surface treatment and condition	Extent	Asbestos identified (presumed, strongly presumed or identified)	Product type	Condition	Surface treatment	Asbestos type	Material assessment score	Recommendations	Photo
81	Fingal Co. Co. Office and Carpark Chinese Restaurant	Ground floor Restaurant				No visible asbestos containing materials identified.							 
82	Fingal Co. Co. Office and Carpark Chinese Restaurant	Ground floor Kitchen				No visible asbestos containing materials identified.							 
83	Fingal Co. Co. Office and Carpark Chinese Restaurant	Ground floor Office/ security room				No visible asbestos containing materials identified.

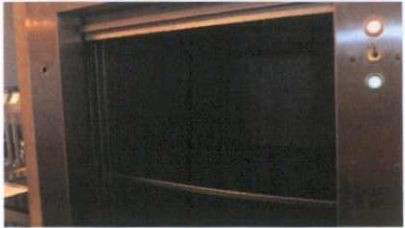
86	Fingal Co. Co. Office and Carpark Chinese Restaurant	Ground floor Dumb waiter		Plasterboard linings to sides		No visible asbestos containing materials identified.

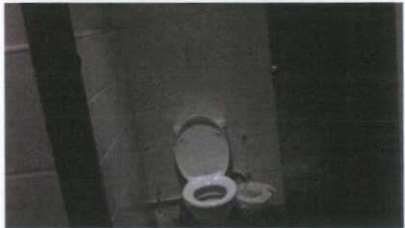
87	Fingal Co. Co. Office and Carpark Chinese Restaurant	Ground floor WC				No visible asbestos containing materials identified.

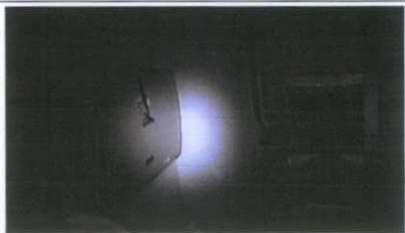
88	Fingal Co. Co. Office and Carpark Chinese Restaurant	Ground floor WC				No visible asbestos containing materials identified.

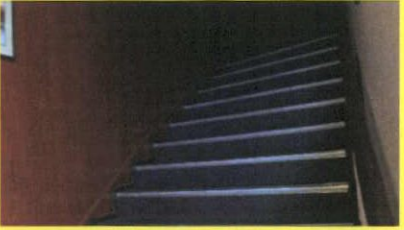
Ref No.	Building	Location or Functional Space	Sample No.	Material Description, surface treatment and condition	Extent	Asbestos identified (presumed, strongly presumed or identified)	Product type	Condition	Surface treatment	Asbestos type	Material assessment score	Recommendations	Photo
89	Fingal Co. Co. Office and Carpark Chinese Restaurant	Stairway ground to 1 st floor.		Fixed flooring not disturbed.		Presumed to contain asbestos VFT.						Investigation by a competent contractor prior to work likely to cause disturbance.

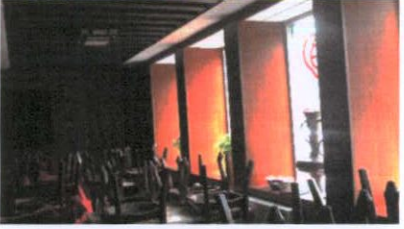
90	Fingal Co. Co. Office and Carpark Chinese Restaurant	1 st floor Openplan restaurant				No visible asbestos containing materials identified.

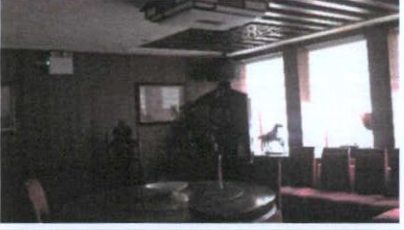
91	Fingal Co. Co. Office and Carpark Chinese Restaurant	1 st floor Private restaurant rooms				No visible asbestos containing materials identified.

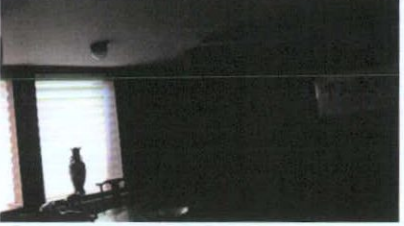
92	Fingal Co. Co. Office and Carpark Chinese Restaurant	1 st floor Private restaurant rooms				No visible asbestos containing materials identified.

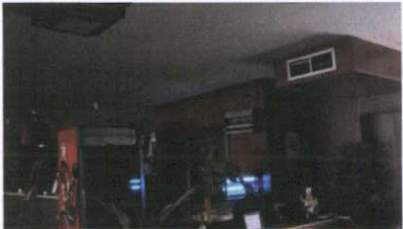
Ref No.	Building	Location or Functional Space	Sample No.	Material Description, surface treatment and condition	Extent	Asbestos identified (presumed, strongly presumed or identified)	Product type	Condition	Surface treatment	Asbestos type	Material assessment score	Recommendations	Photo
93	Fingal Co. Co. Office and Carpark Chinese Restaurant					No visible asbestos containing materials identified.

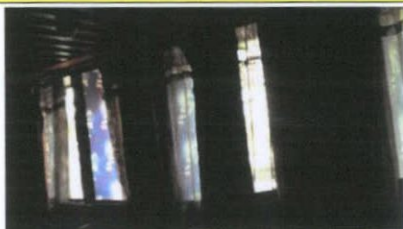
95	Fingal Co. Co. Office and Carpark Chinese Restaurant					No visible asbestos containing materials identified.

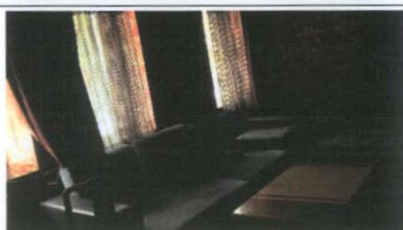
96	Fingal Co. Co. Office and Carpark Chinese Restaurant					No visible asbestos containing materials identified.

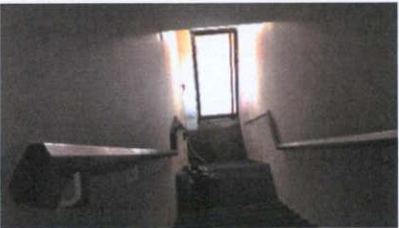
Ref No.	Building	Location or Functional Space	Sample No.	Material Description, surface treatment and condition	Extent	Asbestos identified (presumed, strongly presumed or identified)	Product type	Condition	Surface treatment	Asbestos type	Material assessment score	Recommendations	Photo
97	Fingal Co. Co. Office and Carpark Chinese Restaurant	Exit to O'Connell Street				No visible asbestos containing materials identified.

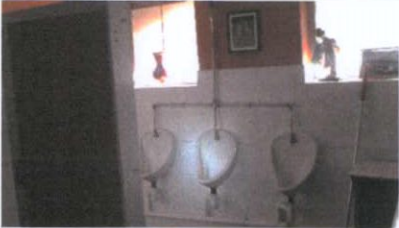
Ref No.	Building	Location or Functional Space	Sample No.	Material Description, surface treatment and condition	Extent	Asbestos identified (presumed, strongly presumed or identified)	Product type	Condition	Surface treatment	Asbestos type	Material assessment score	Recommendations	Photo
101	Fingal Co. Co. Office and Carpark Chinese Restaurant	1 st floor Gents WC		Modern refurb.		No visible asbestos containing materials identified.

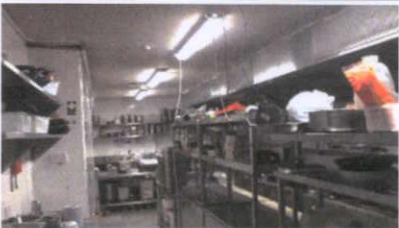
102	Fingal Co. Co. Office and Carpark Chinese Restaurant	1 st floor Main kitchen		Modern refurb. Ceramic tiles to floors.		No visible asbestos containing materials identified.

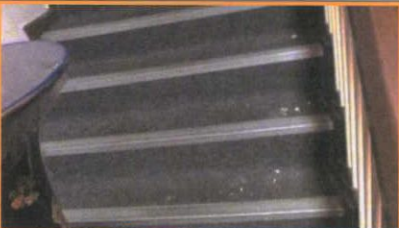
103	Fingal Co. Co. Office and Carpark Chinese Restaurant	Stairway to 2 nd floor.		VFT under carpet		Chrysotile	1	0	0	1	2	Removal and disposal as asbestos waste by a competent contractor prior to work likely to cause disturbance.

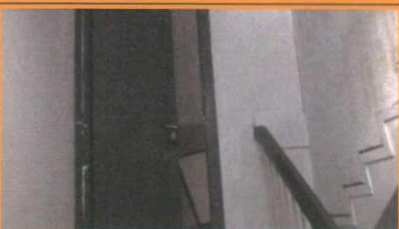
104	Fingal Co. Co. Office and Carpark Chinese Restaurant	2 nd floor Stairway to 3 rd floor of Fingal Co. Co.		VFT on stairway		Chrysotile	1	0	0	1	2	Removal and disposal as asbestos waste by a competent contractor prior to work likely to cause disturbance.

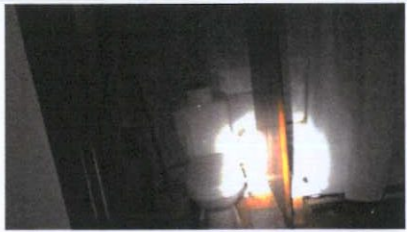
Ref No.	Building	Location or Functional Space	Sample No.	Material Description, surface treatment and condition	Extent	Asbestos identified (presumed, strongly presumed or identified)	Product type	Condition	Surface treatment	Asbestos type	Material assessment score	Recommendations	Photo
105	Fingal Co. Co. Office and Carpark Chinese Restaurant	2 nd floor WC				No visible asbestos containing materials identified.

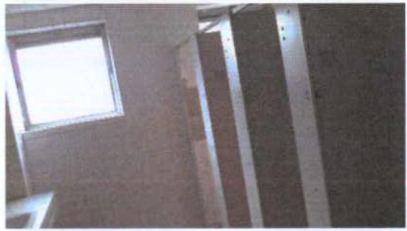
106	Fingal Co. Co. Office and Carpark Chinese Restaurant	2 nd floor WC				No visible asbestos containing materials identified.

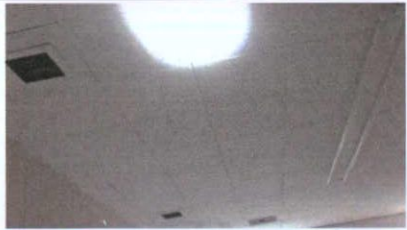
107	Fingal Co. Co. Office and Carpark Chinese Restaurant	2 nd floor WC		Mineral fibre ceiling tiles		No visible asbestos containing materials identified.

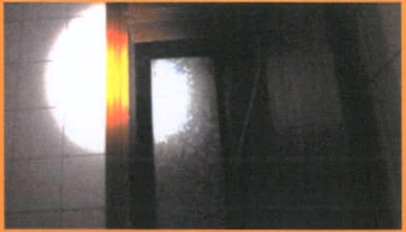
Ref No.	Building	Location or Functional Space	Sample No.	Material Description, surface treatment and condition	Extent	Asbestos identified (presumed, strongly presumed or identified)	Product type	Condition	Surface treatment	Asbestos type	Material assessment score	Recommendations	Photo
109	Fingal Co. Co. Office and Carpark Chinese Restaurant	2 nd floor Gents WC		Woven rope gaskets to air handling duct		Chrysotile	2	1	1	1	5	Removal and disposal as asbestos waste by a competent contractor prior to work likely to cause disturbance.

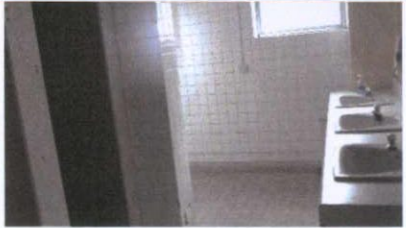
110	Fingal Co. Co. Office and Carpark Chinese Restaurant	2 nd floor Gents WC				No visible asbestos containing materials identified.

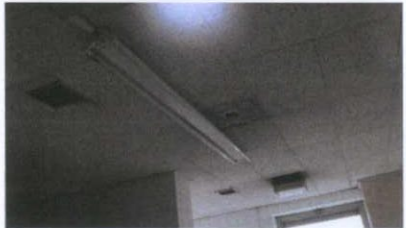
111	Fingal Co. Co. Office and Carpark Chinese Restaurant	2 nd floor Gents WC		Old mineral fibre ceiling tiles.		No visible asbestos containing materials identified.

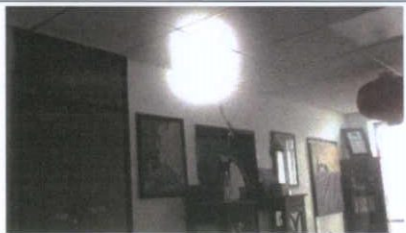
112	Fingal Co. Co. Office and Carpark Chinese Restaurant	2 nd floor Offices				No visible asbestos containing materials identified.

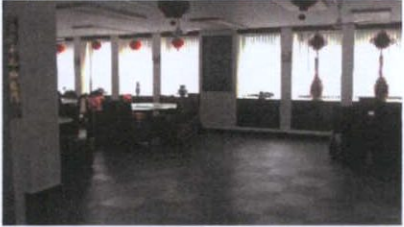
Ref No.	Building	Location or Functional Space	Sample No.	Material Description , surface treatment and condition	Extent	Asbestos identified (presumed, strongly presumed or identified)	Product type	Condition	Surface treatment	Asbestos type	Material assessment score	Recommendations	Photo
113	Fingal Co. Co. Office and Carpark Chinese Restaurant	2 nd floor Unused restaurant				No visible asbestos containing materials identified.

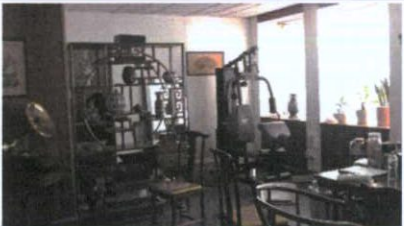
114	Fingal Co. Co. Office and Carpark Chinese Restaurant	2 nd floor Unused restaurant				No visible asbestos containing materials identified.							 
115	Fingal Co. Co. Office and Carpark Chinese Restaurant	2 nd floor Office				No visible asbestos containing materials identified.

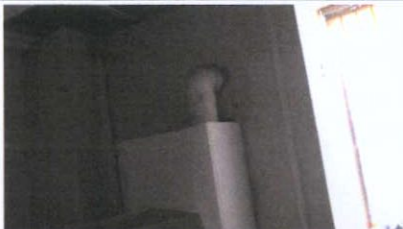
Ref No.	Building	Location or Functional Space	Sample No.	Material Description, surface treatment and condition	Extent	Asbestos identified (presumed, strongly presumed or identified)	Product type	Condition	Surface treatment	Asbestos type	Material assessment score	Recommendations	Photo
117	Fingal Co. Co. Office and Carpark Chinese Restaurant	2 nd floor Water tank room		Modern gas boiler		NAD

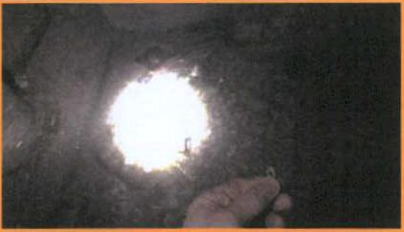
Ref No.	Building	Location or Functional Space	Sample No.	Material Description, surface treatment and condition	Extent	Asbestos identified (presumed, strongly presumed or identified)	Product type	Condition	Surface treatment	Asbestos type	Material assessment score	Recommendations	Photo
121	Fingal Co. Co. Office and Carpark	Basement Plantroom		Asbestos string to MMMF insulation on floor	Small amount	Chrysotile	2	2	2	1	7	Removal and disposal as asbestos waste by a competent contractor prior to work likely to cause disturbance.

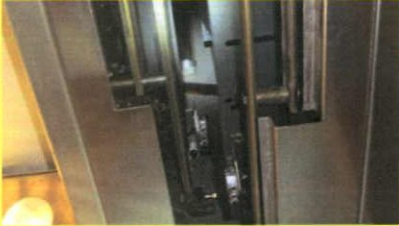
2	No. 59/60 O'Connell Street	Basement lift		Supalux board lining lift core		Presumed to contain asbestos. Sampling not possible						Investigation by a competent contractor prior to work likely to cause disturbance.

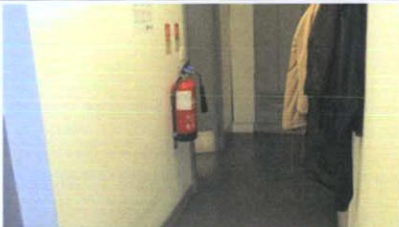
3	No. 59/60 O'Connell Street	Basement storeroom				No visible asbestos containing materials identified							 
4	No. 59/60 O'Connell Street	Basement corridor				No visible asbestos containing materials identified

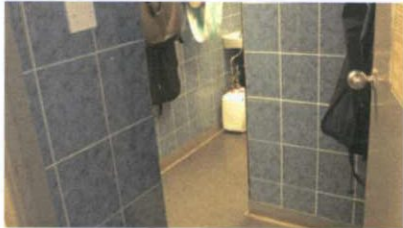
Ref No.	Building	Location or Functional Space	Sample No.	Material Description, surface treatment and condition	Extent	Asbestos identified (presumed, strongly presumed or identified)	Product type	Condition	Surface treatment	Asbestos type	Material assessment score	Recommendations	Photo
5	No. 59/60 O'Connell Street	Basement women's WC				No visible asbestos containing materials identified

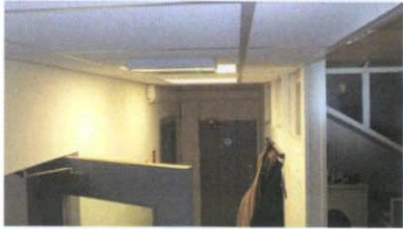
6	No. 59/60 O'Connell Street	Basement corridor				No visible asbestos containing materials identified

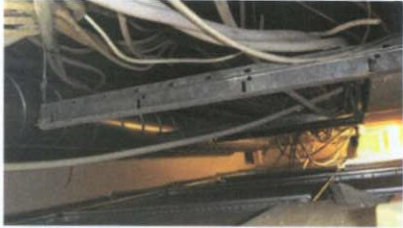
7	No. 59/60 O'Connell Street	Basement corridor ceiling void				No visible asbestos containing materials identified

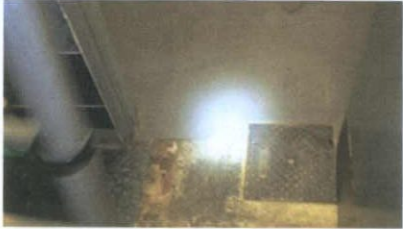
8	No. 59/60 O'Connell Street	Basement Gents WC		Concrete floor		No visible asbestos containing materials identified

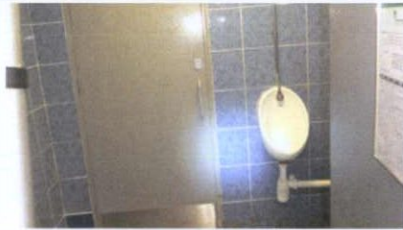
Ref No.	Building	Location or Functional Space	Sample No.	Material Description, surface treatment and condition	Extent	Asbestos identified (presumed, strongly presumed or identified)	Product type	Condition	Surface treatment	Asbestos type	Material assessment score	Recommendations	Photo
9	No. 59/60 O'Connell Street	Basement gents WC				No visible asbestos containing materials identified

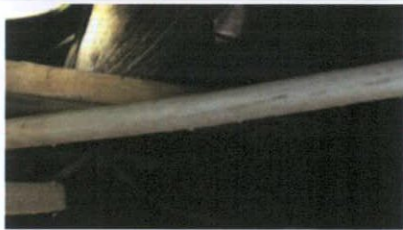
10	No. 59/60 O'Connell Street	Basement gents WC		Ceiling void		No visible asbestos containing materials identified

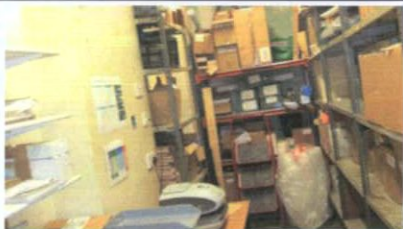
11	No. 59/60 O'Connell Street	Basement file storeroom		Mastic to ductwork		No visible asbestos containing materials identified

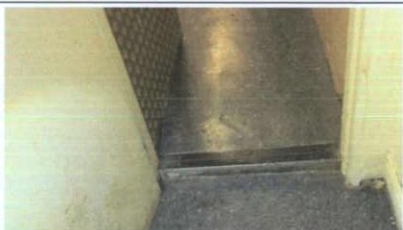
12	No. 59/60 O'Connell Street	Basement corridor		Plastic threads		No visible asbestos containing materials identified

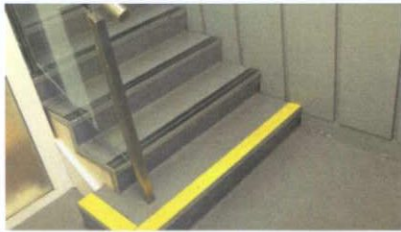
Ref No.	Building	Location or Functional Space	Sample No.	Material Description, surface treatment and condition	Extent	Asbestos identified (presumed, strongly presumed or identified)	Product type	Condition	Surface treatment	Asbestos type	Material assessment score	Recommendations	Photo
13	No. 59/60 O'Connell Street	Basement stairway		Plastic threads		No visible asbestos containing materials identified

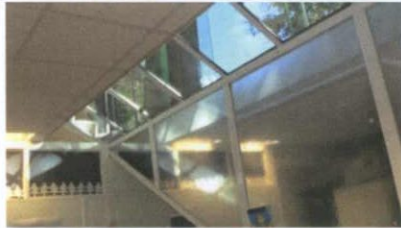
14	No. 59/60 O'Connell Street	Basement Public info office				No visible asbestos containing materials identified

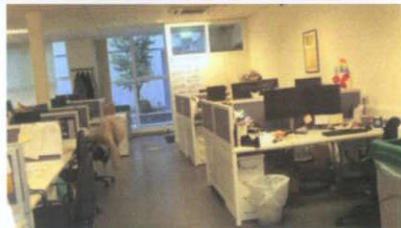
15	No. 59/60 O'Connell Street	Basement Public info office				No visible asbestos containing materials identified

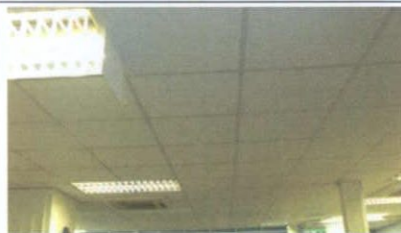
16	No. 59/60 O'Connell Street	Basement Public info office		Mineral fibre ceiling tiles		No visible asbestos containing materials identified

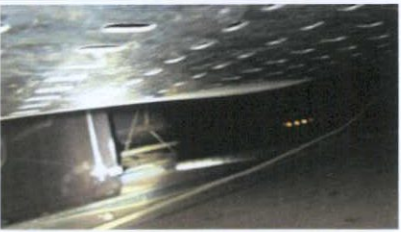
Ref No.	Building	Location or Functional Space	Sample No.	Material Description, surface treatment and condition	Extent	Asbestos identified (presumed, strongly presumed or identified)	Product type	Condition	Surface treatment	Asbestos type	Material assessment score	Recommendations	Photo
17	No. 59/60 O'Connell Street	Basement Public info office		Drop ceiling under slab		No visible asbestos containing materials identified

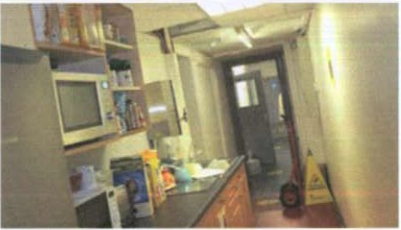
18	No. 59/60 O'Connell Street					No visible asbestos containing materials identified

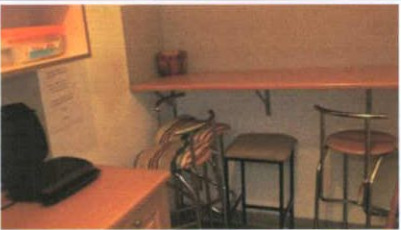
19	No. 59/60 O'Connell Street	Basement staff tea room				No visible asbestos containing materials identified

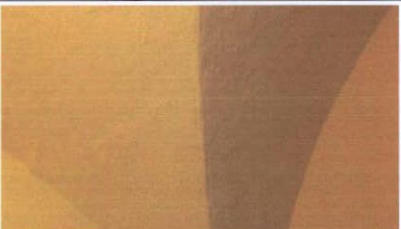
20	No. 59/60 O'Connell Street	Basement staff tea room		Original barrel vaulted ceiling		No visible asbestos containing materials identified

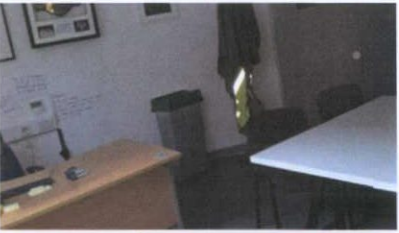
Ref No.	Building	Location or Functional Space	Sample No.	Material Description, surface treatment and condition	Extent	Asbestos identified (presumed, strongly presumed or identified)	Product type	Condition	Surface treatment	Asbestos type	Material assessment score	Recommendations	Photo
21	No. 59/60 O'Connell Street	Basement office				No visible asbestos containing materials identified

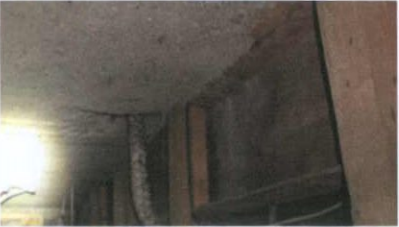
22	No. 59/60 O'Connell Street	Basement office		MMM insulation pipework		No visible asbestos containing materials identified

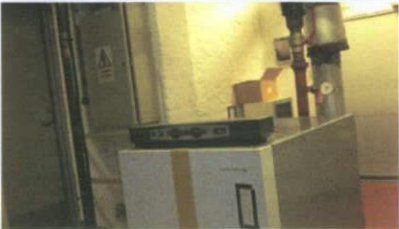
24	No. 59/60 O'Connell Street	Basement main boiler room		Modern boiler unit		No visible asbestos containing materials identified

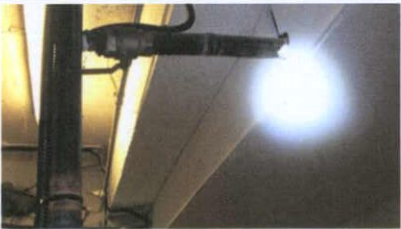
Ref No.	Building	Location or Functional Space	Sample No.	Material Description, surface treatment and condition	Extent	Asbestos identified (presumed, strongly presumed or identified)	Product type	Condition	Surface treatment	Asbestos type	Material assessment score	Recommendations	Photo
25	No. 59/60 O'Connell Street	Basement main boiler room		Plasterboard to ceiling duct.		No visible asbestos containing materials identified

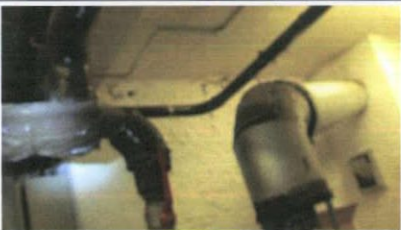
26	No. 59/60 O'Connell Street	Basement main boiler room				No visible asbestos containing materials identified

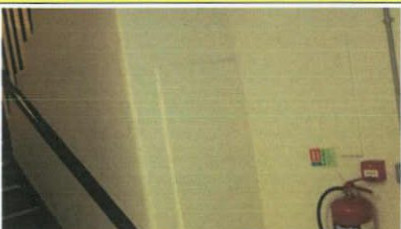
28	No. 59/60 O'Connell Street	Basement back corridor		New panel to duct in corridor.		No visible asbestos containing materials identified

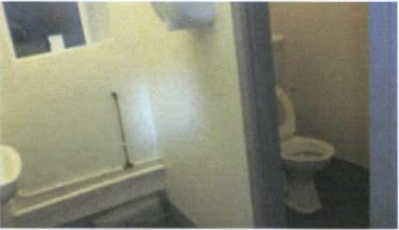
Ref No.	Building	Location or Functional Space	Sample No.	Material Description, surface treatment and condition	Extent	Asbestos identified (presumed, strongly presumed or identified)	Product type	Condition	Surface treatment	Asbestos type	Material assessment score	Recommendations	Photo
29	No. 59/60 O'Connell Street	Basement toilets				No visible asbestos containing materials identified

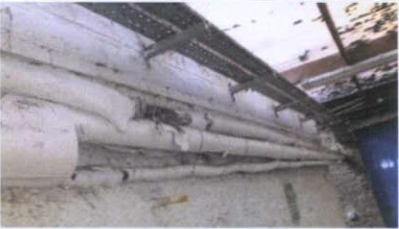
30	No. 59/60 O'Connell Street	Exterior pipe run		Foamrubber insulation to pipework		No visible asbestos containing materials identified

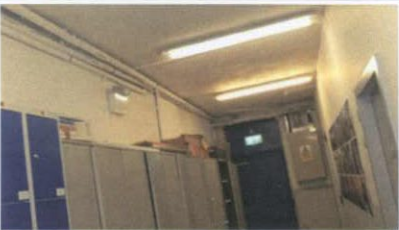
31	No. 59/60 O'Connell Street	Basement locker room				No visible asbestos containing materials identified

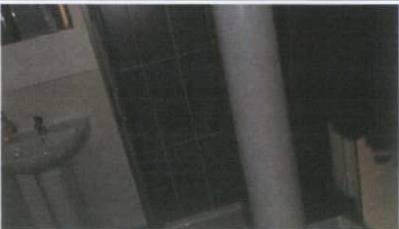
32	No. 59/60 O'Connell Street	Basement Gents WC				No visible asbestos containing materials identified

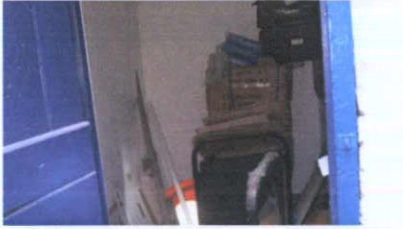
Ref No.	Building	Location or Functional Space	Sample No.	Material Description, surface treatment and condition	Extent	Asbestos identified (presumed, strongly presumed or identified)	Product type	Condition	Surface treatment	Asbestos type	Material assessment score	Recommendations	Photo
33	No. 59/60 O'Connell Street	Garage		Roofs not accessible		Presumed to contain asbestos roofing felts						Investigation by a competent contractor prior to work likely to cause disturbance.	 
34	No. 59/60 O'Connell Street	Garage storeroom				No visible asbestos containing materials identified

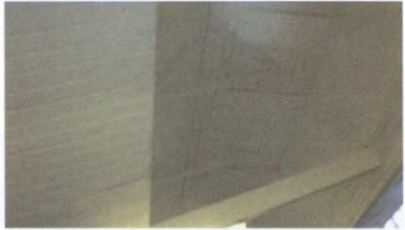
Ref No.	Building	Location or Functional Space	Sample No.	Material Description, surface treatment and condition	Extent	Asbestos identified (presumed, strongly presumed or identified)	Product type	Condition	Surface treatment	Asbestos type	Material assessment score	Recommendations	Photo
37	No. 59/60 O'Connell Street	Ground floor carpark		Timber cladding on roof		No visible asbestos containing materials identified

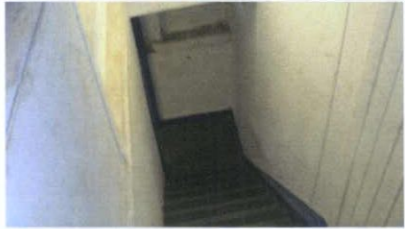
38	No. 59/60 O'Connell Street	Ground floor stairway from carpark				No visible asbestos containing materials identified

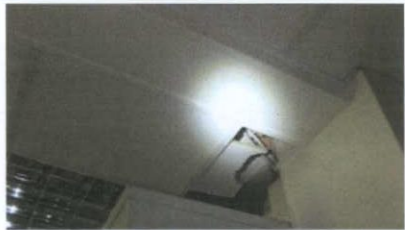
39	No. 59/60 O'Connell Street	Ground floor office				No visible asbestos containing materials identified

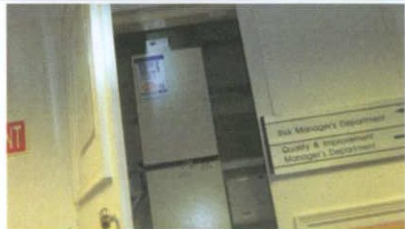
40	No. 59/60 O'Connell Street	Ground floor corridor electrical panel				No visible asbestos containing materials identified

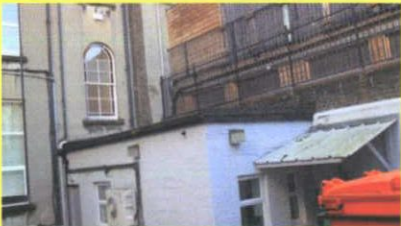
Ref No.	Building	Location or Functional Space	Sample No.	Material Description, surface treatment and condition	Extent	Asbestos identified (presumed, strongly presumed or identified)	Product type	Condition	Surface treatment	Asbestos type	Material assessment score	Recommendations	Photo
41	No. 59/60 O'Connell Street	Ground floor office				No visible asbestos containing materials identified							 
42	No. 59/60 O'Connell Street	Ground floor fire exit				No visible asbestos containing materials identified							 
43	No. 59/60 O'Connell Street	Building exterior flat roof		Substrate roofing felt		Presumed asbestos						investigation by a competent contractor prior to work likely to cause disturbance.

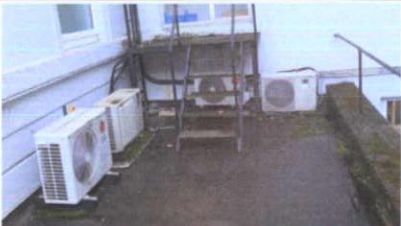
44	No. 59/60 O'Connell Street	Building exterior flat roof		Bitumen asphalt to roof		No visible asbestos containing materials identified

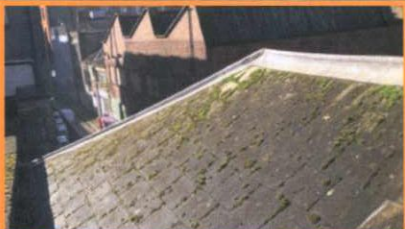
Ref No.	Building	Location or Functional Space	Sample No.	Material Description, surface treatment and condition	Extent	Asbestos identified (presumed, strongly presumed or identified)	Product type	Condition	Surface treatment	Asbestos type	Material assessment score	Recommendations	Photo
45	No. 59/60 O'Connell Street	Building rear annex		AC slates to roof. Good condition. Weathered	15 SM approx.	Chrysotile	1	1	1	1	4	Removal and disposal as asbestos waste prior to work likely to cause disturbance.

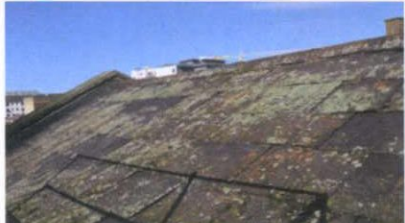
46	No. 59/60 O'Connell Street	Upper rear annex bld.		Natural quarry slates to north pitch?		No visible asbestos containing materials identified

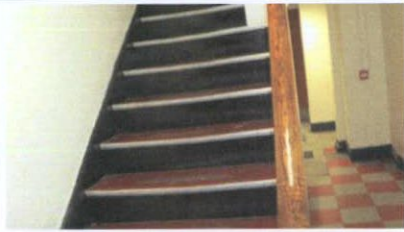
Ref No.	Building	Location or Functional Space	Sample No.	Material Description , surface treatment and condition	Extent	Asbestos identified (presumed, strongly presumed or identified)	Product type	Condition	Surface treatment	Asbestos type	Material assessment score	Recommendations	Photo
49	No. 59/60 O'Connell Street	Basement stairway	2027603	Red Lino		NAD

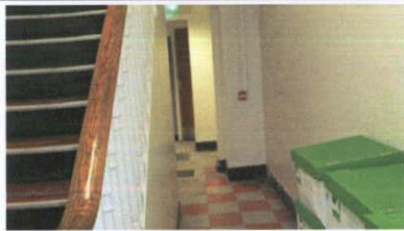
50	No. 59/60 O'Connell Street	Basement corridor		VFT/ Adhesive		NAD

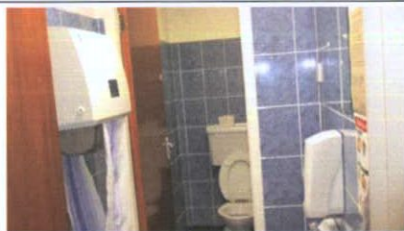
51	No. 59/60 O'Connell Street	Basement ladies WC				No visible asbestos containing materials identified

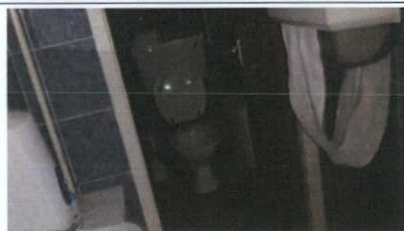
52	No. 59/60 O'Connell Street	Basement mens WC				No visible asbestos containing materials identified

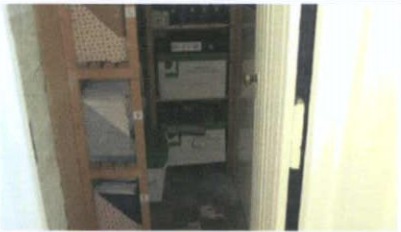
Ref No.	Building	Location or Functional Space	Sample No.	Material Description , surface treatment and condition	Extent	Asbestos identified (presumed, strongly presumed or identified)	Material Assessment Score					Recommendations	Photo
							Product type	Condition	Surface treatment	Asbestos type	Material assessment score		
53	No. 59/60 O'Connell Street	Basement store		Original ceramic floor tiles		No visible asbestos containing materials identified

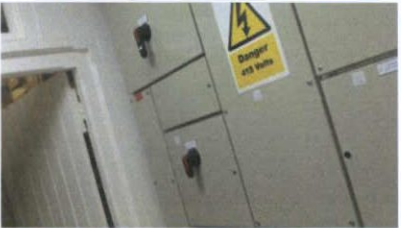
54	No. 59/60 O'Connell Street	Basement electrical panel		Modern electrical panels.		No visible asbestos containing materials identified

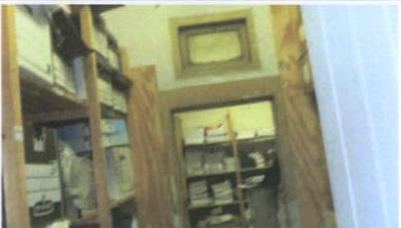
55	No. 59/60 O'Connell Street	No. 60 Basement store				No visible asbestos containing materials identified

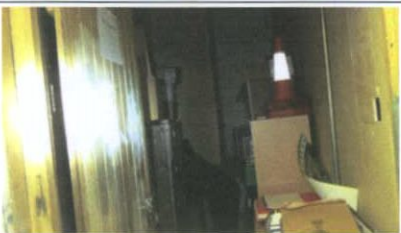
56	No. 59/60 O'Connell Street	No. 60 Basement store				No visible asbestos containing materials identified

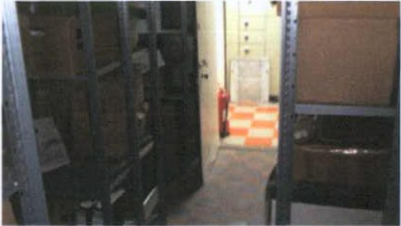
Ref No.	Building	Location or Functional Space	Sample No.	Material Description, surface treatment and condition	Extent	Asbestos identified (presumed, strongly presumed or identified)	Product type	Condition	Surface treatment	Asbestos type	Material assessment score	Recommendations	Photo
57	No. 59/60 O'Connell Street	No. 60 Basement Store				No visible asbestos containing materials identified

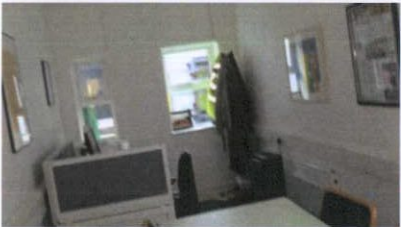
58	No. 59/60 O'Connell Street	No. 60 Basement Store				No visible asbestos containing materials identified

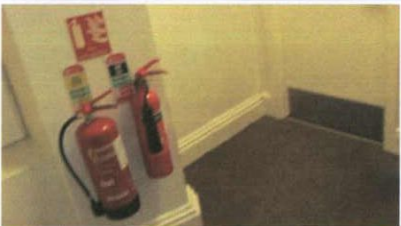
59	No. 59/60 O'Connell Street	No. 60 Basement store				No visible asbestos containing materials identified

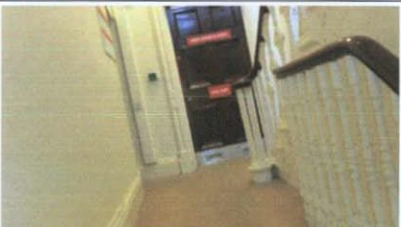
60	No. 59/60 O'Connell Street	No. 60 Ground floor				No visible asbestos containing materials identified

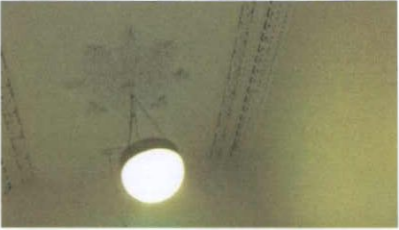
Ref No.	Building	Location or Functional Space	Sample No.	Material Description, surface treatment and condition	Extent	Asbestos identified (presumed, strongly presumed or identified)	Product type	Condition	Surface treatment	Asbestos type	Material assessment score	Recommendations	Photo
61	No. 59/60 O'Connell Street	No. 60 Ground floor front				No visible asbestos containing materials identified

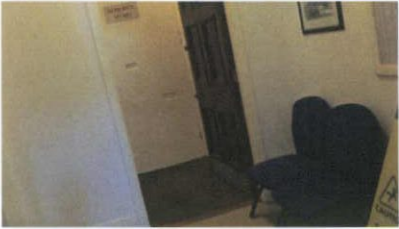
62	No. 59/60 O'Connell Street	Ground floor front offices				No visible asbestos containing materials identified

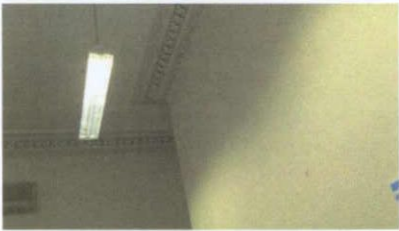
63	No. 59/60 O'Connell Street	Ground floor front corridor				No visible asbestos containing materials identified

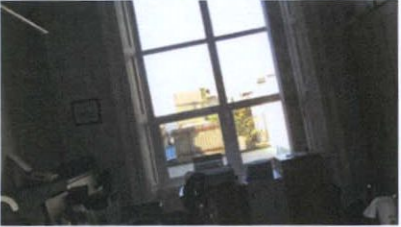
Ref No.	Building	Location or Functional Space	Sample No.	Material Description, surface treatment and condition	Extent	Asbestos identified (presumed, strongly presumed or identified)	Product type	Condition	Surface treatment	Asbestos type	Material assessment score	Recommendations	Photo
65	No. 59/60 O'Connell Street	1 st floor offices				No visible asbestos containing materials identified

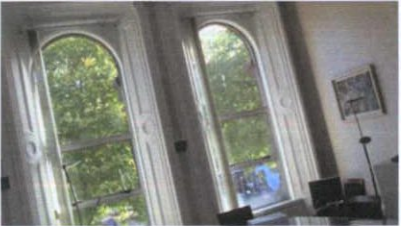
66	No. 59/60 O'Connell Street	1 st floor offices				No visible asbestos containing materials identified

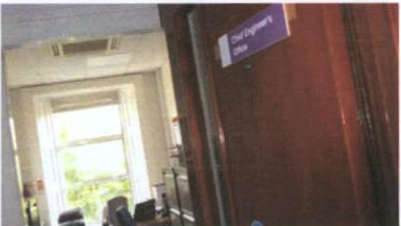
67	No. 59/60 O'Connell Street	2 nd floor Civil Engineers office				No visible asbestos containing materials identified

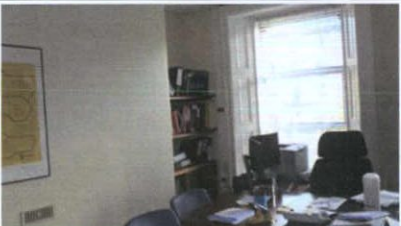
68	No. 59/60 O'Connell Street	2 nd floor Civil Engineers office				No visible asbestos containing materials identified

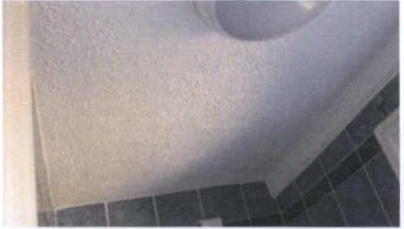
Ref No.	Building	Location or Functional Space	Sample No.	Material Description , surface treatment and condition	Extent	Asbestos identified (presumed, strongly presumed or identified)	Product type	Condition	Surface treatment	Asbestos type	Material assessment score	Recommendations	Photo
69	No. 59/60 O'Connell Street	2 nd floor half landing toilet	2027605	Textured paint	2sm approx.	NAD

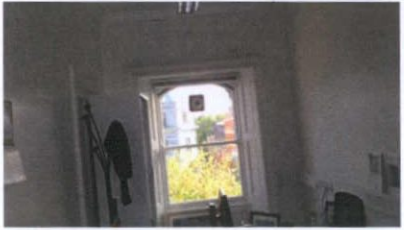
70	No. 59/60 O'Connell Street	3 rd floor Office				No visible asbestos containing materials identified

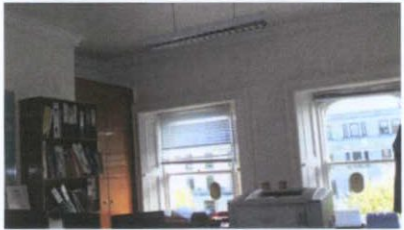
71	No. 59/60 O'Connell Street	3 rd floor Office				No visible asbestos containing materials identified

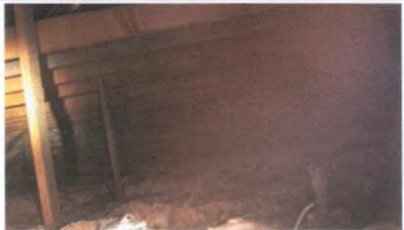
72	No. 59/60 O'Connell Street	3 rd floor attic void		Fiberglass insulation		No visible asbestos containing materials identified

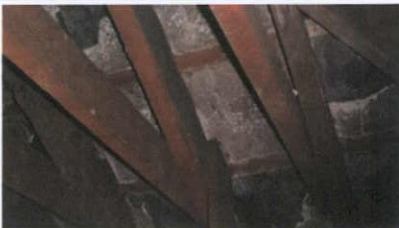
Ref No.	Building	Location or Functional Space	Sample No.	Material Description, surface treatment and condition	Extent	Asbestos identified (presumed, strongly presumed or identified)	Product type	Condition	Surface treatment	Asbestos type	Material assessment score	Recommendations	Photo
73	No. 59/60 O'Connell Street	3 rd floor attic void		Natural quarry slates		No visible asbestos containing materials identified

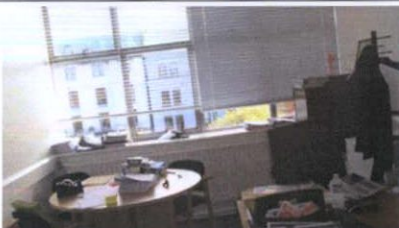
74	No. 59/60 O'Connell Street	3 rd floor Management office				No visible asbestos containing materials identified

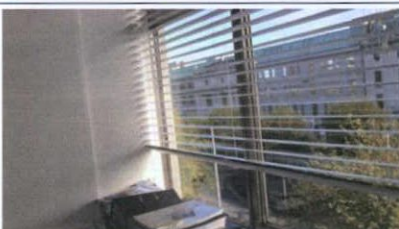
75	No. 59/60 O'Connell Street	3 rd floor Management office		Window frames internally		No visible asbestos containing materials identified

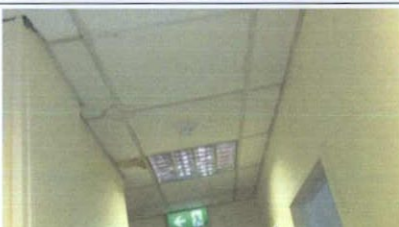
76	No. 59/60 O'Connell Street	3 rd floor Management office Corridor				No visible asbestos containing materials identified

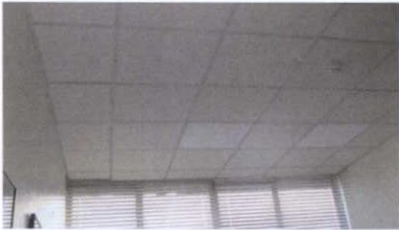
Ref No.	Building	Location or Functional Space	Sample No.	Material Description, surface treatment and condition	Extent	Asbestos identified (presumed, strongly presumed or identified)	Product type	Condition	Surface treatment	Asbestos type	Material assessment score	Recommendations	Photo
77	No. 59/60 O'Connell Street	3 rd floor Offices		Concrete over drop ceiling. Old perforated softboard ceiling tiles over new ceiling		No visible asbestos containing materials identified

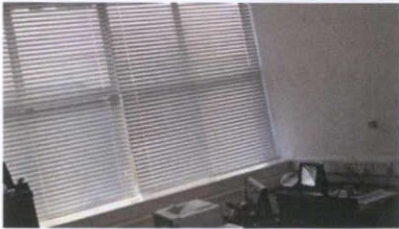
78	No. 59/60 O'Connell Street	3 rd floor Offices				No visible asbestos containing materials identified

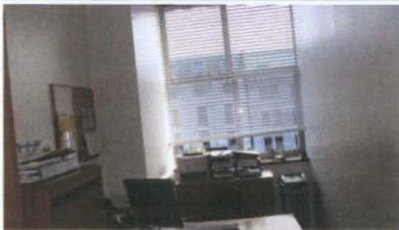
79	No. 59/60 O'Connell Street	3 rd floor Offices				No visible asbestos containing materials identified

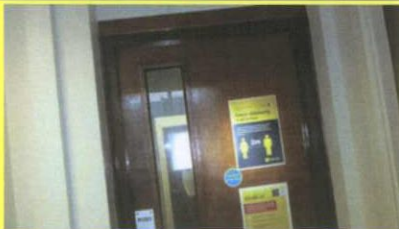
80	No. 59/60 O'Connell Street	3 rd floor Offices		Integral areas of fire doors		Presumed to contain asbestos						investigation by a competent contractor prior to work likely to cause disturbance.

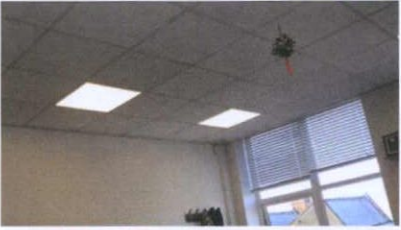
Ref No.	Building	Location or Functional Space	Sample No.	Material Description, surface treatment and condition	Extent	Asbestos identified (presumed, strongly presumed or identified)	Product type	Condition	Surface treatment	Asbestos type	Material assessment score	Recommendations	Photo
81	No. 59/60 O'Connell Street	3 rd floor Offices				No visible asbestos containing materials identified

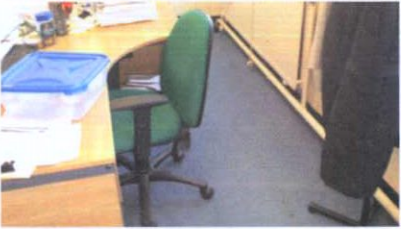
82	No. 59/60 O'Connell Street	3 rd floor Offices				No visible asbestos containing materials identified

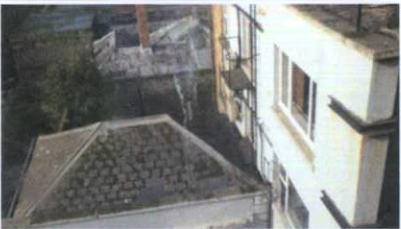
83	No. 59/60 O'Connell Street	3 rd floor Offices				No visible asbestos containing materials identified

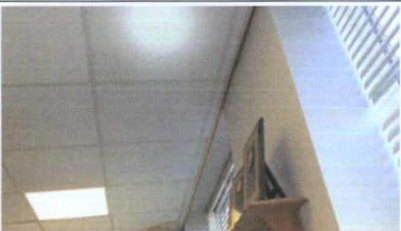
84	No. 59/60 O'Connell Street	3 rd floor Offices				No visible asbestos containing materials identified

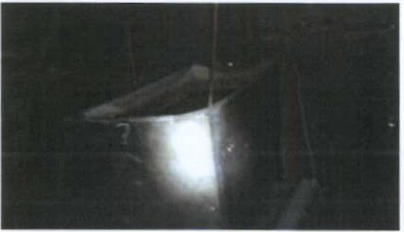
Ref No.	Building	Location or Functional Space	Sample No.	Material Description, surface treatment and condition	Extent	Asbestos identified (presumed, strongly presumed or identified)	Product type	Condition	Surface treatment	Asbestos type	Material assessment score	Recommendations	Photo
85	No. 59/60 O'Connell Street	Roof Tank room				No visible asbestos containing materials identified

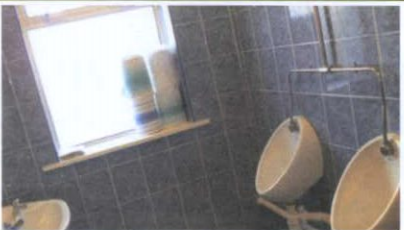
87	No. 59/60 O'Connell Street	2 nd floor WC				No visible asbestos containing materials identified

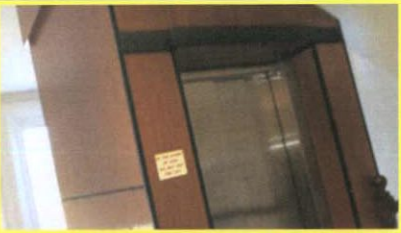
Ref No.	Building	Location or Functional Space	Sample No.	Material Description, surface treatment and condition	Extent	Asbestos identified (presumed, strongly presumed or identified)	Product type	Condition	Surface treatment	Asbestos type	Material assessment score	Recommendations	Photo
89	No. 59/60 O'Connell Street	2 nd floor lobby		Fireboard linings on internal core of the lift.		Presumed asbestos						investigation by a competent contractor prior to work likely to cause disturbance.

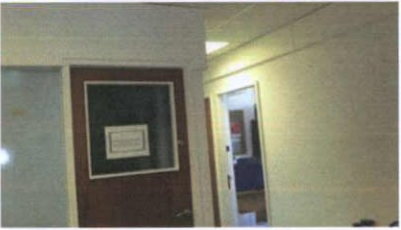
90	No. 59/60 O'Connell Street	3 rd floor corridor				No visible asbestos containing materials identified

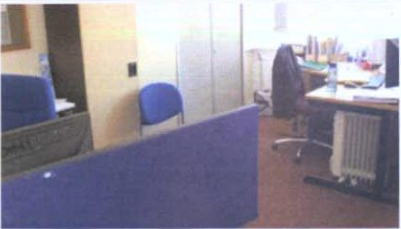
91	No. 59/60 O'Connell Street	3 rd floor room 205				No visible asbestos containing materials identified

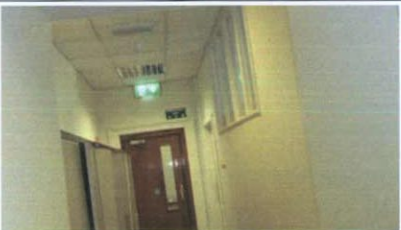
92	No. 59/60 O'Connell Street	3 rd floor corridor				No visible asbestos containing materials identified

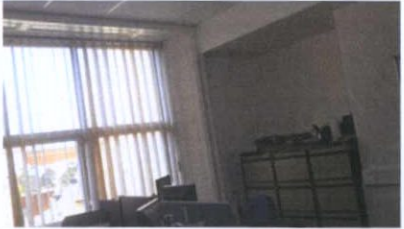
Ref No.	Building	Location or Functional Space	Sample No.	Material Description, surface treatment and condition	Extent	Asbestos identified (presumed, strongly presumed or identified)	Product type	Condition	Surface treatment	Asbestos type	Material assessment score	Recommendations	Photo
93	No. 59/60 O'Connell Street	3 rd floor Management accounts office				No visible asbestos containing materials identified

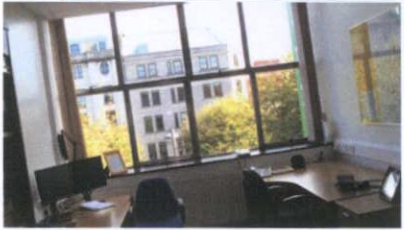
94	No. 59/60 O'Connell Street	3 rd floor room 207				No visible asbestos containing materials identified

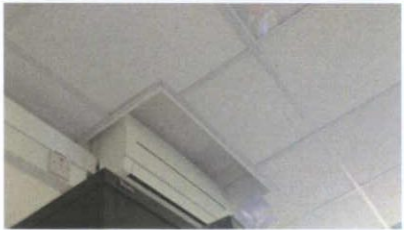
95	No. 59/60 O'Connell Street	3 rd floor room 207		Original softboard ceiling tile		No visible asbestos containing materials identified

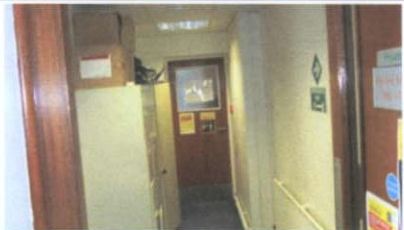
96	No. 59/60 O'Connell Street	3 rd floor room				No visible asbestos containing materials identified

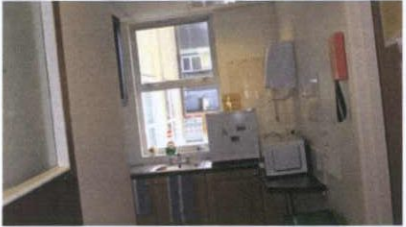
Ref No.	Building	Location or Functional Space	Sample No.	Material Description, surface treatment and condition	Extent	Asbestos identified (presumed, strongly presumed or identified)	Product type	Condition	Surface treatment	Asbestos type	Material assessment score	Recommendations	Photo
97	No. 59/60 O'Connell Street	3 rd floor kitchen				No visible asbestos containing materials identified

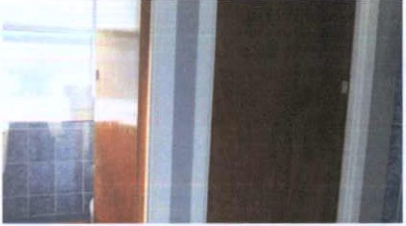
98	No. 59/60 O'Connell Street	3 rd floor Ladies WC		Ceramic tiles		No visible asbestos containing materials identified

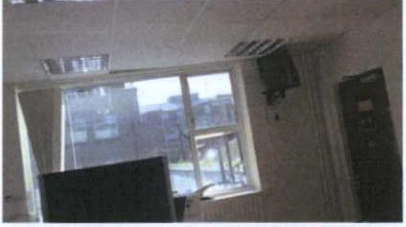
99	No. 59/60 O'Connell Street	3 rd floor HR Department				No visible asbestos containing materials identified

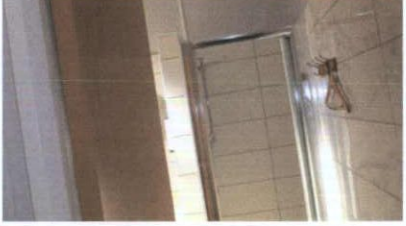
100	No. 59/60 O'Connell Street	3 rd floor WC				No visible asbestos containing materials identified

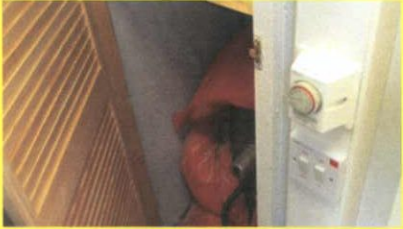
Ref No.	Building	Location or Functional Space	Sample No.	Material Description, surface treatment and condition	Extent	Asbestos identified (presumed, strongly presumed or identified)	Product type	Condition	Surface treatment	Asbestos type	Material assessment score	Recommendations	Photo
101	No. 59/60 O'Connell Street	3 rd Floor WC		Immersion flange gasket		Presumed						investigation by a competent contractor prior to work likely to cause disturbance.

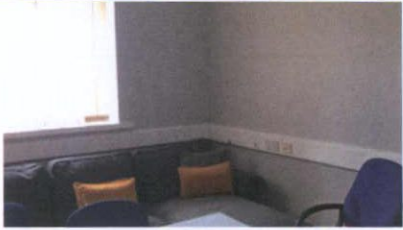
102	No. 59/60 O'Connell Street	3 rd floor Office				No visible asbestos containing materials identified

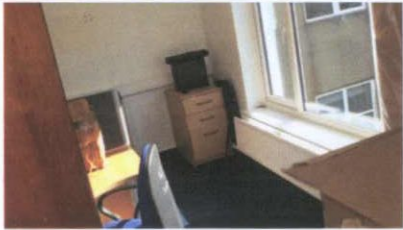
103	No. 59/60 O'Connell Street	3 rd floor Office				No visible asbestos containing materials identified

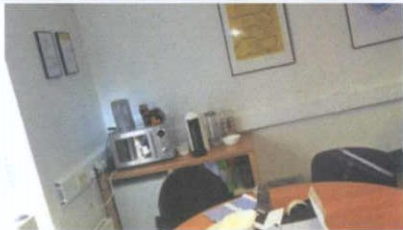
104	No. 59/60 O'Connell Street	1 st floor Office				No visible asbestos containing materials identified

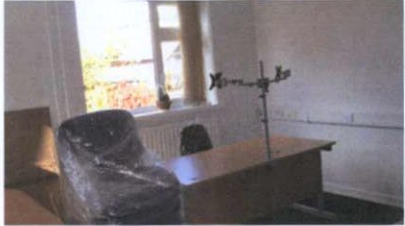
Ref No.	Building	Location or Functional Space	Sample No.	Material Description, surface treatment and condition	Extent	Asbestos identified (presumed, strongly presumed or identified)	Product type	Condition	Surface treatment	Asbestos type	Material assessment score	Recommendations	Photo
105	No. 59/60 O'Connell Street	1 st floor Office				No visible asbestos containing materials identified

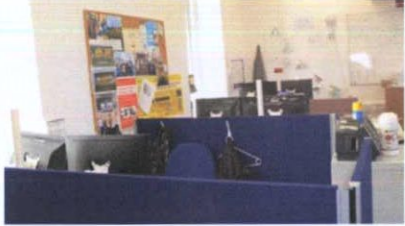
106	No. 59/60 O'Connell Street	1 st floor Personnel and HR Office				No visible asbestos containing materials identified

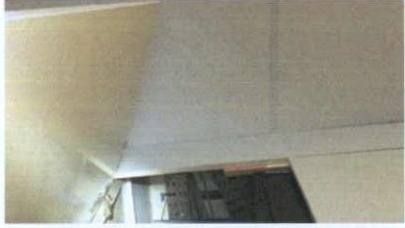
107	No. 59/60 O'Connell Street	1 st floor Personnel and HR Office				No visible asbestos containing materials identified

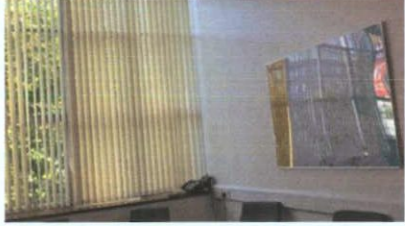
108	No. 59/60 O'Connell Street	1 st floor				No visible asbestos containing materials identified

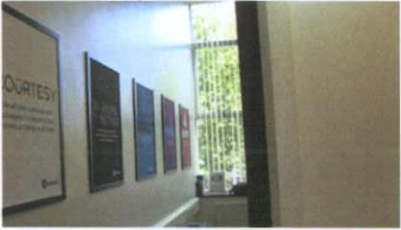
Ref No.	Building	Location or Functional Space	Sample No.	Material Description, surface treatment and condition	Extent	Asbestos identified (presumed, strongly presumed or identified)	Product type	Condition	Surface treatment	Asbestos type	Material assessment score	Recommendations	Photo
109	No. 59/60 O'Connell Street	1 st floor				No visible asbestos containing materials identified

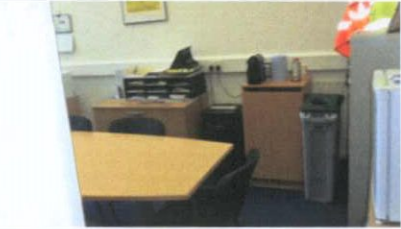
110	No. 59/60 O'Connell Street	1 st floor				No visible asbestos containing materials identified

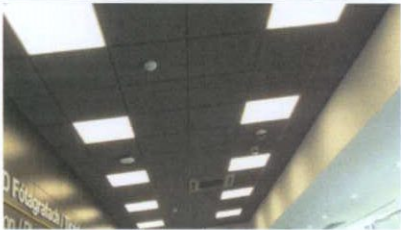
111	No. 59/60 O'Connell Street	Ground floor public counter				No visible asbestos containing materials identified

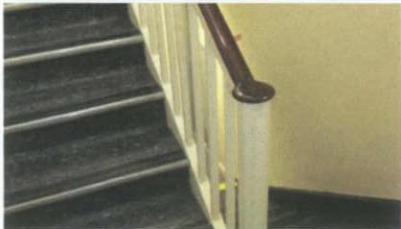
112	No. 59/60 O'Connell Street	Ground floor stairway				No visible asbestos containing materials identified

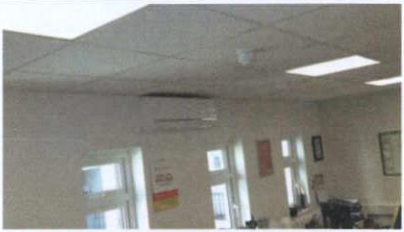
Ref No.	Building	Location or Functional Space	Sample No.	Material Description, surface treatment and condition	Extent	Asbestos identified (presumed, strongly presumed or identified)	Product type	Condition	Surface treatment	Asbestos type	Material assessment score	Recommendations	Photo
113	No. 59/60 O'Connell Street	Back annex Ground floor				No visible asbestos containing materials identified

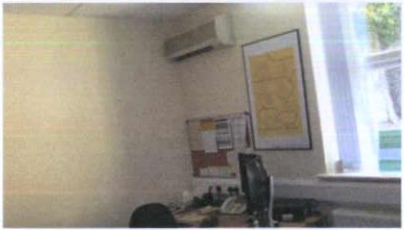
114	No. 59/60 O'Connell Street	Back offices ground floor				No visible asbestos containing materials identified

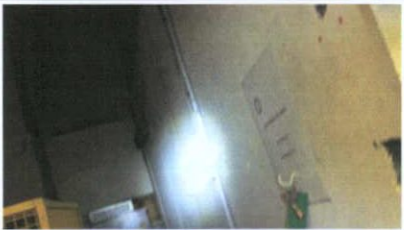
115	No. 59/60 O'Connell Street	Lift Plant room	2027605	Supalux panels to sides of room		NAD

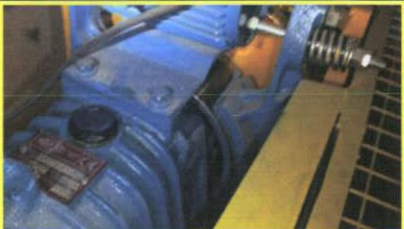
116	No. 59/60 O'Connell Street	Lift Plant room 4 th floor		Brake shoes to lift motor		Presumed asbestos						investigation by a competent contractor prior to work likely to cause disturbance.
