**Site Full Name:**  
No. 58 O'Connell Street  
Dublin 1

## Introduction

About Safety Ltd. was instructed to carry out a Refurbishment and Demolition Asbestos Survey of the above property. The survey and sampling was carried out taking cognizance of the requirements of the Health and Safety Executive (UK) document, *HSG 264, Asbestos: The Survey Guide*.

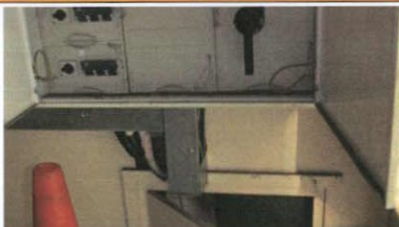
Ref No.	Building or Area of Site	Location or Functional Space	Sample No.	Material Description, surface treatment and condition	Extent	Asbestos identified (presumed, strongly presumed or identified)	Product type	Condition	Surface treatment	Asbestos type	Material assessment score	Recommendations	Photo
1	No. 58 O'Connell St.	Ground floor Entrance lobby		PVC cladding under original ceiling		No visible asbestos containing materials identified.							 
2	No. 58 O'Connell St.	Ground floor Entrance lobby	2028421	Black adhesive under VFT and Evode	Small amount	Chrysotile	1	0	0	1	2	Removal and disposal as asbestos waste by a competent contractor prior to work likely to cause disturbance.	 
3	No. 58 O'Connell St.	Ground floor Entrance lobby Electrical cupboard		Electrical assemblies		No visible asbestos containing materials identified.

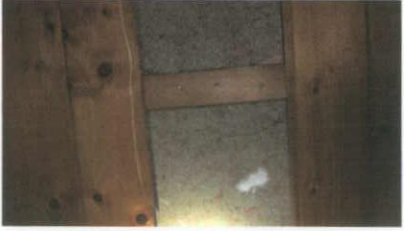
8	No. 58 O'Connell St.	Basement	2028427	Wall bonding plaster		No visible asbestos containing materials identified.

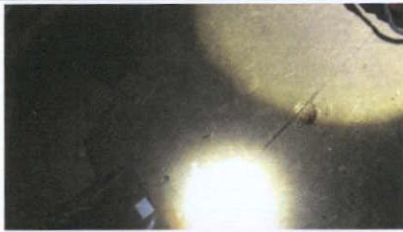
Ref No.	Building or Area of Site	Location or Functional Space	Sample No.	Material Description , surface treatment and condition	Extent	Asbestos identified (presumed, strongly presumed or identified)	Product type	Condition	Surface treatment	Asbestos type	Material assessment score	Recommendations	Photo
9	No. 58 O'Connell St.	Basement	2028423	Lino over concrete		No visible asbestos containing materials identified.

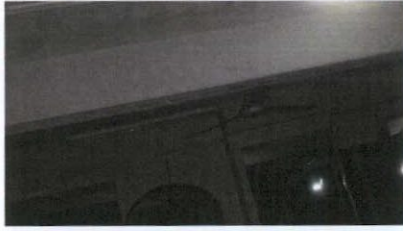
10	No. 58 O'Connell St.	Basement ceilings		Textured coating	2028426	No visible asbestos containing materials identified.

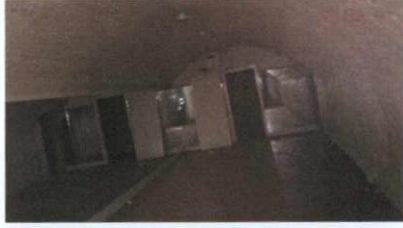
11	No. 58 O'Connell St.	Basement Back of building.				No visible asbestos containing materials identified.

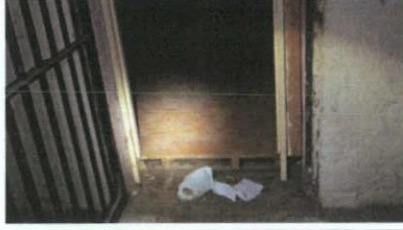
12	No. 58 O'Connell St.	Basement Back of building.		Raised timber floor		No visible asbestos containing materials identified.

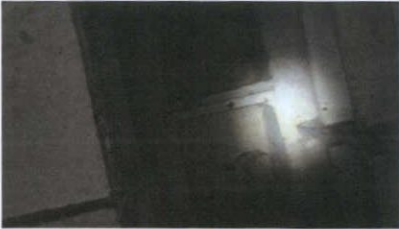
Ref No.	Building or Area of Site	Location or Functional Space	Sample No.	Material Description, surface treatment and condition	Extent	Asbestos identified (presumed, strongly presumed or identified)	Product type	Condition	Surface treatment	Asbestos type	Material assessment score	Recommendations	Photo
13	No. 58 O'Connell St.	Basement Wine cellar				No visible asbestos containing materials identified.

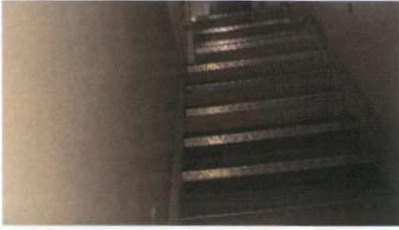
14	No. 58 O'Connell St.	Grund floor stairway				No visible asbestos containing materials identified.

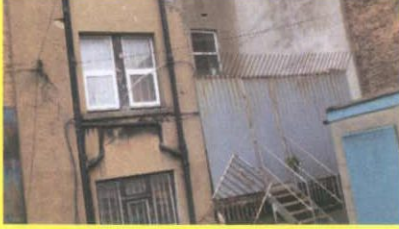
16	No. 58 O'Connell St.	1 <sup>st</sup> Floor Back decked area		Roof under decking not accessible		Presumed asbestos felts						Investigate prior to work likely to cause disturbance.

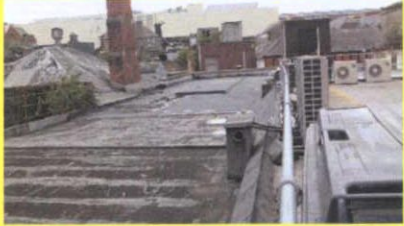
Ref No.	Building or Area of Site	Location or Functional Space	Sample No.	Material Description, surface treatment and condition	Extent	Asbestos identified (presumed, strongly presumed or identified)	Product type	Condition	Surface treatment	Asbestos type	Material assessment score	Recommendations	Photo
17	No. 58 O'Connell St.	Flat roofs		Substrate roofing felts		Presumed asbestos						Investigation by a competent contractor prior to work likely to cause disturbance.

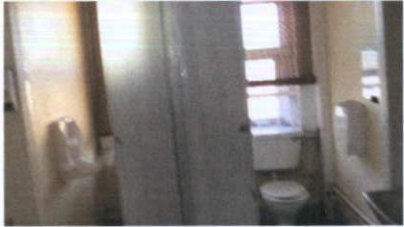
18	No. 58 O'Connell St.	2 <sup>nd</sup> floor Half landing		Terrazzo floor Ceramic toileware		No visible asbestos containing materials identified.

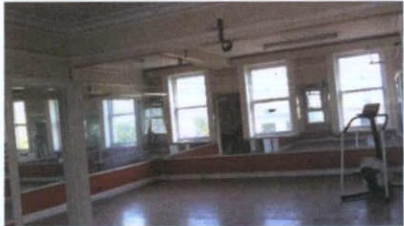
19	No. 58 O'Connell St.	2 <sup>nd</sup> floor				No visible asbestos containing materials identified.

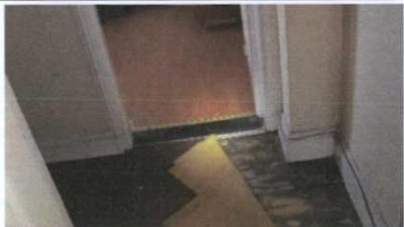
20	No. 58 O'Connell St.	2 <sup>nd</sup> floor		Original timber floors under laminate and carpets.		No visible asbestos containing materials identified.

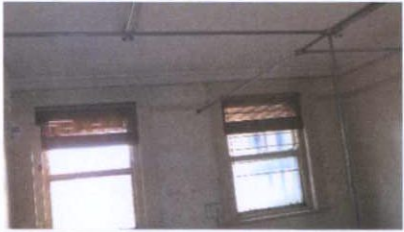
Ref No.	Building or Area of Site	Location or Functional Space	Sample No.	Material Description, surface treatment and condition	Extent	Asbestos identified (presumed, strongly presumed or identified)	Product type	Condition	Surface treatment	Asbestos type	Material assessment score	Recommendations	Photo
21	No. 58 O'Connell St.	2 <sup>nd</sup> floor		Original timber floors under laminate and carpets.		No visible asbestos containing materials identified.

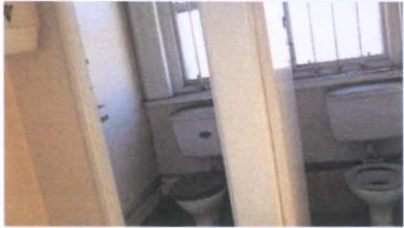
22	No. 58 O'Connell St.	3 <sup>rd</sup> floor Half landing WC's		Terrazzo floors Ceramic toileware		No visible asbestos containing materials identified.

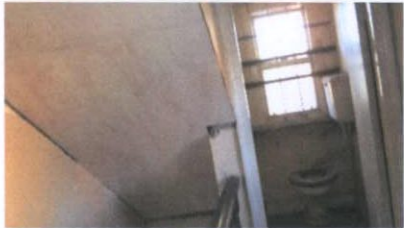
23	No. 58 O'Connell St.	3 <sup>rd</sup> floor WC				No visible asbestos containing materials identified.

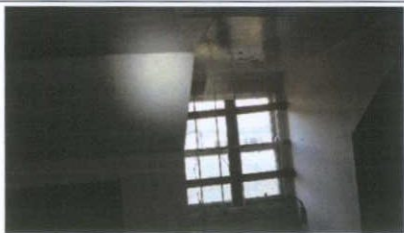
24	No. 58 O'Connell St.	3 <sup>rd</sup> floor Front room				No visible asbestos containing materials identified.

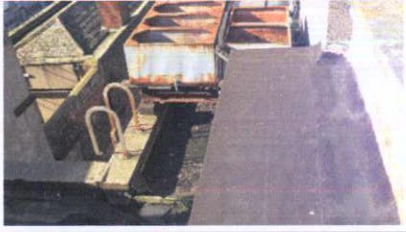
26	No. 58 O'Connell St.	Roof Flat roof	2028430	Substrate roofing felt		NAD

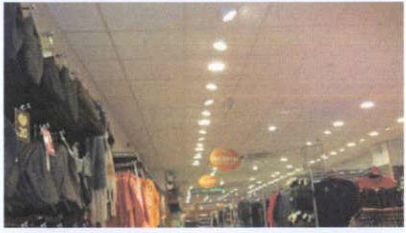
27	No. 58 O'Connell St.	Ground floor		Modern drop ceilings with lay-in ceiling tiles. Ceramic floor tiles.		No visible asbestos containing materials identified.

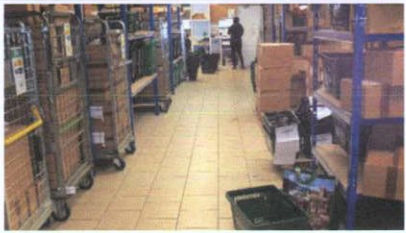
28	No. 58 O'Connell St.	Ground floor Back store room		Ceramic tiles to floor		No visible asbestos containing materials identified.

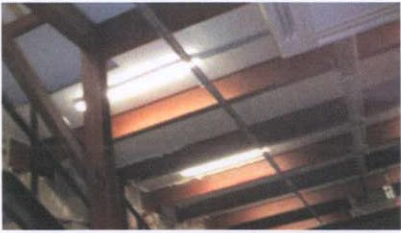
Ref No.	Building or Area of Site	Location or Functional Space	Sample No.	Material Description, surface treatment and condition	Extent	Asbestos identified (presumed, strongly presumed or identified)	Product type	Condition	Surface treatment	Asbestos type	Material assessment score	Recommendations	Photo
29	No. 58 O'Connell St.	Ground floor Back stores		Modern insulation roof sheeting		No visible asbestos containing materials identified.

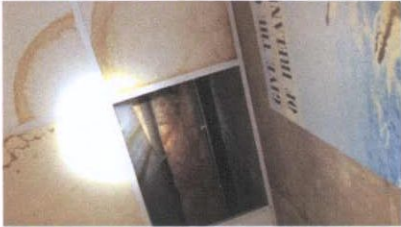
30	No. 58 O'Connell St.	Ground floor Back stores		MMMF insulation between floor joists in ceiling void		No visible asbestos containing materials identified.

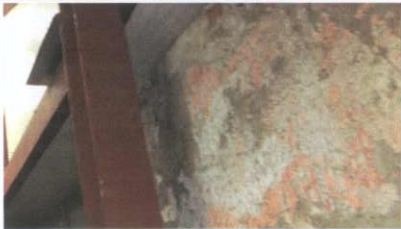
31	No. 58 O'Connell St.	Ground floor stores Old wall beside No. 59	2029304	Old wall paint		NAD

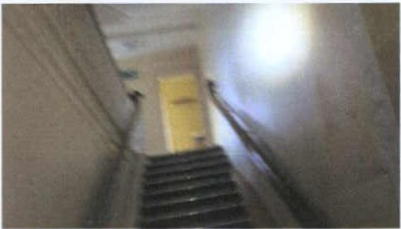
Ref No.	Building or Area of Site	Location or Functional Space	Sample No.	Material Description, surface treatment and condition	Extent	Asbestos identified (presumed, strongly presumed or identified)	Product type	Condition	Surface treatment	Asbestos type	Material assessment score	Recommendations	Photo
1	No. 43 O'Connell St.			Plastic thread 12osings to stairway		No visible asbestos containing materials identified.

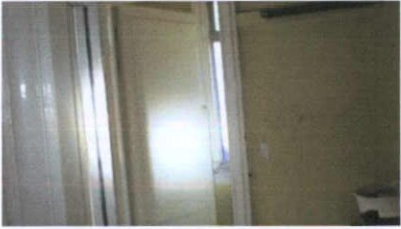
2	No. 43 O'Connell St.	1 <sup>st</sup> floor Landing WC				No visible asbestos containing materials identified.

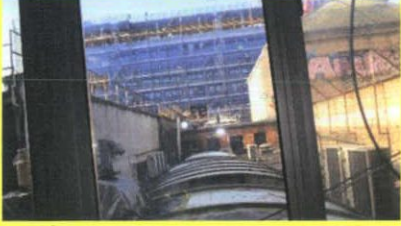
4	No. 43 O'Connell St.	Back buildings and roof		No access		Presumed to contain asbestos						Investigation prior to work likely to cause disturbance.

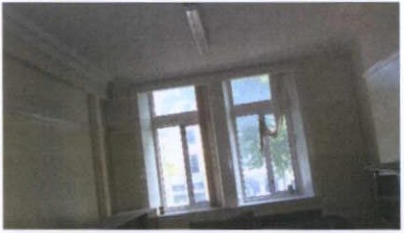
Ref No.	Building or Area of Site	Location or Functional Space	Sample No.	Material Description, surface treatment and condition	Extent	Asbestos identified (presumed, strongly presumed or identified)	Product type	Condition	Surface treatment	Asbestos type	Material assessment score	Recommendations	Photo
5	No. 43 O'Connell St.	1 <sup>st</sup> floor				No visible asbestos containing materials identified.

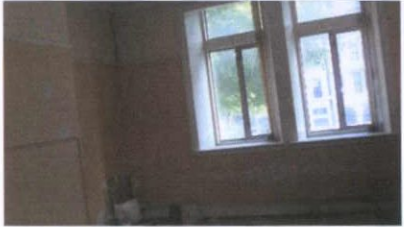
6	No. 43 O'Connell St.	1 <sup>st</sup> floor				No visible asbestos containing materials identified.

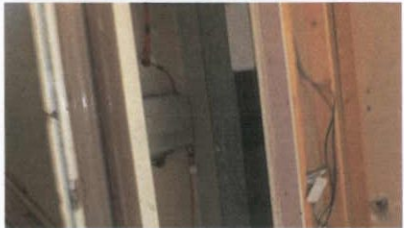
7	No. 43 O'Connell St.	1 <sup>st</sup> floor Service riser				No visible asbestos containing materials identified.

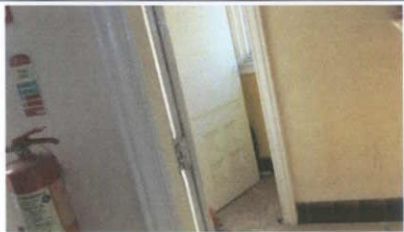
8	No. 43 O'Connell St.	2 <sup>nd</sup> floor Half landing WC				No visible asbestos containing materials identified.

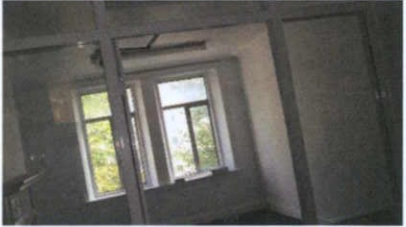
Ref No.	Building or Area of Site	Location or Functional Space	Sample No.	Material Description, surface treatment and condition	Extent	Asbestos identified (presumed, strongly presumed or identified)	Product type	Condition	Surface treatment	Asbestos type	Material assessment score	Recommendations	Photo
9	No. 43 O'Connell St.	2 <sup>nd</sup> floor Front room				No visible asbestos containing materials identified.

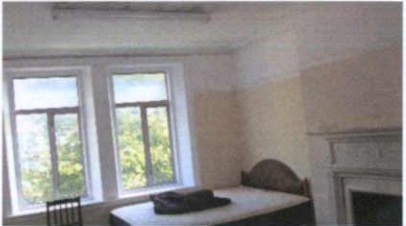
10	No. 43 O'Connell St.	2 <sup>nd</sup> floor Front room				No visible asbestos containing materials identified.

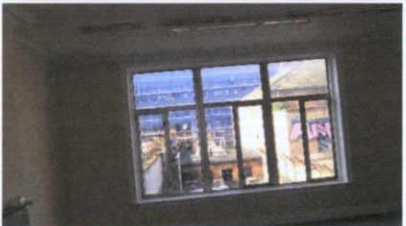
11	No. 43 O'Connell St.	2 <sup>nd</sup> floor Back room				No visible asbestos containing materials identified.

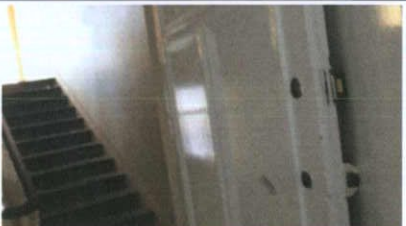
12	No. 43 O'Connell St.	2 <sup>nd</sup> floor		Integral areas of fire doors contain Supalux linings		No visible asbestos containing materials identified.

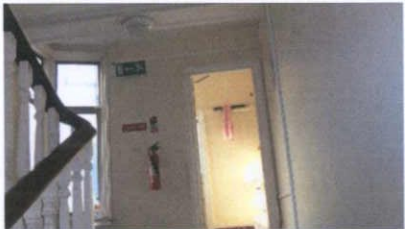
Ref No.	Building or Area of Site	Location or Functional Space	Sample No.	Material Description, surface treatment and condition	Extent	Asbestos identified (presumed, strongly presumed or identified)	Product type	Condition	Surface treatment	Asbestos type	Material assessment score	Recommendations	Photo
13	No. 43 O'Connell St.	3 <sup>rd</sup> floor Half landing WC				No visible asbestos containing materials identified.

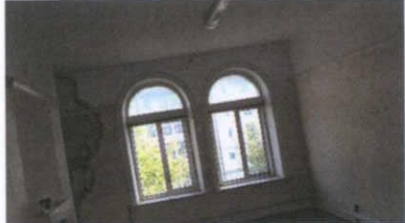
14	No. 43 O'Connell St.	3 <sup>rd</sup> floor Front room				No visible asbestos containing materials identified.

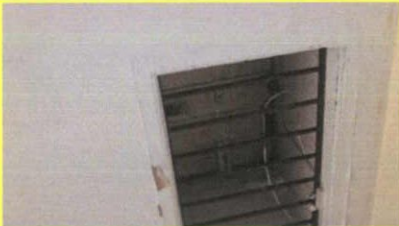
19	No. 43 O'Connell St.	4 <sup>th</sup> floor Roof access		No access padlocked		Presumed to contain asbestos.						Investigation prior to work likely to cause disturbance.

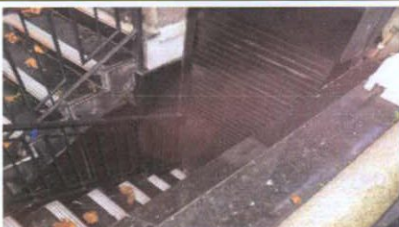
20	No. 43 O'Connell St. Ned Kellys	Front Facade				No visible asbestos containing materials identified.

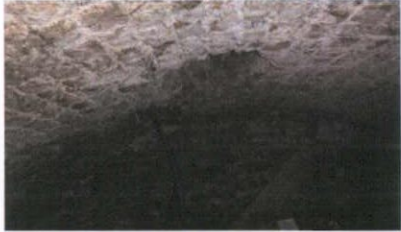
Ref No.	Building or Area of Site	Location or Functional Space	Sample No.	Material Description, surface treatment and condition	Extent	Asbestos identified (presumed, strongly presumed or identified)	Product type	Condition	Surface treatment	Asbestos type	Material assessment score	Recommendations	Photo
21	No. 43 O'Connell St. Ned Kellys	Basement Old Coal Cellar				No visible asbestos containing materials identified.

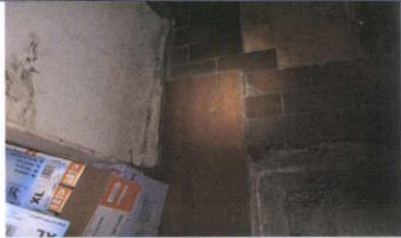
22	No. 43 O'Connell St. Ned Kellys	Basement Floor to coal cellar		Ceramic tiles to floor		No visible asbestos containing materials identified.

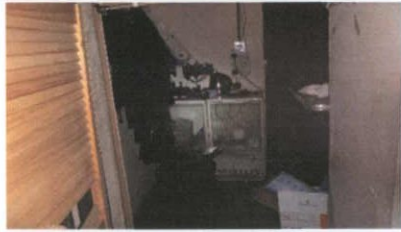
23	No. 43 O'Connell St. Ned Kellys	Basement Office				No visible asbestos containing materials identified.

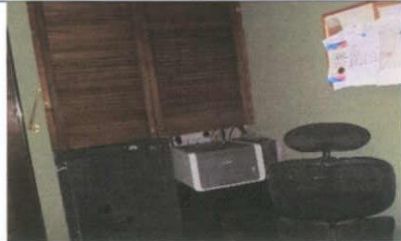
24	No. 43 O'Connell St. Ned Kellys	Ground floor office up spiral stairway				No visible asbestos containing materials identified.

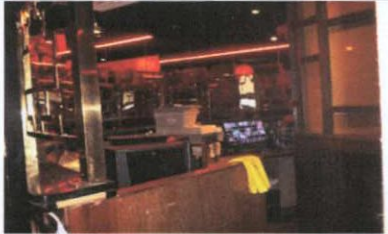
Ref No.	Building or Area of Site	Location or Functional Space	Sample No.	Material Description, surface treatment and condition	Extent	Asbestos identified (presumed, strongly presumed or identified)	Product type	Condition	Surface treatment	Asbestos type	Material assessment score	Recommendations	Photo
25	No. 43 O'Connell St. Ned Kellys	Basement bar				No visible asbestos containing materials identified.

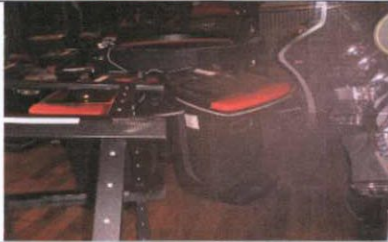
26	No. 43 O'Connell St. Ned Kellys	Basement Gaming machine area				No visible asbestos containing materials identified.

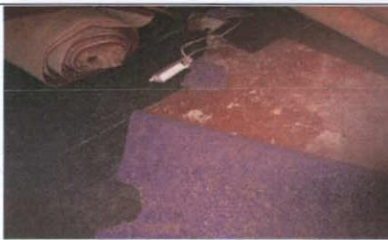
28	No. 43 O'Connell St. Ned Kellys	Basement Centre floor area		Painted concrete floor under carpet		No visible asbestos containing materials identified.

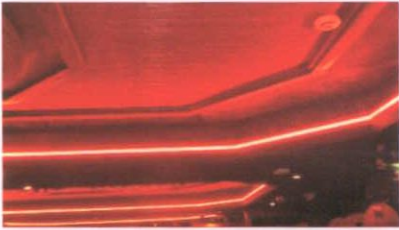
Ref No.	Building or Area of Site	Location or Functional Space	Sample No.	Material Description, surface treatment and condition	Extent	Asbestos identified (presumed, strongly presumed or identified)	Product type	Condition	Surface treatment	Asbestos type	Material assessment score	Recommendations	Photo
29	No. 43 O'Connell St. Ned Kellys	Basement Ceilings				No visible asbestos containing materials identified.

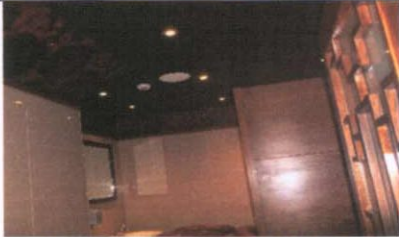
30	No. 43 O'Connell St. Ned Kellys	Basement Gents WC				No visible asbestos containing materials identified.

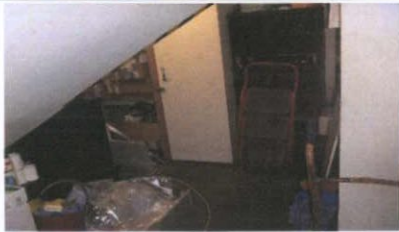
31	No. 43 O'Connell St. Ned Kellys	Basement Store room				No visible asbestos containing materials identified.

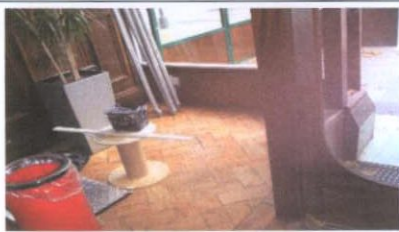
32	No. 43 O'Connell St. Ned Kellys	Ground floor Entrance				No visible asbestos containing materials identified.

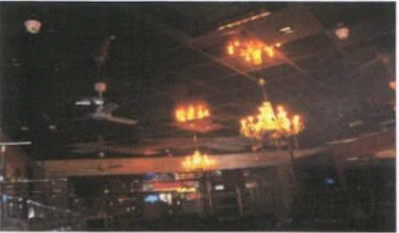
Ref No.	Building or Area of Site	Location or Functional Space	Sample No.	Material Description, surface treatment and condition	Extent	Asbestos identified (presumed, strongly presumed or identified)	Product type	Condition	Surface treatment	Asbestos type	Material assessment score	Recommendations	Photo
37	No. 43 O'Connell St. Ned Kellys	Ground floor Back gaming area				No visible asbestos containing materials identified.

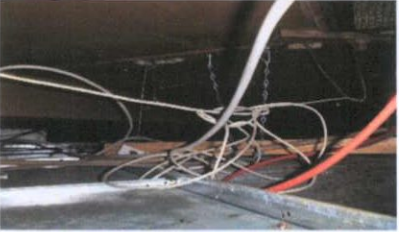
38	No. 43 O'Connell St. Ned Kellys	Ground floor Back gaming area		Lat and plaster ceilings		No visible asbestos containing materials identified.

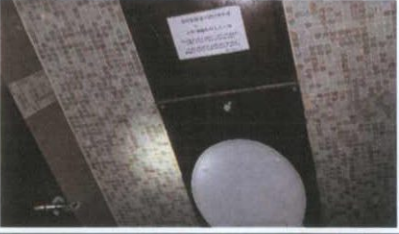
39	No. 43 O'Connell St. Ned Kellys	Ground floor Ladies WC				No visible asbestos containing materials identified.

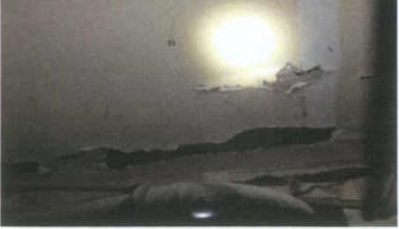
40	No. 43 O'Connell St. Ned Kellys	Ground floor Ladies WC Ceiling void				No visible asbestos containing materials identified.

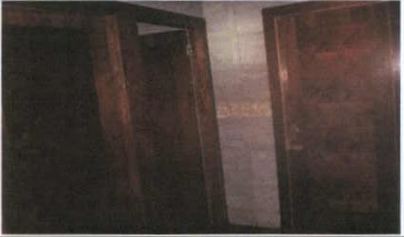
Ref No.	Building or Area of Site	Location or Functional Space	Sample No.	Material Description, surface treatment and condition	Extent	Asbestos identified (presumed, strongly presumed or identified)	Product type	Condition	Surface treatment	Asbestos type	Material assessment score	Recommendations	Photo
41	No. 43 O'Connell St. Ned Kellys	Ground floor Gents WC				No visible asbestos containing materials identified.

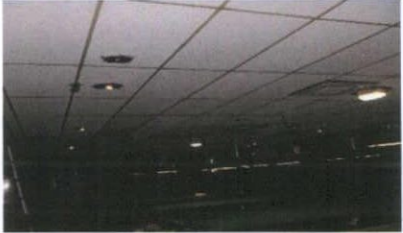
Ref No.	Building or Area of Site	Location or Functional Space	Sample No.	Material Description, surface treatment and condition	Extent	Asbestos identified (presumed, strongly presumed or identified)	Product type	Condition	Surface treatment	Asbestos type	Material assessment score	Recommendations	Photo
45	No. 43 O'Connell St. Ned Kellys	1 <sup>st</sup> floor Snooker room				No visible asbestos containing materials identified.

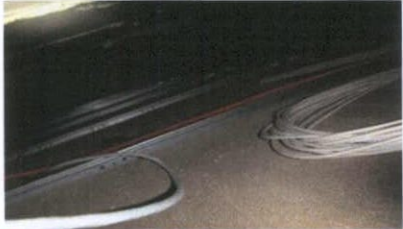
46	No. 43 O'Connell St. Ned Kellys	1 <sup>st</sup> floor Snooker room Ceiling void				No visible asbestos containing materials identified.

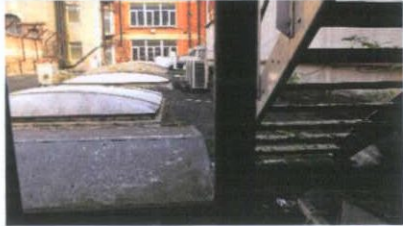
47	No. 43 O'Connell St. Ned Kellys	1 <sup>st</sup> floor Roofs				No visible asbestos containing materials identified.

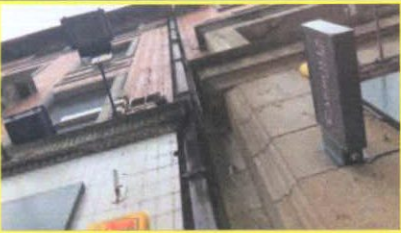
Ref No.	Building or Area of Site	Location or Functional Space	Sample No.	Material Description , surface treatment and condition	Extent	Asbestos identified (presumed, strongly presumed or identified)	Product type	Condition	Surface treatment	Asbestos type	Material assessment score	Recommendations	Photo
1	No. 57 O'Connell St.	Front façade		Lead sealed cast-iron downpipe collars		Presumed to contain asbestos woven rope packing.						Investigation by a competent contractor prior to work likely to cause disturbance.

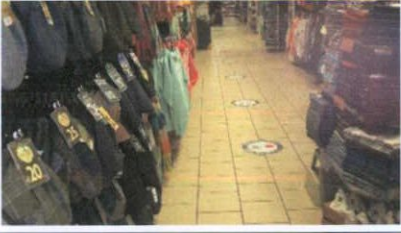
2	No. 57 O'Connell St.	Ground floor Shop.		Ceramic tiles		No visible asbestos containing materials identified.

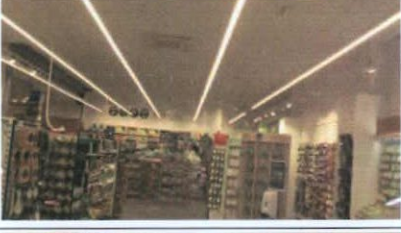
3	No. 57 O'Connell St.	Ground floor Shop.		Modern drop ceiling with lay-in ceiling tiles.		No visible asbestos containing materials identified.

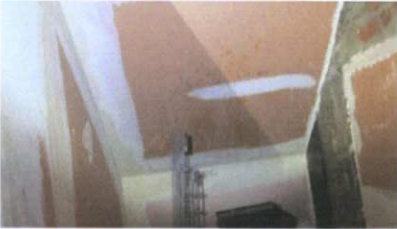
Ref No.	Building or Area of Site	Location or Functional Space	Sample No.	Material Description, surface treatment and condition	Extent	Asbestos identified (presumed, strongly presumed or identified)	Product type	Condition	Surface treatment	Asbestos type	Material assessment score	Recommendations	Photo
5	No. 57 O'Connell St.	Basement		Plasterboard under stairway		No visible asbestos containing materials identified.

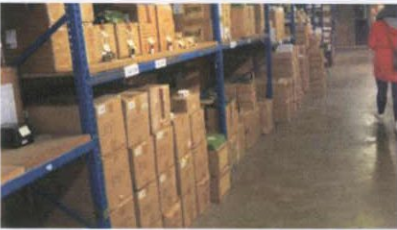
6	No. 57 O'Connell St.	Back stores				No visible asbestos containing materials identified.

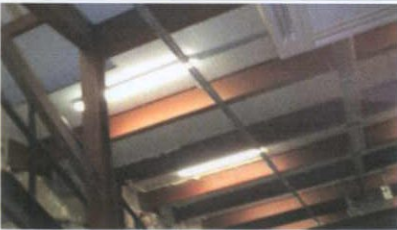
7	No. 57 O'Connell St.	Back store rooms		New insulated profile steel roof over back yard.		No visible asbestos containing materials identified.

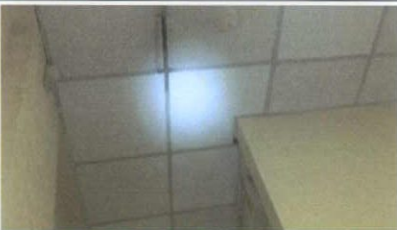
8	No. 57 O'Connell St.	1 <sup>st</sup> floor landing		Drop ceiling with lay-in ceiling tiles		No visible asbestos containing materials identified.

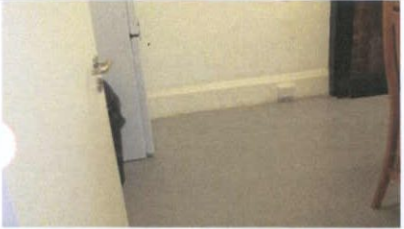
Ref No.	Building or Area of Site	Location or Functional Space	Sample No.	Material Description, surface treatment and condition	Extent	Asbestos identified (presumed, strongly presumed or identified)	Product type	Condition	Surface treatment	Asbestos type	Material assessment score	Recommendations	Photo
13	No. 57 O'Connell St.	1 <sup>st</sup> floor Staff canteen		Lino over floor		No visible asbestos containing materials identified.

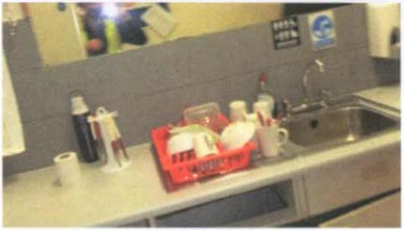
14	No. 57 O'Connell St.	1 <sup>st</sup> floor Kitchen		Lino over floor		No visible asbestos containing materials identified.

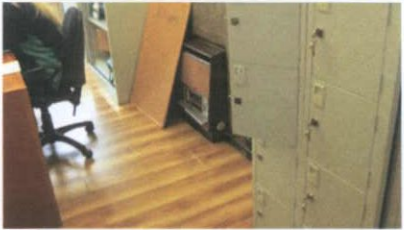
15	No. 57 O'Connell St.	1 <sup>st</sup> floor Offices		Laminate flooring.		No visible asbestos containing materials identified.

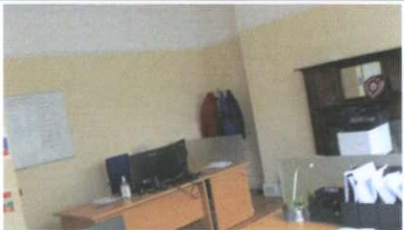
16	No. 57 O'Connell St.	1 <sup>st</sup> floor Offices				No visible asbestos containing materials identified.

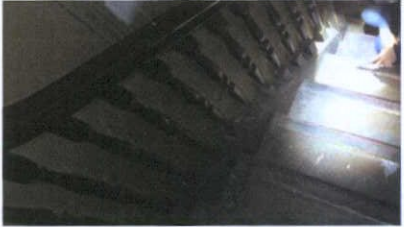
Ref No.	Building or Area of Site	Location or Functional Space	Sample No.	Material Description, surface treatment and condition	Extent	Asbestos identified (presumed, strongly presumed or identified)	Product type	Condition	Surface treatment	Asbestos type	Material assessment score	Recommendations	Photo
17	No. 57 O'Connell St.	1 <sup>st</sup> floor Stairway to 2 <sup>nd</sup> floor	2029301	Brown lino to steps		NAD

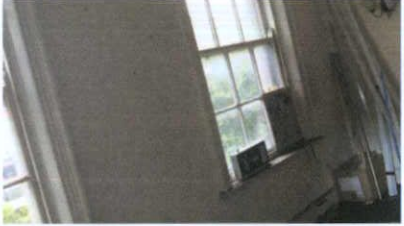
18	No. 57 O'Connell St.	2 <sup>nd</sup> floor Front room				No visible asbestos containing materials identified.

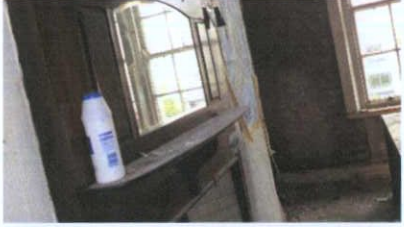
19	No. 57 O'Connell St.	2 <sup>nd</sup> floor Front room				No visible asbestos containing materials identified.

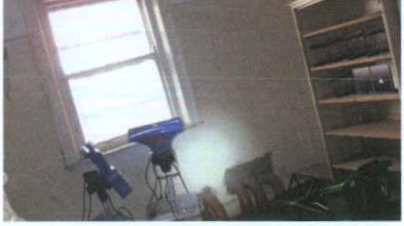
20	No. 57 O'Connell St.	2 <sup>nd</sup> floor Store room				No visible asbestos containing materials identified.

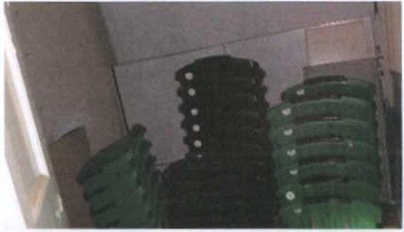
Ref No.	Building or Area of Site	Location or Functional Space	Sample No.	Material Description, surface treatment and condition	Extent	Asbestos identified (presumed, strongly presumed or identified)	Product type	Condition	Surface treatment	Asbestos type	Material assessment score	Recommendations	Photo
21	No. 57 O'Connell St.	2 <sup>nd</sup> floor Store room				No visible asbestos containing materials identified.

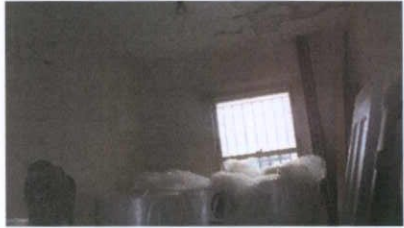
22	No. 57 O'Connell St.	2 <sup>nd</sup> floor Store room				No visible asbestos containing materials identified.

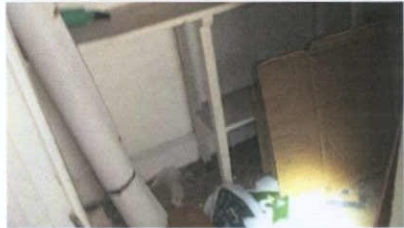
23	No. 57 O'Connell St.	2 <sup>nd</sup> floor Store room				No visible asbestos containing materials identified.

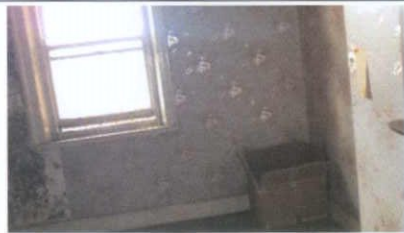
24	No. 57 O'Connell St.	3 <sup>rd</sup> floor Back room				No visible asbestos containing materials identified.

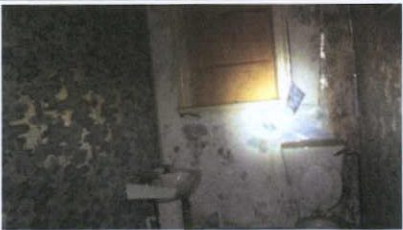
Ref No.	Building or Area of Site	Location or Functional Space	Sample No.	Material Description, surface treatment and condition	Extent	Asbestos identified (presumed, strongly presumed or identified)	Product type	Condition	Surface treatment	Asbestos type	Material assessment score	Recommendations	Photo
25	No. 57 O'Connell St.	3 <sup>rd</sup> floor				No visible asbestos containing materials identified.

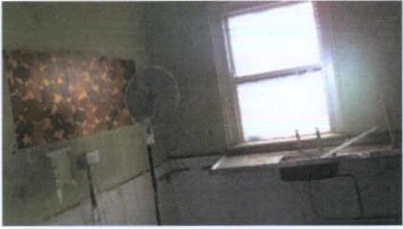
26	No. 57 O'Connell St.	3 <sup>rd</sup> floor				No visible asbestos containing materials identified.

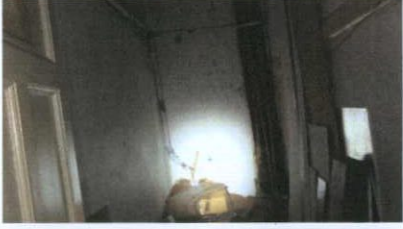
27	No. 57 O'Connell St.	3 <sup>rd</sup> floor				No visible asbestos containing materials identified.

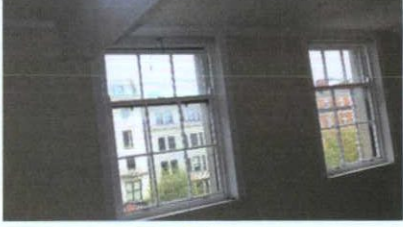
28	No. 57 O'Connell St.	3 <sup>rd</sup> floor Front room	2029302	Textured paint to ceiling		NAD

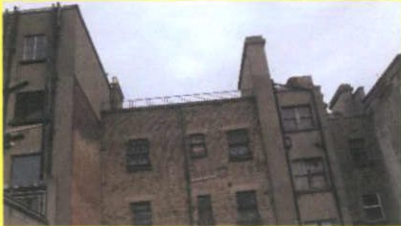
31	No. 57 O'Connell St.	Main Roof		Roofing felts		Presumed asbestos						Investigation by a competent contractor prior to work likely to cause disturbance.

<b>Ref:</b>	<b>Presumed/Strongly Presumed Asbestos</b> [Requires dismantling and investigation by a competent asbestos contractor prior to work likely to cause disturbance.]
<b>1</b>	Roofing felts are presumed to contain asbestos until proven otherwise. No access to roof.
