A4.7.6.2. Summary of forensic analysis findings

A4.7.7 No 11 Moore Street**A4.7.7.1. Significance to 1916**

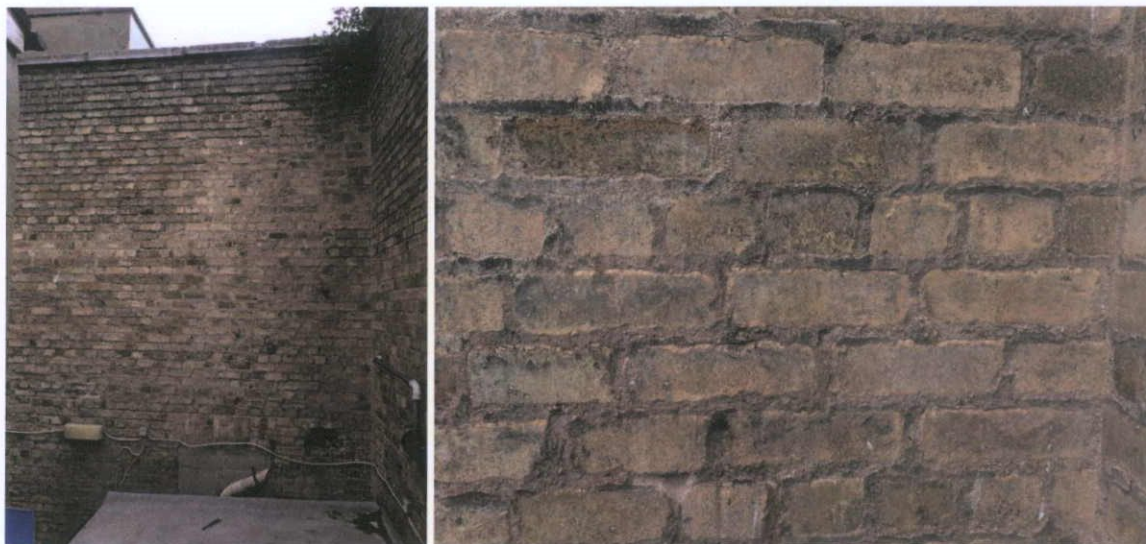
Fig.4.1.1: General view of the brickwork at the rear of 37 Henry Place adjacent to the alley separating Nos.9 and 10 Henry Place.

The rear elevation is adjacent to No.10 Henry Place and was built predominantly with a new yellow stock brick (hereafter referred to as a c.1920 brick) and a small fraction of probably salvaged yellow clamp-fired brick. The pointing was finished 'flush' and the bedding mortar contains a wide range of lithics which are different to those seen in early building in Dublin City, and not likely to have been obtained from a sand pit

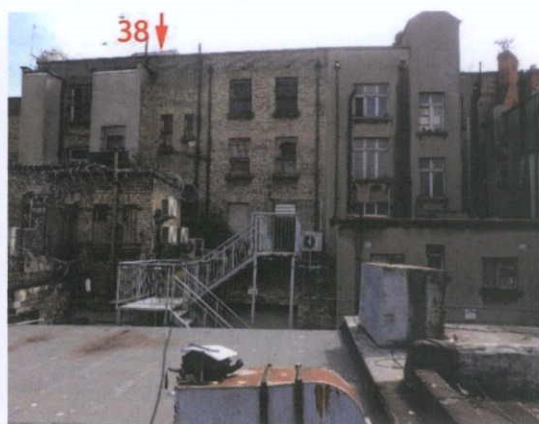
Fig.4.2.3: No.38 Henry Street forming part of a terrace using identical c.1920 yellow stock brick.

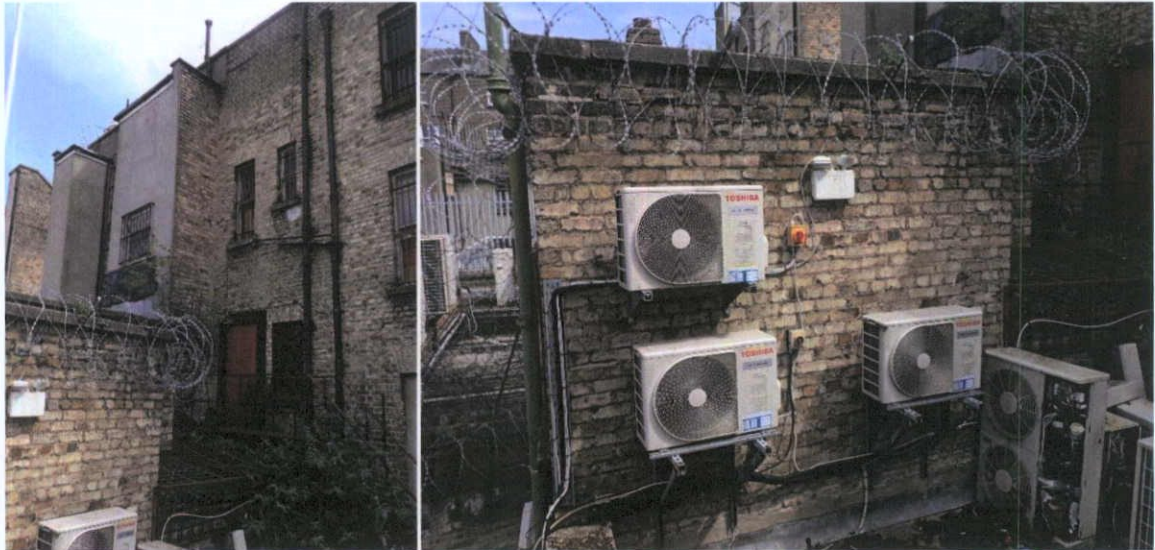
Fig.4.2.4: Yellow stock brick masonry fabric used for the rear and for the return of the building. The same brick is used in the neighbouring rear elevations of Nos.37 and 39 Henry Street, and all three buildings appear to have been erected at the same time.

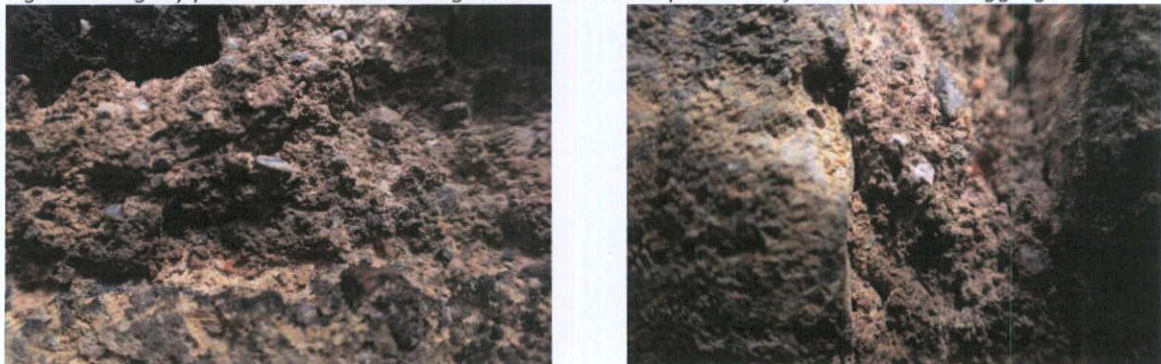
Fig.4.2.6: Crushed brick in the bedding mortars at the rear of No.38 Henry Street.

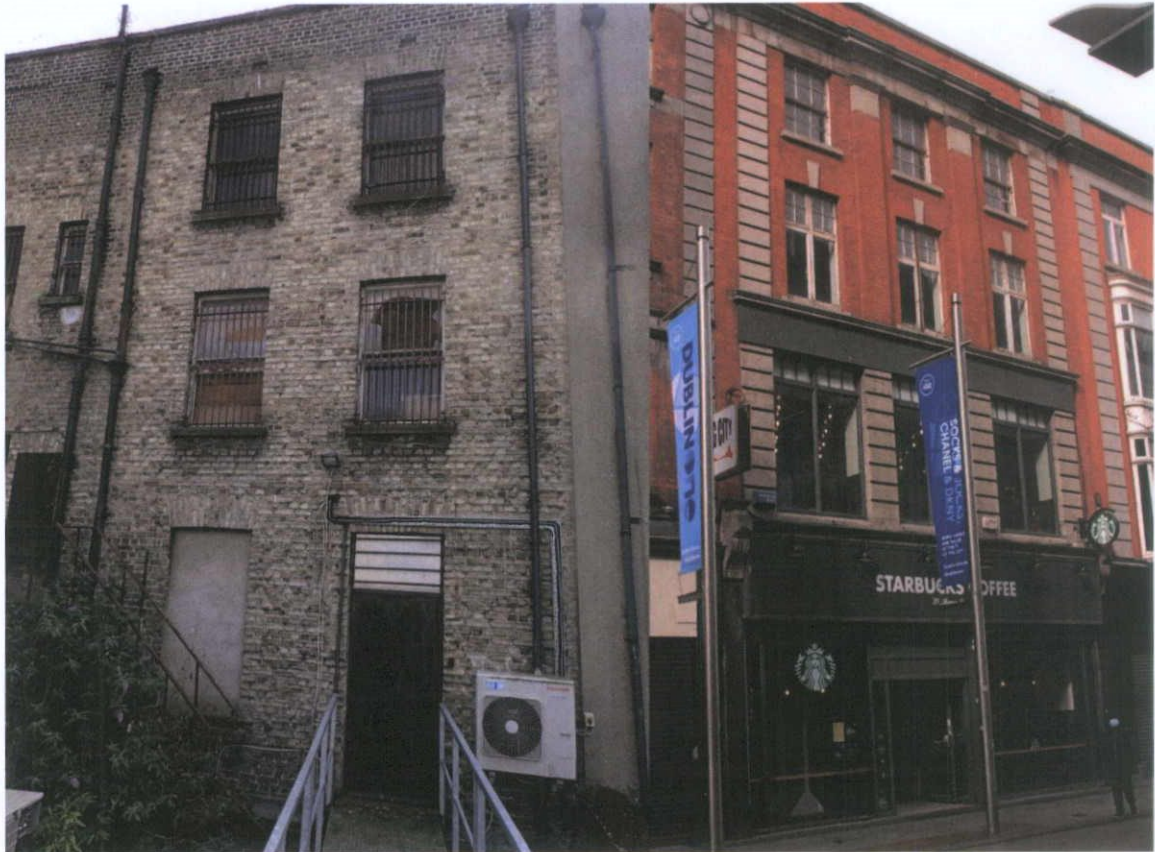
Fig.4.3.1: General views of the rear elevation (note rebuilt parapet) and façade of 39 Henry Street. The rear elevation brickwork matches that of No.38 and is contemporary with same.

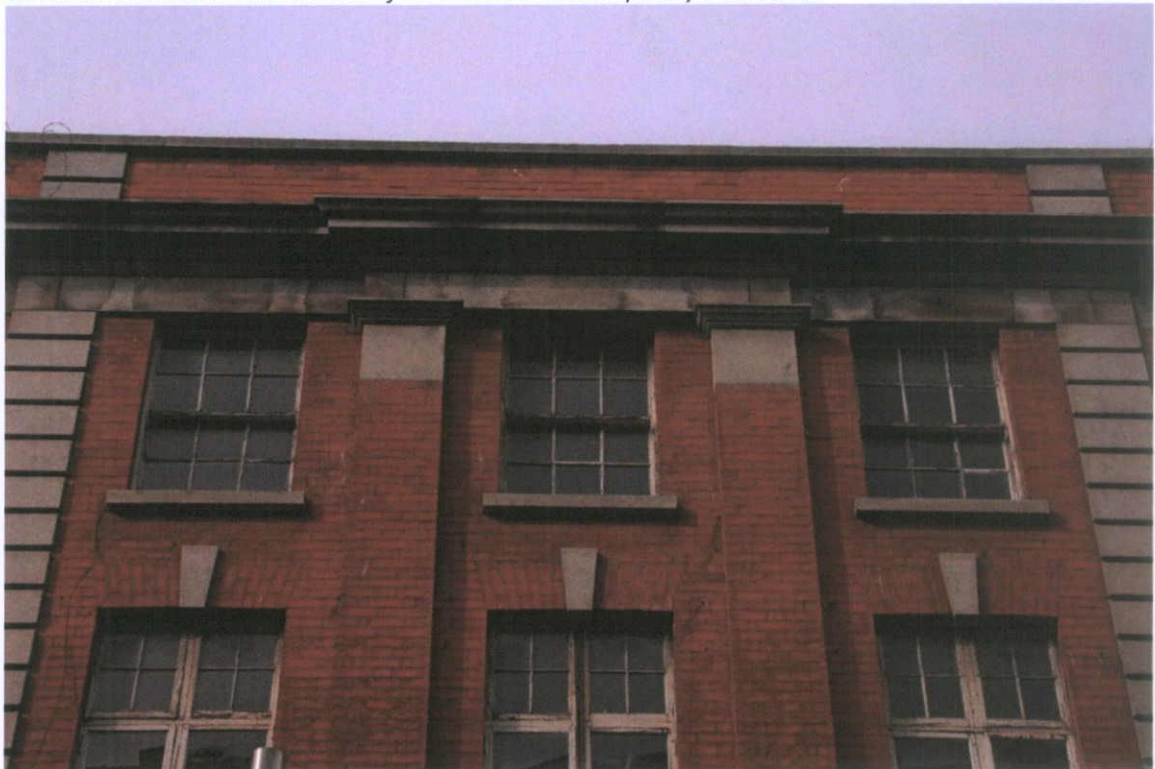
Fig.4.3.2: The superstructure is built with machine-cut red brick with granite used for architectural detailing. The granite shows brown staining, but the building surface is generally free from soiling and has been cleaned in the past.

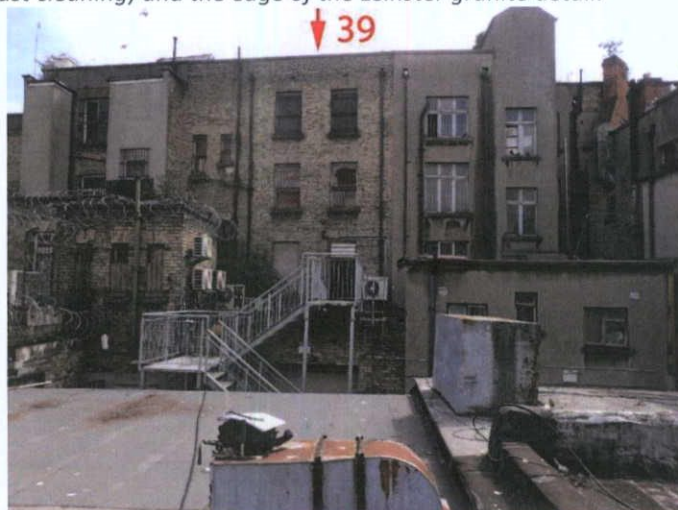
Fig.4.3.4: No.39 Henry Street forms part of a terrace using identical yellow stock brick, and all buildings appear to have been built at the same time.

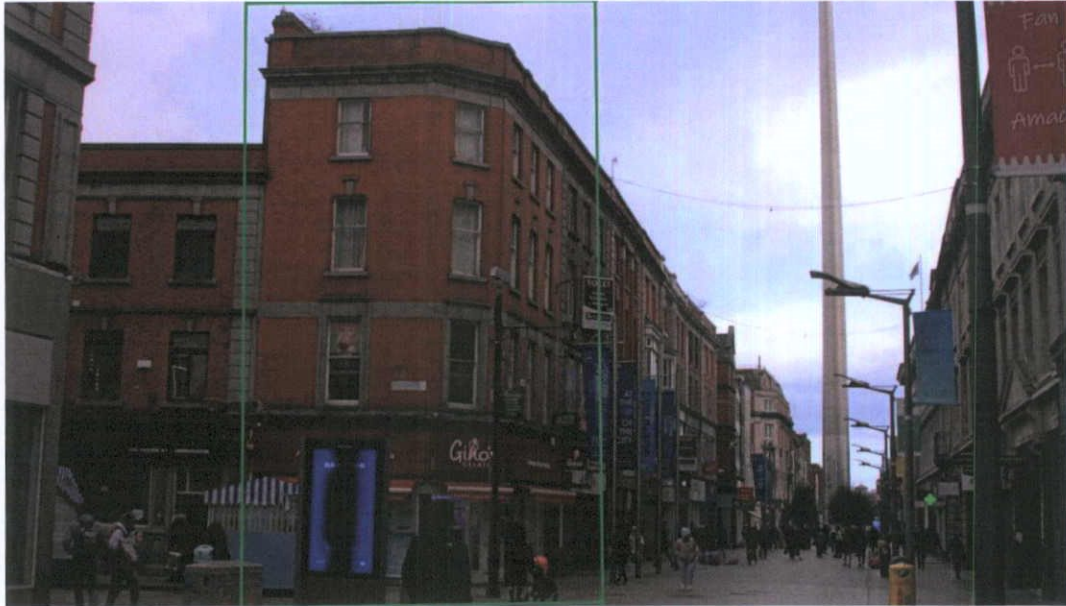
Fig.4.5.1: The brickwork on the soiled façade of No.40 Henry Street consists of well-fired machine-cut red clay brick with weatherstruck Portland Cement-based pointing mortars. Leinster granite was used for architectural detailing. The work probably dates to c.1917-1920.

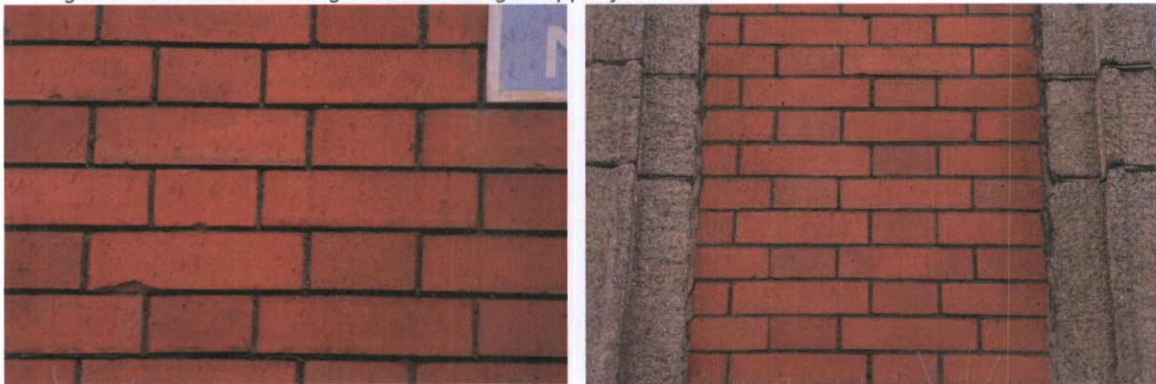
Fig.4.5.3: Detail of the c.1917-1920 brickwork at 41 Henry Street.

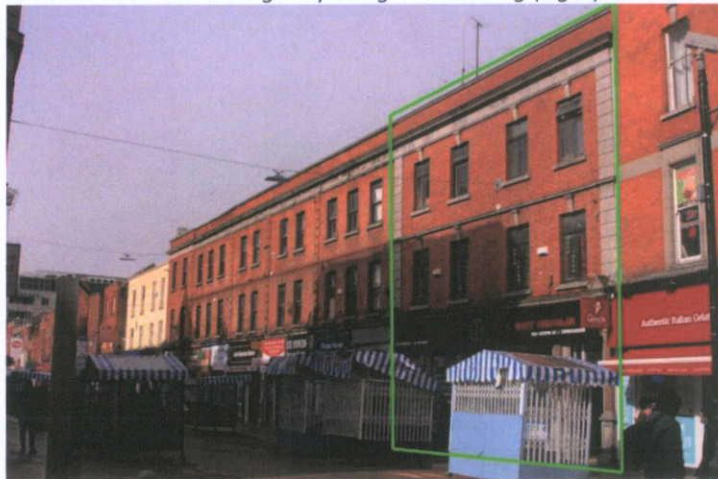
Fig.4.6.2: 1-2 Moore Street. The brickwork is remarkably free from soiling, indicating that it has been cleaned in the relatively recent past.

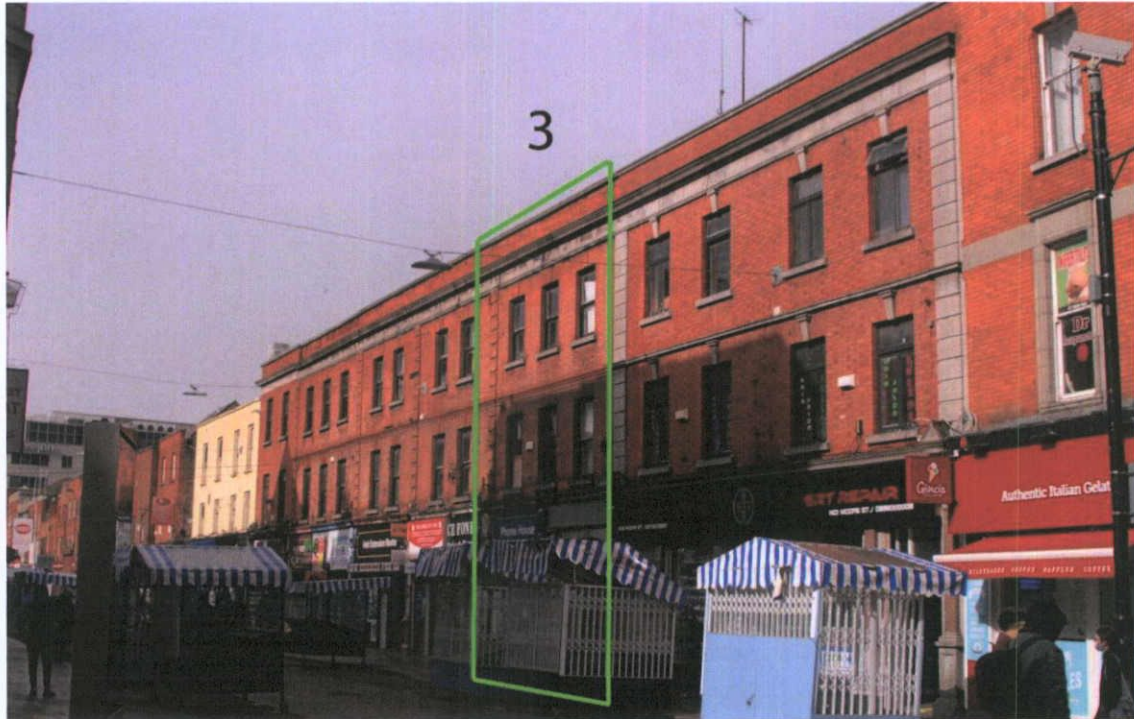
Fig.4.7.1: No.3 Moore Street forms the southernmost member of a terrace of four buildings of similar design and construction.

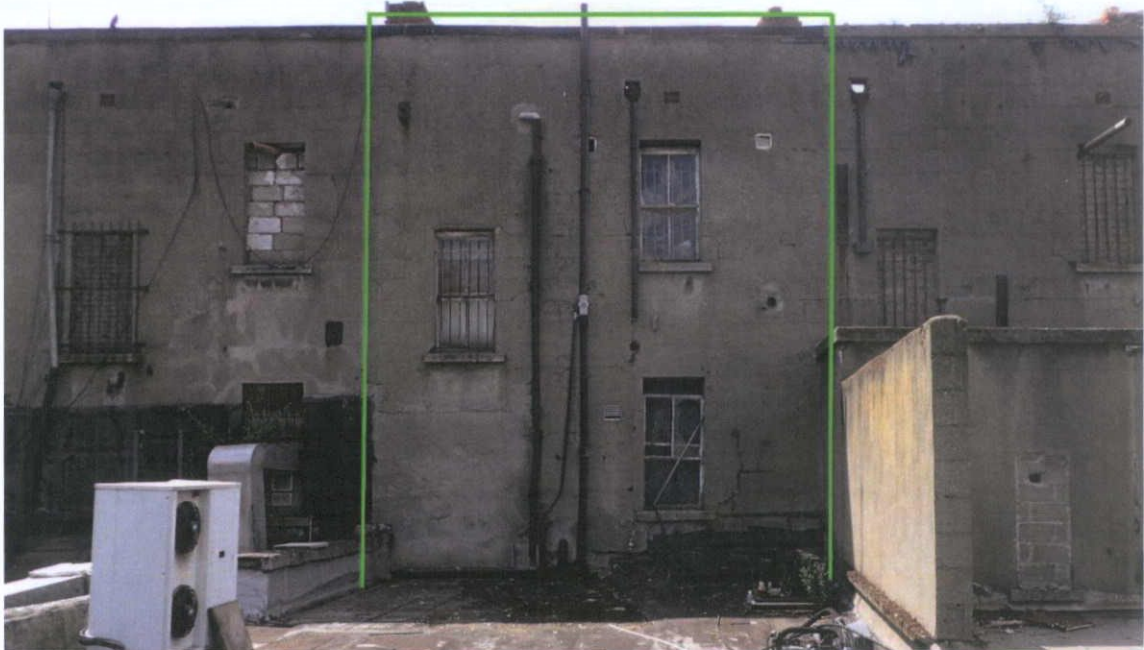
The rear elevation (Fig.4.8.4) is of concrete with crushed brick aggregate added to the dark-grey cement matrix in addition to natural stone aggregate. The party walls and internal walls are also of concrete. The internal plasterwork, also c.1917, is a traditional lime plaster, including lime lumps and crushed yellow and red brick pozzolan and fuel fragments (coal). Brick pozzolan is common throughout the plasterwork. The external concrete render to rear is coarse-grained and contains burnt vitrified aggregate and brick fragments.

Fig.4.8.4: Note the rendered rear of No.4 mirrors the treatment of No.3 and 5.

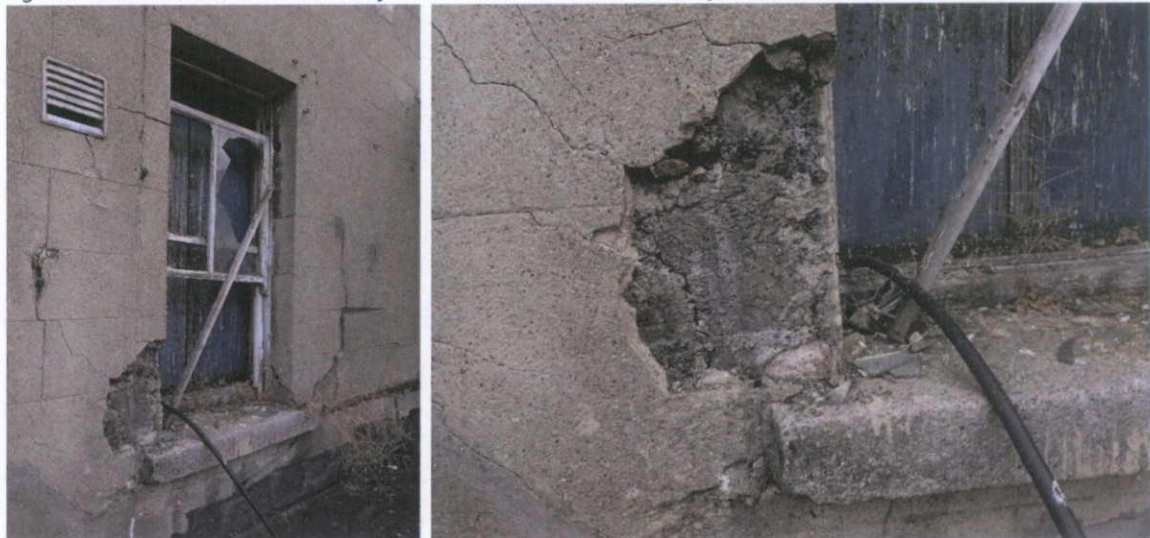
Fig.4.8.5: Ruled and lined Portland Cement render over a concrete structure. Rear elevation, No.4 Moore St.

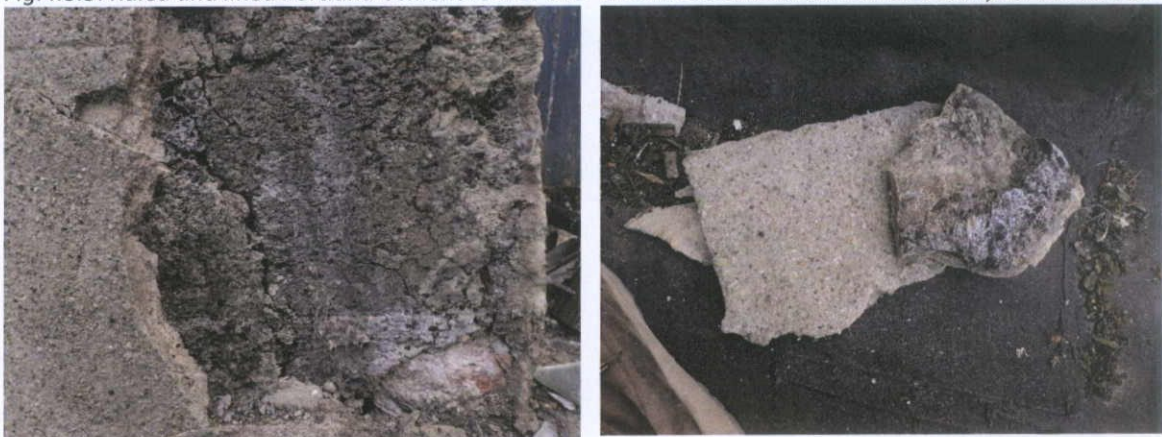
Fig.4.8.6: Concrete fabric beneath the Portland Cement render coat.

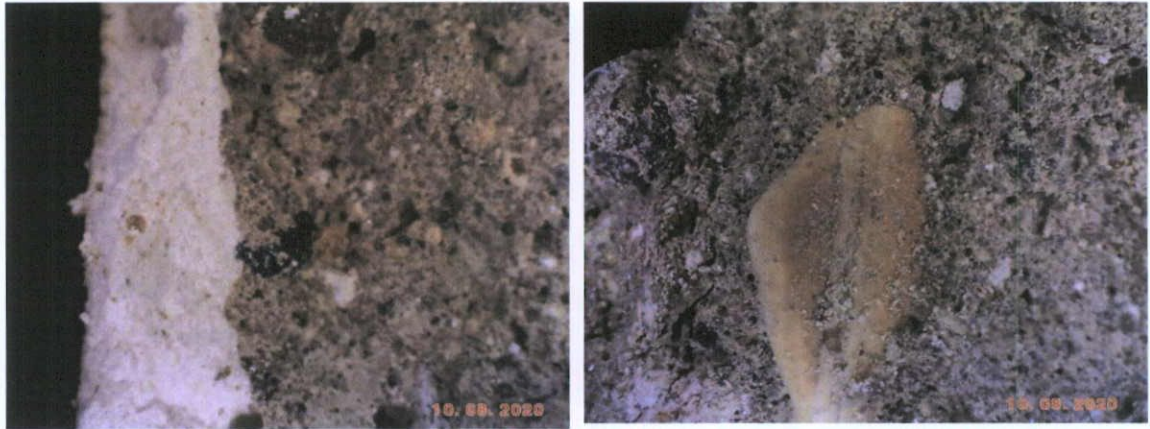
Fig.4.8.6: Microscope cross-section of the internal plaster of No.4 Moore Street, with coarse shell fragment.

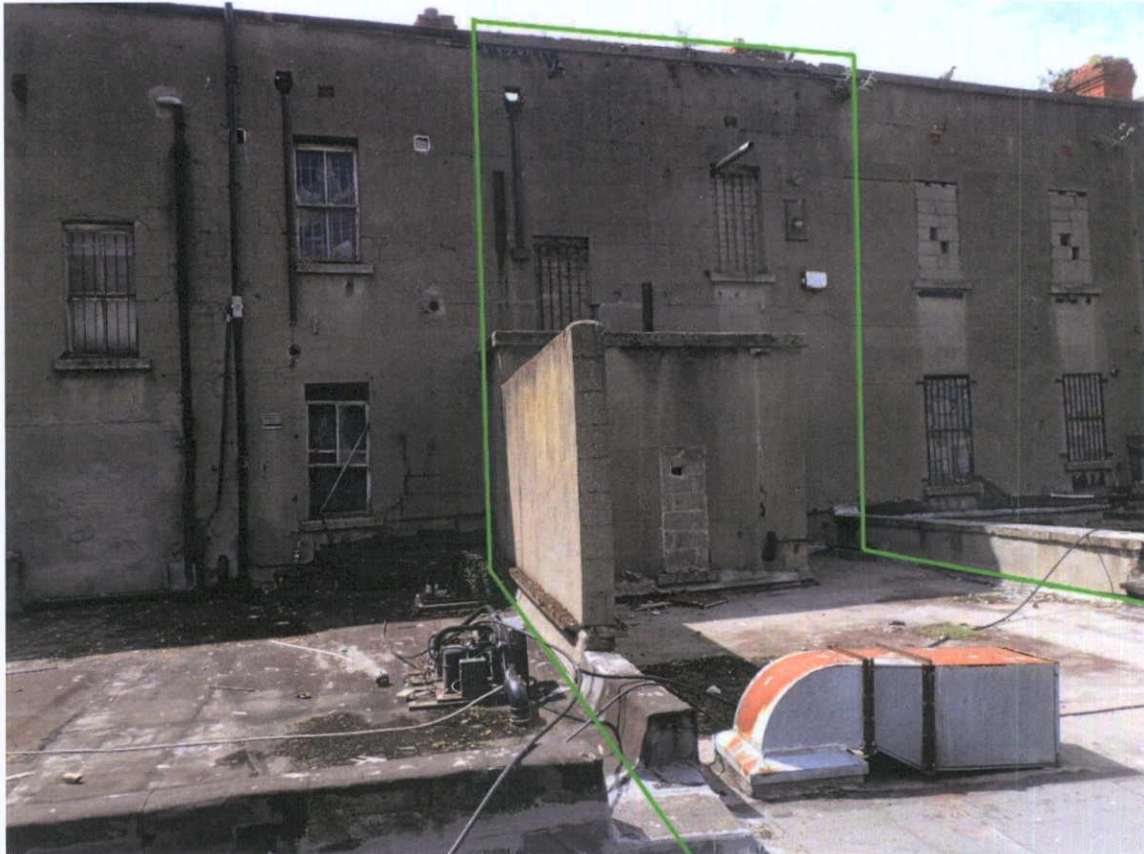
Fig.4.9.4: The rear elevation of No.5 Moore Street, built c.1917. Note that the colour and composition of the Portland Cement render and the configuration of the openings of Nos.5 and 4 matches; while the neighbouring No.6 Moore Street (right of image) was built using a slightly different Portland Cement render mix and with a different window arrangement.
