**4.11 7 Moore Street:** The three-storey two-bay brick-fronted terraced building rising to a granite frieze and cornice, similar to the c.1917 limestone terrace of Nos.3-6 Moore Street built immediately to south, but lacking the brick ‘soldier’ quins and brick specials used as a string course between the first and second floors. Despite being a different construction project to the adjacent terrace, the brick in both developments match (compare Figs.4.2.10 & 4.11.2) and reflect the brick in common usage at the time.

**4.12 8-9 Moore Street:** This building comprises two eighteenth century buildings combined into one premises; now appearing as a painted three-storey four-bay brick-fronted building, and connected to Nos.11-13 Henry Place at the rear. The façade brickwork is painted yellow, while the north gable has been painted black. Two buildings are marked in this location on John Rocque's 1760 map, and when the internal brick lining was broken open (see Fig.4.12.7), the brick contains distinctive angular limestone aggregate also seen at No.42 O'Connell Street and other Georgian buildings in the area, and may be brick made at the 'Old Brick Field' noted on Moore Street on Rocque

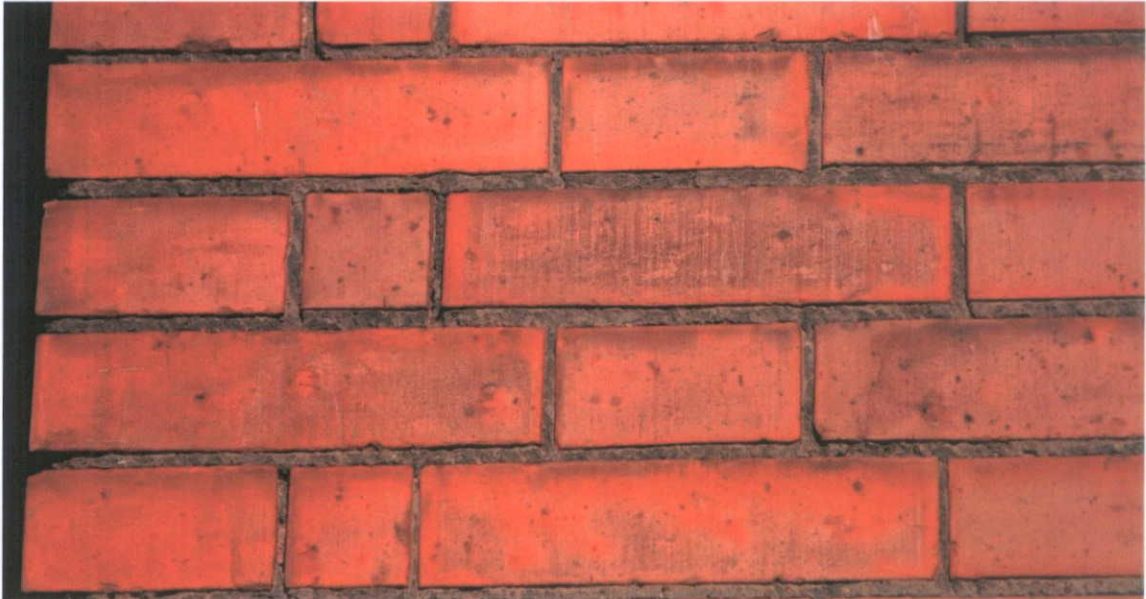
Fig.4.10.2: Machine-cut brick with subtle surface colour variations are characteristic of this brick.

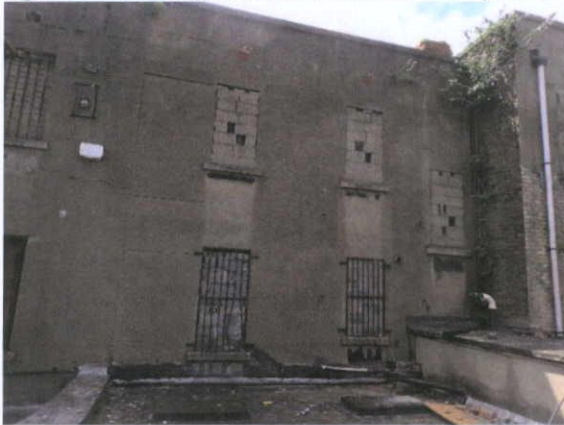
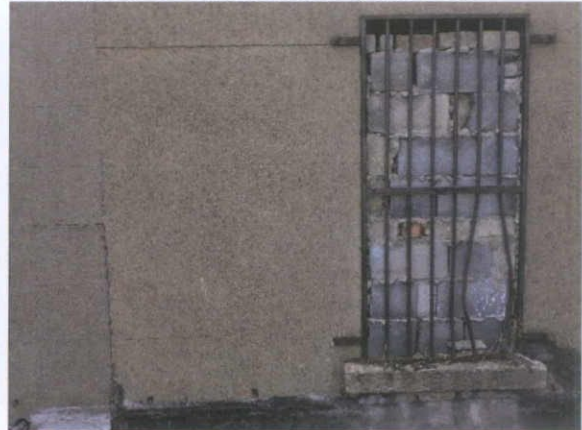
Fig.4.10.3: The rear elevation has a Portland Cement render which has weathered differently to its neighbor, indicating that the cement binders are slightly different in composition.

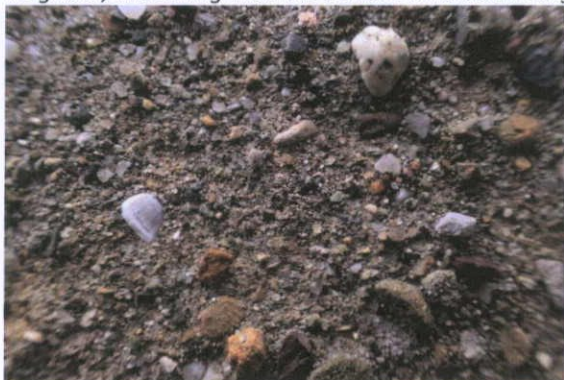
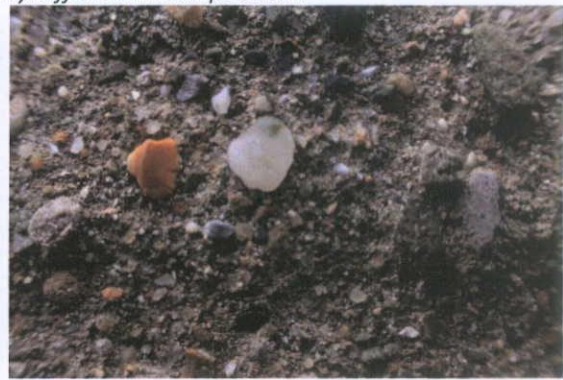
Fig.4.10.3: Detail of the aggregate standing proud of the surface of the render at the rear of No.6 Moore Street consisting of rounded natural aggregate and shell.

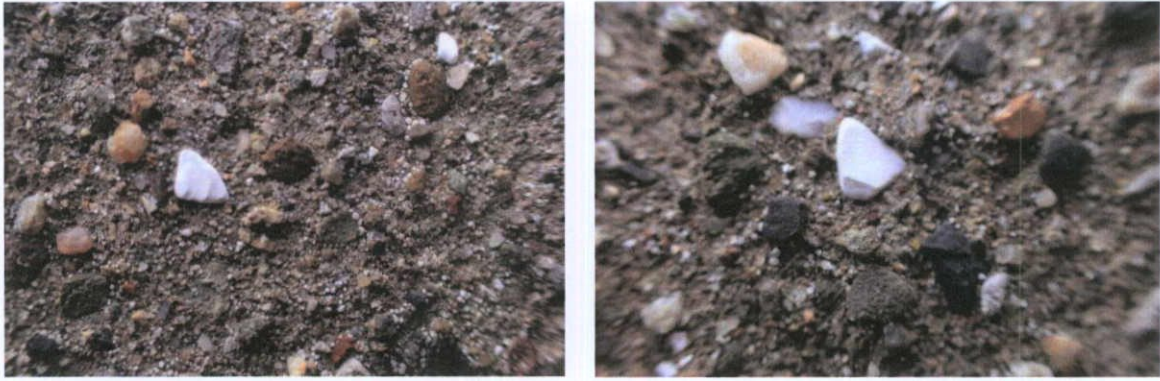
Fig.4.10.4: Shell forms a significant proportion of the aggregate, indicating the use of a beach sand.

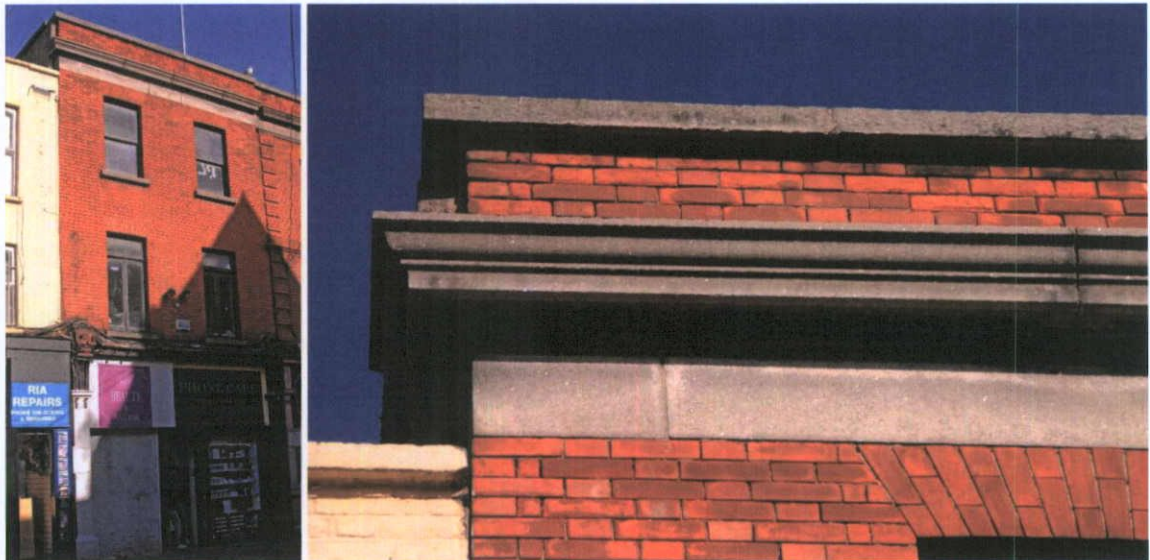
Fig. 4.11.1: No.7 Moore Street has granite coping stones, frieze and cornice.

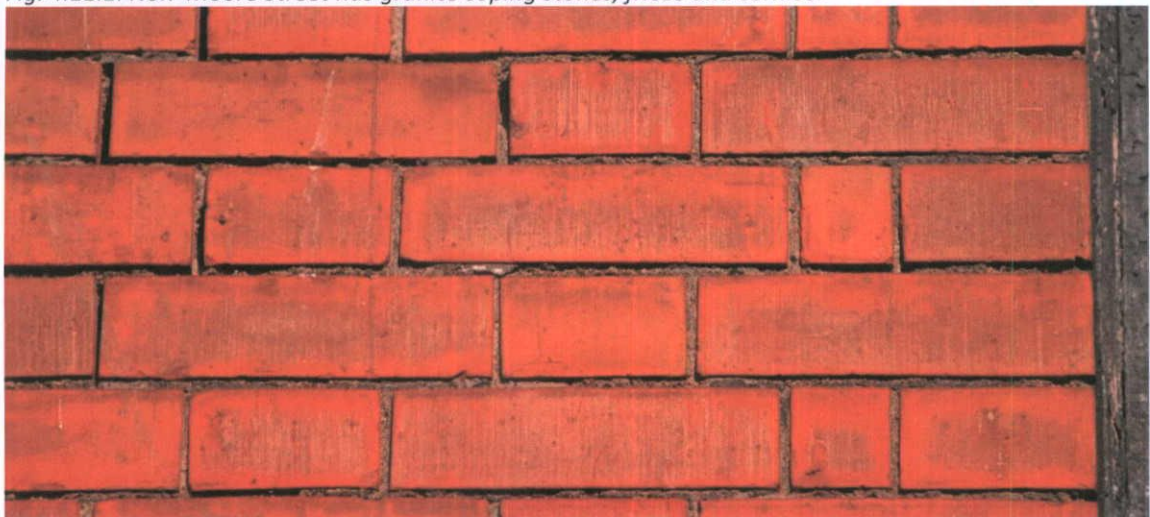
Fig.4.11.2: Detail of the brickwork on the façade of No.7 Moore Street.

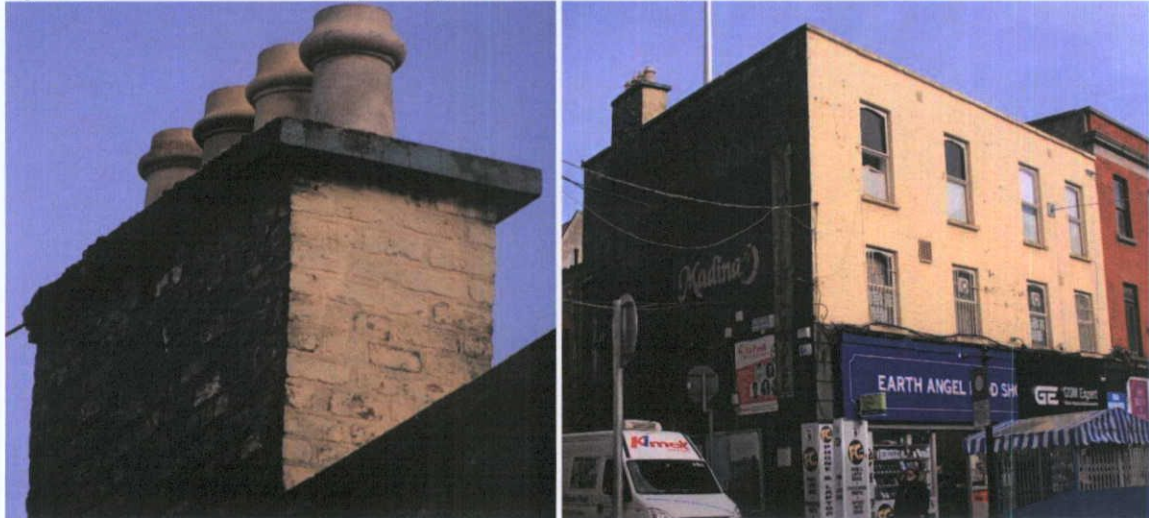
Fig.4.12.2: The brick on the front and side elevations are concealed by paint.

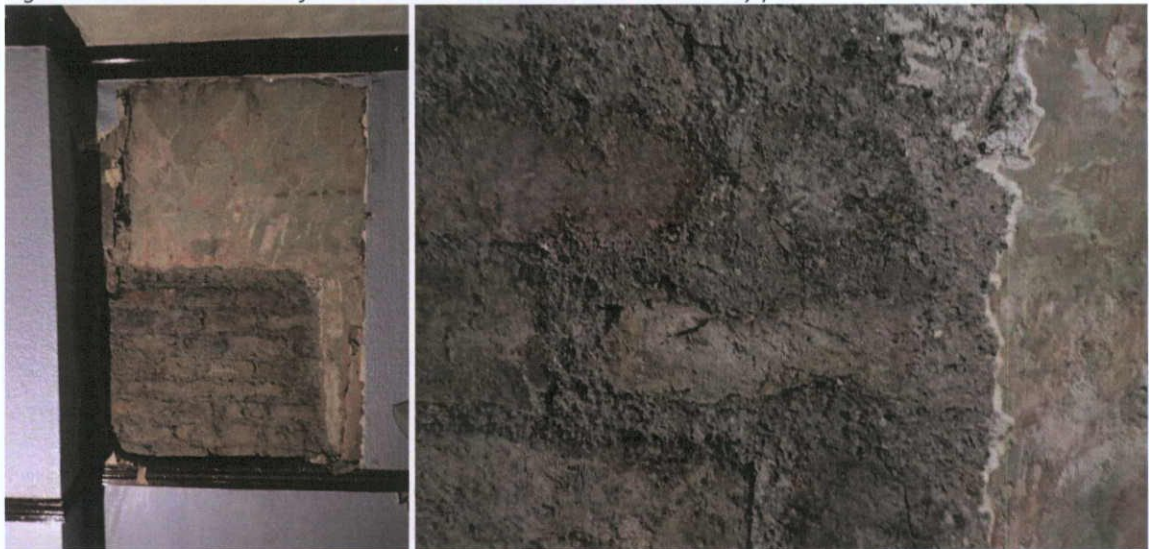
Fig.4.12.3: Yellow and red stock brick bedded in thick lime bedding mortars on the internal face of the north wall of No.9 Henry Street.

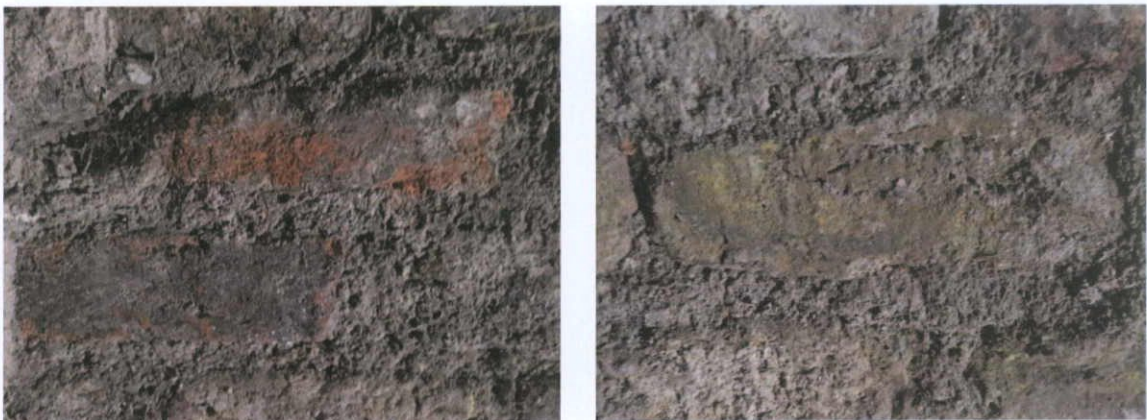
Fig.4.12.5: Red and yellow stock brick, internal wall lining, north wall, 9 Henry Place.

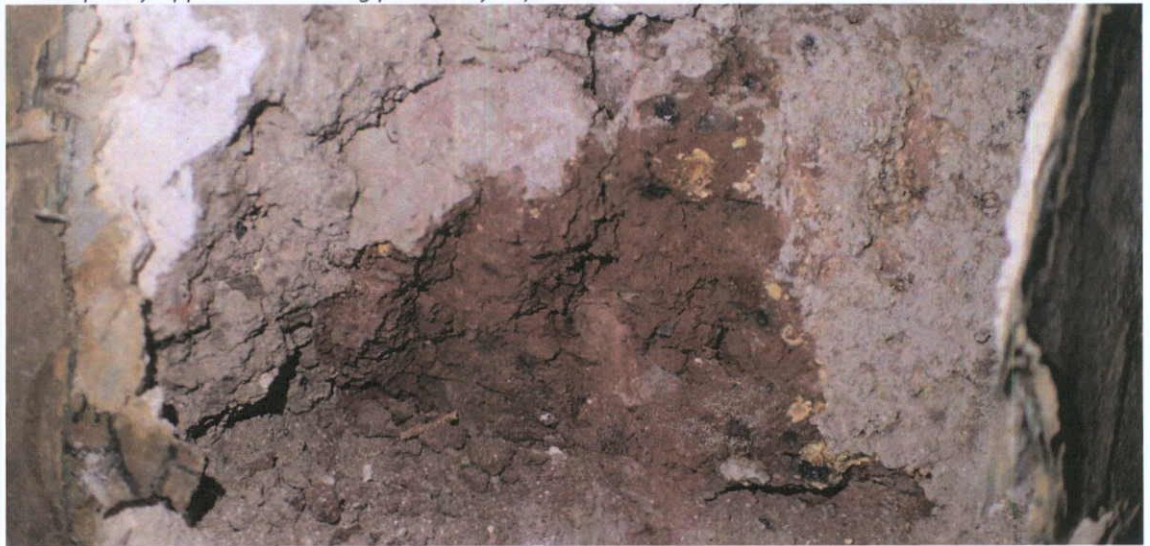
*Fig.4.12.7: Hand-made clamp-fired brick with angular limestone aggregate similar to that seen at No.42 O'Connell Street and other Georgian buildings in the area. This type of brick may have been fired at the Moore Street brickfield.*

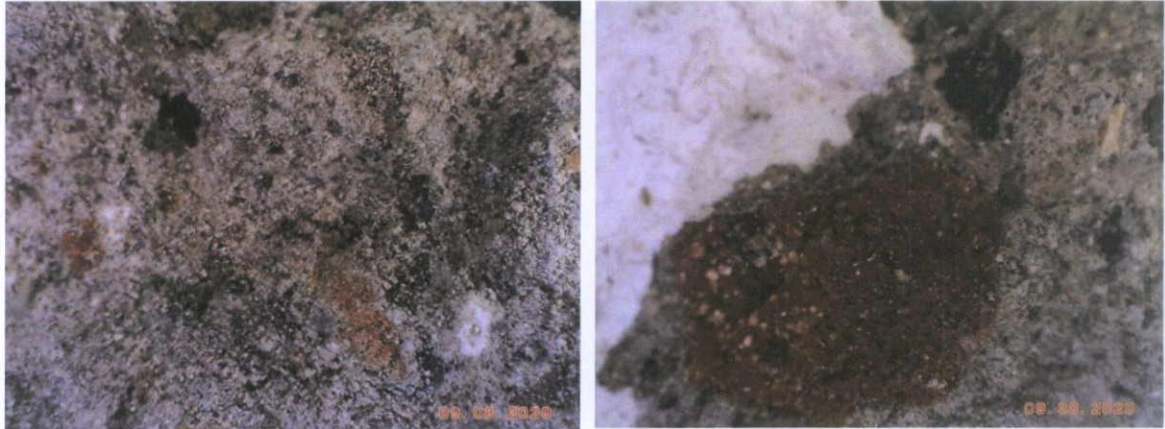
Fig.4.12.8: Brick pozzolan in the lime bedding mortars at first floor level.

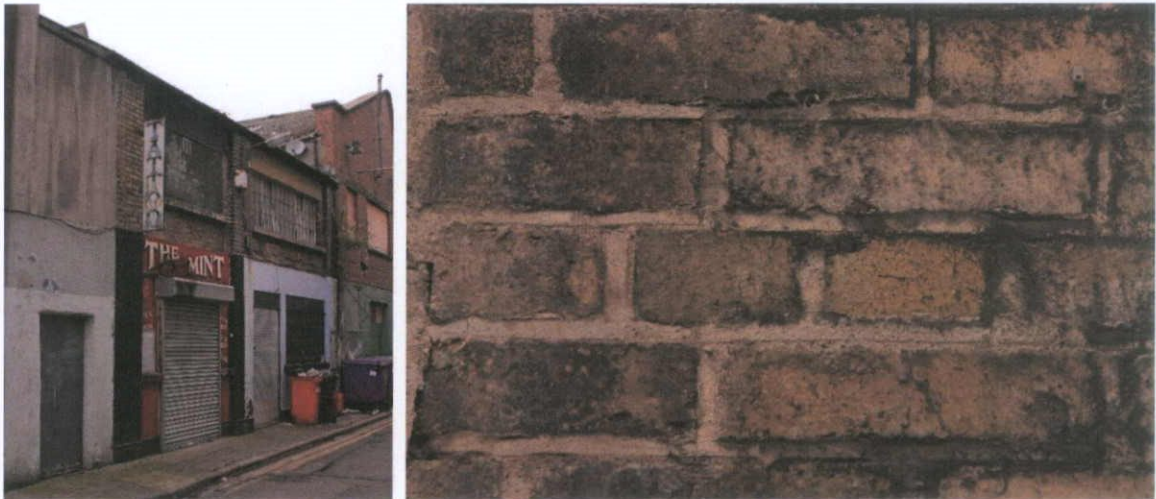
**4.13 4 Henry Place:** The first floor is of a buff yellow stock brick with later Portland Cement repointing mortars, and probably original lined pointing surviving in the bays. The brick is heavily soiled and difficult to opine as to date without a closer inspection.

Fig.4.13.1: General view of No.4 Henry Place with a detail of soiled yellow stock brick at first floor level with crudely lined pointing.

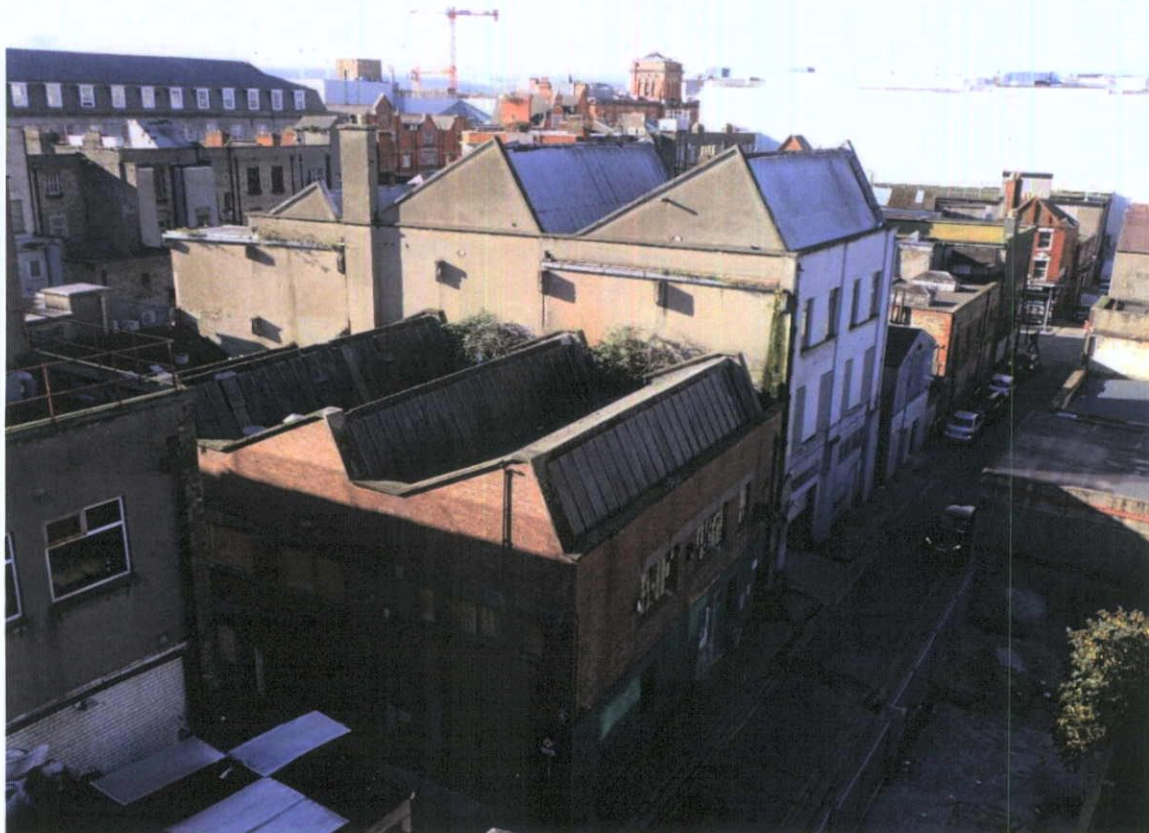
Fig.4.14.1: General view of the building showing a rendered and painted ground floor level, with a brick first floor rising to a sawtooth roof.

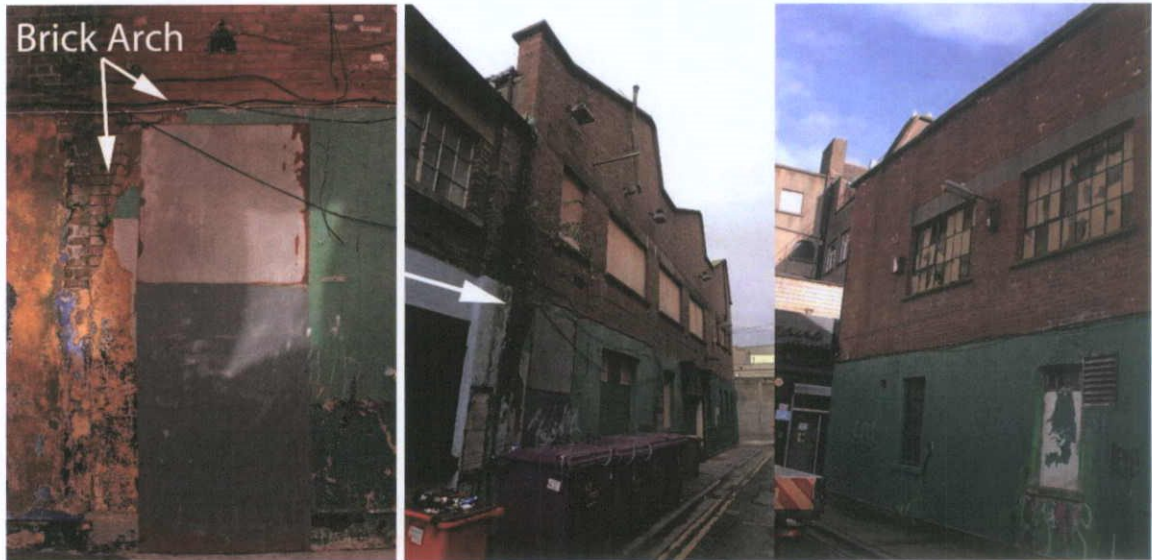
Fig.4.14.2: Brick-arched opening on the east elevation.

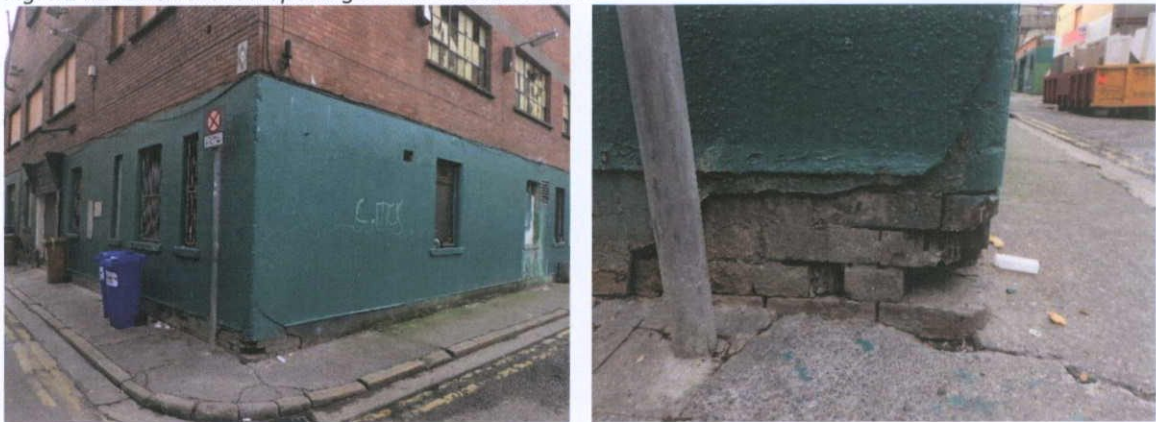
Fig.4.14.3: Render coating the nineteenth century brickwork at ground floor level, with twentieth century brickwork above (left), with extruded perforated brick with rounded edges at the corner (right).

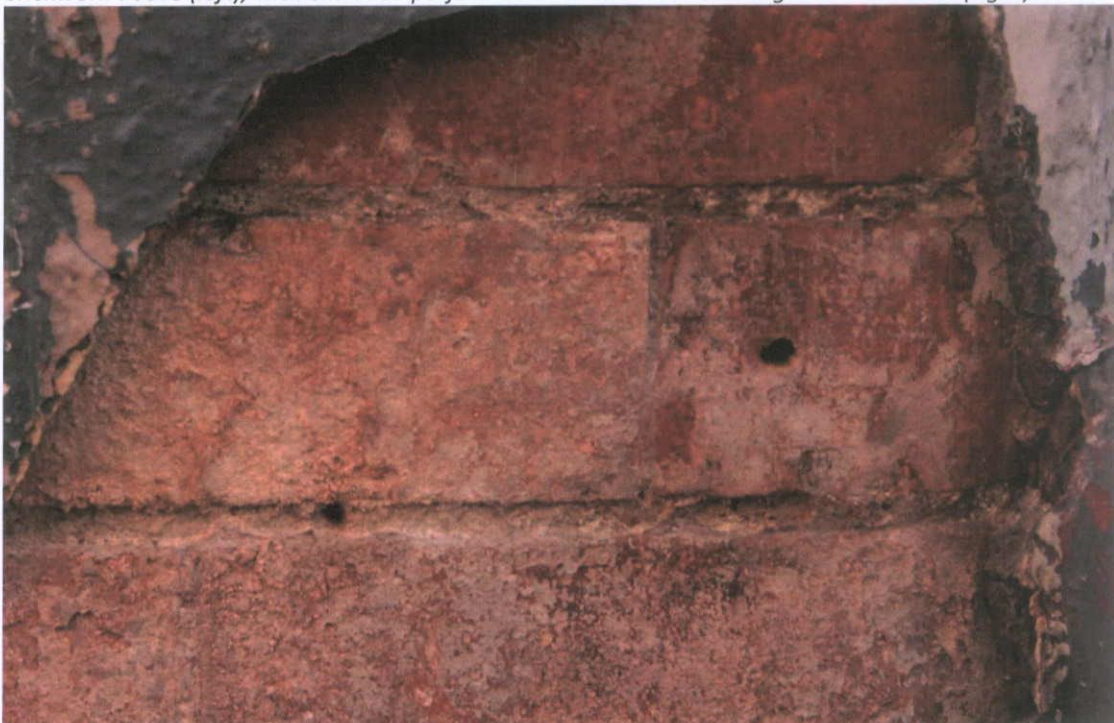
Fig.4.14.4: Detail of the curved brickwork at the north-east corner of the building.

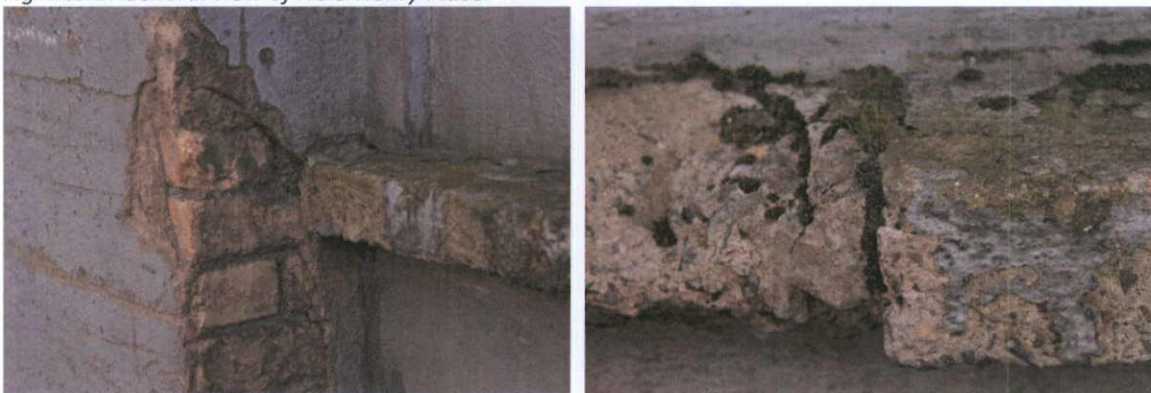
*Fig.4.15.2: The piers on the façade are of yellow stock brick, while the cill is concrete.*

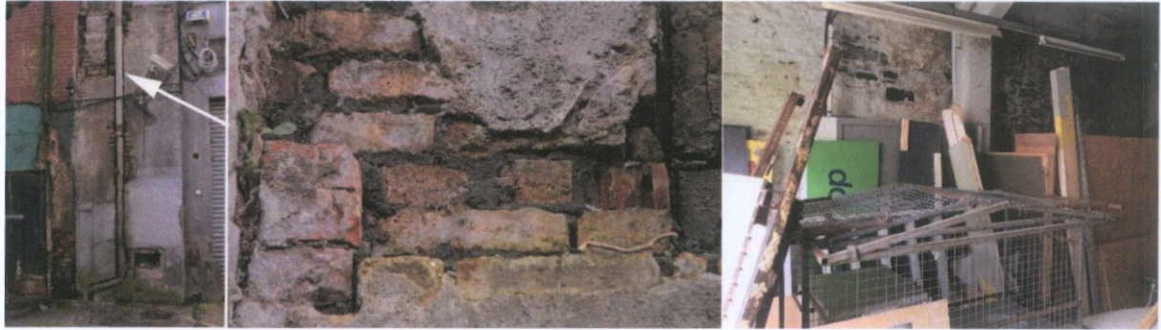
Fig.4.15.3: Exposed wall end at the junction of 5-8 and 9 Henry Place shows a mix of bricks in Portland Cement bedding mortars; internally, the limewash east wall at ground floor level is Calp limestone masonry, and consistent with 19<sup>th</sup> century work.

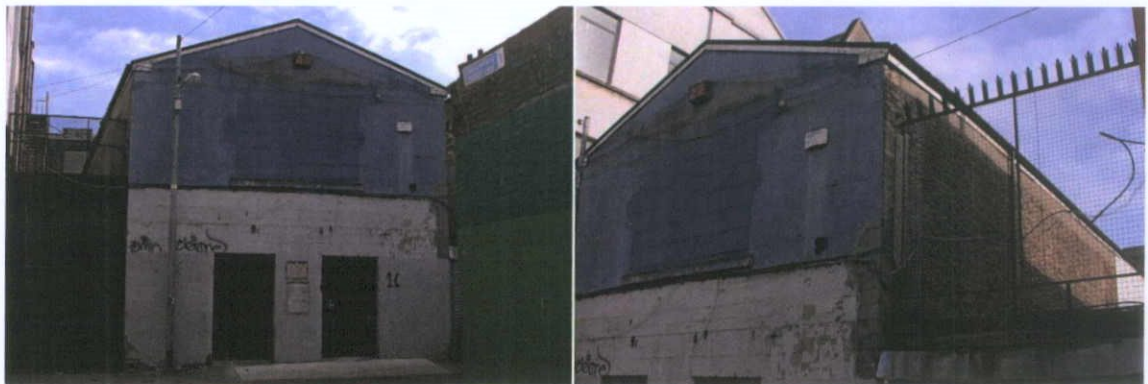
Fig.4.16.1: View of the north façade of 10 Henry Place, and the rendered first floor of the west elevation (this render was not accessible).

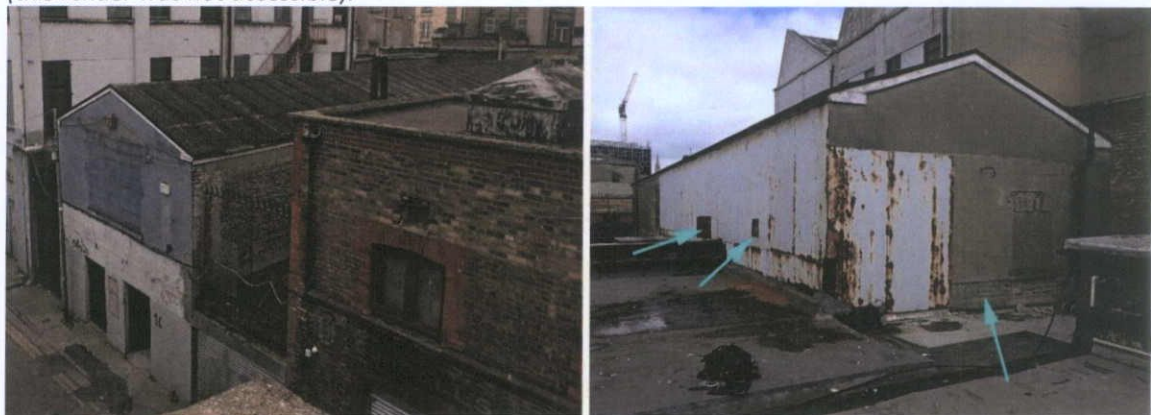
Fig.4.16.2: General view of No.10 Henry Place, with areas of masonry opened up at first floor level on the south and west elevations indicated.

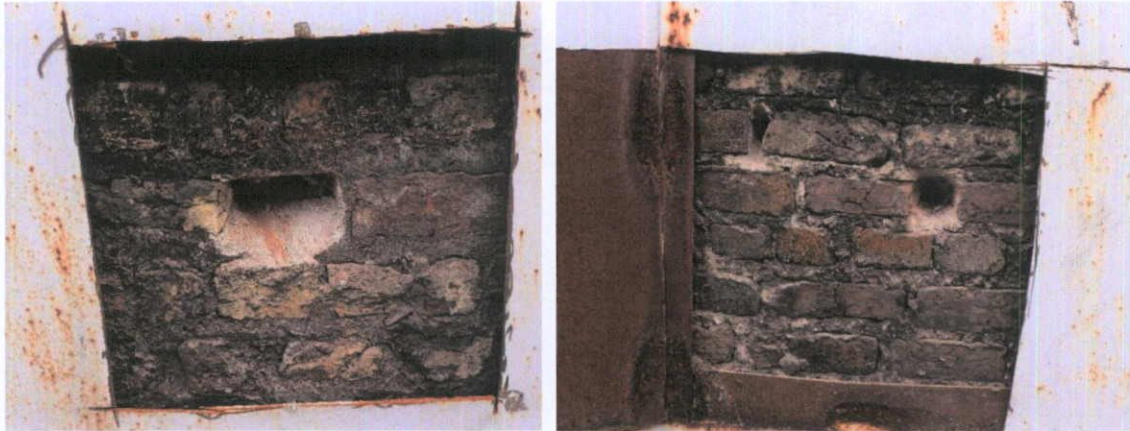
Fig.4.16.3: Nineteenth century yellow stock brick, first floor level, west elevation.

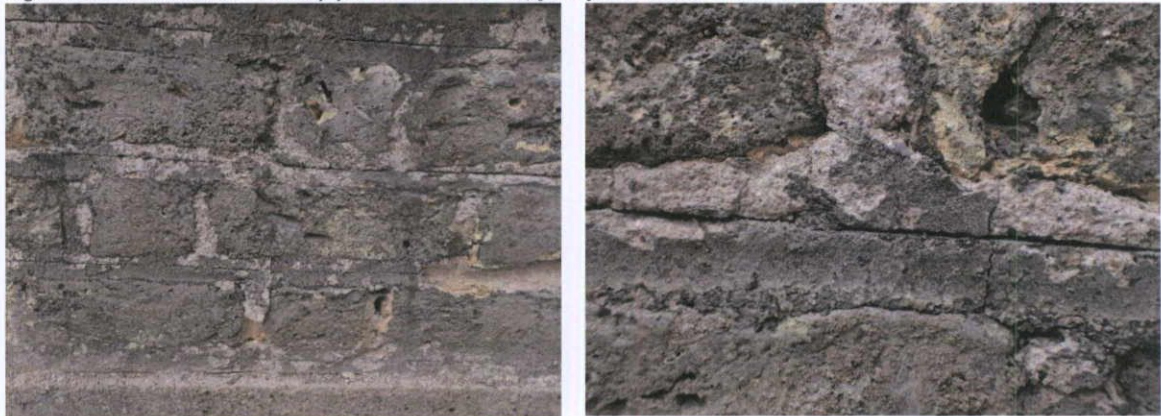
Fig.4.16.4: 'Pennystruck' lime pointing mortars, first floor level, south elevation.

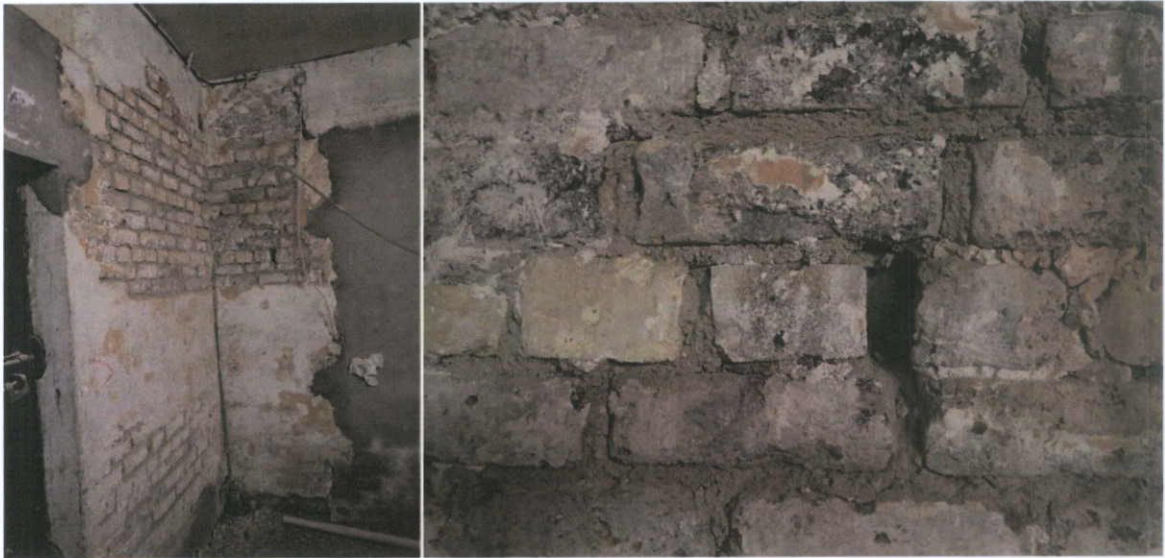
Fig.4.16.7: The north-east corner of the building formed of c.1920s yellow stock brick in a cementitious bedding mortar. There was no trace of any earlier brickwork in this part of the building.

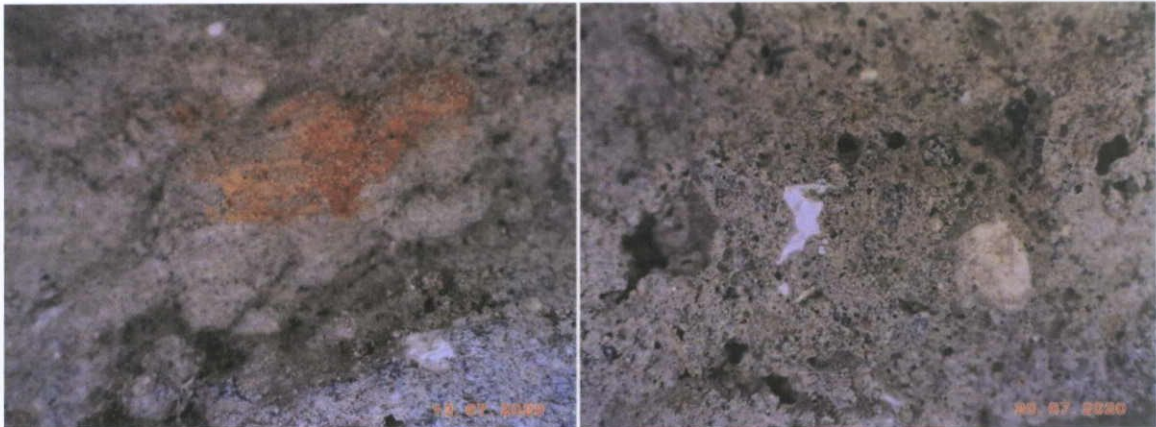
Fig.4.16.8: Cementitious bedding mortar binding the 1920s yellow stock brick at the north-east corner, exposed internally.

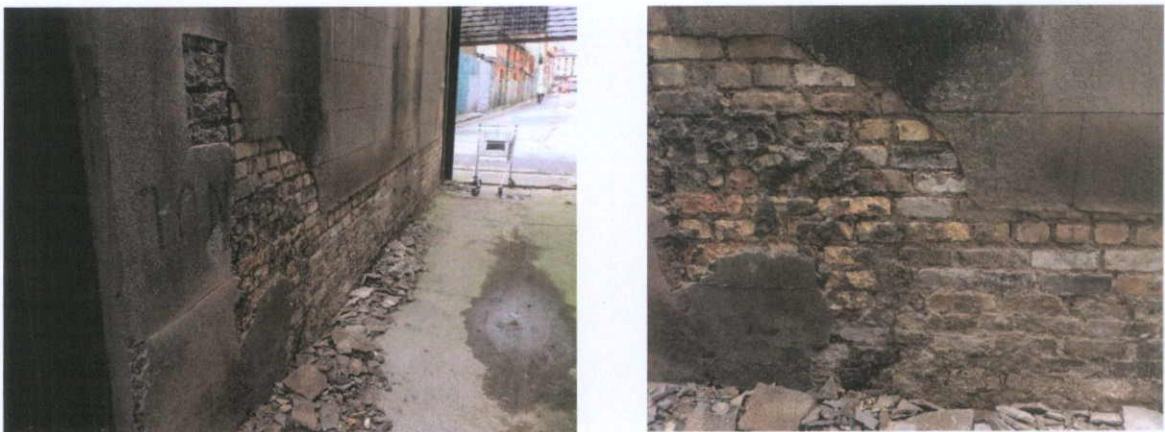
Fig.4.16.9: c.1920 yellow stock brick beneath a Portland Cement render at the north end of the east elevation.

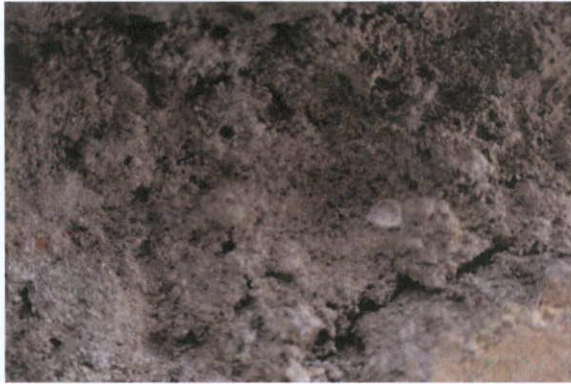
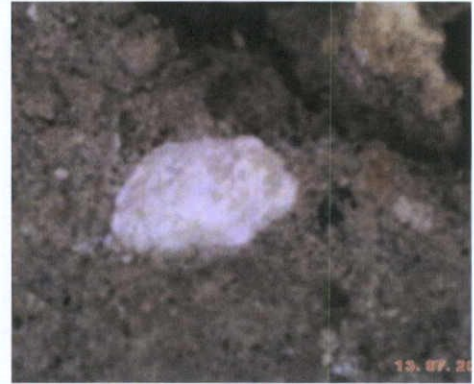
Fig.4.16.10: Cementitious bedding mortar seen externally at the north end of the east elevation.

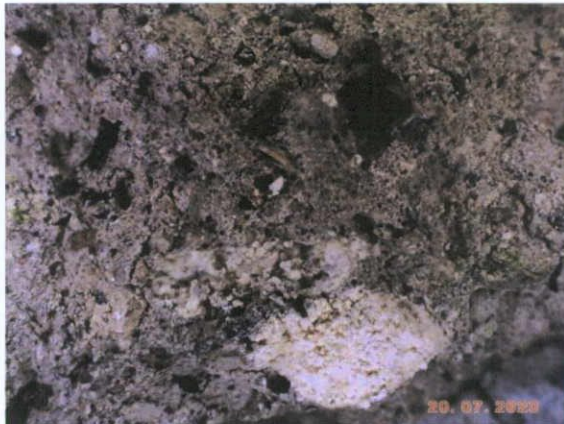
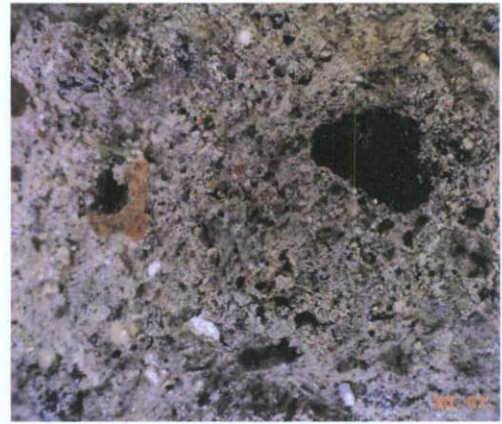
Fig.4.16.11: The cementitious bedding mortar contains crushed yellow and stock brick. Construction work may have availed of building debris (crushed to form aggregate).

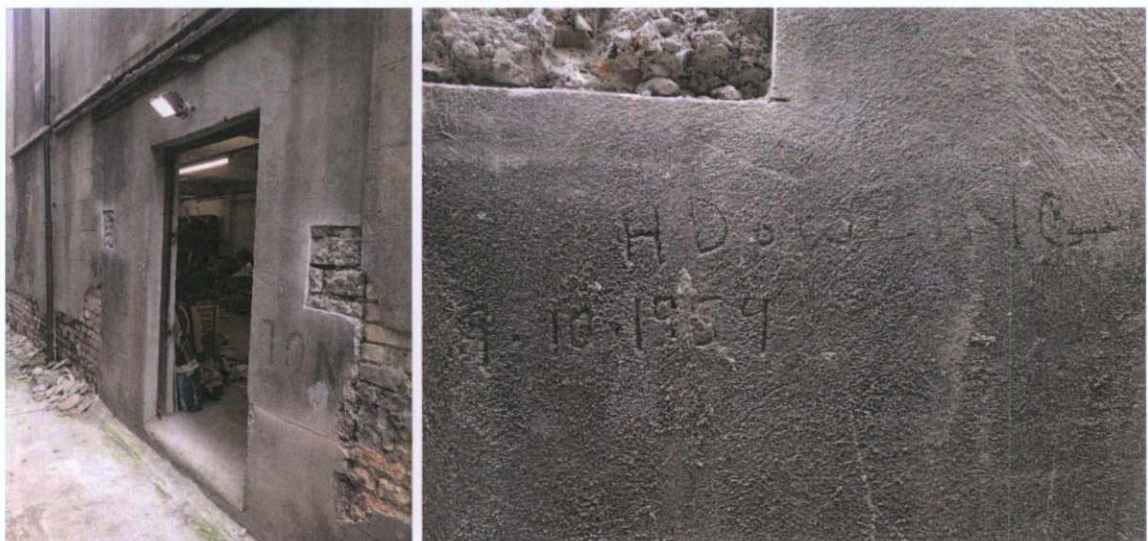
Fig.4.16.12: The 1920s brick wall was altered in 1959.

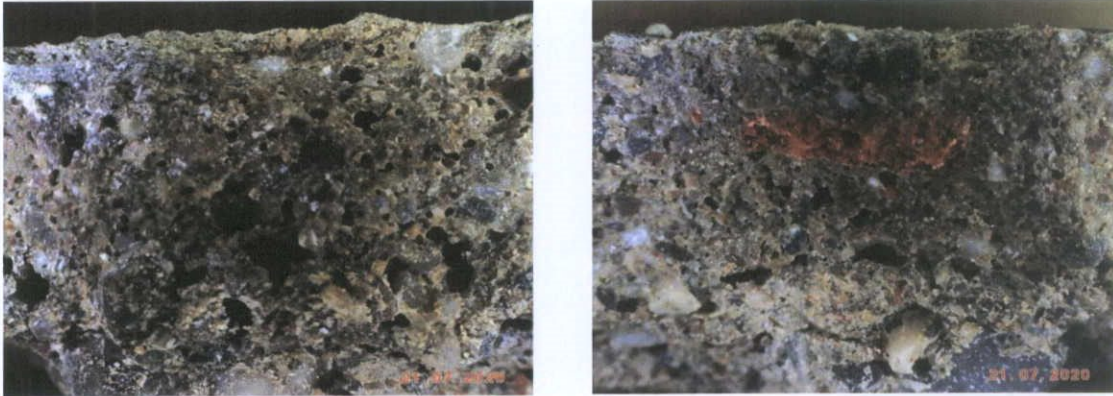
Fig.4.16.13: Cross-section of the 1959 Portland Cement render on the east wall of No.10 Henry Place.

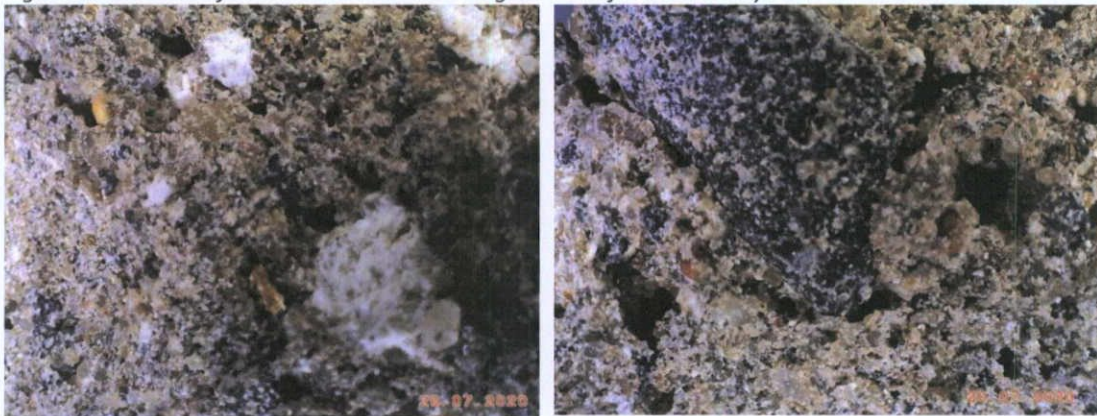
Fig.4.16.17: The aggregate in the cementitious bedding mortar contains natural stone and reused building materials.

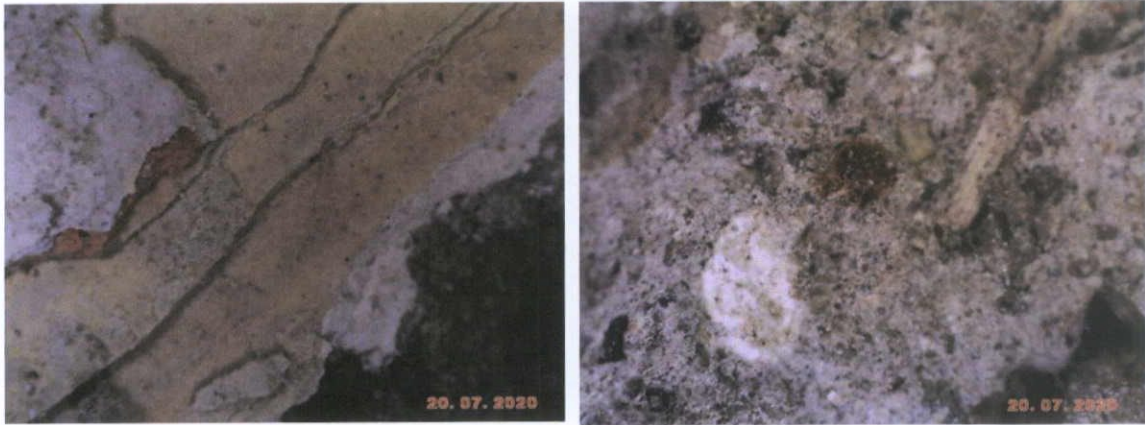
Fig.4.16.20: Detail of the cementitious plastering mortar. This has the same components and mix as used to bed the c.1920 yellow stock brickwork.

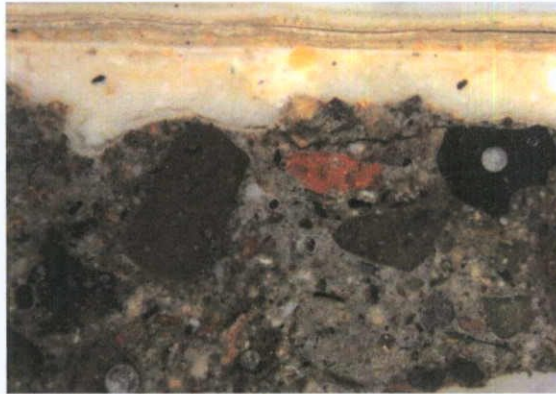
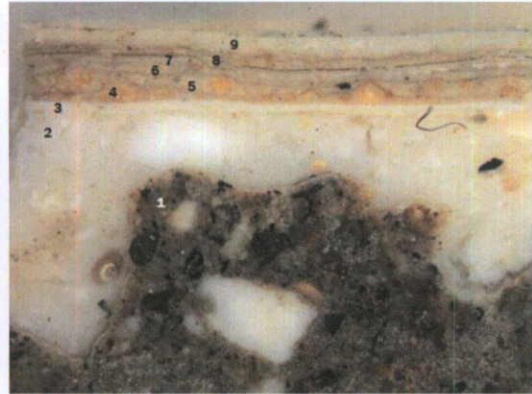
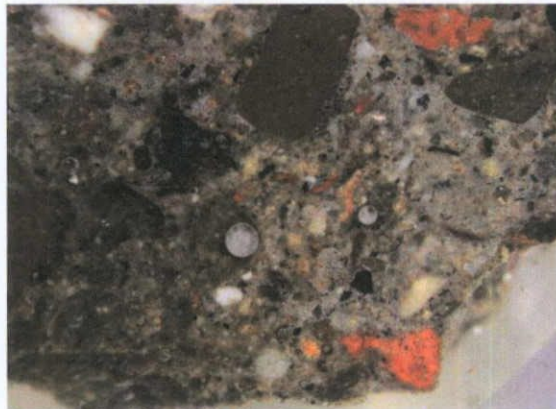
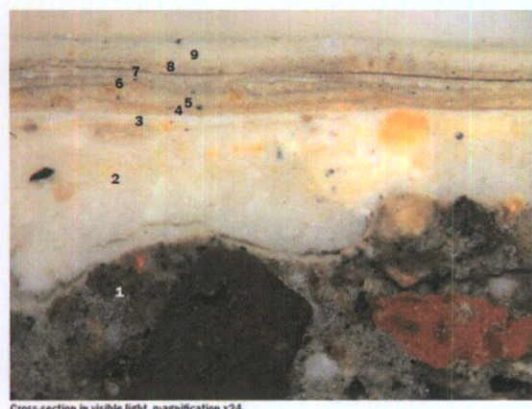
Fig.4.16.23: Most of the plaster on the internal wall surface along the west wall is composed of a cement binder with abundant crushed brick aggregate.

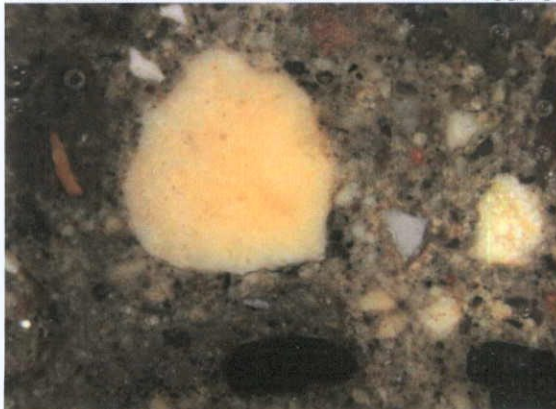
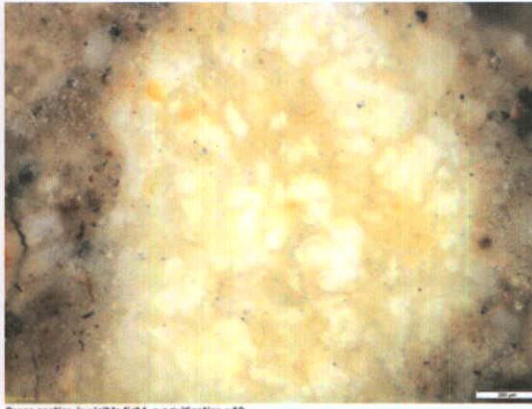
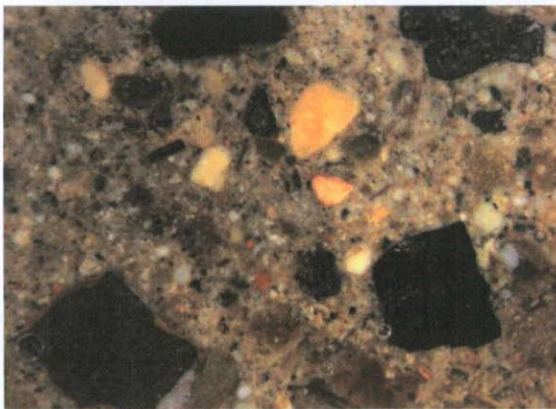
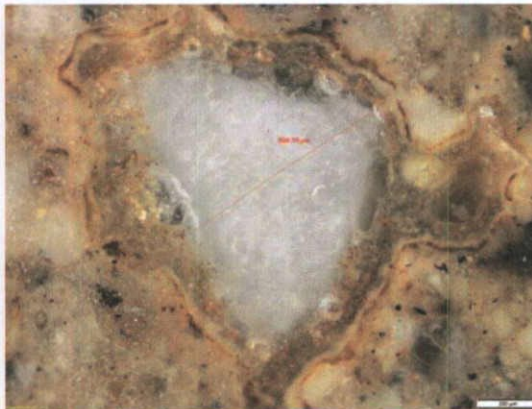
Fig.4.16.24: Cross-section of cementitious plastering mortar.

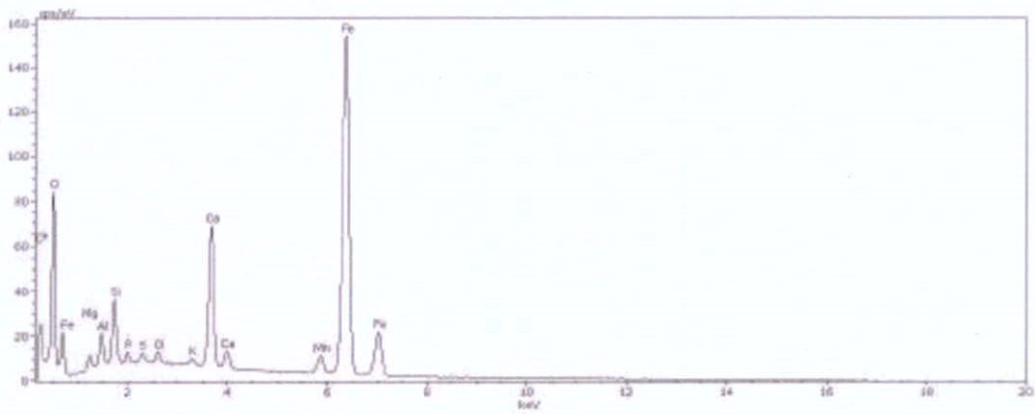
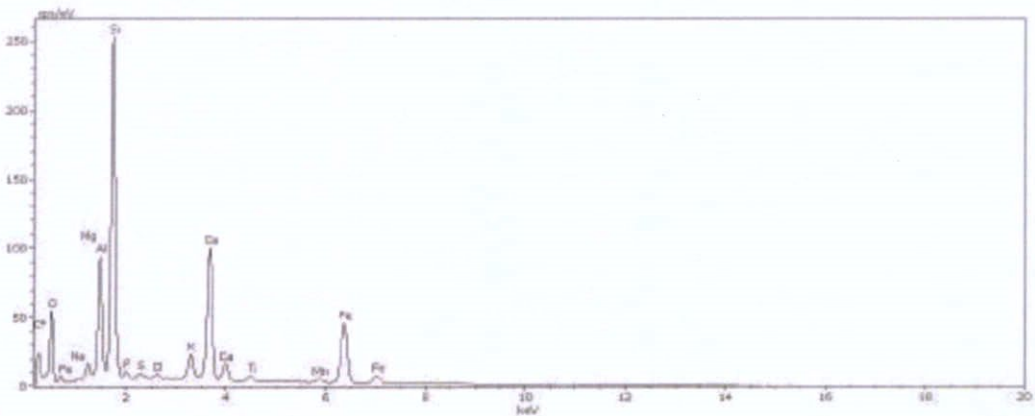
Fig.4.16.25: SEM-EDS analysis of the cementitious binder binding the 1920s yellow stock brick showing clinker phases

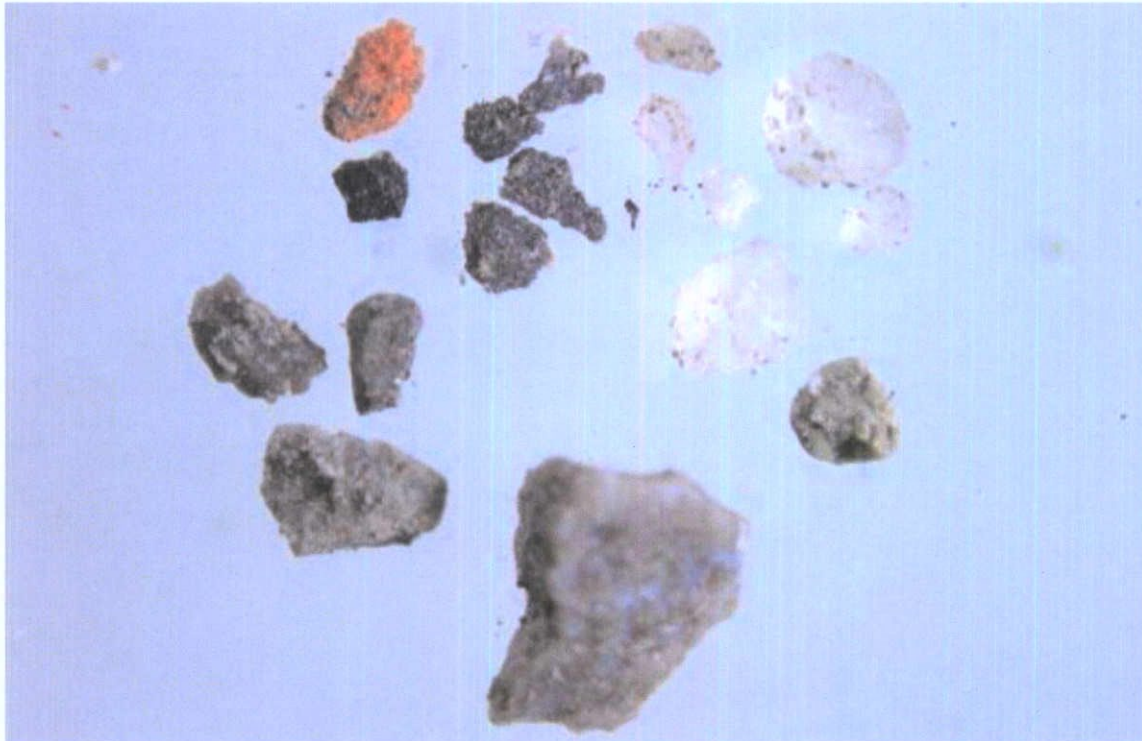
Fig.4.16.26: In contrast, the aggregate of the lime-based bedding mortars consists mainly of limestone, quartz, some chert and a fraction of brick aggregate.

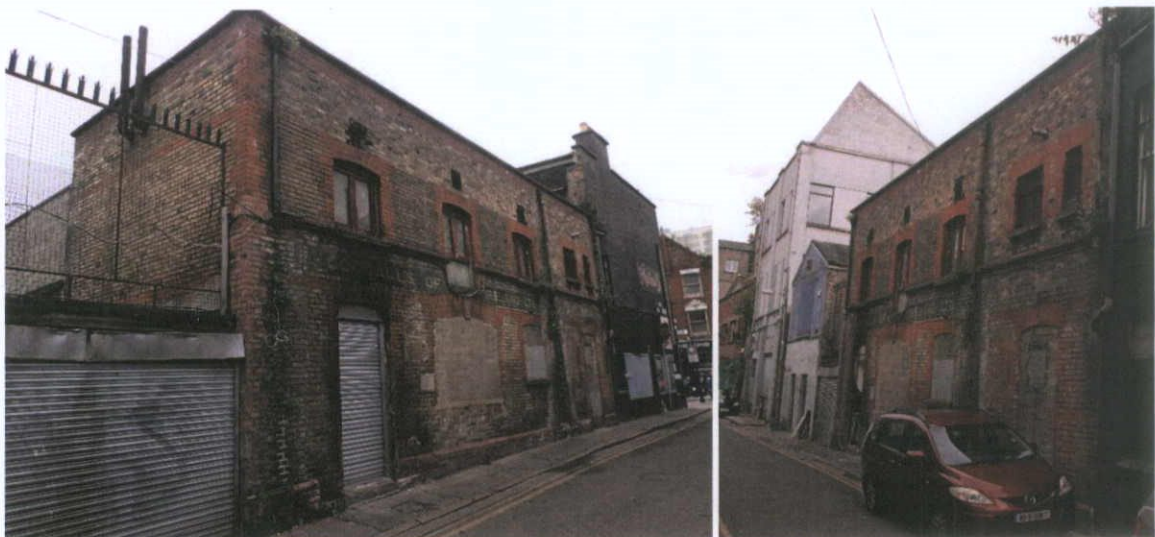
**4.17 11-13 Henry Place:** This two-storey five-bay warehouse building consists of yellow stock brick with red brick for windows, quoins and architectural details. The parapet has been raised with later modern red brick bedding in Portland Cement. The brickwork has been damaged with new openings inserted above windows, blocked-up openings at ground floor level and failure of the rainwater goods leading to saturation of the brick masonry which has damaged the bedding mortars. The building retains a painted sign for 'Goodalls of Ireland Ltd.'. Internally the brick fireplace at first floor level of the east elevation is composed of hand-made and clamp-fired brick but plastered in a cement mortar. The inside face of the north wall has been plastered throughout in cement. The external brickwork is consistent with the last quarter of the 19th century.

Fig.4.17.1: General view of Nos.11-13 Henry Place.
