**4.11 7 Moore Street:** The three-storey two-bay brick-fronted terraced building rising to a granite frieze and cornice, similar to the c.1917 limestone terrace of Nos.3-6 Moore Street built immediately to south, but lacking the brick ‘soldier’ quins and brick specials used as a string course between the first and second floors. Despite being a different construction project to the adjacent terrace, the brick in both developments match (compare Figs.4.2.10 & 4.11.2) and reflect the brick in common usage at the time.

**4.12 8-9 Moore Street:** This building comprises two eighteenth century buildings combined into one premises; now appearing as a painted three-storey four-bay brick-fronted building, and connected to Nos.11-13 Henry Place at the rear. The façade brickwork is painted yellow, while the north gable has been painted black. Two buildings are marked in this location on John Rocque's 1760 map, and when the internal brick lining was broken open (see Fig.4.12.7), the brick contains distinctive angular limestone aggregate also seen at No.42 O'Connell Street and other Georgian buildings in the area, and may be brick made at the 'Old Brick Field' noted on Moore Street on Rocque

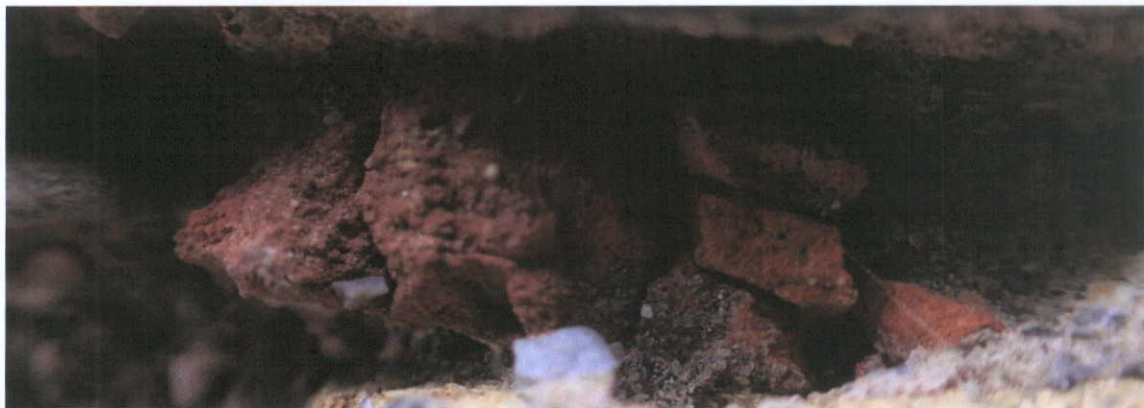
Fig.4.17.5: Crushed brick used as aggregate in the mortar.

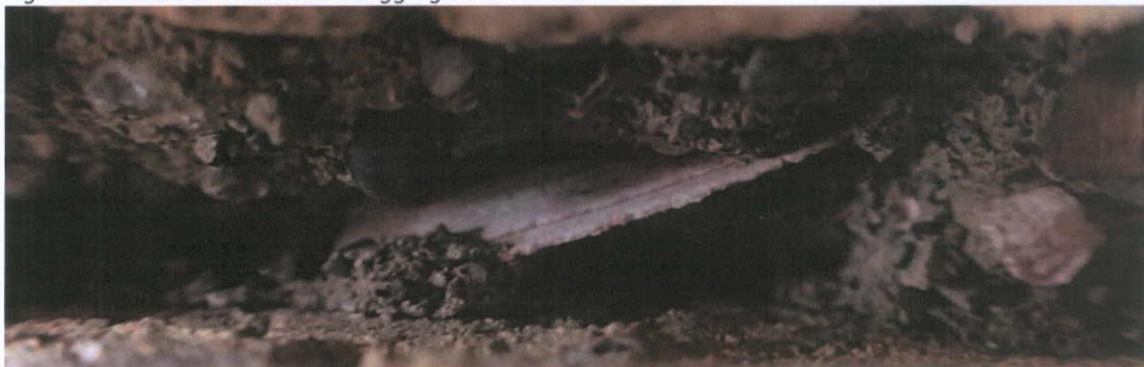
Fig. 4.17.6: Shell used as porous calcareous aggregate in the mortar.

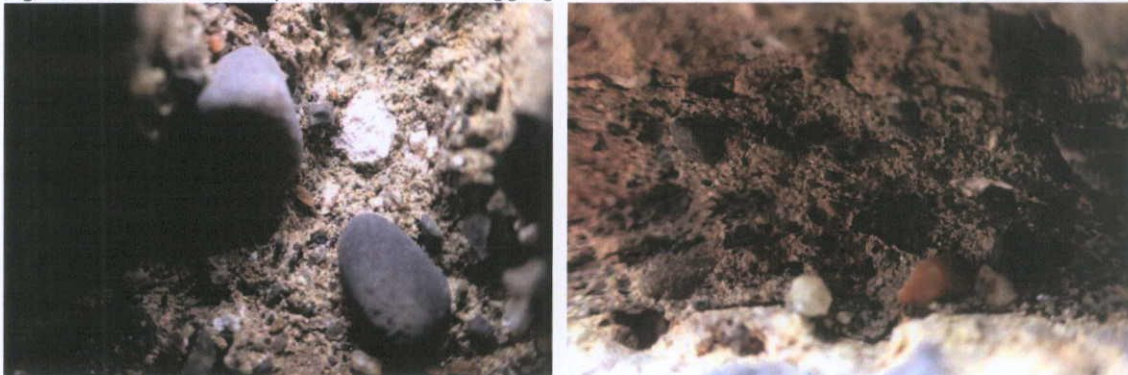
Fig. 4.17.7: Rounded limestone aggregate and sub-angular quartz with coarse burnt fuel fragments.

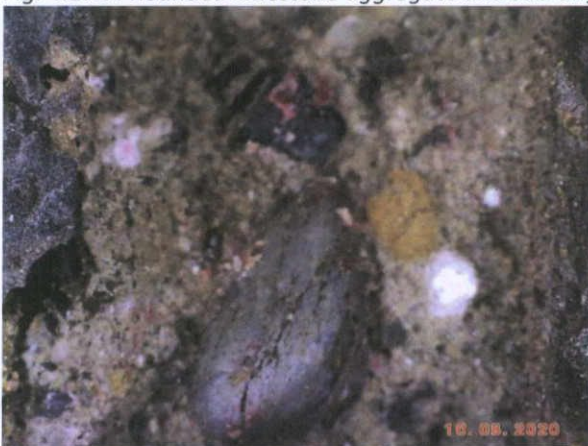
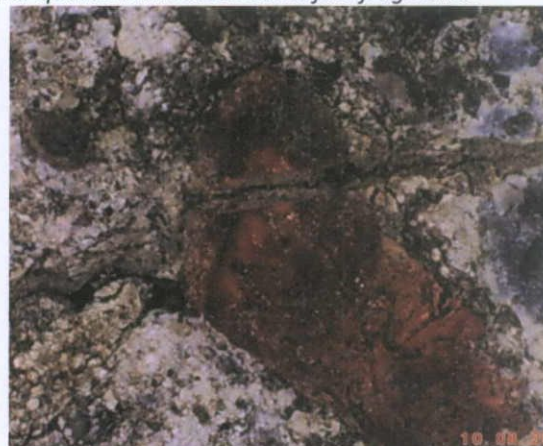
Fig. 4.17.8: Rounded limestone and crushed yellow brick aggregate

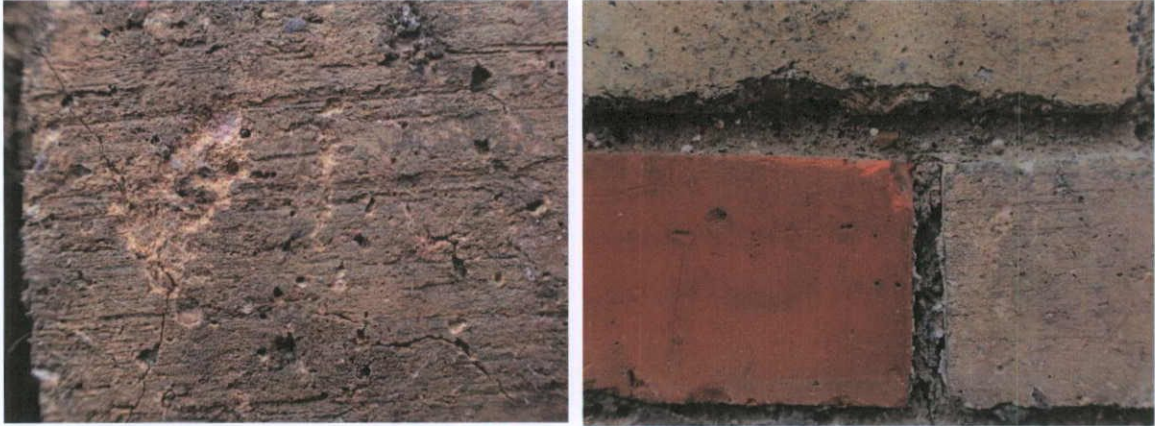
Fig. 4.17.9: Crushed brick in the mortar.

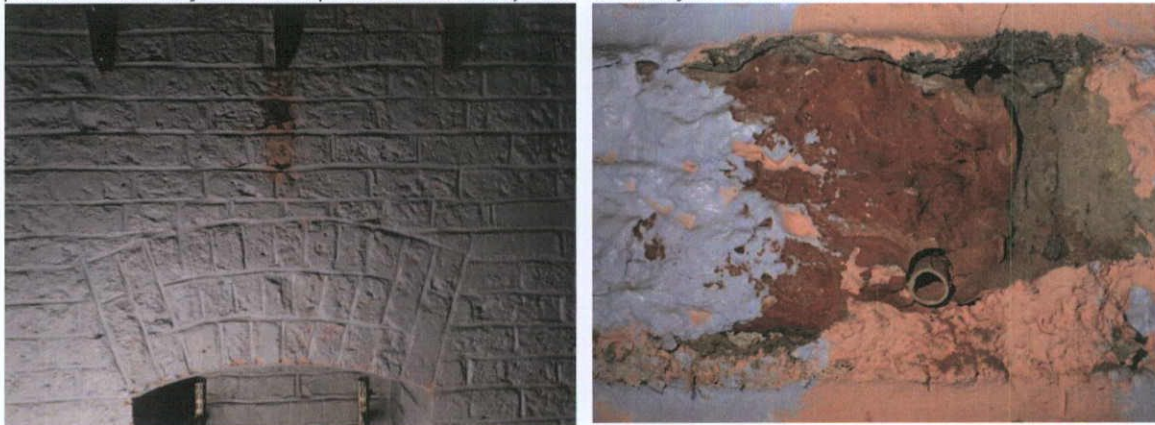
Fig. 4.17.12: The brick fireplace in the east wall at first floor level.

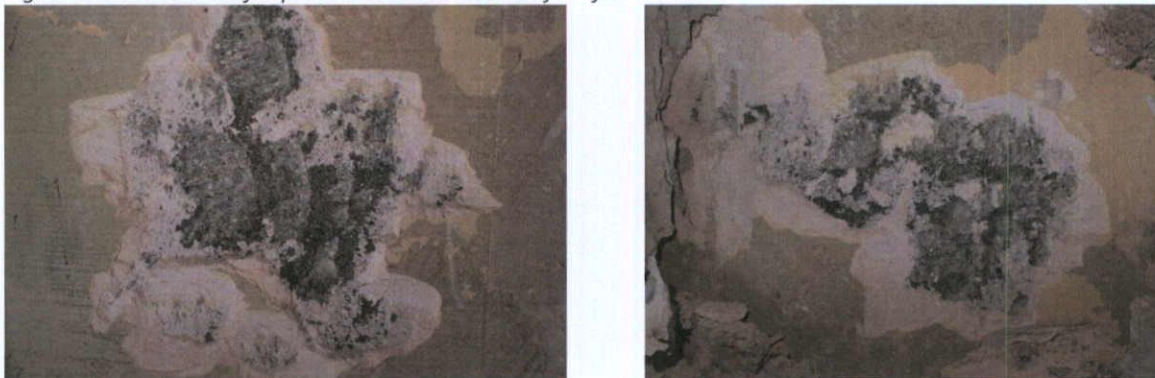
Fig. 4.17.13: Cement used to plaster the inside of the north wall at first floor level.

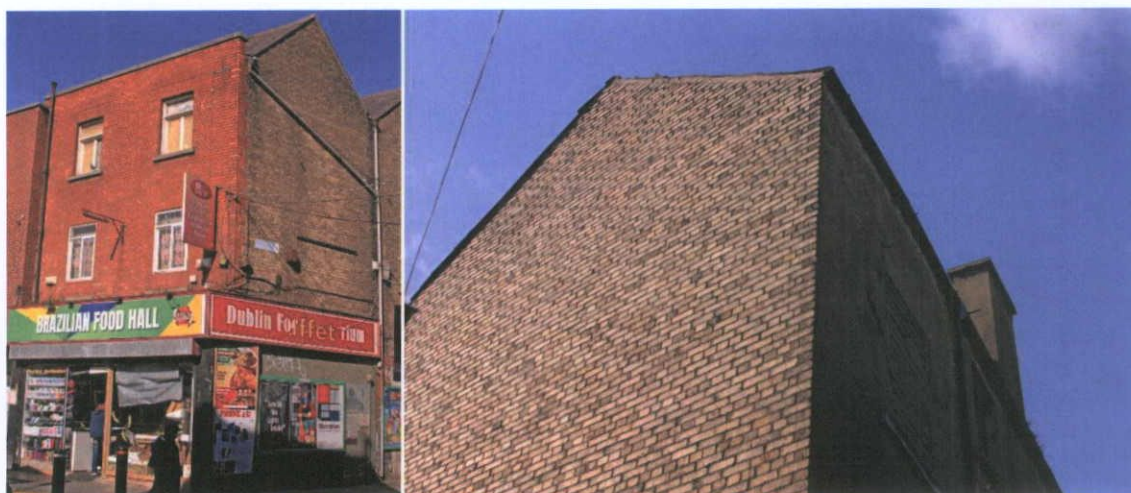
Fig.5.1.1: Façade and side (south) elevations of No.10 Moore Street with the rear (east) rendered.

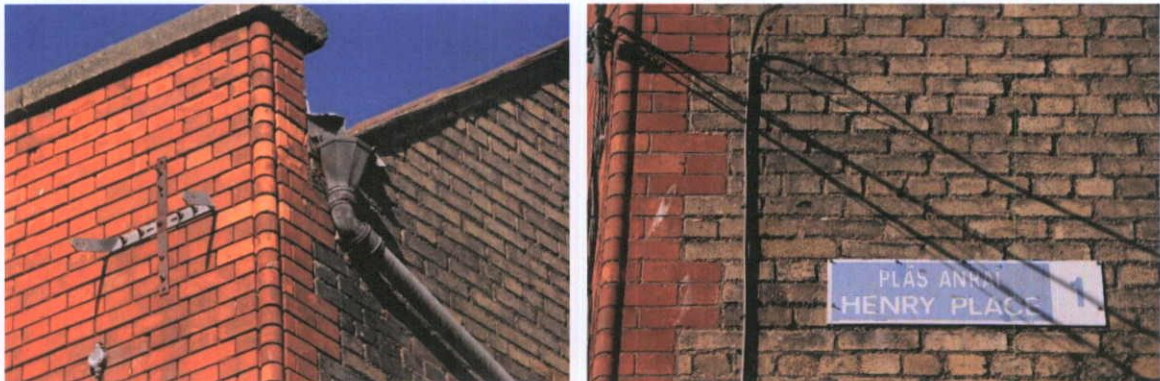
Fig.5.1.3: The red brick façade has moulded specials rising to the coping stones at parapet level (which are found on late nineteenth century and early twentieth century work) and is tied into the yellow stock brick side elevation with 'block and start' work.

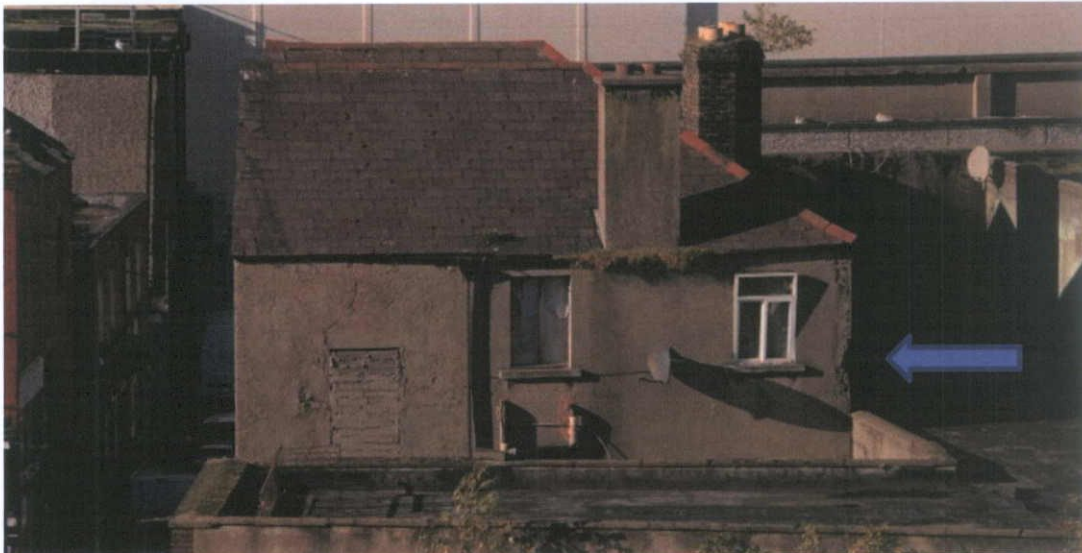
Fig.5.1.5: The rear of No.10 Moore Street is rendered. The north side (arrowed) was opened up.

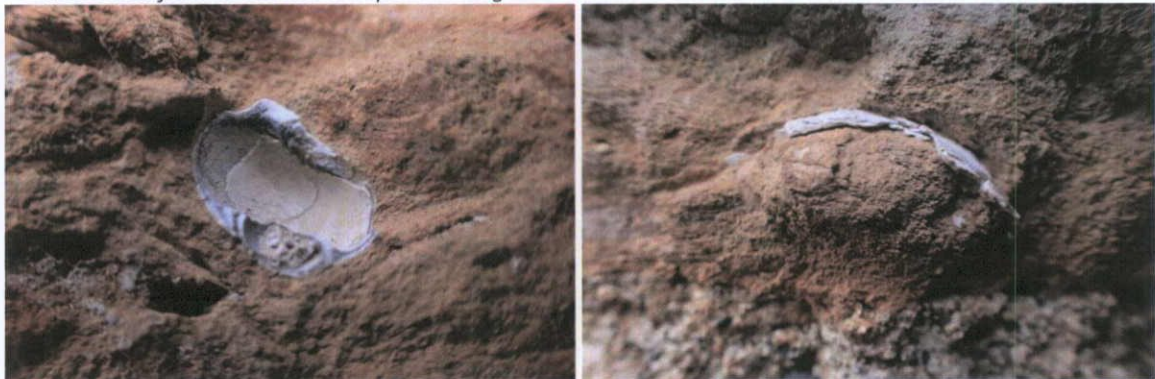
Shells are an uncommon find in historic Irish brick. The shells are partially calcined indicating that they were held within the brick at the time of firing. Shell can occur in raw brick clay in coastal areas (e.g. Lord Merrion's brick fields in Sandymount) due to occasional coastal flooding, or can occur as food waste. The shells exposed in the brickwork are consistent with food waste<sup>2</sup>. The brickwork in Nos.10, 13 and 18 are certainly pre-1916, and may be examples of early brickwork on Moore Street.

Fig.5.1.8: Detail of brick from the north elevation of No.10 Moore Street showing examples of shell inclusions in the fired clay matrix.

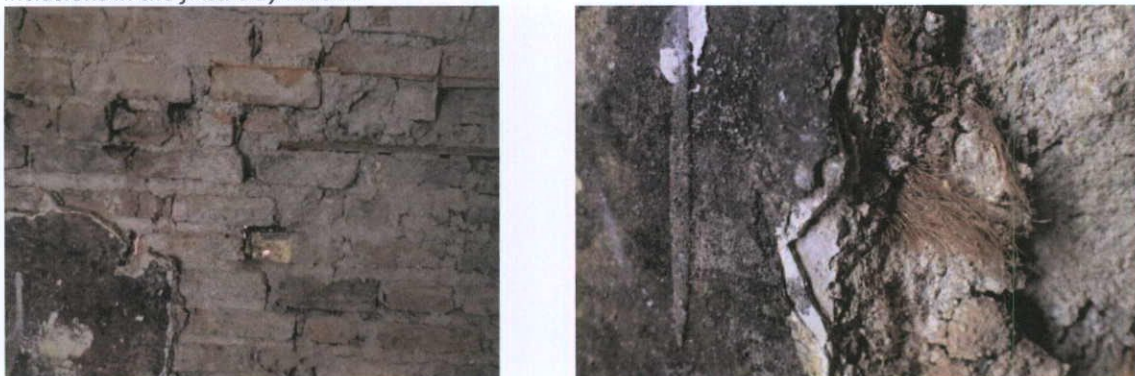
A 'creephole' can be seen in the north elevation at second floor level which is indicated by a disturbance and subsequent patching of the brick masonry fabric, suggesting that this part of the building is associated with the 1916 Easter Rising. The walls retain early haired lime plaster adjacent to the 'creephole' as well as 'lined' pointing joints.

Fig.5.1.9: Internal face of the wall show in Fig.5.1.6 with a change in both brick and mortar at the 'creephole' (left); while the surviving wall plaster has early haired lime plaster layers surviving beneath twentieth century surface finishes (right).

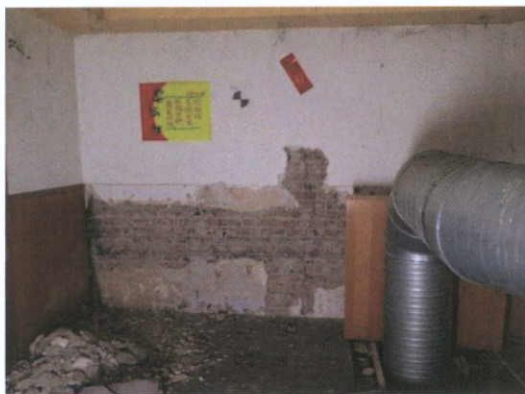
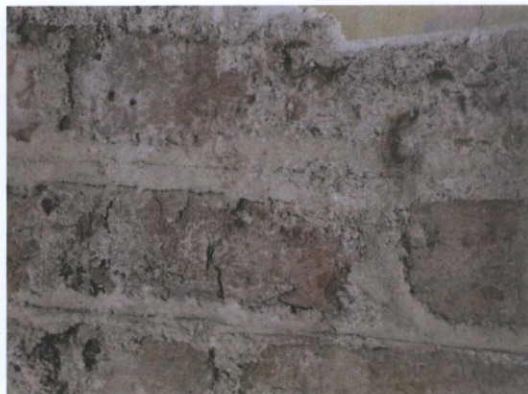
Fig.5.1.10: The party wall between Nos.10 and 11 Moore Street contains early brickwork with lime mortars struck in the same style as the internal walls of the mid-eighteenth century No.42 O'Connell Street.

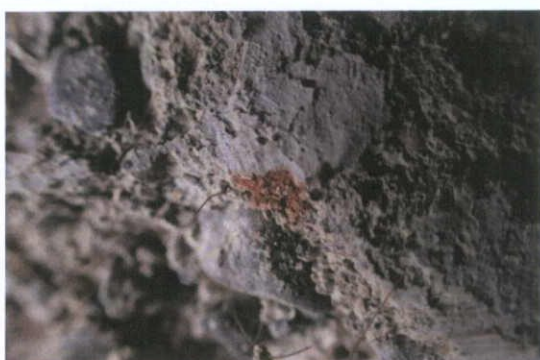
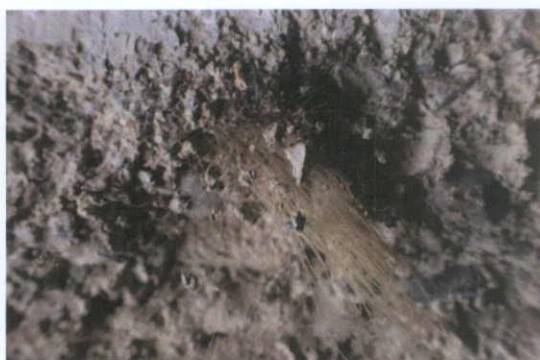
Fig.5.1.11: The bedding mortars of the party wall contains sub-rounded limestone aggregate and brick pozzolan (left); while the lime plasters on the wall have clumps of animal hair (right).

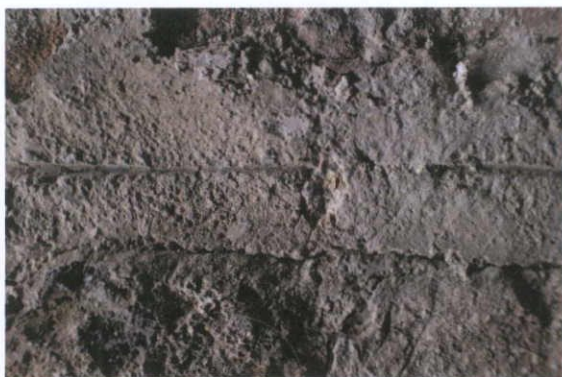
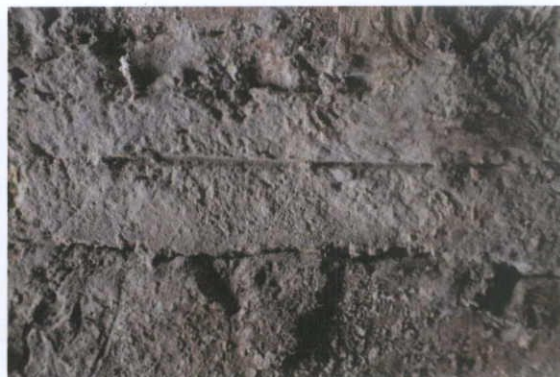
Fig.5.1.12: Lined mortar joint on the brick party wall between No.10 and 11 Moore Street, with traces of the animal hairs from the haired lime plaster adhering to the joint (right). This finish is also found on the eighteenth century internal walls of No.42 O'Connell Street.

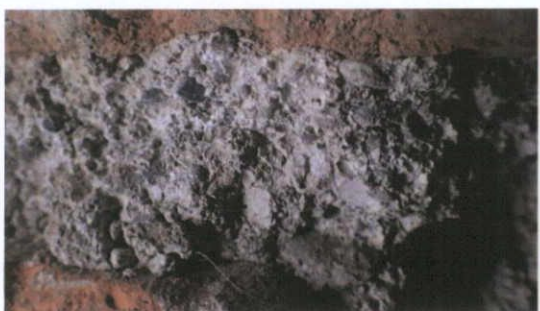
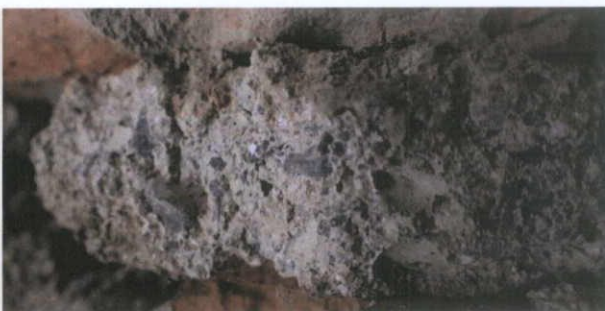
Fig.5.1.13: Poorly sorted bedding mortar containing limestone, chert and quartz aggregate.

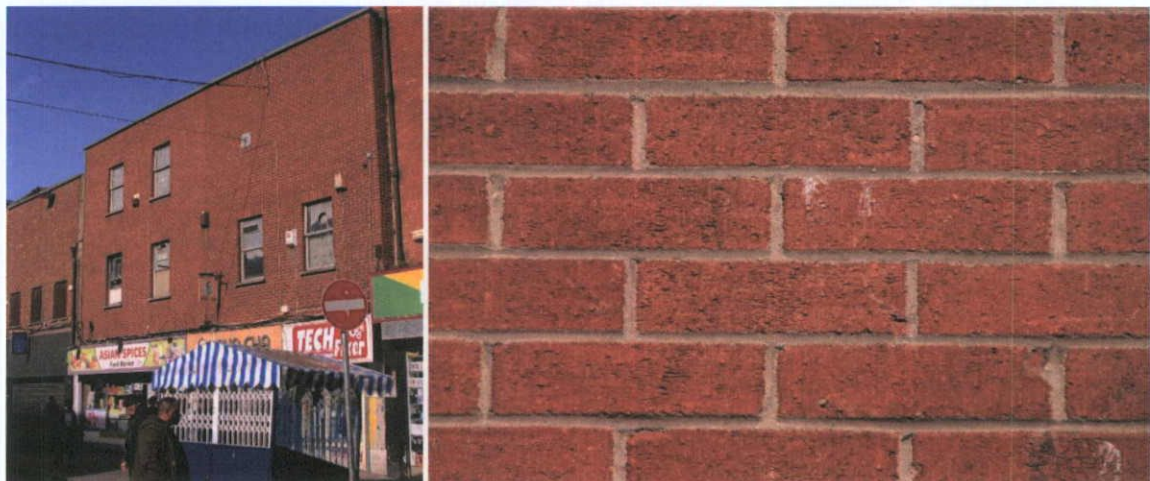
Fig.5.2.1: The façade of 11-12 Moore Street was built of machine-cut textured brick bedding in Portland Cement and finished with a 'bucket handle' joint, this finish is common from the late 1950s-1980s. The brick is widely used in the twentieth century, and this type of textured brick could date from anywhere from the 1930s to the 1990s.

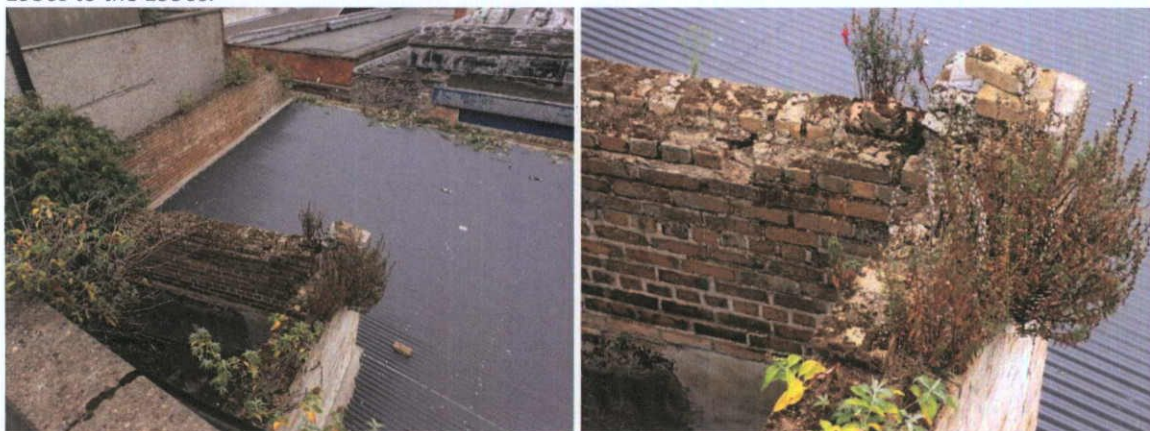
Fig.5.2.2: Yellow stock brick sampled from the rear return of No.12 Moore Street.

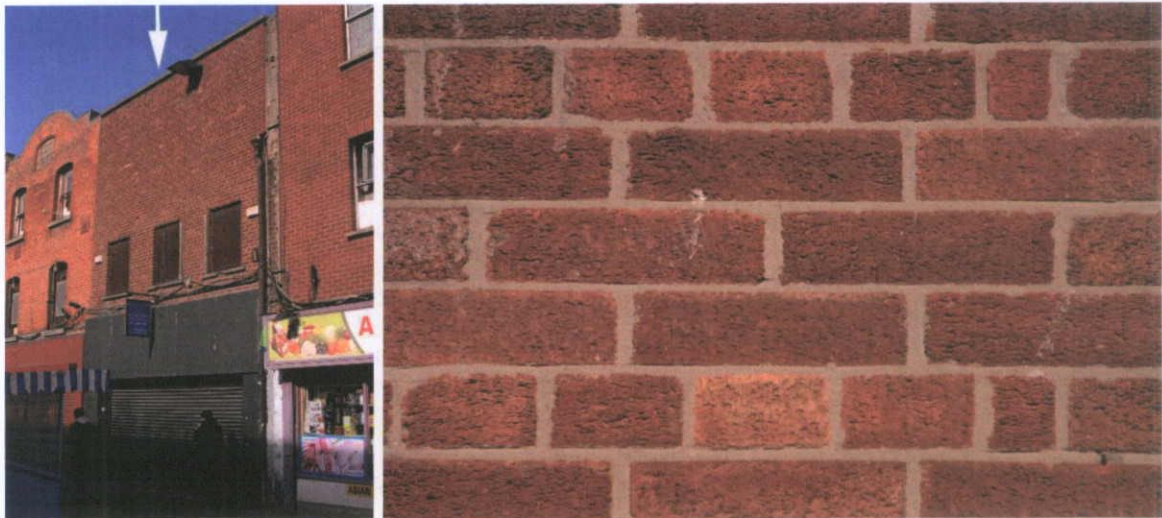
Fig.5.3.1: The façade of 13 Moore Street was built of machine-cut textured brick bedding in Portland Cement and finished with flush joint.

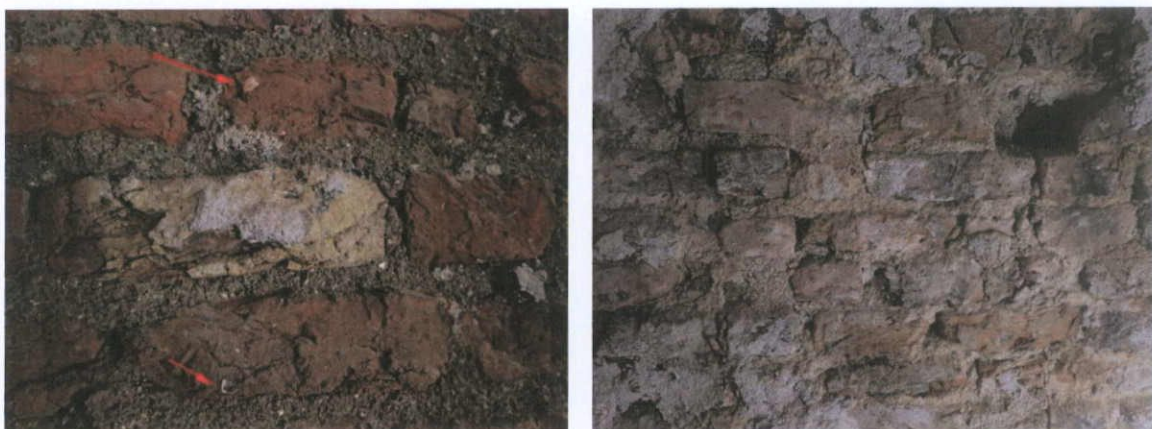
The late eighteenth/early nineteenth century brick in the party wall with No.12 Moore Street is a distinctive hand-made clamp-fired brick containing shell inclusions. This type of brick is also seen in the brick masonry of Nos. 10, 12, 18, 20 and 21 Moore street, and is also found in the chimney stack of No.59 O’Connell Street. These bricks are poorly formed and probably hand-moulded, with distortions exacerbated by the firing process. Firing was uncontrolled with some bricks under-fired and relatively ‘soft’, and other bricks showing ‘hot spots’ and areas which were over-fired, vitrified, coloured black and appearing glassy. The raw clay shows no evidence of processing or sorting.

Fig.5.3.2: 13 Moore Street, Ground Floor, Rear Room, north face of south wall (party wall with No.12). Detail of handmade brickwork from the internal party wall between Nos.13 & 12 Moore Street with burnt shell inclusions (arrowed) within the fired clay matrix (left). The original brick at first floor level (right) is also hand-made and of varying dimensions and qualities, laid in deep lime mortar joints. These are ‘place’ bricks intended to be coated with a lime plaster.

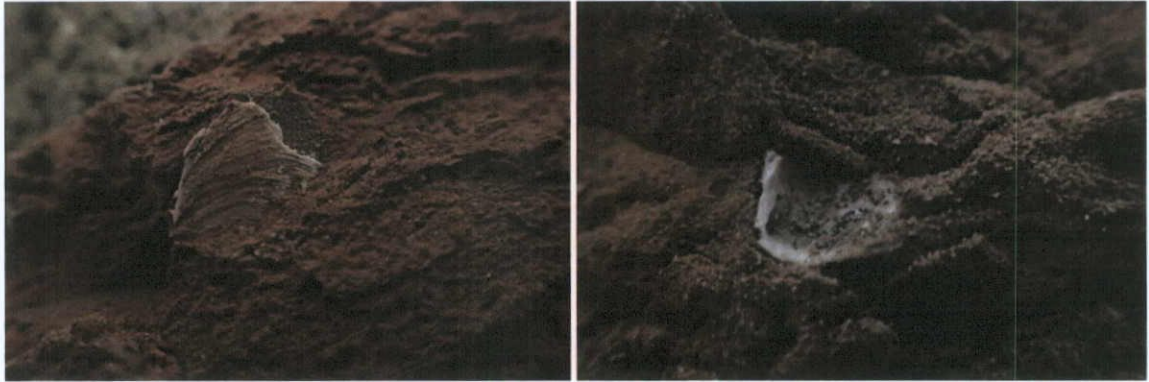
Fig.5.3.3: 13 Moore Street, Ground Floor: Detail of burnt shell inclusions in the brick.

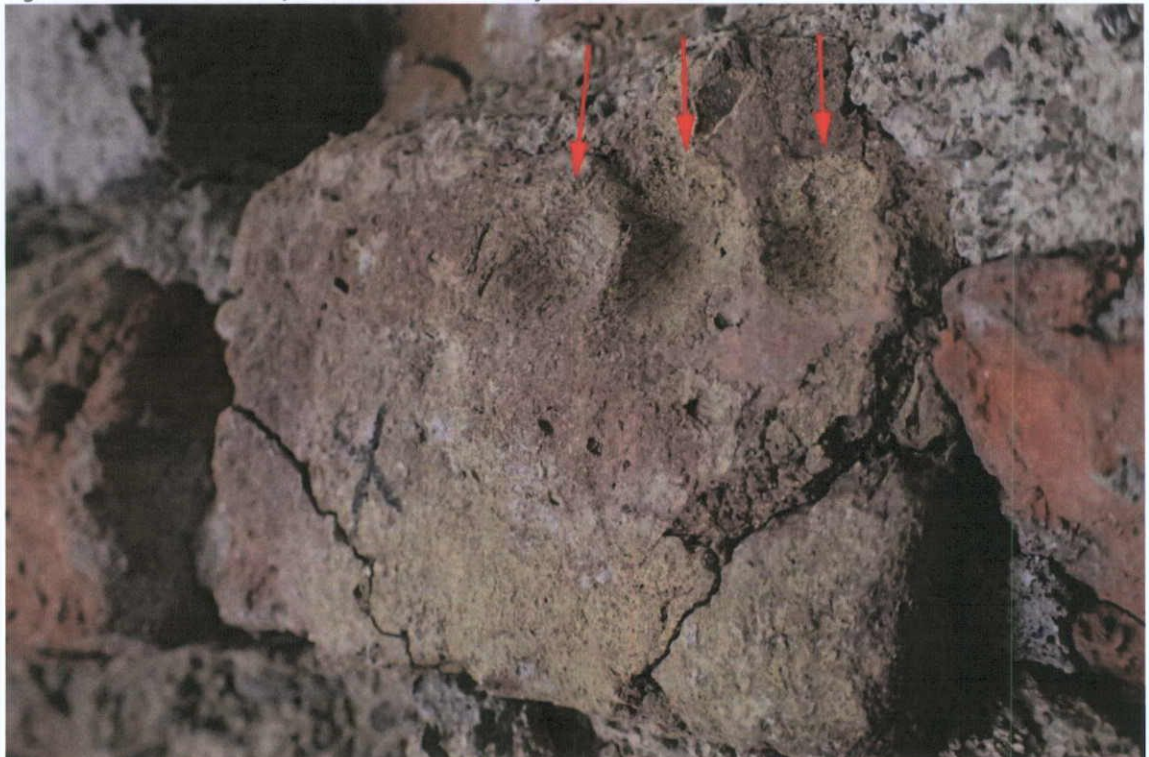
A distinctive eighteenth century hand-made clamp-fired brick type is found at Nos. 10, 13, 18, 20 and 21 Moore Street. At ground floor level of No13 Moore Street, one of these bricks bears the fingermarks of a child (Fig.5.3.4) and is rare physical evidence of the common use of child labour in brickmaking and construction in eighteenth and nineteenth century Ireland. A proportion of this brick is 'shell lime' brick and shows such striking similarities that they should be considered contemporaneous.

Fig.5.3.4: Fingerprint impression (probably from a child or young adolescent) formed in the brick. This occurs when the brick is 'green' and is turned prior to firing.

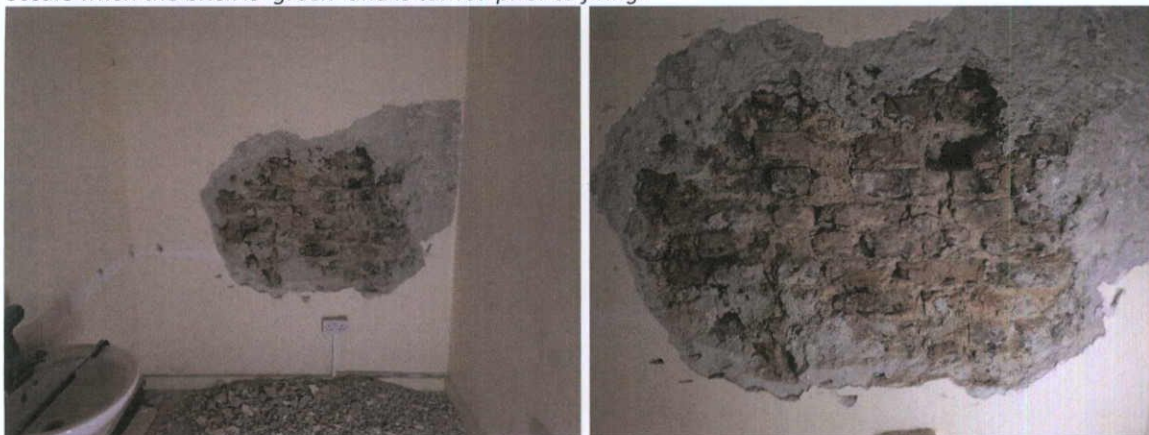
Fig.5.3.5: Internal party wall at upper floor level showing hand-made brick bedded in a lime bedding mortar.

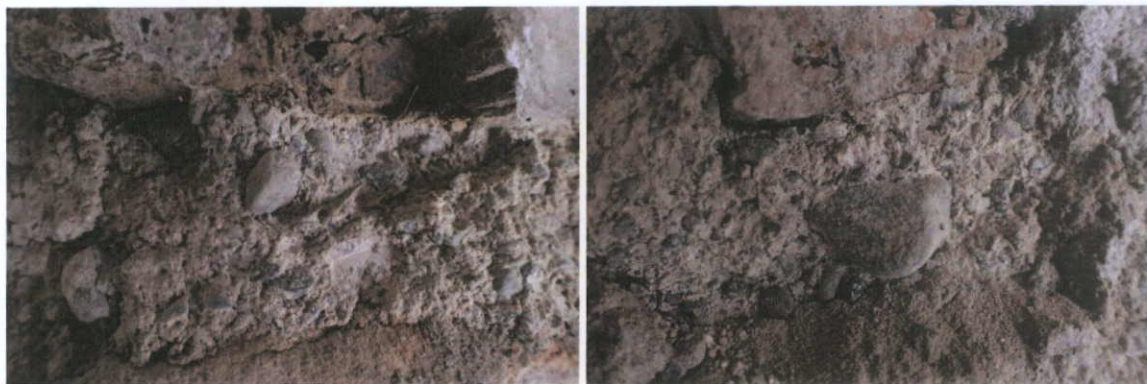
Fig.5.3.6: The original bedding mortar is lime based, without obvious pozzolanic additions, and containing rounded limestone pebble to gravel-sized aggregate.

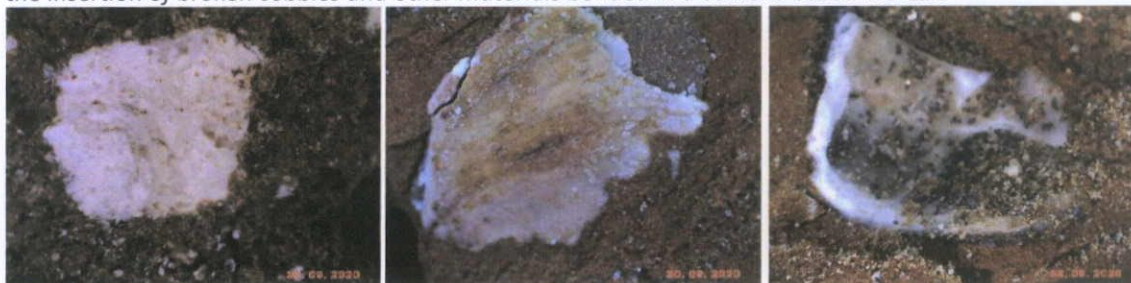
Fig.5.3.8: The late eighteenth/early nineteenth century mortars contain abundant lime limps (left) but no obvious porous brick aggregate or pozzolanic brick dust; while a proportion of the brick contain shell fragments as inclusions within the matrix – these are partially fired indicating that they were contained within the brick during manufacture.

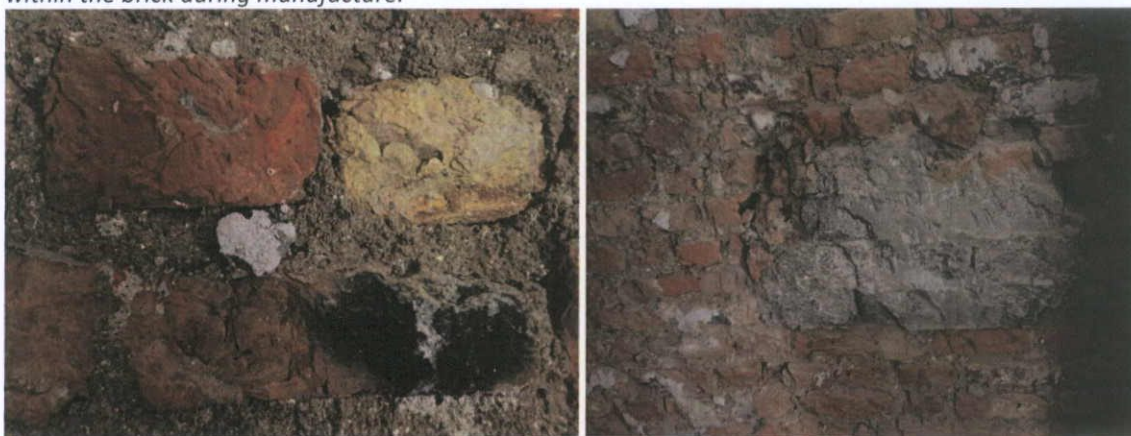
Fig.5.3.9: Late eighteenth/early nineteenth century brickwork, ground floor, south wall, with concrete infill.

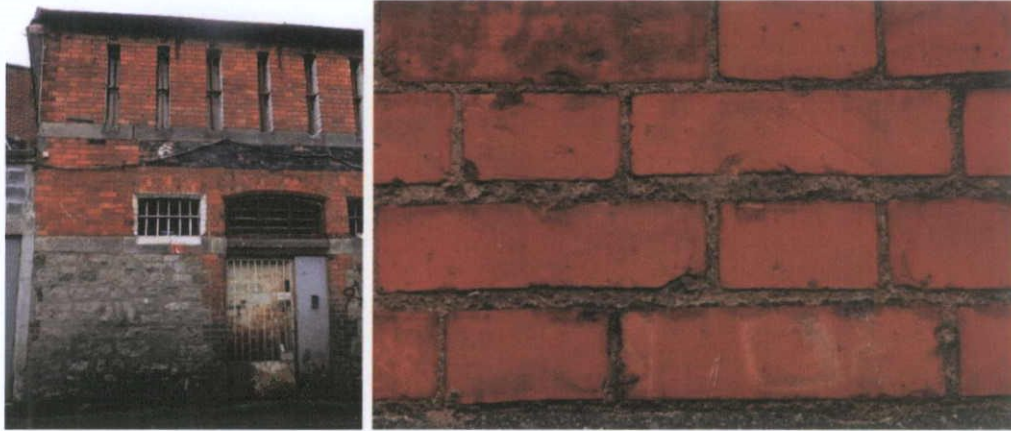
Fig.5.5.3: View showing brick over granite string course with Calp limestone at ground floor level; and a view of kiln-fired machine-cut extruded brick, with a 'kiss-mark' visible.

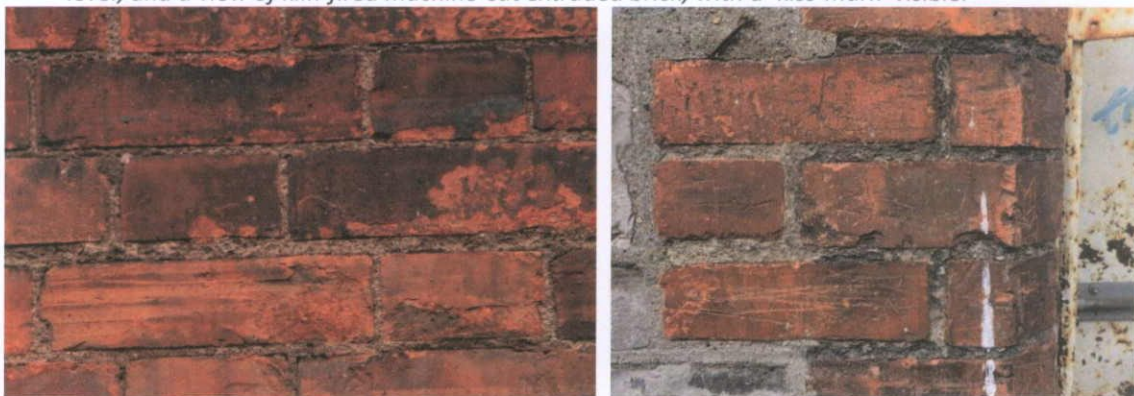
Fig.5.5.4: The brickwork was laid in a lime-based mortar finished flush.

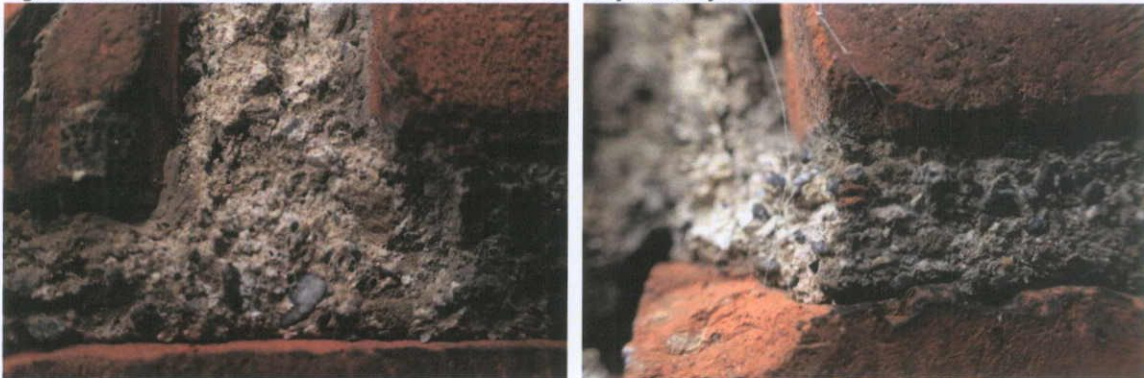
Fig.5.5.5: The lime-based bedding mortar contains sub-rounded to sub-angular aggregate, fine lime lumps and partially slaked limestone and some crushed brick.

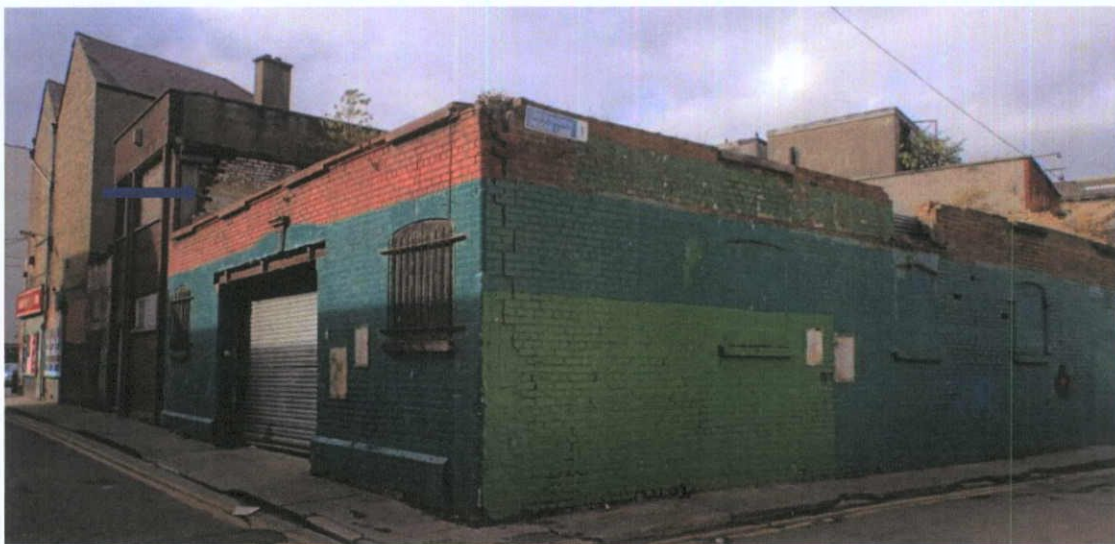
*Fig.5.6.1: The building appears to have been cut down with upper floors removed. Part of the west wall at first floor level survives (arrowed). There is no wall-top, coping or other finish to the brick walls.*

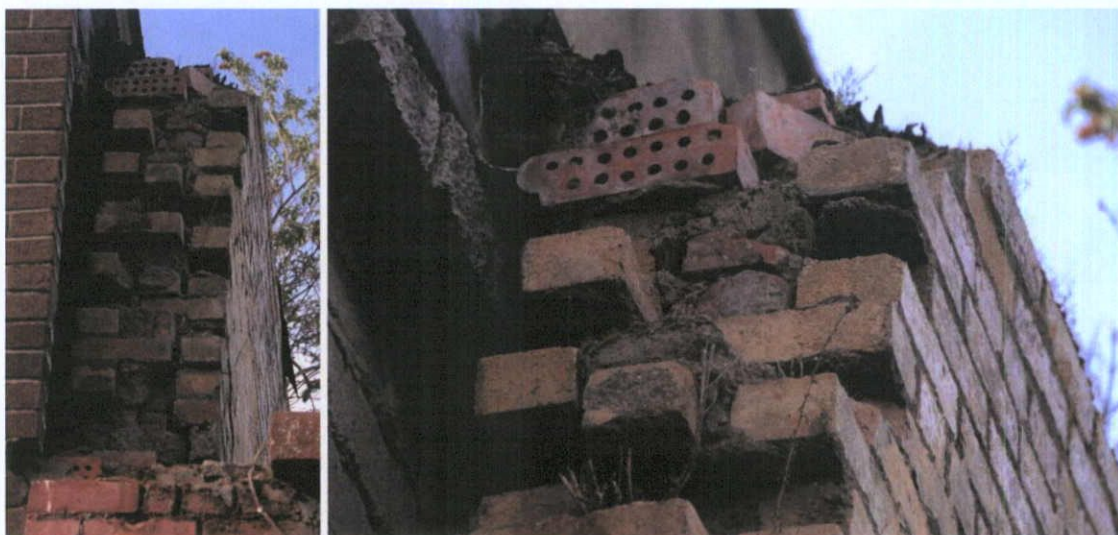
*Fig.5.6.2: Detail of the inner leaf of yellow stock brick forming the west wall at first floor level; with moulded perforated red brick indicating decorative treatment to the west elevation of the building.*

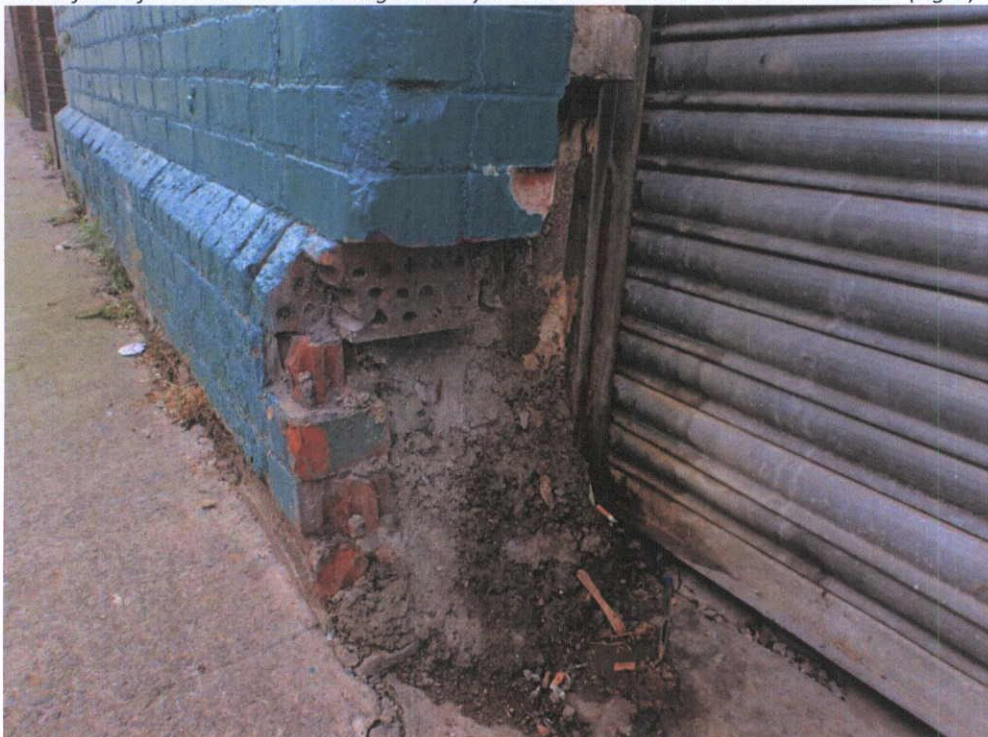
Fig.5.6.9: The south wall is of extruded brick and terracotta with yellow stock brick as internal wall linings, and is probably late nineteenth century construction work.

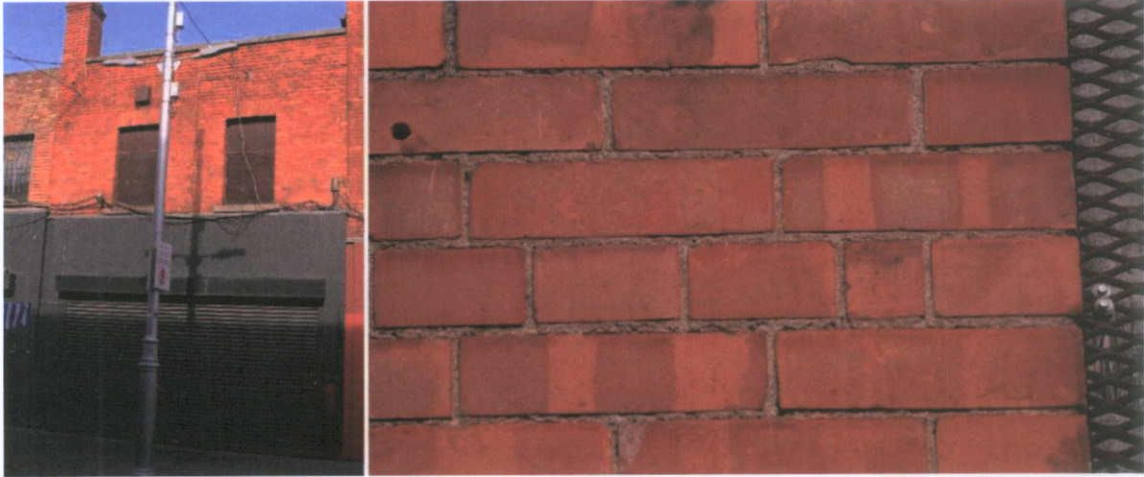
Fig.5.7.3: The first floor has brick with 'kiss marks' from the firing process. This type of brick is found in buildings in Dublin City from the 1890s and used thereafter for a number of decades.

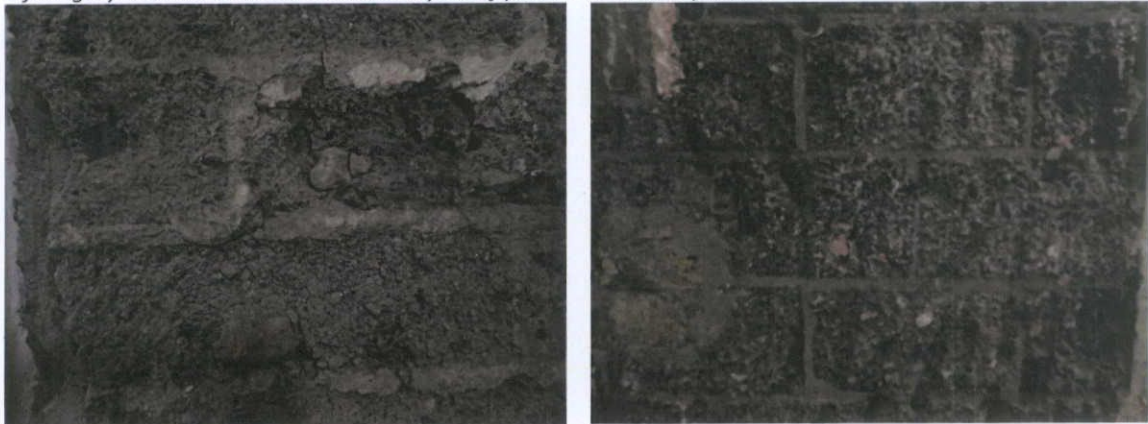
The rear wall of No.18 Moore St is also of concrete blockwork. This is made of very similar concrete to that seen in the party wall between Nos.18 and 19, and again bedded in a fine-grained cement mortar. The blocks are smaller in dimension, but of similar composition and of similar poor quality. Given the similarity to the concrete blocks in the party wall coupled with the poor quality of the concrete, on the balance of probabilities, this concrete is likely to date from after 1916.

Fig.5.7.5: Concrete blockwork with natural stone, clinker and occasional iron fragments used to form the party wall with No.17 Moore Street, with a similar concrete block of smaller dimension used to form the rear wall of No.18 Moore Street.

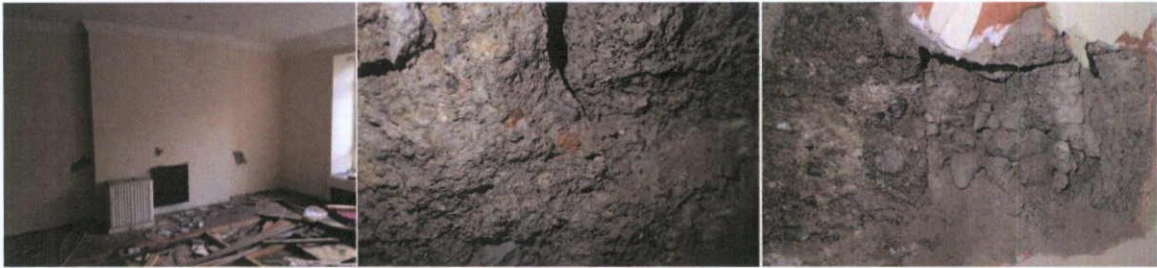
Fig.6.1.3: The south wall of the building (party wall with No.19 Moore Street) is of concrete construction.

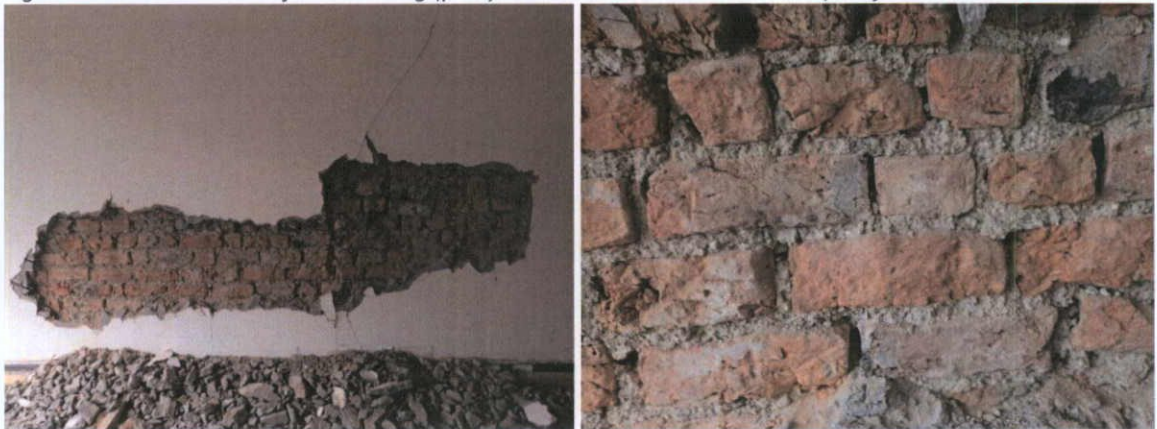
Fig.6.1.4: The party wall between Nos.20 and 21 is of hand-made clamp-fired brick laid in deep lime mortar joints.

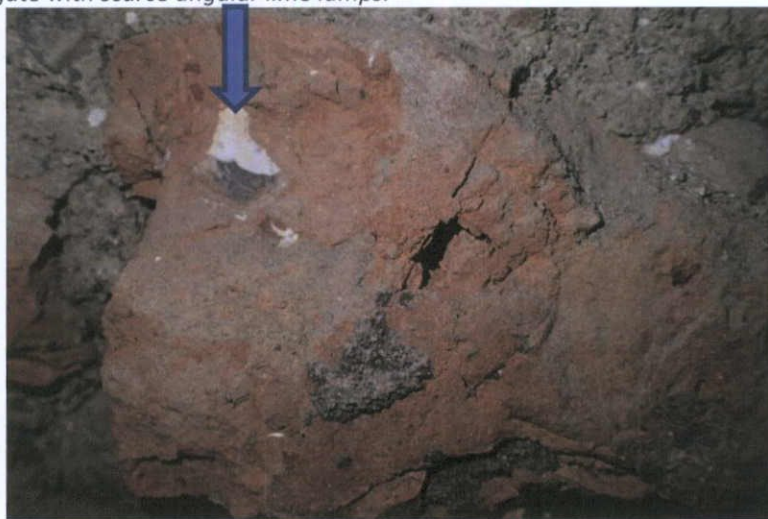
Fig.6.1.6: Shell (arrowed), partially fired, inclusion within the brick.

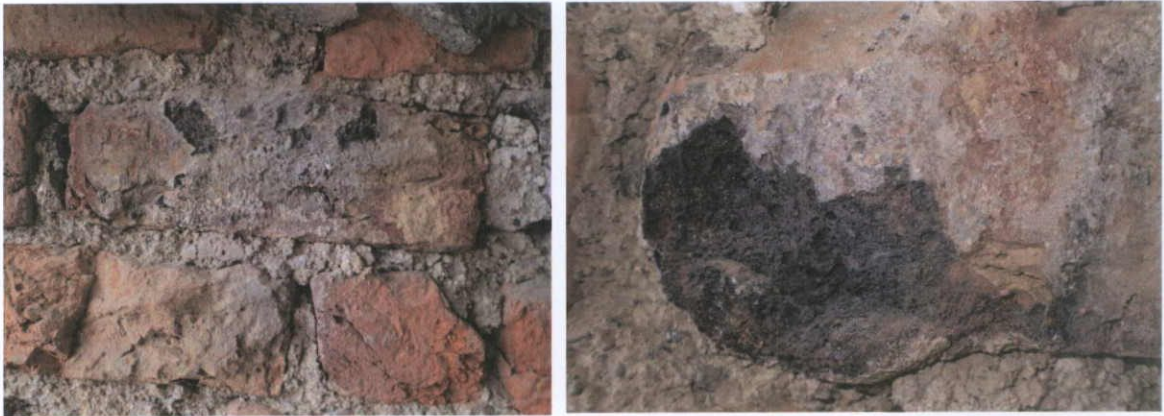
Fig.6.1.7: Many of the bricks were unevenly fired, with sections over-fired and partially vitrified.

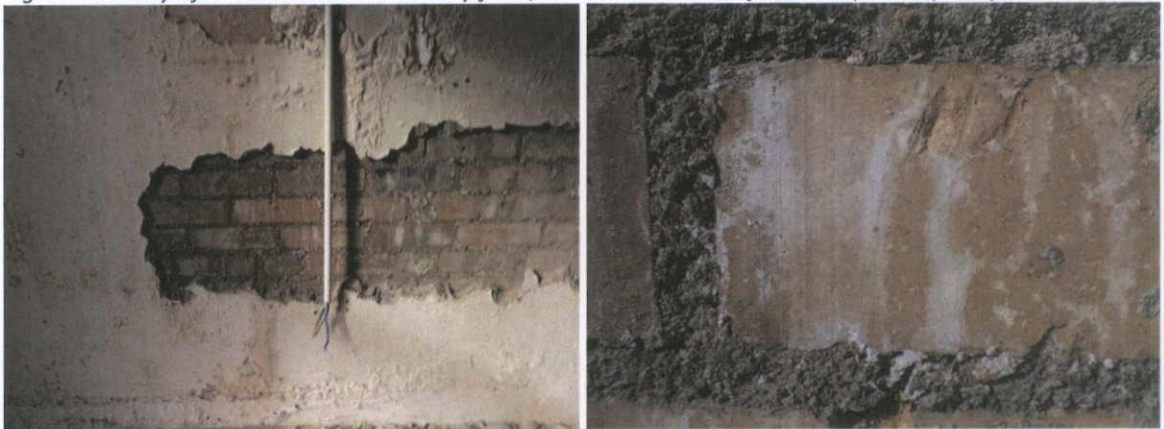
Fig.6.1.8: The north wall (party wall with No.22) consists of kiln-fired extruded machine-cut yellow stock brick. Similar brick is found in the link building between 42 O'Connell Street and O'Connell Hall.

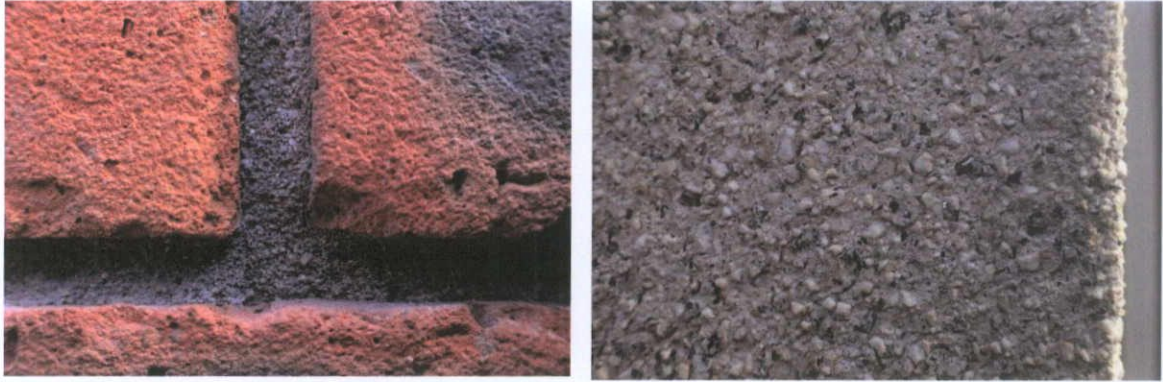
Fig.8.3.3: Detail of the brick and Portland Cement mortar (left) and cast stone quoin (right).

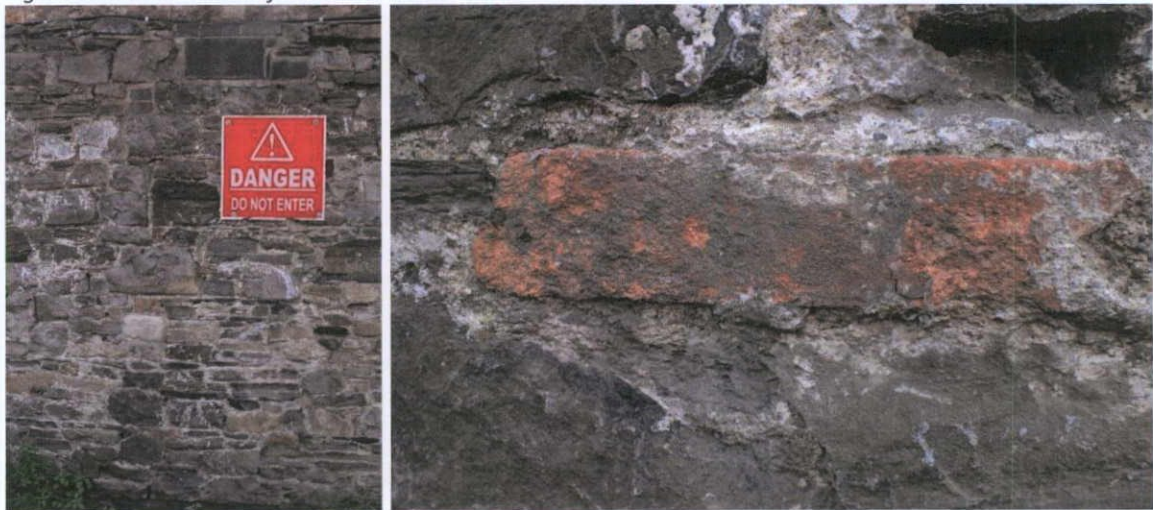
Fig.6.4.2: Calp limestone masonry section with thin brick forming part of the fabric. Note that the masonry contains flaggy and rounded stones. The masonry is similar to the Calp limestone masonry forming the internal east wall at 9 Henry Place (probably the remnants of a nineteenth century stable).
