**4.11 7 Moore Street:** The three-storey two-bay brick-fronted terraced building rising to a granite frieze and cornice, similar to the c.1917 limestone terrace of Nos.3-6 Moore Street built immediately to south, but lacking the brick ‘soldier’ quins and brick specials used as a string course between the first and second floors. Despite being a different construction project to the adjacent terrace, the brick in both developments match (compare Figs.4.2.10 & 4.11.2) and reflect the brick in common usage at the time.

**4.12 8-9 Moore Street:** This building comprises two eighteenth century buildings combined into one premises; now appearing as a painted three-storey four-bay brick-fronted building, and connected to Nos.11-13 Henry Place at the rear. The façade brickwork is painted yellow, while the north gable has been painted black. Two buildings are marked in this location on John Rocque's 1760 map, and when the internal brick lining was broken open (see Fig.4.12.7), the brick contains distinctive angular limestone aggregate also seen at No.42 O'Connell Street and other Georgian buildings in the area, and may be brick made at the 'Old Brick Field' noted on Moore Street on Rocque

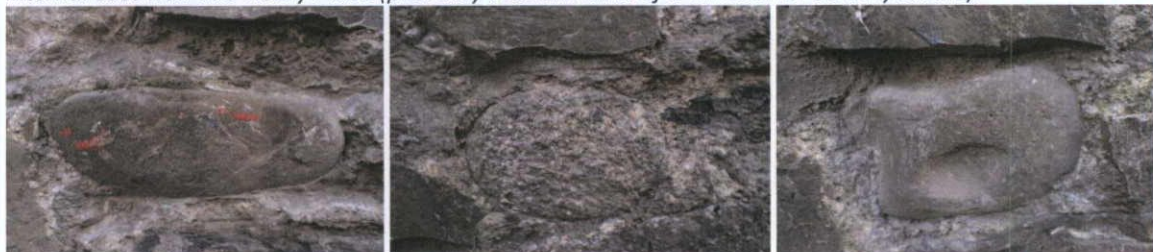
Fig.6.4.3: Rounded cobble-sized limestone is also found in the wall fabric.

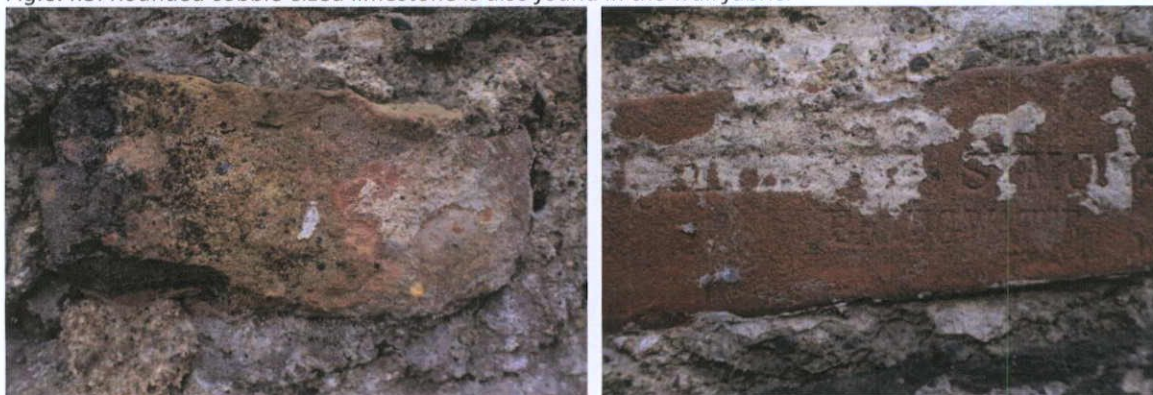
Fig.6.4.4: Irregular distorted clamp-fired vitrified yellow brick, possibly 18<sup>th</sup> century (left) and imported stamped 'Colhurst Symon & Co. Ltd Bridgwater' from Somerset. This brickmaker was in operation from 1857 until the 1960s

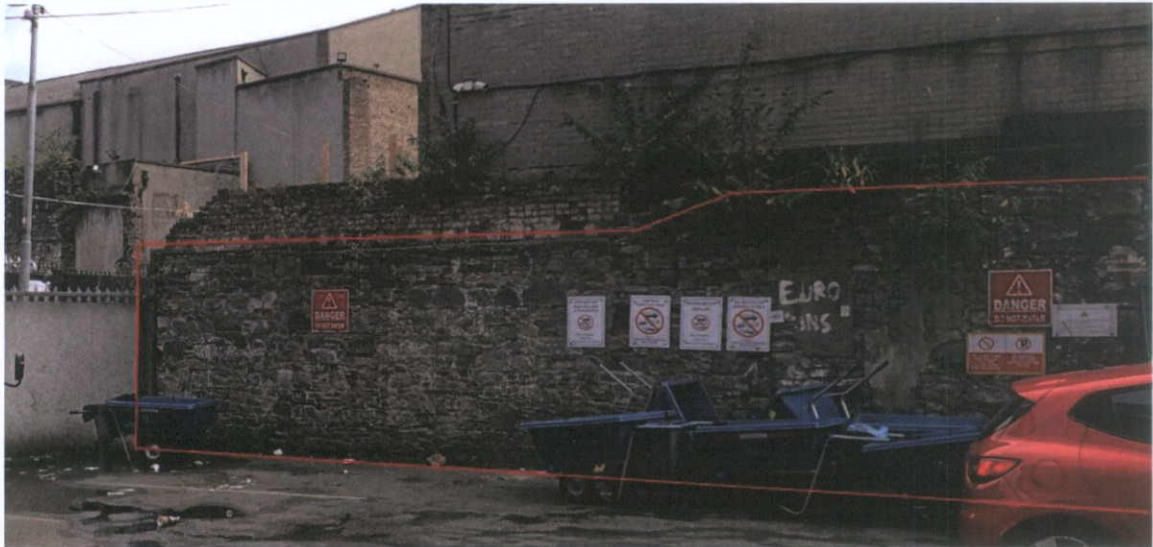
Fig.6.4.5: The eastern section of the wall consists of hewn Calp limestone masonry bonded in a lime-based mortar.

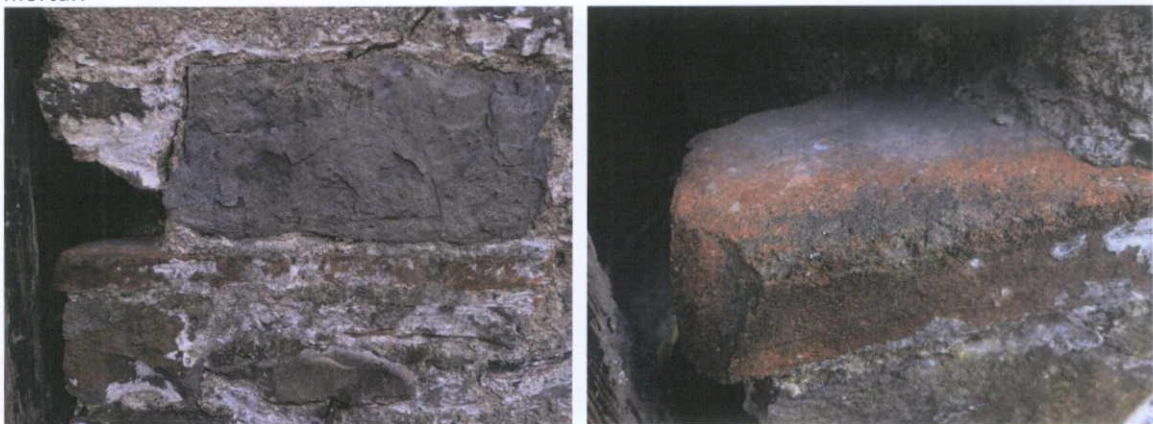
Fig.6.4.6: Ceramic tile used within the masonry.

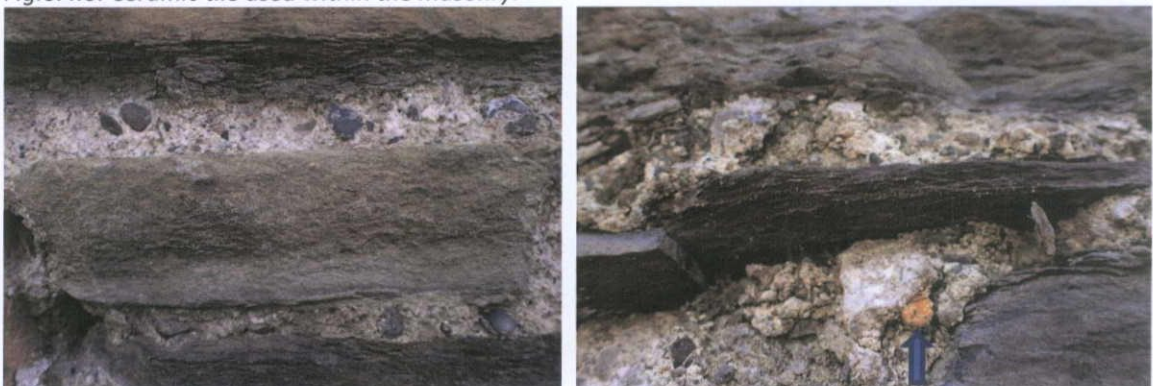
Fig.6.4.5: Deep lime mortar joints with poorly sorted predominantly coarse limestone aggregate, slate pinnings and scarce coarse brick aggregate (arrowed).

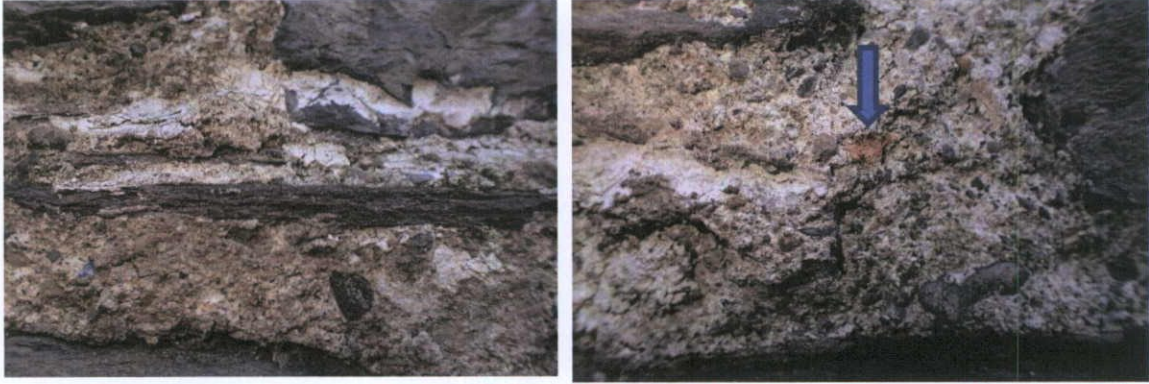
Fig.6.4.6: Slate pinnings (left) and coarse brick aggregate (right, arrowed) as an occasional component of the aggregate fraction of the mortar.

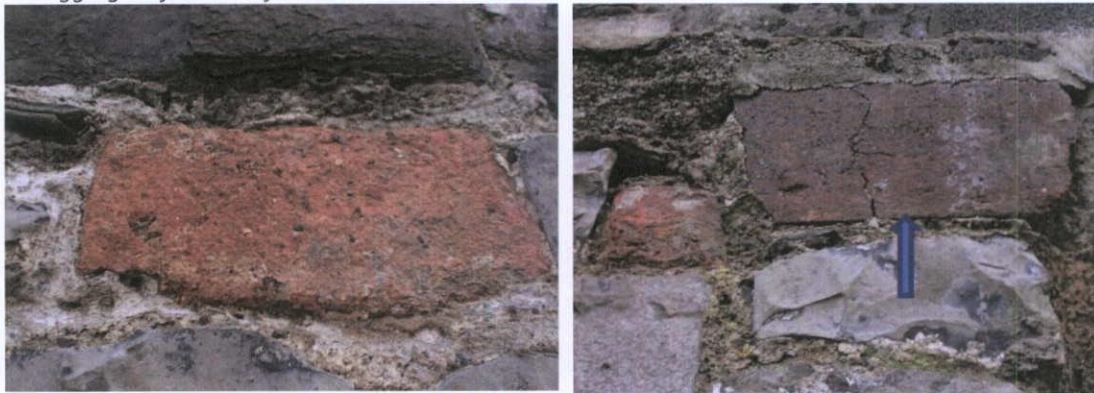
Fig.8.4.9: Warped hand-made clamp fired brick (left) while the upper course contain occasional imported brick (right, arrowed) presumably added as a levelling-up course before the concrete was poured).

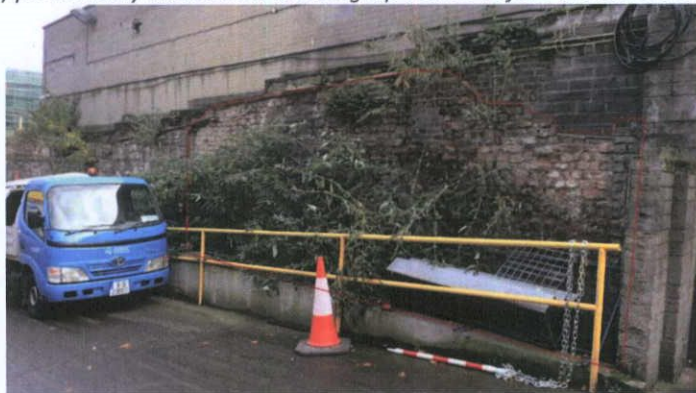
Fig.8.4.10: The western section of the wall is composed of red and yellow place brick, and appears to represent internal lining.

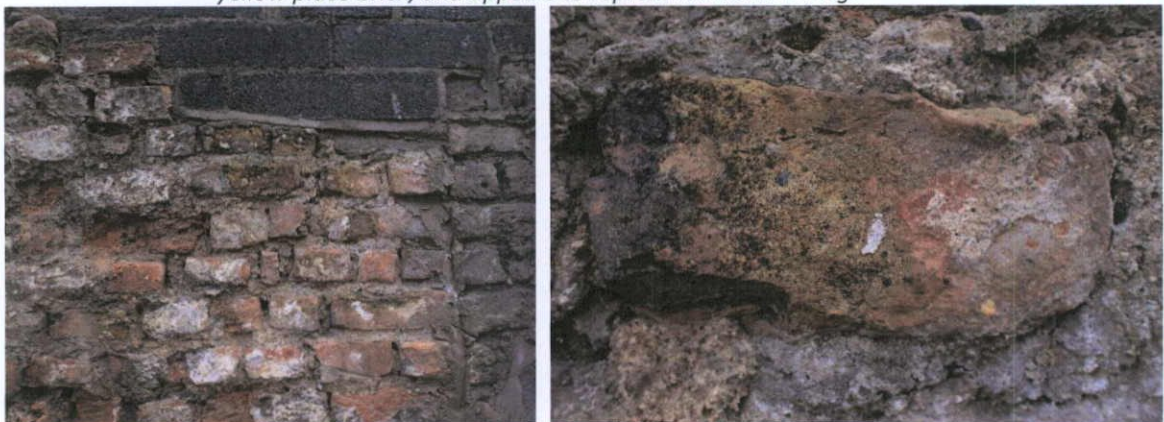
Fig.8.4.11: Poorly formed hand-made place brick, with modern concrete construction adjacent.

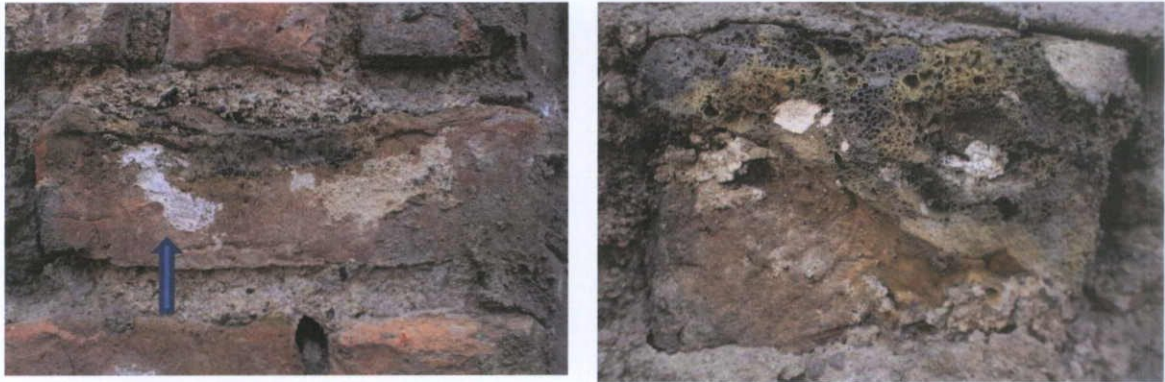
Fig.8.4.12: Poorly-fired place brick in a deep lime-based mortar joint, showing a remnant of a lime-based plaster adhering to part of the surface (left, arrowed). Right: Poorly-fired place brick showing vitrified areas, voids, warping, but with traces of limewash on the surface of the brick.

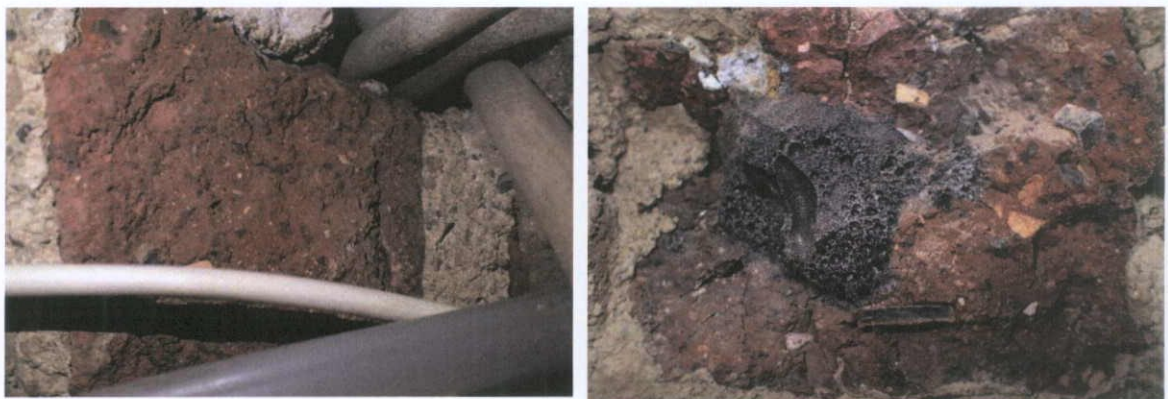
Fig.9.1.1: Brick with coarse angular limestone inclusions from the basement of No.43 O'Connell Street (left), and seen in the internal walls of No.71 Parnell Street (right).

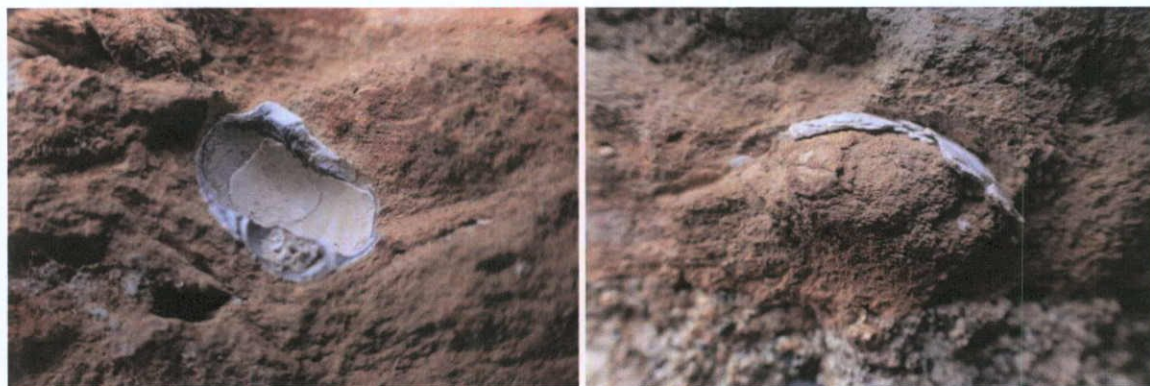
Fig.9.1.2: 'Shell brick' is found at a number of buildings on Moore Street including No.10 Moore
