Appendix 1 – Sampling

The sampling below relates to buildings from all five sites under consideration in the Dublin Central project.

This report was prepared at the request of Molloy & Associates Conservation Architects to inform the Dublin Central Built Heritage Review for Hammerson Plc. The purpose of the work was to analyse the physical fabric of buildings on O’Connell Street, Parnell Street, Henry Street, Moore Street, Moore Lane and Henry Place; and to use the physical evidence gathered through study of the building materials to gain a better understanding of the significance and dating of each of the buildings. This report is Volume 2 (of 2)¹ and focuses on the buildings contains in Sites 1 and 2 in the Dublin Central project.

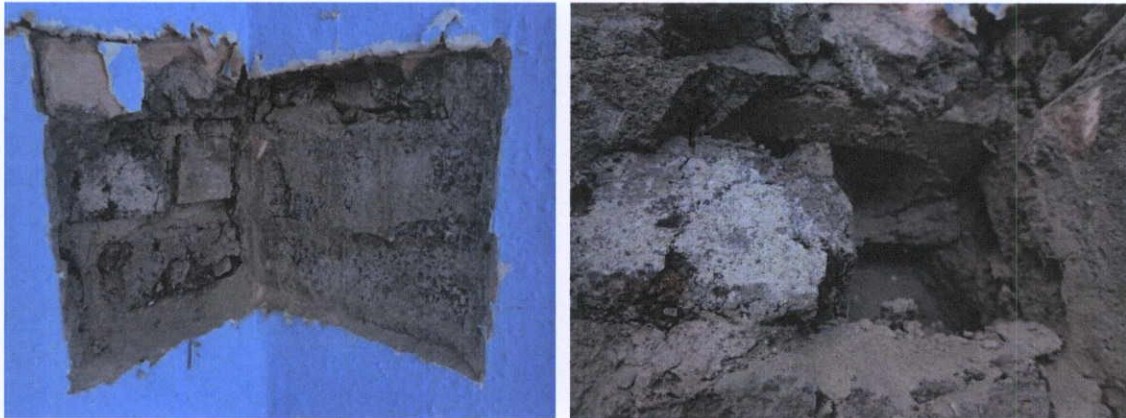
4.1 71 Parnell Street: The four-storey two-bay building has a yellow 'stock' brick façade over a shopfront, with the east side of the façade slightly advanced of the west side. The brick is laid in English garden wall bond. The internal face of the façade wall is composed of concrete blockwork (Fig.4.1.1), but the internal party walls contain brickwork comparable to that seen in mid-eighteenth century works at Nos.42 and 43 O'Connell Street. This brick contains distinctive fired limestone shards (Figs.4.1.2 & 4.1.3), and may represent brick from the 'Old Brick Field' marked on John Rocque's mid-eighteenth century map of Dublin.

Fig.4.1.1: Inner face of the façade wall at the stairwell showing concrete blockwork, with repairs to the party wall.

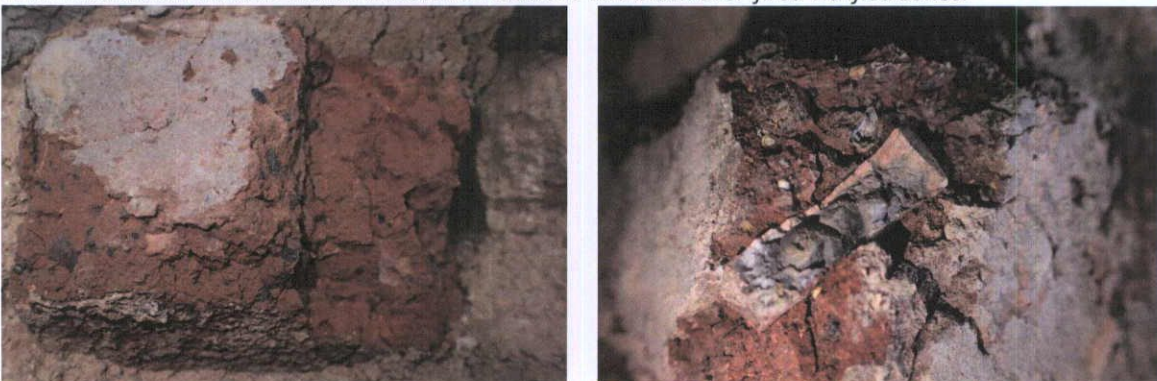
Fig.4.1.3: Coarse burnt inclusions (left) and calcined limestone inclusion (right).

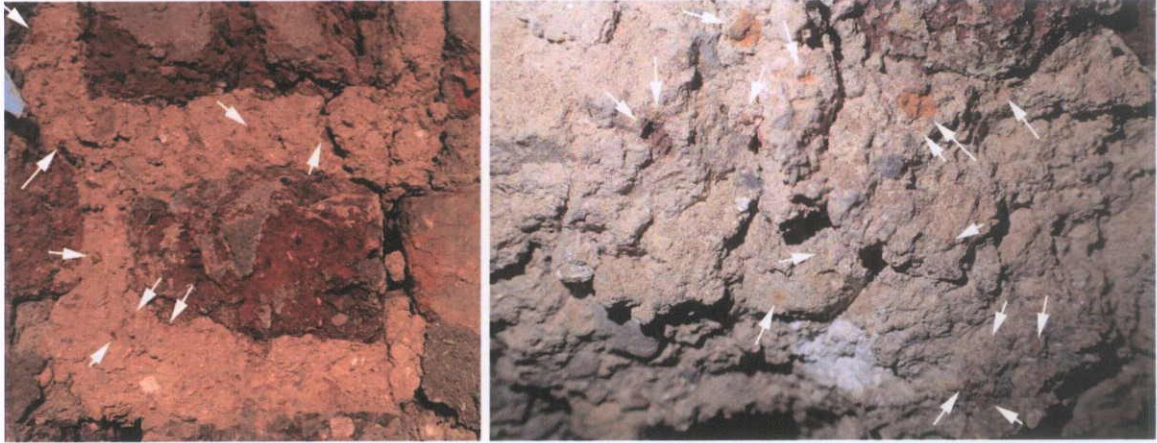
Fig.4.1.4: Brick pozzolan (arrowed) was added to the mortar. This imparts hydraulic qualities to the mortar, while the larger brick fragments also function as porous aggregate. The mortars commonly show relatively coarse 'lime lumps'.

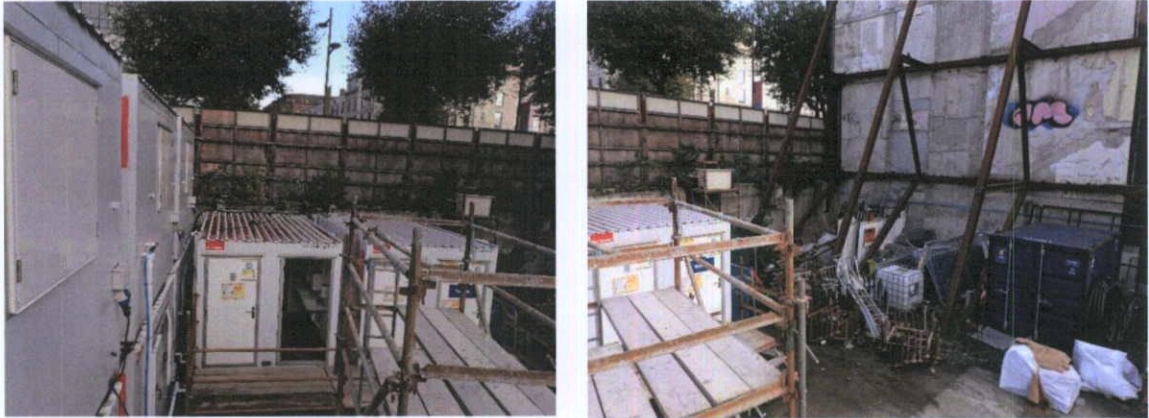
Fig.4.2.2: Reinforced concrete on the east (left) and south (right) boundaries.

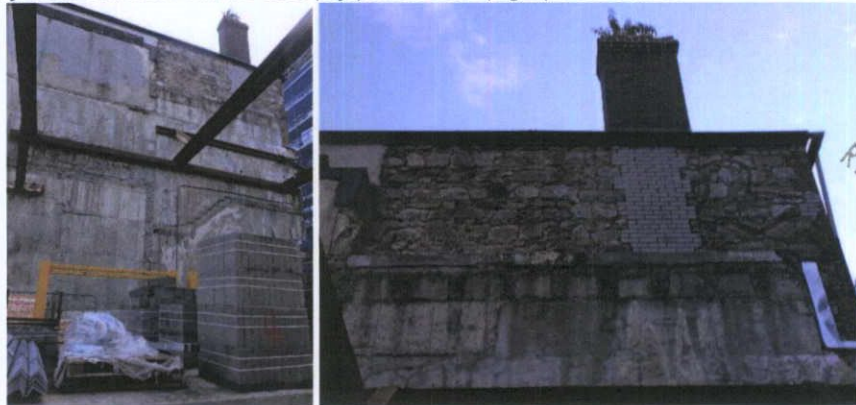
Fig.4.2.3: Reinforced concrete on the south side, with historic masonry of the adjacent property visible at the south-west corner of the site.

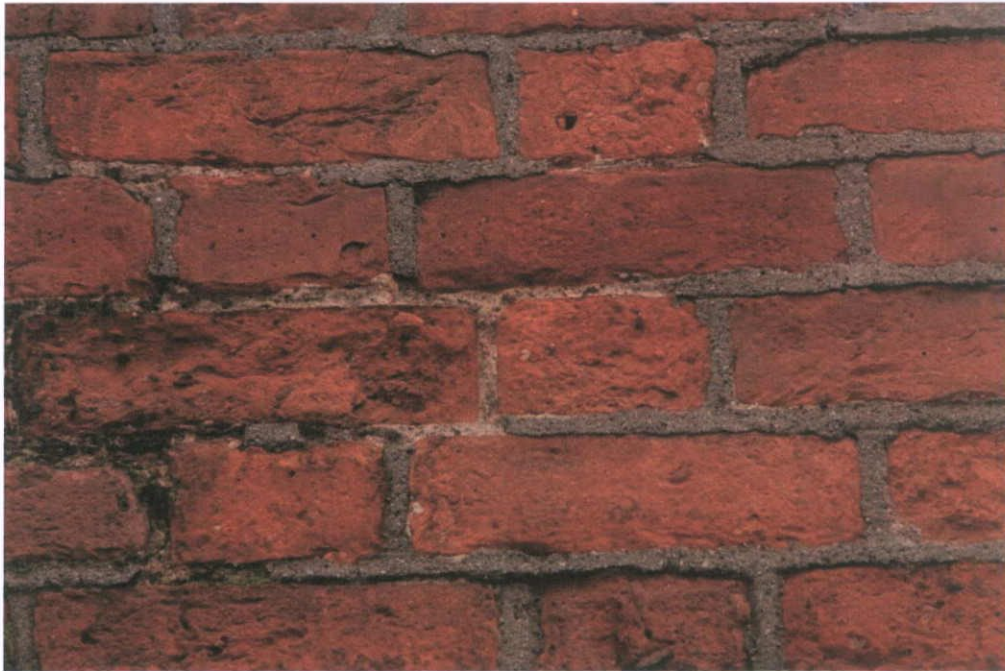
Fig.4.3.4: The façade brick is handmade and contains abundant inclusions of pebbles and fired material. The lime bedding mortar contains relatively coarse aggregate (up to ½ the joint height).

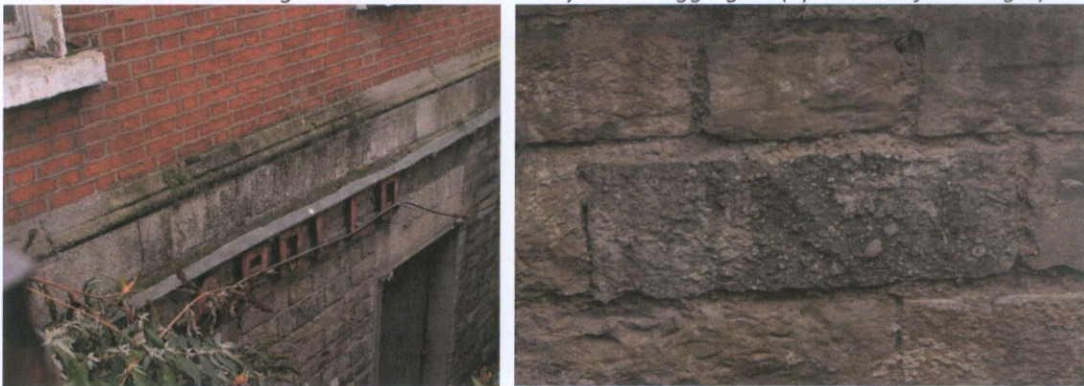
Fig.4.3.5: The basement level is separated from the brick superstructure by a moulded granite strong course, with the well-cut Calp limestone face of the basement wall laid in a coarse-grained lime mortar. One large limestone block is coarsely fossiliferous and may be Ardbraccan limestone.

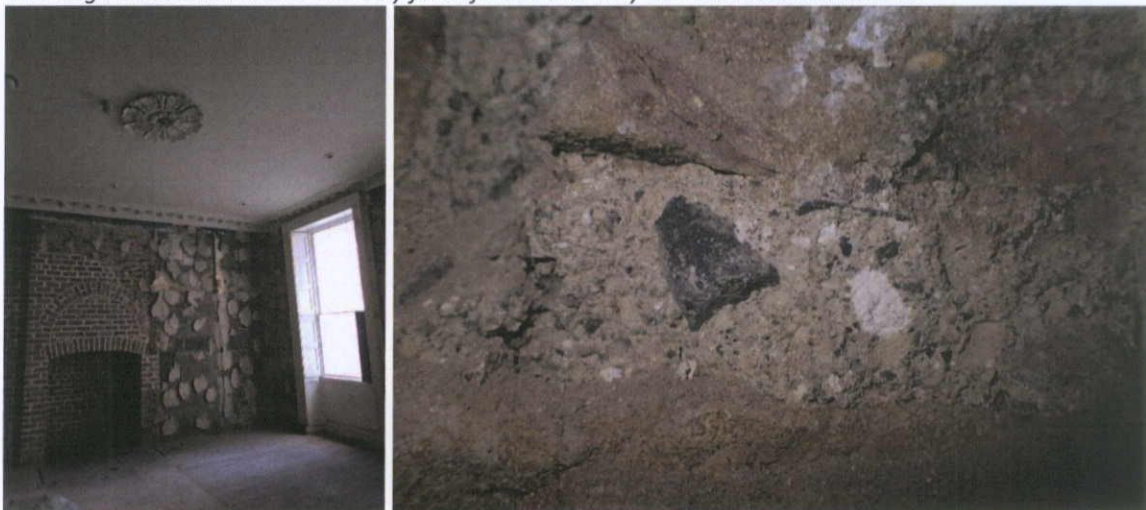
Fig.4.3.6: The ground floor shows later alterations, but the party wall shows place brick laid in a coarse-grained lime bedding mortar with poorly sorted limestone, quartz and chert aggregate and large lime lumps.

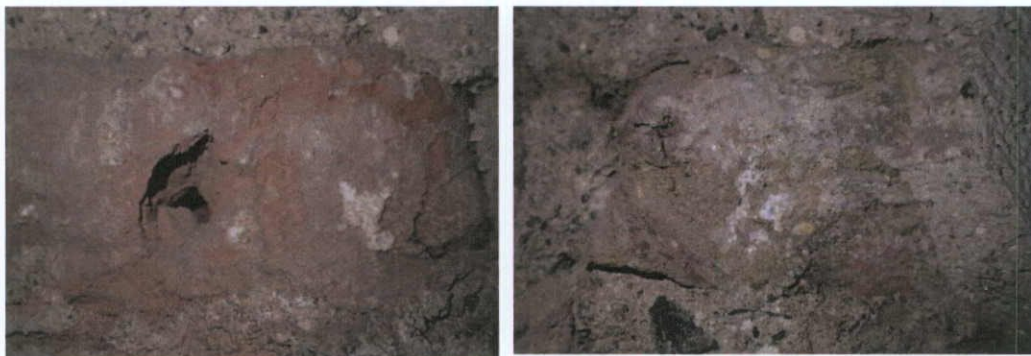
Fig.4.3.7: Place bricks in a coarse-grained lime bedding mortar. Internal walls at first floor level.

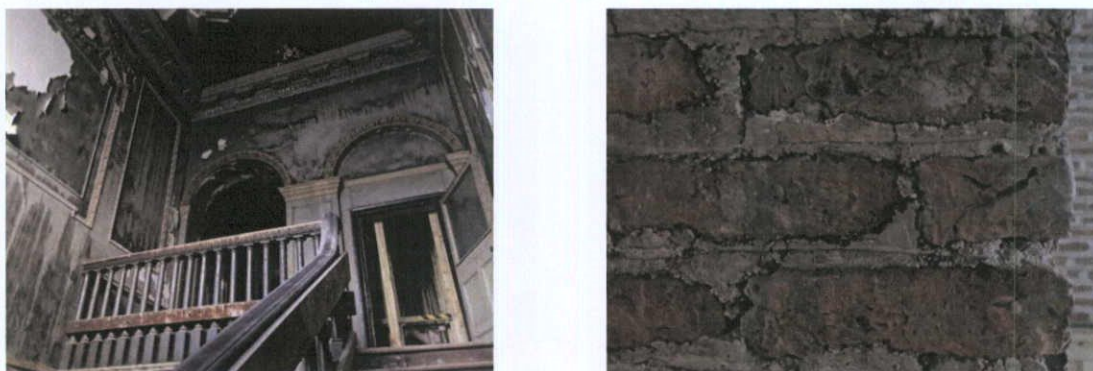
Fig.4.3.8 (left): The internal wall surfaces of the staircase retains decorative plasterwork finishes and enrichment. These were not sampled, but analysis of Georgian plasterwork elsewhere in north Dublin City indicates that the flatwork and the enrichment are composed of different materials – each of which uses very high-grade components and required a great deal of craftsmanship in successful execution.

Fig.4.3.9 (right): The internal walls were built with place brick, lower in quality than the facing brick used for the façade (Fig.4.3.4) and showing numerous manufacturing defects. The lime mortar of the internal walls has been horizontally struck throughout.

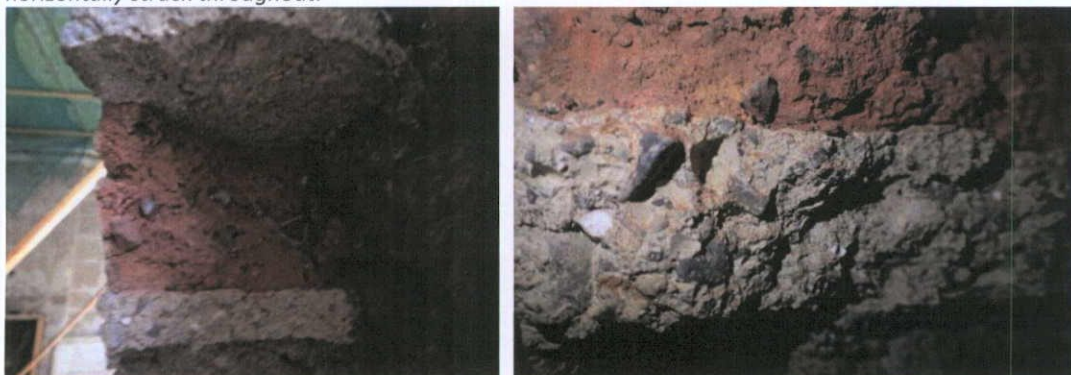
Fig.4.3.10: The large aggregate in the coarse-grained bedding mortars is similar in shape, dimension and mineralogical composition to the stone inclusions seen in the handmade bricks – suggesting a similar source. This is probably brick from the Moore Street brickfield.

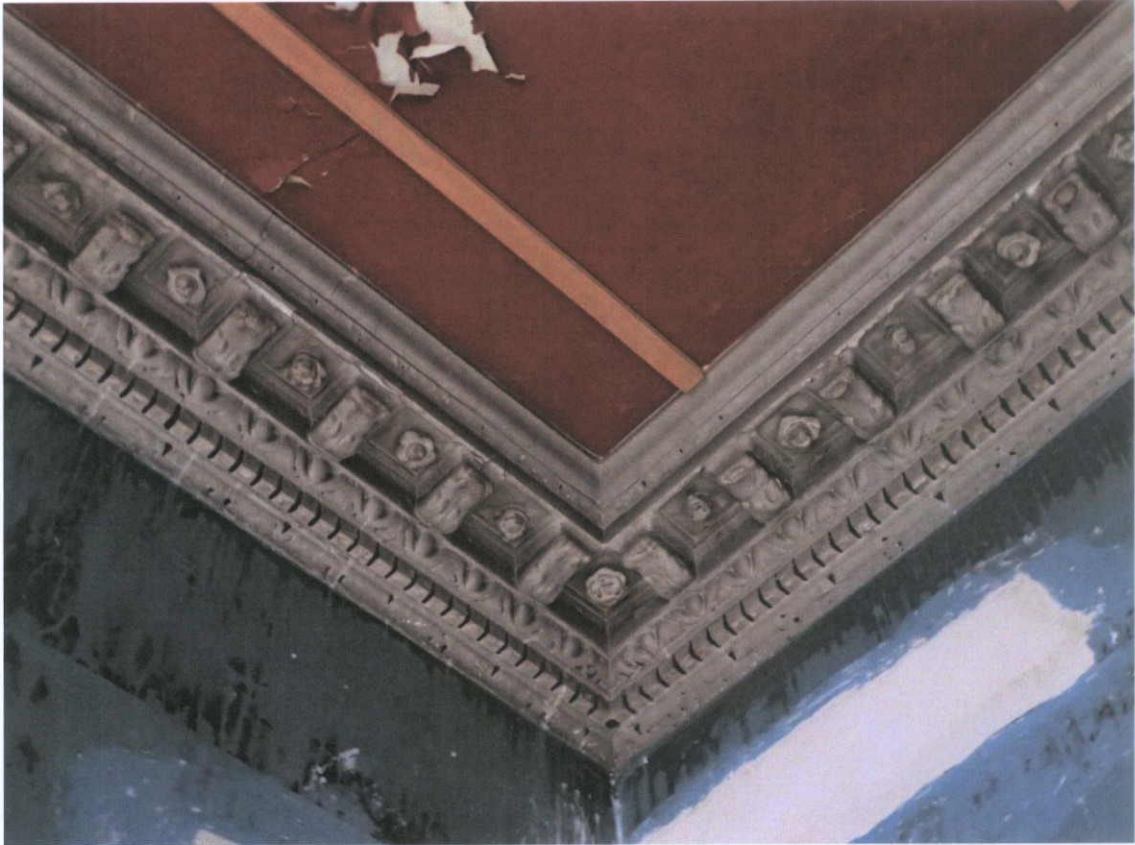
Fig.4.3.12: Detail of the ceiling at the head of the staircase showing three different materials:
a) Flatwork ceiling plaster (probably haired lime with additions)
b) Ornate cornice probably built out from timber or brick base
c) Flatwork wall plaster (probably not haired, but likely to contain brick pozzolan).

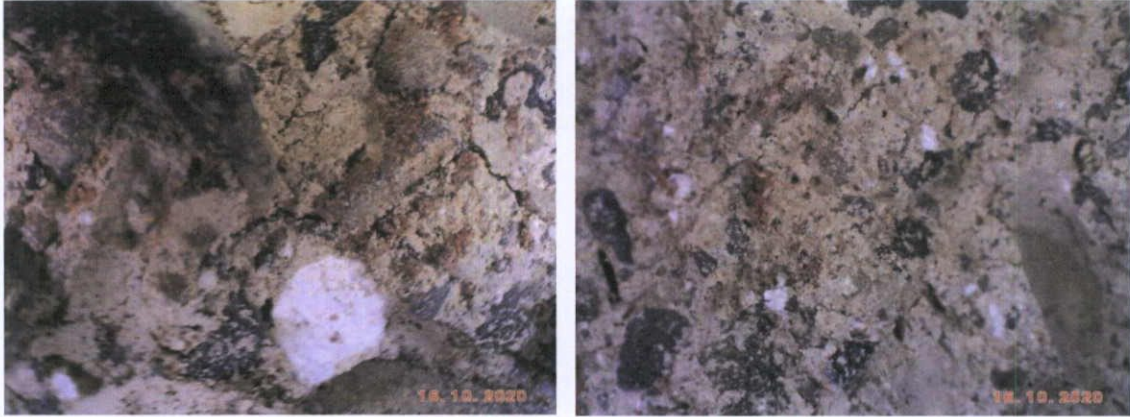
Fig.4.3.14: Microscopic views of a coarse-grained pozzolanic lime mortar used to bed the place brick of the internal walls and wall linings of 41 O'Connell Street. Note common occurrence of large lime lumps.

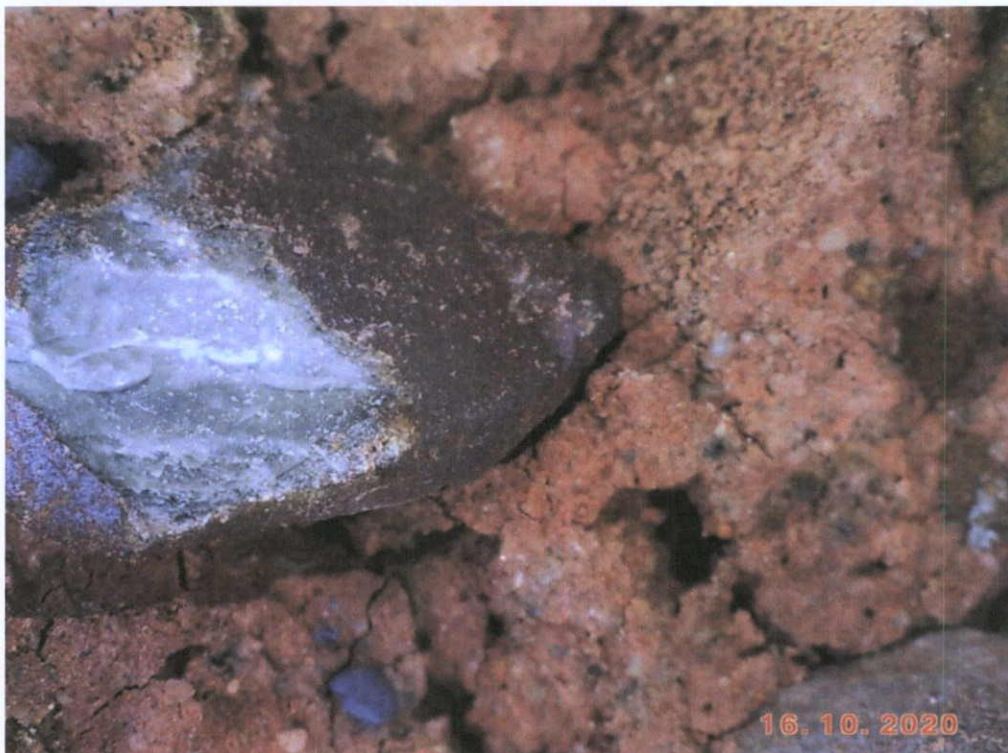
Fig.4.3.15: Microscopic detail of the core of a brick, likely to originate from the Moore Street brickfield. The brick contains poorly sorted and often partially calcined limestone and fine quartz.

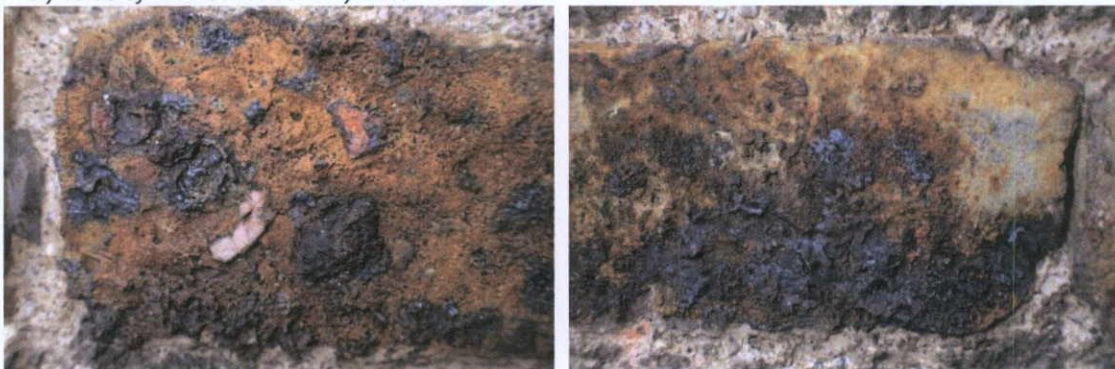
Fig.4.4.5: Overburn clamp-fired yellow stock brick showing calcined stone and vitrified zones.

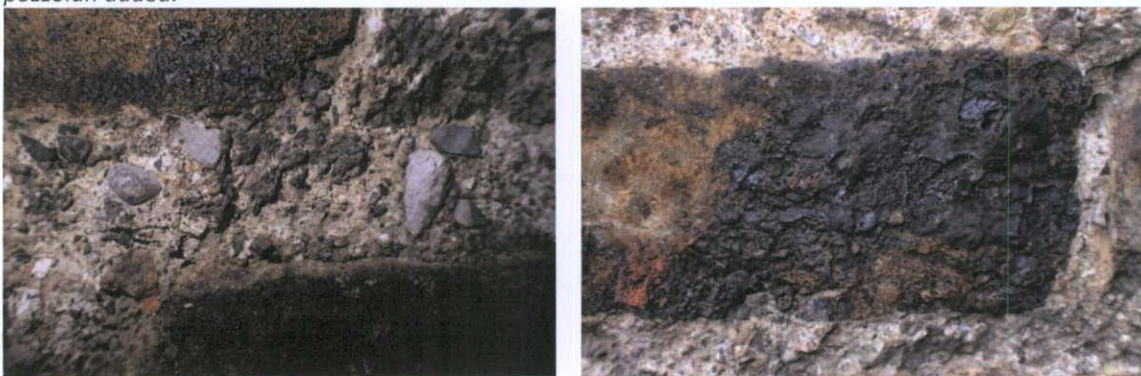
Fig.4.4.7: Coarse-grained limestone, quartz and chert with brick pozzolan and lime lumps.

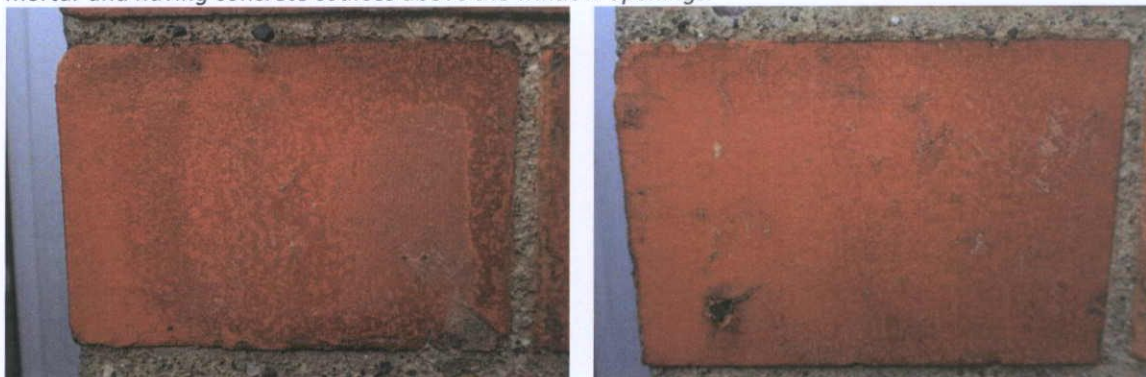
Fig.5.1.3: The fired brick has colour variations from kiln firing. The brick is laid in a relatively coarse-grained bedding mortar of variable aggregate (very different to those seen in Georgian and Victorian period mortars from Dublin City) of limestone, chert, quartz, sandstone and other lithics.

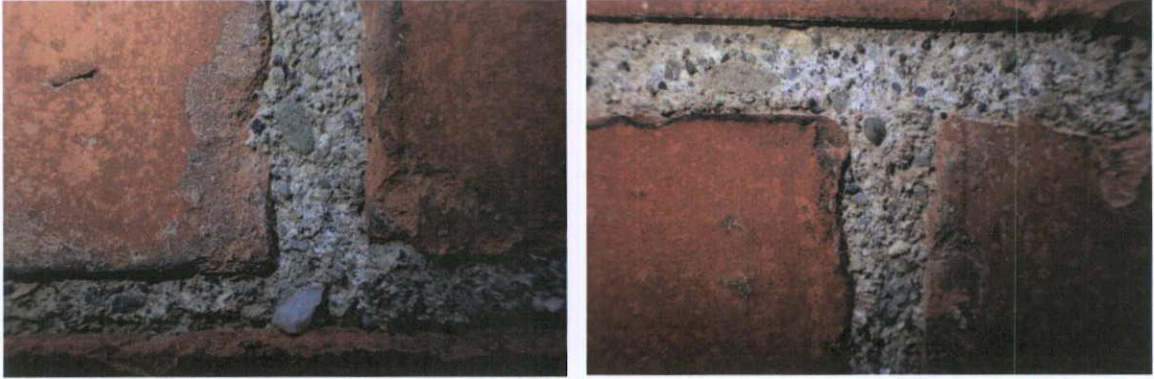
Fig.5.1.4: Detail of aggregate-rich matrix, very different in composition, texture and character to Georgian and Victorian mortars. Brick pozzolan has been added to the bedding mortar.

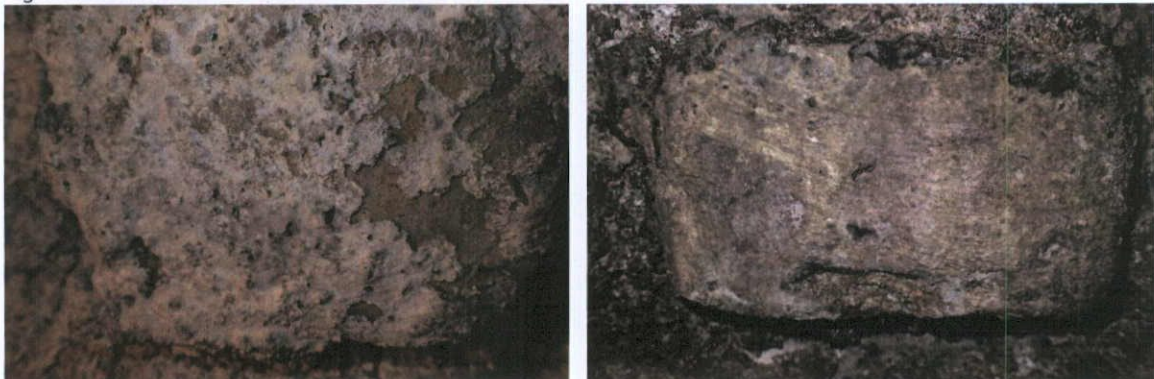
Fig.5.1.7: The vault brickwork was coated with a limewash (brush marks remain evident).

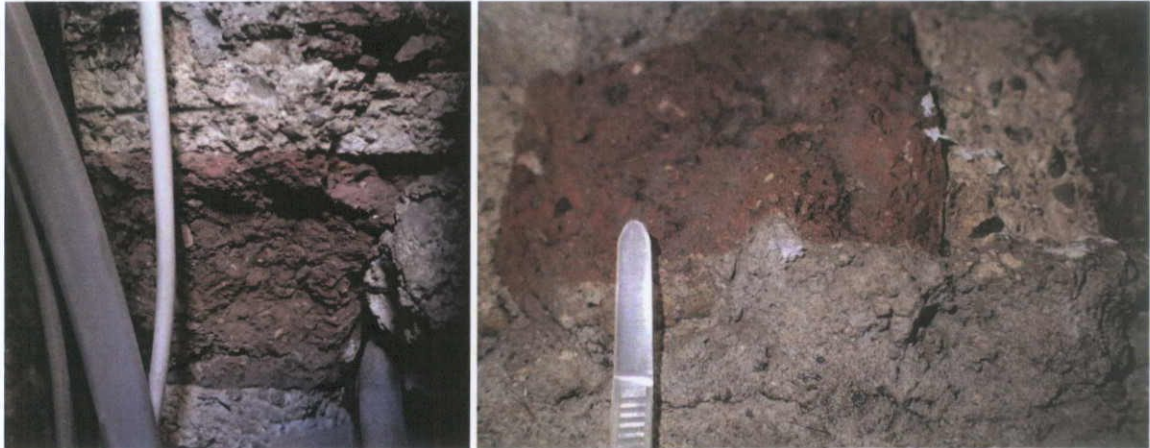
Fig.5.1.8: The coarse-grained lime bedding joints are horizontally struck joints. The lime mortar contains limestone, quartz, chert and lime limps. The clamp-fired brick is similar to that seen in No.42. The mortar and clamp-fired brick contain similar aggregate (morphology, size range and mineralogy) suggesting a similar source of raw materials. This is probably brick from the Moore Street brickfields.

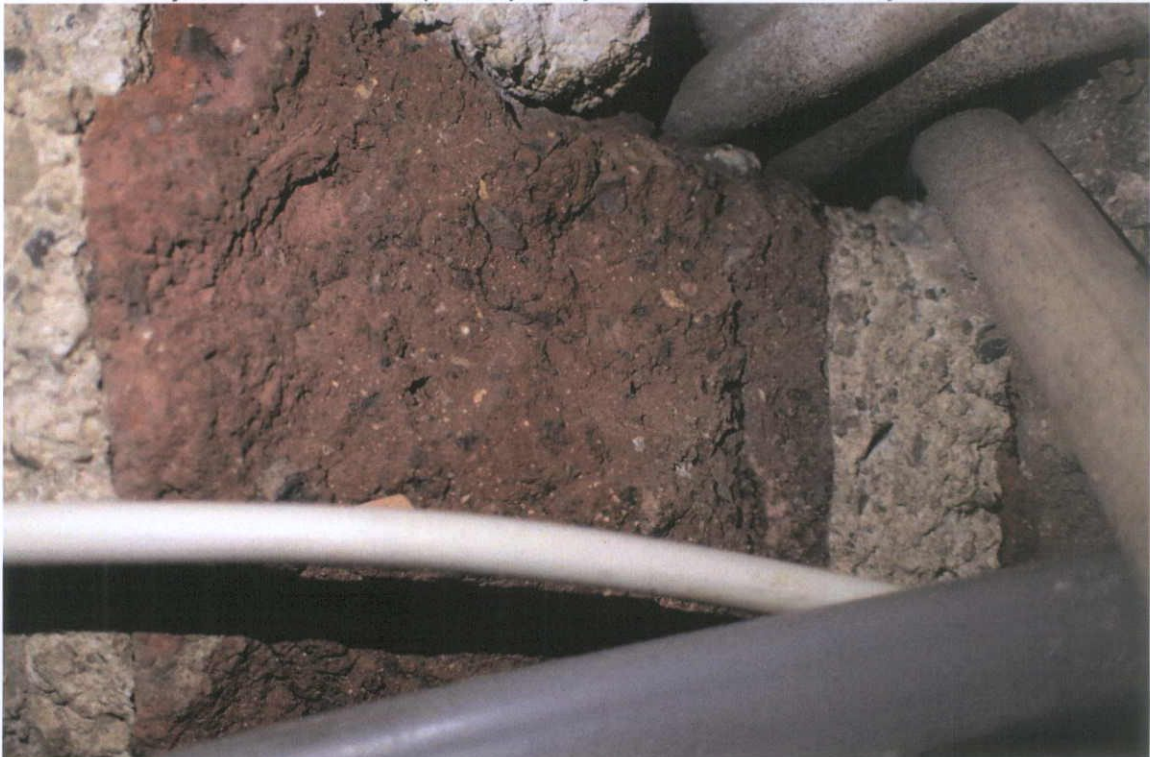
Fig.5.1.9: Detail of a clamp-fired brick seen at basement level showing limestone inclusions.

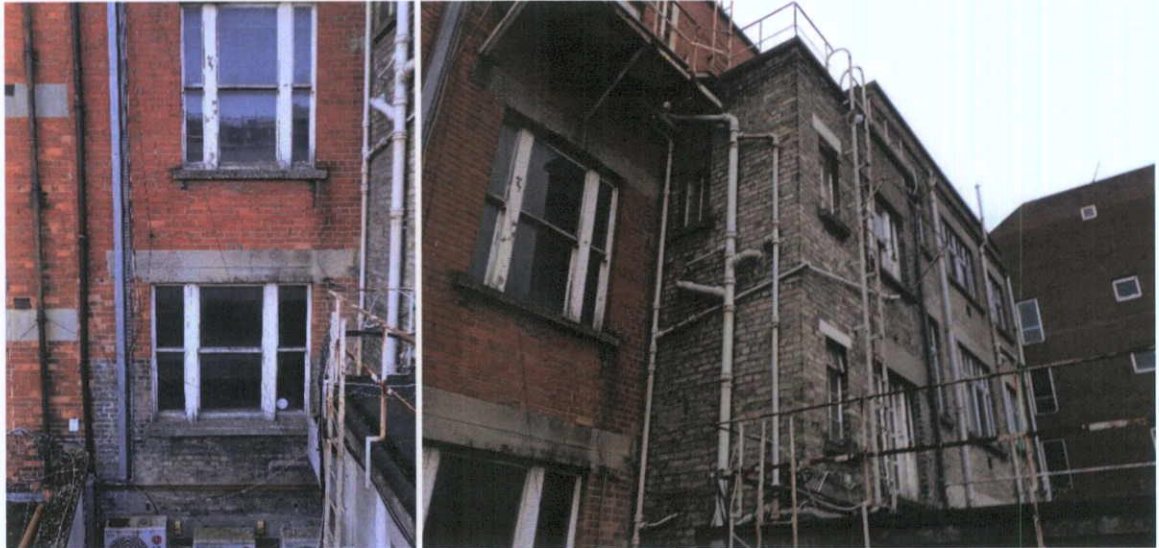
Fig.5.2.1: The rear of 44 O'Connell Street consists of 1920s red brick with concrete lintels similar to that seen at 43 O'Connell Street, with a yellow stock brick return.

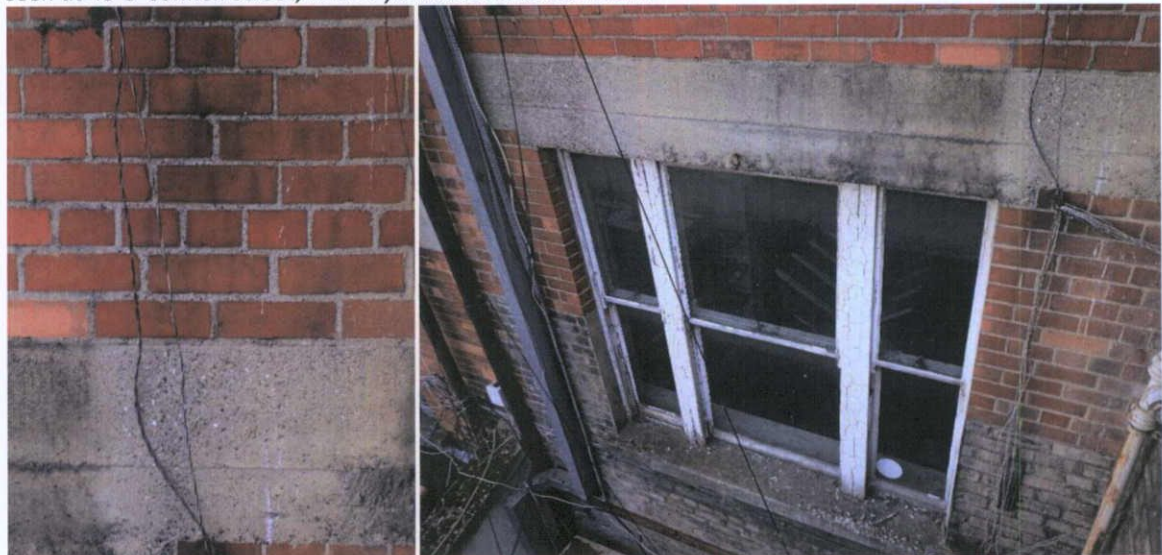
Fig.5.2.2: Detail of the 1920s machine-cut brick and concrete lintel of the superstructure, above yellow stock brick at the rear basement level.

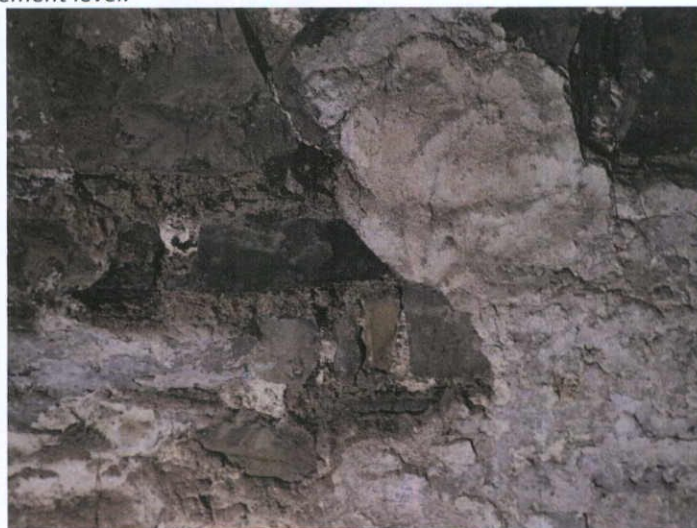
Fig.5.2.3: Dublin Calp limestone at basement level with single-coat lime plaster and multiple coats of limewash.

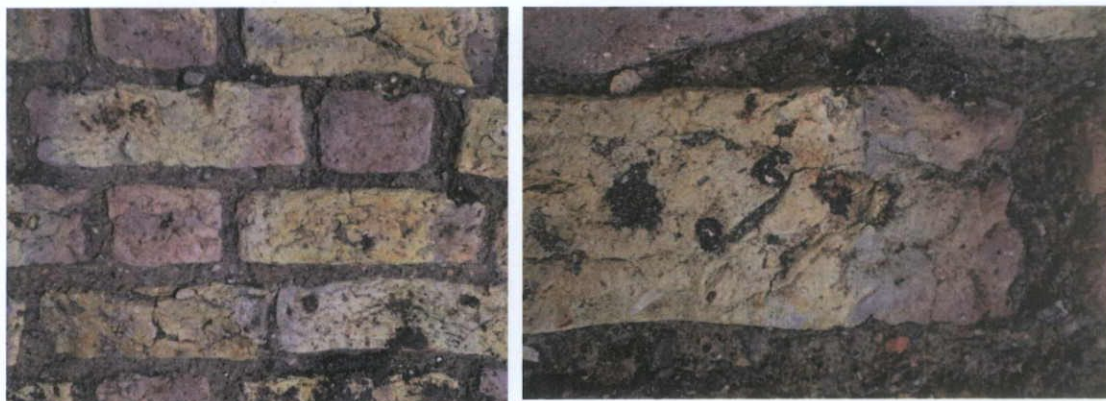
Fig.5.2.4: Detail of yellow-pink clamp-fired stock brick from the basement vaults set in saturated pozzolanic lime mortar; with traces of brick dust adhering to the surface of the brick.

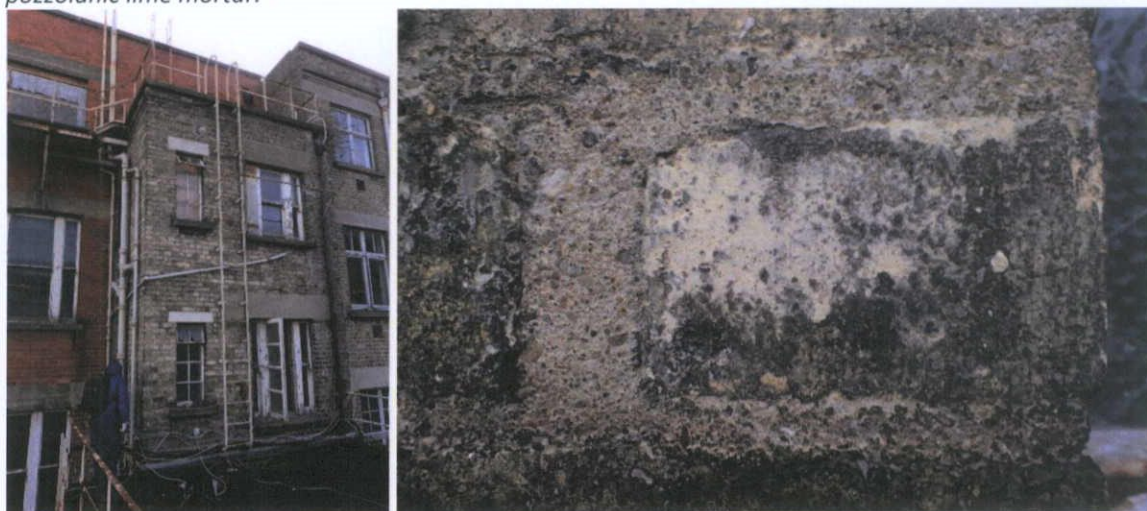
Fig.5.2.6: The return is made from c.1920s yellow stock brick in a lime-cement mortar, with concrete lintels above the openings and forming the parapet coping.

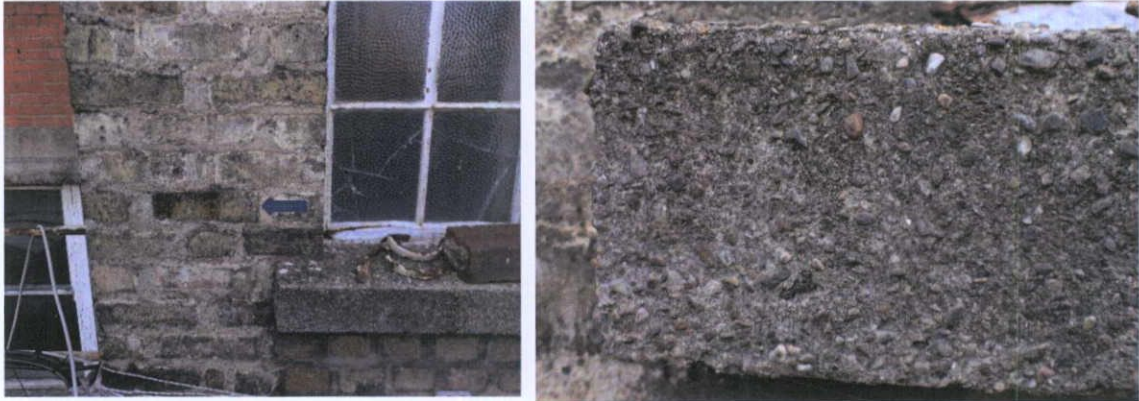
Fig.5.2.7: The window cills are of concrete. The 1920s yellow stock brick also includes occasional earlier clamp-fired yellow stock brick (arrowed), likely to be an example of salvage.

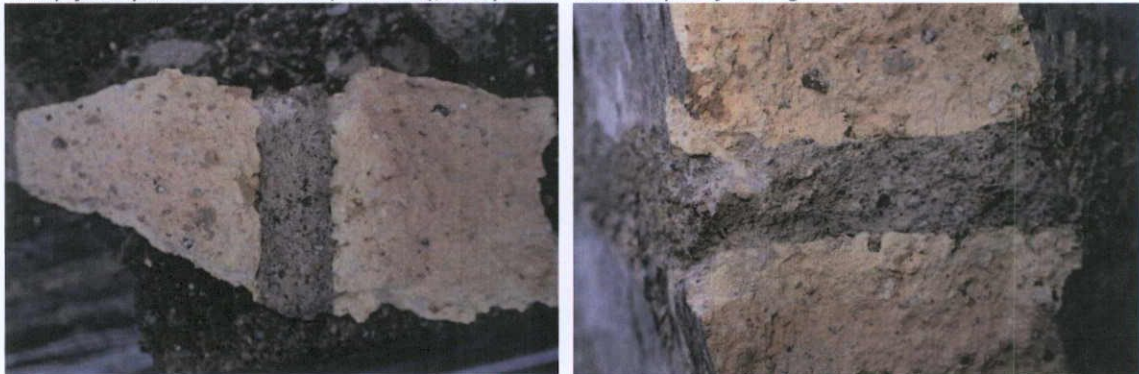
Fig.5.2.8: Cross section showing the 1920s brick with natural stone inclusions in an evenly-fire matrix and bonded with a cementitious bedding mortar. Sample #90.

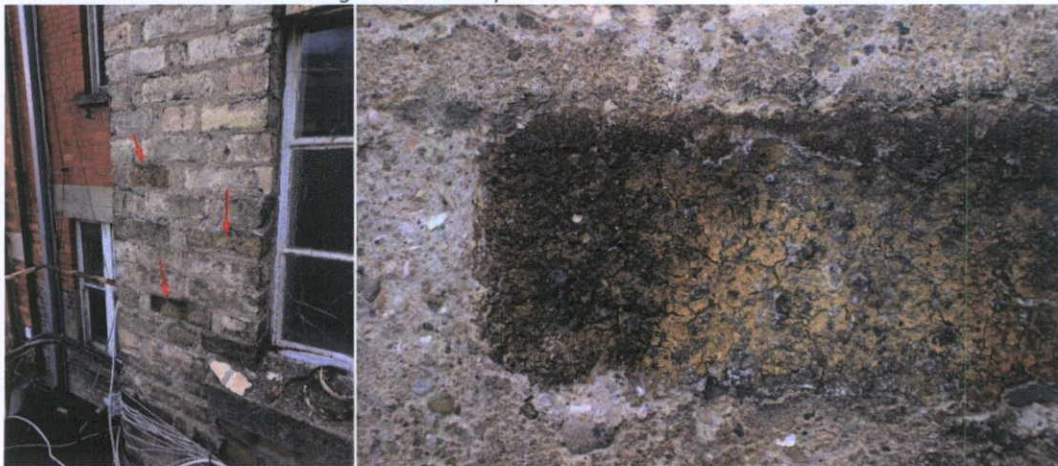
Fig.5.2.10: Salvaged earlier clamp-fired yellow stock brick in the return.

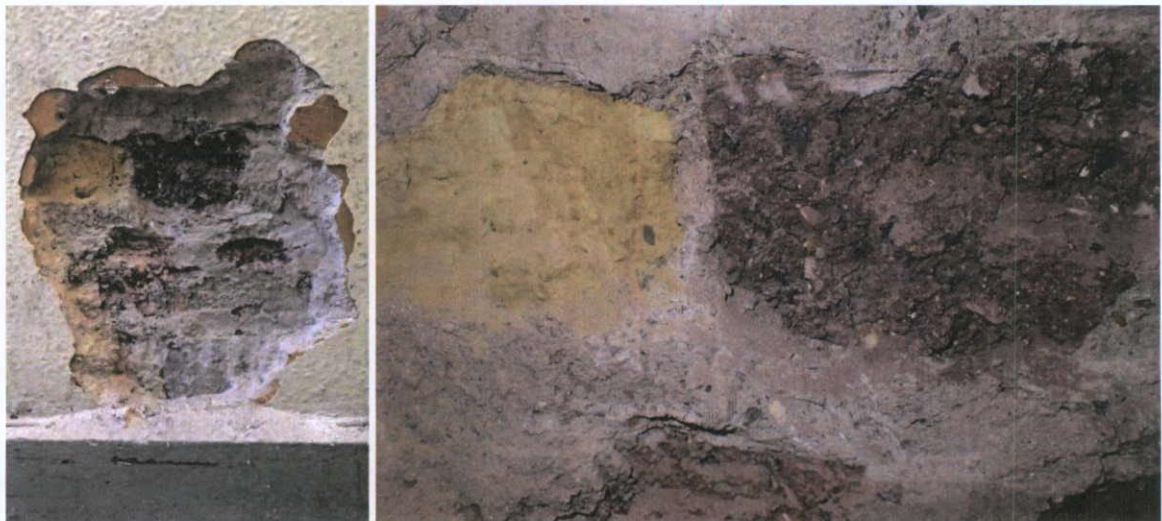
Fig.5.2.17: Ground floor, south wall, interior showing 1920s yellow stock brick and dark-red hand-made clamp-fired brick above skirting level, both bedded in a cementitious bedding mortar. The red brick appears to be a Georgian period brick, similar to others seen along the west side of O'Connell Street and possibly an example of a brick from the Moore Street brickfield. This appears to be a salvaged brick, reused in the masonry of the 1920s construction work.

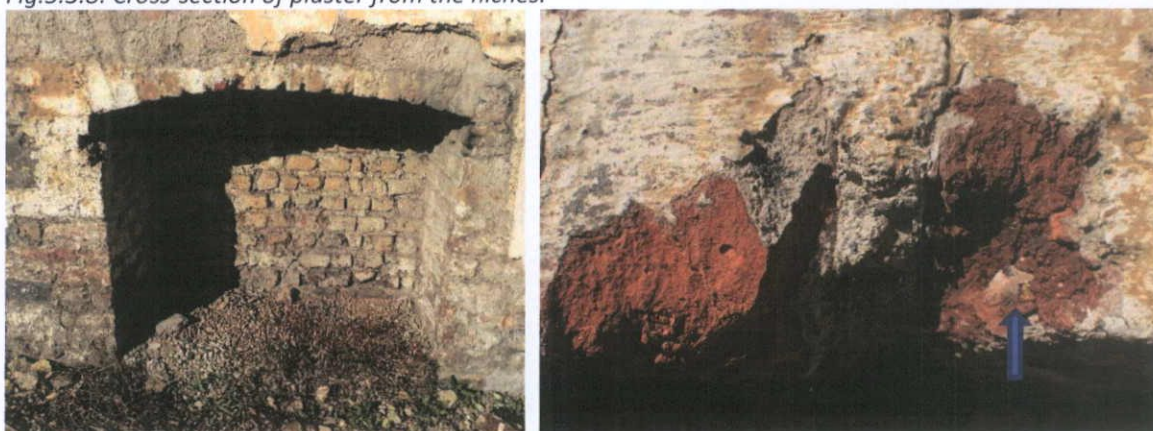
Fig.5.3.9: The yellow stock brick colour on the fireplace bricks is a surface colouration caused by the firing conditions, with the brick core a red colour and containing pebble sized inclusions in the matrix (arrowed). The surface has been coated with a limewash, with brush marks remaining visible on the surface. This was subsequently covered by the plaster which was applied onto the wall.

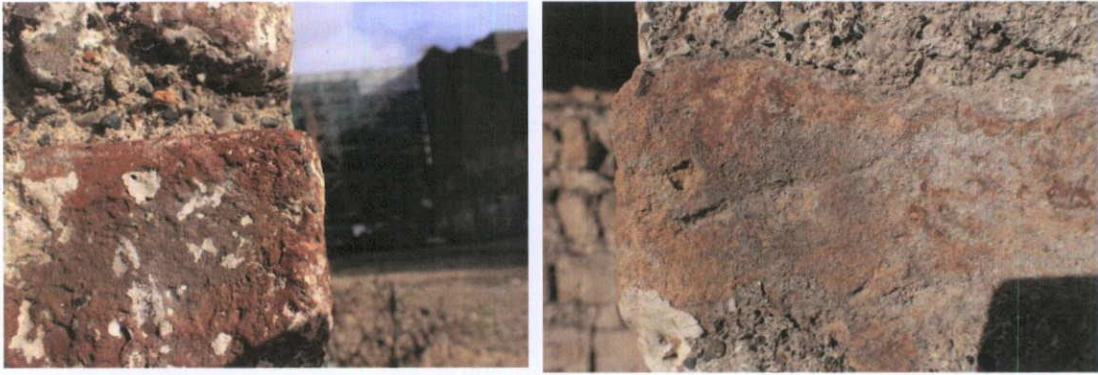
Fig.5.3.10: The stock brick at the chimney retains surface defects from the moulding process.

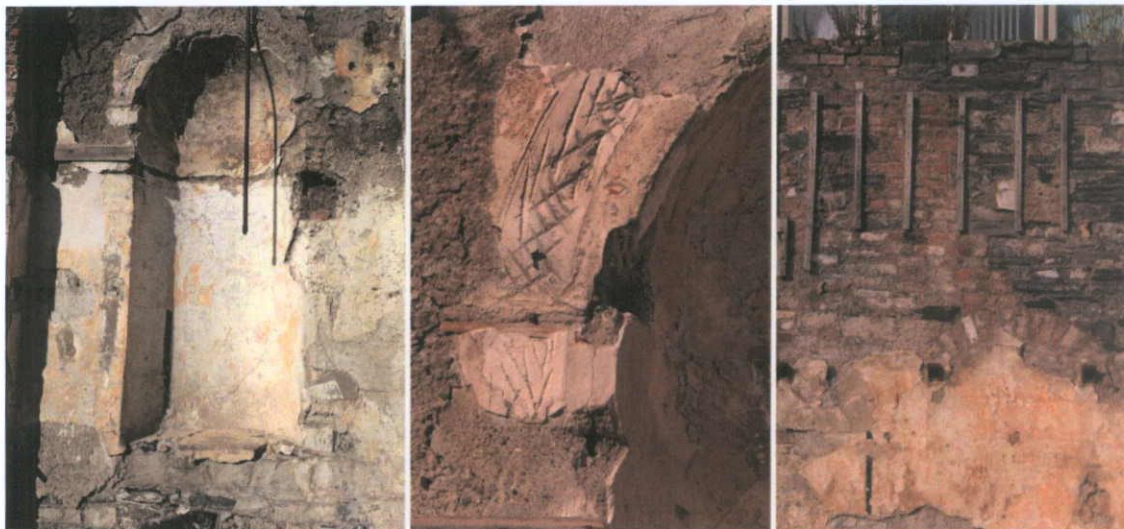
Fig.5.3.13: The western niche retains keying from now-lost embellishment; with timber battens indicating later alteration to the wall surface.

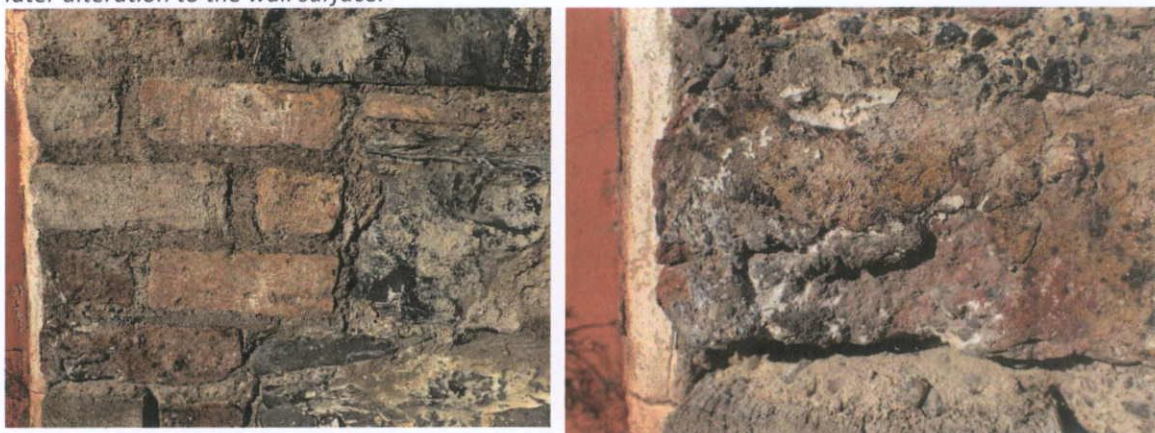
Fig.5.3.14: The chimney breast is edged by irregular clamp-fired brick.

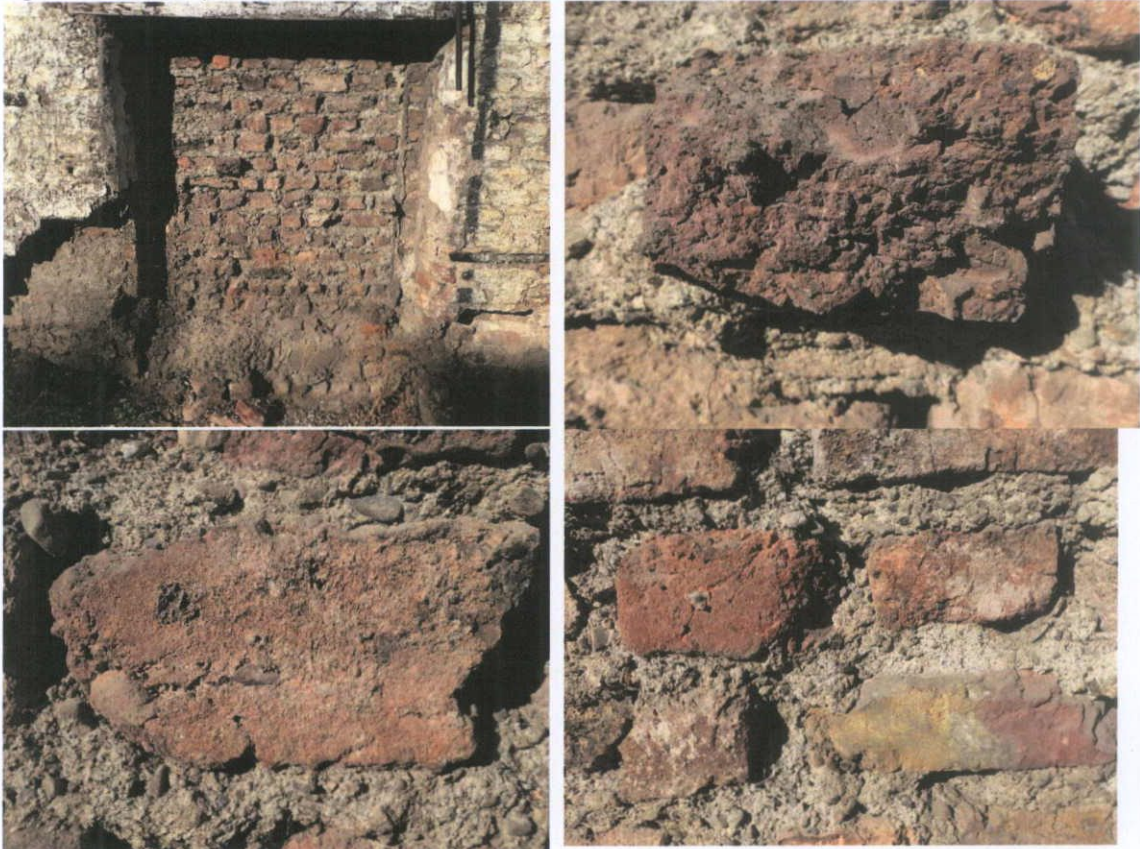
Fig.5.3.20: Irregular clamp fired brick in lime bedding joints infilling a door opening.

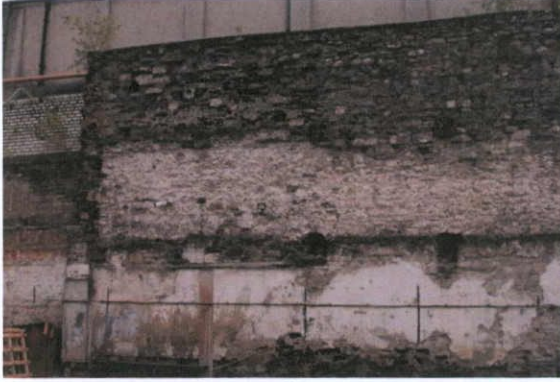
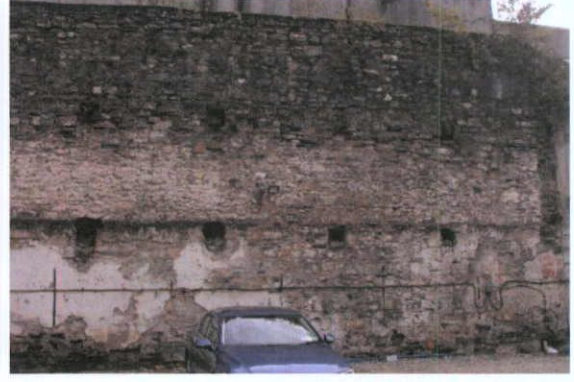
Building E: Three-storey Calp limestone masonry wall with rectangular (chute?) openings and limewash and/or lime plaster at ground and first floor levels. The Calp limestone masonry is bedded in a medium-grained lime bedding mortar while the surviving plaster at ground floor level is lime-based, with brick pozzolan and abundant lime lumps.

Fig.5.3.27: General view of Section E.

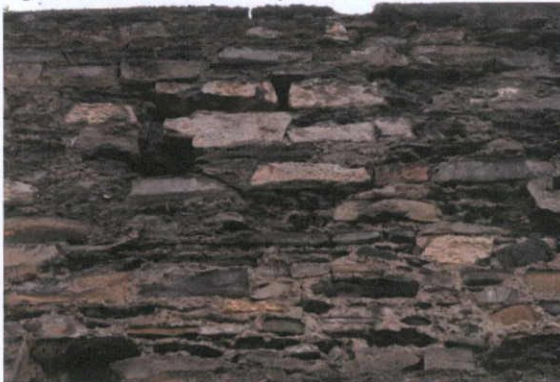
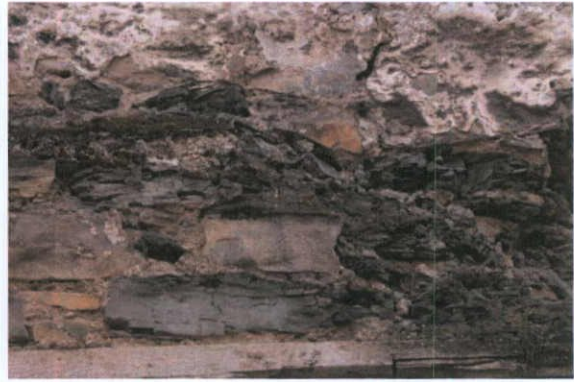
Fig.5.3.28: Calp limestone masonry.

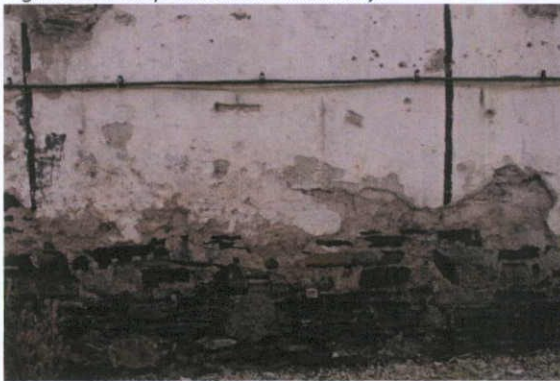
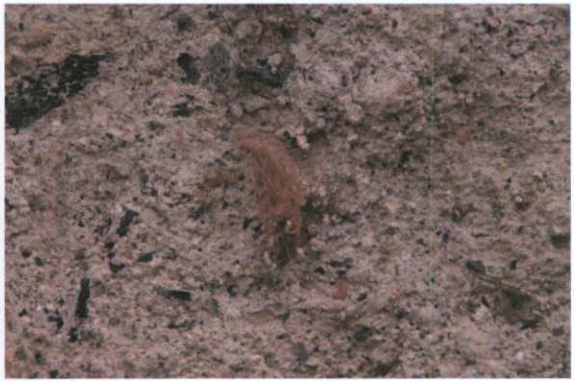
Fig.5.3.29: Detail of the plaster showing brick pozzolan and animal hair. The fine brick dust (& saturation) has contributed to the pinkish hue of this section of the mortar.

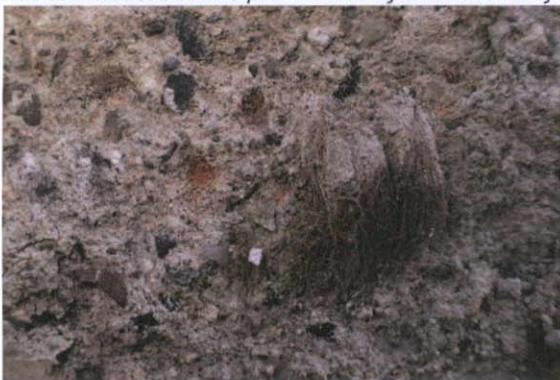
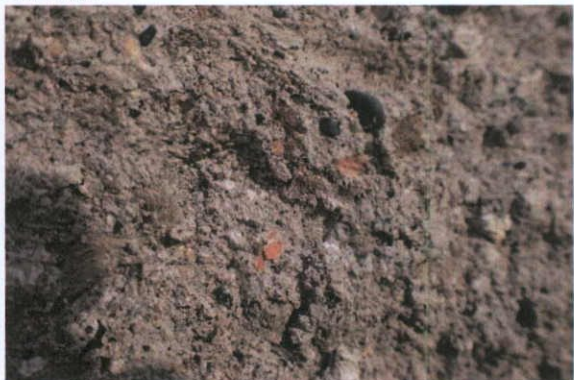
Fig.5.3.30: Detail of the surface of the exposed plaster showing limestone aggregate, occasional burnt fuel fragments, clumps of animal hair added to improve mechanical strength (but with poor craftsmanship as the hair is not teased through) and crushed brick (porous aggregate) and fine brick dust.

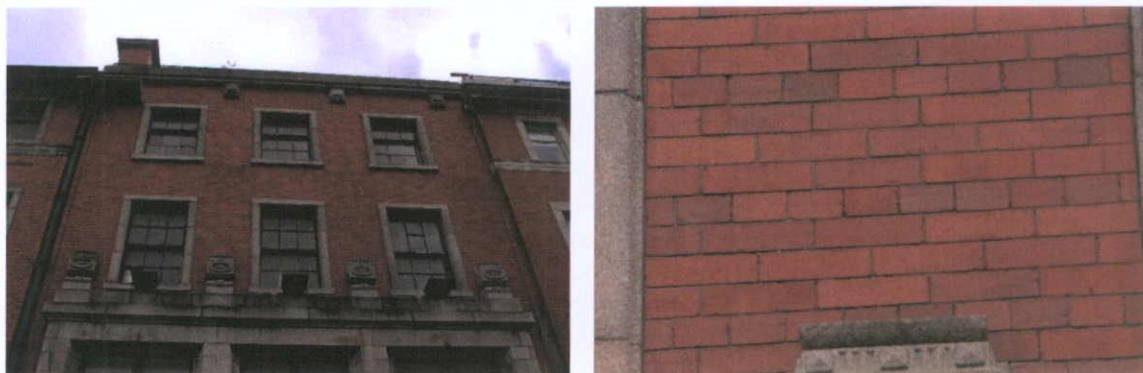
Fig.5.4.1: Brickwork at the façade of 57 O’Connell Street.
