Appendix 1 – Sampling

The sampling below relates to buildings from all five sites under consideration in the Dublin Central project.

This report was prepared at the request of Molloy & Associates Conservation Architects to inform the Dublin Central Built Heritage Review for Hammerson Plc. The purpose of the work was to analyse the physical fabric of buildings on O’Connell Street, Parnell Street, Henry Street, Moore Street, Moore Lane and Henry Place; and to use the physical evidence gathered through study of the building materials to gain a better understanding of the significance and dating of each of the buildings. This report is Volume 2 (of 2)¹ and focuses on the buildings contains in Sites 1 and 2 in the Dublin Central project.

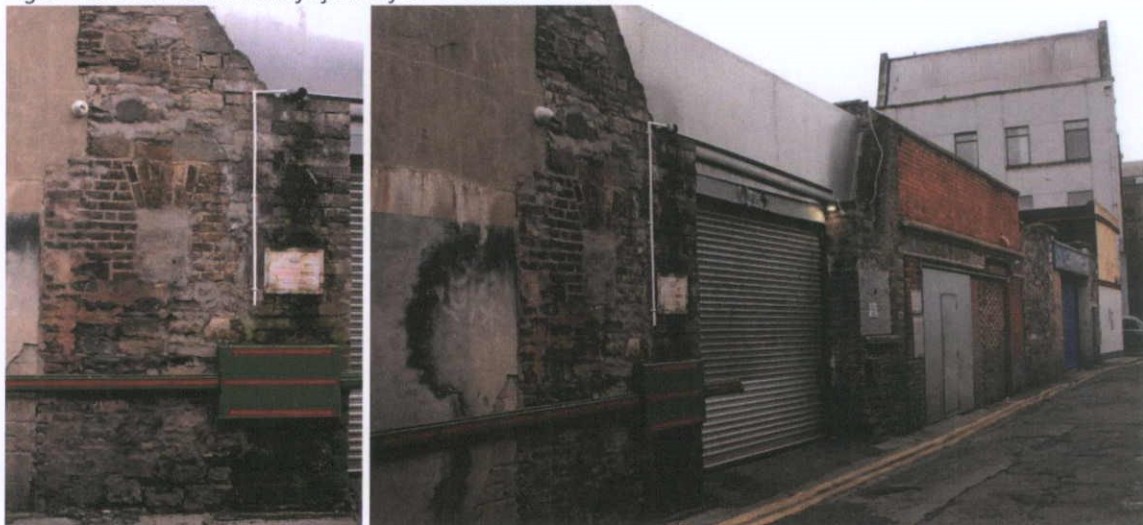
Fig.5.4.2: Calp masonry fabric at the rear of the building with a brick window, and a granite cill.

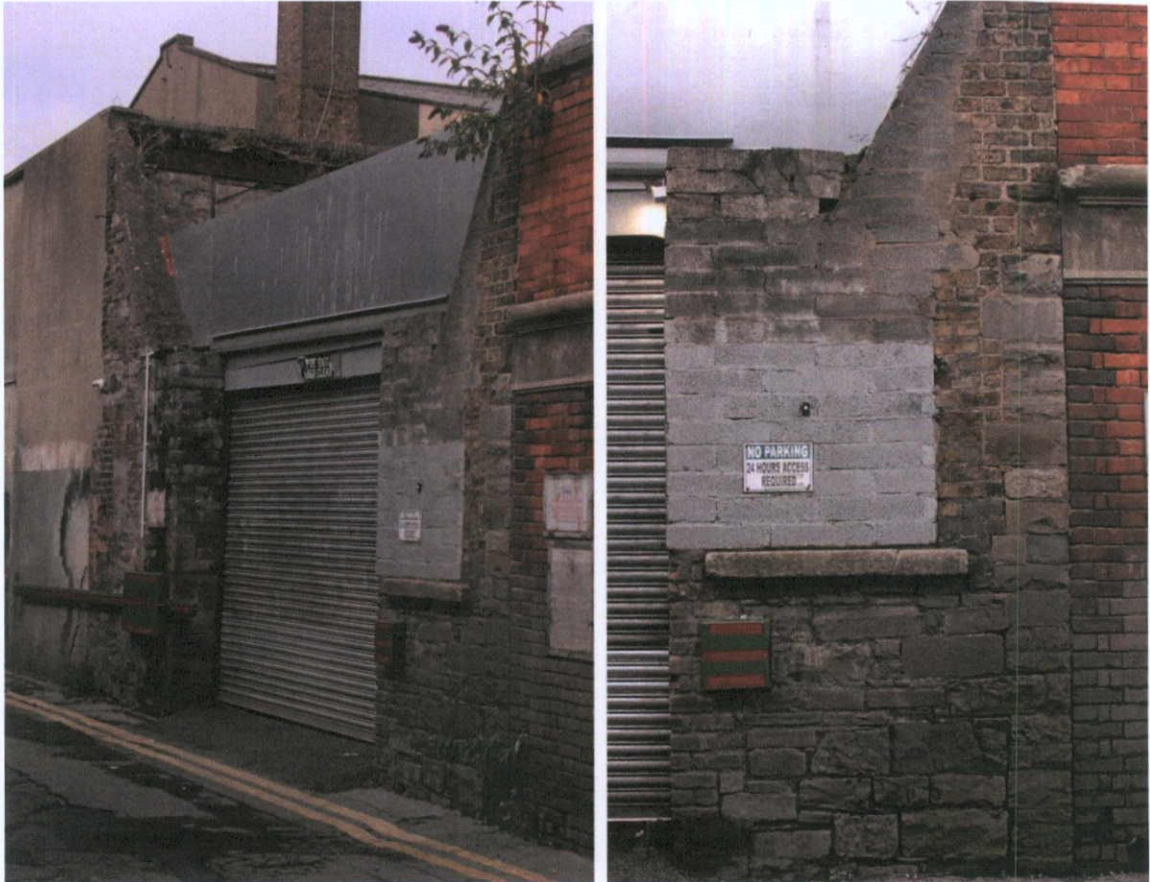
Fig.5.4.3: Detail of coursed hewn Calp masonry and brick fabric.

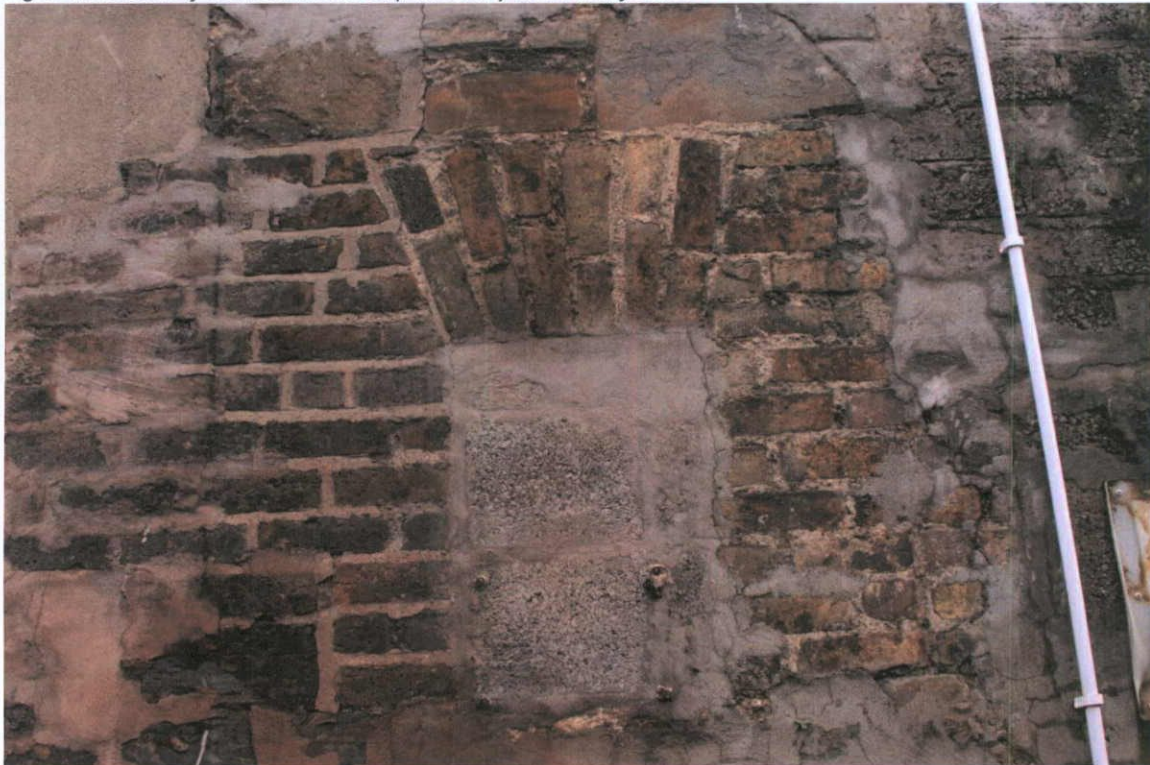
The rear on Moore Lane has a fragment of Calp limestone masonry with a brick opening, and a granite window cill on the south side. The brick forming the window is hand-made clamp-fired yellow stock brick with black vitrified zones; however, the yellow surface conceals a red core. This brickwork retains flush lime bedding/pointing mortar. These bricks are bedded in a coarse-grained lime mortar. The yellow stock brick jambs on the south side of the opening has a cylindrical groove - said to be from a bullet impact from the 1916 Easter Rising.

Fig.5.4.4: Detail of the yellow stock brick window.

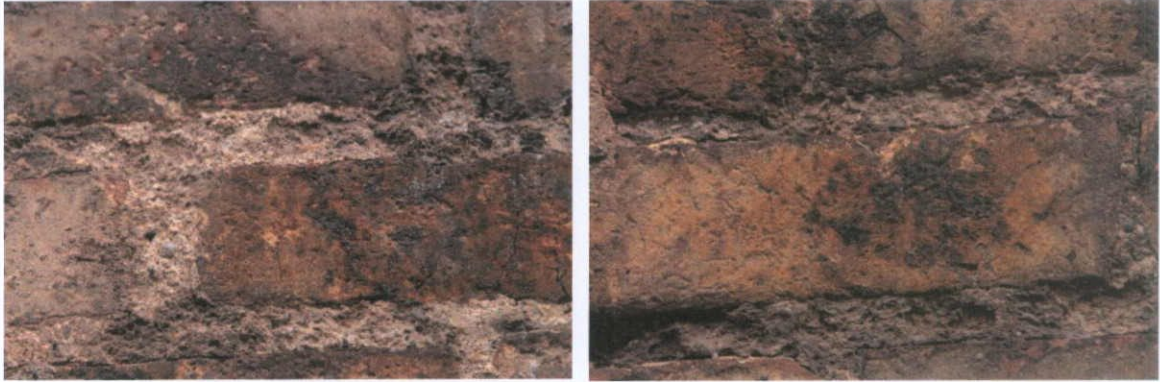
Fig.5.4.5: Clamp-fired yellow stock brick from the north window.

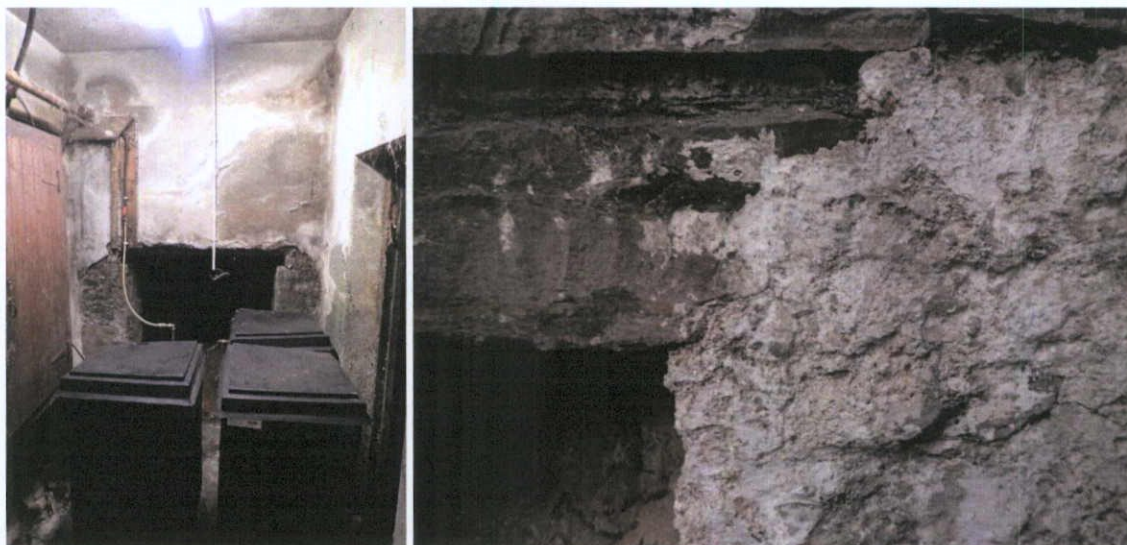
Fig.5.4.8: Calp limestone masonry at basement level at the front of No.57 O'Connell Street.

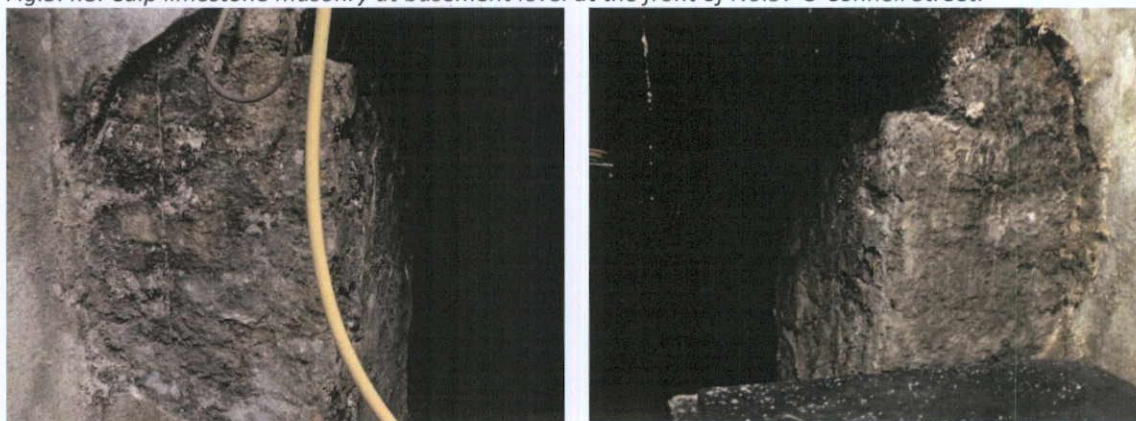
Fig.5.4.9: Detail of Calp limestone bedded in lime mortar at the front of No.57 O'Connell Street.

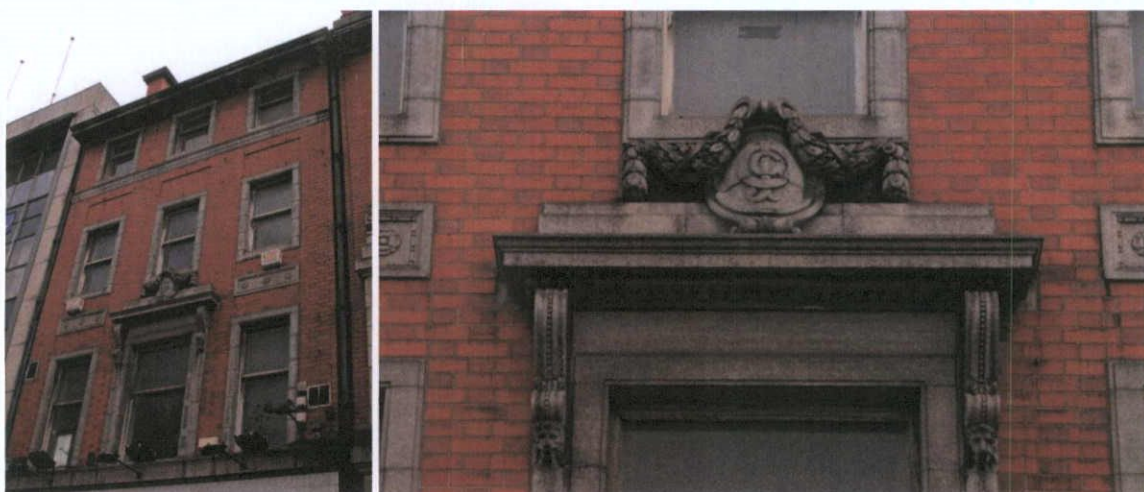
Fig.5.5.1: Granite and brick at the façade.

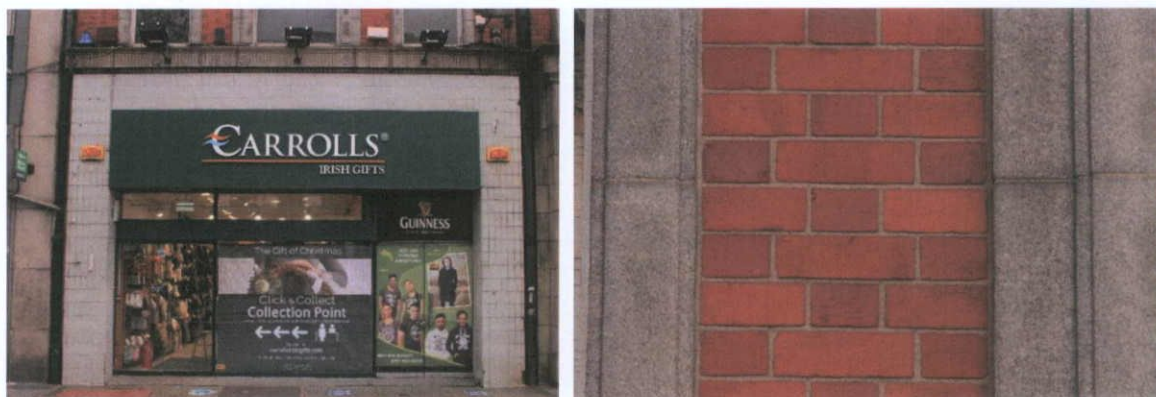
Fig.5.5.2: Modern shopfront with earlier granite course above (left); and a detail showing kiln-fired c.1920s brick in flush mortar joints (right).

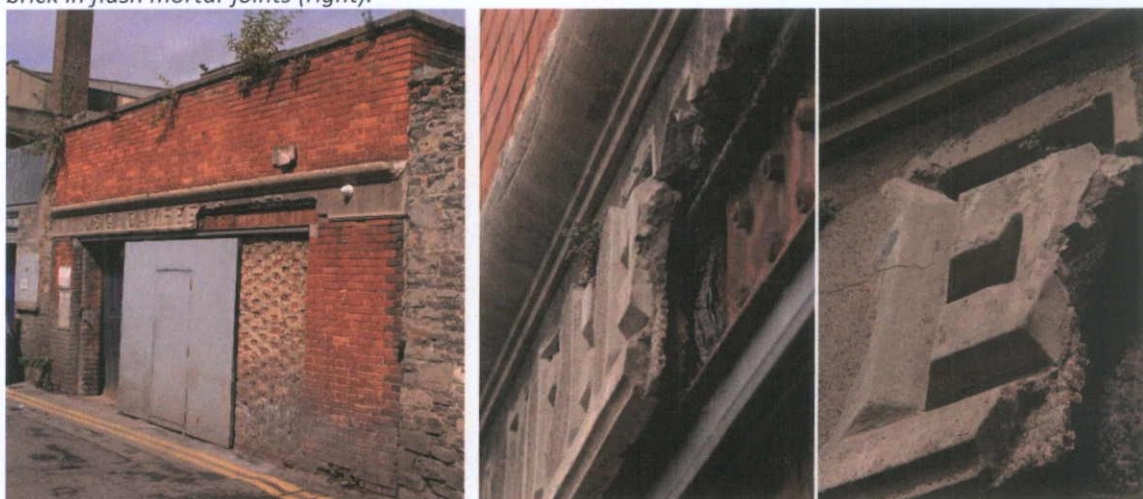
Fig.5.5.3: Campbell's store at the rear on Moore Lane.

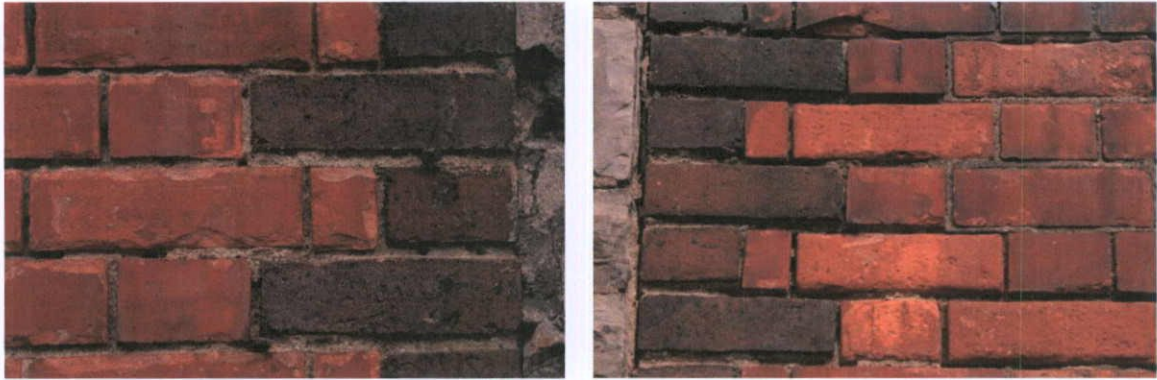
Fig.5.5.5: Brick polychrome at the entrance.

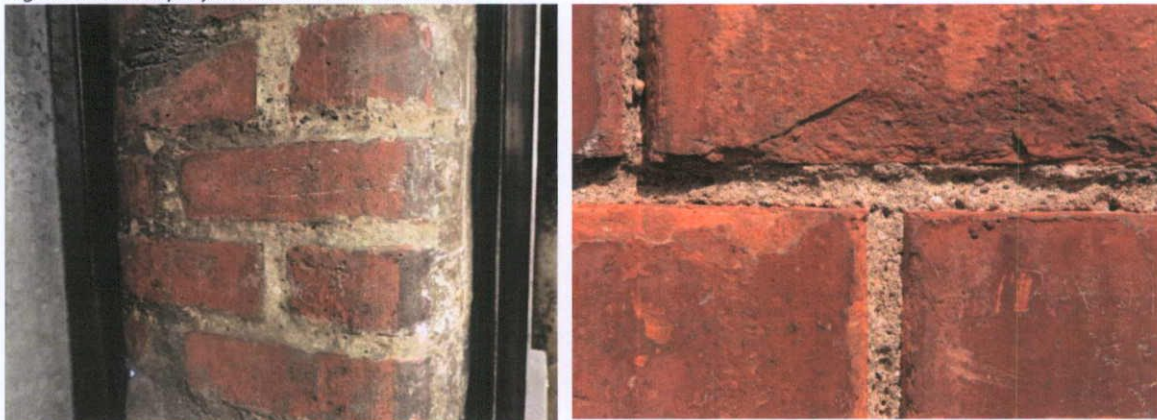
Fig.5.5.6: Perforated red brick used for flatwork and rounded corners.

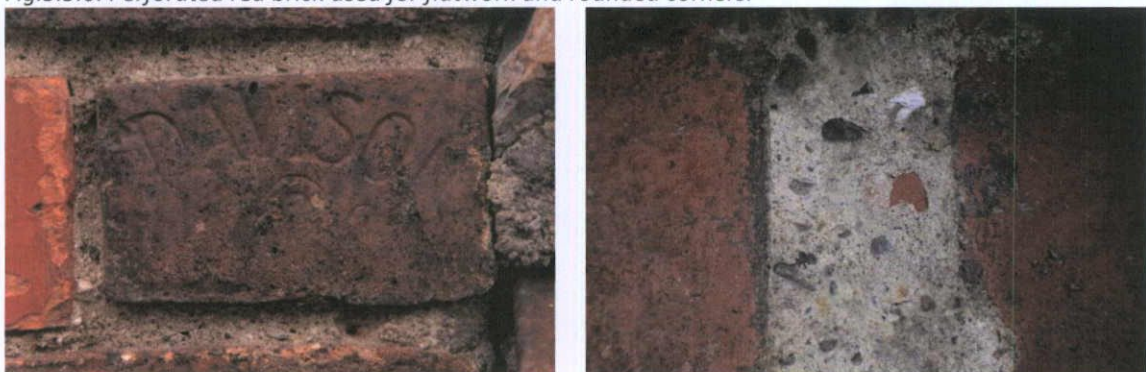
Fig.5.5.7: Brick stamped 'Davison' (left) and detail of the mortar mix containing poorly sorted sub-angular limestone as well as crushed red and yellow brick pozzolan. Charles Davison's Ewloe Barn Brick and Tile Works were active from 1933 to 1951 at Buckley in Flintshire, Wales².

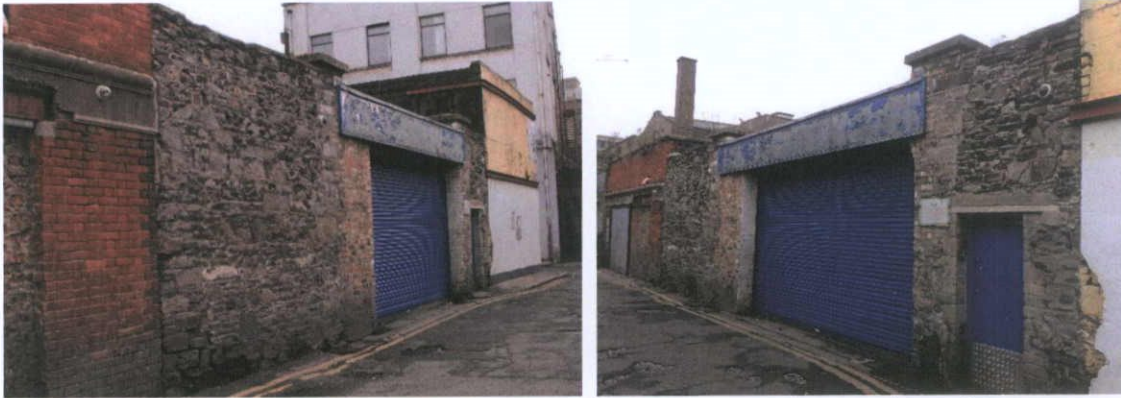
Fig.5.6.1: General view of the Calp limestone masonry wall at the rear of No.59 O'Connell St.

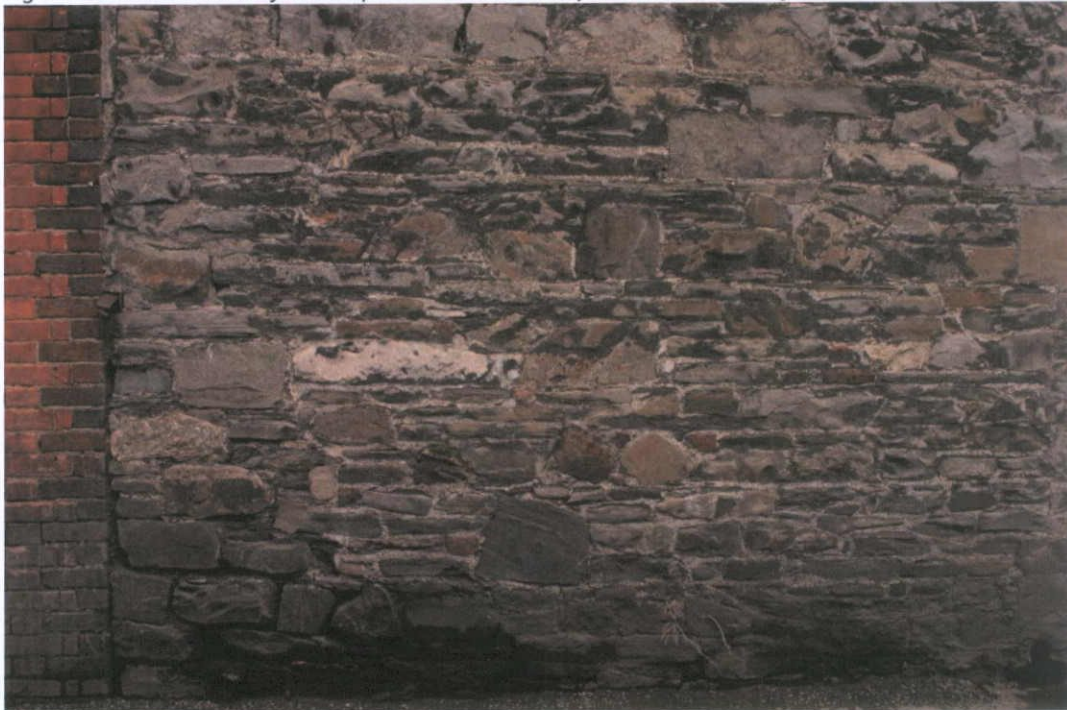
Fig.5.6.2: View of the wall showing flaggy Calp.

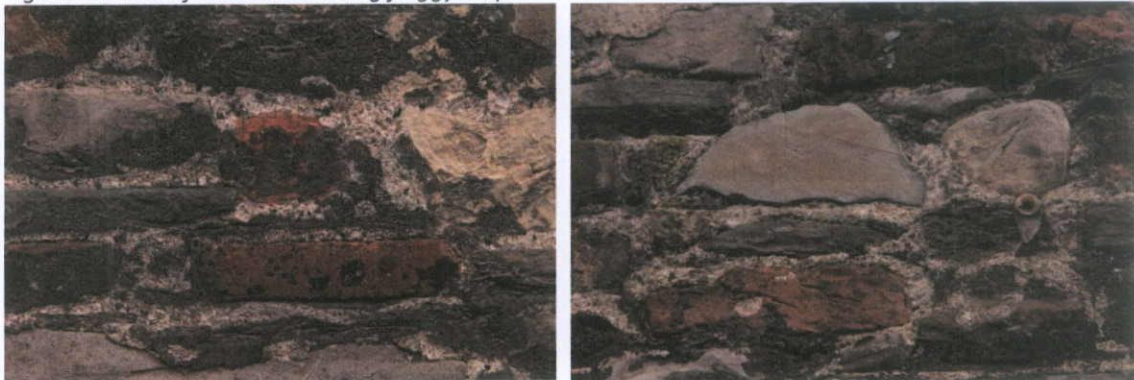
Fig.5.6.3: Thin irregular probably Georgian brick.

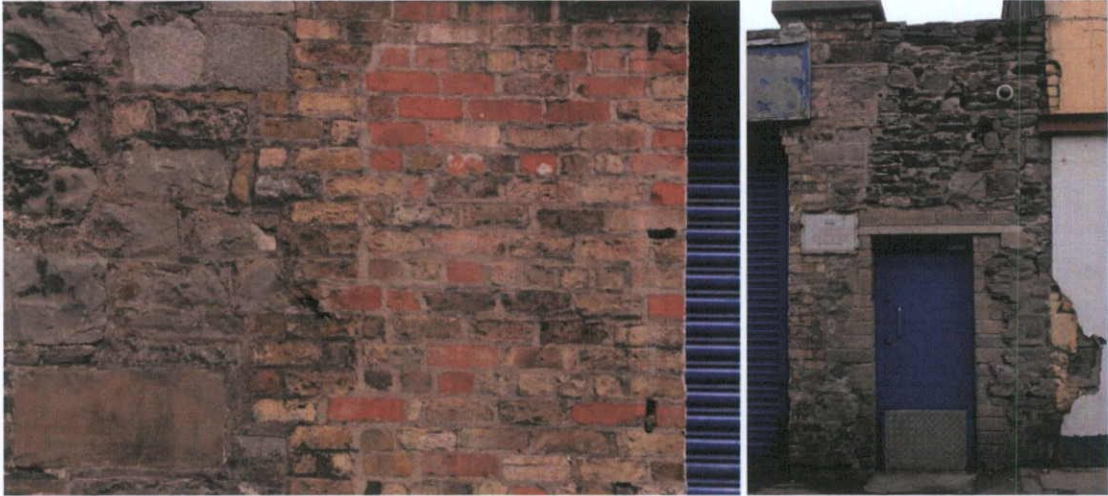
Fig.5.6.4: Later brick gate pier toothed-in to the Calp limestone masonry.

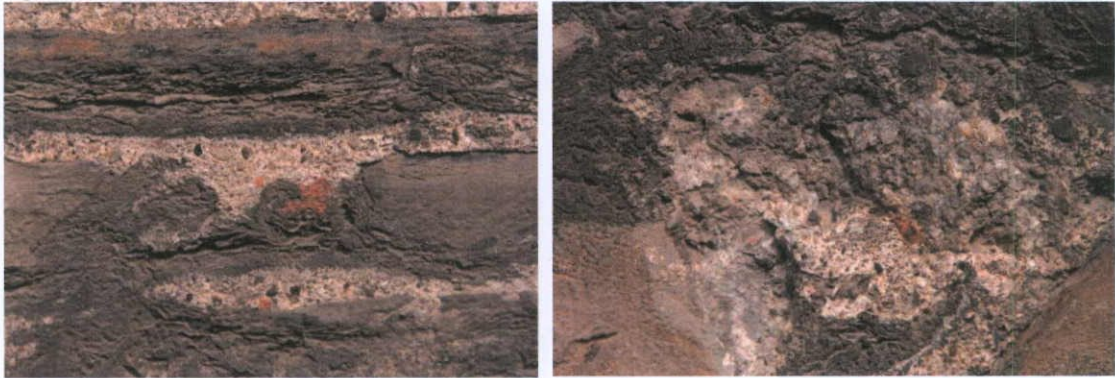
Fig.5.6.5: Crushed brick in the Calp limestone bedding mortars.

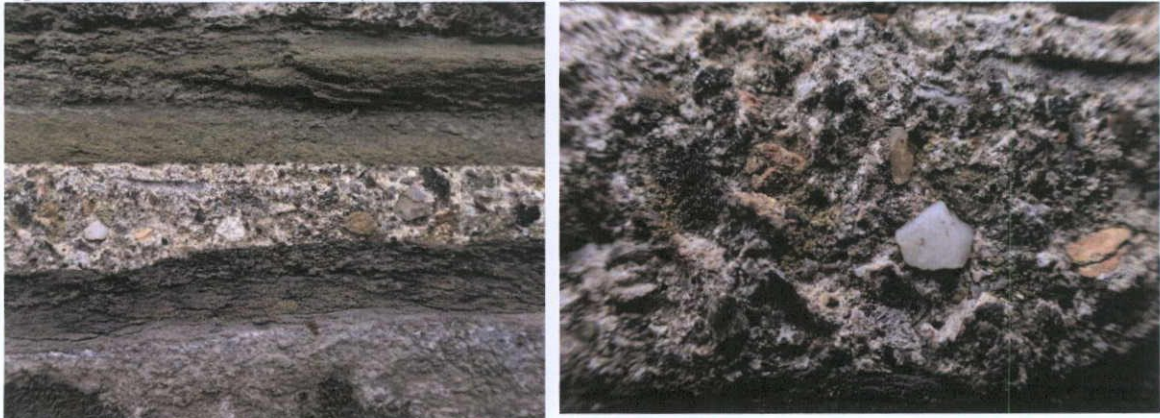
Fig.5.6.6: Detail of a gritty lime-based mortar between greenwacke and Calp limestone (left) and a microscope detail of the soiled surface of the mortar showing quartz and partially calcined limestone.

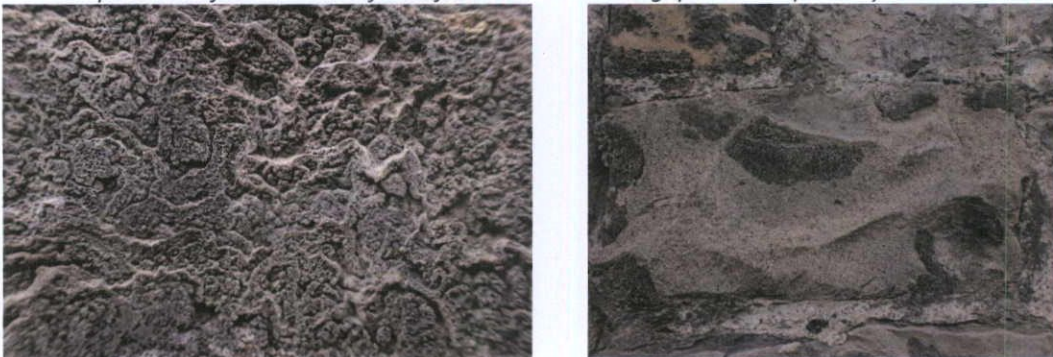
The Moore Lane rear entrance consists of Calp limestone masonry containing some fragments of Georgian brick and tile with a well-developed black gypsum crust across the face of the masonry. The deeply folded black soiling crust attests to very long exposure from airborne pollutants. The wall has two gate piers in brick with concrete caps toothed-in to the Calp limestone wall. The lime-based bedding mortars contain abundant crushed brick pozzolan and poorly-sorted coarse-grained aggregate of limestone, quartz, sandstone, chert

Fig.5.6.7: Black gypsum soiling crusts on the surface of the mortar and stone.

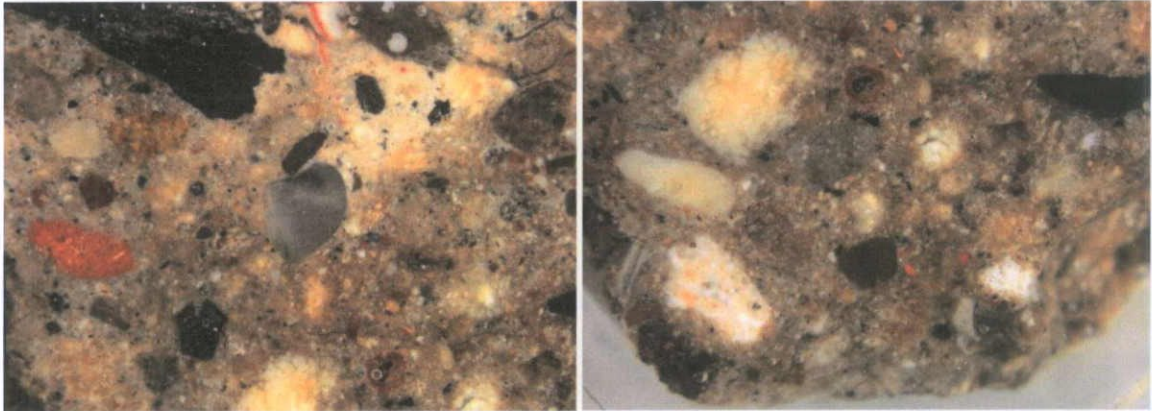
Fig.5.6.8: Cross section in visible light (magnification x13) showing natural stone aggregate with brick pozzolan in a lime binder.

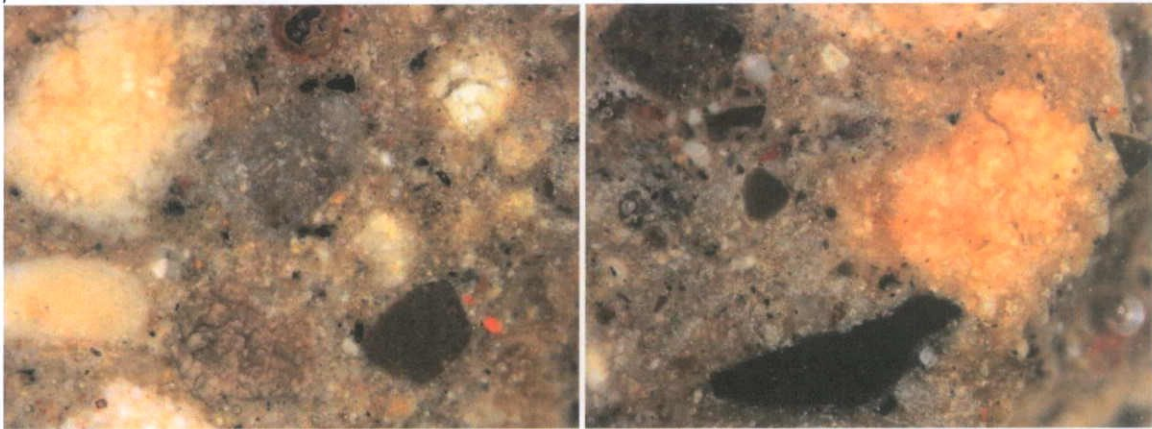
Fig.5.6.9: Cross section in visible light (magnification x24) showing reactive aggregate, coarse lime lumps and fine brick pozzolan in a lime binder.

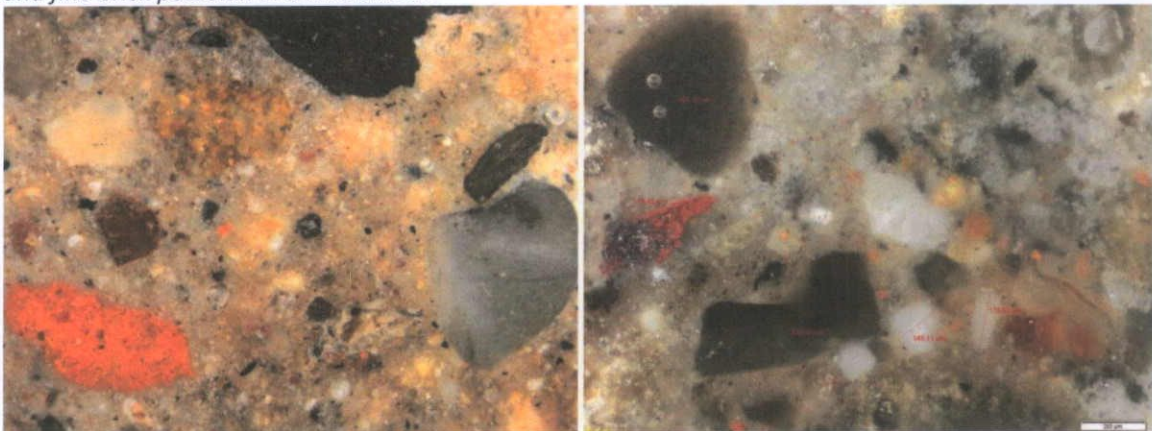
Fig.5.6.10: Cross section in visible light (magnification x40) showing limestone, quartz, chert, crushed brick aggregate and fine brick pozzolan.

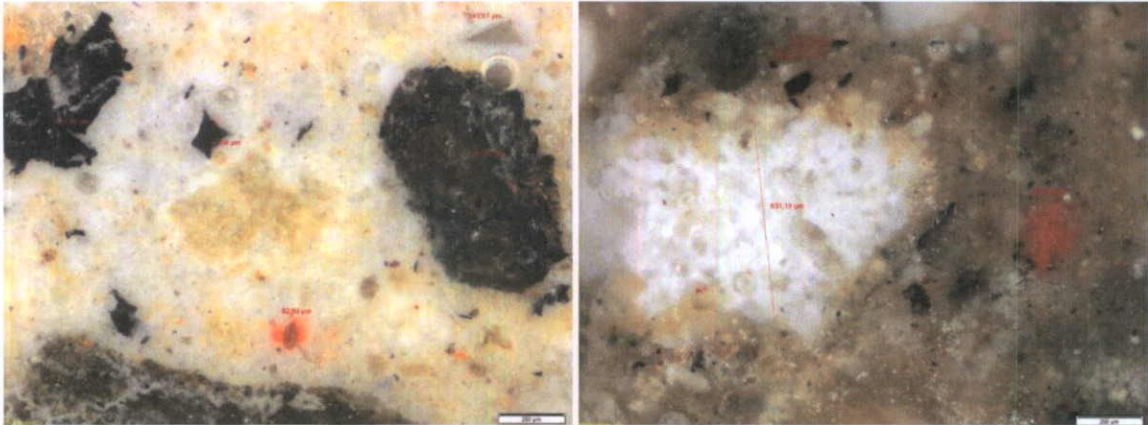
Fig.5.6.11: The lime binder is not homogenous and contains abundant lime lumps and occasionally partially fired limestone fragments, with fine brick dust pozzolan found throughout. Cross section in visible light (magnification x40).

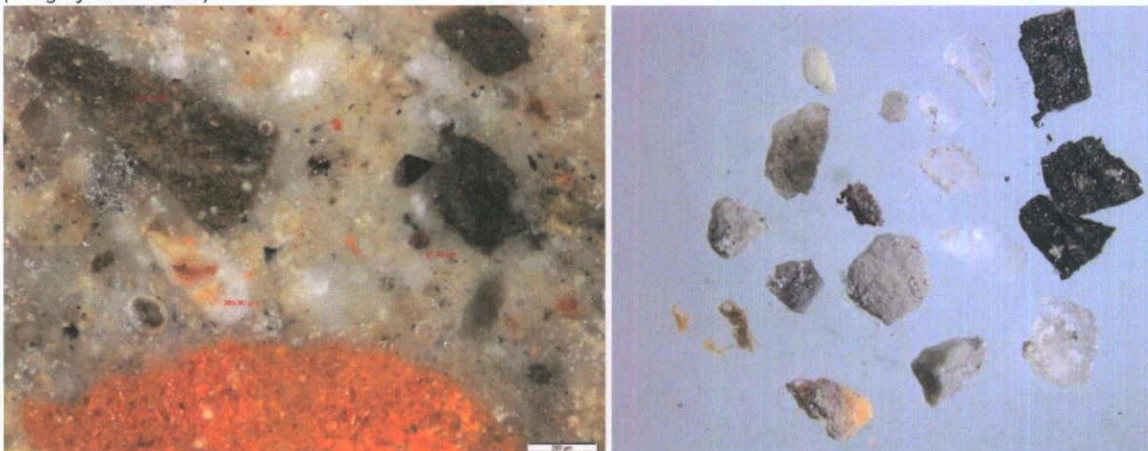
Fig.5.6.12: Brick is present throughout the mortars as coarse brick shards acting as porous aggregate (left, cross section in visible light magnification x40); while the majority of the aggregate is composed of limestone, quartz and chert (right, magnification x13.5).
