Interior – Ground Floor – Retail**Unit 2 – Fortune Terrace Restaurant****Outline of unit**

Unit 2 is the largest of the ground floor retail units. It houses The Fortune Terrace restaurant which also occupies the first floor of the building. The ground floor of the restaurant holds a front reception area, male, female and accessible WC's, security room, main dining area and ground floor kitchen. There is an emergency exit at the rear of the restaurant that leads out to the ground floor car park. There is a laminate floor to the front of the shop and a tiled floor to the rear. There are modern plaster finishes to the concrete walls, plasterboard ceiling finishes, and a number of light-weight partitions throughout, as well as a dumbwaiter within a lift shaft.

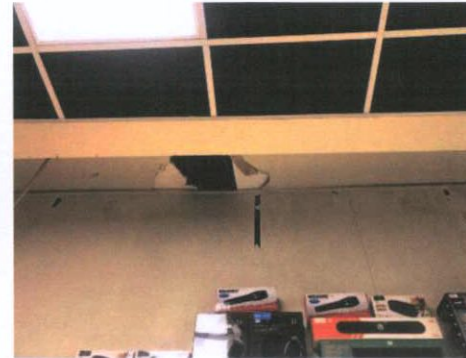
Plate 44: Damage to ceiling in main retail space

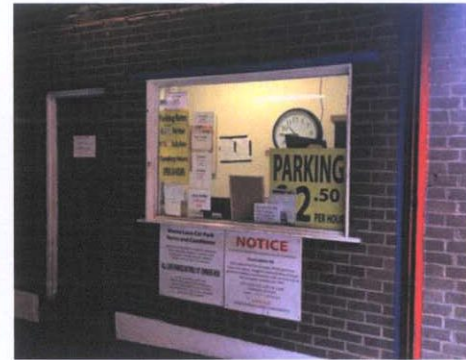
Plate 86: Car park attendant Kiosk

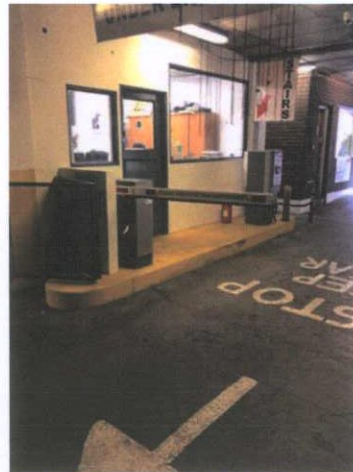
Plate 89: Car entrance barrier and office

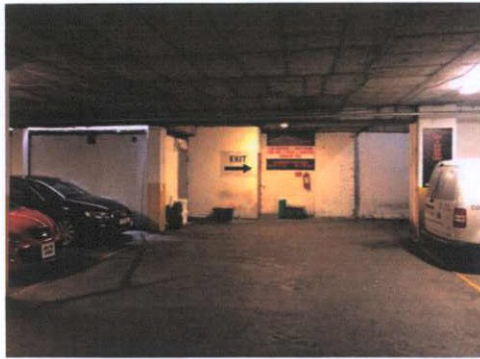
Plate 92: West wall at rear of car park

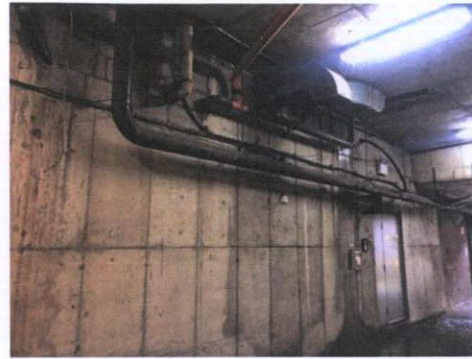
Plate 93: Building services on west wall

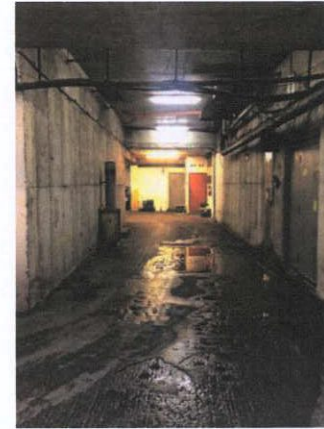
Plate 94: West corridor of car park with retail units fire exits on right

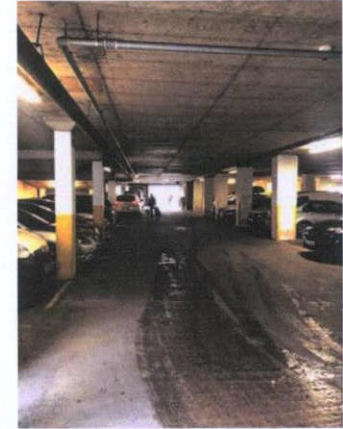
Plate 95: South corridor leading to exit on Moore Lane

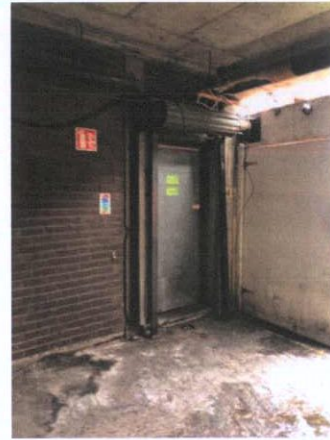
Plate 97: Exit from Pick & Pay shop in south east corner

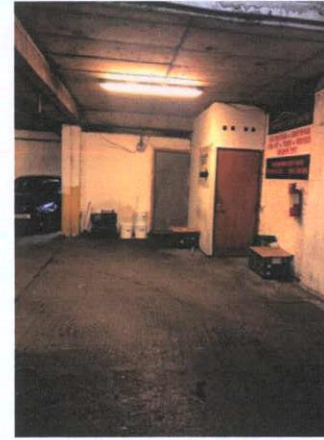
Plate 98: WC Block for Wings restaurant located in the north east corner

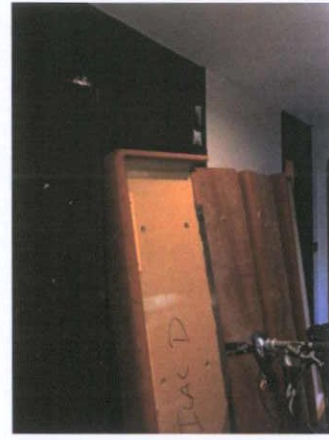
Plate 109: Storage unit in WC hallway

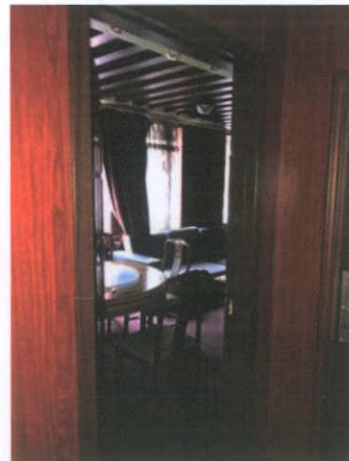
Plate 113: Entrance to private room 1

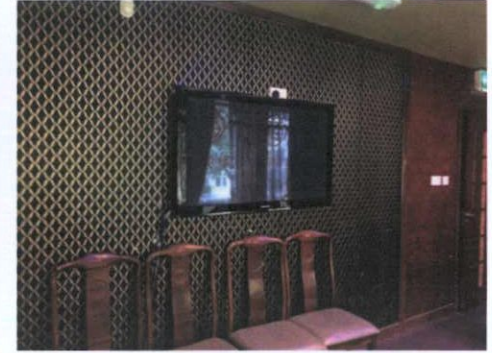
Plate 119: West wall of private room 1

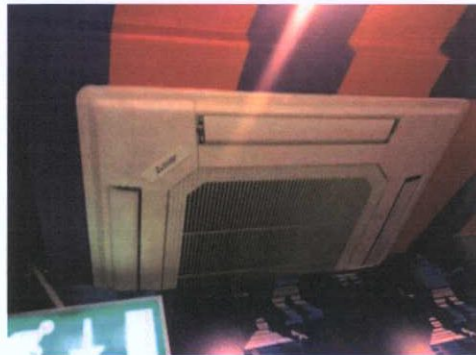
Well-maintained area with some minor damage. Poor positioning of air conditioning units. Door frames are damaged.

Plate 120: Air Conditioning unit blocked by partition wall

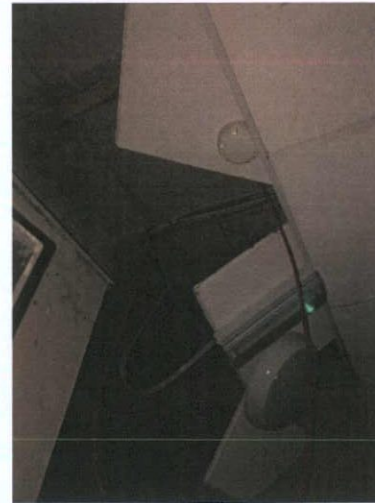
A stairway leads to O'Connell Street for emergency access. Damage to lighting services is visible. Walls were concrete construction.

Plate 138: Damage to lighting in fire exit staircase

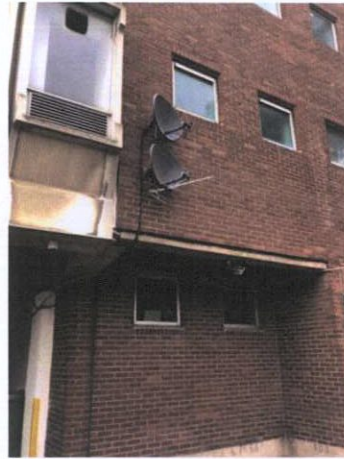
Plate 167: South west wall of west stair core

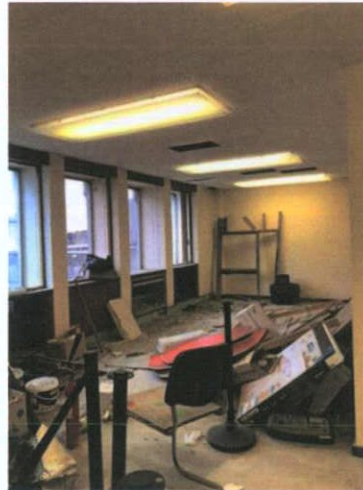
Plate 202: Room partially demolished — West wall

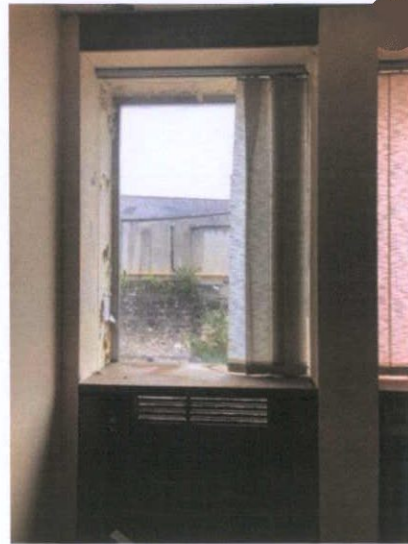
Plate 206: Window in office

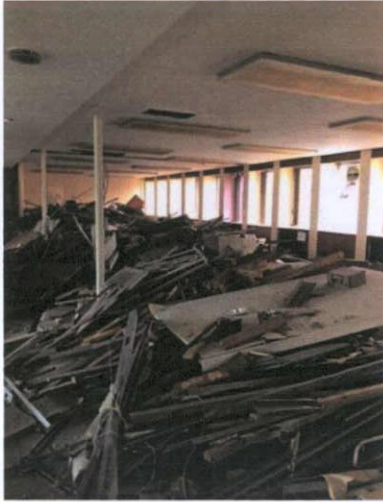
Plate 213: South section of main room used to store materials from demolition

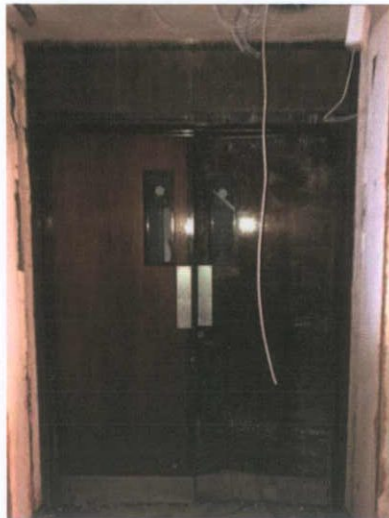
Plate 225: Exit doors to front of building that have been blocked up behind to separate areas

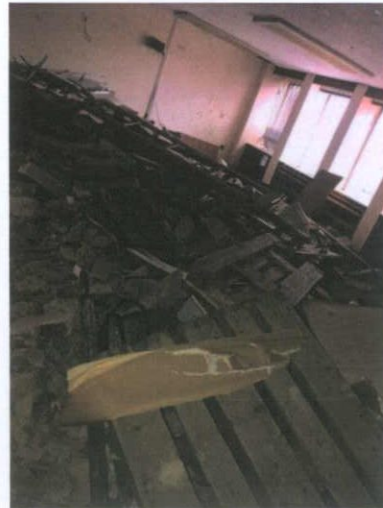
Plate 279: Room 14 — Non accessible due to demolished material

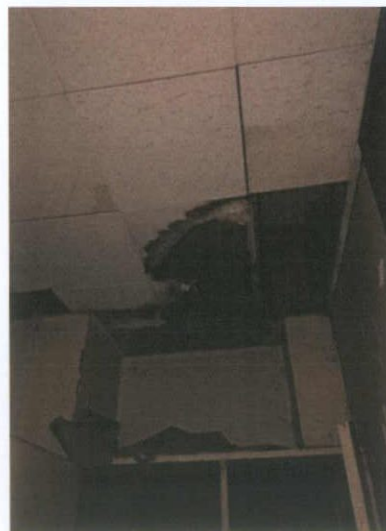
Plate 296: Damage to ceiling of kitchenette

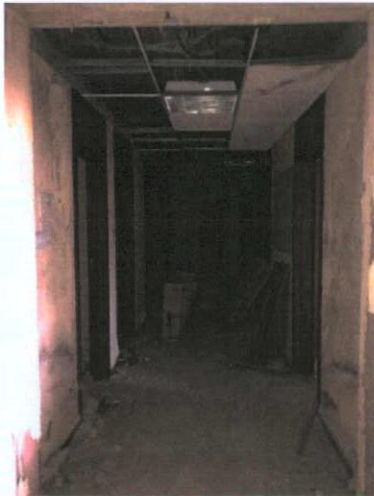
Plate 302: Main corridor facing east- no through access to rest of floor due to block wall

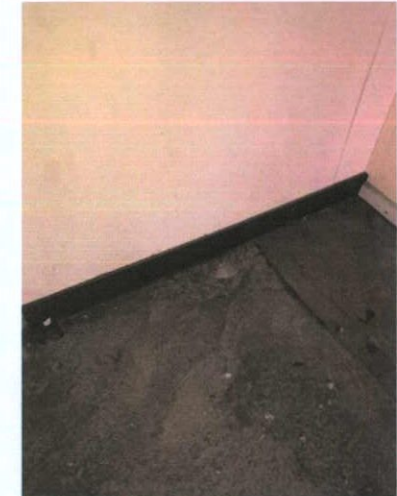
Plate 305: Carpet visible underneath metal stud partitions

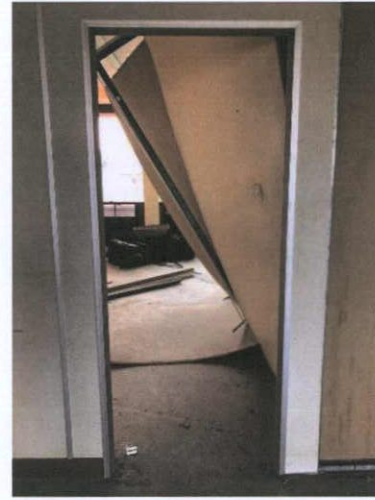
Plate 334: Room 1 — Entrance with damaged stud partition

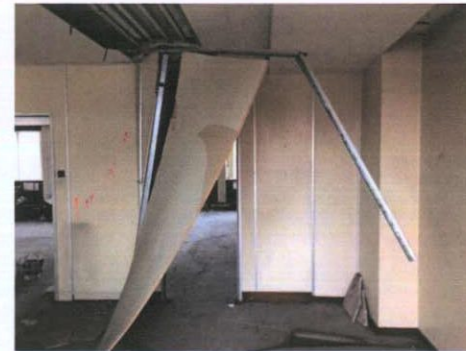
Plate 338: South wall showing damaged partition

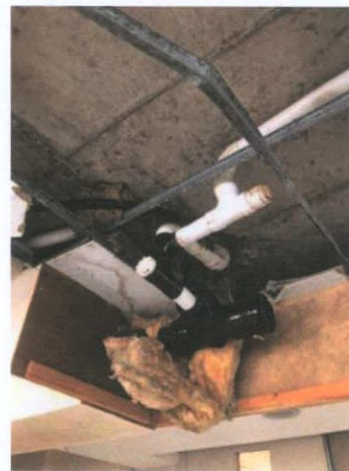
Plate 361: Exposed drainage pipes in ceiling

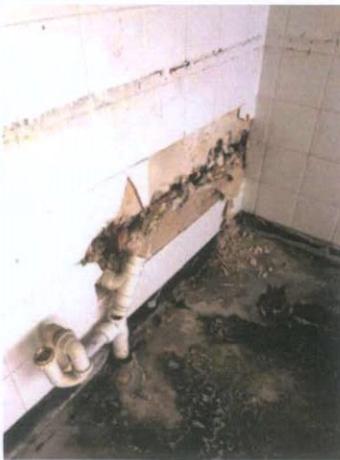
Plate 399: Damage to wall

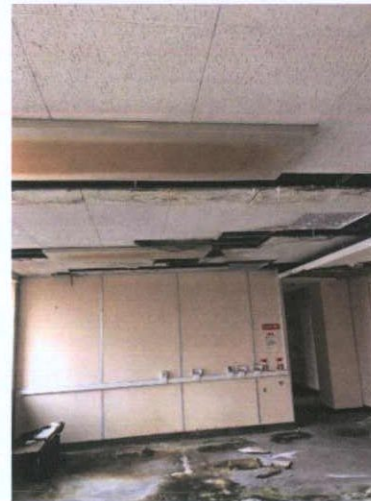
Plate 425: Room 7 — Ceiling damage

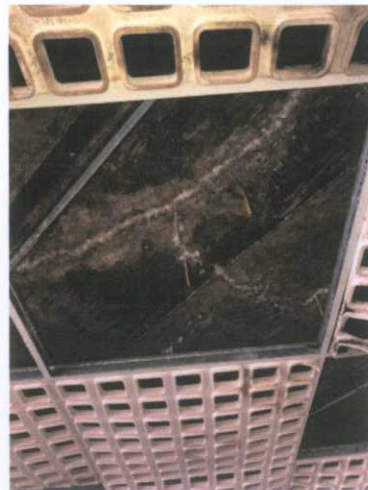
Plate 432: Room 8 — Water leaking through ceiling

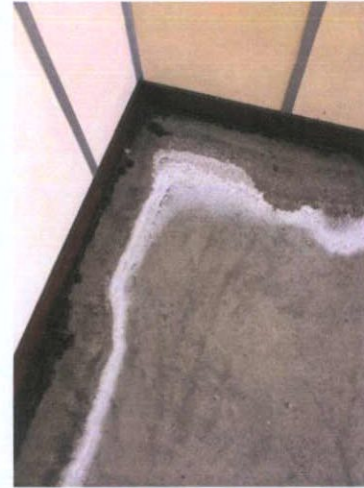
Plate 437: Room 9 — Carpet under partition

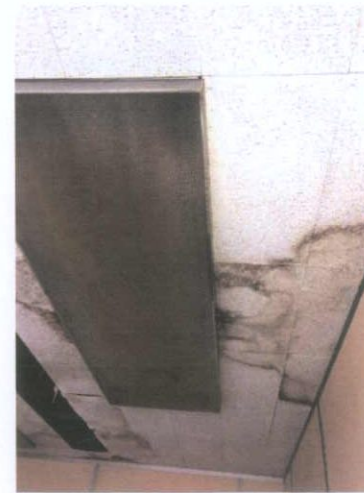
Plate 449: Room 11 — Ceiling water damage

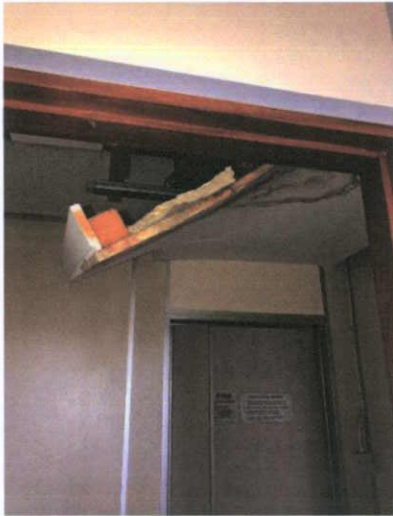
Plate 451: Damage to ceiling in secondary hallway

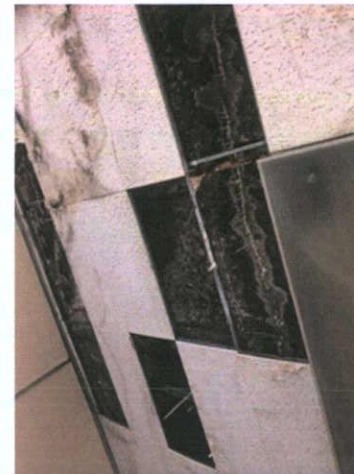
Plate 457: Room 12 — Roof leaking into room

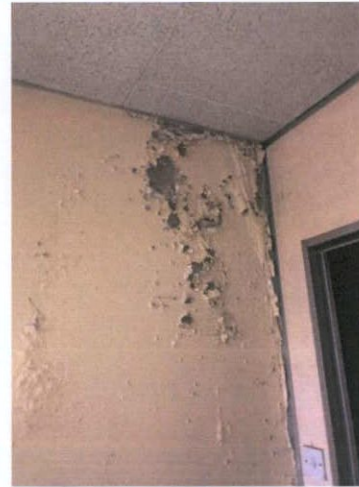
Plate 469: Room 15 — Damage to east wall
