**Report Ref: P2970\_Issue 2**

**Preliminary Risk Assessment**

**Cavan Regional Sports Campus, Cavan,  
County Cavan**

**Issued: March 2024**

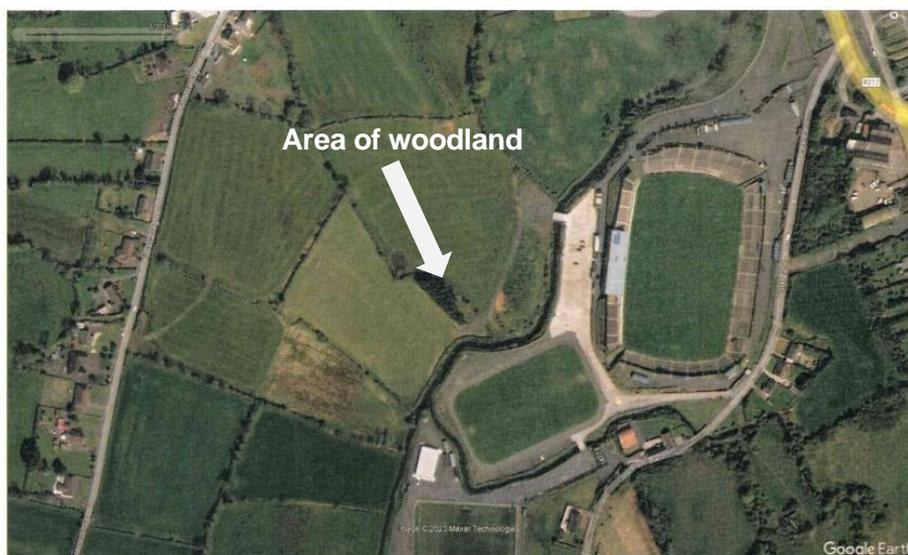
The field boundary and associated small area of woodland observed to exist between Field 9 and Field 11, as observed by comparing aerial photography dated between 2021 and 2022 (Figure 4), has recently been removed creating a strip of bare / disturbed cleared ground now partly occupied by the new playing field.

Google Aerial 2023	The area of recent hedgerow / woodland clearance / disturbed ground is evident. The field boundary and associated small area of woodland observed to exist between Field 9 and Field 11, has been removed creating a strip of bare / disturbed cleared ground now partly occupied by the new playing field. Work has begun on the creation of the car park in Field 9.

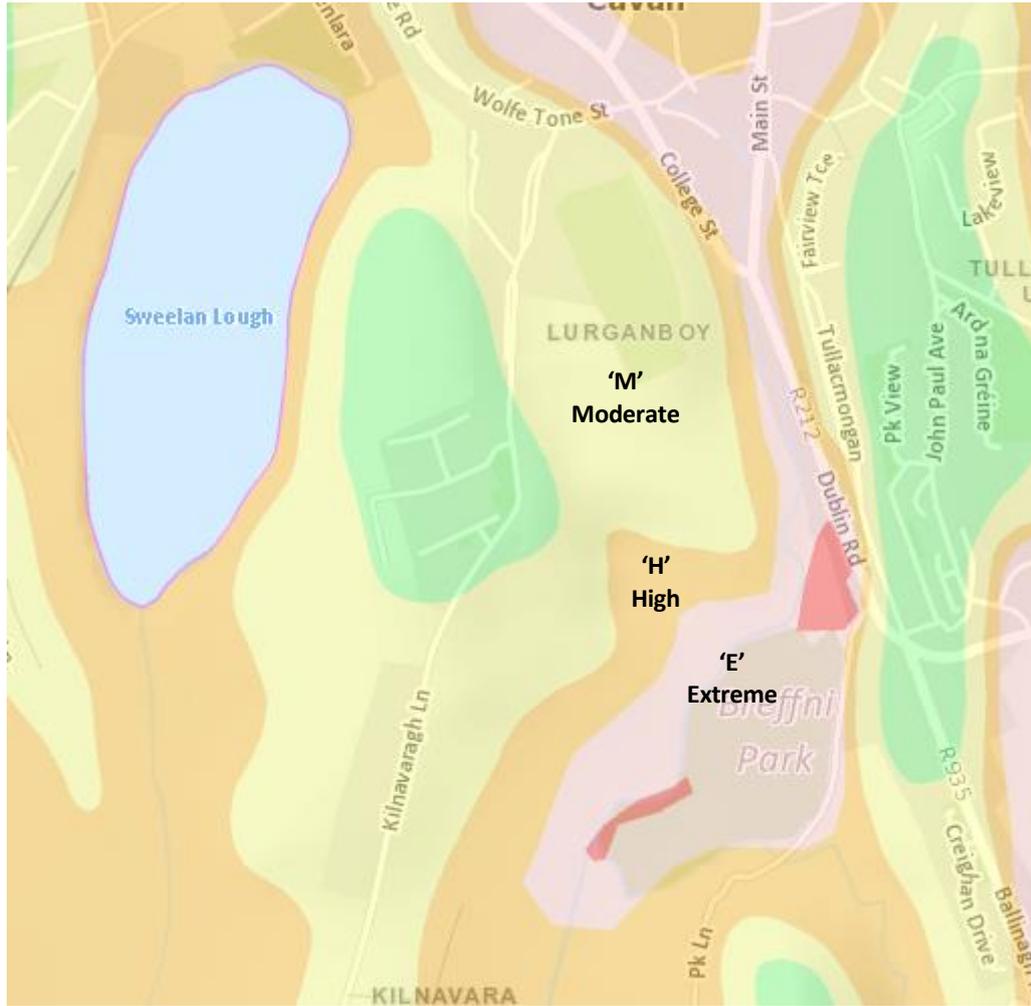
Figure 12: Groundwater Vulnerability Map

A review of the GSI Groundwater Vulnerability indicates that the site is largely characterised by a vulnerability rating of 'Moderate', with the southeast of the site along the margins of the Cavan River listed as having a vulnerability rating of 'High' to 'Extreme', as shown in **Figure 12**. The latter vulnerability rating is likely in relation to the possible existence of shallow unconfined groundwater occurring in permeable drift deposits (Sand/Gravel) along the river margin.

There may be areas of potential Superficial Aquifer, of high vulnerability status along the river margin (sands/gravels). These may be contributing to river baseflow. Any disruption to this flow caused by development may impact of stream hydraulics. Any pollution risk to this system due to construction and development may impact on the water quality of the Cavan River and its tributaries.

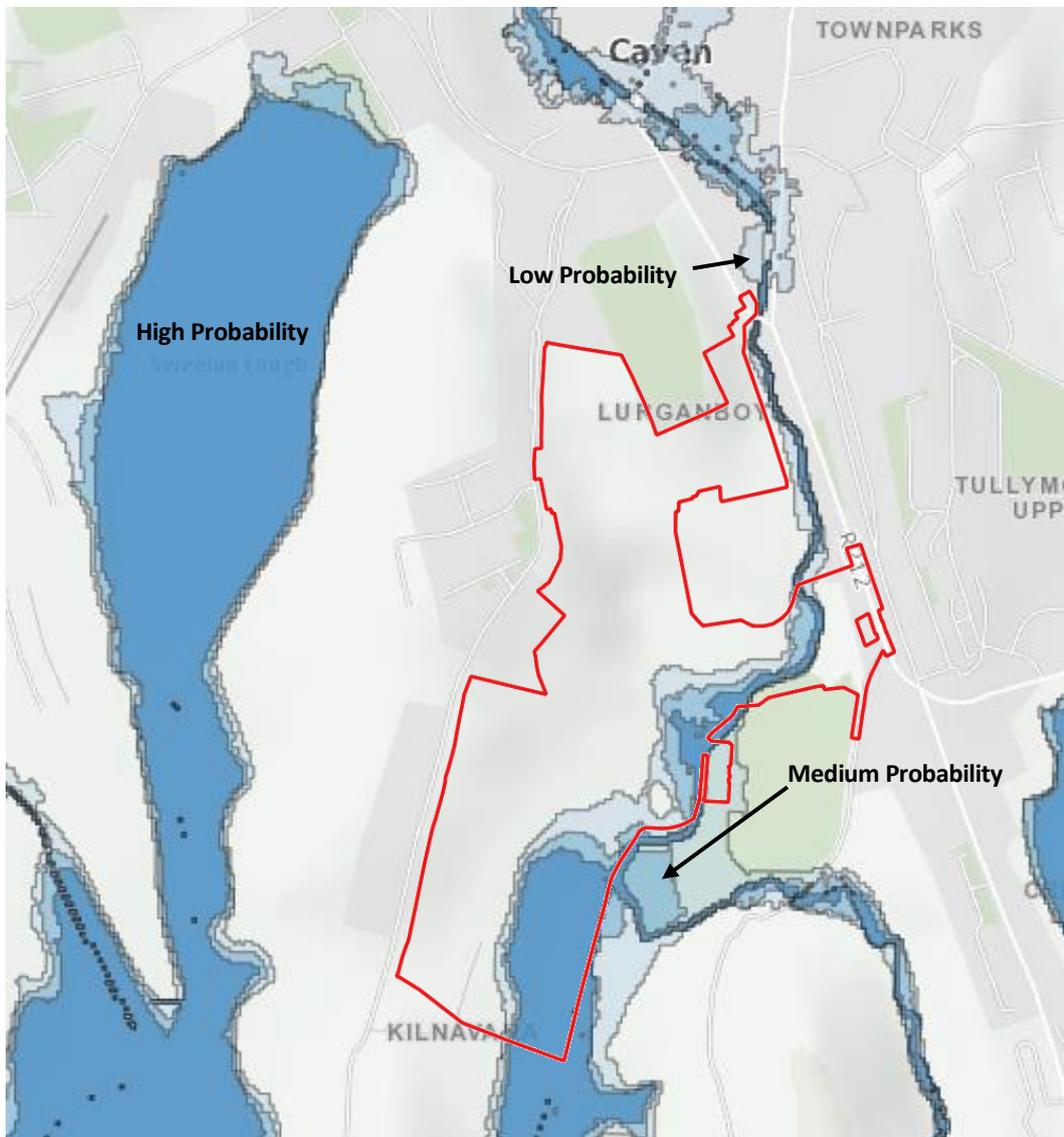
**Figure 14: FloodInfo Flood Mapping**

A review of the FloodInfo Ireland Flood Maps indicates that the western/southwestern areas of the site adjacent to the Cavan River is located within the 'High Probability' for River Flooding, as shown below in **Figure 14**.

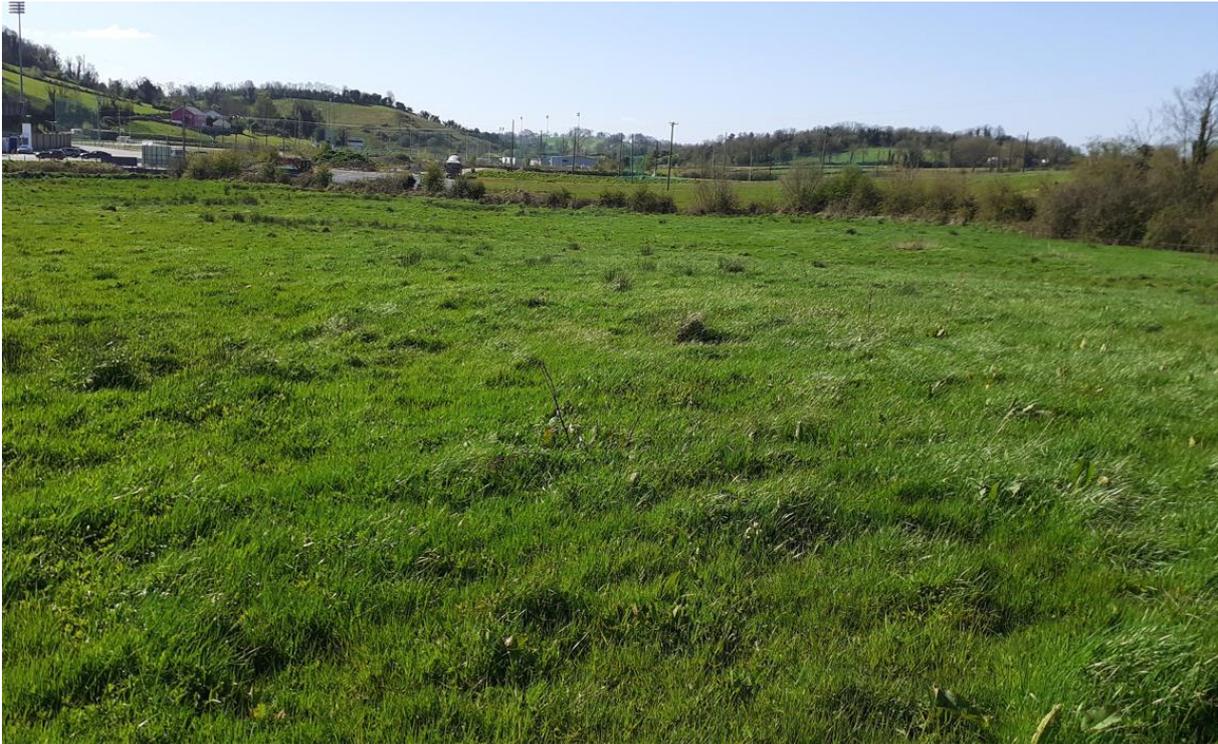
**Plate 3: Field 1 looking south**

This area of site can be accessed via an access road into Royal School Cavan. From this access road, there is an all-weather gravel sports pitch used by the school (Plate 1). To the west of this pitch is the Kilnavarragh Stream. South of the pitch is Field 1 (Plate 3), which is greenfield land. The topography slopes to the south/southeast in this area, where the field borders the Cavan River. There was an area of marshy land in the southwest of this field along the Kilnavarragh Stream. Drainage pipes from Breffni Park grounds (Plate 6) were identified flowing into the Cavan River.

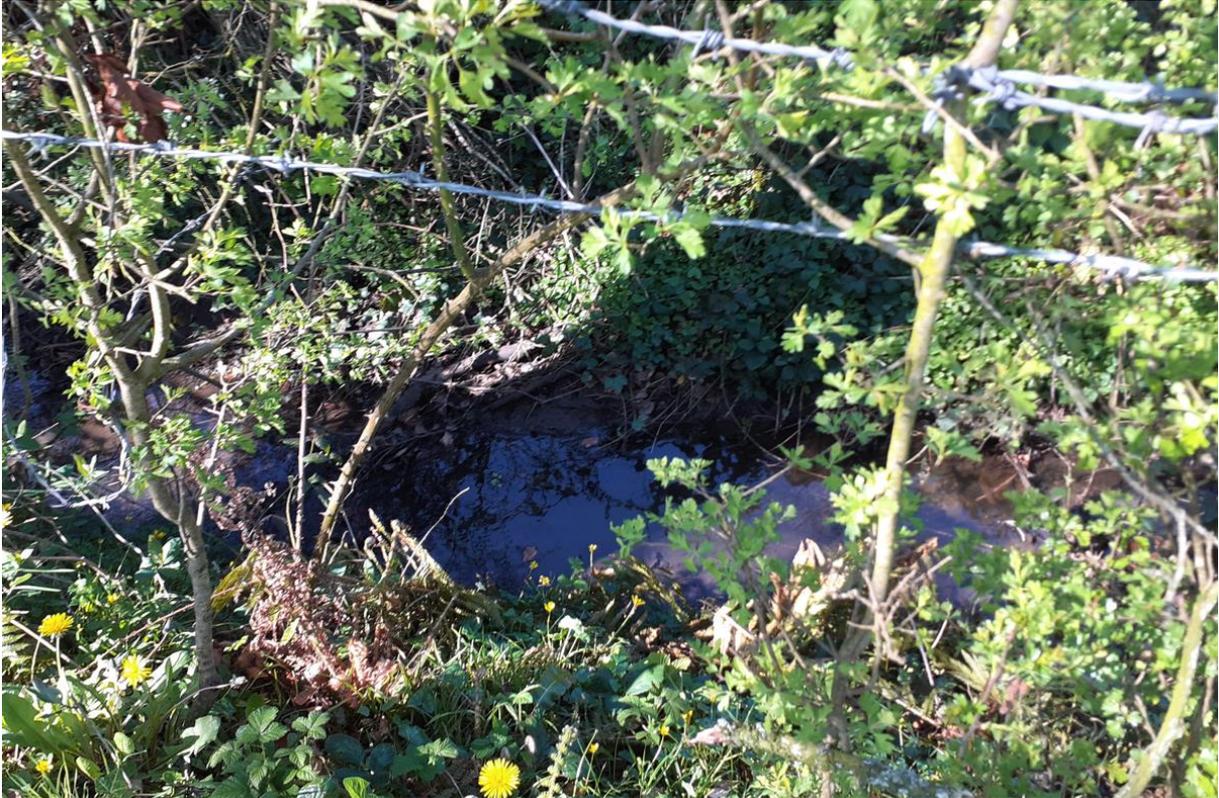
**Plate 5: Kilnavarragh Stream. (Western Boundary Field 1)**

During the site walkover, the Kilnavarragh Stream was identified to be dissecting the site into east and west, flowing in an open channel south through the site and converging with the Cavan River along the eastern site boundary. A small watercourse / ditch was observed draining lands north of the school. Various other very small field drains / ditches were recorded along various field boundaries within and around the site.

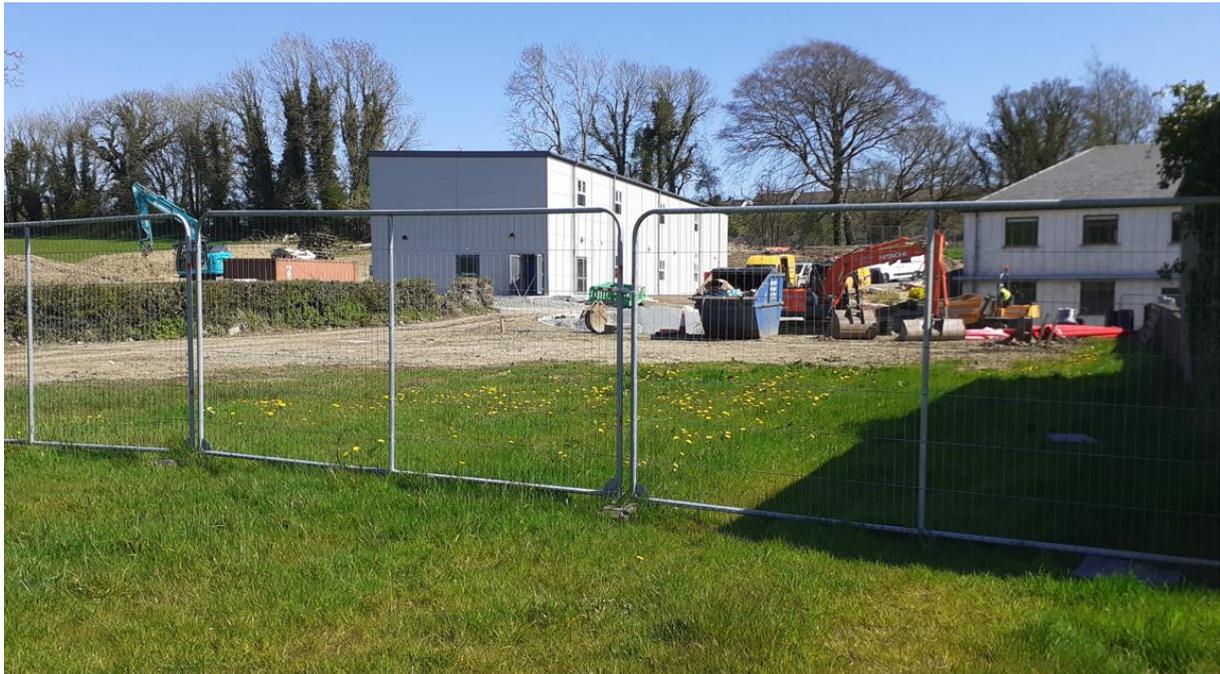
**Plate 11: Construction of New School Building East of Field 2**

North of Field 1 is a gravel pitch currently used by Royal School Cavan as a Car Park in the south and a Physical Education ground. Slightly upgradient of the Gravel Pitch is a grass field (Field 2). East of Field 2, beyond the site boundary and encroaching into Field 4 is an active construction site (Plate 11) where the construction of a new 2-storey school building structure has recently been completed. Groundworks within this area include a land cut / reprofiling and land-raising in an area behind the new-constructed retaining structure (Plate 17).

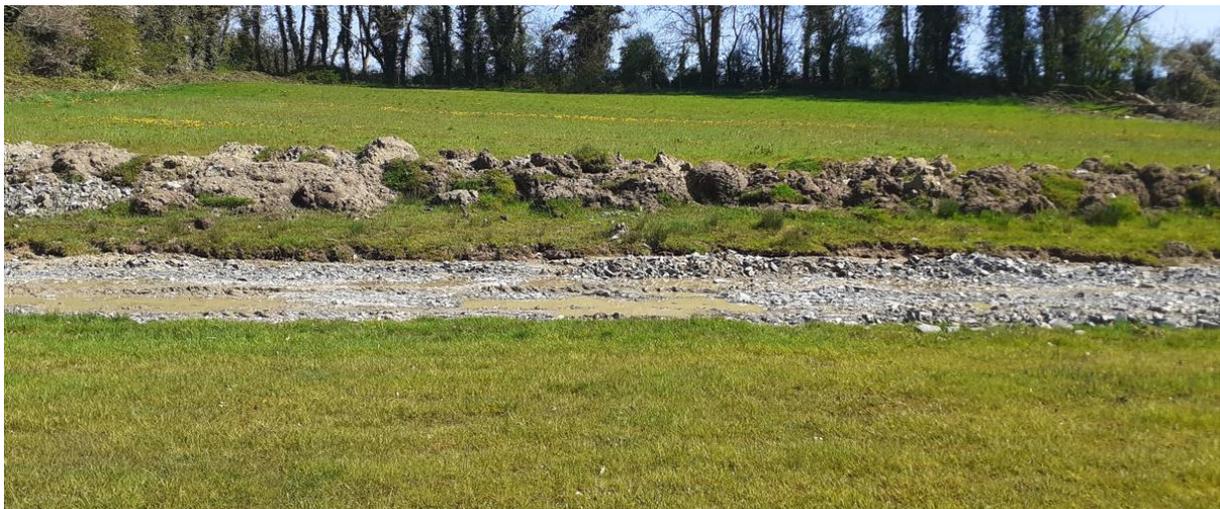
**Plate 12: Field 3 looking towards Field 4. Gravel Road for construction vehicles**

To the north of the new school building, within Field 3 and Field 4, localised land-stripping has been undertaken to create a new hardcore access lane (Plate 13). This leads northwards, opening up into a large area of very recent minor land raise (Plate 13, 14 and 15). A c.1m thick layer of what appears to be mainly clay materials arising from the school development cut has been spread out over agricultural lands to the north of the school development. The western area of Field 3 and the eastern area of Field 4 have remained mainly greenfield.

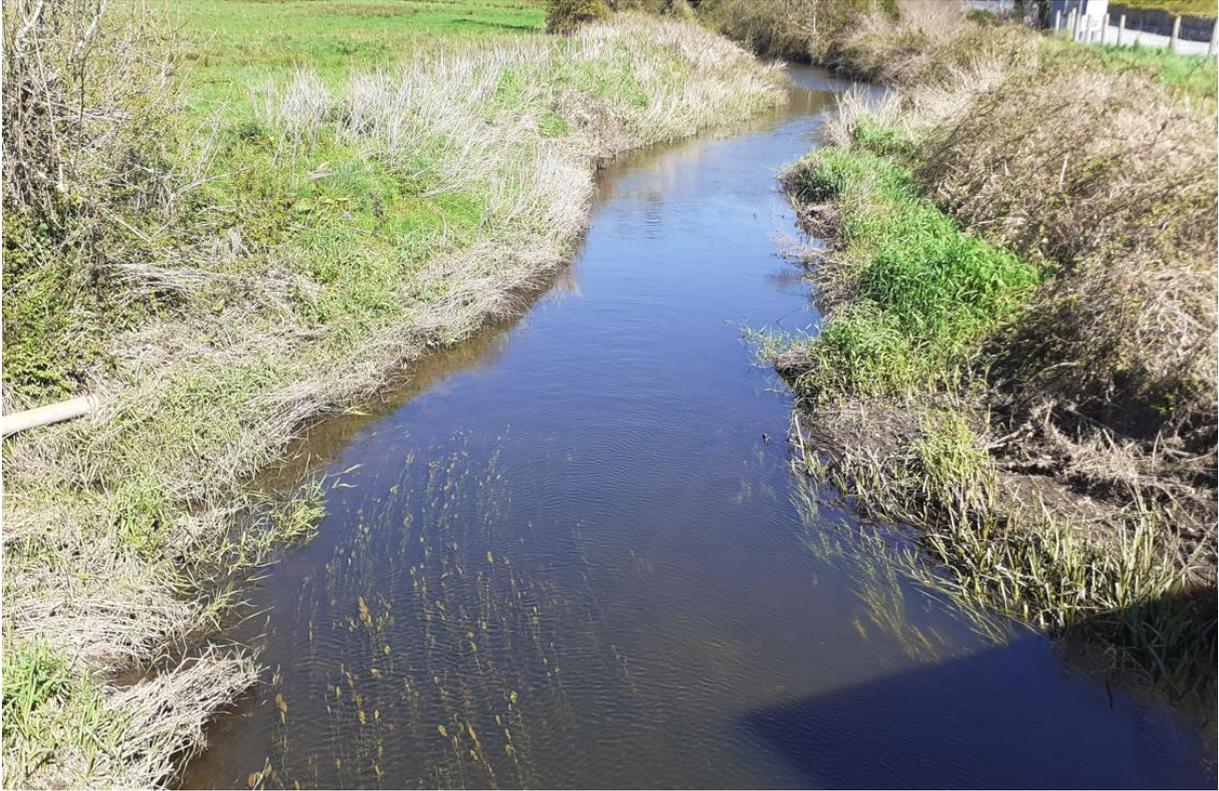
**Plate 19: Cavan River from the bridge between Breffni Park and Field 9**

Field 9 can be accessed via a newly-constructed bridge across the Cavan River located within the grounds of Breffni Park GAA grounds car park (Plate 19). The land slopes upgradient in a northwest direction from the bridge. In the east of this field, a car park associated with Cavan GAA is currently under construction (Plate 20). A GAA playing pitch has recently been constructed along the south/southwest of Field 9 (Plate 26). This would have required a programme of ground disturbance cut and fill / alteration of land profile to create a flat platform on what have originally been sloping lands.

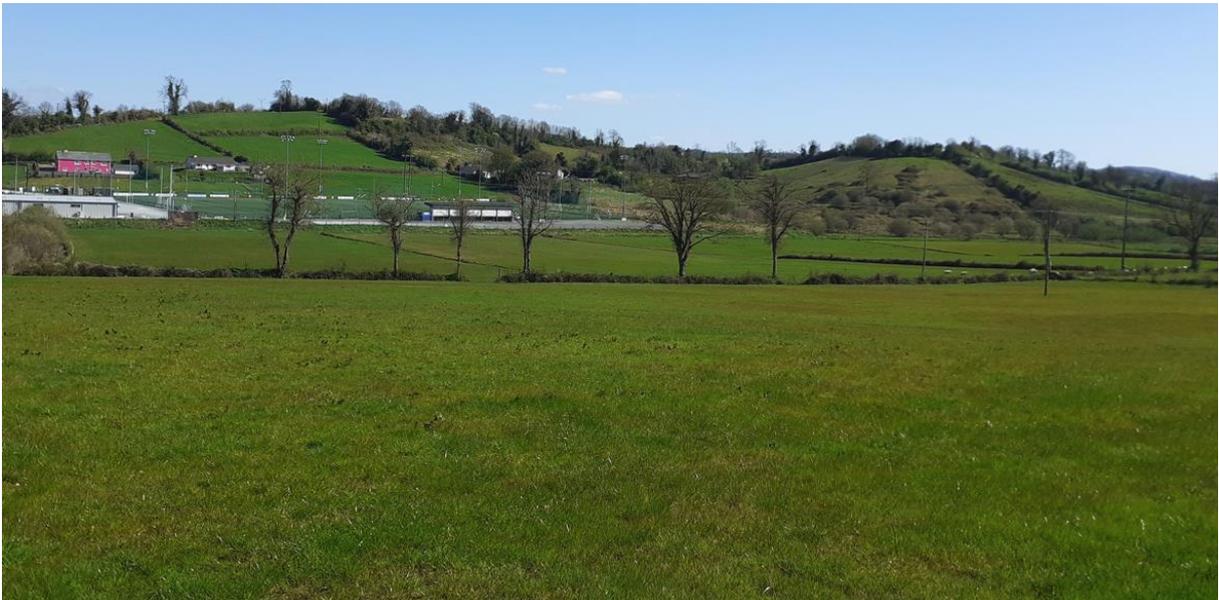
**Plate 28: Field 13-15, looking east**

Field 13-17 are located in the southernmost regions of the site (Plate 28 to Plate 30). The walkover of these fields indicated that the vast majority of areas are all greenfield land, with no evidence of contaminating land use evident. There is a clear decrease in elevation between Fields 16 and 17 and the lower Fields 13-15, with the lower fields meeting the Cavan River on the eastern boundary. Fields 13-15 showed extensive flooding during the site visit, likely from field drains present along the field boundaries. The flooding covered a large portion of the eastern sections of the fields (Plate 31 to Plate 33).
