**Fehily Timoney Peat
Stability Assessment of
Meenbog Wind Farm Site
(2021)**

Meenbog Wind Farm

Peat Stability Assessment of Meenbog Wind Farm Site

Abstract: This assessment addresses the stability of the site of the Meenbog Wind Farm, County Donegal following a peat failure at the site on 12 November 2020.

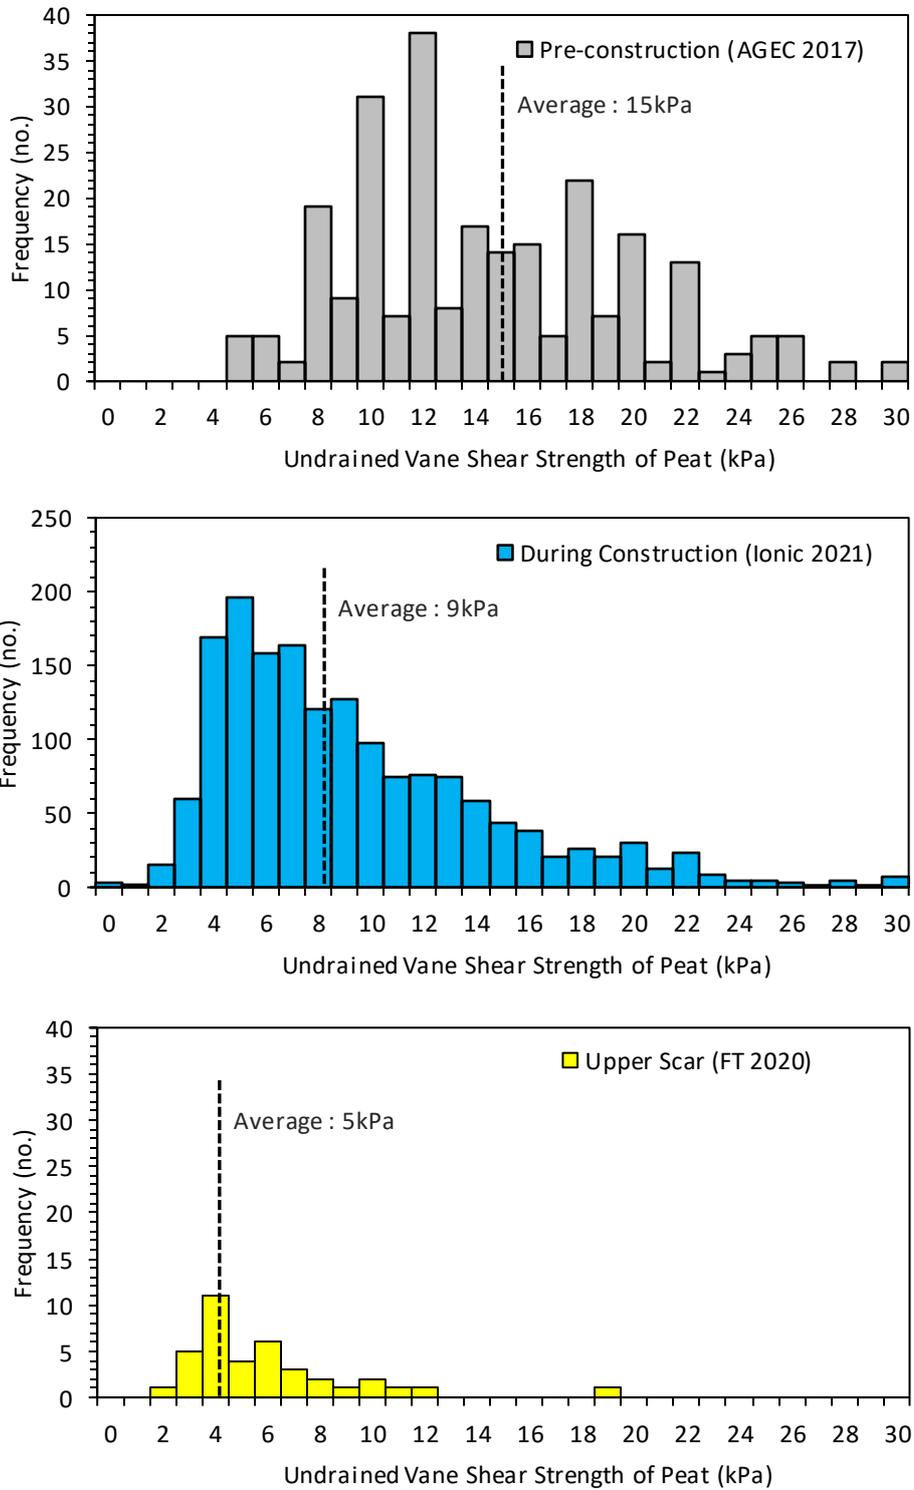
Figure 3: Range of undrained peat strength

The results are shown in **Figure 3** and are compared to the pre-construction results and for results obtained from the upper scar of the 12 November 2020 peat failure. The results from the 12 November failure for the upper scar area (see Section 8.) are notably less than those recorded from the other ground investigations.

The pre-construction results show a more erratic distribution of peat strength, which is attributed to testing being carried out at essentially turbine bases, where there were notable variations in peat conditions (**Figure 3**). The majority of the investigation during construction was predominantly along access roads where there was a more uniform change in peat conditions. The undrained peat strength with depth (**Figure 4**) also shows similar results for both investigations.

The vane shear strength test results for the upper scar of the 12 November 2020 peat failure showed significantly lower results than the pre-construction and during construction investigations, see **Figure 3** and Appendix A2. The upper scar of the peat failure showed an undrained shear strength range from 2 to 9kPa, with an average of slightly less than about 5kPa. These values are notably low and are likely at the lower limit of what can be practically measured with the hand vane. The results show a reasonably consistent strength with depth and represent the lower bound strength profile with depth for all the test results (**Figure 5**).

As the primary source of the failed material, which was essentially peat, was the upper scar the results from this location are of most interest. The hand vane results indicate undrained shear strengths in the range 2 to 19kPa, with an average value of about 6kPa. The results for the upper scar are shown in **Figure 3** and are compared to the site wide results obtained for the EIAR.

- (3) Body of very weak peat immediately upslope. Essentially immediately upslope of the floating road was a flat plateau area that was partly formed of essentially a large body of notably saturated and very weak peat. This body of saturated and very weak peat relied for lateral stability on the peat slope upon which the floating road was being constructed. Hand vane results by FT post-failure showed undrained shear strengths in the range 2 to 9kPa, with an average value of slightly less than about 5kPa. These low recorded peat strengths are significantly lower than the site-wide results and would represent a body of very weak peat (**Figure 3**).

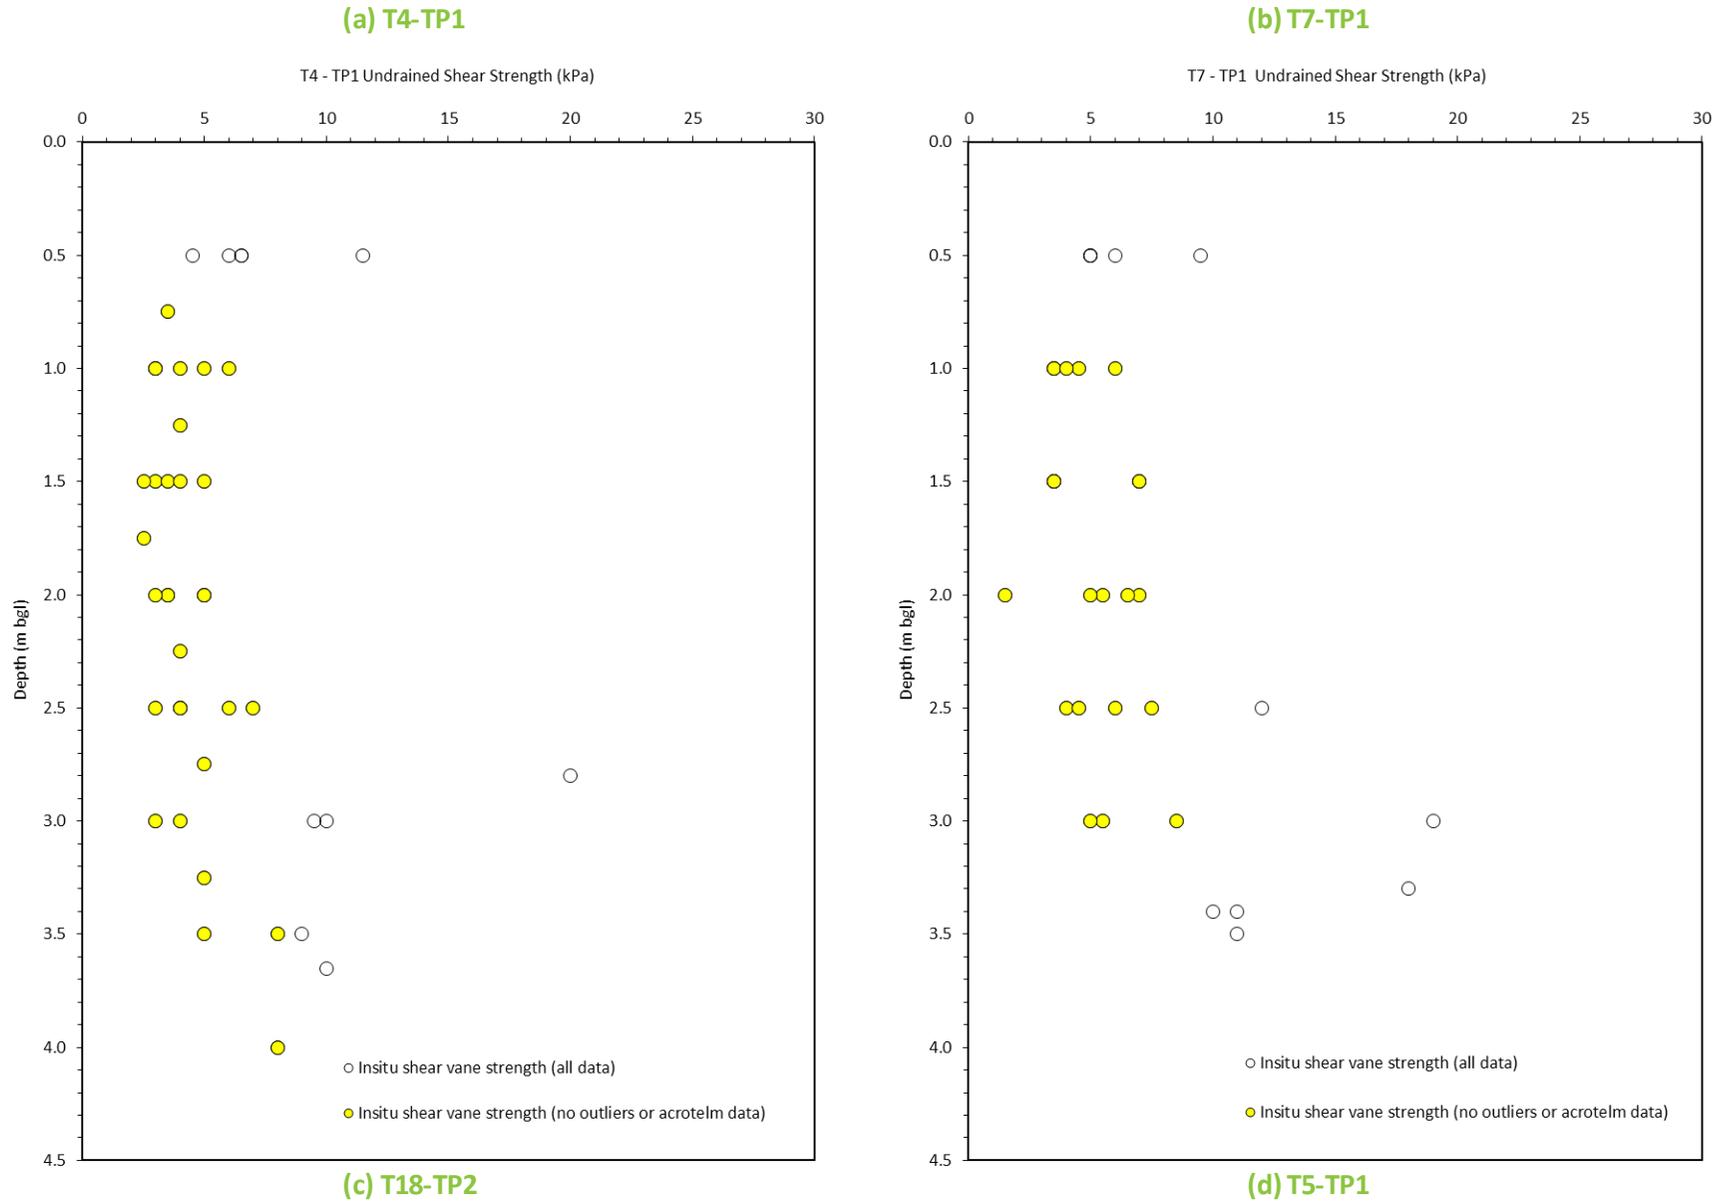
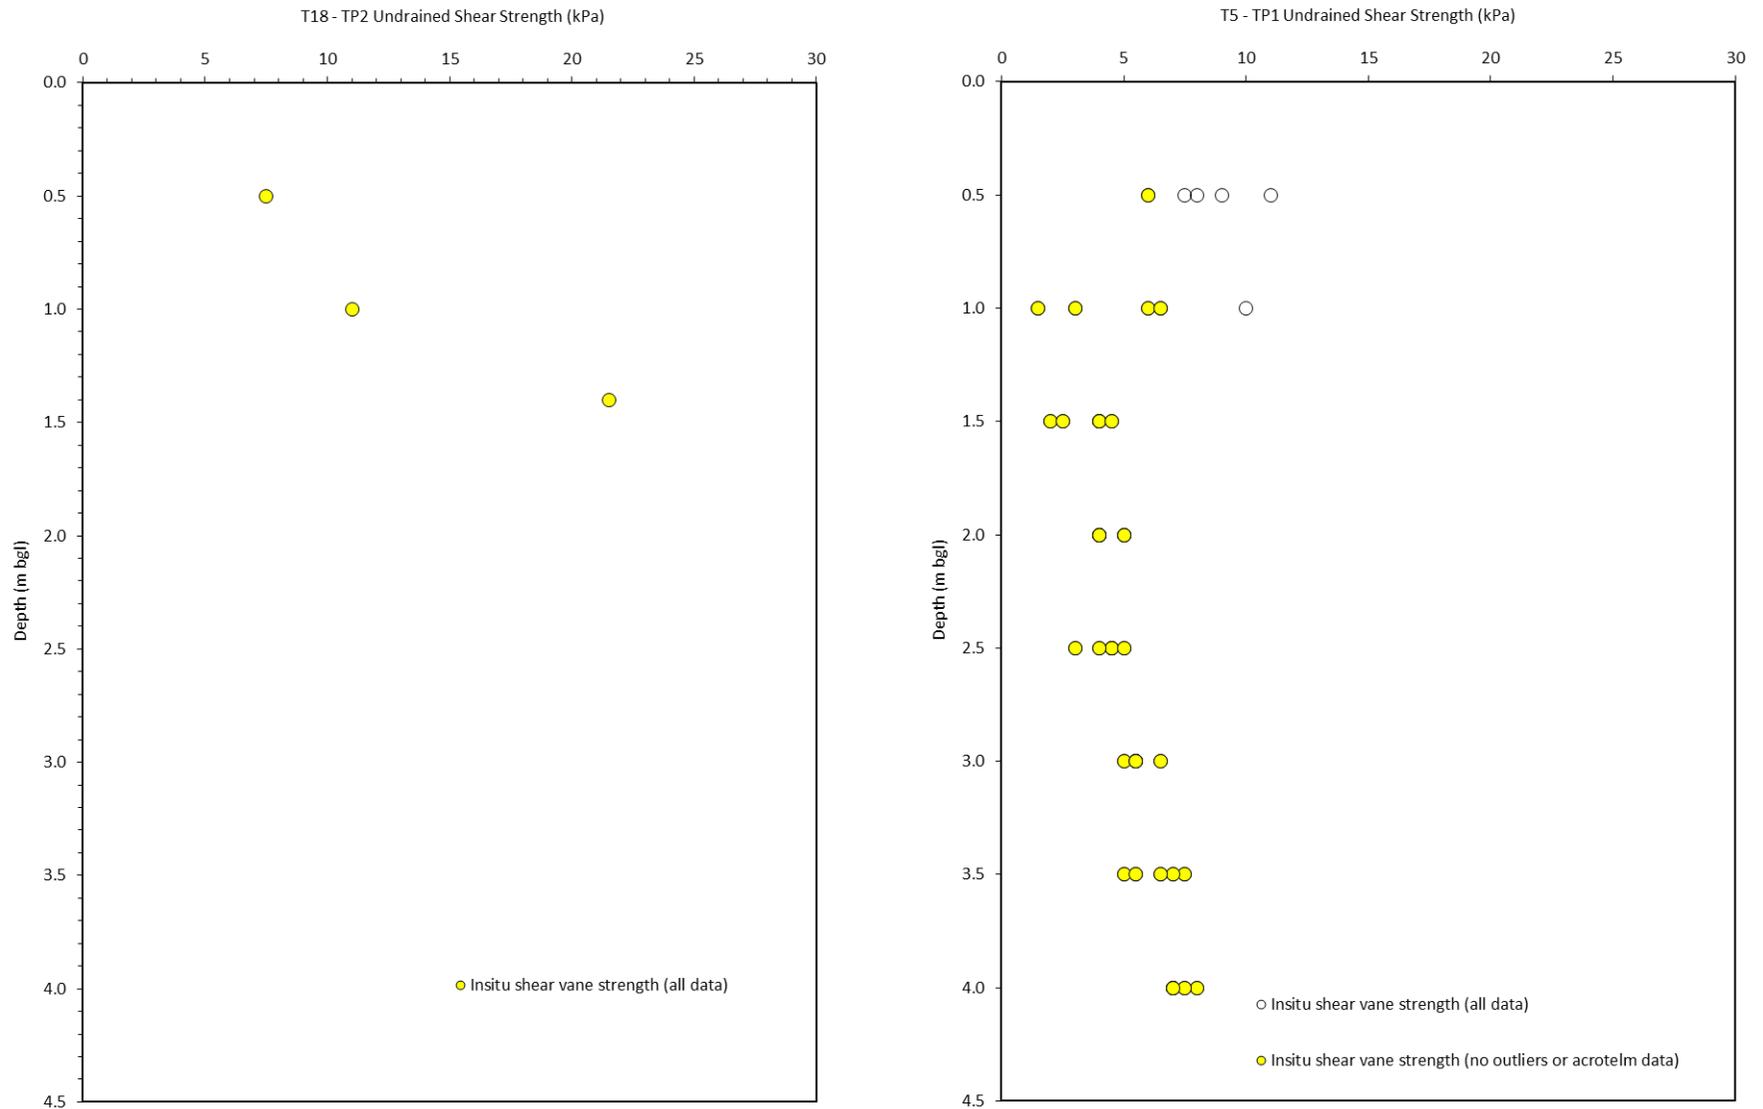
Figure 11: Further investigation - insitu shear strength vane testing of peat at trial pit locations

The results of the insitu shear vane testing of peat at the location of the trial pits are included in **Figure 11 (a) to (d)**.

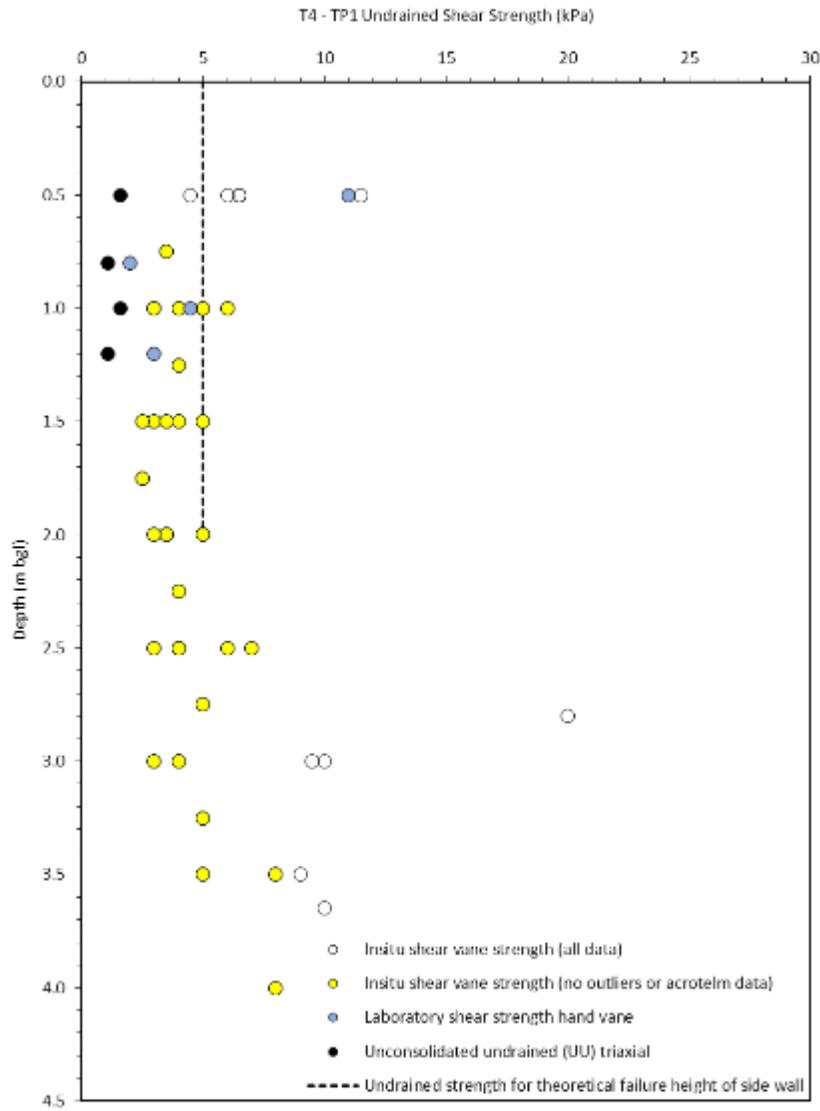
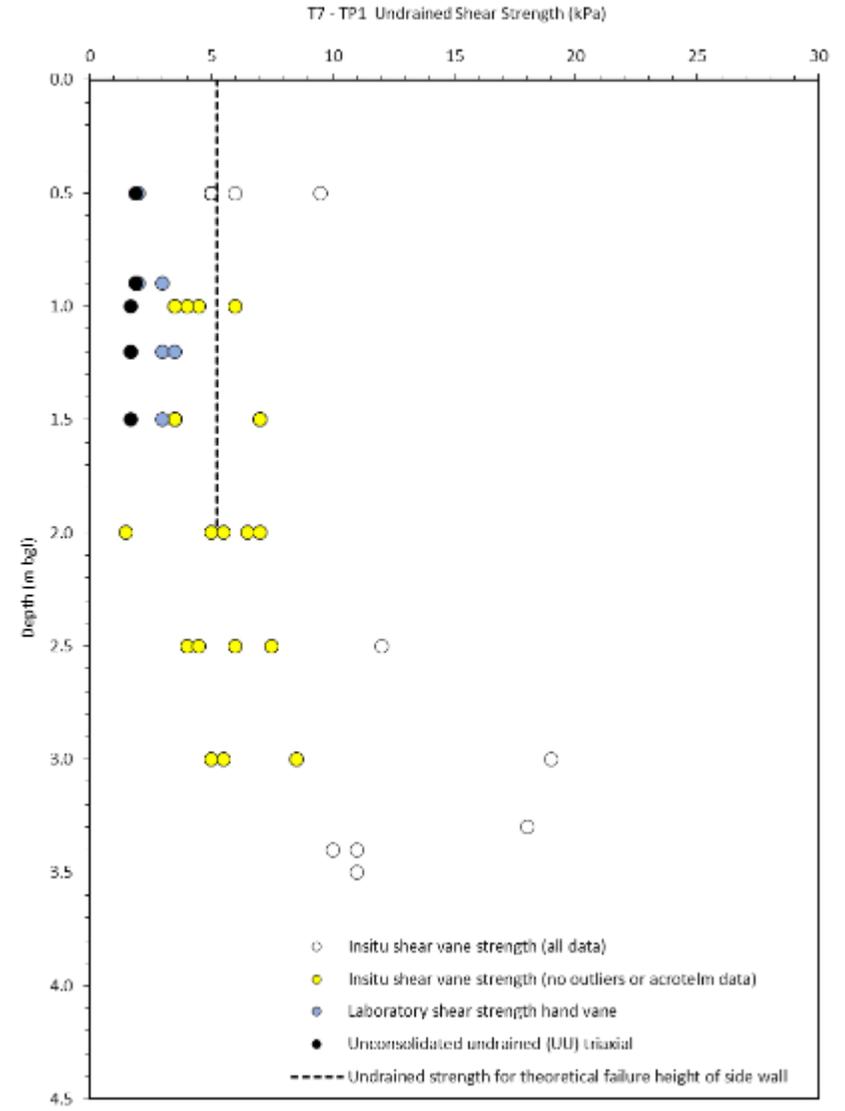
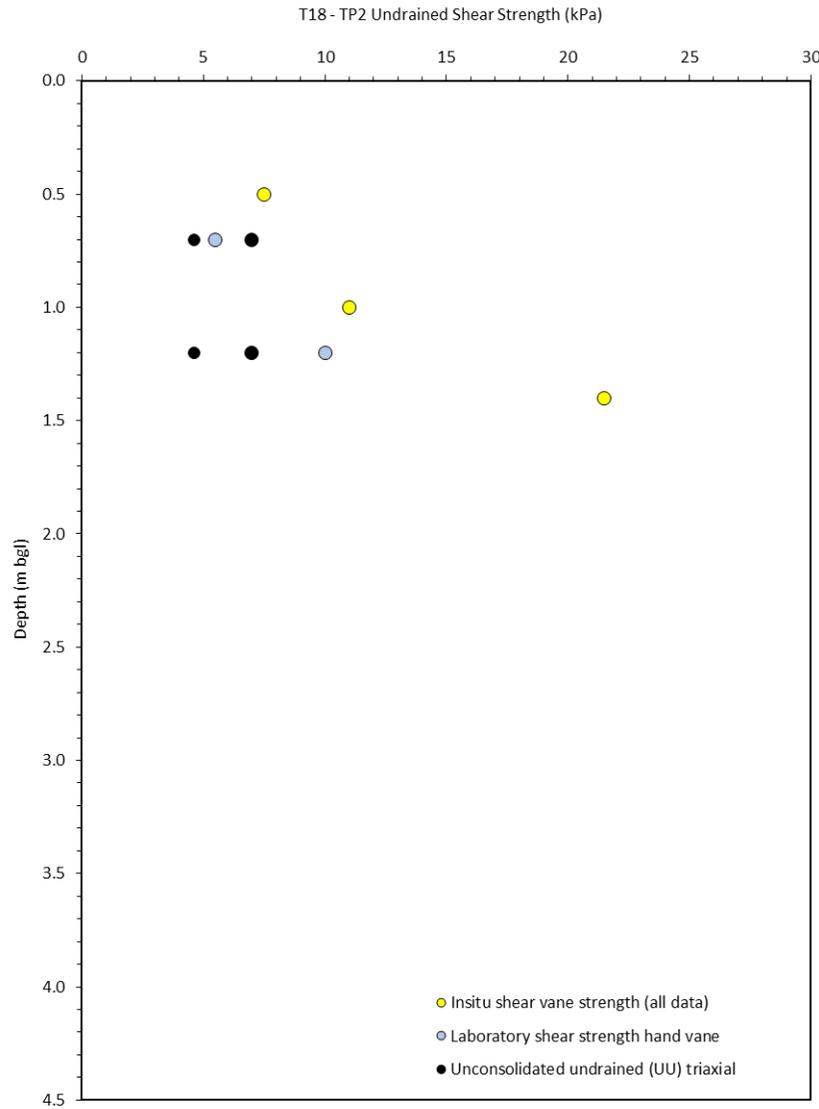
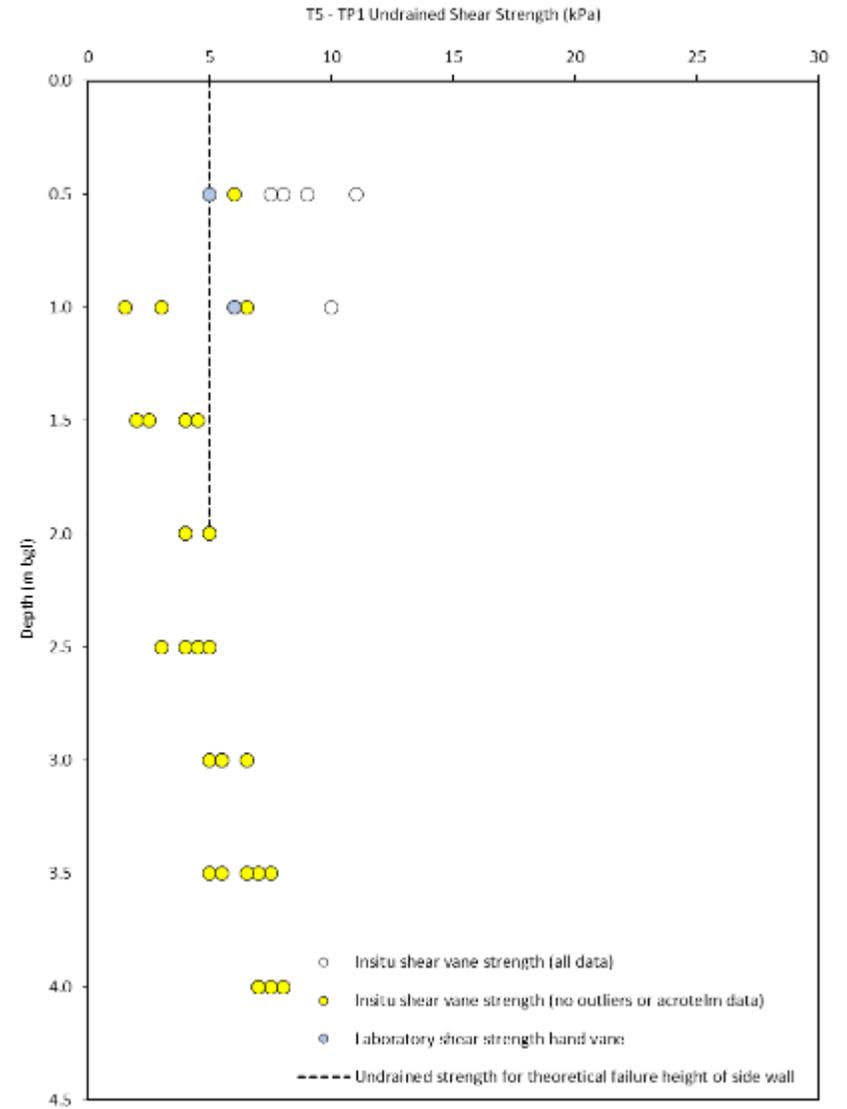
Figure 12: Further investigation - shear strength testing of peat using a variety of methods

A comparison of the results obtained for the above test methods is summarised in **Table 10** with the results shown graphically in **Figure 12 (a) to (d)**.

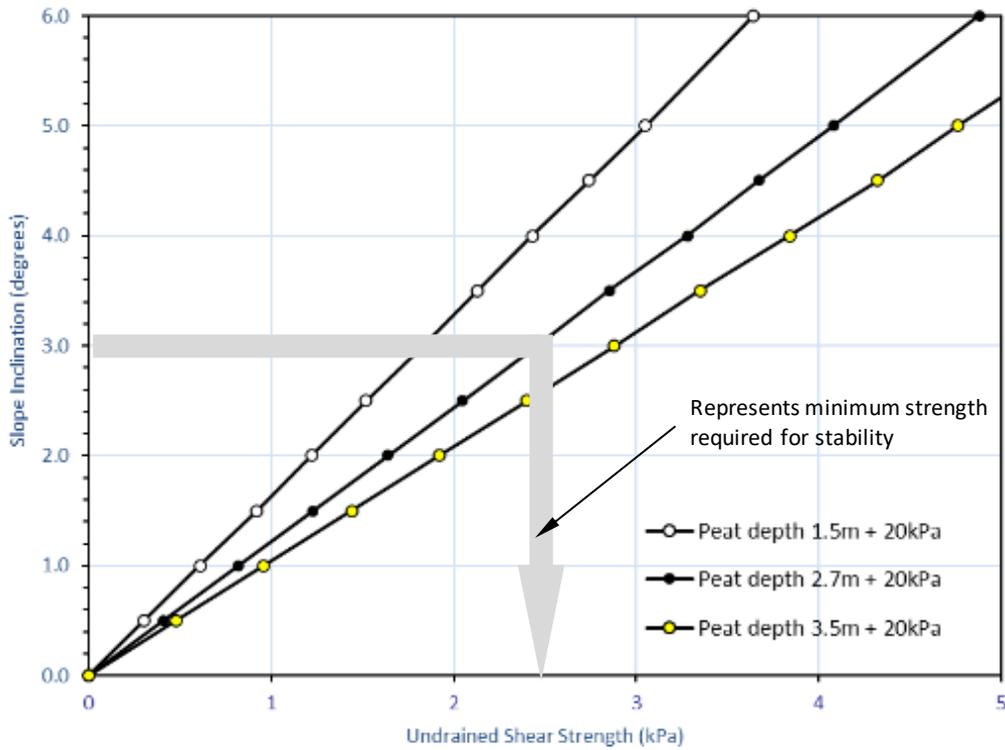
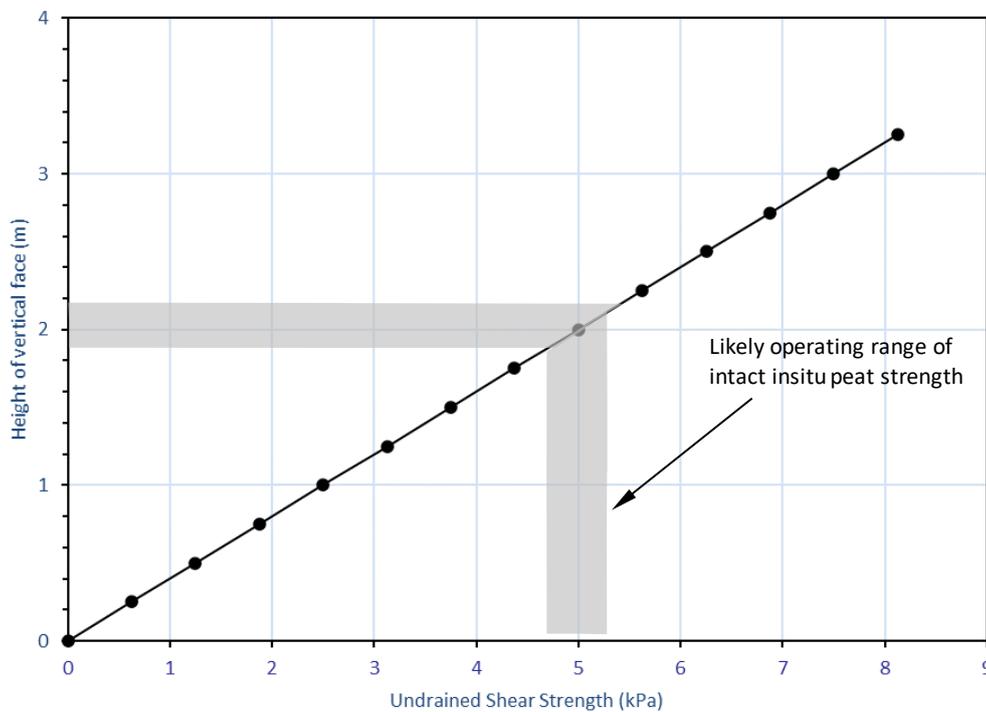
Figure 15: Further investigation - results of sensitivity analysis of peat failure of 12 November 2020

The results of the analysis together with an example of stability output are shown in **Figure 15**. The main findings of the analysis, which are considered indicative only, are as follows:

(a) Sliding analysis - plot lines represent onset of stability for various peat depths at floating road to T7

(b) Stable vertical height of peat in upper scar

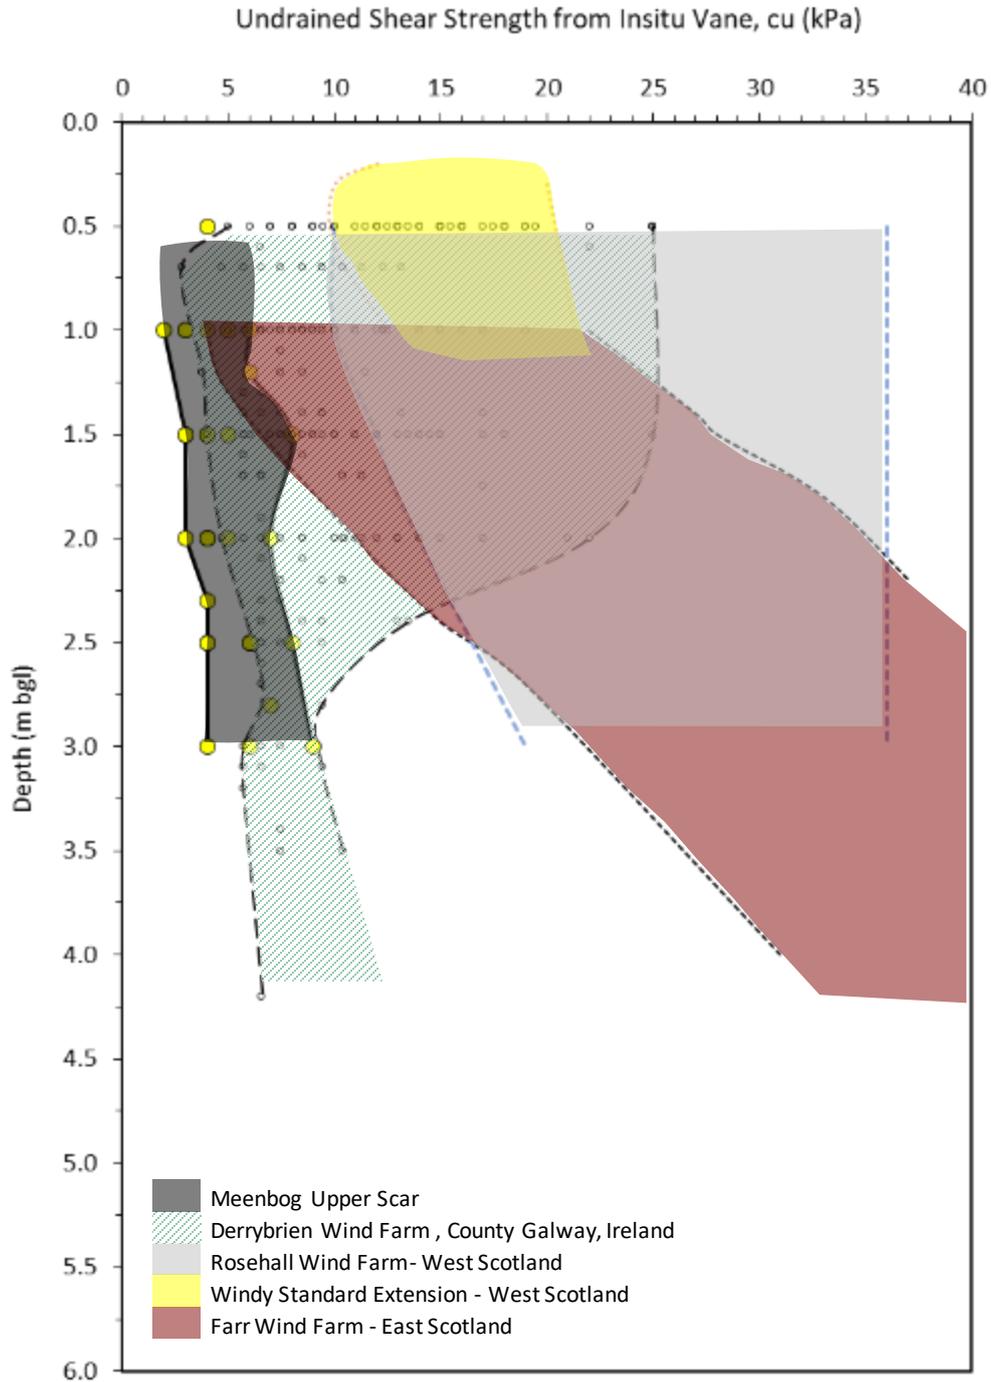
Figure 16: Further investigation – comparison of insitu vane strength for different peat sites

- (1) Results above based on insitu shear vane testing of peat sites in Ireland and Scotland.
- (2) The Scottish sites comprised a range of peat depth but overall were well-drained with peat strength increasing with depth. These sites were not affected by undrained peat failure.
- (3) The Derrybrien and Meenbog site were both affected by peat failure.

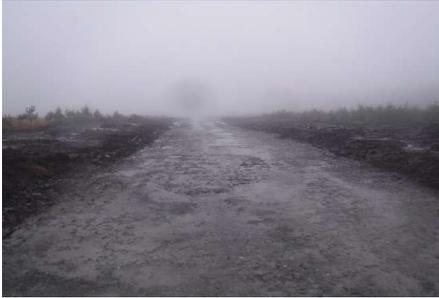
Location ID	General Notes	Photos	
Track to T1	Floating track to T1. Side casting of peat both sides. No evidence of stability issues.

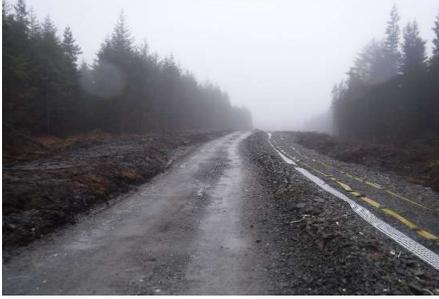
Track to T2	Floating track to T2. Side casting of peat both sides. No evidence of stability issues.

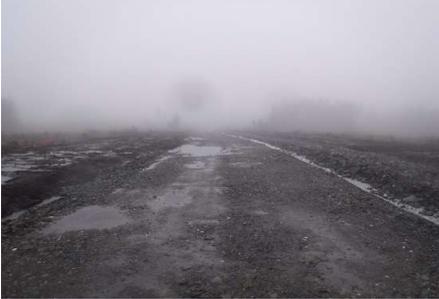
Track to T3	Floating track. Peat side cast (approx 1m deep) on both sides of access track. 4 degree slope.

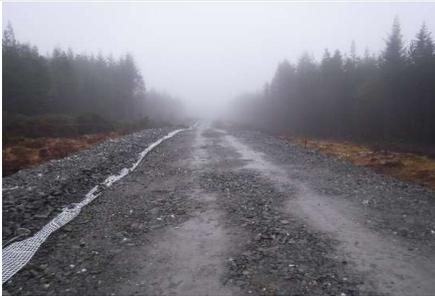
Track to T4	Floating track. No side casting. 4 degree slope.

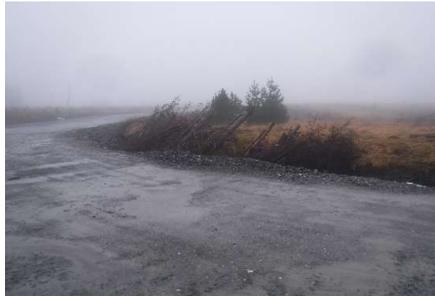
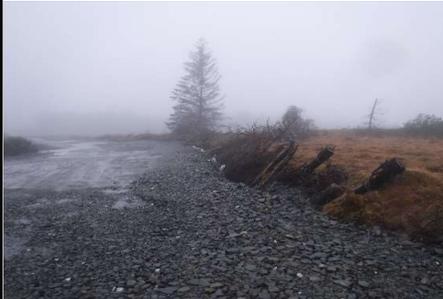
Junction between T1 and T2/4	Floating road, evidence of settlement of underlying peat.

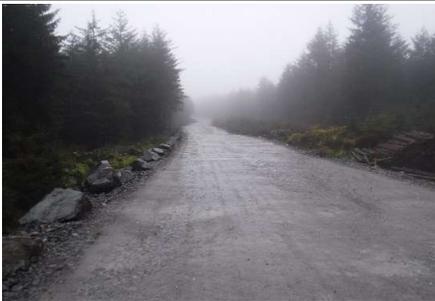
Track T6-T8	5 degree slope, no side casting, no evidence of stability issues.

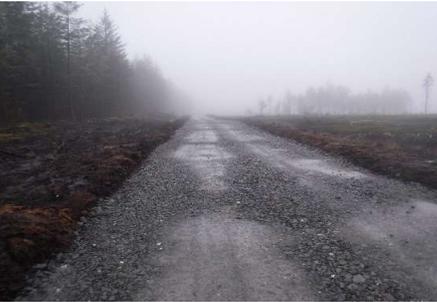
Track to T8	3 degree slope, side casting both sides. Not evidence of stability issues.

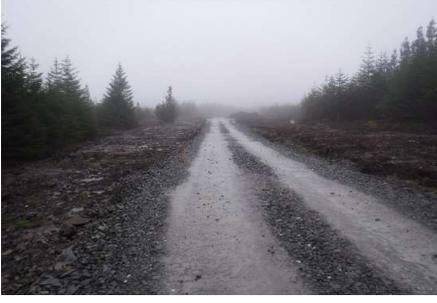
Track to T9	View towards T9. Slope 2-4 degrees, side casting both sides, <1m. No evidence of stability issues.

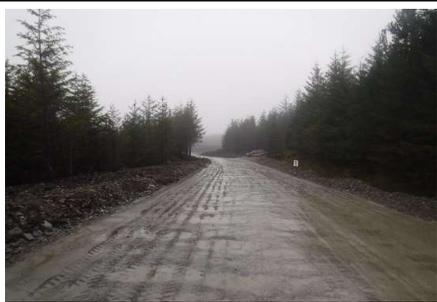
T10-T14	Minor area of side casting downslope

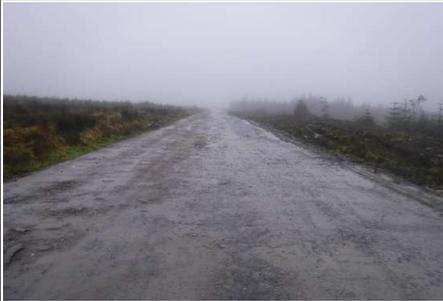
Track near T12	6 degree slope. Minor area of side casting downslope. No evidence of stability issues.

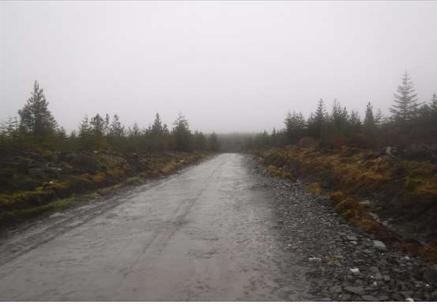
T16-T17	View towards T17, no evidence of stability issues.

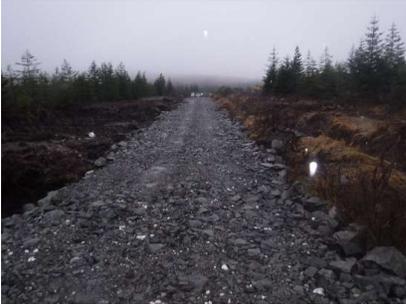
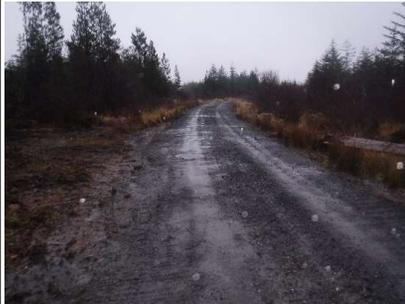
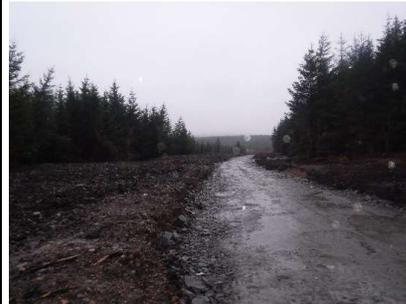
Upgrade of existing to T18	Existing track appears to be floated on sidelong ground, upslope of stream.

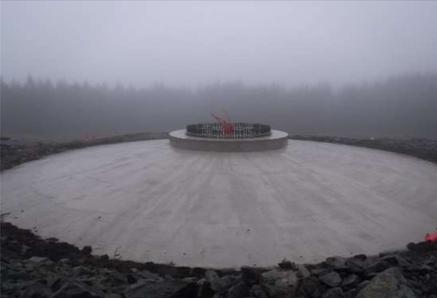
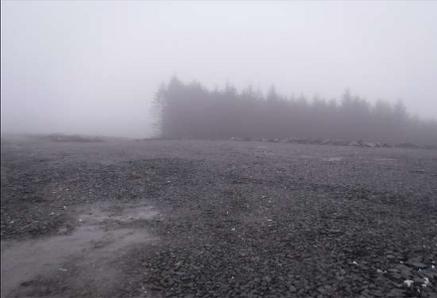
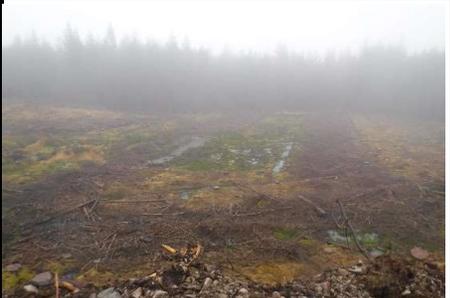
Location ID	General Notes	Photos		
T1	Upslope of H/S - 3 degree slope. H/S side slopes 40 degrees. Flat, saturated area downslope of H/S. No evidence of stability issues.

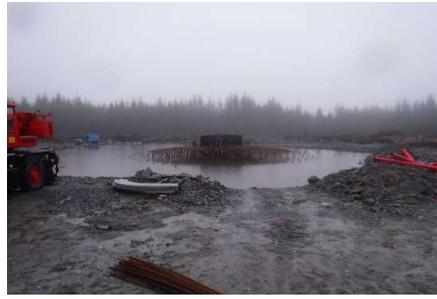
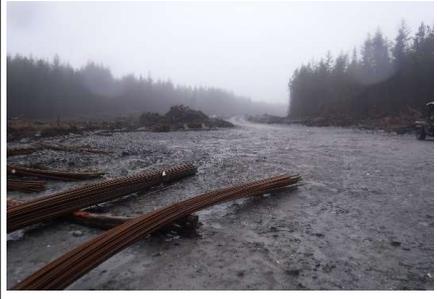
A view of a sloping area with sparse vegetation and patches of bare earth, leading down towards a wooded area.
T2	3 degree slope around hardstand. Turbine excavation flooded, pump turned off. No evidence of stability issues.

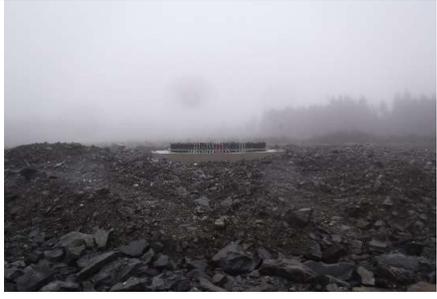
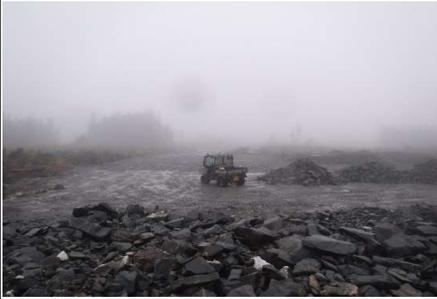
T3	Relatively flat, 1-2 degree slopes around hardstand. No evidence of stability issues.

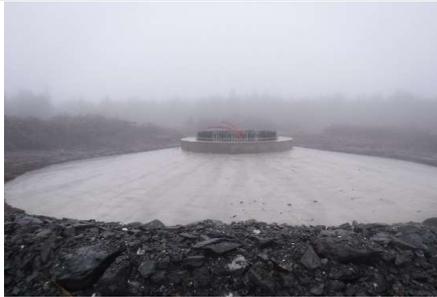
<p data-bbox="856 464 968 488">T4 Turbine</p>

T4	Relatively flat, 1-2 degree slopes around hardstand. Peat 1-2m in thickness. No evidence of stability issues.

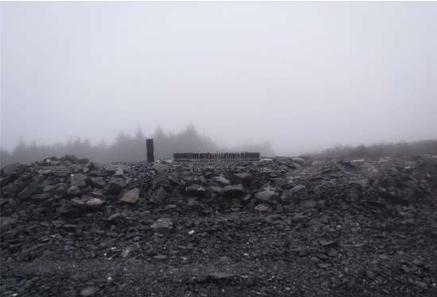
<p data-bbox="856 1162 968 1187">T6 Turbine</p>

<p data-bbox="1646 813 1986 837">Tension cracks around hardstand</p>
T6	5 degree slope around hardstand. Minor side casting of peat (<0.5m). No evidence of stability issues.

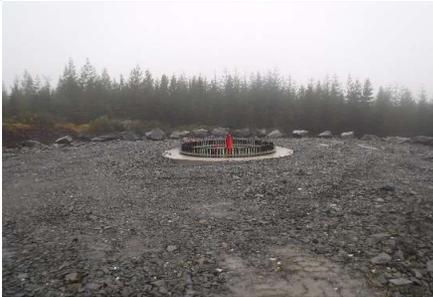
<p>T8 Turbine</p>

<p>T8</p>	<p>5 degree slope upslope for hardstand. Minor side casting around hardstand. Barrage close to hardstand to retain material that failed upslope.</p>

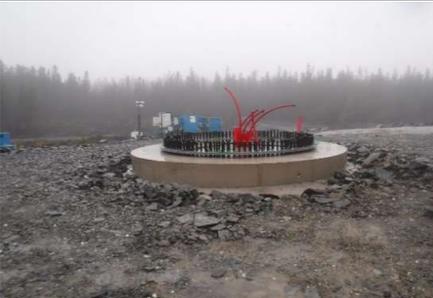
<p>T9 Turbine</p>

<p>Barrage</p>
<p>T9</p>	<p>2 degree slope around hardstand. Peat side cast upslope of hardstand, <1m thick. No evidence of stability issues.</p>

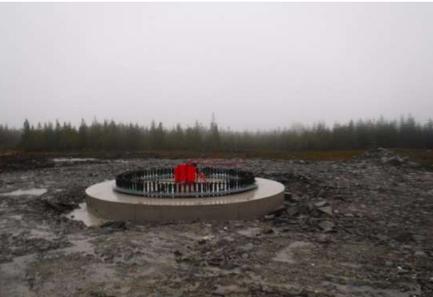
<p>T10 Turbine</p>

<p>T9 Hardstand</p>	
<p>T10</p>	<p>1-2 degree slope around hardstand. Shallow side casting of peat around hardstand and access track. No evidence of stability issues.</p>

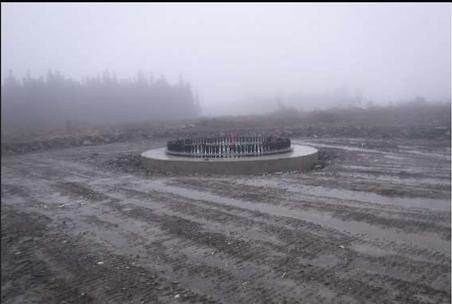
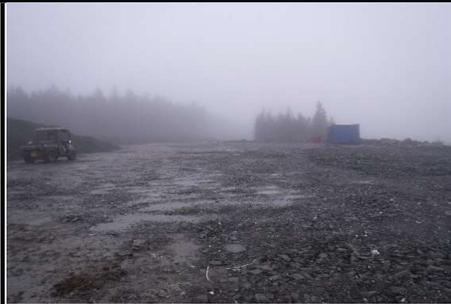
<p>T11</p>	<p>2-3 degree slopes around hardstand. Small area of side casting upslope from hardstand. No evidence of stability issues.</p>

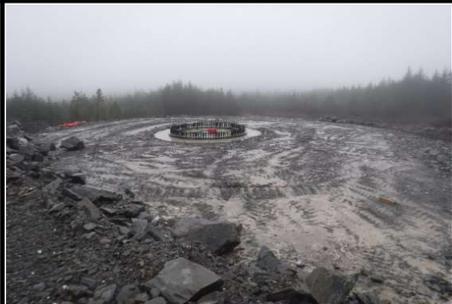
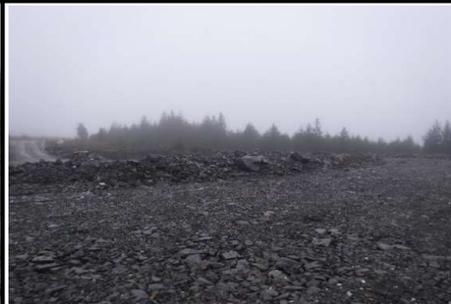
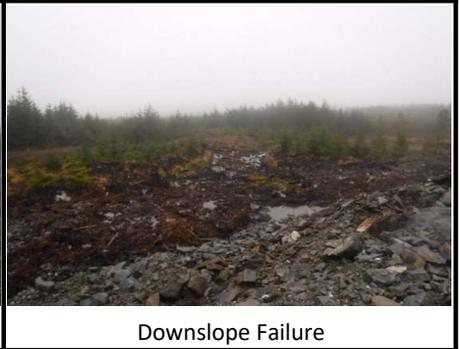
<p>T12</p>	<p>4 degree slope around hardstand. Small peat slide downslope of hardstand</p>

Downslope Failure

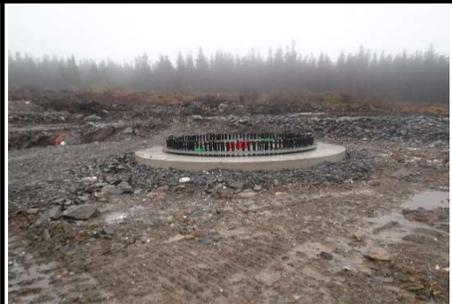
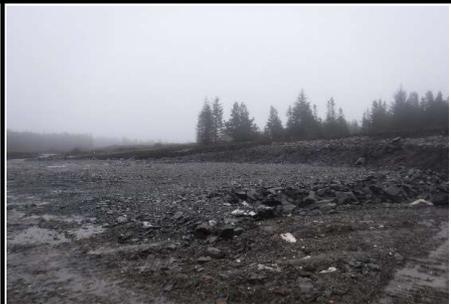
<p>T13</p>	<p>3-4 degree slopes around hardstand. Small area of side casting upslope from hardstand. No evidence of stability issues.</p>

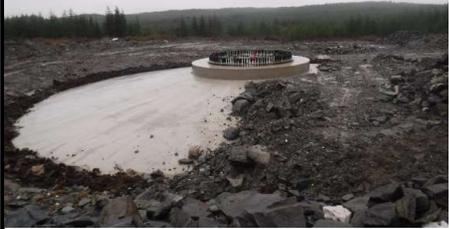
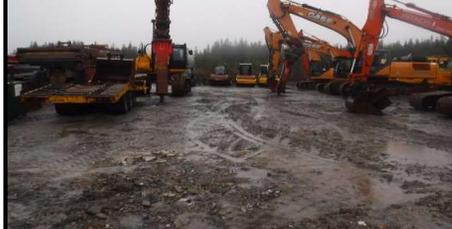
<p>T14</p>	<p>2-3 degree slope around hardstand. Peat side cast around hardstand and access track. No evidence of stability issues.</p>

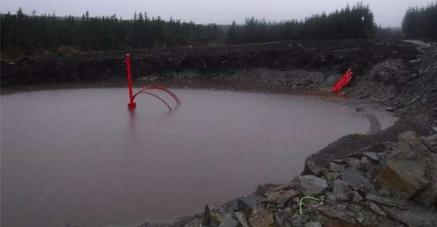
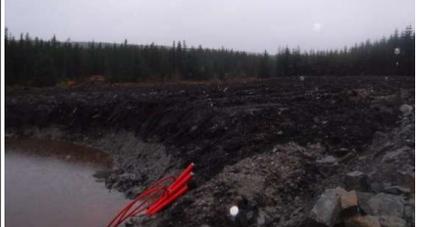
<p>T18</p>	<p>3 degrees slope around hardstand. Peat side cast both upslope and downslope, towards stream.</p>

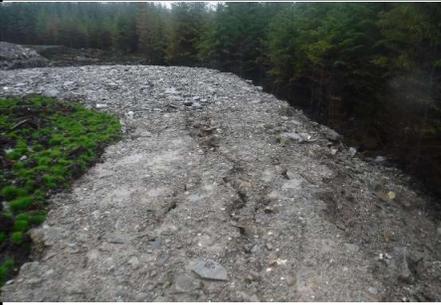
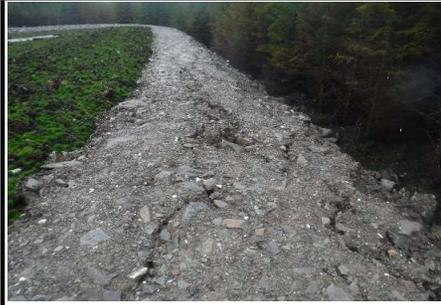
<p data-bbox="829 565 993 594">Peat Repository</p>

Location ID	General Notes	Photos		
T15 Peat Repository	2-4 degree slope around hardstand. Peat stored both north and west of the hardstand. Area to the north shows signs of movement in perimeter berm.

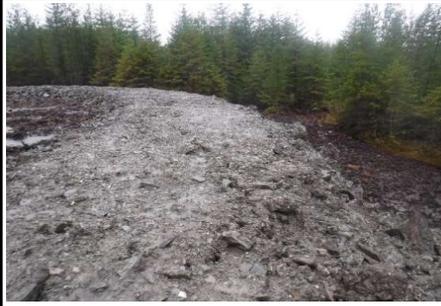
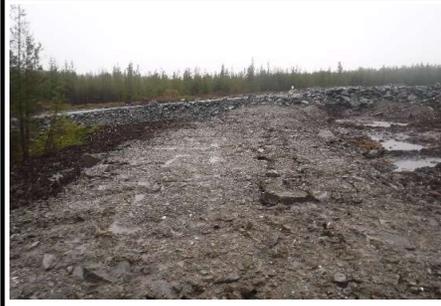
<p data-bbox="829 917 993 946">Peat Repository</p>

<p data-bbox="1703 565 1934 594">Surface of stored peat</p>
T17 Peat Repository	3 degree slope around turbine and hardstand. Peat side cast upslope and hardstand. Peat storage area downslope, berm shows evidence of minor movement.

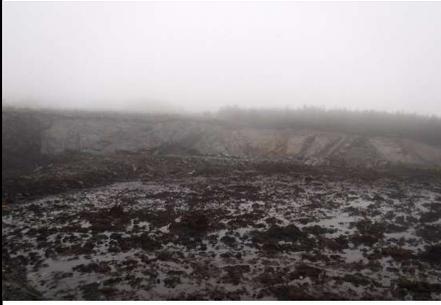
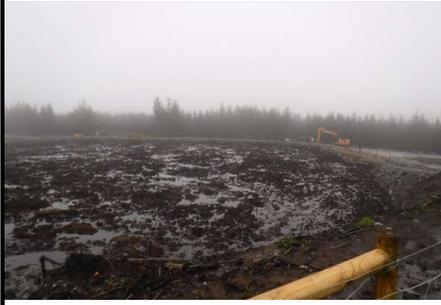
<p data-bbox="1278 917 1442 946">Peat Repository</p>	
Backfilled BP (Main)	Peat backfilled into borrow pit. Berm alongside access track, around 4m in height. No evidence of stability issues.

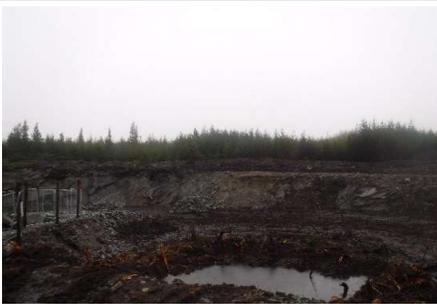
<p>Backfilled BP (near T15)</p>	<p>Peat backfilled into borrow pit. Berm alongside access track, around 4m in height. No evidence of stability issues.</p>

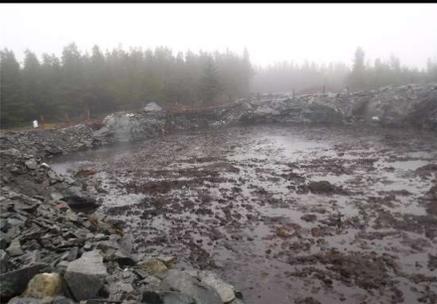
<p>Backfilled BP (near T16)</p>	<p>Peat backfilled into borrow pit. Berm alongside section of access track, around 4m in height. No evidence of stability issues.</p>

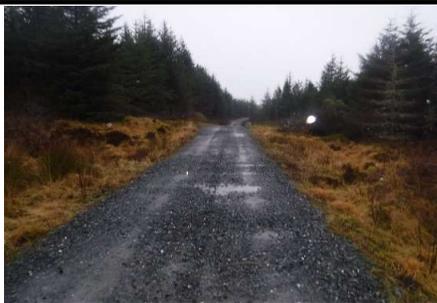
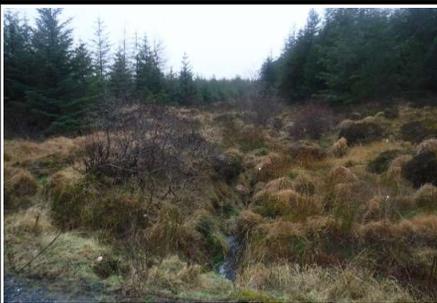
<p>Drain crossing of track to T18</p>	<p>Narrow drain crossed by existing track. Shallow (<0.5m) peat.</p>
