**Fehily Timoney Peat
Stability Assessment of
Meenbog Wind Farm Site
(2021)**

Meenbog Wind Farm

Peat Stability Assessment of Meenbog Wind Farm Site

Abstract: This assessment addresses the stability of the site of the Meenbog Wind Farm, County Donegal following a peat failure at the site on 12 November 2020.

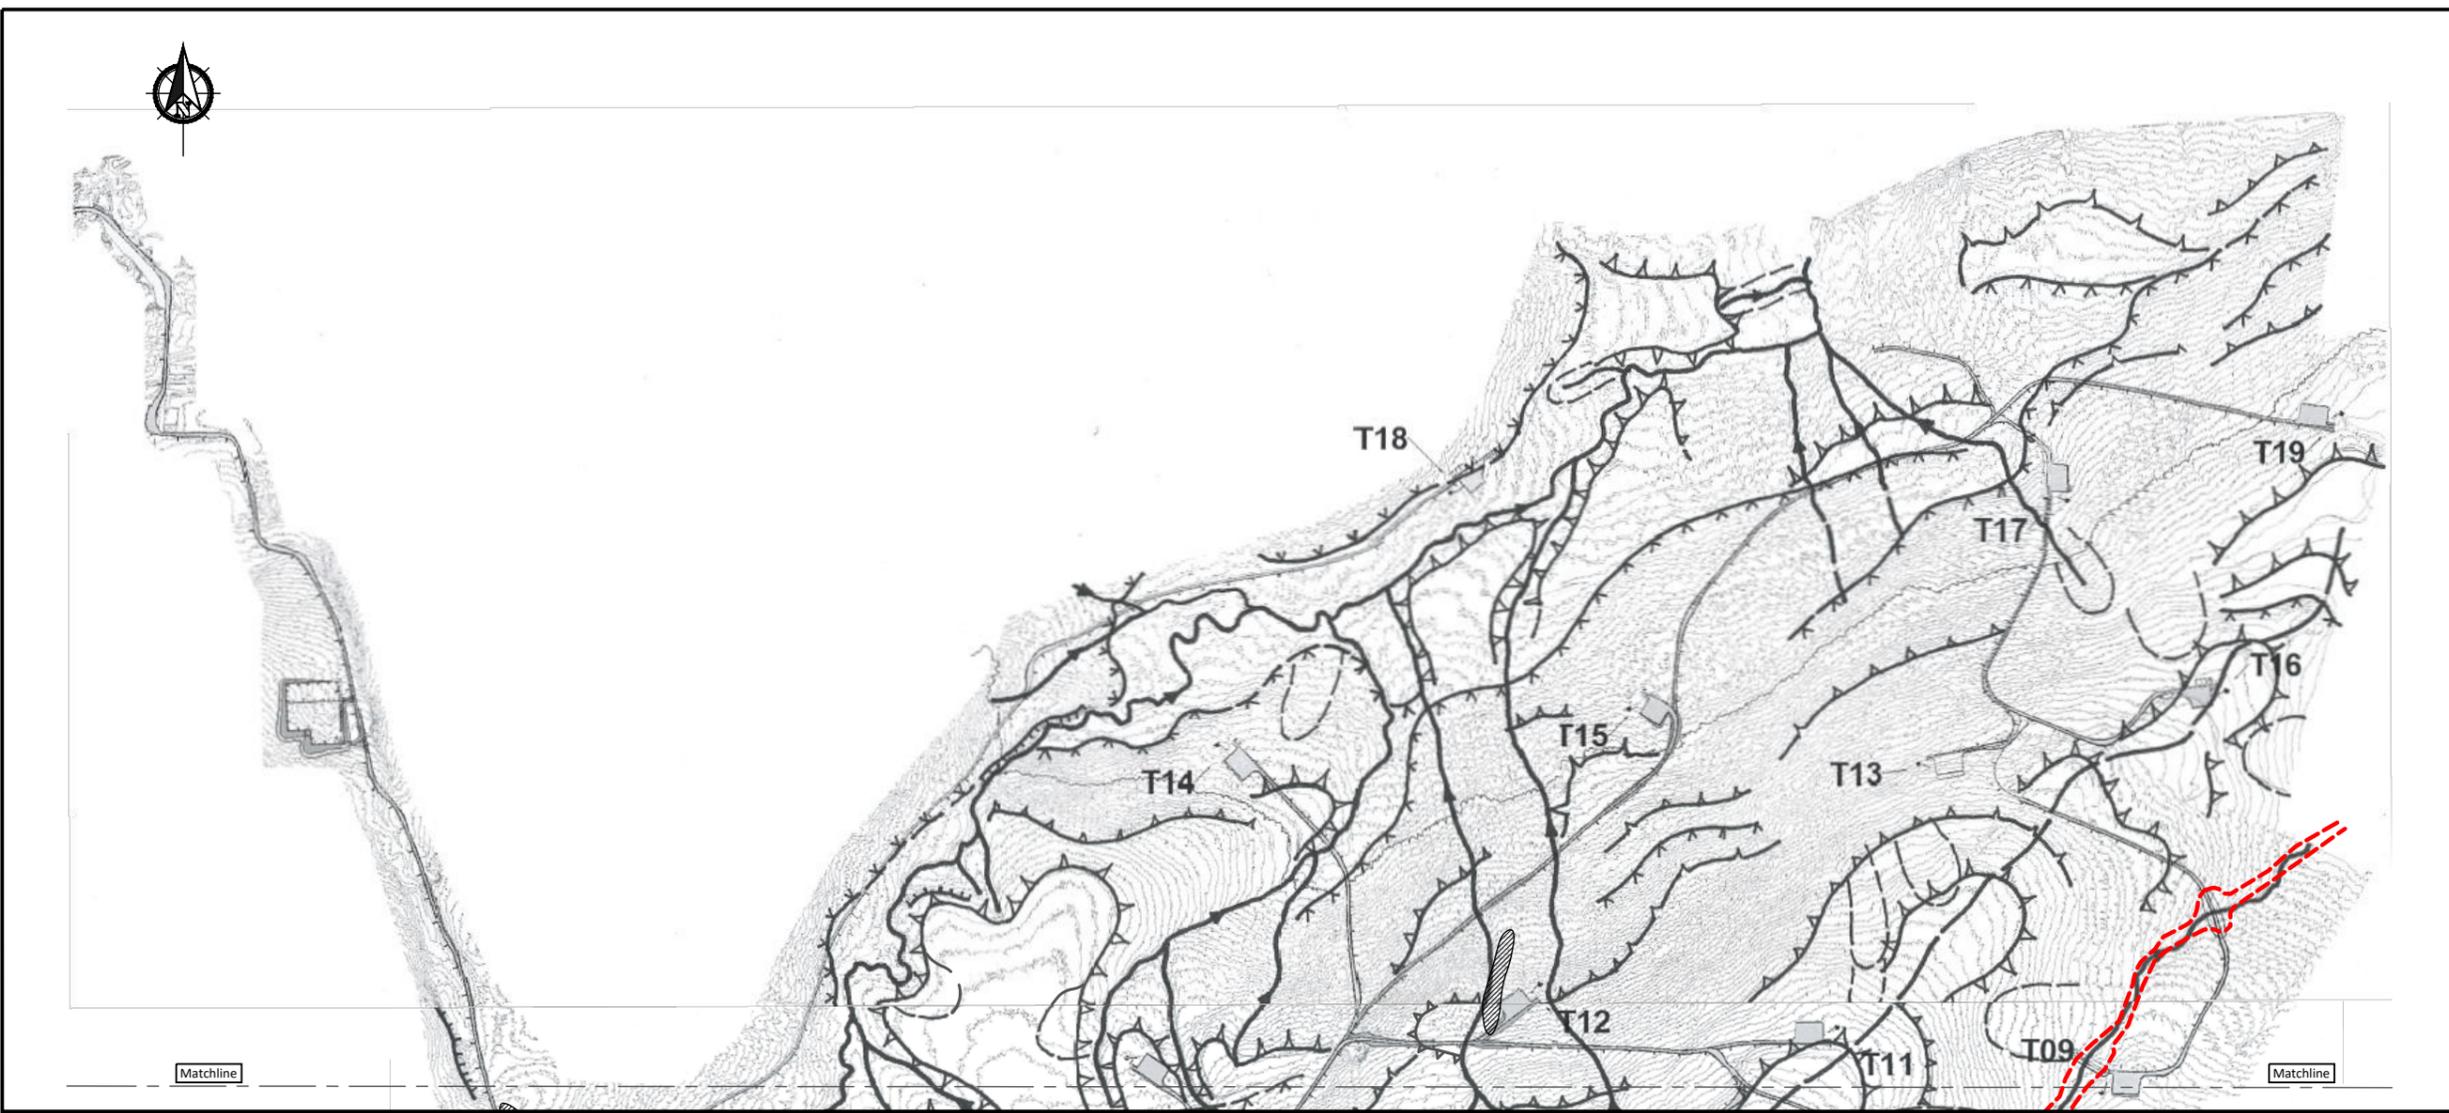
PLAN
Scale 1:14000

Peat Hazard and Risk Assessment (Geomorphological Plans)

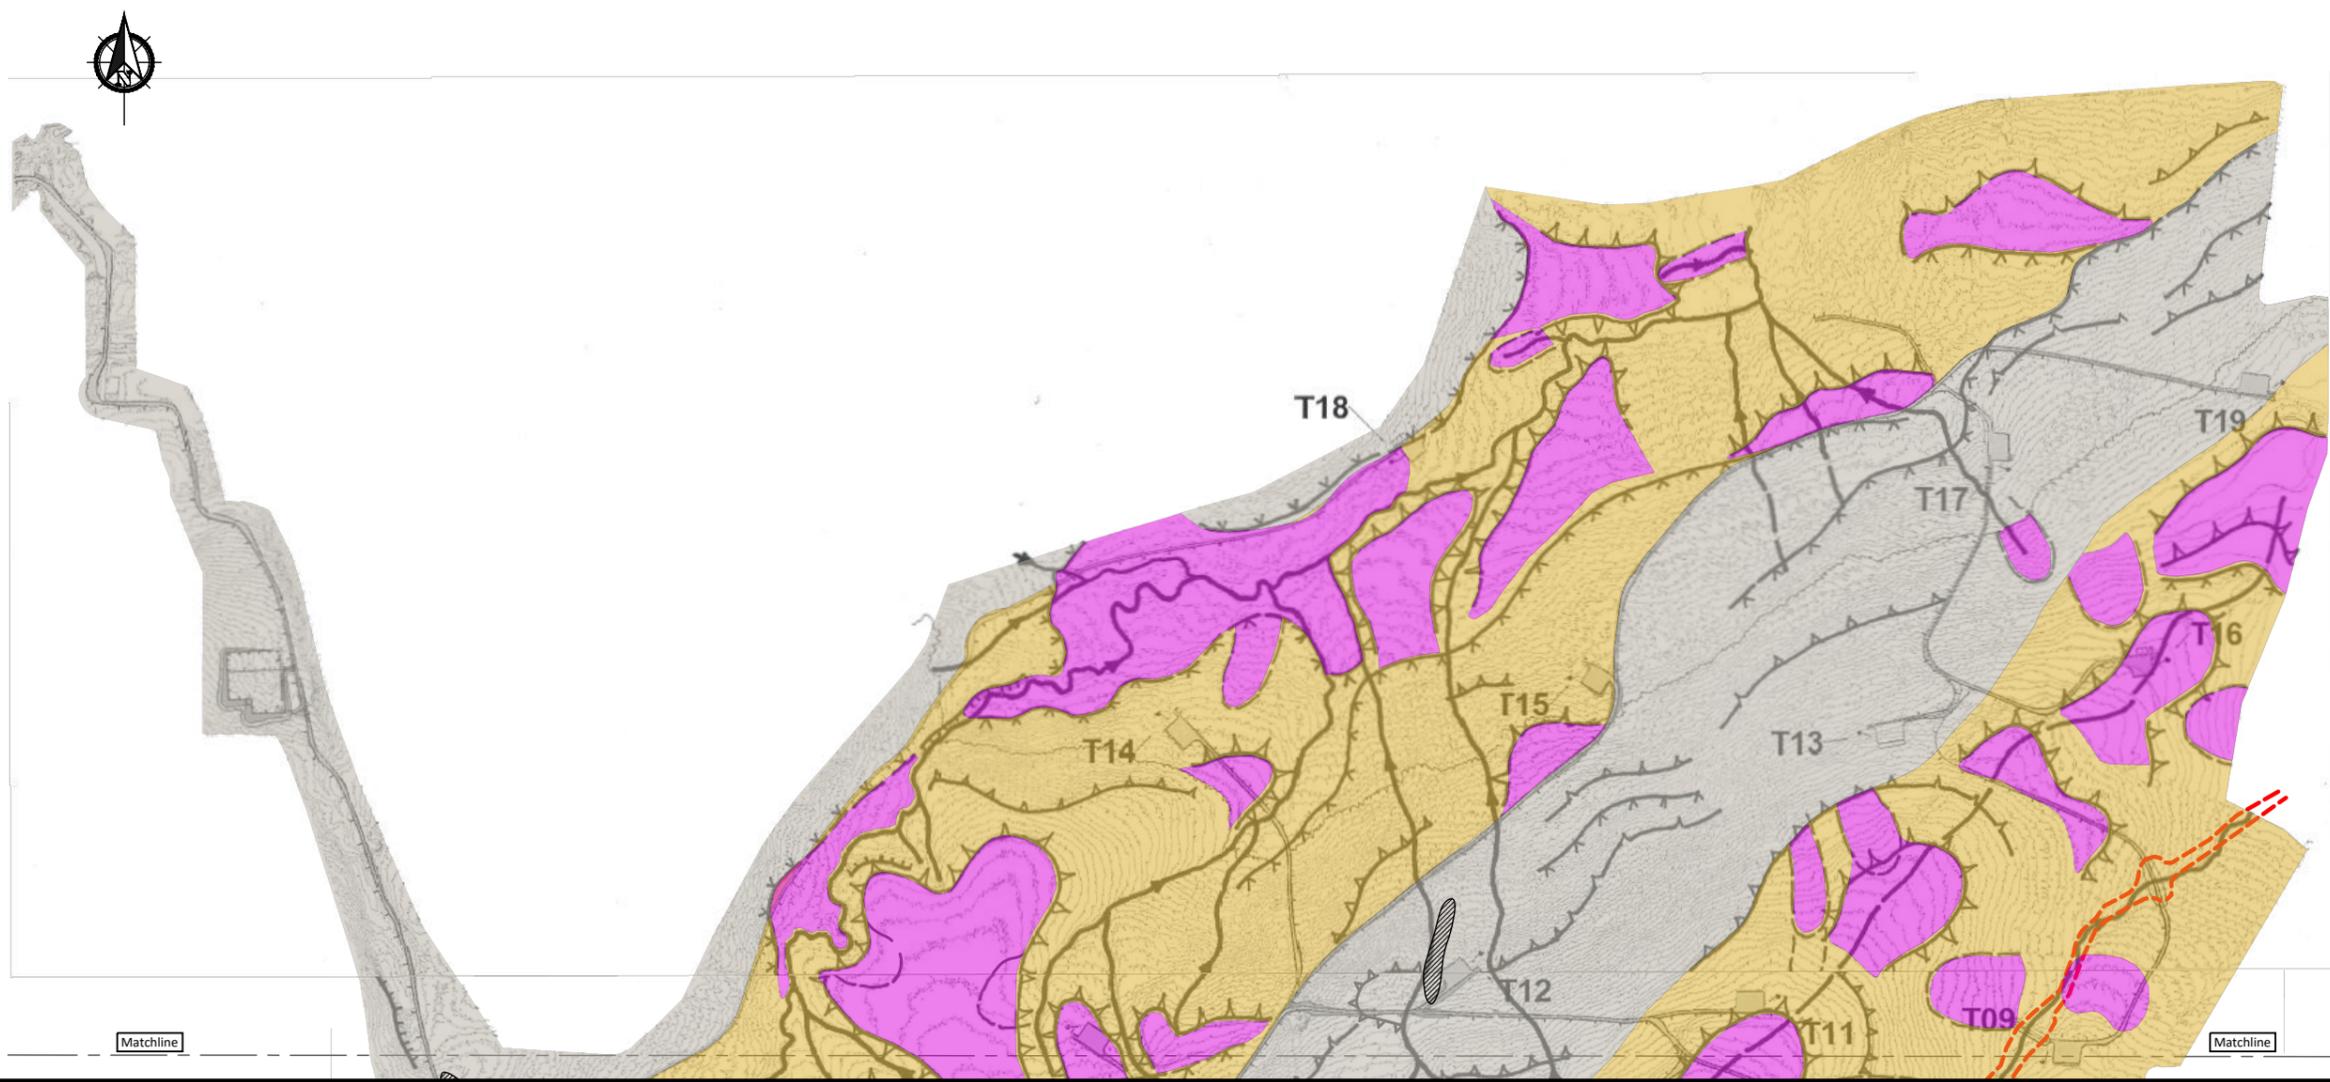
PLAN
Scale 1:14000

- Legend - Relative Potential Peat Stability Hazard**
- Probable
 - Likely
 - Unlikely
- Note - For explanation of legend refer to report text.

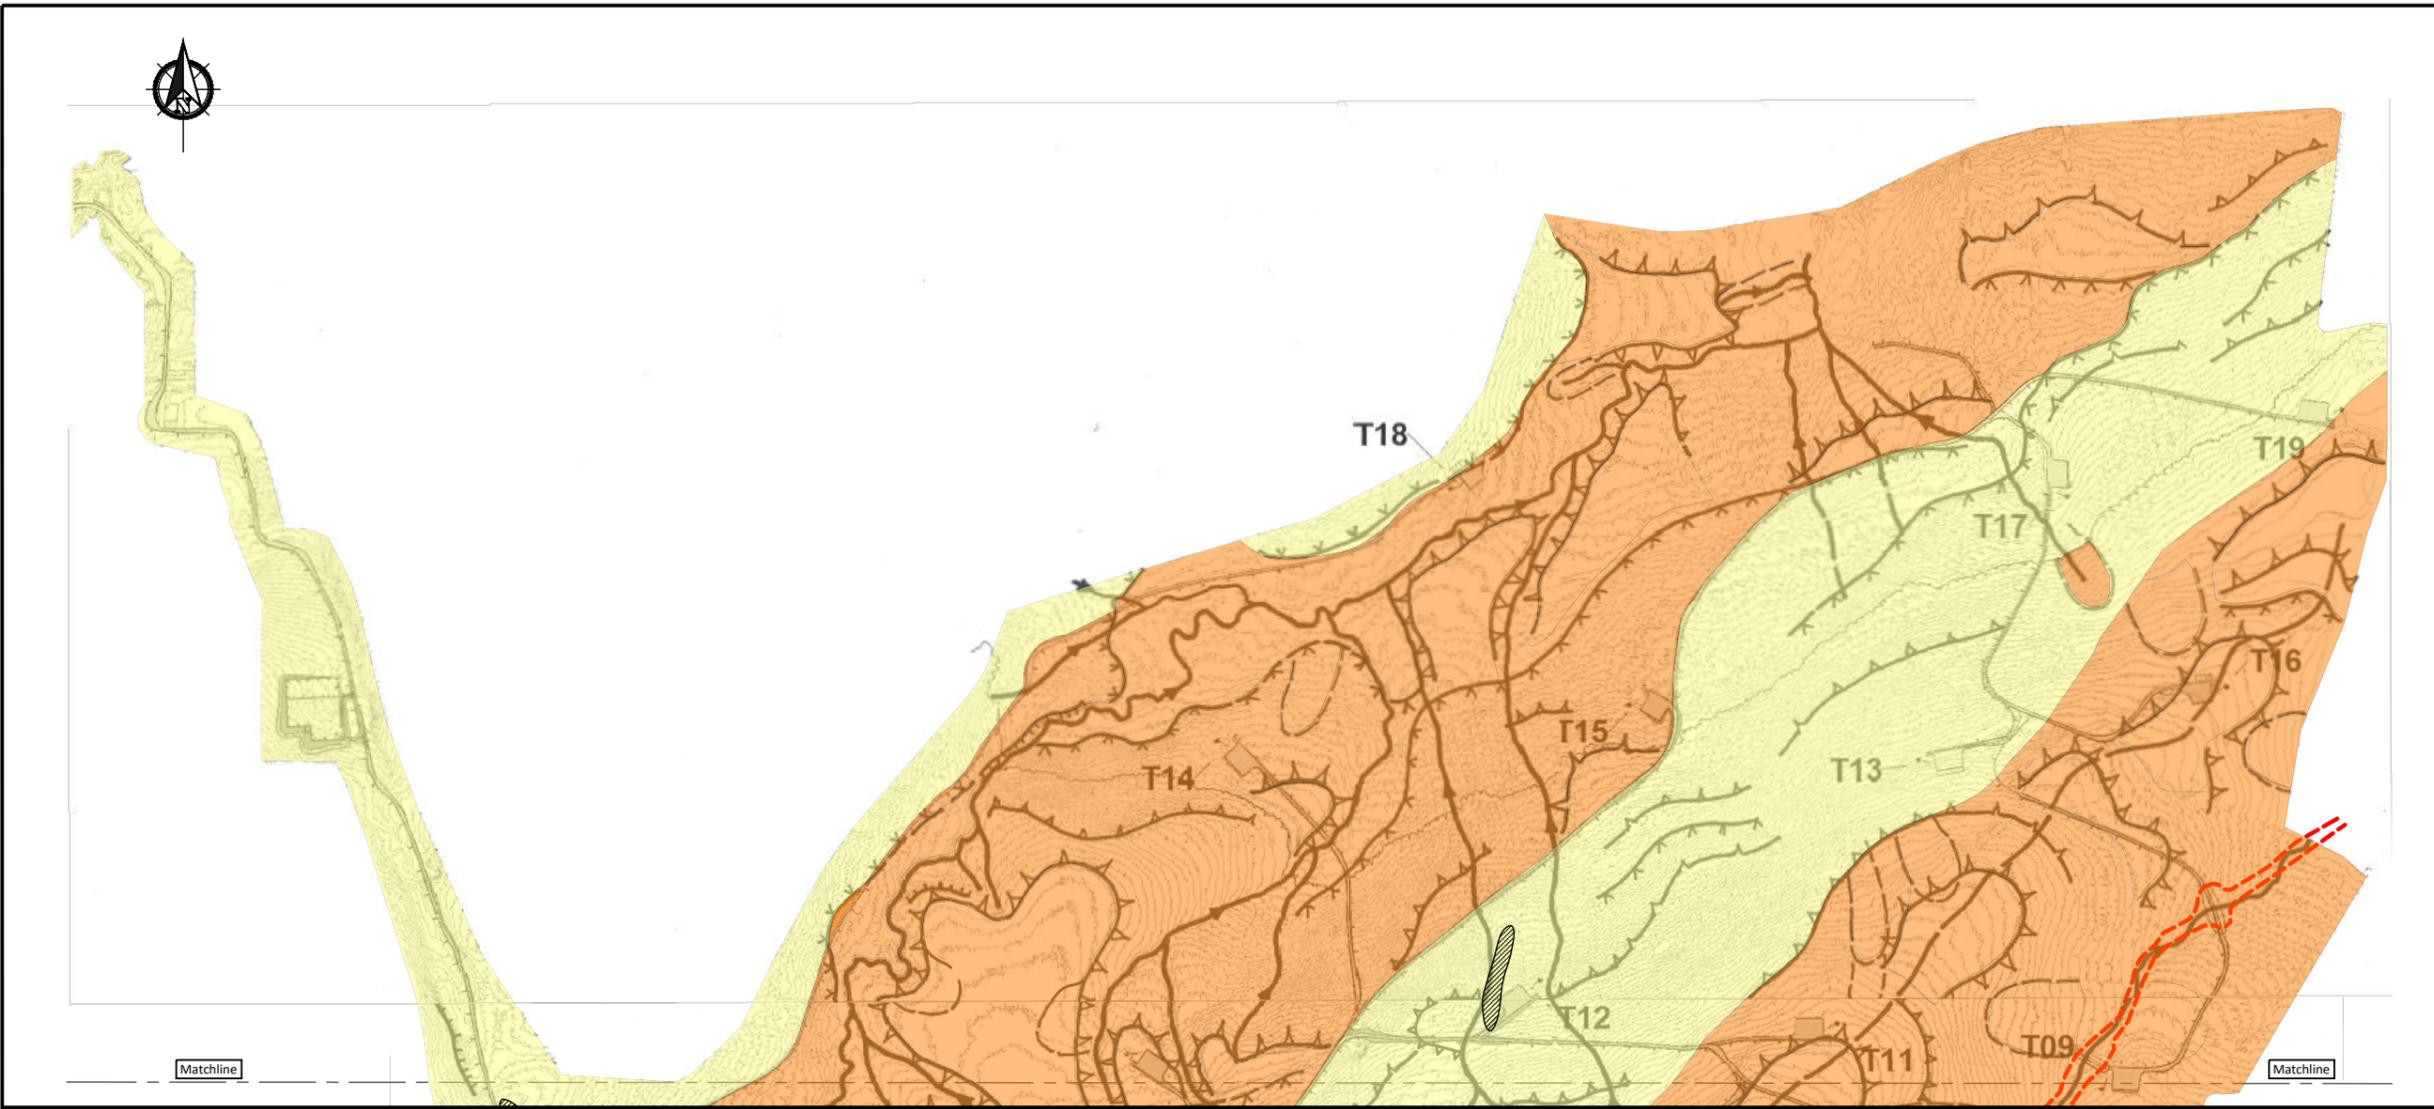
PLAN
Scale 1:14000

- Legend - Zonation of Peat Stability Risk**
- Moderate
 - Low
- Note - For explanation of legend refer to report text.

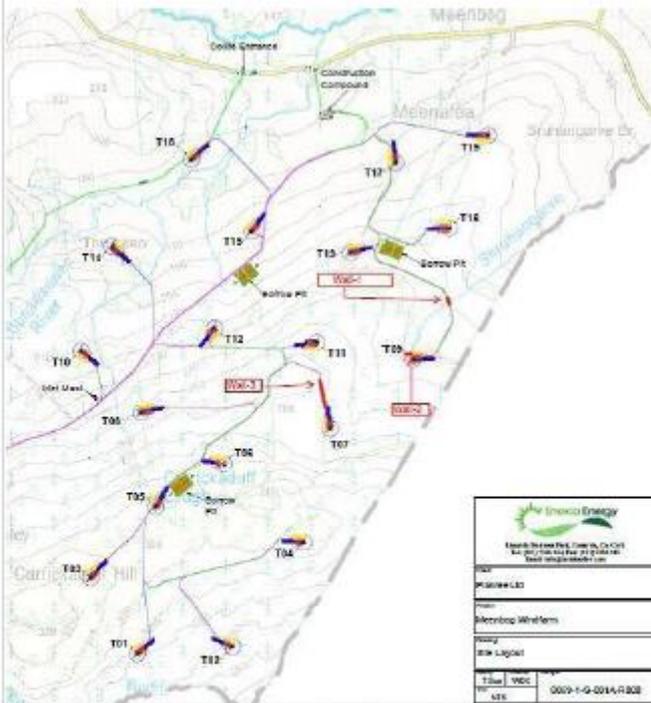
Figure 2: Schematic received by email from Donegal County Council on the 17th November 2020 showing proposal from operator to construct 3 walls to mitigate against further damage and peat instability (note: Wall 1 constructed on the 12th/13th November 2020, Wall 2 and Wall 3 proposed).
