PEAT STABILITY RISK ASSESSMENT

Peat Stability Risk Assessment (PSRA) for Kilgarvan Wind Farm Repowering

Client	MKO
Document Ref.	22022-R-01-PSRA-02
Project Title	Kilgarvan Wind Farm Repowering
Date	11/01/2024

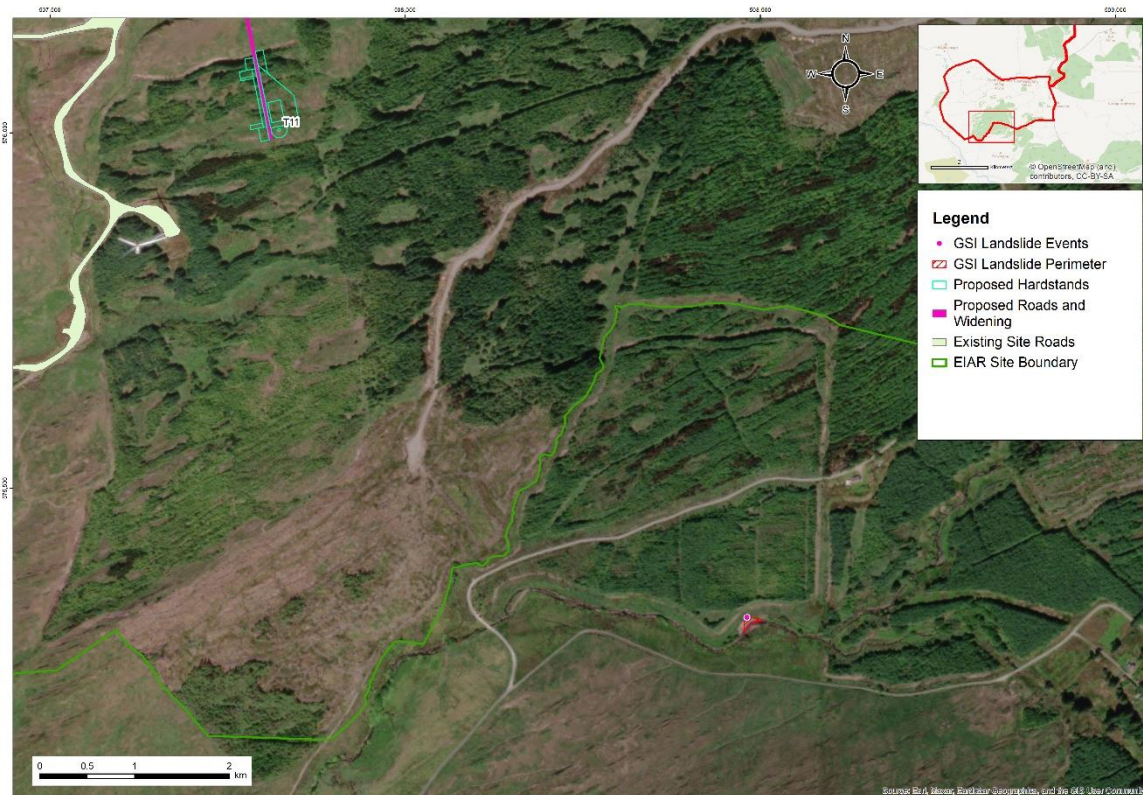
Figure 1-1: GSI landslide inventory (2023) landslide event close to site boundary.

According to the GSI landslide inventory (GSI, 2023), the closest landslide is located about 1 km southeast of the nearest turbine (T11) and less than 400m from the EIAR Site Boundary. The area of the slides is 224m². Figure 1-1 shows the landslide event closest to the EIAR Site Boundary. The locations of the past landslide events identified in the GSI landslide archive are shown in Figure G- 2 in Appendix G.

The landslide event is located on the outside bank of a bend on the River Glanloe. The information on the date, cause, severity or consequence of the event is not recorded with in the landslide archive. The landslide location and geometry are indicative of a shallow slip (less than one metre). The landslide is located at the maximum erosive face of the river (external side of the river’s curvature). It is interpreted due to the morphology and location that the toe of the soil was eroded causing the instability slope and hence the landslide. The GSI Quaternary mapping data (2023) suggest that the area is composed of glacial till material. The plan area of the landslide is less than

250m² and the suspected shallow landslide depth suggest that the volume of disturbed material is relatively small. The failure may have caused a small blockage to the river and disruption flow but would likely to have has a negligible impact on the receiving river environment.

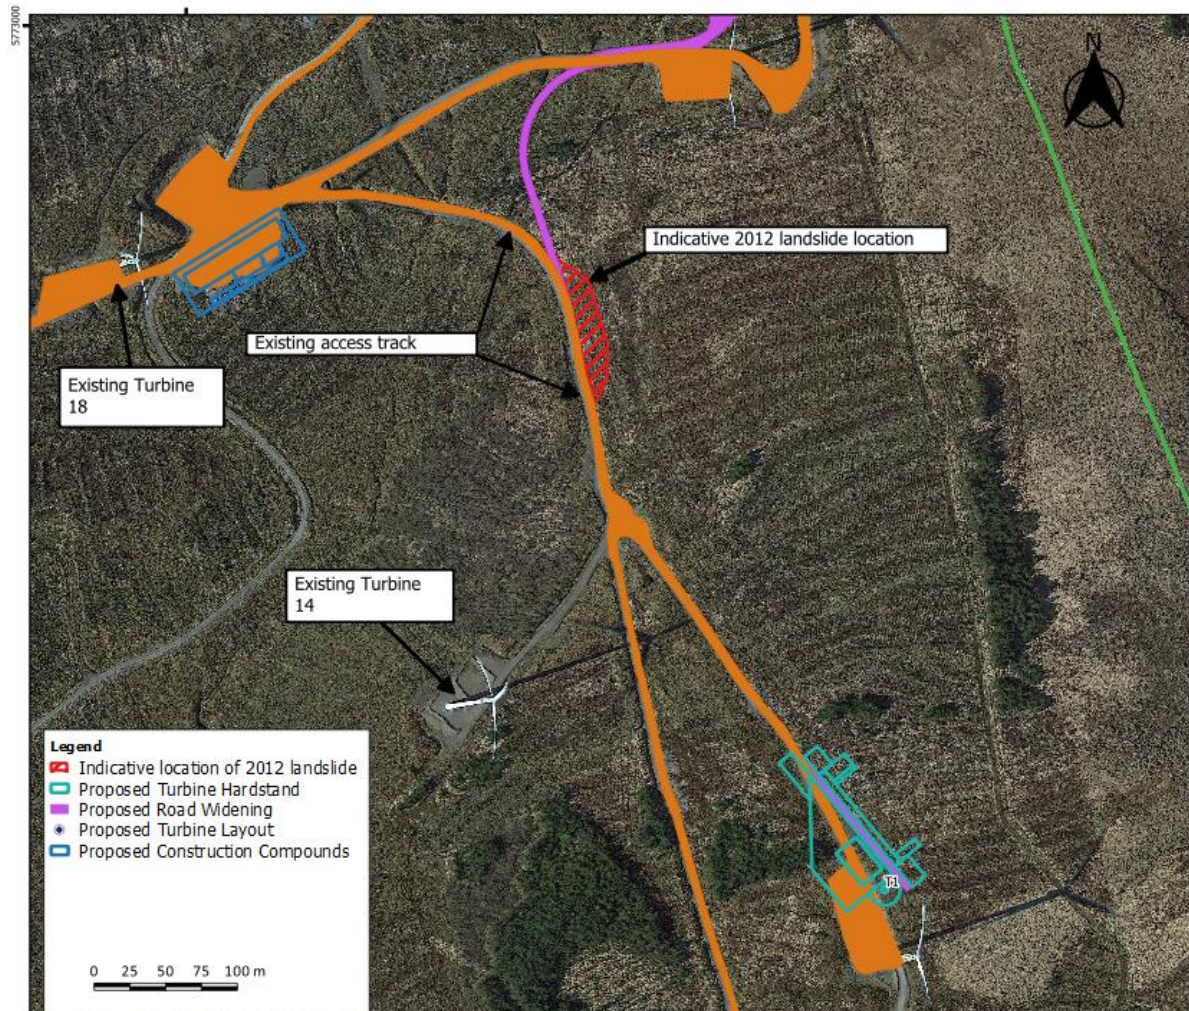
Figure 2-2: Location of 2012 Landslide.

AGECE carried out an assessment of a peat failure event which occurred at the access track to existing T14 (location shown in Figure 2-2). The failure occurred following a period of excessive rainfall on the 17th/18th of October 2012, triggering a translational slide causing material to fall onto the adjacent (downslope) access track, partially blocking access. The failure occurred on a pre-failure slope of approximately 8°, was rectangular in plan up to 6m wide and extending approximately 26m along the access track. The peat failure volume is estimated at approximately 170m³, with an extended disturbed area of approximately 450m³ (Figure G- 3 in Appendix G).

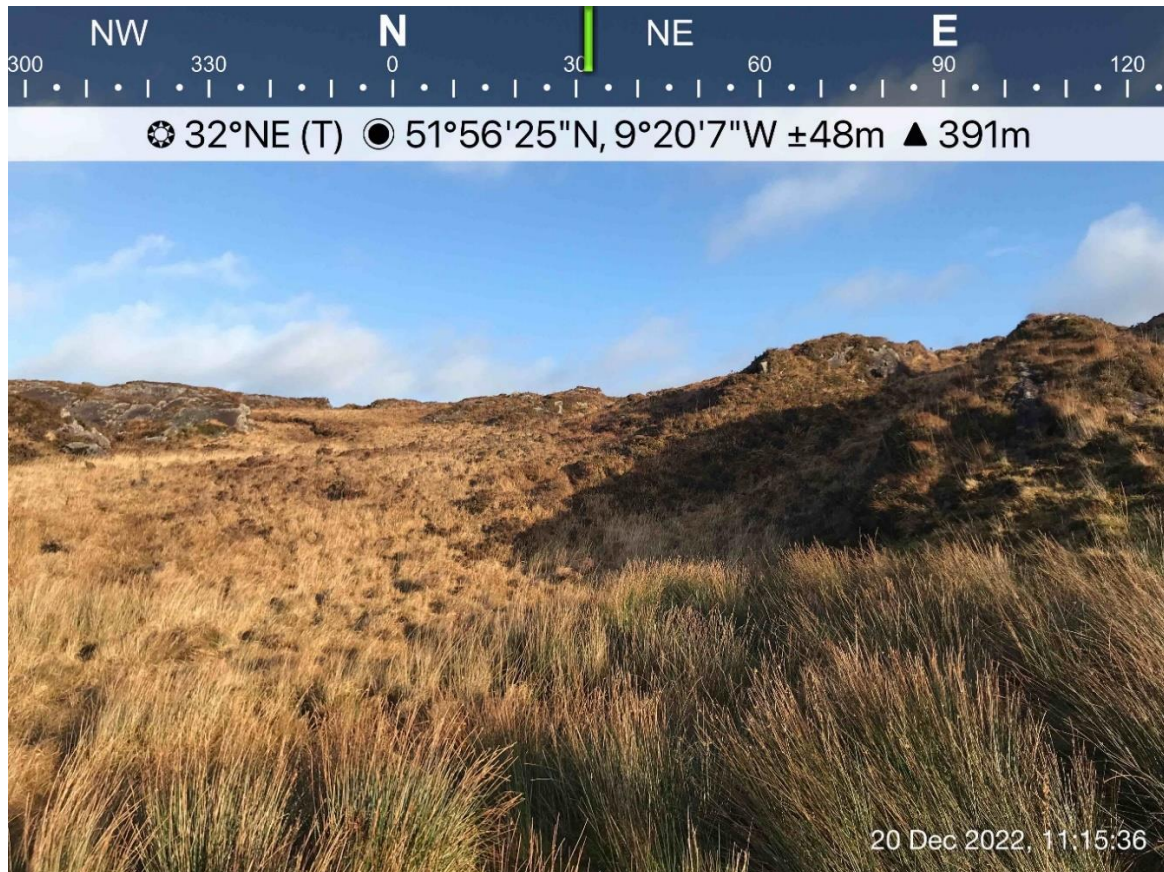
Figure 3-1: Undulating Bedrock and Peat Topography Close to T5.

GDG visited the site on several locations between March 2021 and October 2023 to conduct site walkovers, peat probing and to supervise ground investigation (GI) works being carried out by subcontractors. An indication of the site conditions of bedrock ridges and confined peat patches, along with a generally undulating topography are shown in Figure 3-1 and Figure 3-2.

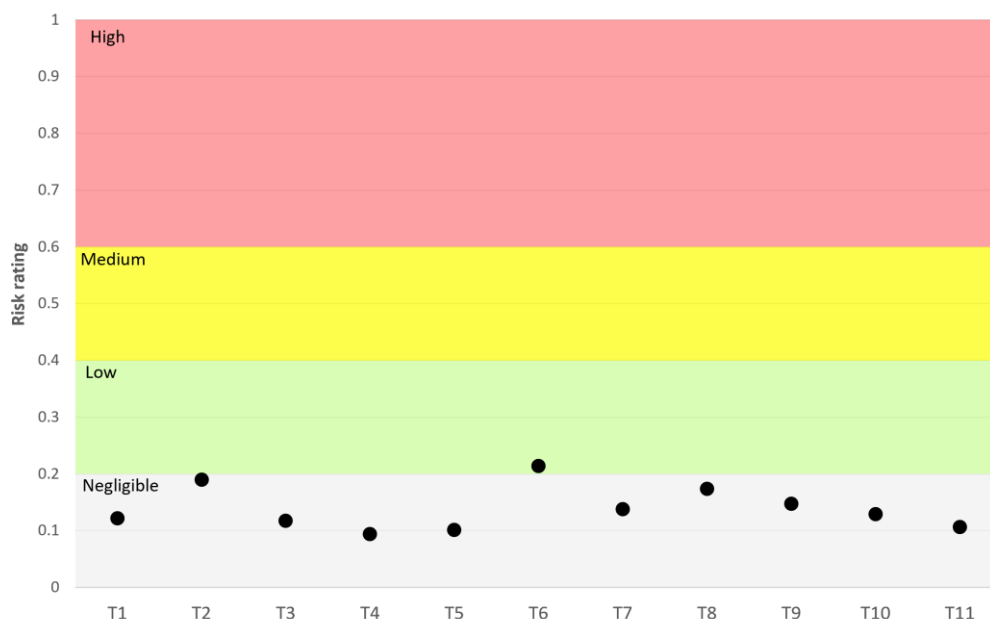
Figure 5-1: Risk ratings at the proposed turbine locations.

Risk in each wind farm infrastructure element is calculated with Equation 5.1-1, i.e. multiplying the scores of the hazard and the scores of the consequences. The risk rating ranges between 0 and 1, and the following levels of risk rating have been distinguished (Figure 5-1 and Figure 5-2):

- High (0.6 to 1): Avoid project development at these locations. Mitigation is generally not feasible.
- Medium (0.4 to 0.6): Project should not proceed unless risk can be avoided or mitigated at these locations without significant environmental impact to reduce risk ranking to low or negligible.
- Low (0.2 to 0.4): Project may proceed pending further investigation to refine assessment and mitigate hazard through relocation or re-design at these locations.
- Negligible (0 to 0.2): Project should proceed with monitoring and mitigation of peat landslide hazards at these locations as appropriate.

Appendix M gathers the risk calculation process at each turbine considering the four scenarios of hazard: Undrained; undrained with a surcharge of 1 m; drained; and drained with a surcharge of 1 m. Figure 5-1 and Figure 5-2 summarise the risk rating obtained at the turbines and compound locations. All the turbines and compounds aside from T06 are located in sectors of negligible risk. T06 is in an area of low risk. This is still considered to be an acceptable risk rating and the project may proceed pending further investigation to refine assessment and mitigate hazard through detail design at the location.

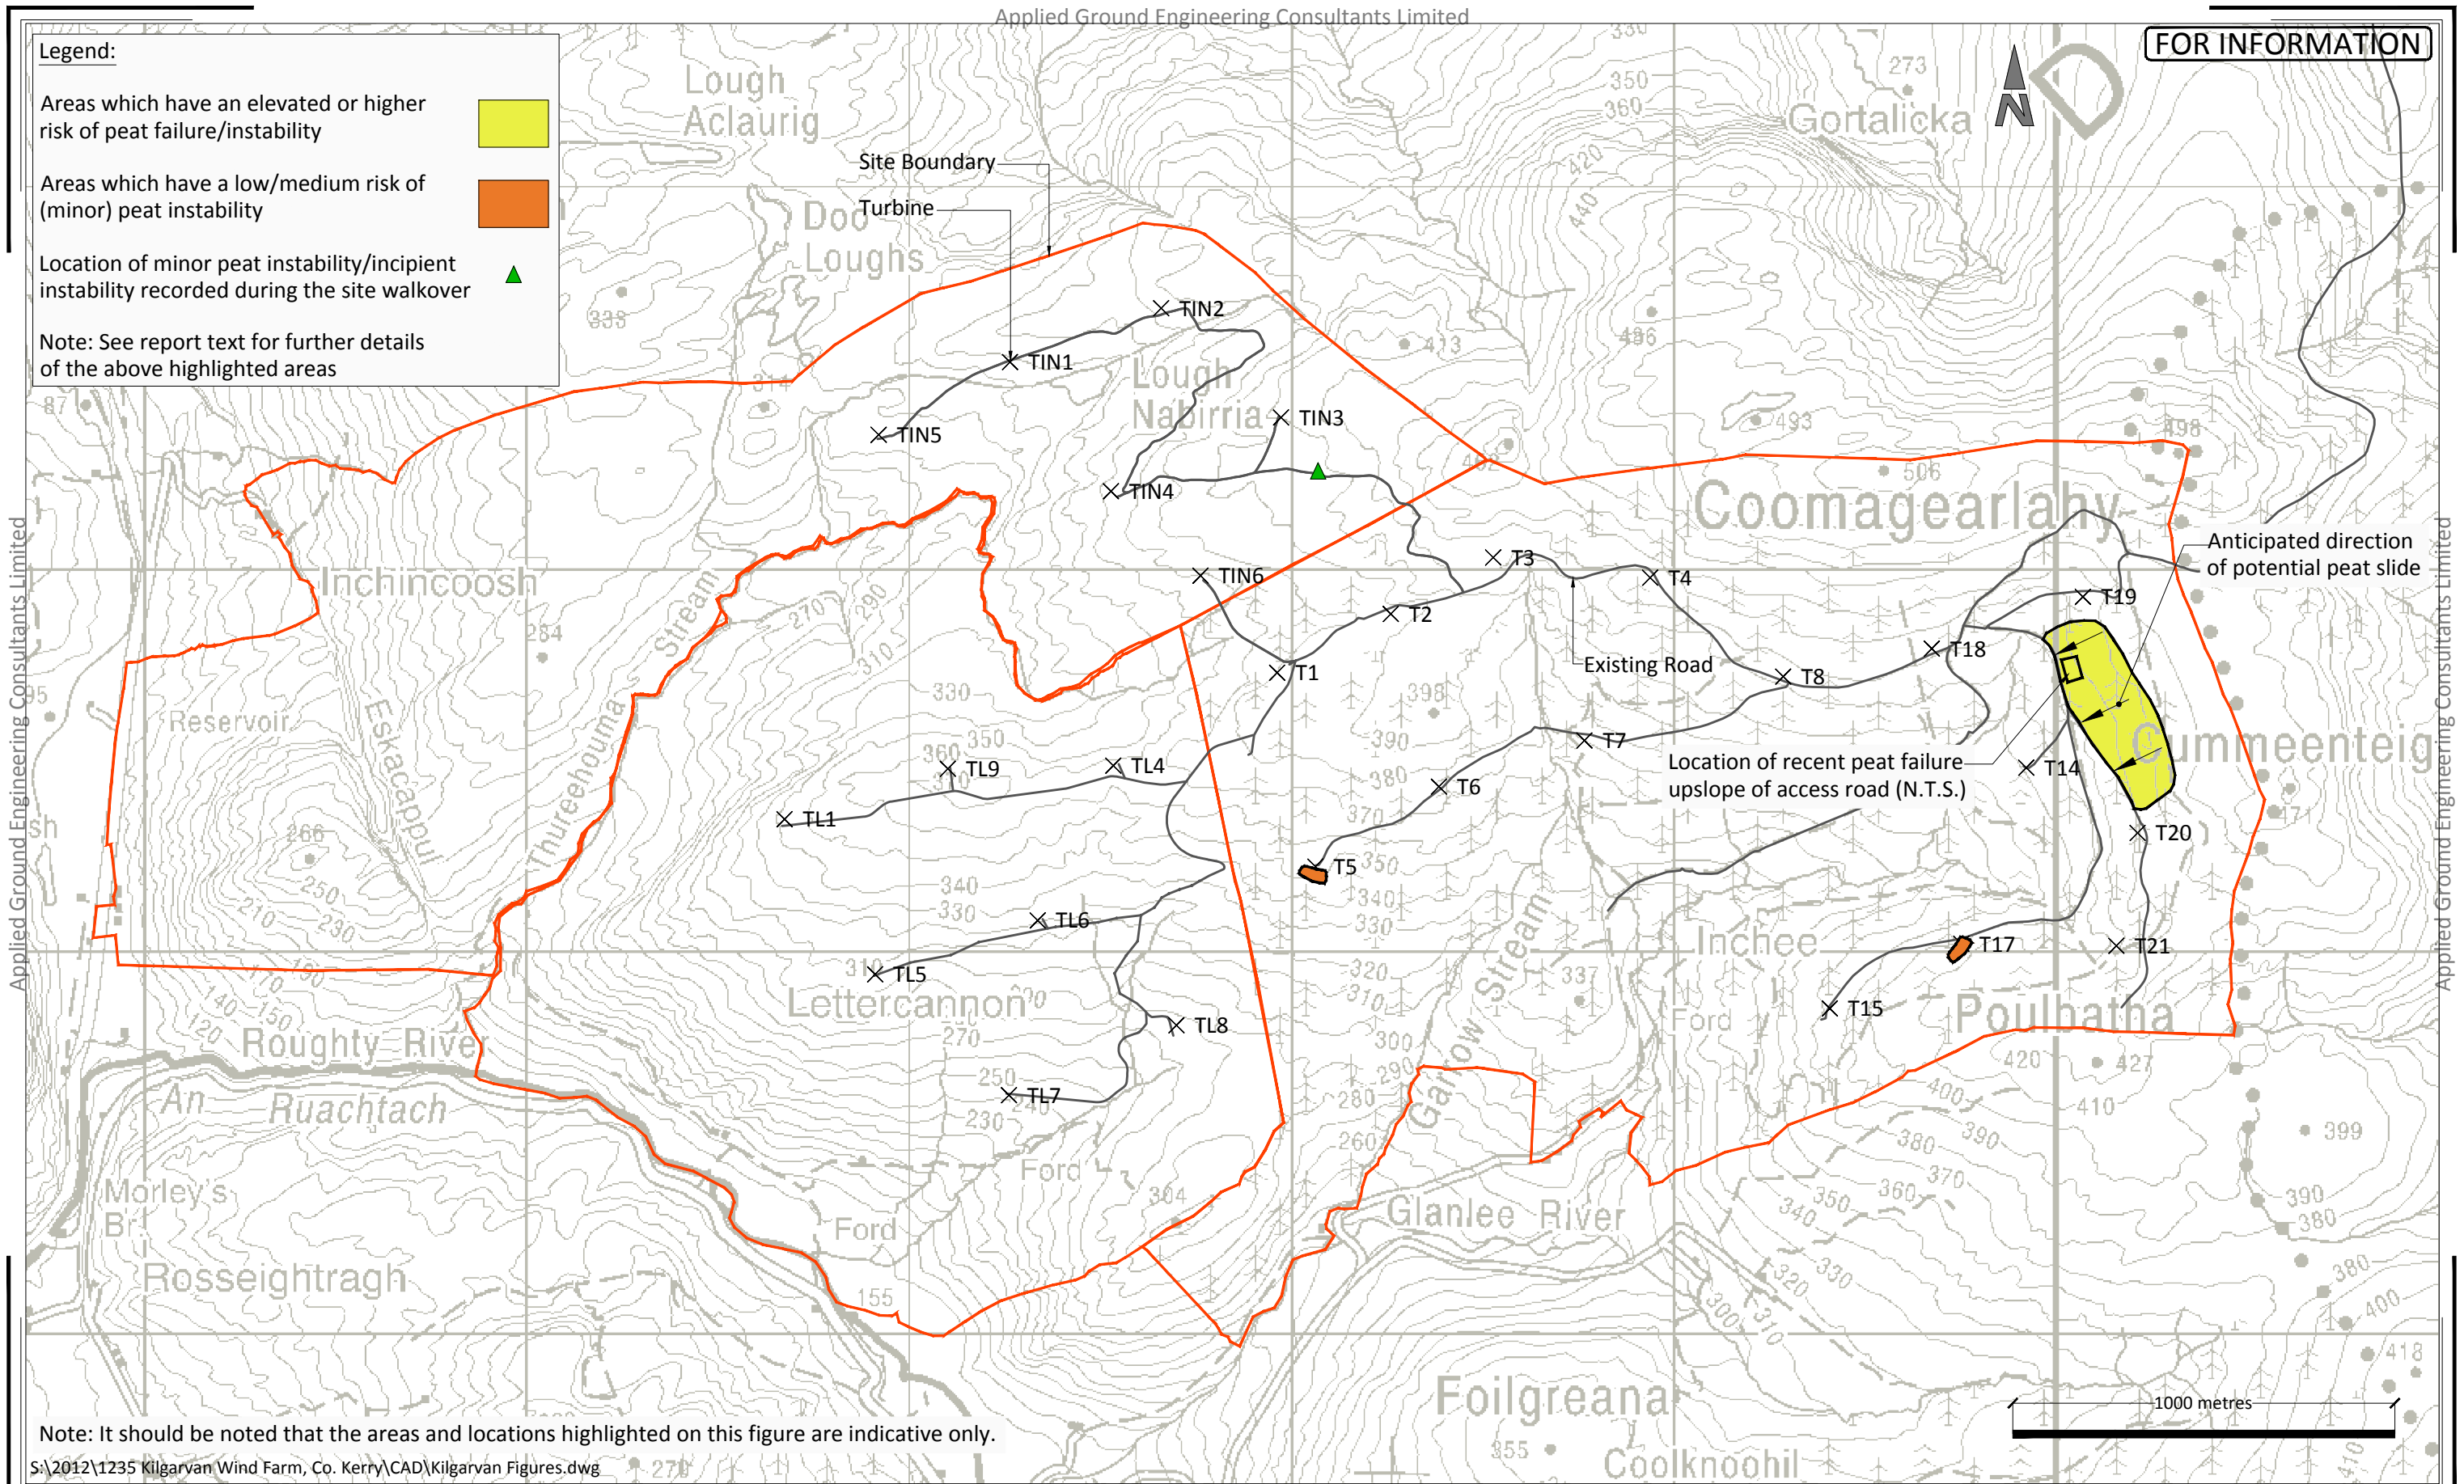
The results of the undrained analysis for the natural peat slopes are presented in Appendix B and the results of the undrained analysis for the most critical load case (load condition 2) are shown on Figure 2.

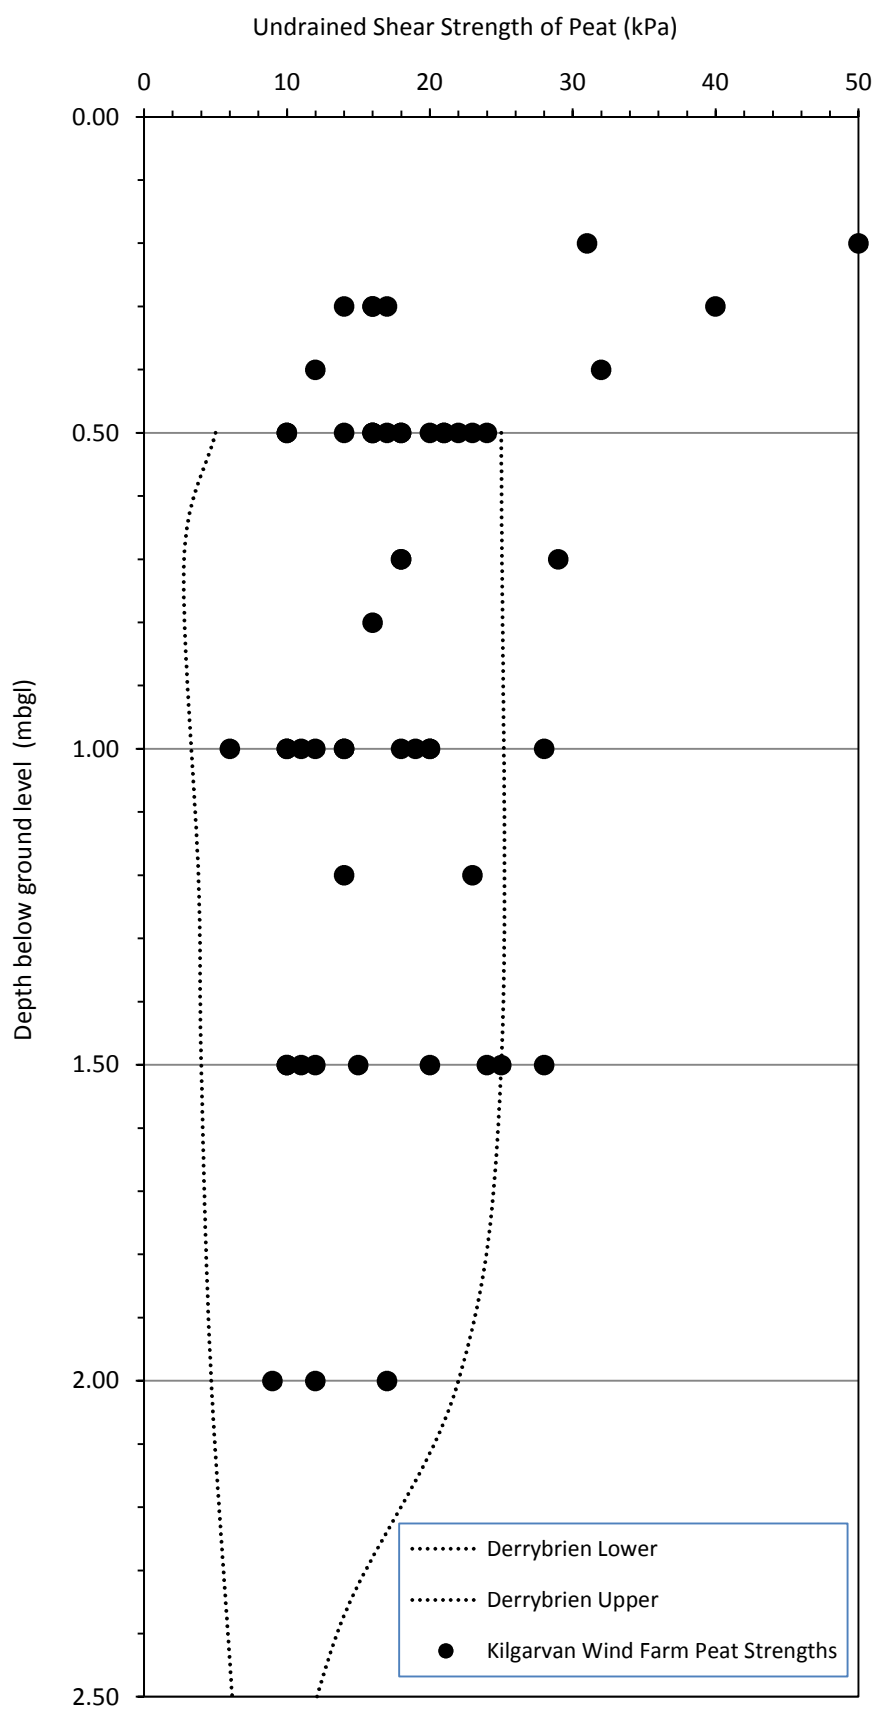
The results of the vane testing carried out by AGECE are presented in Figure 4.

Figure 4 Undrained Shear Strength (c_u) Profile for Peat with Depth

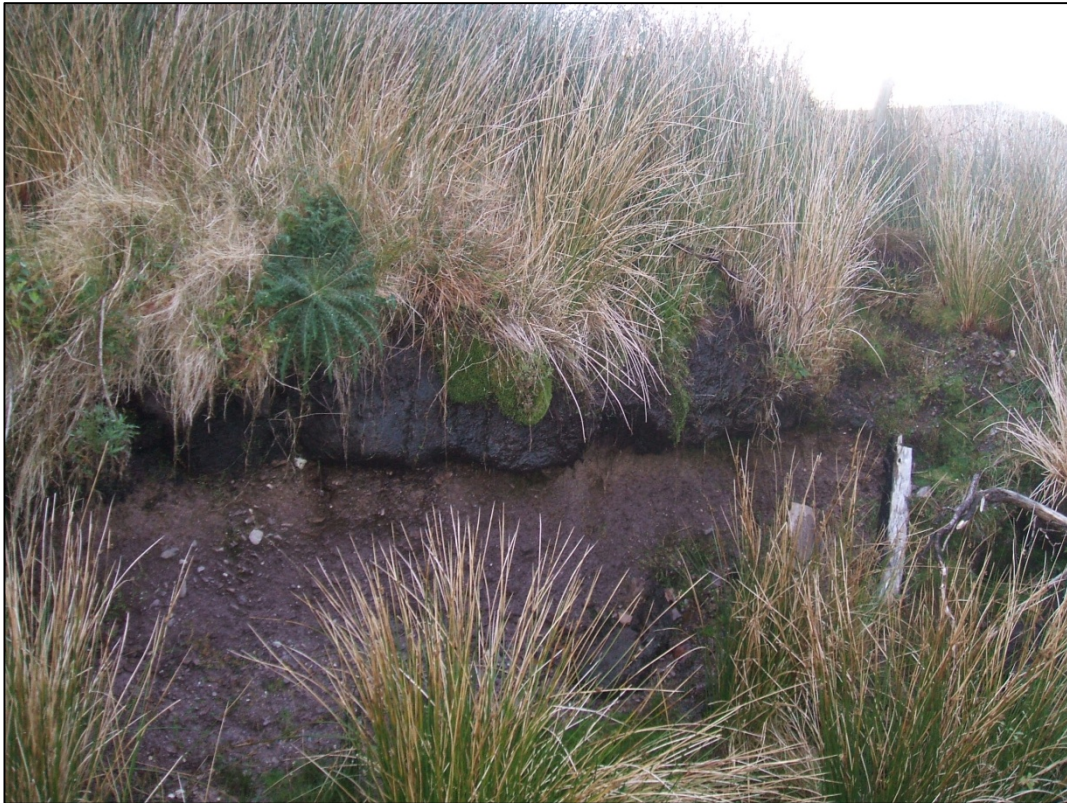
- (10) Some slight creep movement of the peat was noted in localised areas across the site (Photo 5). This is not unexpected as creep movement in upland peat areas is a natural occurrence.

Photo 5 Example of creep movement of peat on site

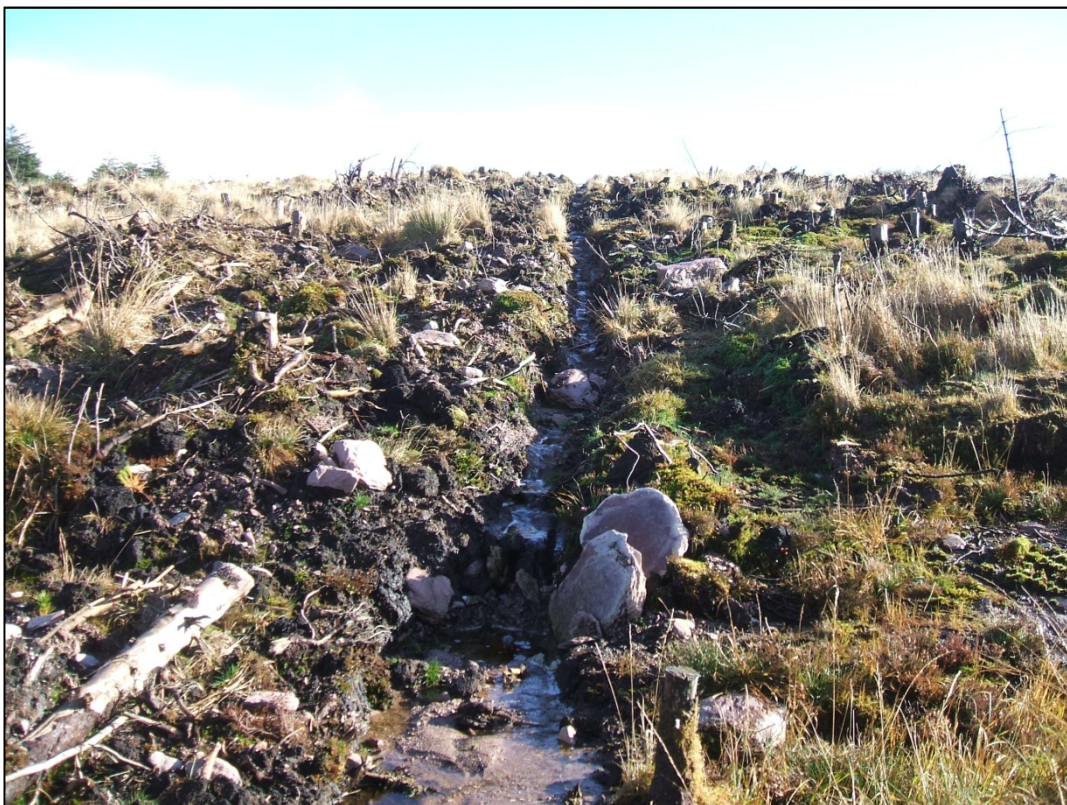
Photo 6 Slope v-ditch constructed in elevated or higher risk area on site

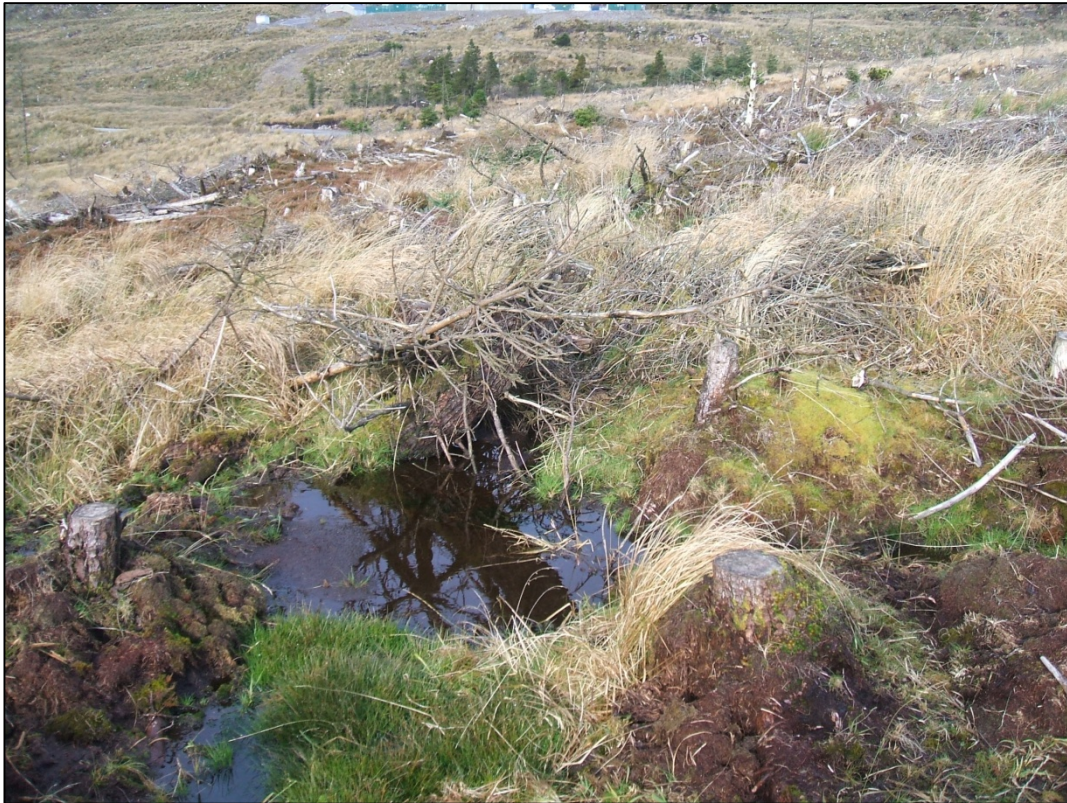
Photo 7 Ponding of water at termination of slope v-ditches

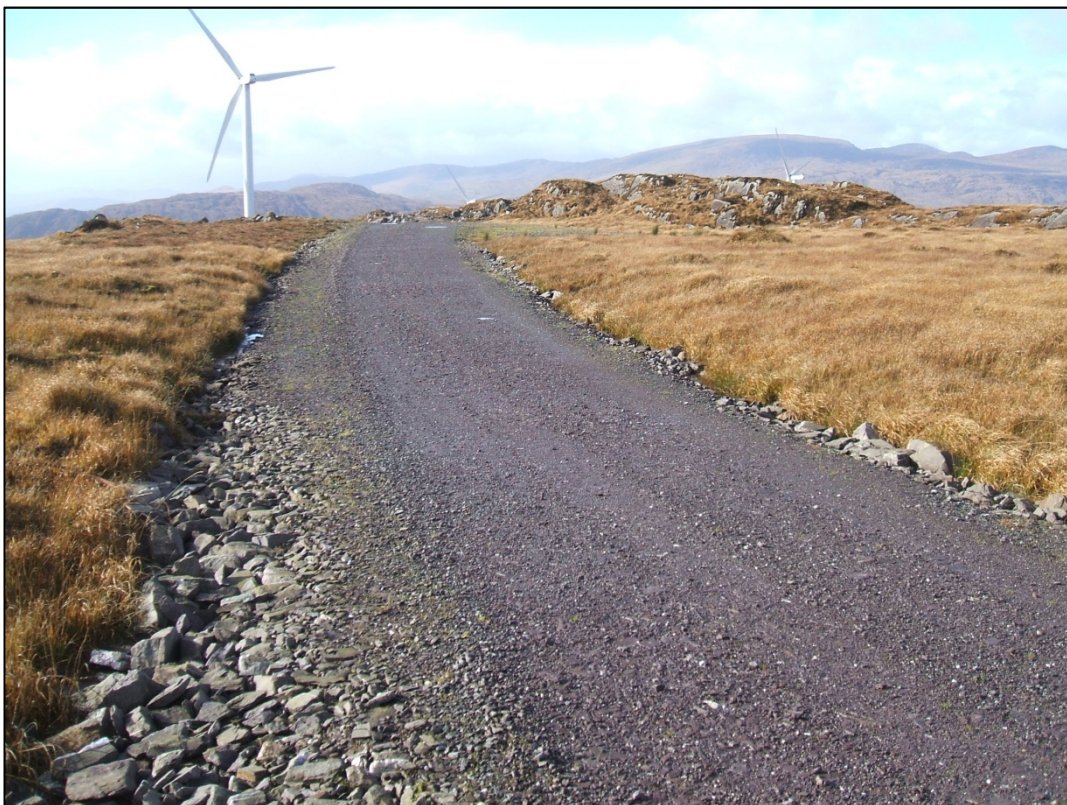
Photo 8 Localised sinking of the floated access road

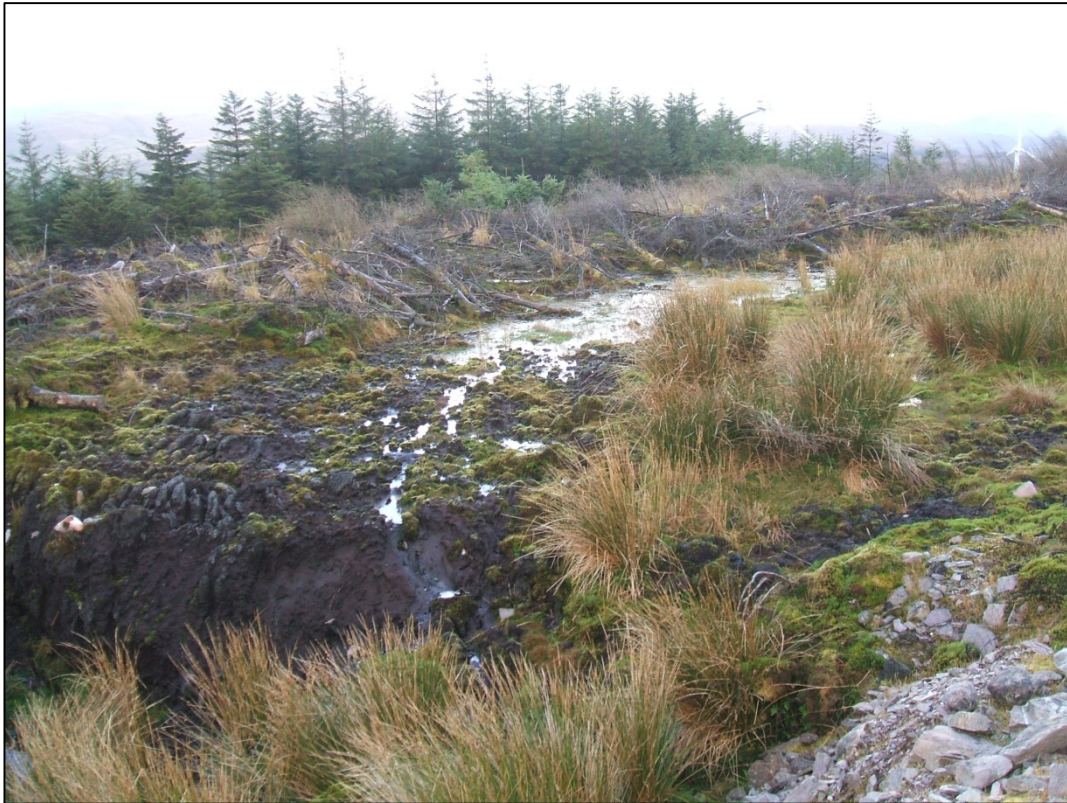
Photo 9 Ponding of water south of turbine T5

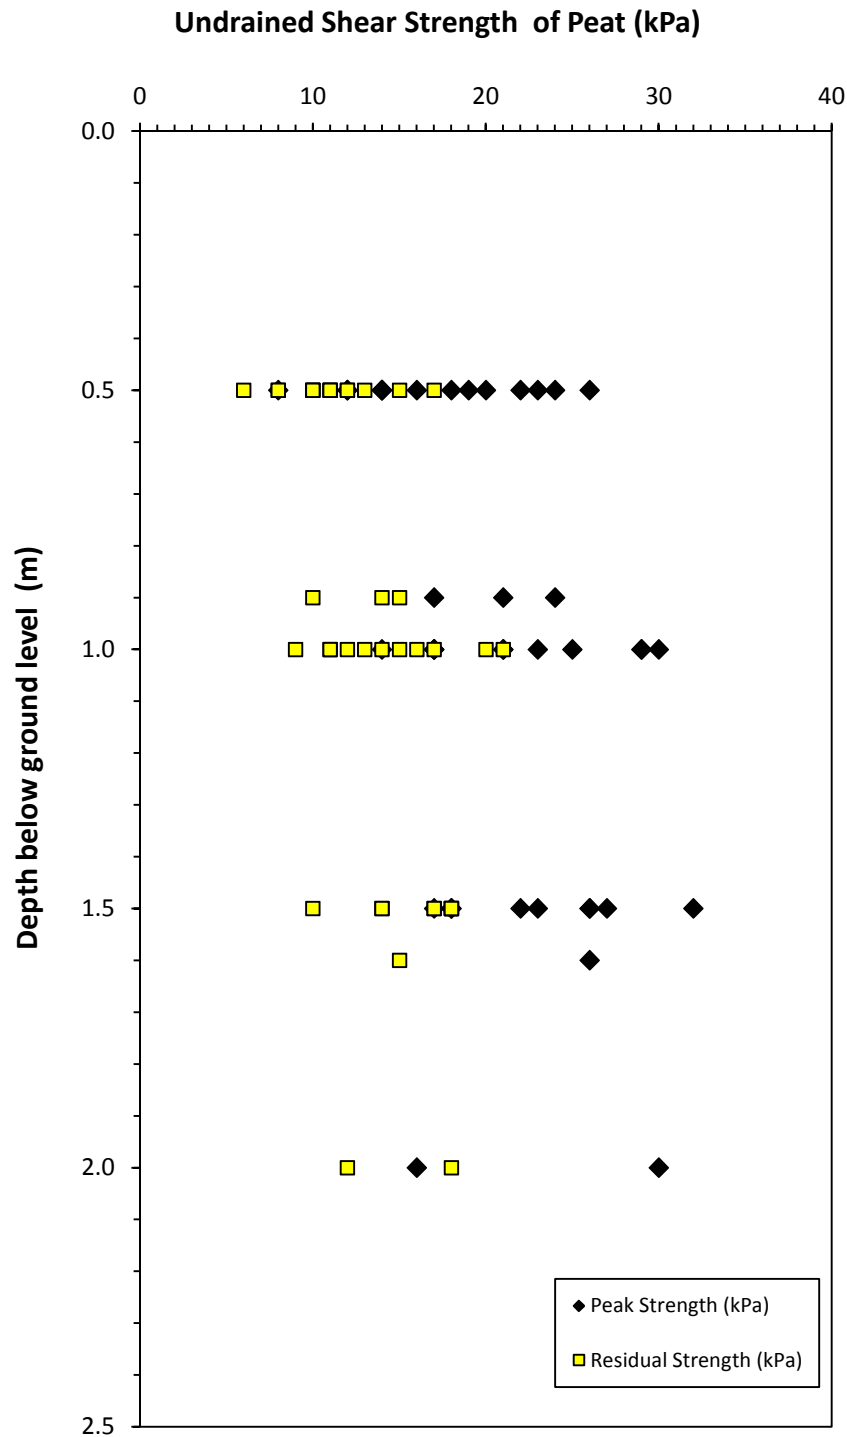
- (11) Undrained and residual shear strengths were recorded in both non-intact and intact peat at/around the failure scar (Figure 1). Undrained shear strength values range from 8 to 32kPa with an average of 21kPa. Residual shear strength values ranged from 4 to 21kPa with an average of 13kPa.

Figure 1 Undrained & Residual Shear Strengths (c_u) Profile for Peat with Depth around the Failure Scar

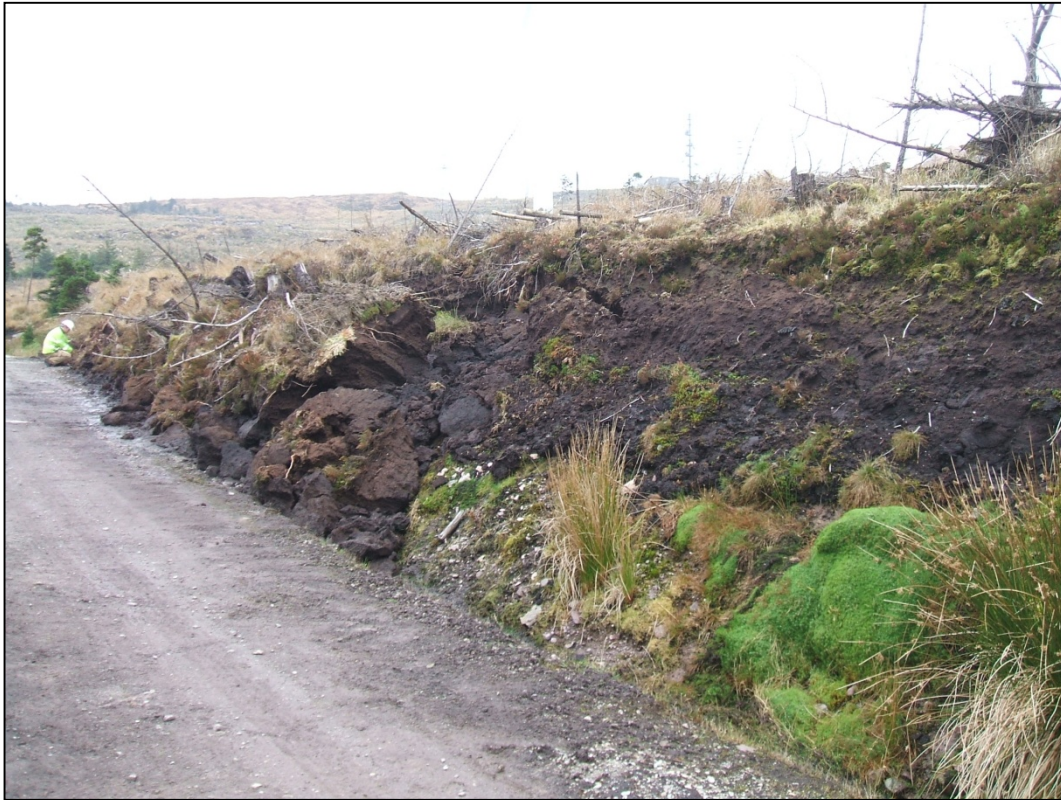
Photo 1 Extent of peat debris along the existing road
