Appendix 12.2

1. Hydromorphology Assessment

This appendix to the EIAR consists of an impact appraisal of the proposed Google Ireland GIL DC3 Datacentre, hereafter referred to as the Proposed Development, under the heading of Water.

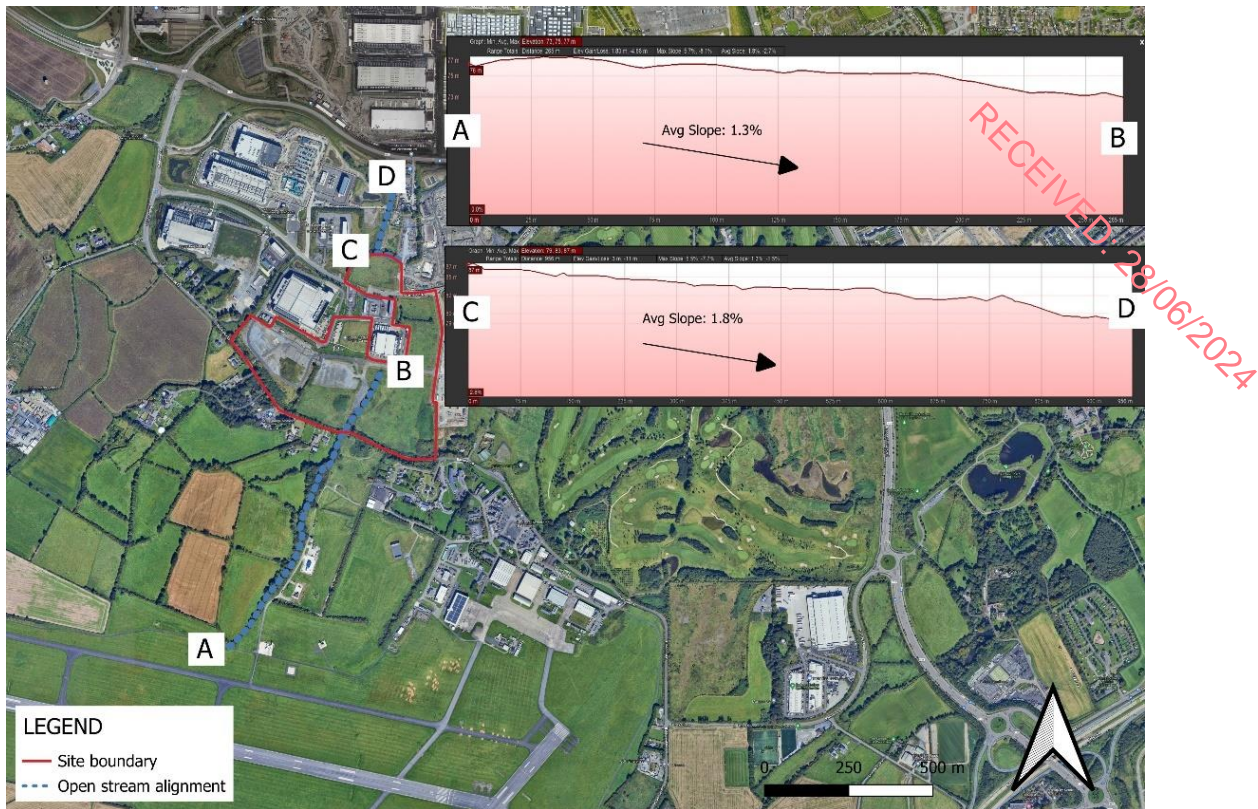
The topography of the Liffey and Dublin Bay WFD Catchment is dominated by the Wicklow Mountains to the south and the discharge to sea level in the east (Figure 1.7). The longitudinal profile of the watercourse traversing the Proposed Development site indicates an average bed gradient of 1.24% (Figure 1.8). The Proposed Development occurs in a generally flat terrain, with an average elevation of 82 mOD, and two notable fluctuations in the topographic level on each side of the watercourse associated with spoil heaps (Figure 1.9).

Figure 1.8: Longitudinal profile of watercourse along reach A-B and C-D. Source: Google Earth Pro³

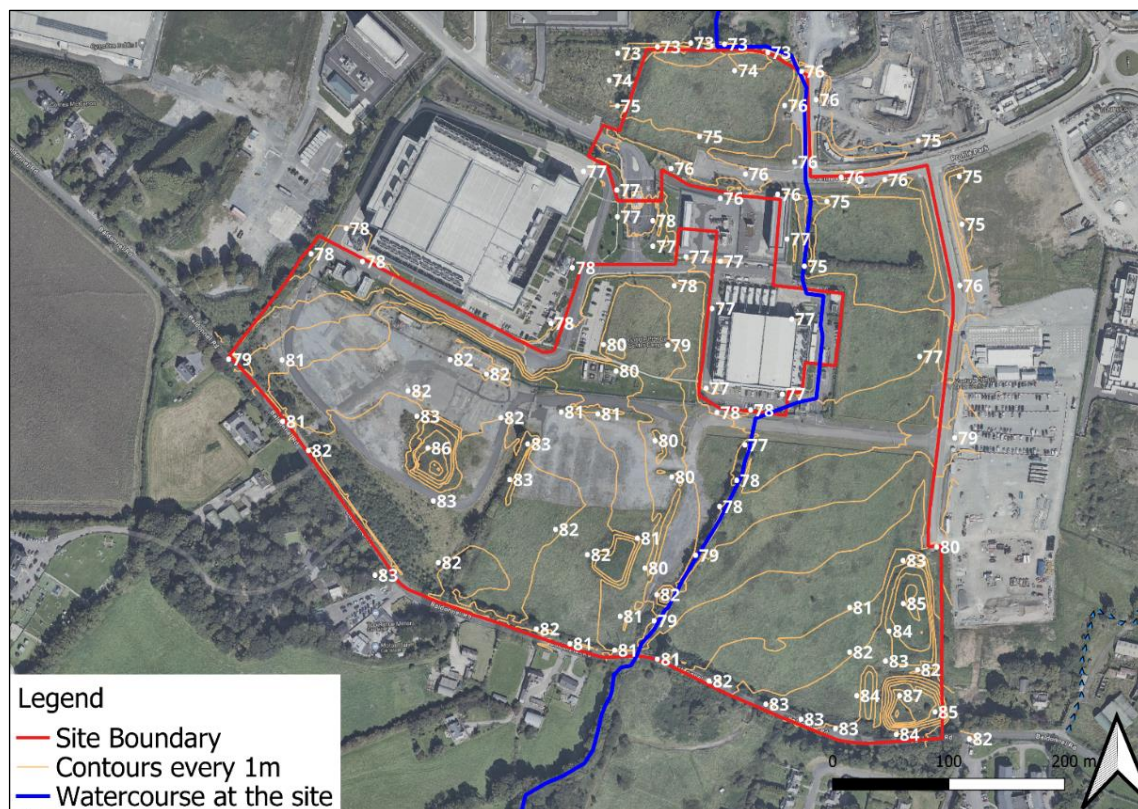
Figure 1.9: Topography of the Proposed Development site (generated from the site-specific topographic survey).

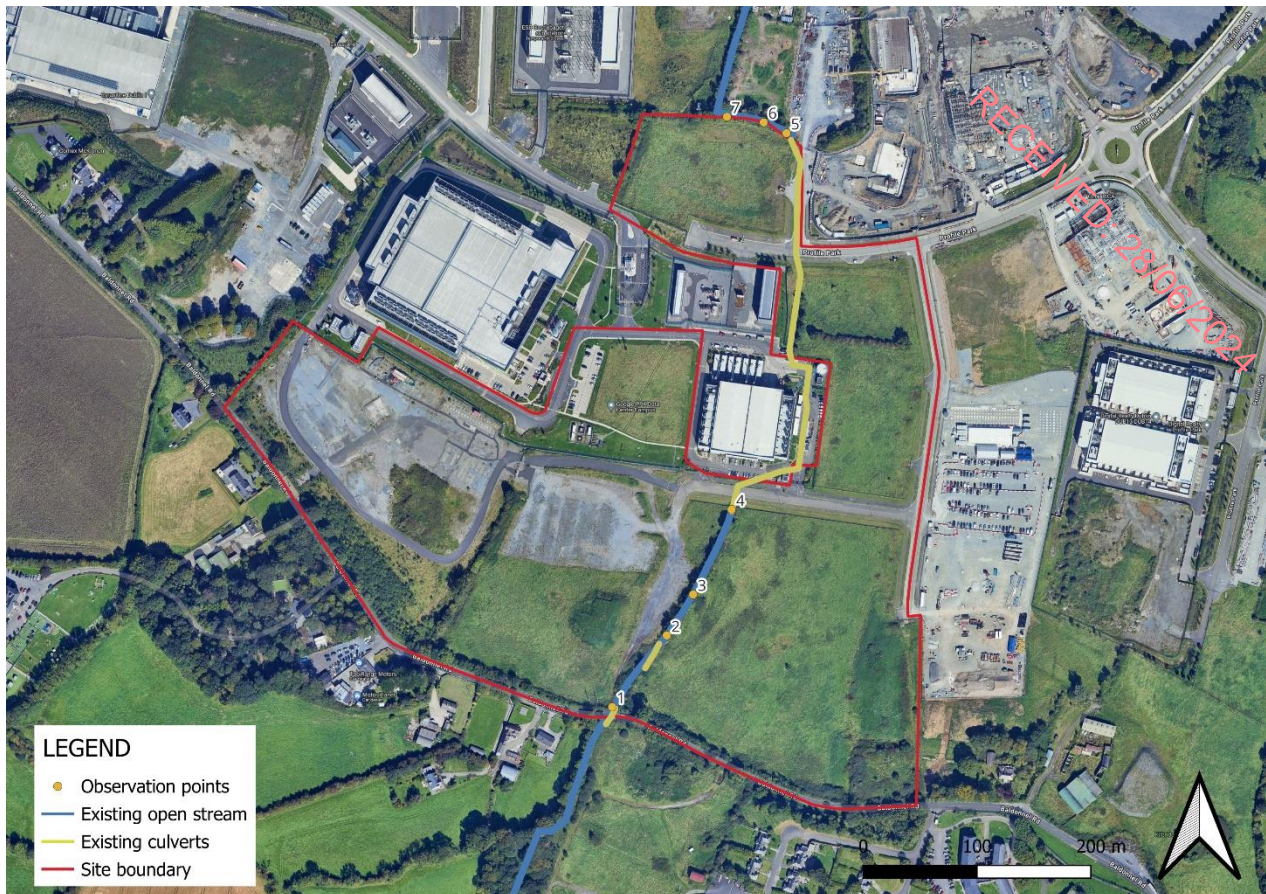
Field observations were conducted approximately every 60 meters along the reach of the on-site watercourse (points 1 to 4) and approximately every 40 meters in the off-site watercourse downstream from the Proposed Development site (points 5 to 7) (Figure 1.12). The exact locations of the survey points were determined by accessibility on site, as dense vegetation made access difficult in certain areas. This assessment excludes the culverted reach of watercourse and provides an overall RHAT score and WFD status for the on-site watercourse.

Figure 1.12: RHAT observation points for the on-site watercourse traversing the Proposed Development (points 1-4) and the off-site watercourse downstream of the Proposed Development (points 5-7).
