## Primary Route Assessment - CMBG Wind Farm, County Kerry

343154

Wednesday, 20 October 2021

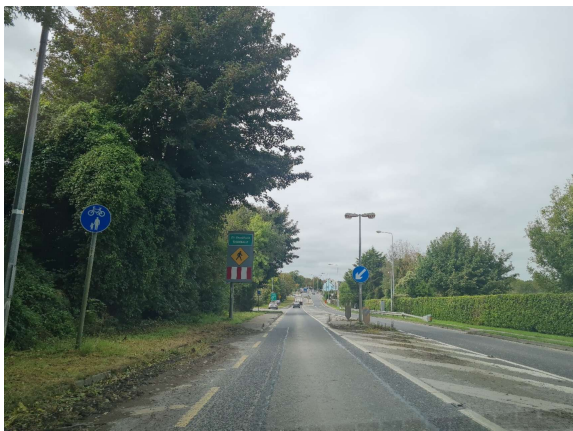
### **Location 3 - Splitter Island On N28**

Visual inspection indicates that there are no issues at this location.

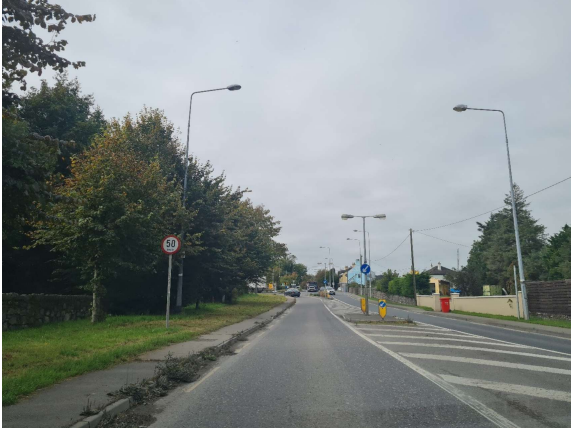
#### **Location 4 - Splitter Island On N28**

Visual inspection indicates that there are no issues at this location.

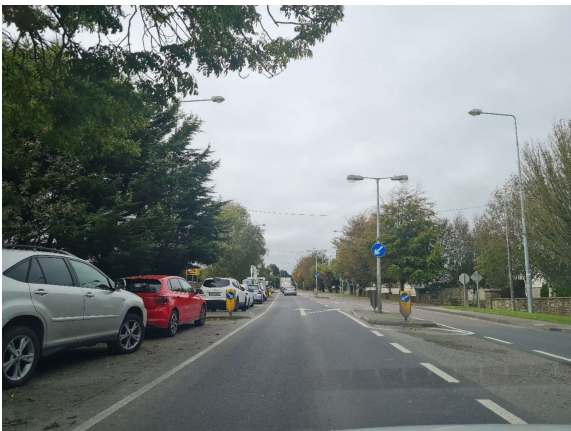
#### **Location 6 - Splitter Island On N28**

Visual inspection indicates that there are no issues at this location.

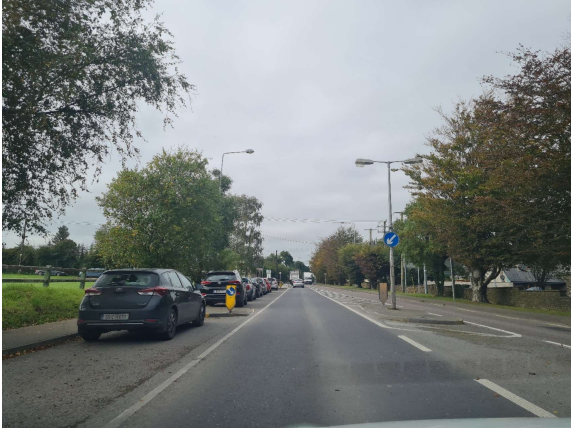
### **Location 7 - Splitter Island On N28**

Visual inspection indicates that there are no issues at this location.

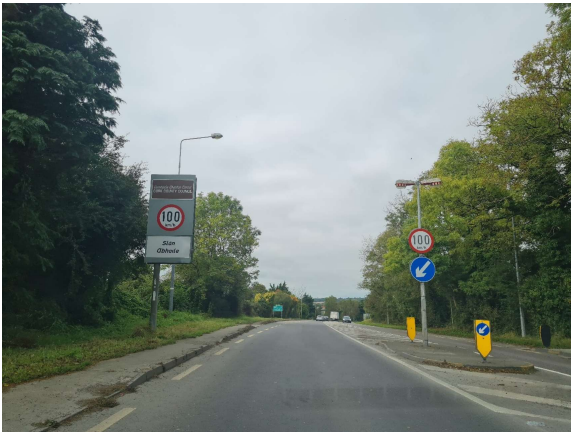
### **Location 8 - Splitter Island On N28**

Visual inspection indicates that there are no issues at this location.

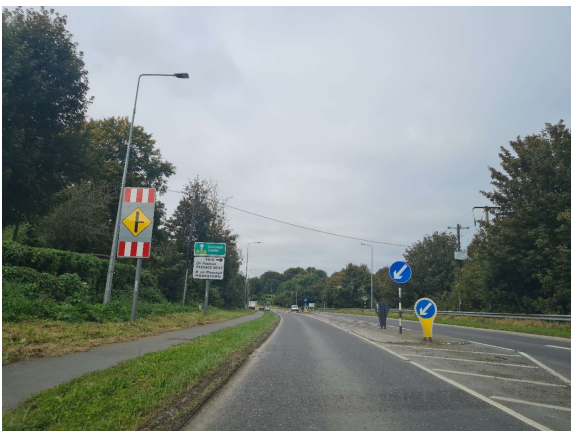
### **Location 9 - Splitter Island On N28**

Visual inspection indicates that there are no issues at this location.

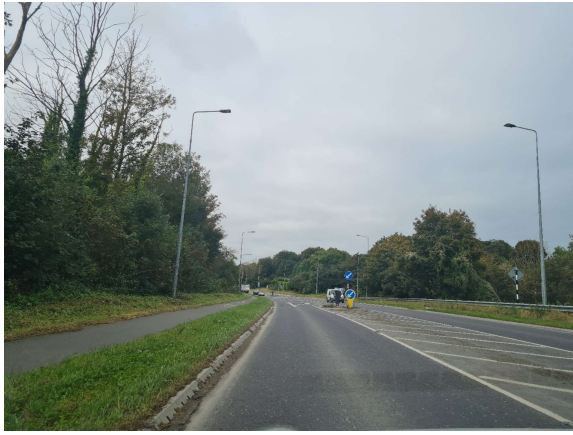
### **Location 10 - Splitter Island On N28**

Visual inspection indicates that there are no issues at this location.

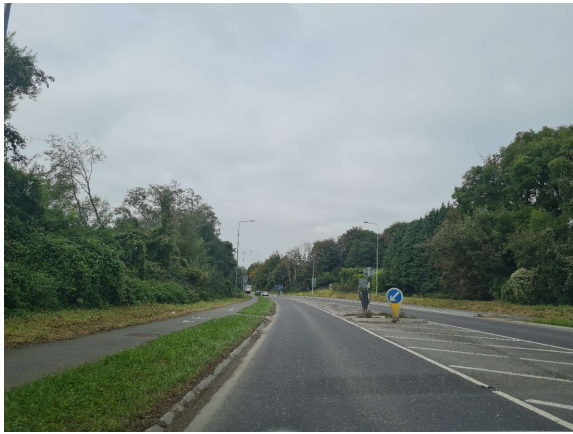
### **Location 11 - Splitter Island On N28**

Visual inspection indicates that there are no issues at this location.

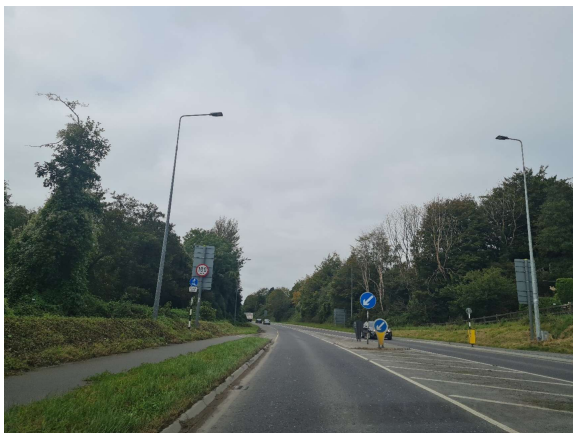
### **Location 12 - Splitter Island On N28**

Visual inspection indicates that there are no issues at this location.

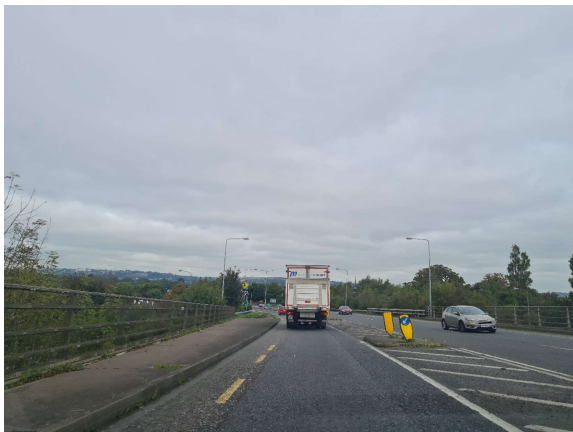
### **Location 14 - Splitter Island On N28**

Visual inspection indicates that there are no issues at this location.

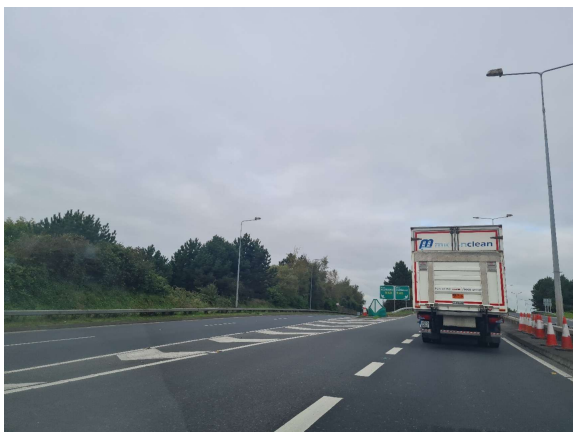
### **Location 15 - N28/N40 Junction**

Visual inspection indicates that there are no issues at this location.

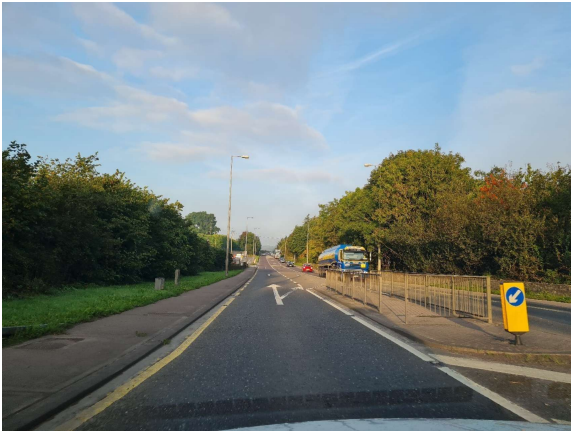
### **Location 16 - Splitter Island On N22**

Visual inspection indicates that the loaded vehicle will navigate this location without any issues.

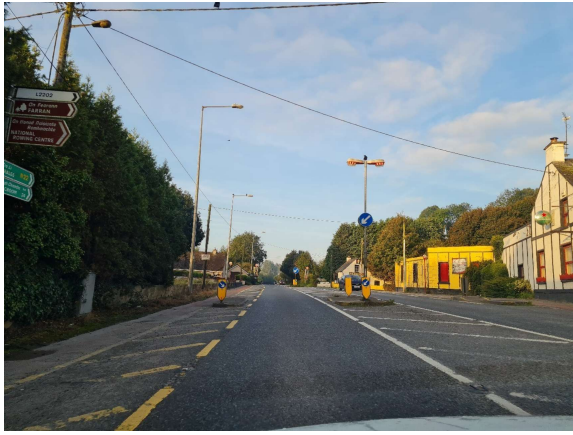
### **Location 19 - Splitter Island On N22**

Visual inspection indicates that the loaded vehicle will navigate this location without any issues.

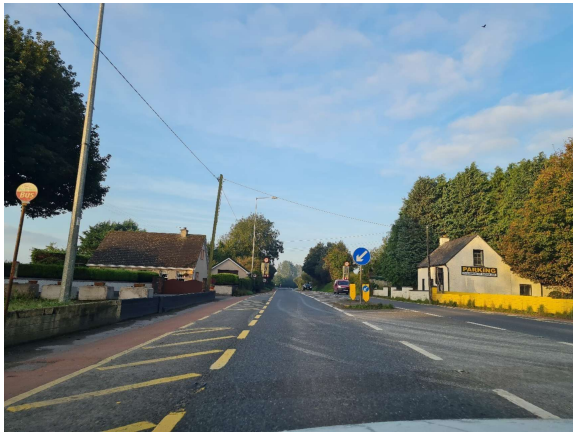
### **Location 20 - Splitter Island On N22**

Visual inspection indicates that the loaded vehicle will navigate this location without any issues.

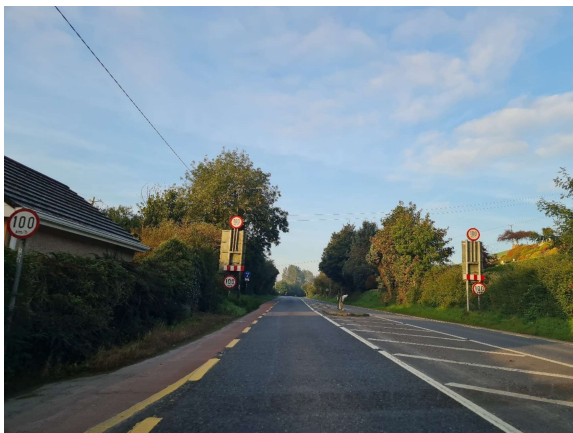
### **Location 21 - Splitter Island On N22**

Visual inspection indicates that the loaded vehicle will navigate this location without any issues.

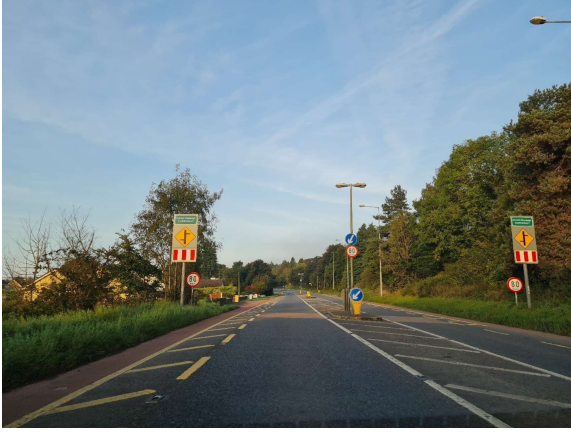
### **Location 22 - Splitter Island On N22**

Visual inspection indicates that the loaded vehicle will navigate this location without any issues.

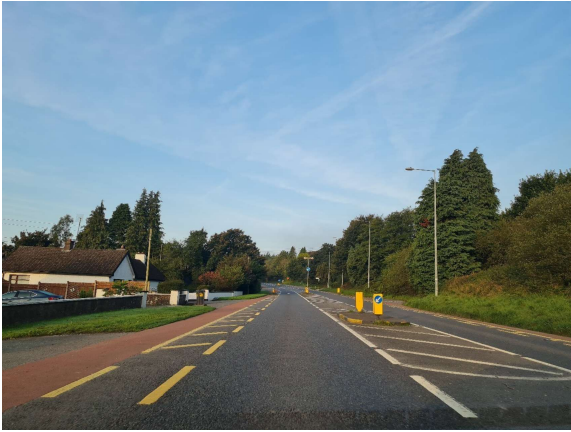
### **Location 23 - Splitter Island On N22**

Visual inspection indicates that the loaded vehicle will navigate this location without any issues.

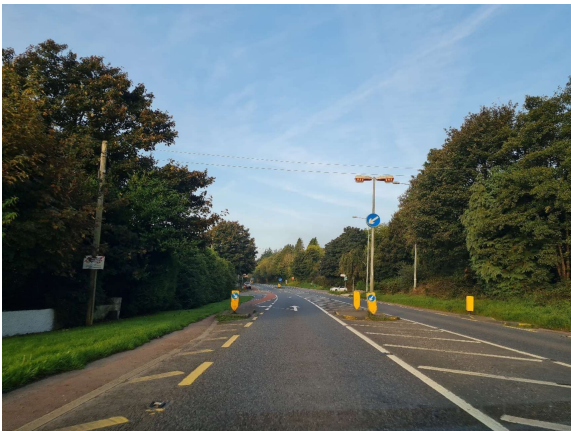
### **Location 24 - Splitter Island On N22**

Visual inspection indicates that the loaded vehicle will navigate this location without any issues.

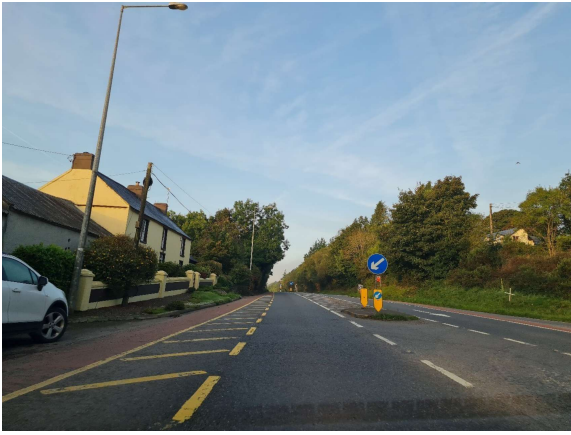
### **Location 25 - Splitter Island On N22**

Visual inspection indicates that the loaded vehicle will navigate this location without any issues.

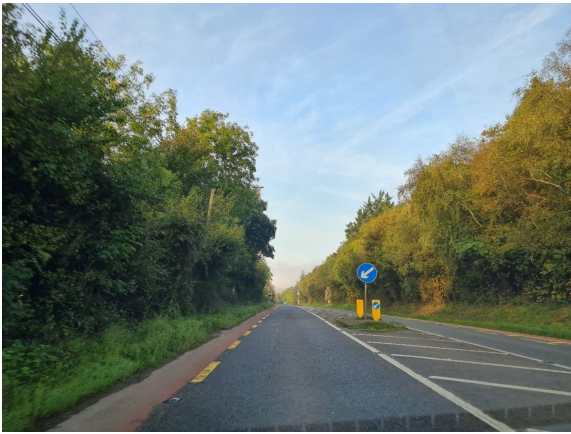
### **Location 26 - Splitter Island On N22**

Visual inspection indicates that the loaded vehicle will navigate this location without any issues.

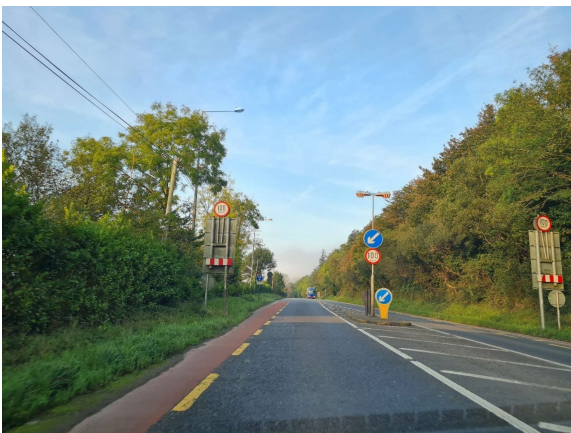
### **Location 27 - Splitter Island On N22**

Visual inspection indicates that the loaded vehicle will navigate this location without any issues.

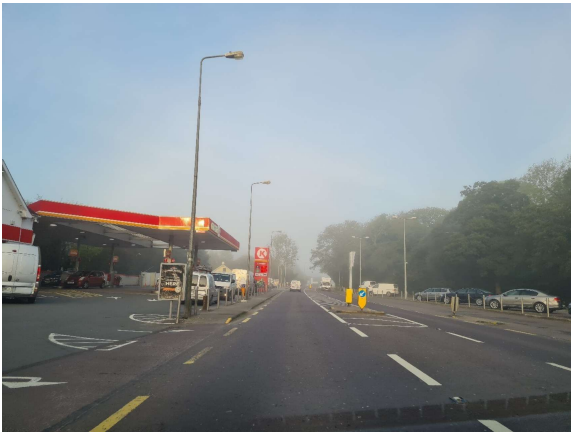
### **Location 29 - Splitter Island On N22**

Visual inspection indicates that the loaded vehicle will navigate this location without any issues.

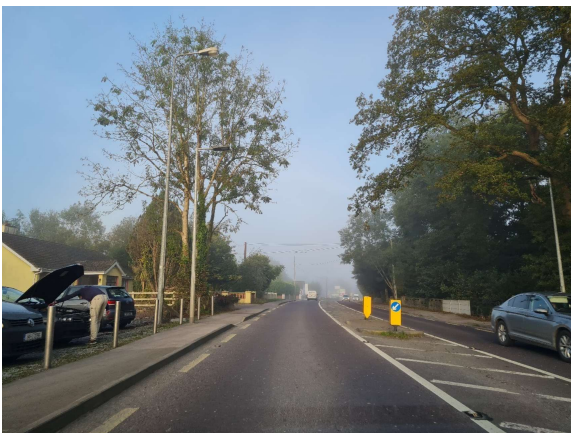
### **Location 30 - Splitter Island On N22**

Visual inspection indicates that the loaded vehicle will navigate this location without any issues.

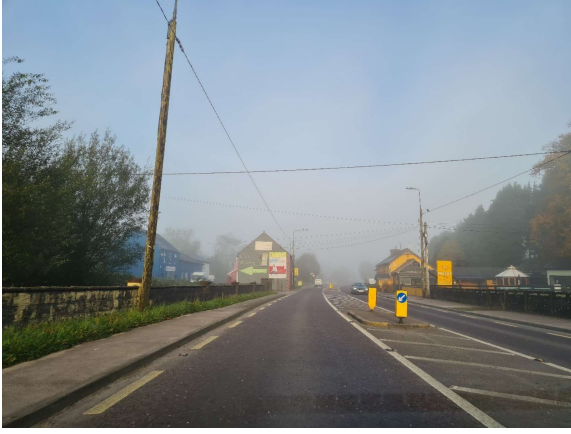
### **Location 31 - Splitter Island on N22**

Visual inspection indicates that the loaded vehicle will navigate this location without any issues.

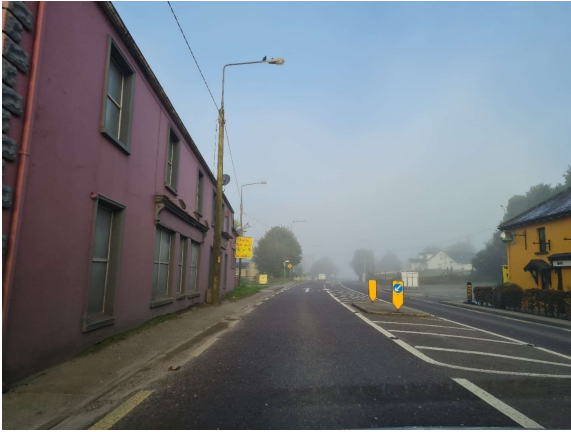
### **Location 32 - Splitter Island On N22**

Visual inspection indicates that the loaded vehicle will navigate this location without any issues.
