Appendix 10. Land, Soils and Geology

**10.1 Wuxi Biologics WwPTP Site
Investigation Report' (Murphy Group, 2023)**

CLIENT	Wuxi Biologics
CONTRACT TITLE	Wuxi Biologics Wastewater Pre-Treatment Plant
CONTRACT NUMBER	1011-000121
OPERATING UNIT	M6

Wuxi Biologics WwPTP Site Investigation Report

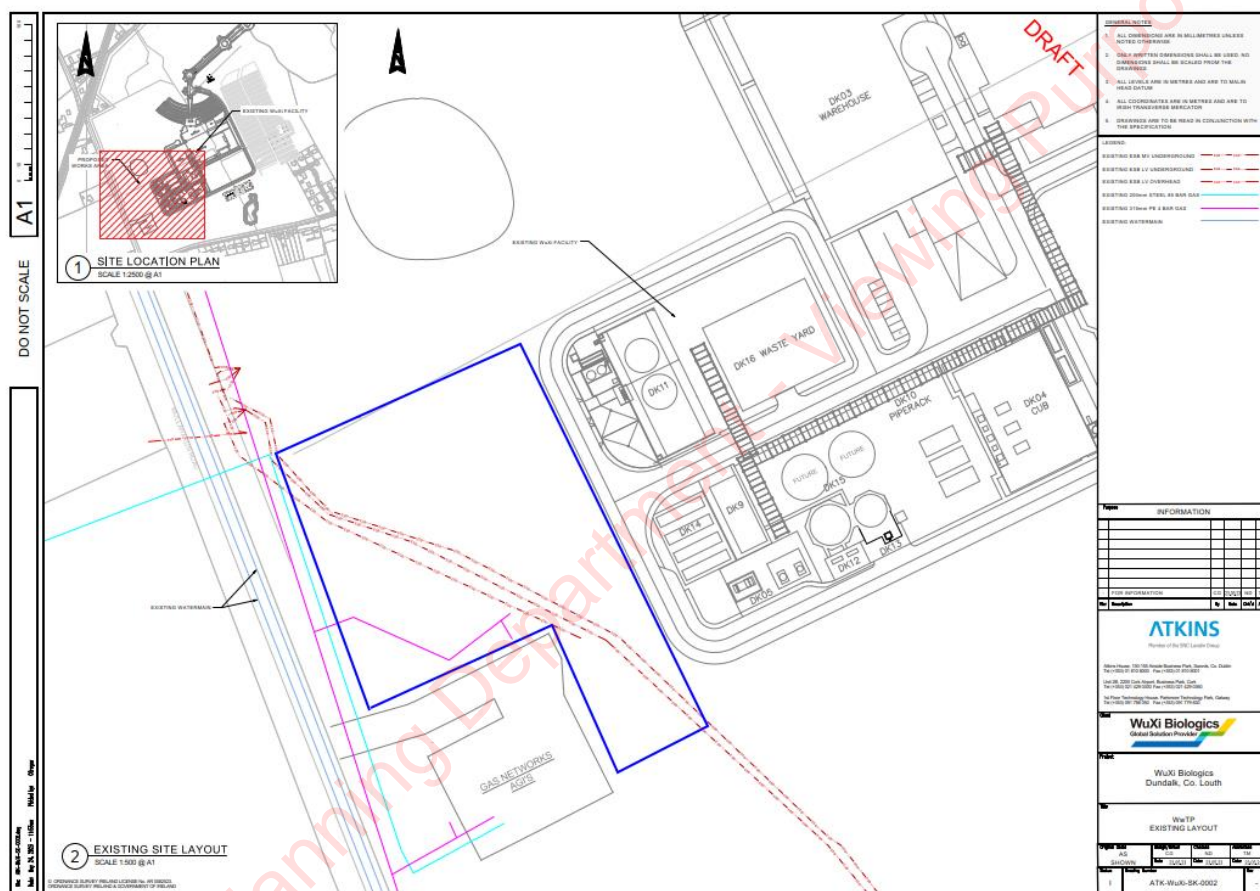
The proposed location is in a field with known Gas and Electric services. The ESB and GNI were contacted and the latest service drawings consulted. The area outlined in blue is where the proposed WwPTP The red dashed lines below denote the ESB services and the pink and cyan solid lines, denote the Gas services. We also needed to find the gas main feeding the plant from the AGI side, we had no as built information of this pipeline.

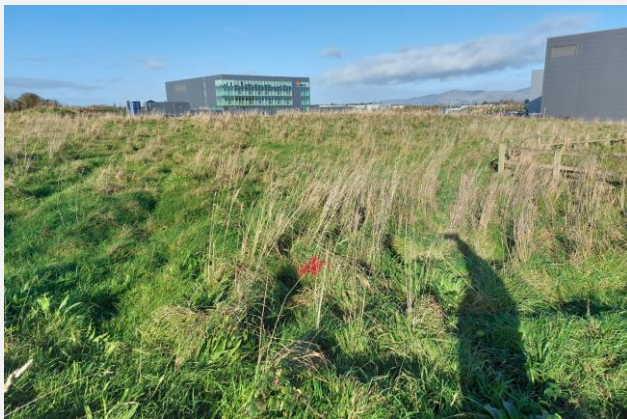
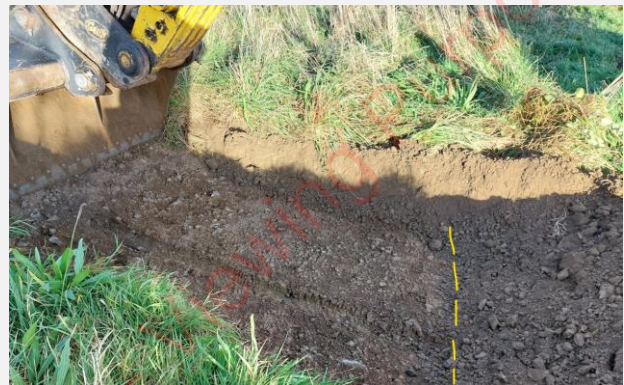
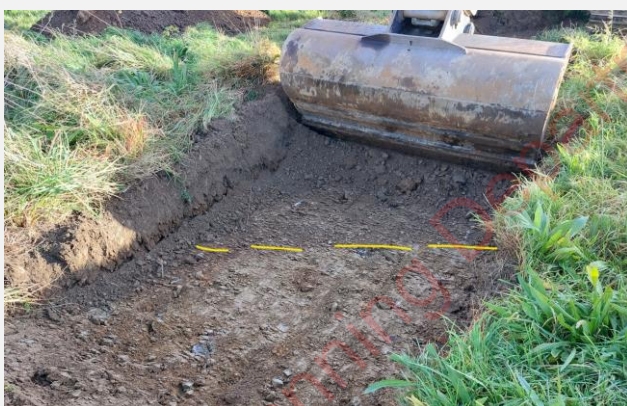
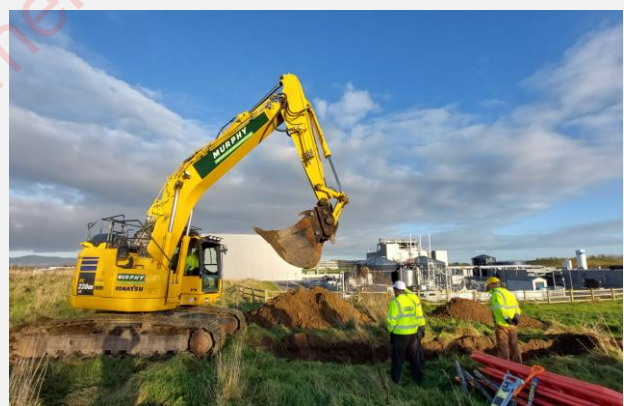
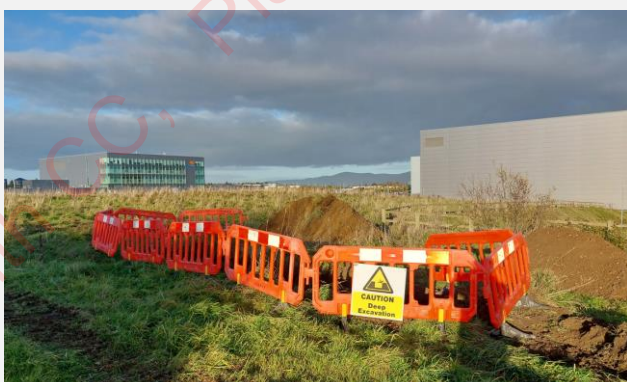
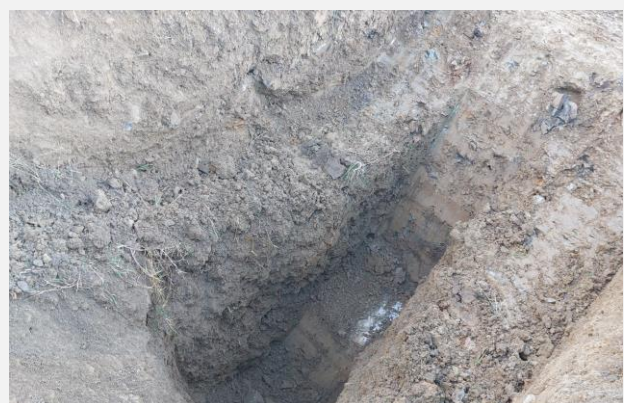
PROJECT	Wuxi Biologics WwPTP	CONTRACT NO	1011-000121
LOGGED BY	C ÓTuairisg	DATE	15/11/23
WEATHER CONDITIONS	Dry Bright Cold	CO-ORDINATES	704099.725, 803010.537
TRIAL PIT NO.	TP01	Sheet of

GL 23.056 mOD Brown Clay soil with blue shale angular small to medium boulders.

2.8 mBGL large boulder encountered, could move it slightly with the bucket and blue flakes of shale were broken off with the bucket.

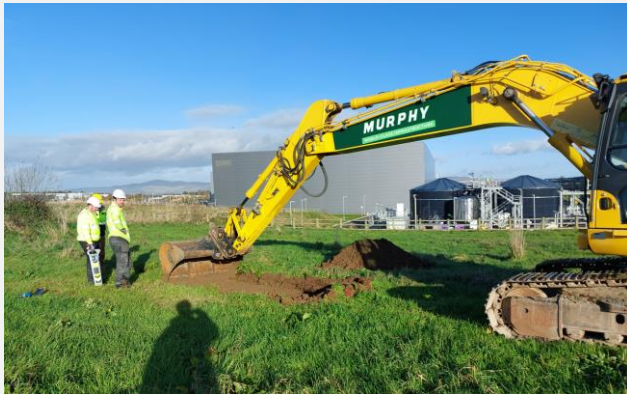
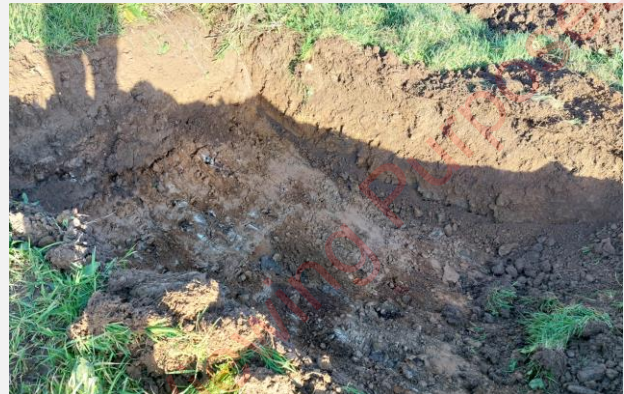
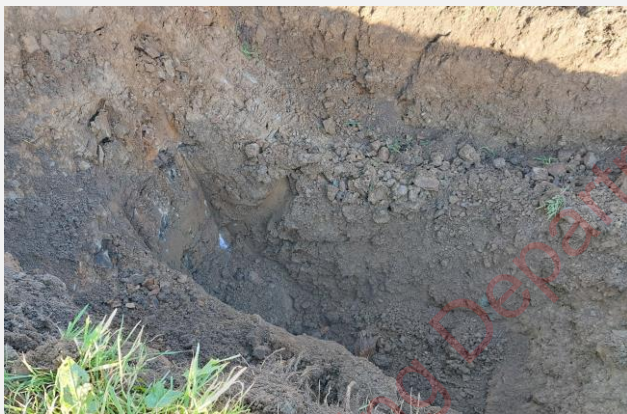
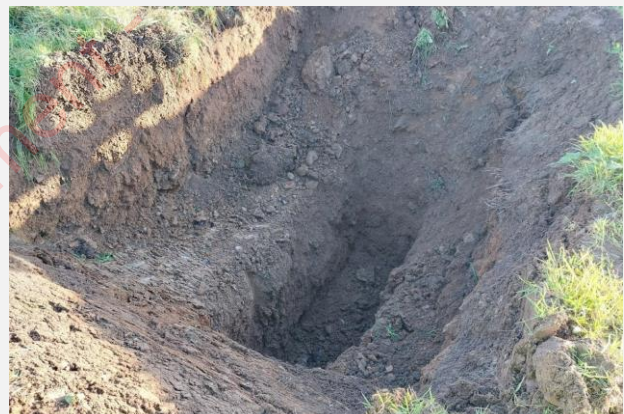
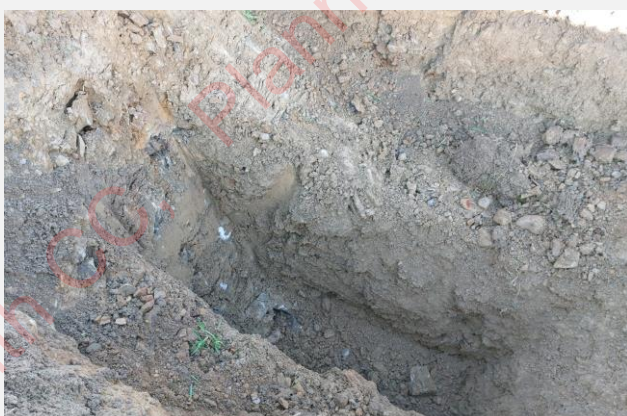
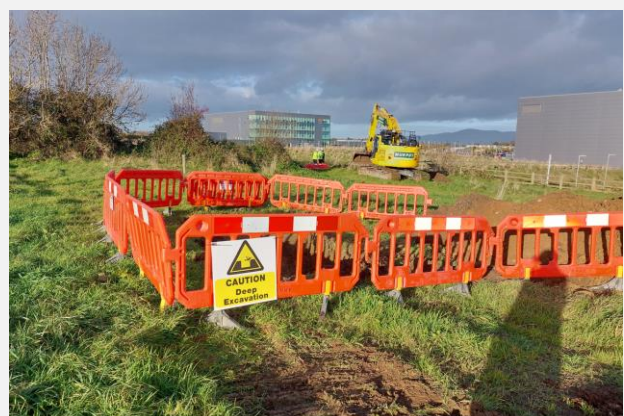
PROJECT	Wuxi Biologics WwPTP	CONTRACT NO	1011-000121
LOGGED BY	CÓTuairisg	DATE	15/11/23
WEATHER CONDITIONS	Dry Bright Cold	CO-ORDINATES	704090.235, 802979.212
TRIAL PIT NO.	TP02	Sheet of

Large Shale boulders encountered at 2.8m BGL so approx. 21.000 mOD. Angular rock that smokes and breaks easily when pulled with the machine bucket. Flakes of blue shale

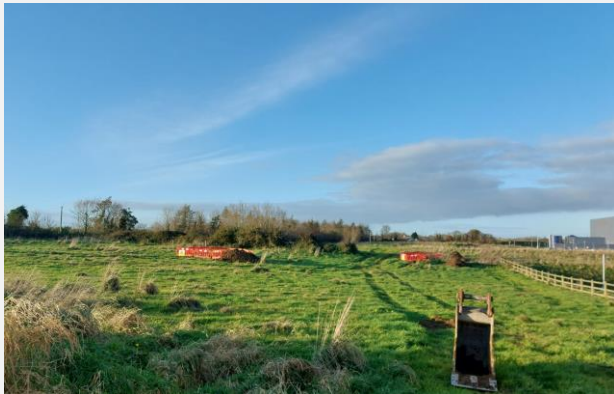
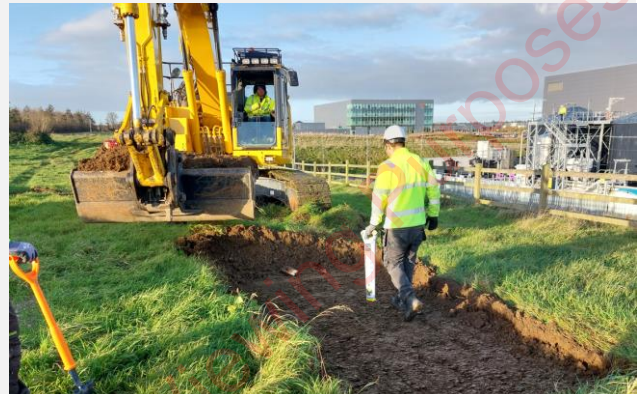
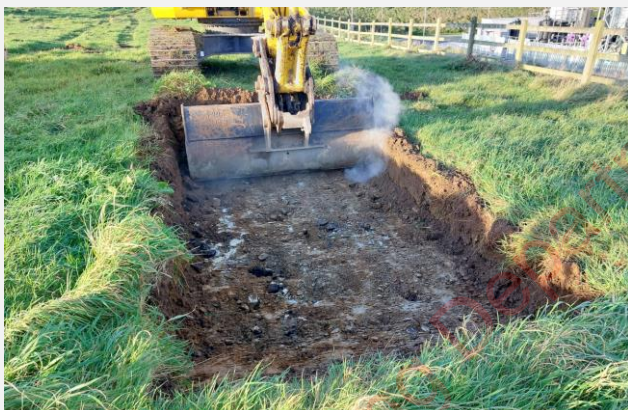
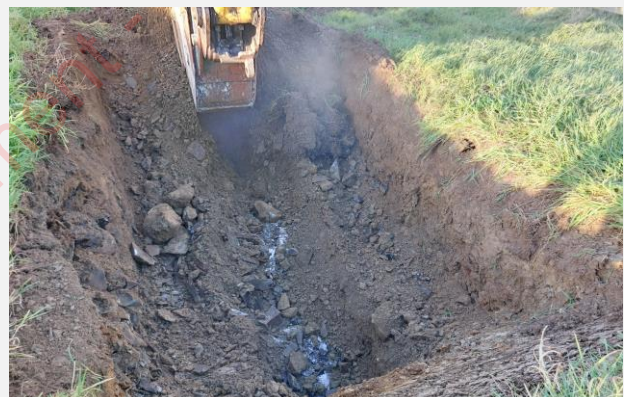
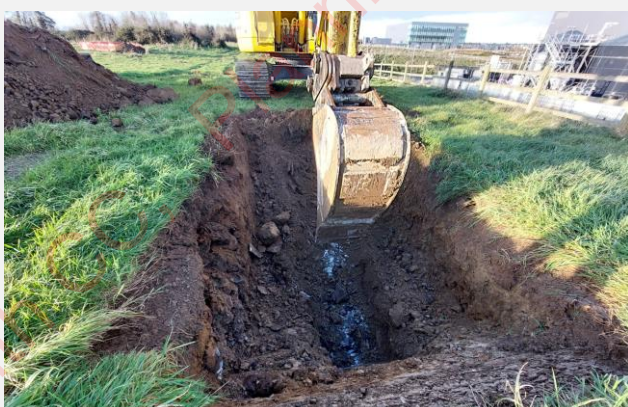
PROJECT	Wuxi Biologics WwPTP	CONTRACT NO	1011-000121
LOGGED BY	CÓTuairisg	DATE	15/11/23
WEATHER CONDITIONS	Dry Bright Cold	CO-ORDINATES	E: 704138.573 N: 802948.375
TRIAL PIT NO.	TP03	Sheet of

Shale bedrock encountered at 1.8m BGL so approx. 21.650 mOD. Angular rock that smokes and breaks when pulled with the machine bucket.

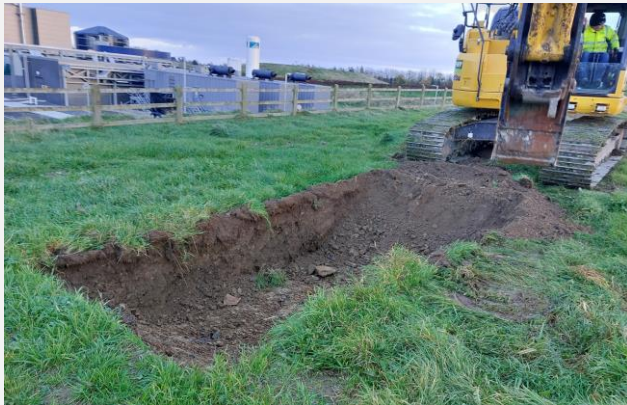
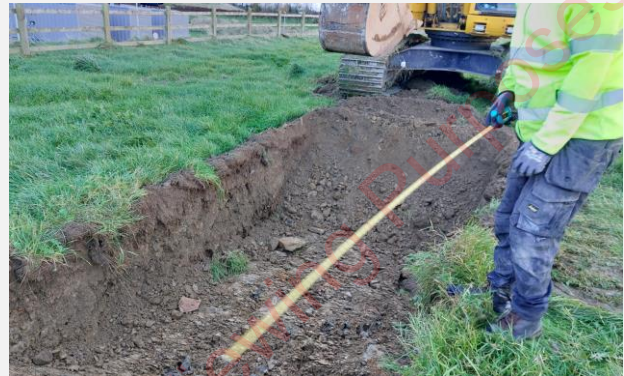
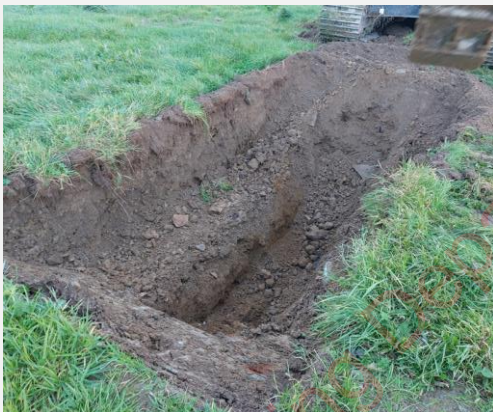
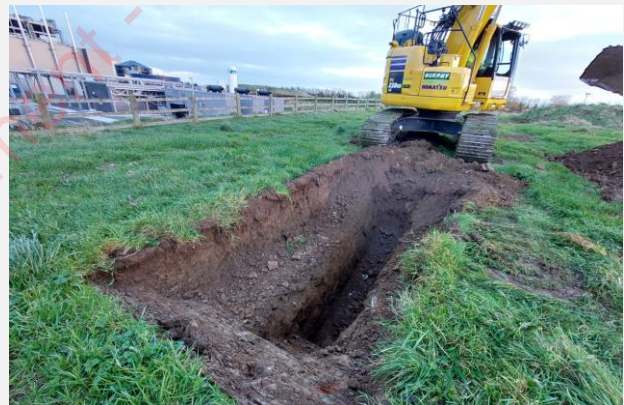
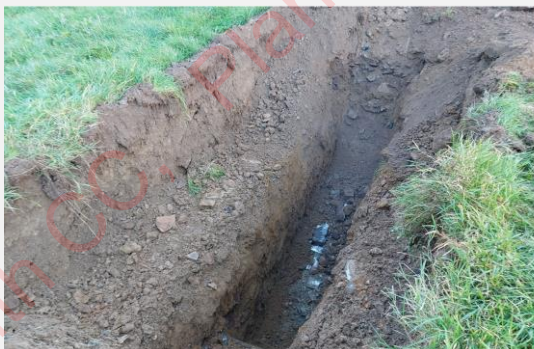
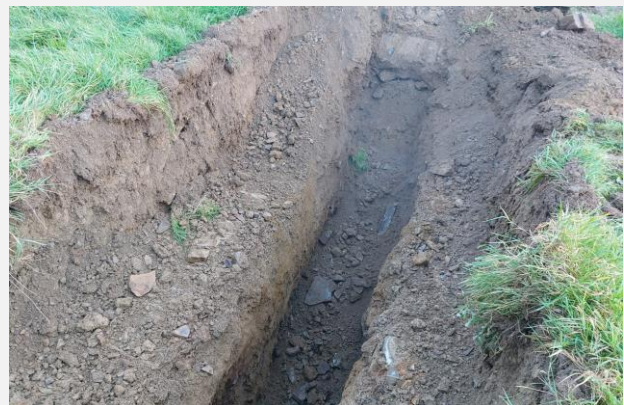
PROJECT	Wuxi Biologics WwPTP	CONTRACT NO	1011-000121
LOGGED BY	CÓTuairisg	DATE	15/11/23
WEATHER CONDITIONS	Dry Bright Cold	CO-ORDINATES	E: 704122.715 N: 802969
TRIAL PIT NO.	TP04	Sheet of

Shale Bedrock encountered at 2.9 mBGL so approx. 20.900 mOD. Bedrock slopes upward from north to south approx. 200mm 2.8m – 3.0m BGL

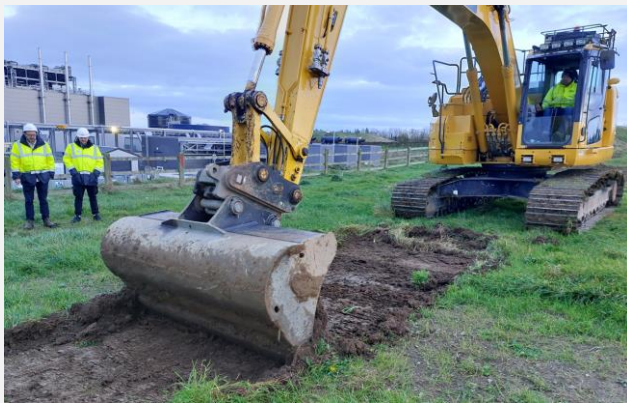
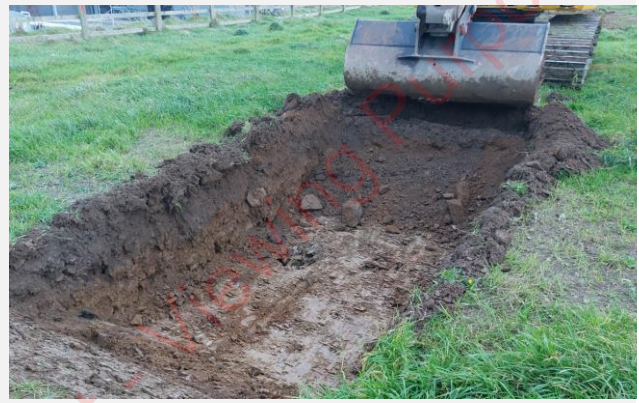
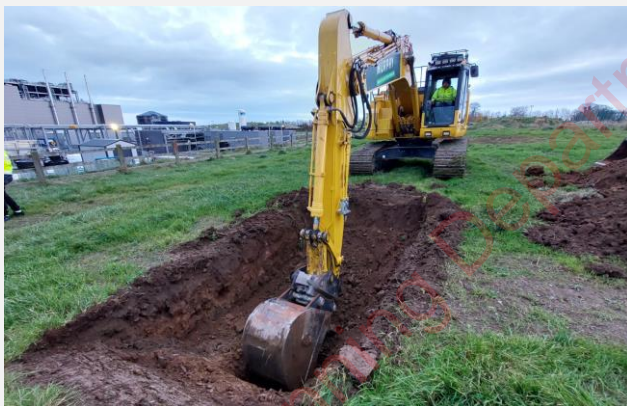
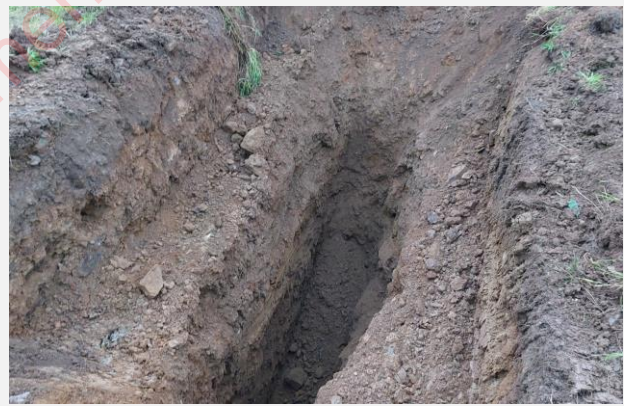
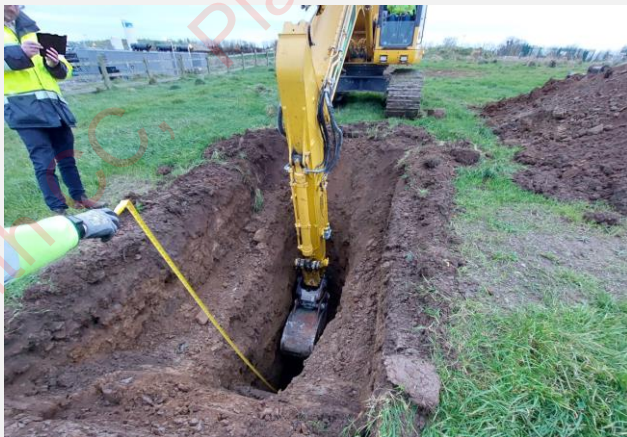
PROJECT	Wuxi Biologics WwPTP	CONTRACT NO	1011-000121
LOGGED BY	CÓTuairisg	DATE	15/11/23
WEATHER CONDITIONS	Dry Bright Cold	CO-ORDINATES	E: 704116.926 N: 802982.087
TRIAL PIT NO.	TP05	Sheet of

No Bedrock encountered at 4.3 mBGL so approx. 18.100 mOD. Medium brown clay soil with small to medium boulders.

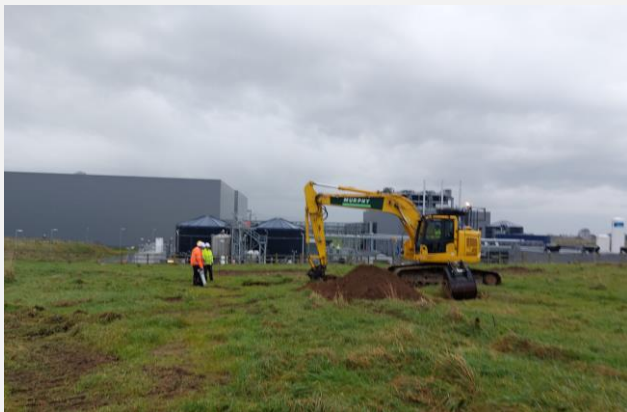
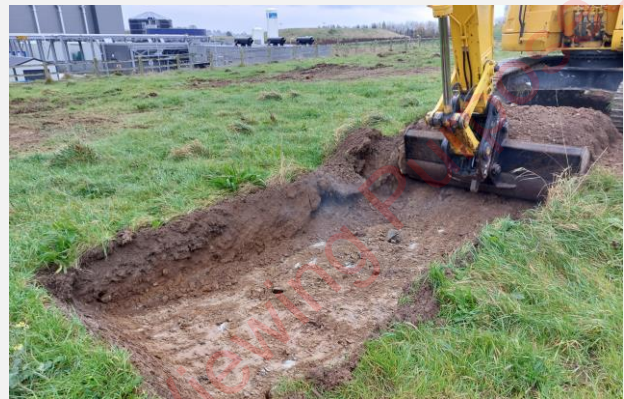
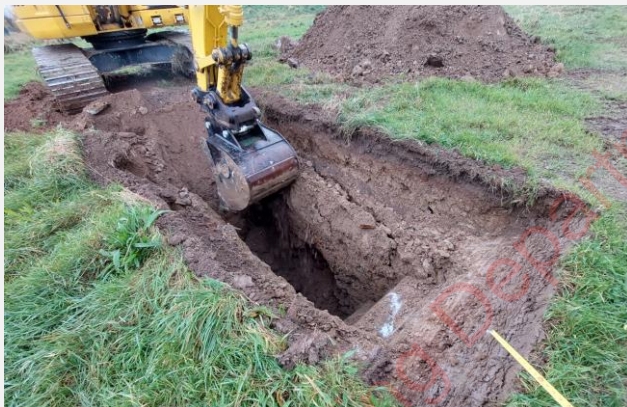
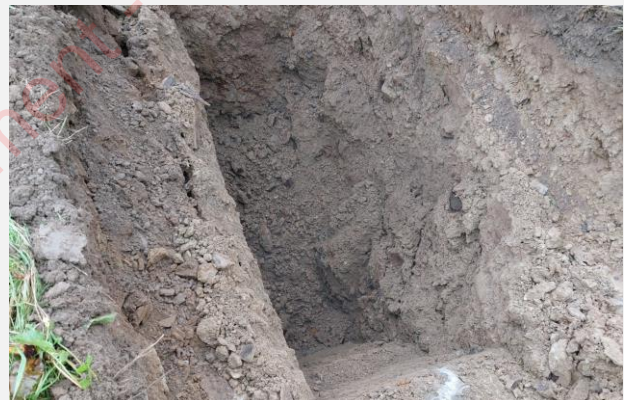
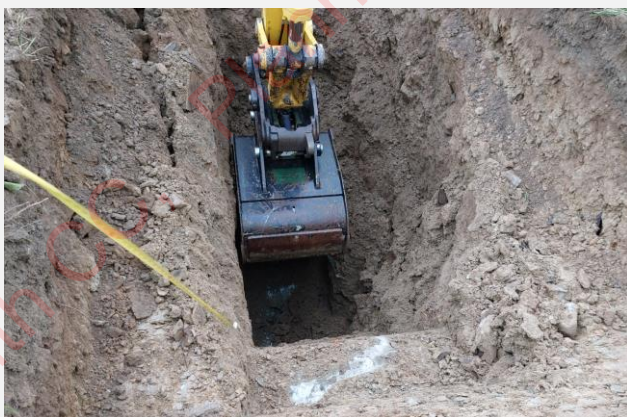
PROJECT	Wuxi Biologics WwPTP	CONTRACT NO	1011-000121
LOGGED BY	CÓTuairisg	DATE	16/11/23
WEATHER CONDITIONS	Overcast, Drizzly, Cold	CO-ORDINATES	E: 704105.905 N: 802968.803
TRIAL PIT NO.	TP06	Sheet of

Bedrock encountered at 3.8 mBGL so approx. 19.540 mOD. Medium brown clay soil with small to medium boulders.

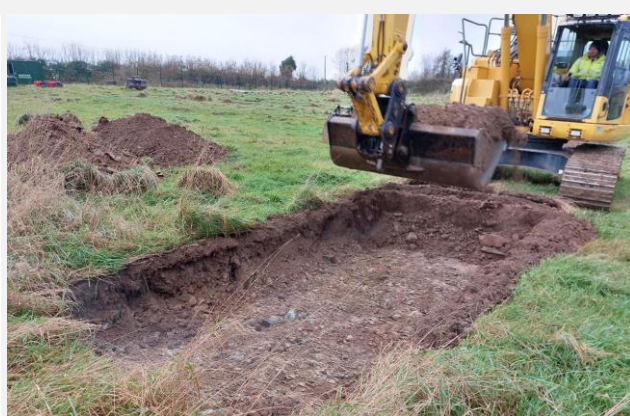
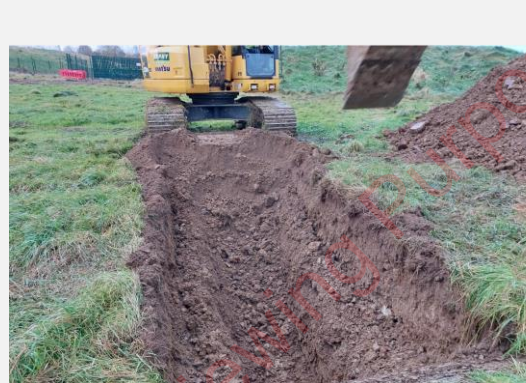
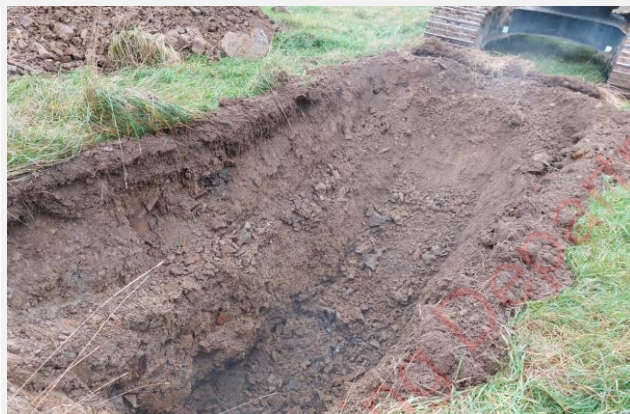
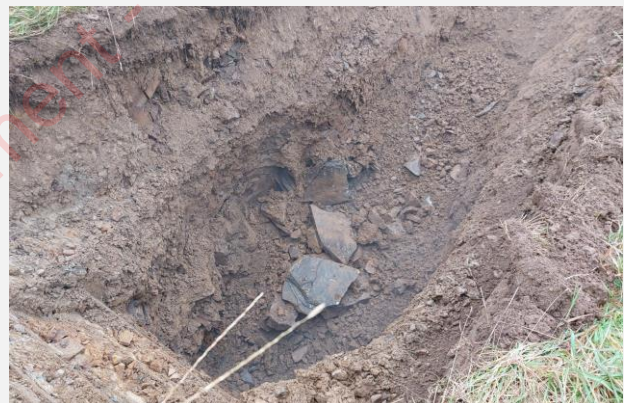
PROJECT	Wuxi Biologics WwPTP	CONTRACT NO	1011-000121
LOGGED BY	CÓTuairisg	DATE	16/11/23
WEATHER CONDITIONS	Overcast, Drizzly, Cold	CO-ORDINATES	E: 704117.495 N: 802951.309
TRIAL PIT NO.	TP07	Sheet of

Strata			
Depth from mBGL	Depth to mBGL	Description	In-Situ Testing (e.g. HSV, Resistivity)
		23.869 mOD	
0 – 0.8m		Dig with wide grading bucket – brown clay-soil	
0.8 m – 4.0 m		Continue with narrow bucket sloped bedrock from 3m to 4m BGL	
3.0m – 4.0m		Bedrock sloping upward north to south	
Avg 3.5m

Sloped Bedrock encountered at 3.0 – 4.0 mBGL so taking avg=erage of 3.5m, the bedrock is encountered at approx. 20.370 mOD. Medium brown clay soil with small to medium boulders.

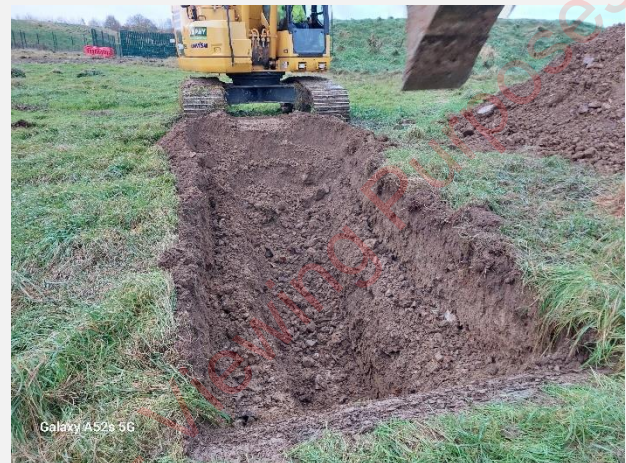
PROJECT	Wuxi Biologics WwPTP	CONTRACT NO	1011-000121
LOGGED BY	CÓTuairisg	DATE	16/11/23
WEATHER CONDITIONS	Overcast, Drizzly, Cold	CO-ORDINATES	E: 704090.162 N: 802956.603
TRIAL PIT NO.	TP08	Sheet of

Strata			
Depth from mBGL	Depth to mBGL	Description	In-Situ Testing (e.g. HSV, Resistivity)
		24.295 mOD	
0 – 01.0m		Dig with wide grading bucket – brown clay-soil	
1.0 m – 2.3 m		Continue with narrow bucket - bedrock at 2.3m BGL	
2.3m		Blue grey bedrock

Bedrock encountered at 2.3 mBGL , approx. 21.000 mOD. Blue grey Shale

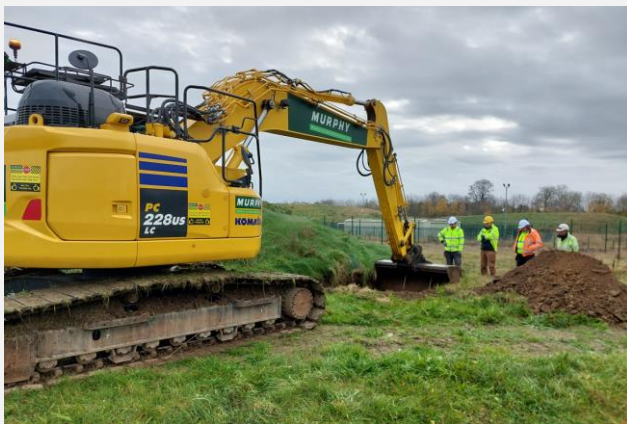
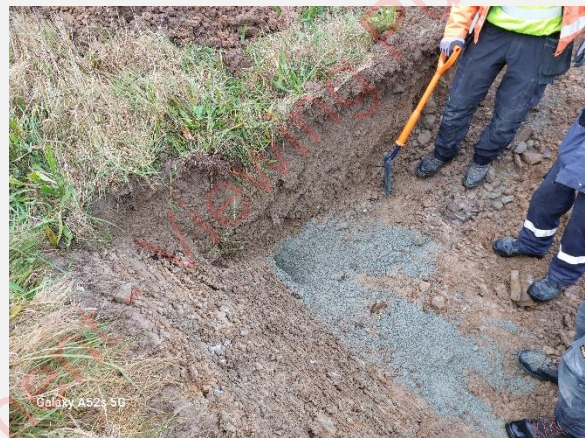
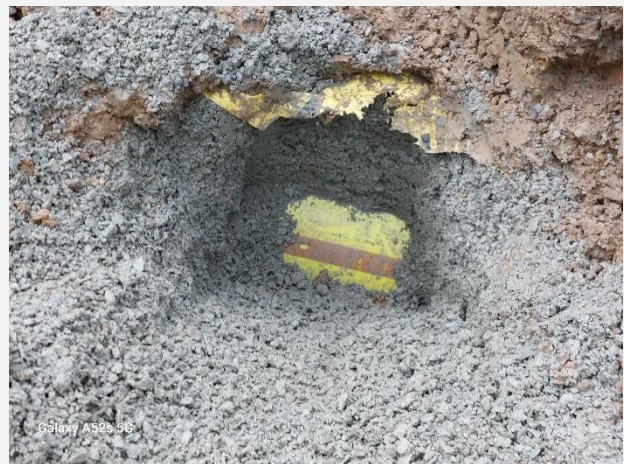
PROJECT	Wuxi Biologics WwPTP	CONTRACT NO	1011-000121
LOGGED BY	CÓTuairisg	DATE	16/11/23
WEATHER CONDITIONS	Overcast, Drizzly, Cold	CO-ORDINATES	E: 704078.886 N: 802924.843
ST01	ST01	Sheet of

Strata				
Depth from mBGL	Depth to mBGL	Description	In-Situ Testing (e.g. HSV, Resistivity)	
		25.356 mOD		
0 – 0.8m		Dig with wide grading bucket – brown clay-soil		
0.8 m – 1.3 m		We encountered grey grit, typical of gas pipe surround material – hand dig with insulated spade		
1.3m		We encountered PE Gas distribution main, with warning tape (yellow brown striped main 315mm Dia according to Brendan, the GNI inspector		
		Top of pipe 24.068 mOD – Approx 1.3m below ground level		
Groundwater (Depth & Flow Rate)	Stability / Shoring	Dimensions	Plant	Ground Level

All excavations on gas mains observed by Wuxi Archaeologist and GNI inspector. 315mm Dia PE Gas distribution mains encountered at 1.3 mBGL, approx. 24.068 mOD. Pipe surround is grey grit and yellow Gas main warning tape in place. Location is approx. 2.2m southwest of drawing supplied by GNI

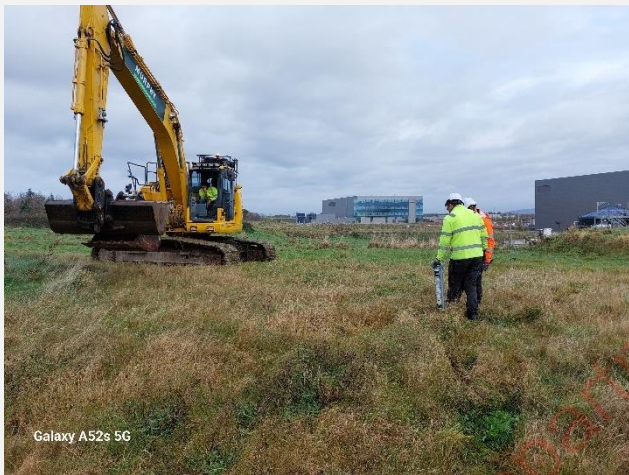
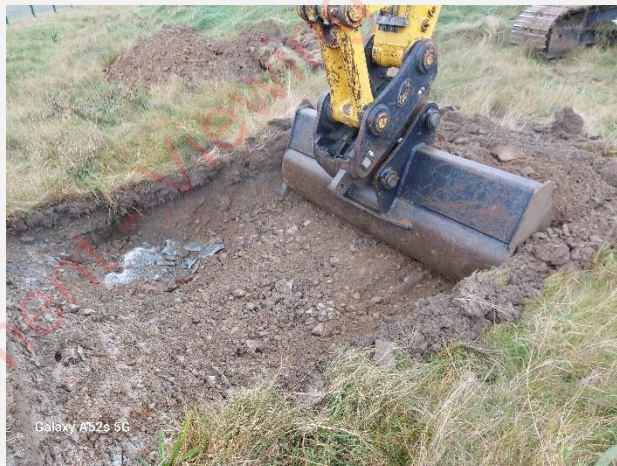
PROJECT	Wuxi Biologics WwPTP	CONTRACT NO	1011-000121
LOGGED BY	CÓTuairisg	DATE	16/11/23
WEATHER CONDITIONS	Overcast, Drizzly, Cold	CO-ORDINATES	E: 704117.921 N: 802930.307 E: 704118.729 N: 802926.107
ST01	ST02-ST03	Sheet of

Strata				
Depth from mBGL	Depth to mBGL	Description	In-Situ Testing (e.g. HSV, Resistivity)	
		ST02 (24.337 mOD) ST03 (24.304)		
0 – 0.5m		ST02 Dig with wide grading bucket – brown clay-soil- Large Boulders encountered, change location as Gas main unlikely to be backfilled with large boulders over it.		
0 – 0.3m		ST03 We moved closer to AGI for a second slit trench. We encountered grey grit, typical of gas pipe surround material – hand dig with insulated spade		
0.3m – 1.0m		We encountered PE Gas distribution main, with warning tape (yellow brown striped main 315mm Dia according to Brendan, the GNI inspector		
		Top of pipe 23.420 mOD – Approx 0.9m below ground level		
Groundwater (Depth & Flow Rate)	Stability / Shoring	Dimensions	Plant	Ground Level

All excavations on gas mains observed by Wuxi Archaeologist and GNI inspector. 315mm Dia PE Gas distribution mains encountered at 0.9 mBGL, approx. 23.4 mOD. Pipe surround is grey grit and yellow Gas main warning tape in place. Location is approx. 3m closer to AGI (south of drawing supplied by GNI)

This PE gas main has a capped end and a 60mm Dia test arm and top hat T piece as shown in the photos. This main does NOT branch into the AGI skid as indicated on the drawing provided by GNI, it terminates near the pedestrian gate to the AGI skid.

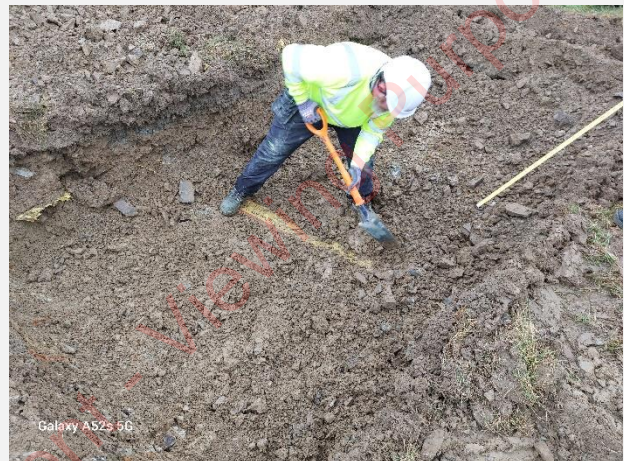
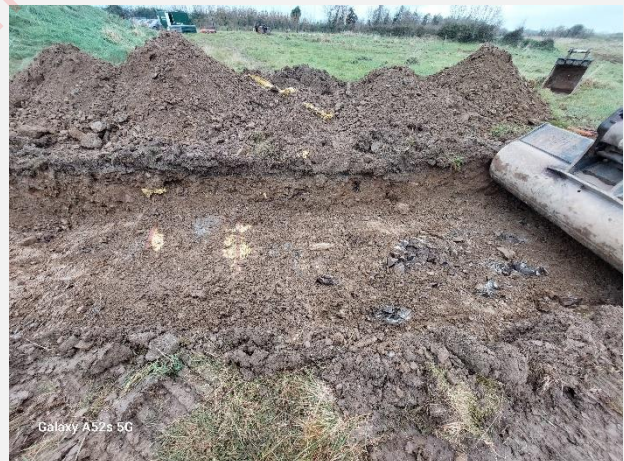
PROJECT	Wuxi Biologics WwPTP	CONTRACT NO	1011-000121
LOGGED BY	CÓTuairisg	DATE	16/11/23
WEATHER CONDITIONS	Overcast, Drizzly, Cold	CO-ORDINATES	E: 704116.758 N: 802934.249
ST01	ST04	Sheet of

Strata				
Depth from mBGL	Depth to mBGL	Description	In-Situ Testing (e.g. HSV, Resistivity)	
		24.281 mOD		
0 – 0.75m		ST04 Dig with wide grading bucket – brown clay-soil- No gravel/grit/dust encountered		
0.75 m		CAT used to trace likely ESB services		
0.75m		We encountered ESB tile board (brown plastic board with yellow warning top		
		Top of tile board 23.6 mOD Approx Leanmix underneath. Didn't excavate further.		
Groundwater (Depth & Flow Rate)	Stability / Shoring	Dimensions	Plant	Ground Level

All excavations on ESB Cables observed by Wuxi Archaeologist. Atkins/Wuxi directed that we contact ESB networks before we commence excavating near cables to log onto their system and give a contact no.. This is done again at the end of the shift to log off. ESB cables traced with CAT on power mode with audible tone and shrill alarm and when near and directly above the cables.

We traced 2 separate signals and found 2 distinct lines of ESB warning tile board running NW to SE in ST04. Note that these are approx. 11m further west than indicated on the ESB service drawings and we only found evidence of 2 cables, not 3.

Leanmix concrete under the warning tile board. Good practise would have the tile board located 300mm above the ducts, and this was confirmed by the CAT. We can therefore assume the ESB ducts are approximately **23.300 mOD**

New cable warning tape placed over the tile board approx. 0.5m below surface when backfilling the trench

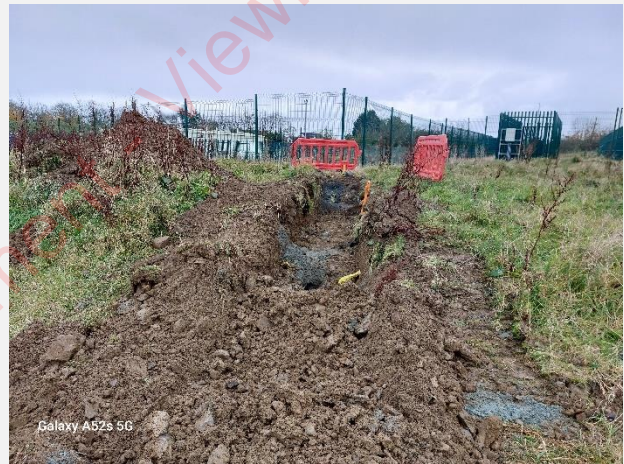
PROJECT	Wuxi Biologics WwPTP	CONTRACT NO	1011-000121
LOGGED BY	CÓTúairisg	DATE	16/11/23
WEATHER CONDITIONS	Overcast, Drizzly, Cold	CO-ORDINATES	E: 704141.982 N: 802921.817
ST01	ST05	Sheet of

Strata				
Depth from mBGL	Depth to mBGL	Description	In-Situ Testing (e.g. HSV, Resistivity)	
		24.110 mOD		
0 – 0.55m		ST05 is a long trench Dig with wide grading bucket – brown clay-soil- No gravel/grit/dust encountered		
0.55 m		CAT used to trace likely ESB services near fence corner. Grey gravel material and ESB tileboard encountered at 23.660 mOD, approx. 0.5m below the ground. 2 distinct signals heard.		
0.6m – 1.0m		We encountered gas warning tape (Gas Main Below) approx. 6m east along the trench from the ESB services. Yellow PE gas main approx. 1m BGL		
0.9m		Red 4" corrugated duct for CCTV, as advised by WuXi rep. Yellow mesh warning tape 200mm above duct.		
Groundwater (Depth & Flow Rate)	Stability / Shoring	Dimensions	Plant	Ground Level

We traced 2 separate signals and found ESB warning tile board near the corner of the palisade fence of Haynestown AGI. Note that these are approx. 9 m further west than indicated on the ESB service drawings and we only found evidence of 2 cables, not 3. We didn't uncover the tile board of the second ESB service as it is running quite close to the fence and excavating nearer to the fence may have undermined the concrete post foundations. The CAT gave a very strong signal to confirm the location of the cable.

Leanmix concrete found under the warning tile board. Good practise would have the tile board located 300mm above the ducts, and this was confirmed by the CAT. We can therefore assume the ESB ducts are approximately **23.350 mOD**

We continued north with ST05, as we wanted to find the gas feed to WuXi plant from the AGI skid, We encountered a 315 yellow PE main but it was orientated 90° to what we expected. **23.133mOD** approx. 900mm below ground level. Warning tape and grey grit surrounded the PE gas main.

We also found additional mesh barrier tape and a red 4" corrugated duct which is the CCTV feed from the plant to the AGI. This terminates in a chamber near the pedestrian gate of the AGI skid. **22.490mOD** approx. 850mm below ground level.

New cable warning tape placed over the tile board approx. 0.5m below surface when backfilling the trench

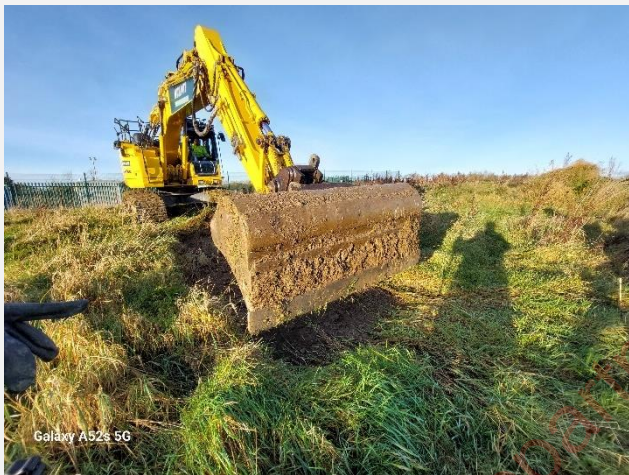
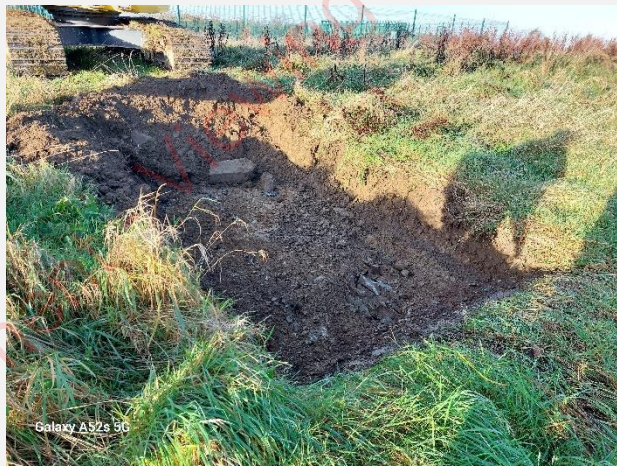
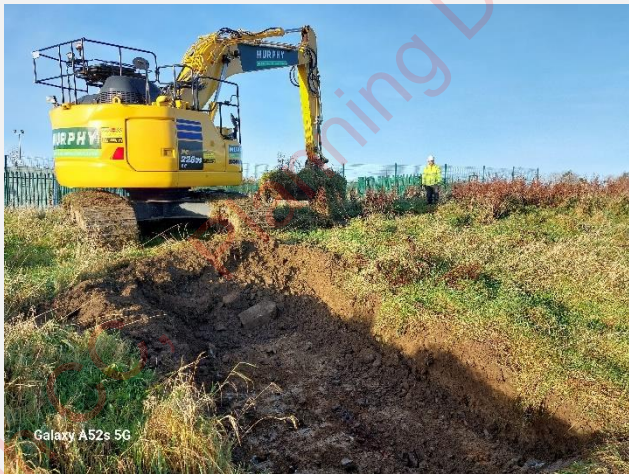
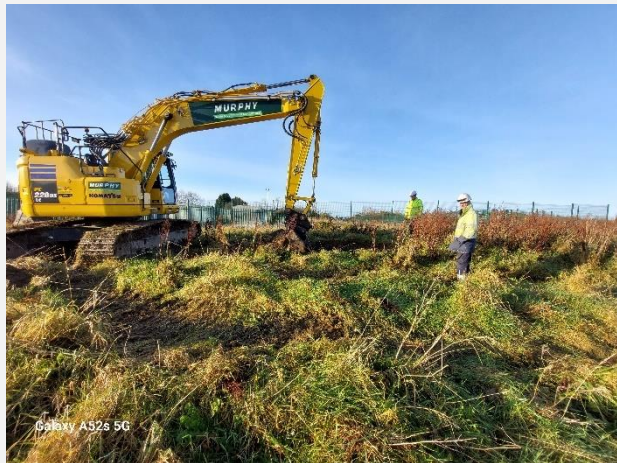
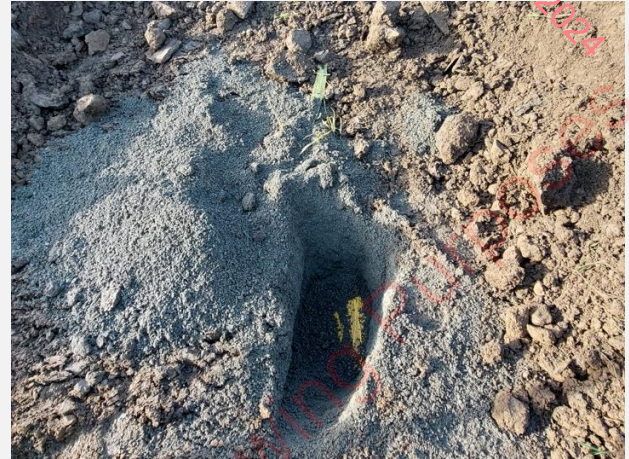
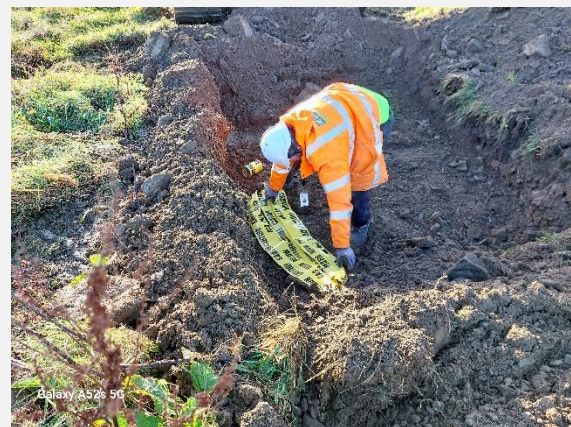
PROJECT	Wuxi Biologics WwPTP	CONTRACT NO	1011-000121
LOGGED BY	CÓTuairisg	DATE	17/11/23
WEATHER CONDITIONS	Overcast, Drizzly, Cold	CO-ORDINATES	E: 704056.009 N: 802963.304
ST01	ST06	Sheet of

Strata				
Depth from mBGL	Depth to mBGL	Description	In-Situ Testing (e.g. HSV, Resistivity)	
		23.400 mOD		
0 – 0.6m		Dig with wide grading bucket – brown clay-soil- no grey grit and yellow warning tape encountered. Move closer to the boundary fence		
0 - 0.6 m		We encountered gas warning tape (Gas Main Below) and grey grit. Dig by hand to uncover yellow PE gas main approx. 1.2m BGL		
0 - 0.6		We moved towrd the AGI to find the 90° bend. We encountered gas warning tape (Gas Main Below) approx. halfway between the fences. 90 collar found.		
1.2m		Yellow PE gas main (suspect 315mm Dia as we found an offcut piece) approx. 1.2m BGL at 22.461m OD		
Groundwater (Depth & Flow Rate)	Stability / Shoring	Dimensions	Plant	Ground Level

ST06 All excavations on ESB Cables observed by Wuxi Archaeologist and GNI inspector

The gas supply main was found in 2 spots in this trench, approx. 1.2m BGL. We found the yellow straight part and the black 90° fusion collar

Grey grit and warning tape were found and new warning tape installed during backfill.

New cable warning tape placed over the tile board approx. 0.5m below surface when backfilling the trench

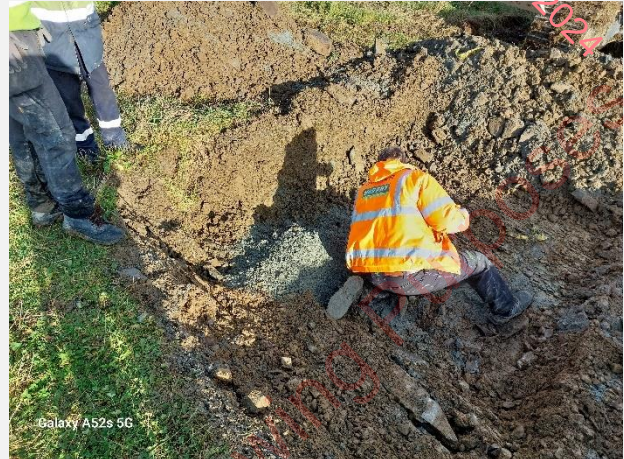
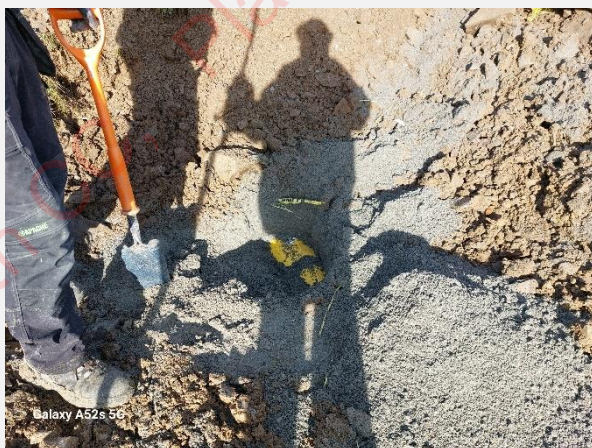
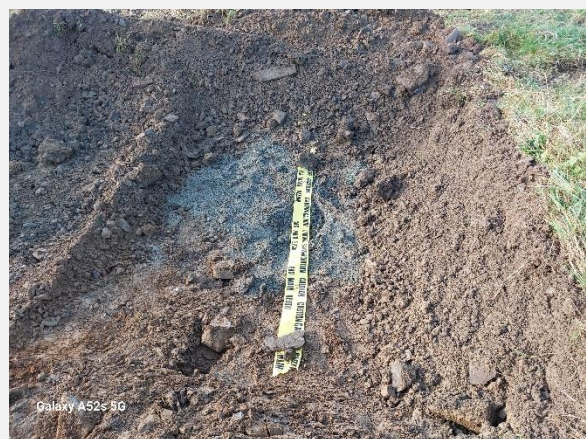
PROJECT	Wuxi Biologics WwPTP	CONTRACT NO	1011-000121
LOGGED BY	CÓTuairisg	DATE	17/11/23
WEATHER CONDITIONS	Overcast, Drizzly, Cold	CO-ORDINATES	E: 704138.613 N: 802935.597
ST01	ST07	Sheet of

Strata				
Depth from mBGL	Depth to mBGL	Description	In-Situ Testing (e.g. HSV, Resistivity)	
		23.970 mOD		
0 – 0.55m		Dig with wide grading bucket – brown clay-soil- no grey grit and yellow warning tape encountered. Move closer to the boundary fence		
0 - 0.6 m		We encountered gas warning tape (Gas Main Below) and grey grit. Dig by hand to uncover yellow PE gas main approx. 1.2m BGL		
0 - 0.6		We moved towrd the AGI to find the 90° bend. We encountered gas warning tape (Gas Main Below) approx. halfway between the fences. 90 collar found.		
1.2m		Yellow PE gas main (suspect 315mm Dia as we found an offcut piece) approx. 1.2m BGL at 22.461m OD		
Groundwater (Depth & Flow Rate)	Stability / Shoring	Dimensions	Plant	Ground Level

The gas supply main was found in 2 spots in this trench, approx. 0.75 BGL. We found the yellow straight part and the yellow 90° swept fusion bend at 23.211 mOD

We can now be confident of the route and level of the PE gas main that feeds the Wuxi plant from the AGI skid

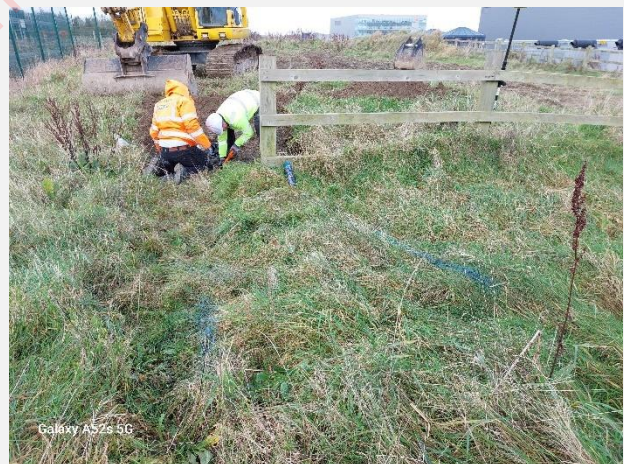
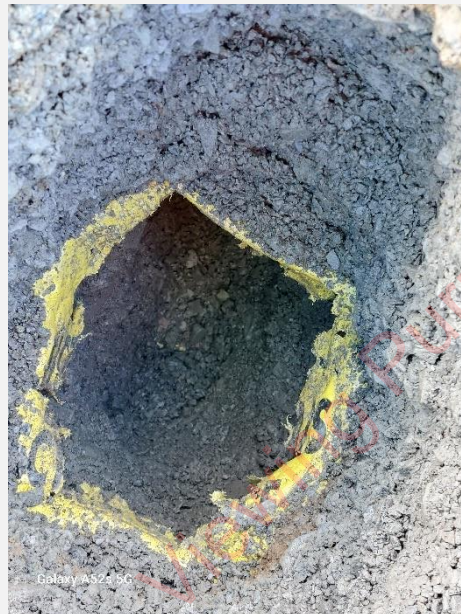
PROJECT	Wuxi Biologics WwPTP	CONTRACT NO	1011-000121
LOGGED BY	CÓTuairisg	DATE	20/11/23
WEATHER CONDITIONS	Overcast, Drizzly, Cold	CO-ORDINATES	E: 704156.311 N: 802893.093
ST01	ST09	Sheet of

Strata				
Depth from mBGL	Depth to mBGL	Description	In-Situ Testing (e.g. HSV, Resistivity)	
		22.953 mOD		
0 – 0.3m		Trace Cables from substation with CAT, Medium brown clay soil with small boulders		
0.3 m		Leanmix material, loose and gravelly		
0.3 - 0.5m		Grey gravelly material, warning tape encountered.		
0.75m		ESB warning tile found beneath warning tape		
Groundwater (Depth & Flow Rate)	Stability / Shoring	Dimensions	Plant	Ground Level

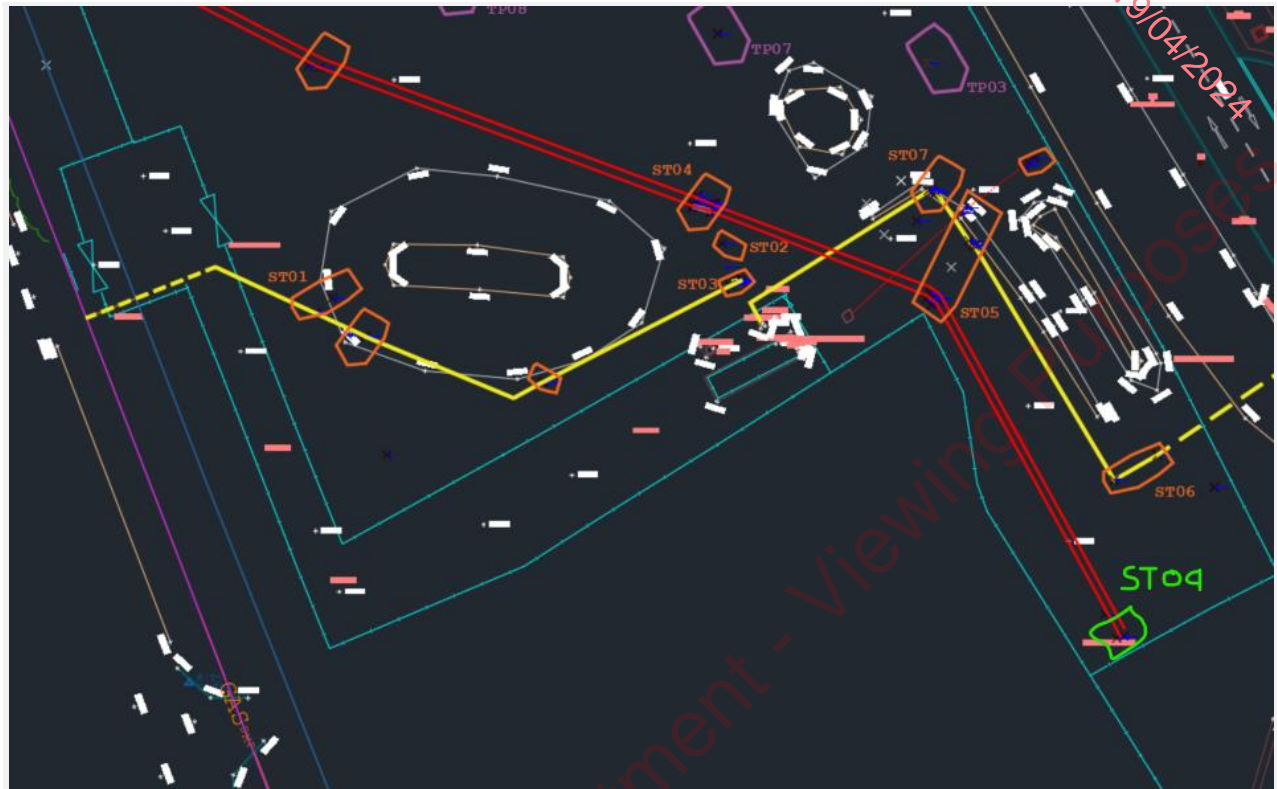
ESB tile warning board encountered 750mm BGL

Assume if ESB ducts are 300mm below leanmix (good practice), they are approx. 24.700m OD

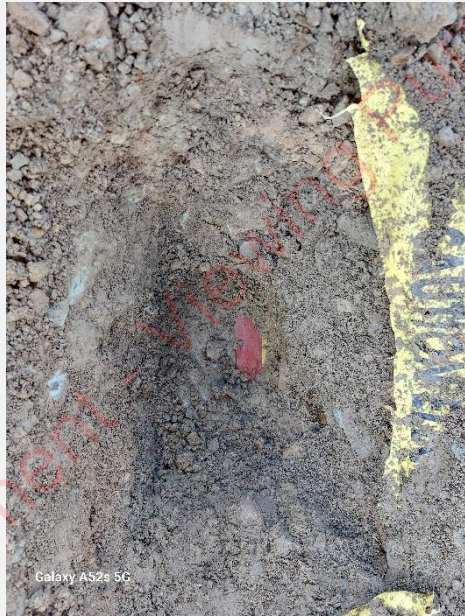
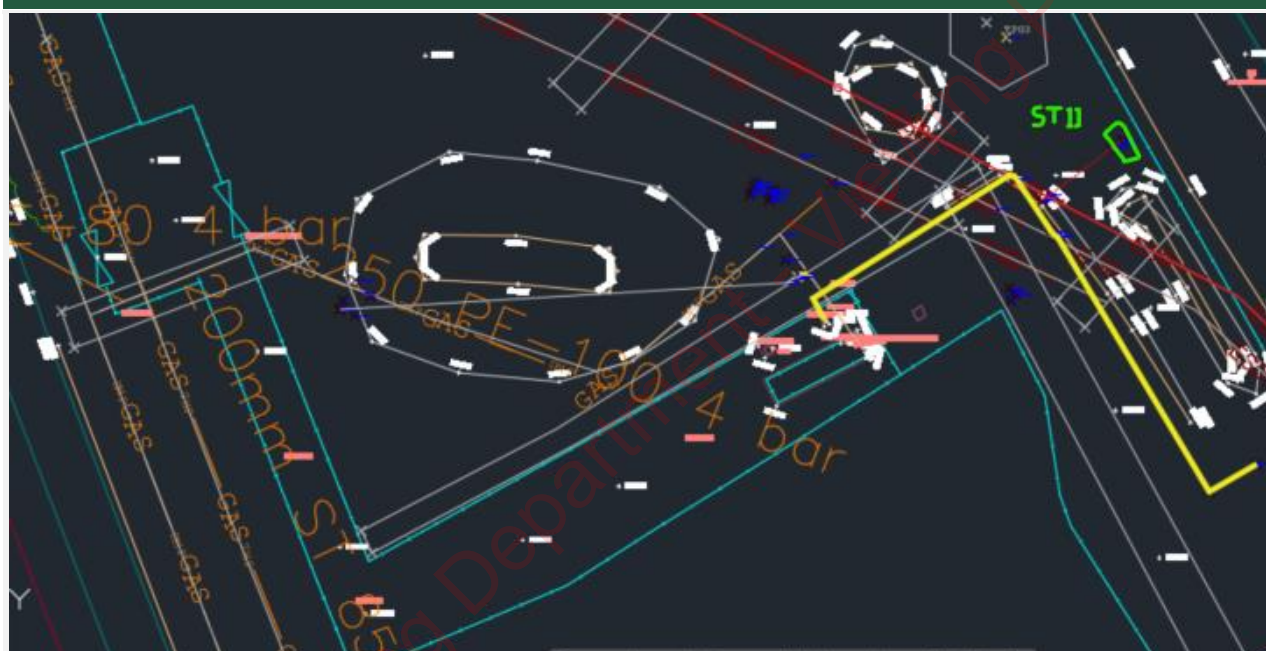
Duct uncovered 900mm BGL it is approx. 22.490 m OD

We traced it to a concrete chamber outside the AGI pedestrian access gate.
