Appendix 10. Land, Soils and Geology

**10.1 Wuxi Biologics WwPTP Site
Investigation Report' (Murphy Group, 2023)**

CLIENT	Wuxi Biologics
CONTRACT TITLE	Wuxi Biologics Wastewater Pre-Treatment Plant
CONTRACT NUMBER	1011-000121
OPERATING UNIT	M6

Wuxi Biologics WwPTP Site Investigation Report

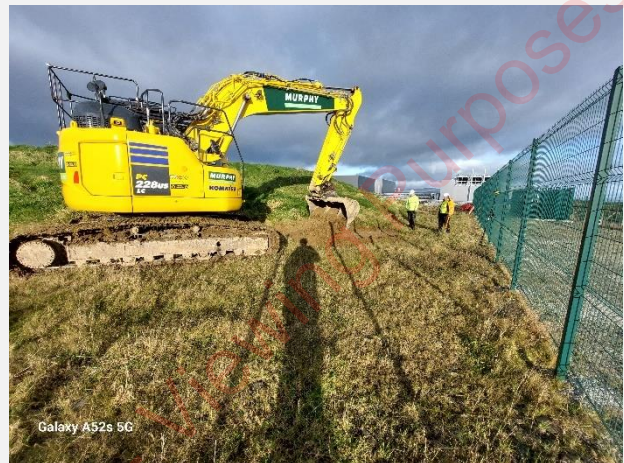
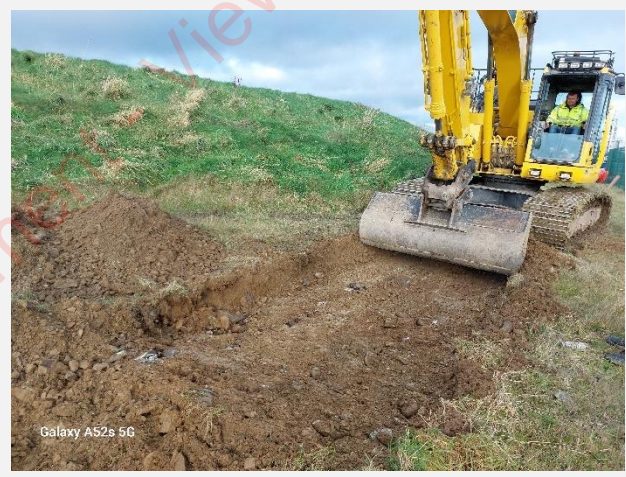
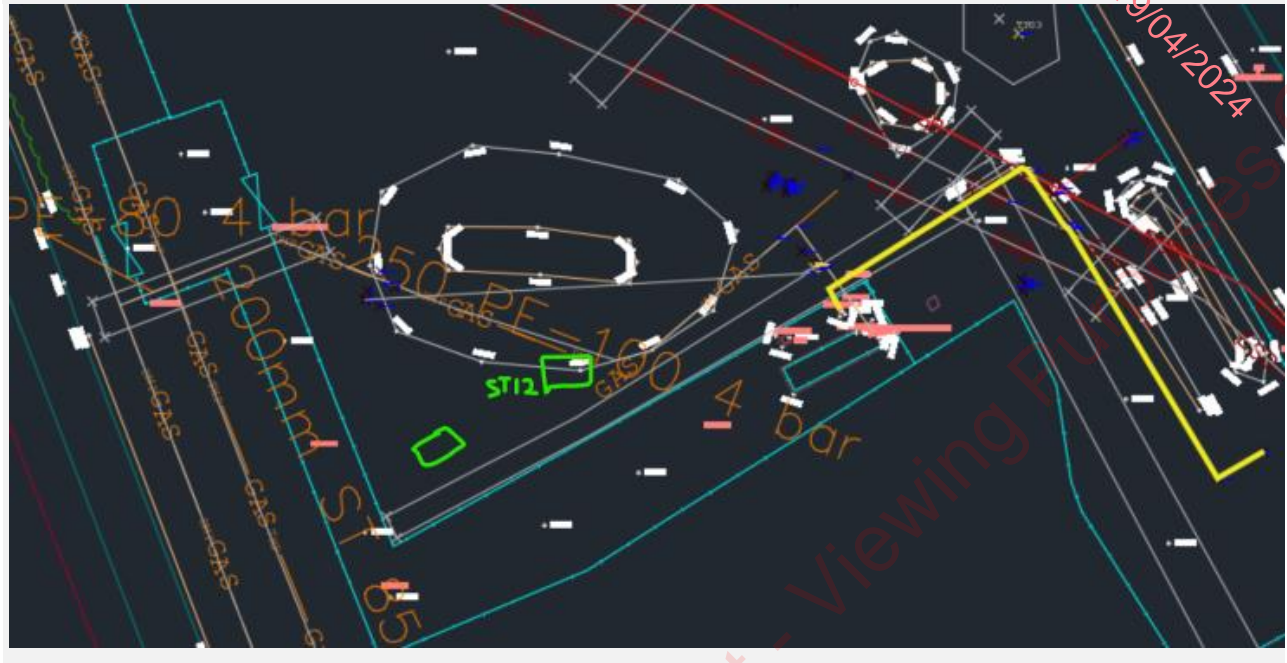
Gas main (315mm Dia) brown and yellow pipe installed by GNI

pipe uncovered 950mm BGL it is approx. 23.360 m OD

Second location further west excavated to find the bend, but large boulders near the surface confirmed not in this location.

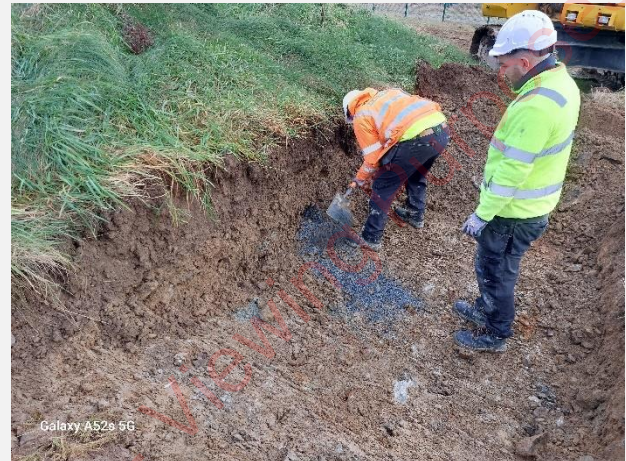
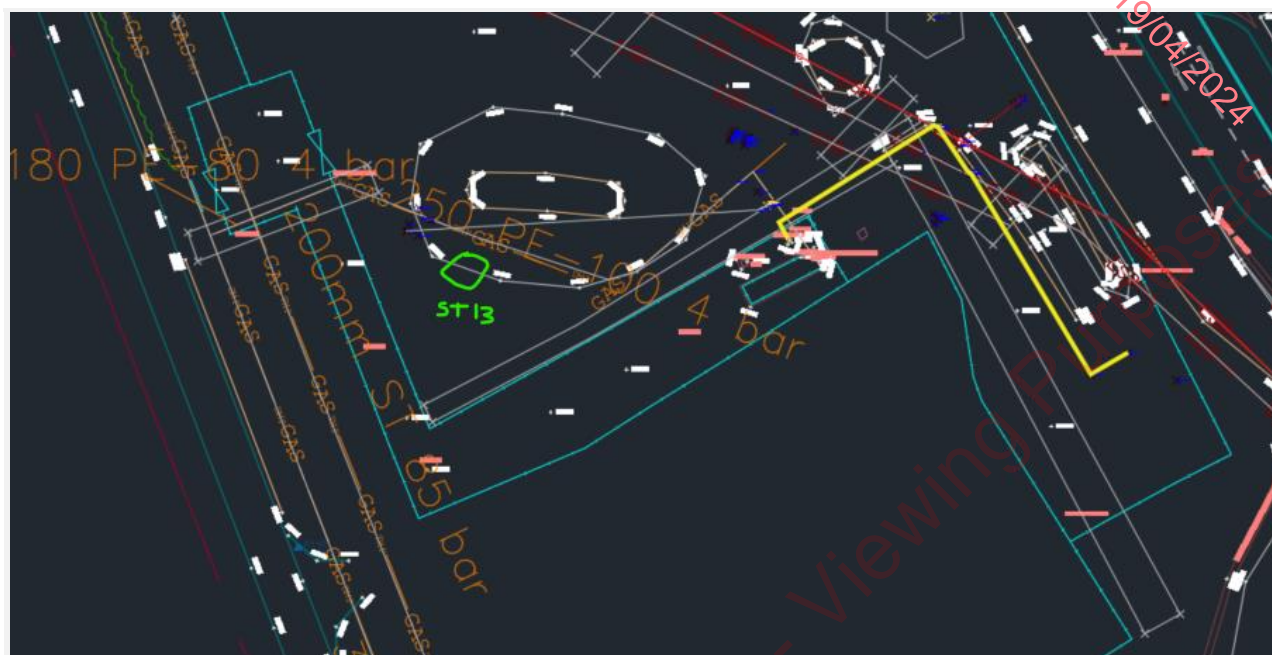
Gas main (315mm Dia) brown and yellow pipe installed by GNI

pipe uncovered 550mm BGL it is approx. 24.010 m OD

Pipe very shallow in this location. But ground rises in a small hill just above it.
